Investigation of the neutral voltage in an unearthed network

Causes, effect and mitigation

Department of Energy and Environment
Division of Electrical Power Engineering
CHALMERS UNIVERSITY OF TECHNOLOGY
Göteborg, Sweden 2007

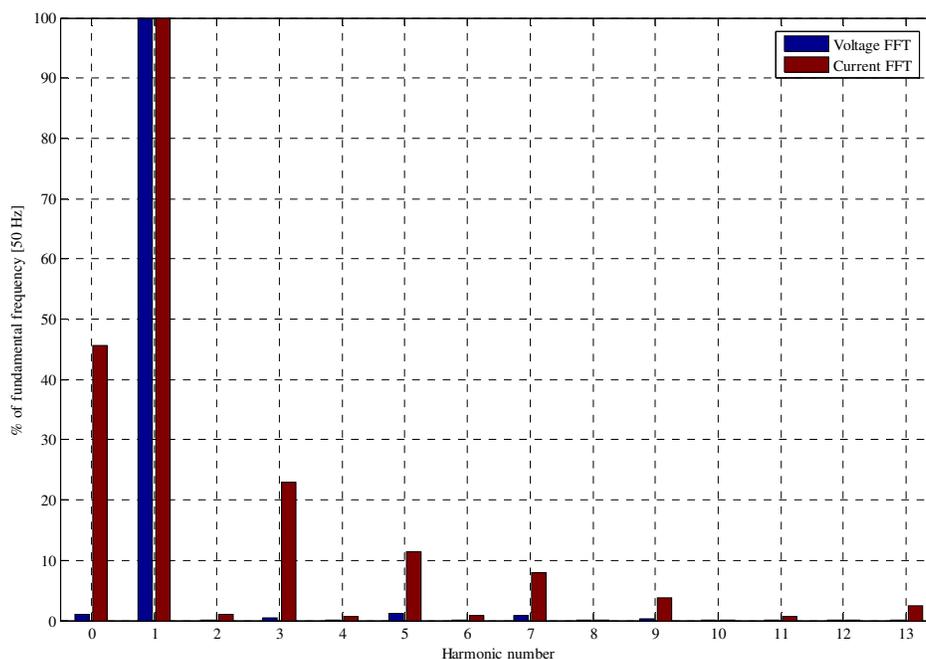
Figure 4.1: FFT of the phase A voltage and earth current.

As can be seen in Figure 4.1, the current is highly distorted while the voltage is rather smooth and fine. It has around 25% third harmonic in the current and is decreasing linearly with increasing harmonic number, which is exactly the appearance of a single phase rectifier with a voltage stiff dc-link. The reason for this behaviour is that the time relay used to trip the alarm is a dc relay with a standard voltage stiff ac-dc converter [6]. It can therefore be concluded that the current distortions in the earth current is a product of the equipment used to monitor the neutral voltage and not any outside source.

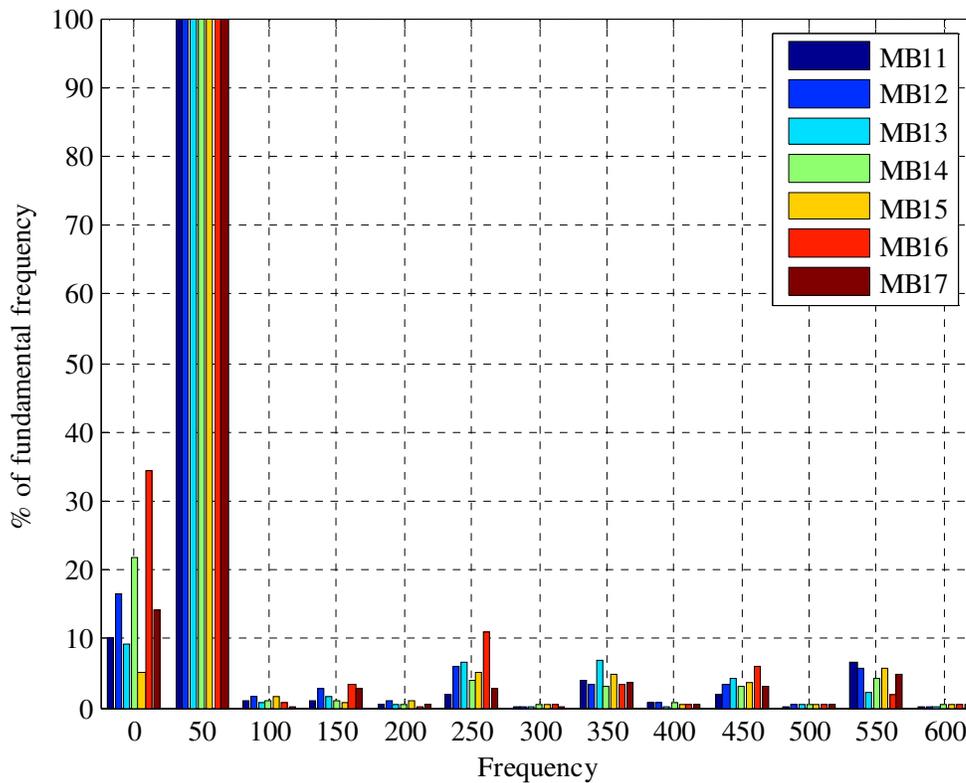
Figure 4.2: FFT for leakage currents in sub B

The Figure 4.2 shows that the leakage currents have very little harmonic content with a multiple of three. Therefore it can be concluded that the neutral voltage likely isn't created by harmonics, especially since it does not contain any large harmonics at all, only fundamental frequency.

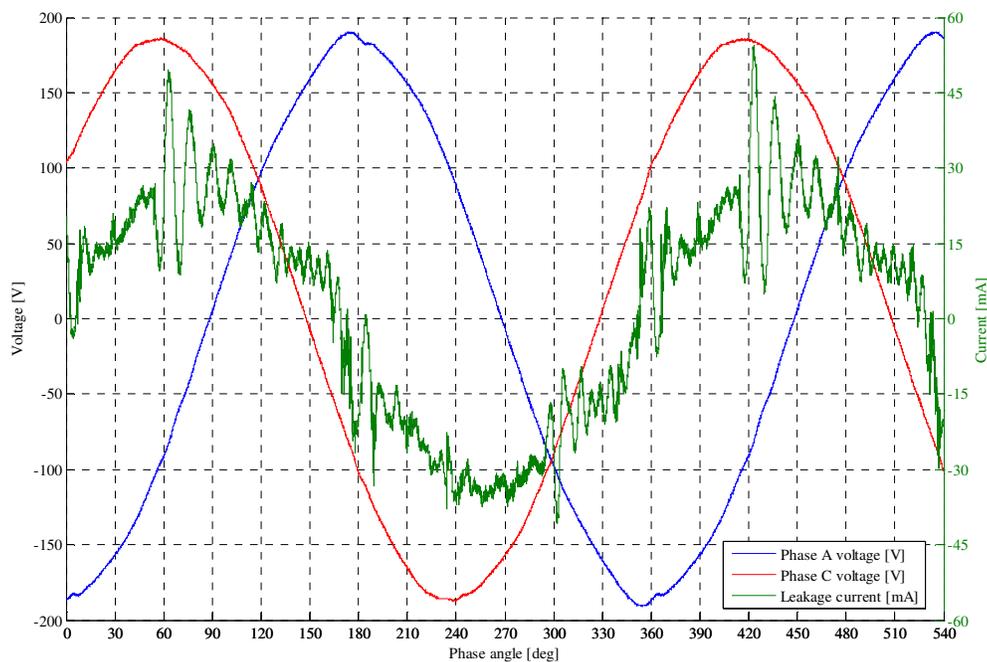
Figure 4.5: Leakage current for output MB13

It is seen from this figure that the leakage current is either 30 degrees after Phase C or 90 degrees before Phase A. There is clear waveform distortion in the voltage at the same phase angles as the leakage current has its resonance phenomenon compared to phase C which is relatively distortion free. Combined with the 90 degrees phase lead it is likely that this current is created by capacitive current from phase A to ground.

Where the voltage swing comes from is difficult to determine, but a reasonable guess is that the UPS is creating these swings as a by-product of its switching operation. It may also be caused by large loads that are connected to the parent system, especially with loads as thyristor bridge rectifiers which draws an extremely non-linear current. Other plausible culprits are diode bridge rectifiers with voltage stiff dc-link, and although the phase angle is quite high for single phase loads, for this system that is connected line to line the distortions

During the measurement process a strange ringing phenomena was detected in the leakage current. The current had a superimposed 1800 Hz sinusoidal signal at specific phase angles of the voltage. An example of the phenomena is visible in the previously shown figure; Figure 4.5.

It was at first regarded as a problem in connected loads, as the voltages seemed unaffected. However, when examined more closely it was detected that the voltage indeed had some disturbance also at these precise angles. It was therefore concluded that the phenomena was caused by the UPS' switching rather than load influence.

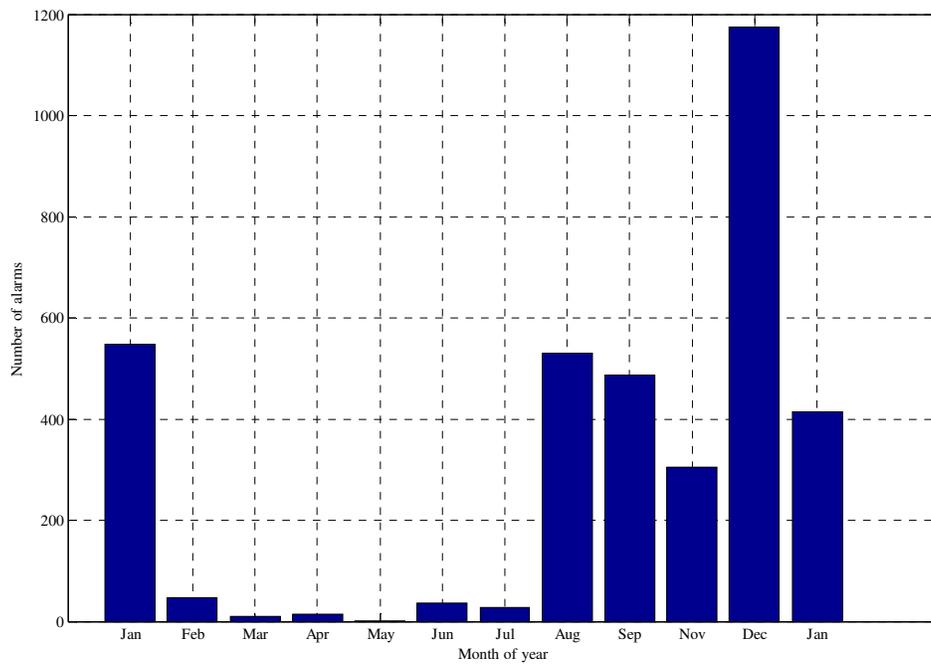
Figure 4.10: Number of alarms each month of the year; between August 2003 and January 2007

The number of alarms sorted by day of month, shown in Figure 4.10, definitely has an interesting appearance compared to Figure 4.9. The number of alarms in February to July is so very much lower than the number of alarms in August to January that it is reasonable to analyse the differences and try to determine the reason. This has however proved to be quite difficult as the number of variables that affects the system is large. It may although be possible to draw the conclusion that the problem at least in part, is affected by something relating to time of year.

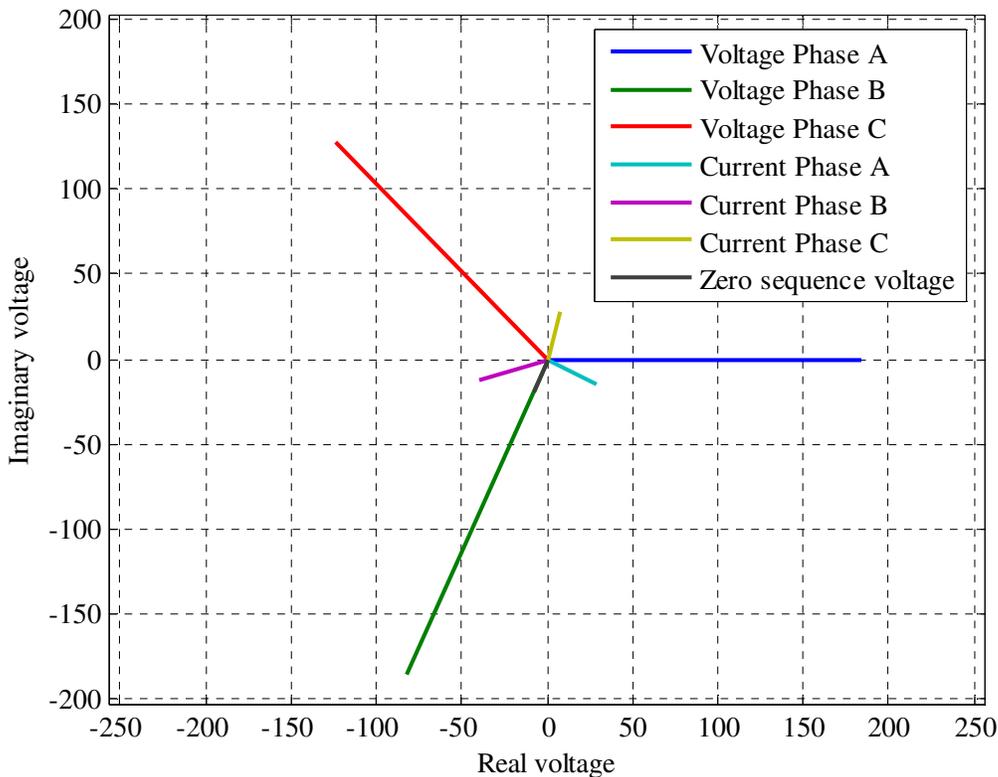
Figure 4.11: Phasor diagram over voltages and currents of sub D measured 2005-10-24

The phasor diagram below, Figure 4.11, shows that there is quite a bit of phase angle difference between the measured voltages and what the voltages should be ideally. There is also a rather large mismatch in voltage magnitude. Subtracting the calculated zero sequence voltage clears almost all of these problems. As loads are connected between phases this zero sequence voltage does not affect the voltage that loads are experiencing.

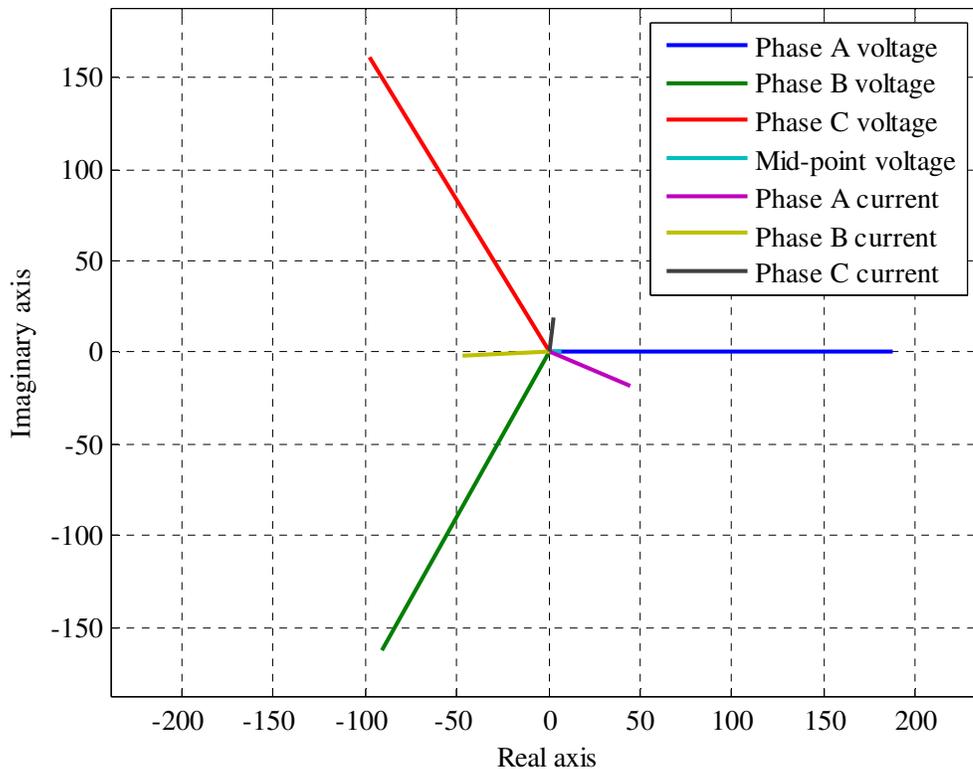
Figure 4.12: Phase voltages and currents for sub A at fundamental frequency (50 Hz)

Figure 4.12 shows a phasor diagram of the phase voltages and currents of sub A and from that figure it is possible to visually determine that the voltages are not symmetrical. The asymmetry is not large, but it is seen from phase B and C not being equally close to the -100 V real line. The currents are quite unsymmetrical with phase C current quite a bit lower than the other two. The phase angle of the currents are the expected lagging, and in a reasonable range somewhere around 15-30 degrees. The uneven loading of the transformer may be the reason that the voltages are not symmetrical. Table 4.2 presents the sequence voltages and currents. It is noteworthy to see that the properties seen in Figure 4.12 are reflected in the decomposed sequence voltages and currents.

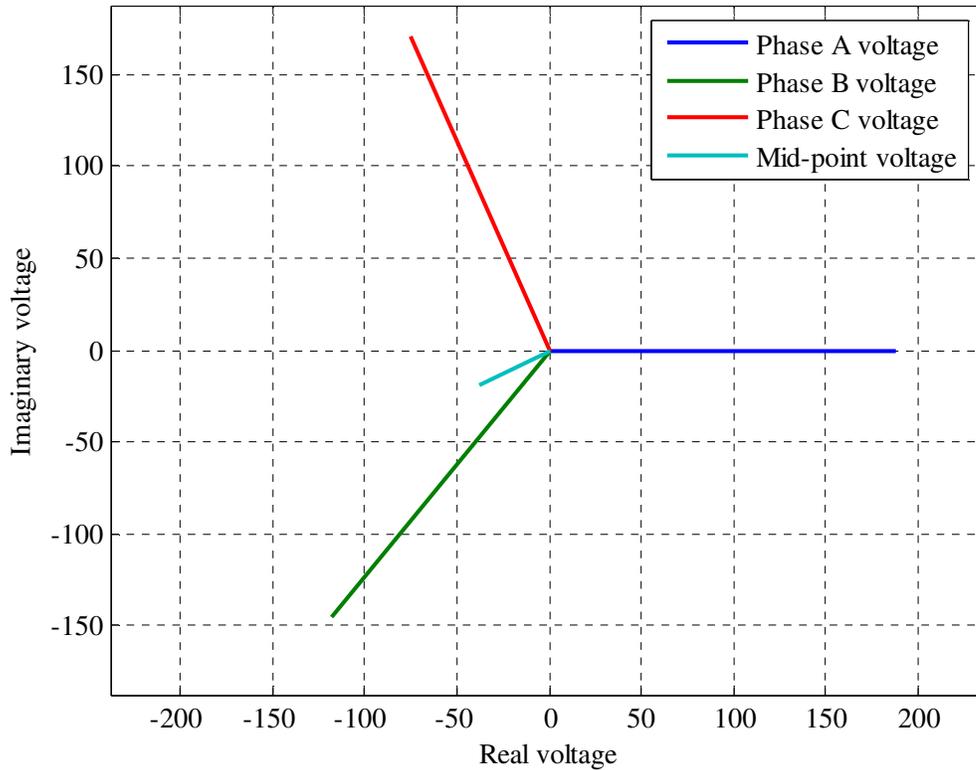
Figure 4.14: Complex voltages at the fundamental frequency for sub B

The complex voltages in Figure 4.14 appear to be quite badly balanced. It appears as though the A phase is shifted about 10° from its correct position, the reason for this however lies in measurement problems, as the voltages were not measured at the same time, since the oscilloscope only had two inputs.

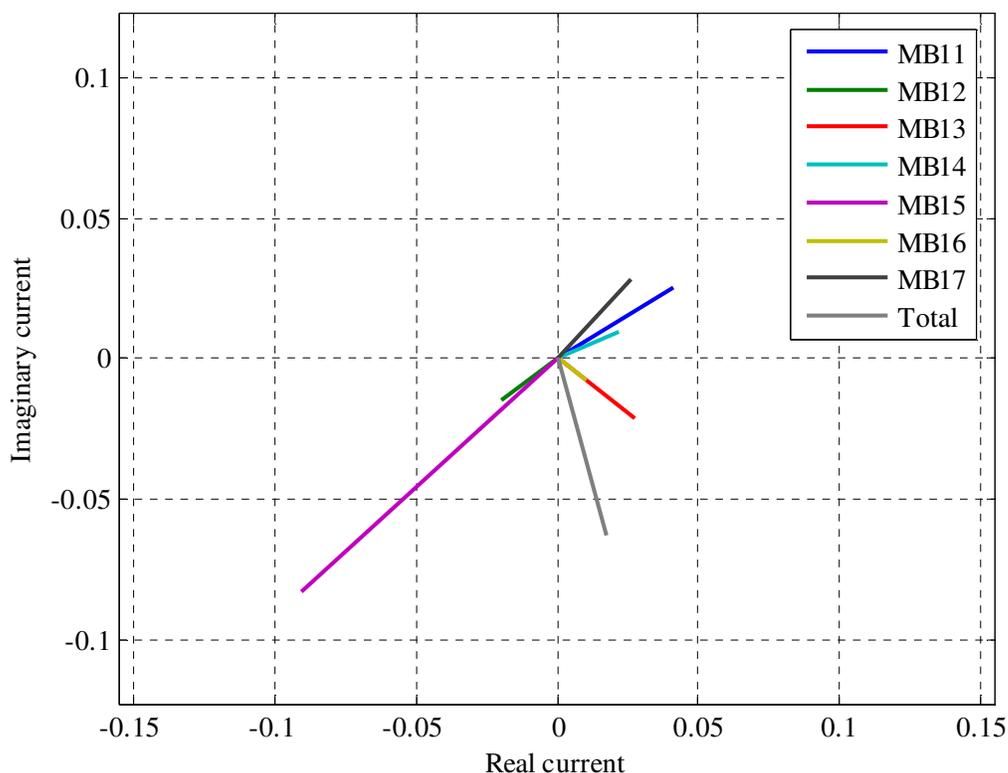
Figure 4.15: Leakage current phasors of sub B

As evident from Figure 4.15 the currents cancel each other out somewhat, but there is a significant resulting current that increases the total earth current. The main noteworthy thing in this phasor diagram is the fact that the output MB15 is significantly worse in the leakage current aspect since it has double the voltage of the second largest output.

In Table 4.3 the leakage current in mA RMS and the ratio leakage to earth current is presented. The interesting thing in this table is that the leakage currents are in all but one case larger than the total earth current, significantly larger in fact. This shows that the assumption earlier that the leakage currents cancel each other out is likely to be true.

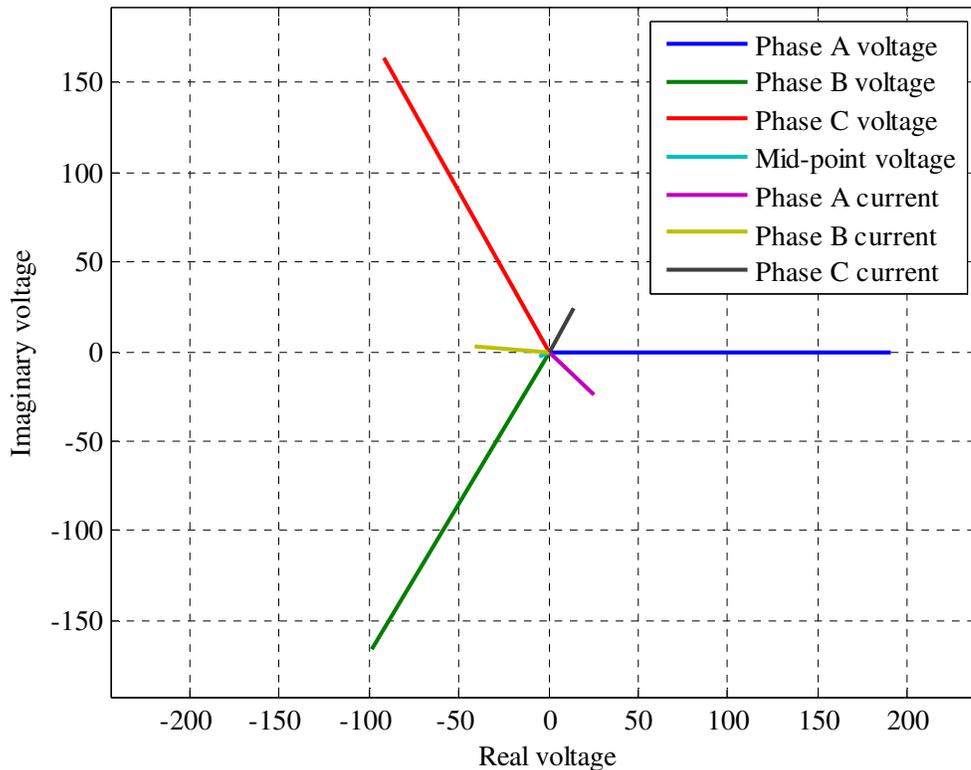
Figure 4.16: Phase voltages and -currents; and neutral voltage for sub C

The voltages on sub C is not balanced properly, as is easily seen from Phase B and C in Figure 4.16, and might therefore give some addition to the total neutral voltage. This contribution however is likely quite small as the voltage magnitudes differ less than the corresponding angles.

To see exactly how much unbalance is present in the system the sequence voltages and currents were calculated from the FFT. The result is shown in Table 4.4. From these values the amount of unbalance can be calculated to 1.2 % of voltage unbalance and 21.6 % of current unbalance. The voltage unbalance is within the recommended values, but the current unbalance suggests that there is room for improvement with regards to load balancing.

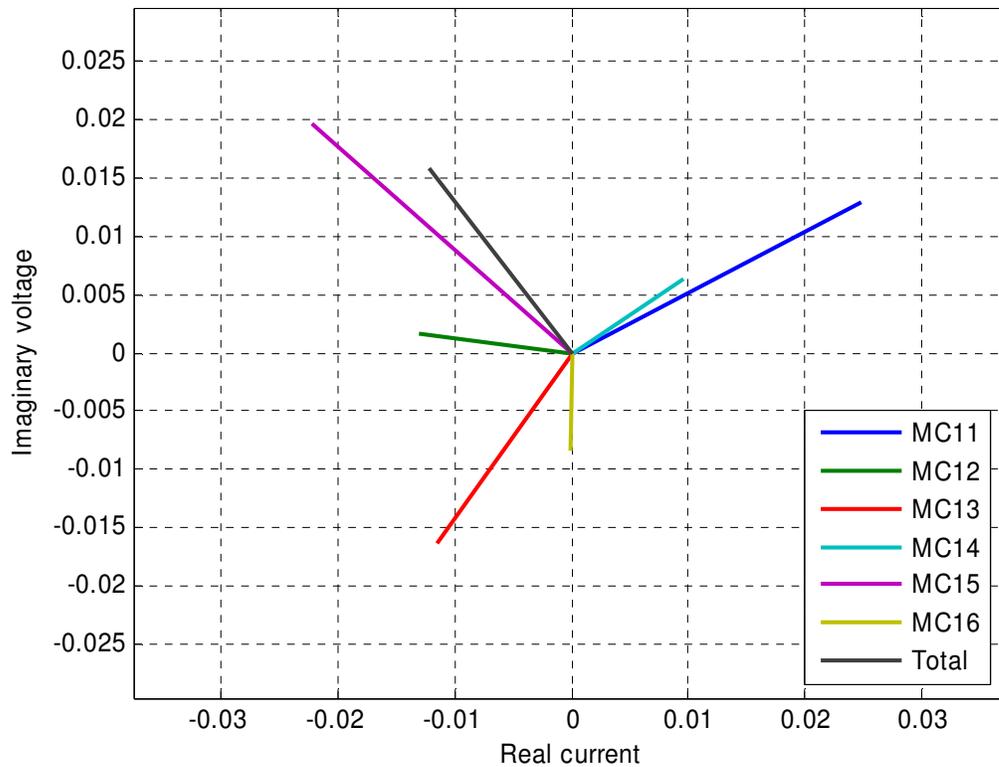
Figure 4.17: Leakage current phasors of sub C

The leakage currents shown in Figure 4.17 are rather evenly spread which likely contributes to the low neutral voltage. Their amplitude is also low, but not low enough to single-handedly account for the low midpoint voltage. These two favourable properties combined would likely give a good influence on the neutral voltage.

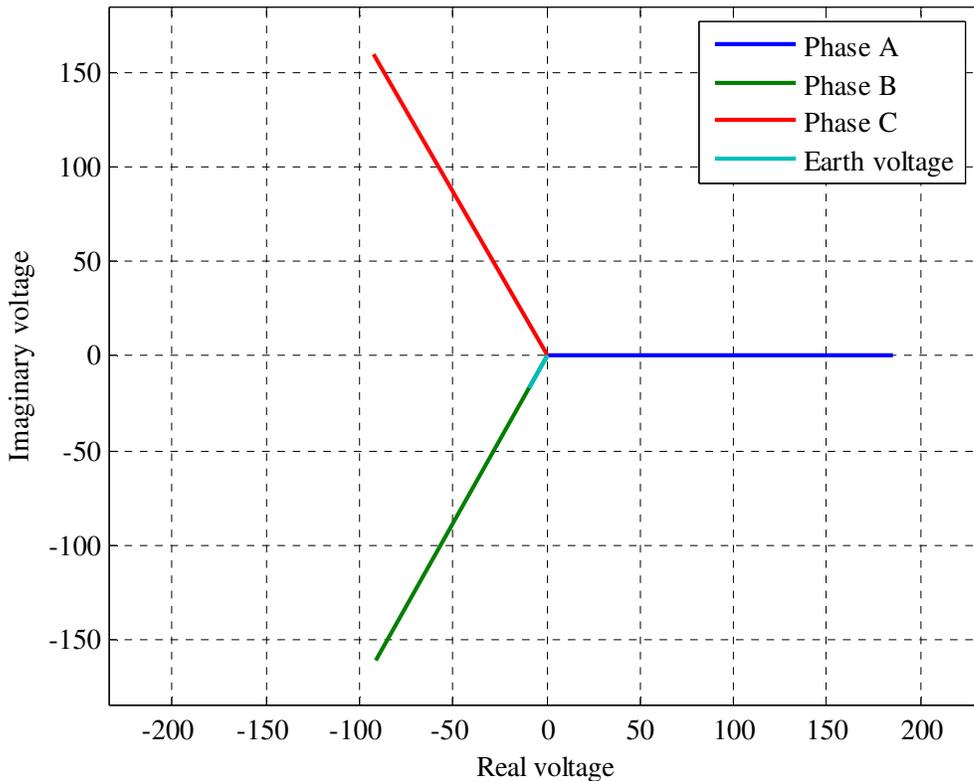
Figure 4.18: Phasor diagram of the voltages for sub D; including earth voltage

The earth voltage as seen in Figure 4.18 is very nearly completely in phase with phase B. It is in fact not very easy to locate the phasor in the above diagram as it is almost drowned out by the green phasor. This is likely caused by some conductance between the B phase and earth. When comparing the earth voltage in Figure 4.18 with the zero sequence voltage in Figure 4.11 shows that they are nearly exactly identical both in magnitude and phase. The conclusion that can be drawn is that the fault has been present for a very long time, likely a long time prior to the earliest measurements.

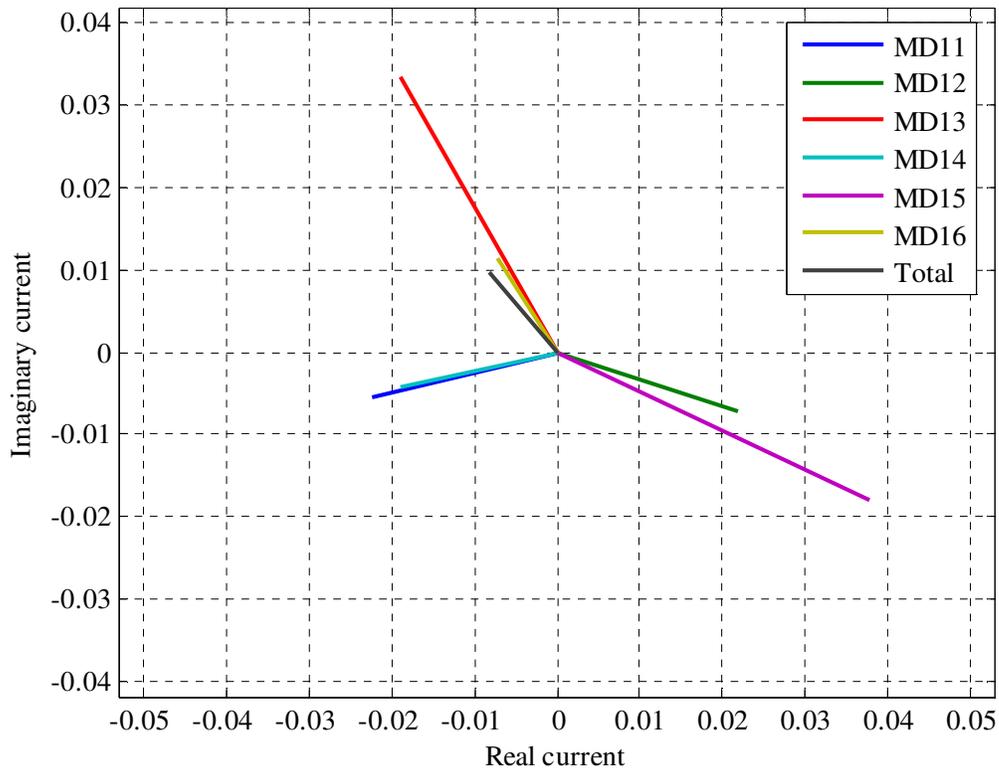
Figure 4.19: Phasor diagram of leakage currents in sub D

The phasor diagram of the leakage currents, Figure 4.19, shows that the assumption made earlier, that the currents cancel each other out somewhat. The dark grey total current is far less than any of the individual leakage currents. It is interesting to note that the currents are fairly aligned along one axis with some sticking out to one side. The reason to this, if any, has not been pursued further due to time constraints.
