TRM Strengthening of Historic Masonry Vaults

Evaluation of use in the Church of Saint Bassiano in Italy and possibilities for Skörstorp's Church in Sweden

Master thesis in the Master's Programme Structural Engineering and Building Technology

ANNIE SKEPPSTEDT

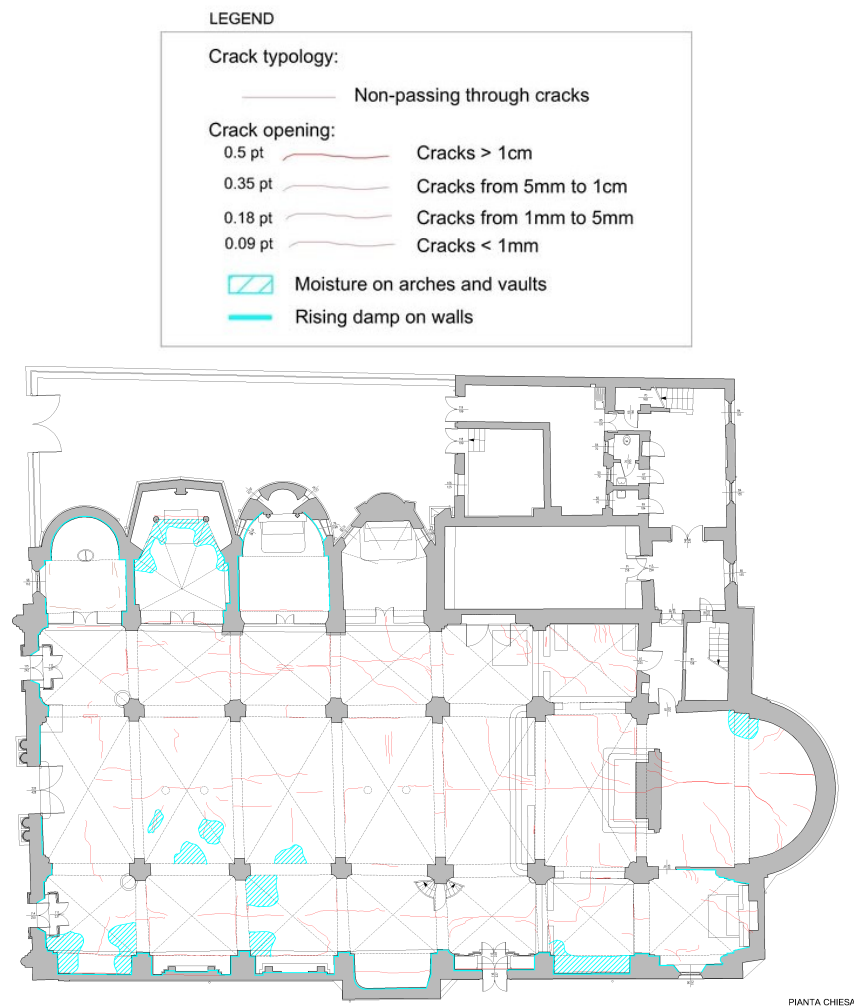
Figure 3.6: Plan view of St. Bassiano showing crack pattern survey from 2013 provided by Giuliana Cardani.

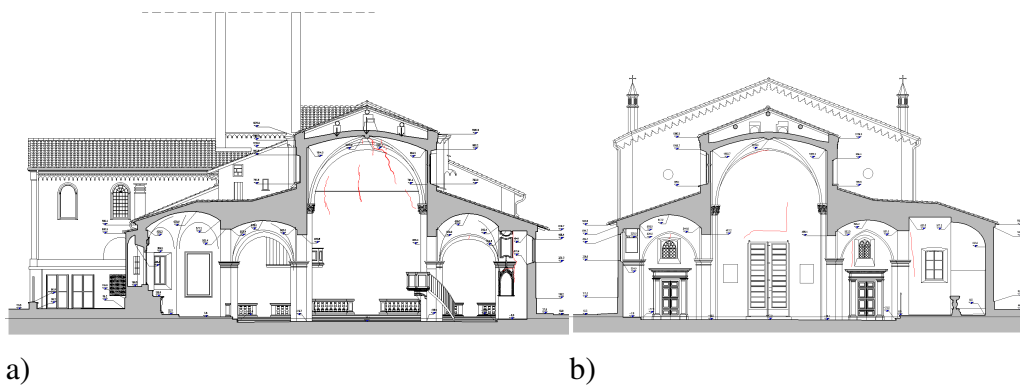
Figure 3.7: Section view of St. Bassiano showing crack pattern of a) east wall including the apse and b) intrados of the west wall, i.e. the front side of the church.

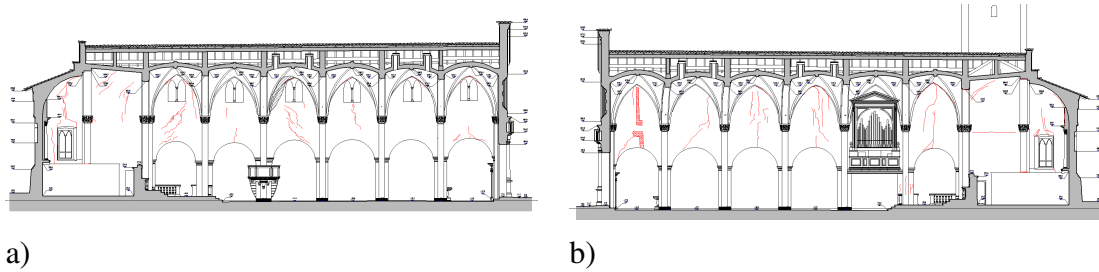
The sectional views, Figure 3.8, illustrate cracking in the main nave walls. Cracks in the upper masonry may indicate outward thrust caused by the vaults and roof structure. Additionally, the diagonal cracks in the lower sections of the walls could be the result of differential foundation settlement. If certain sections of the foundation are settling unevenly, tensile stresses may be developing in the masonry, leading to cracking. Looking at the crack pattern of the first and third arch in a) it suggests a settlement of the two middle pillars of these three arches. The same can be said for the second and fourth arch in b), indicating a settlement of the two middle pillars in conjunction with these arches.

Figure 3.8: Section view of St. Bassiano showing crack pattern of a) south wall of the main nave and b) north wall of the main nave.

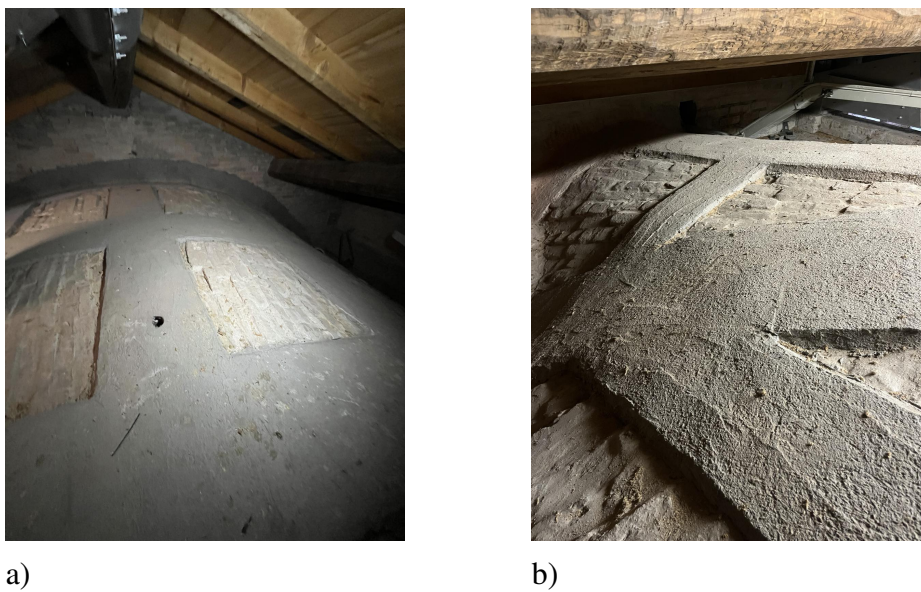
Figure 3.11: Pictures of current state of the TRM application on St. Bassiano, a) Barrel vault and b) Ribbed vault.

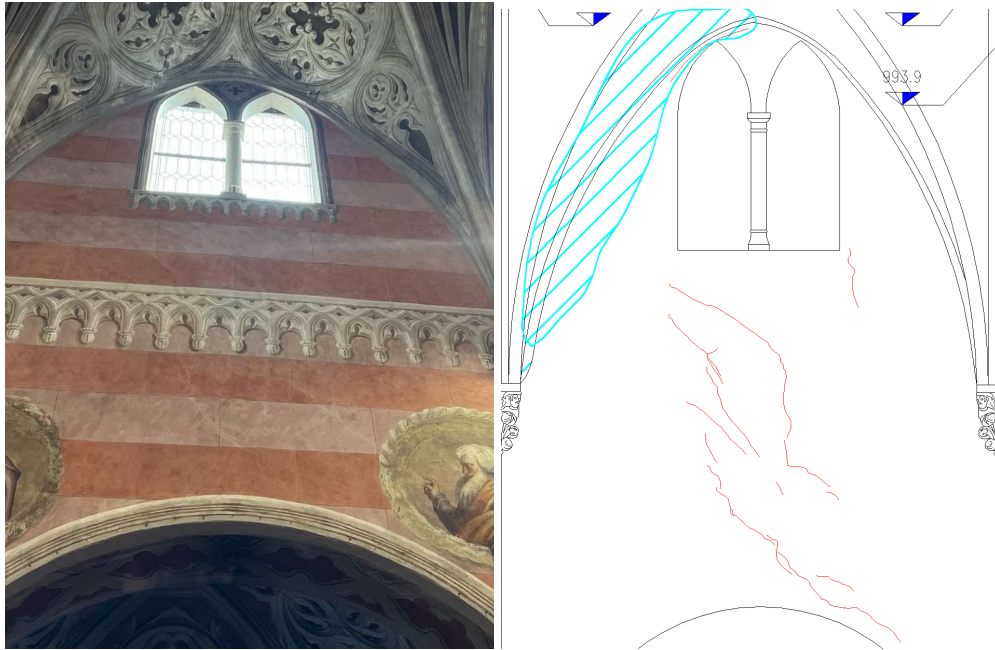
In 2023 a renovation of the plasters of the main nave was carried out. Cracks were superficially closed and the walls were cleaned. This makes it slightly more difficult to evaluate the crack patterns detailed in the previous survey for this section of the church. Looking closely, it is possible to faintly see shadows where the cracks are, see Figure 3.14. What can be stated is that the cracks are still prevalent; however, they do not seem to have grown and they have not opened up again since then.

Figure 3.14: a) Picture of wall above fourth south arch in main nave of St. Bassiano in its current state and b) close up of crack pattern from previous survey.

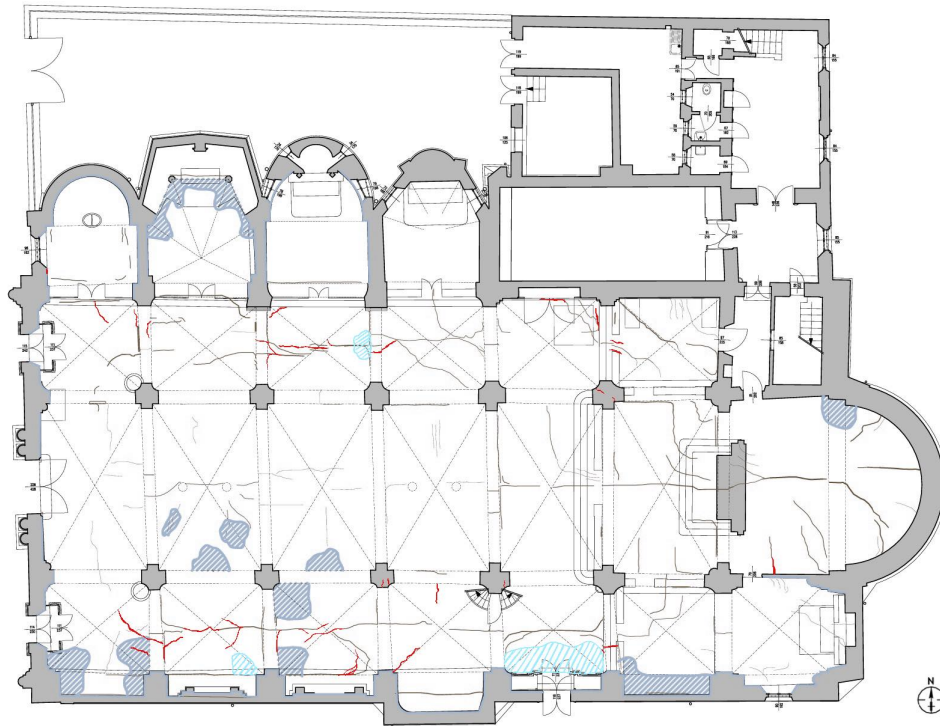
From the plan view, it is possible to compare the crack pattern to the current one present in the side aisles. The crack pattern drawn shows the cracks on the vaults. In Figure 3.15, the cracks drawn in red marks the cracks that could be seen in the current state of the church. They can either signify a new crack taking form, or a continuation of an existing crack, having expanded in length or in width. Noticeable here is that the damage is quite extensive in both side aisles. Most prominent in the north side aisle is the damage in the 3rd bay, with more cracks forming and the middle crack in the centerpiece elongating. There is also added water damage which was not noted in the previous survey. In the south side aisle the first four bays (from the left) have the most new cracks with some added water damage to the second and fifth bays. The vaults in the side aisle now have cracks in the middle reaching almost through the entire length of the aisle. Although, on the contrary, no new cracks appear in the intrados of the main nave.

Figure 3.15: Plan view of crack pattern survey in St. Bassiano with new crack formations in red and new water damage in cyan blue.

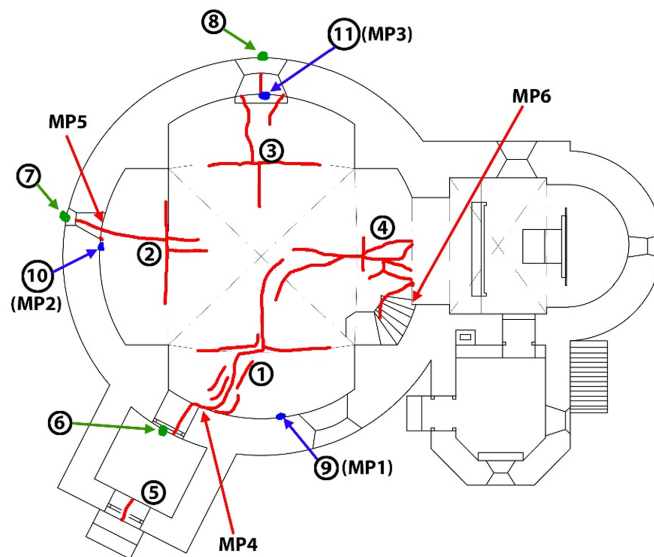
In 2020, a detailed crack survey was conducted at Skörstorp's Church to investigate the long-standing and evolving cracking in the round nave. The investigation revealed a widespread pattern of cracks, with cracks visible in the interior walls, the attic space, and the exterior façades of the church. The crack mapping, see Figure 4.6, shows different zones: red-marked cracks (numbers 1–5) inside the nave and vaults, blue-marked cracks (numbers 9–11) in the attic, and green-marked cracks (numbers 6–8) on the outer walls.

Figure 4.6: Plan view of Skörstorp's church from crack-investigation carried out by Carl Thelin in 2020 with cracks marked out in red, used with permission.

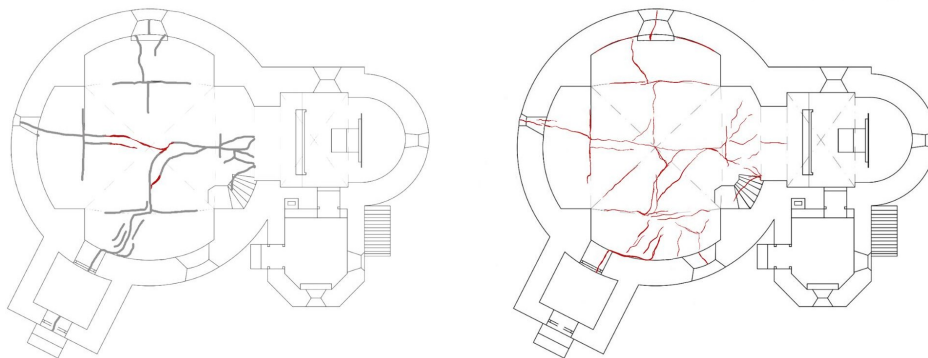
The plan view of the church from the 2025 investigation, see Figure 4.7 a), highlights the differences from the 2020 crack-mapping, with new or worsened cracks marked in red. Notably, cracks now appear to span fully across the vault, and previously separated cracks are now connecting at multiple points. A detailed crack pattern was also produced; see Figure 4.7 b), showing both the larger and the smaller cracks across the vault and walls.

Figure 4.7: Plan view of Skörstorp's Church from crack-investigation made by the author in 2025 with a) difference from 2020 marked with red and b) a more detailed view of the cracks (marked in red).

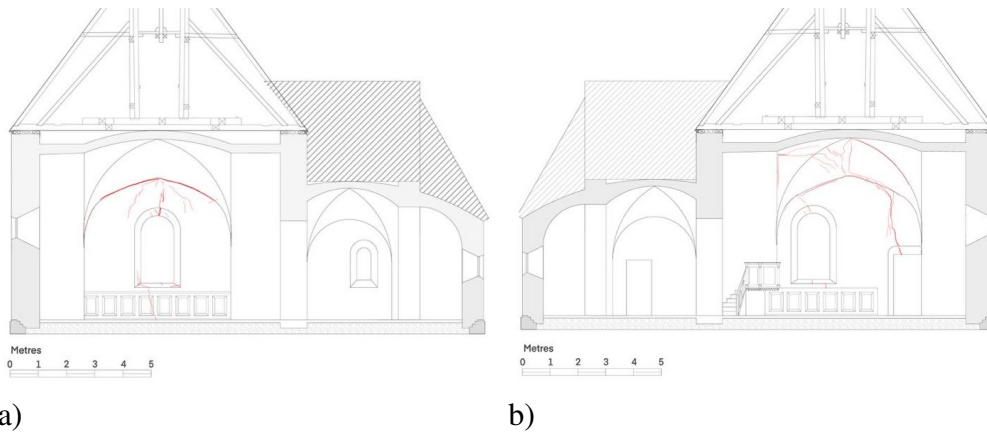
To better understand the vertical extent of the damage, sectional views were prepared. Figure 4.8 and Figure 4.9 show sections across the north-south and east-west diagonals of the round nave. These sections reveal that some cracks extend continuously from the crown of the vault, down through the wall, passing window and door openings, and continuing down to the foundation level.

Figure 4.8: Section view of Skörstorp's Church from crack-investigation 2025 with cracks marked in red a) North and b) South

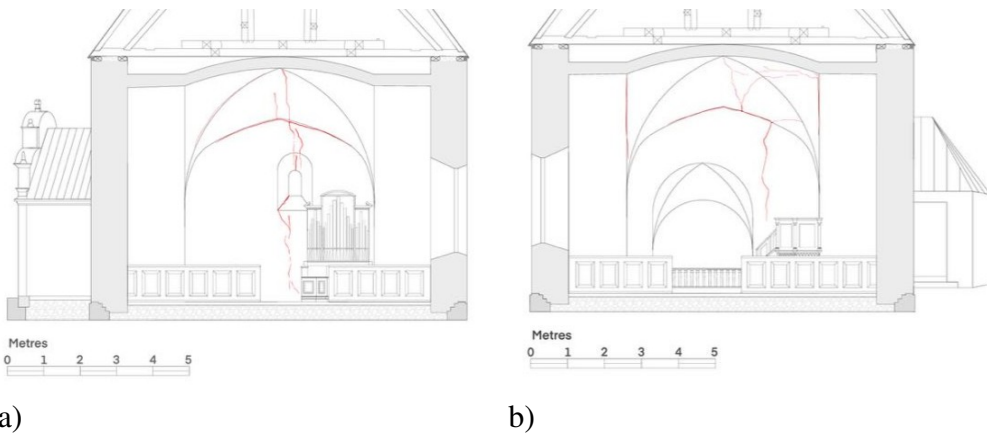
Figure 4.9: Section view of Skörstorp's church from crack-investigation 2025 with cracks marked in red a) West and b) East
