Evaluation of quick clay failures and the impact of climate change on slope stability

ACEX11 Bachelor thesis

BACHELOR'S THESIS 2024

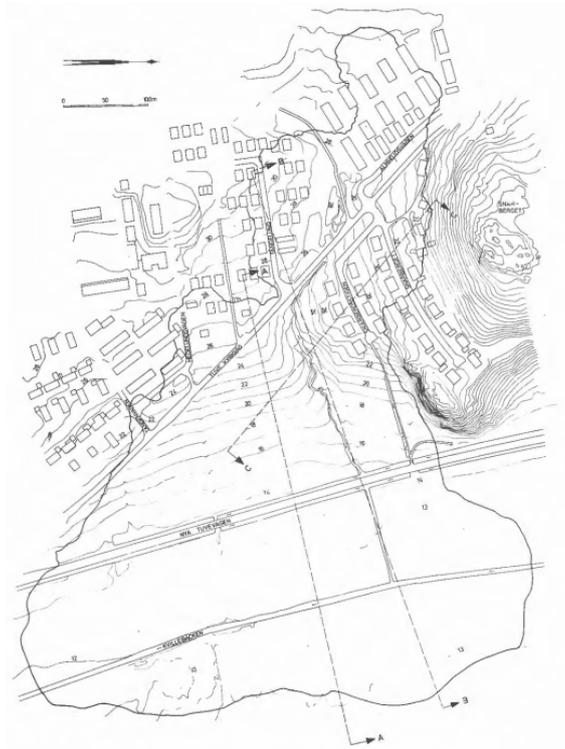
Figure 4: Picture taken from Tuve before the landslide occurred, showing areas topography and landslides area marked in the figure [25]

Kvilledalen where the landslide occurred (figure 4), is located a few meters above the sea level at its lowest point. The area resembles a small valley with mountains covering north and south. Through this valley a small stream was followed. In the specific area between the new Tuvevägen and Tuve Kyrkväg, there was a slope with the steepest sections east of Tuve Kyrkväg. The slope inclination in these areas were about 1:5 and steepest as 1:3. The stream had eroded a ravine and it was culverted and discharged into Kvilledalen down into Kvillebäcken [25].

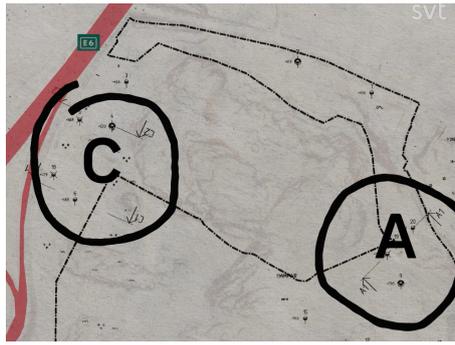
In 2013 the area was investigated to assess the risk of landslide. The stability was measured at multiple locations, where two areas A and C (figure 5) were marked as risk areas. Stenungsunds recent landslide occurred in area C with the greatest risk for instability [31].

Figure 5: Risk areas A and C [31].

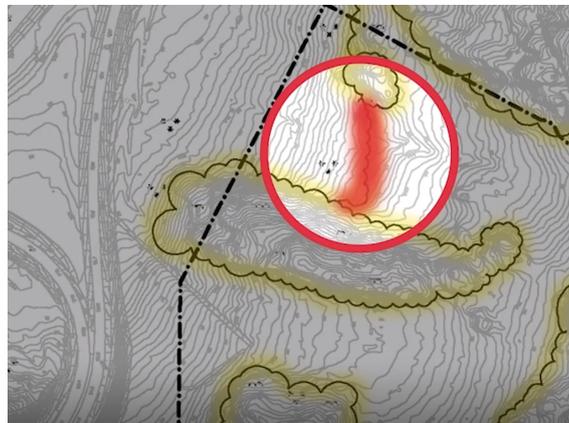
Figure 6: The red area marked in the figure was presented to consist of bedrock close to surface but it did not [35]

According to the Swedish Geotechnical Institute, the inaccurate map influenced their assessment of landslide risk before construction [35]. If the bedrock had not been marked on the slope, the agency would likely have recommended further investigations and stability calculations.

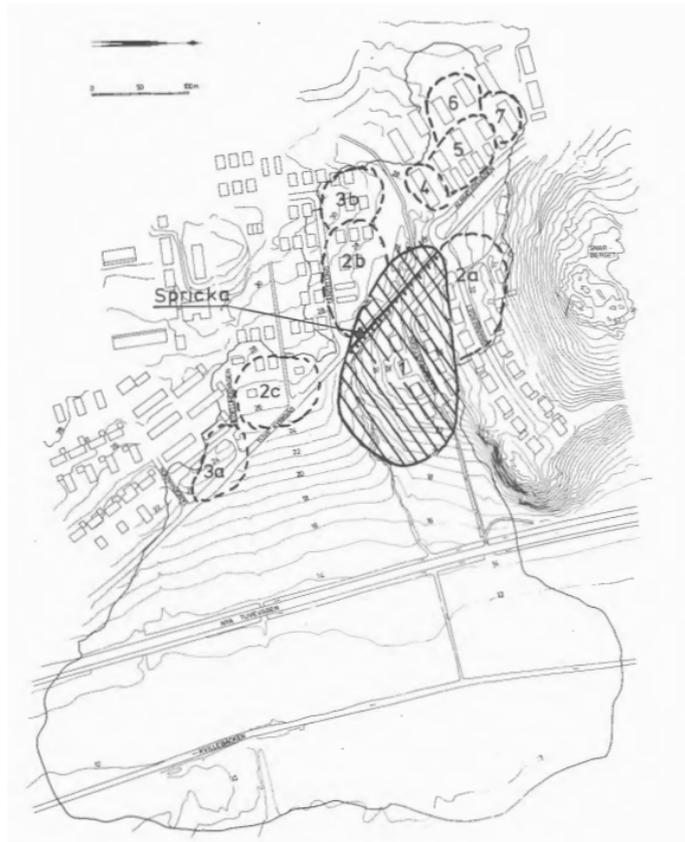
Figure 10 shows the sequence observed in Tuve by eyewitnesses. The goal of the simulations was to show which section was the crucial one with the potential to trigger the progressive landslide. A crack in area one is thought to be one of the reasons for the failure. Hence for better understanding, a shallow slide in section B was analyzed.

Figure 10: Serial behavior in Tuve slide. [25]

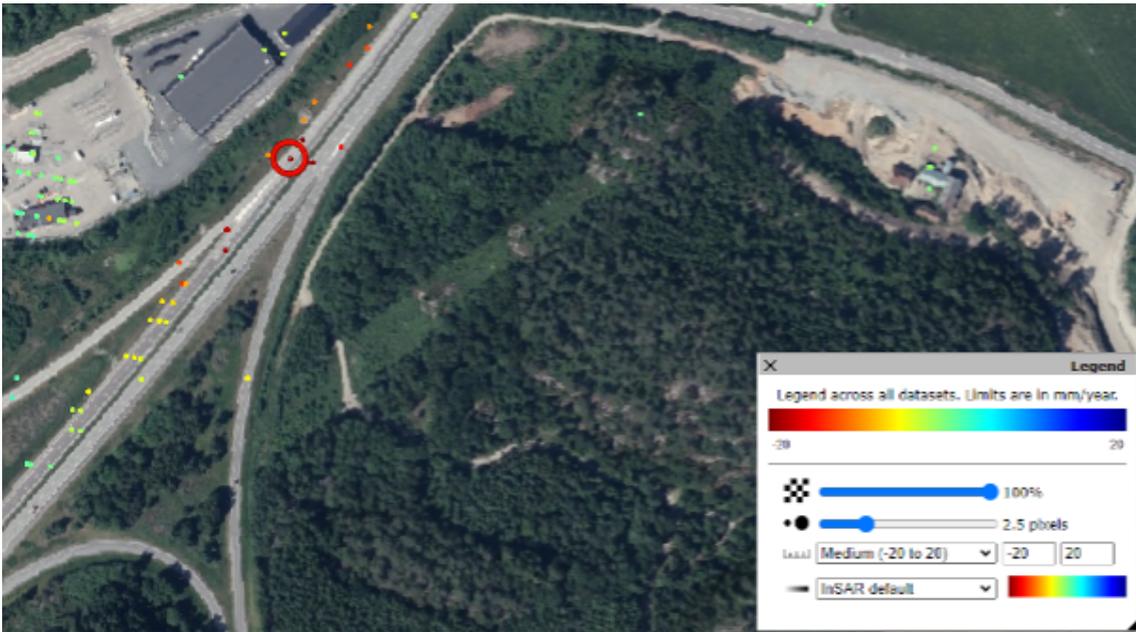
Looking at satellite images from inSAR unusually large settlements are observed where the landslide later occurred. In figure 14 one can see a clear correlation between the red dots and the area later involved in the landslide. The data is from 2015-2021 and the settlement over time is displayed in figure 15.

Figure 14: Area in Stenungsund where the landslide occurred. Dots represent a value in which the movement of the ground in the y axis has changed over time. [51]

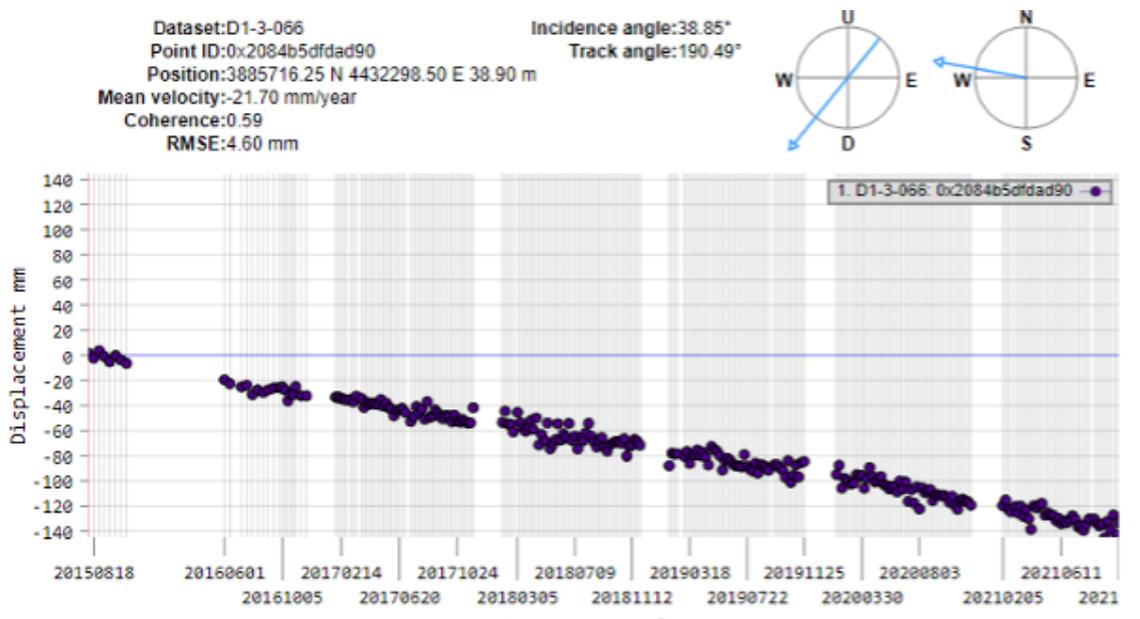
Figure 15: Movement of chosen point from 2015 to 2021 in millimeter. [51]

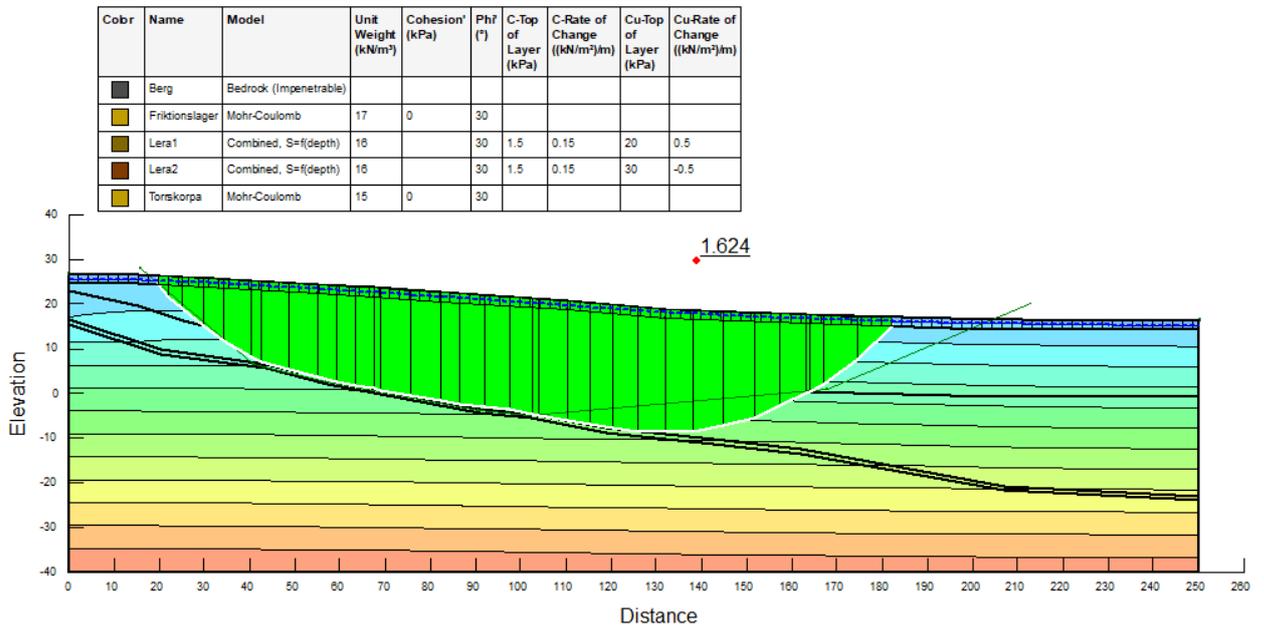
Figure 18: Factor of safety at time = 0 in section A-A.

Figure 18 shows the calculated safety factor equal to 1.624 at the initial phase without infiltration.

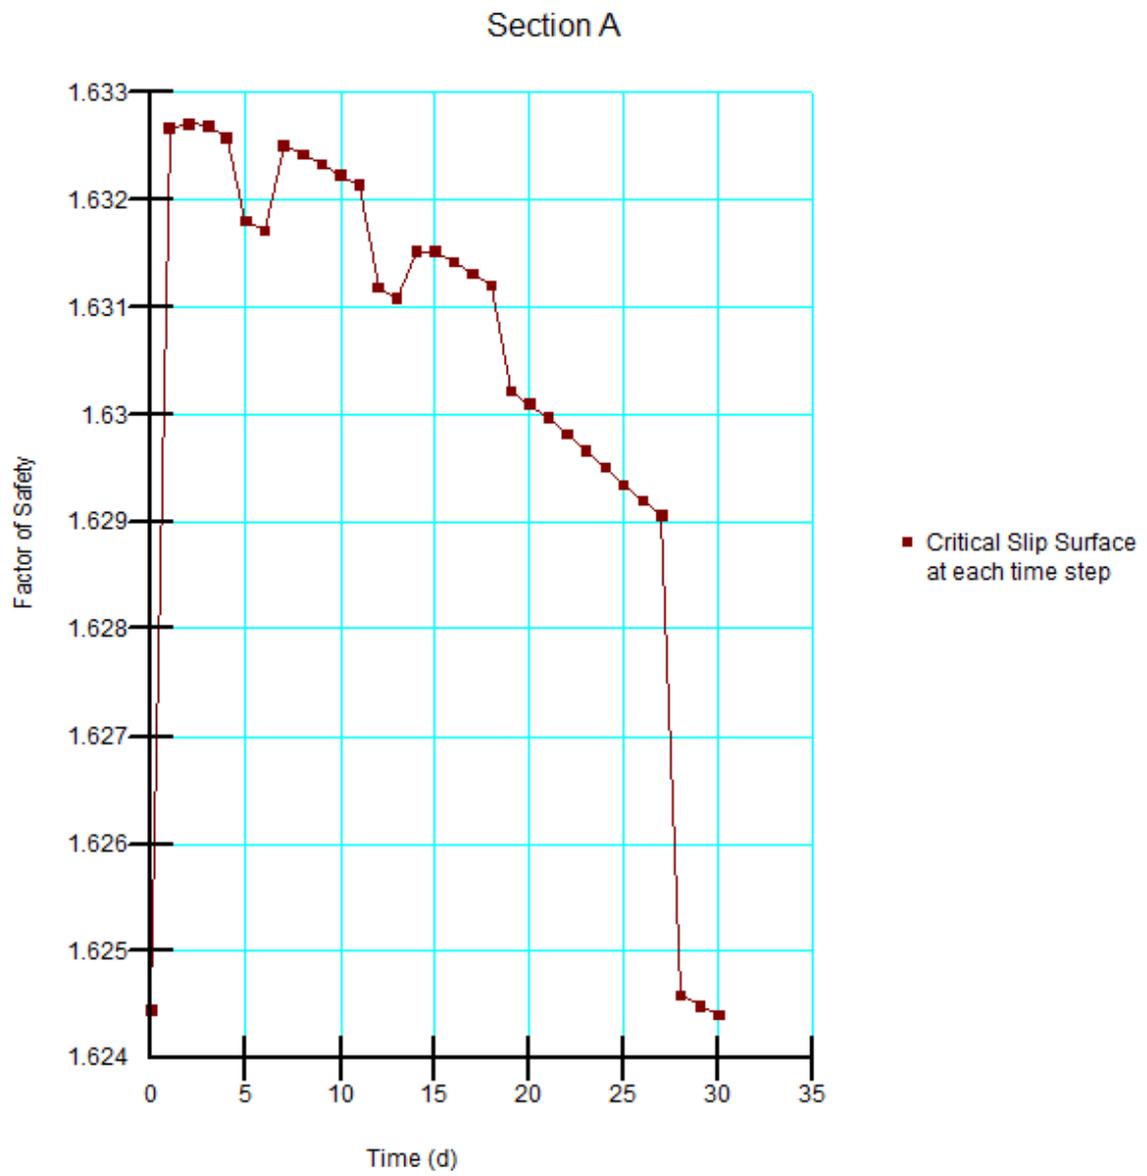
Figure 20: Change of safety factor in section A-A.

Figure 20 shows the change in safety factor over the slip surface in section A-A over a period of 30 days.

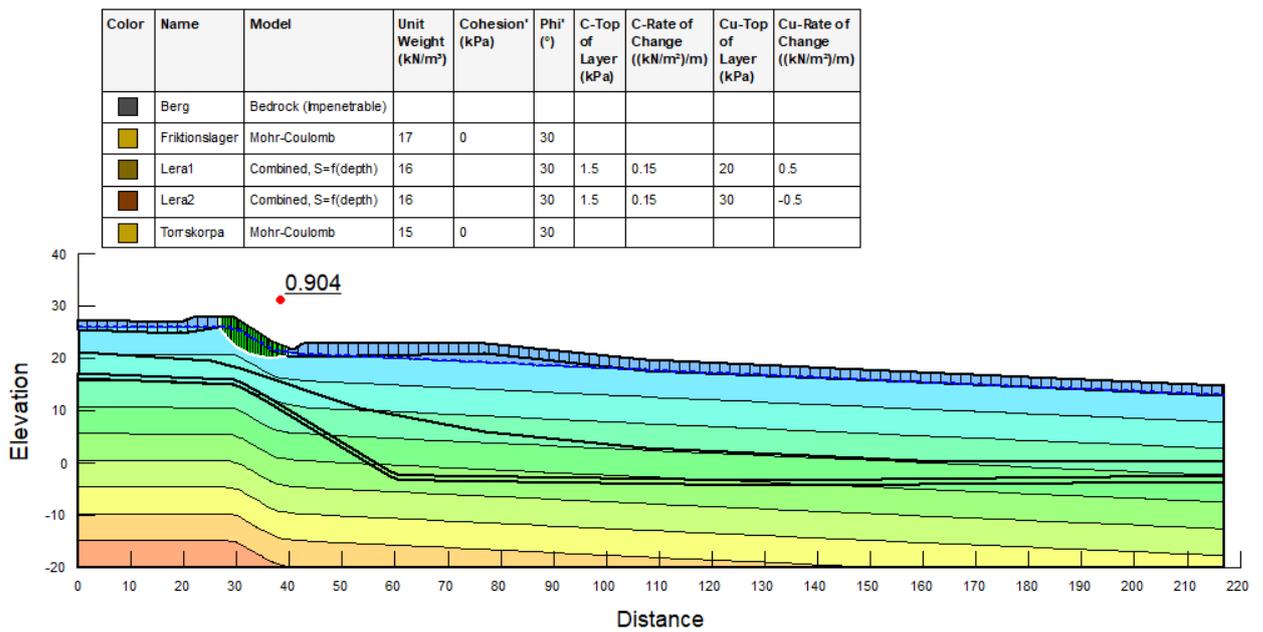
Figure 23: Safety factor of the marked slip surface in time=0 for section B-B.

Figure 23 shows the initial safety factor for the local slope marked in the figure calculated as 0.904. The safety factor being below 1 indicates failure in slope.

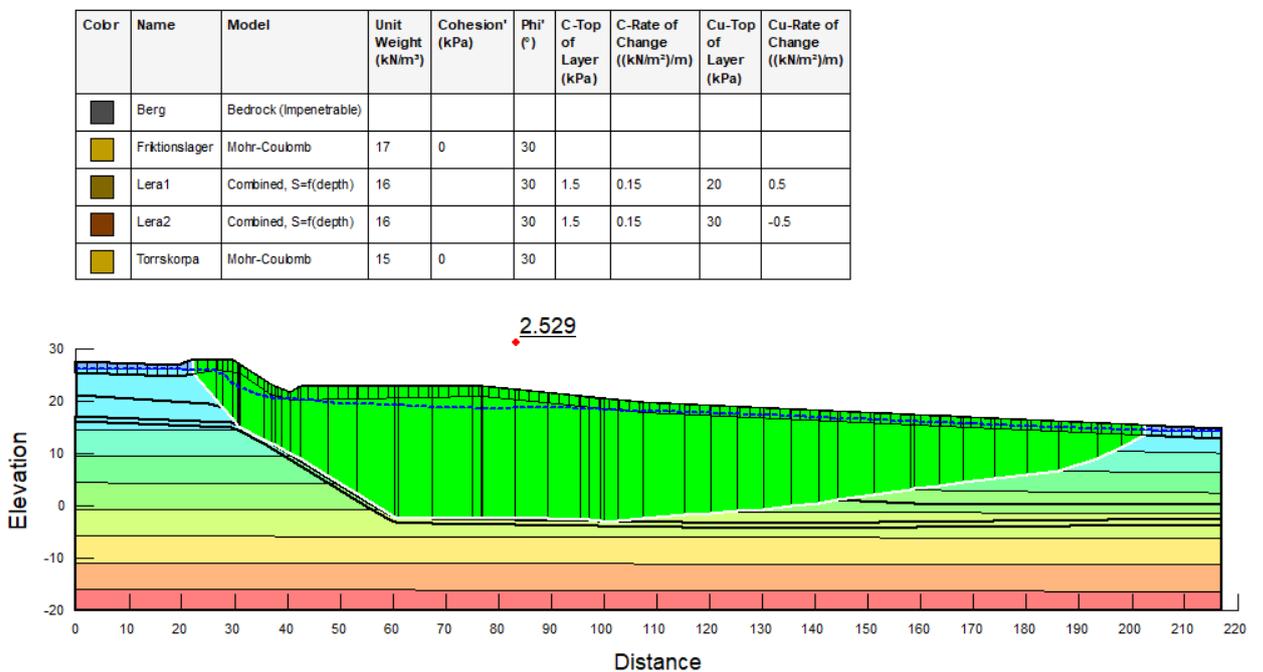
Figure 24: Factor of safety for a bigger slip surface at time = 0 in section B-B.

Figure 24 shows the calculated safety factor to be 2.364 of the slope with a larger covering slip surface.

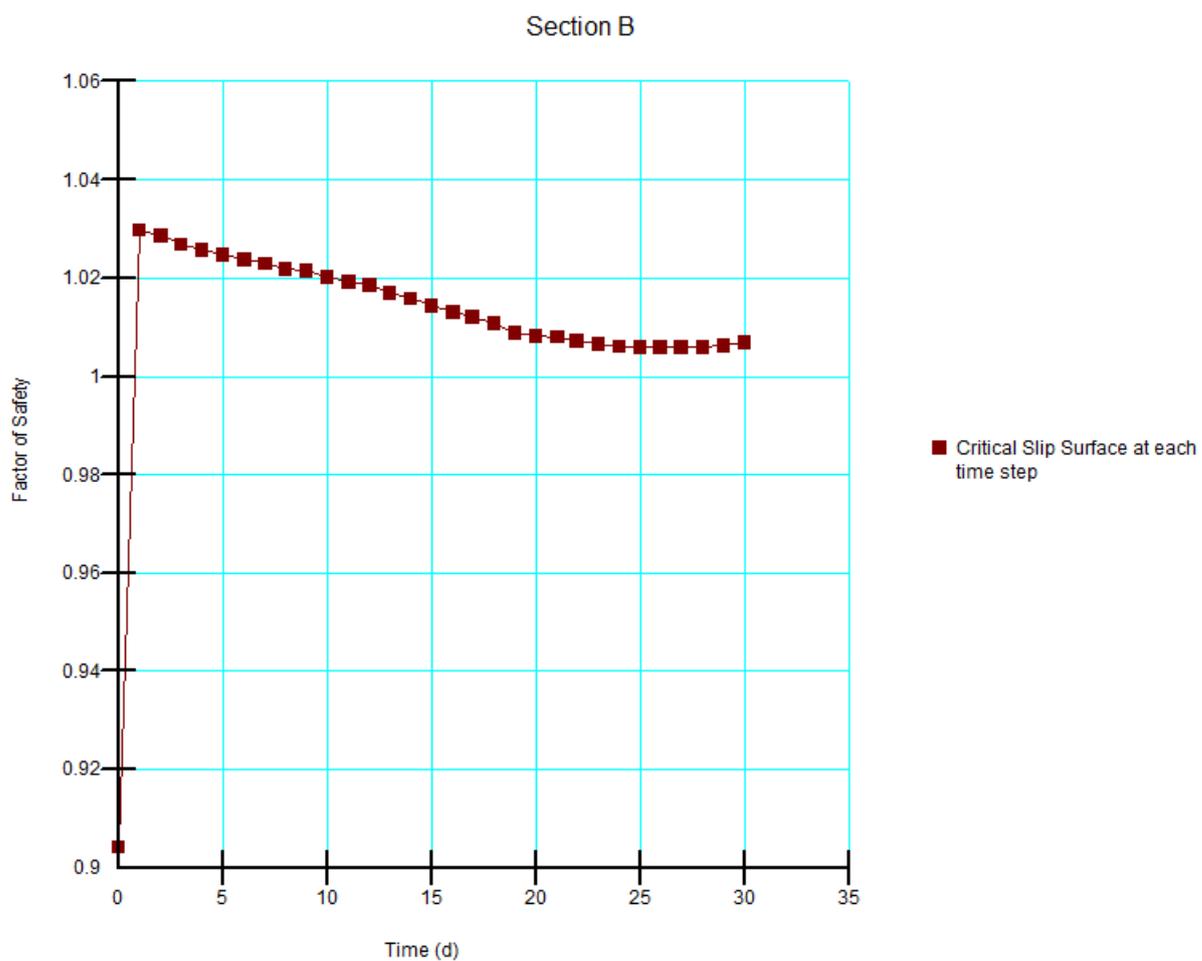
Figure 26: Factor of safety for the local/smaller slip surface in section B-B.

Figure 26 shows the change in the factor of safety for the local slip surface at section B-B.

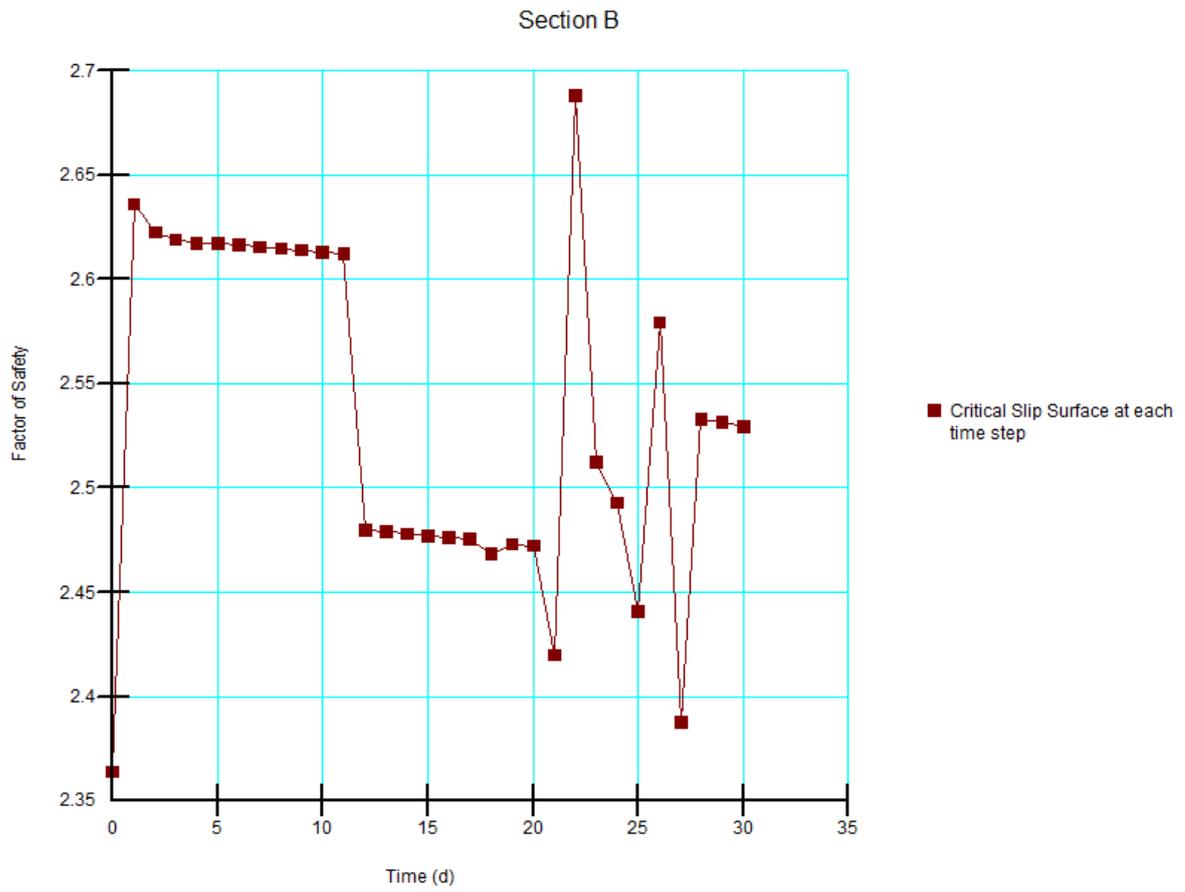
Figure 27: Initial conditions in section B-B.

Figure 27 shows the change in the factor of safety in the larger slip surface in section B-B.

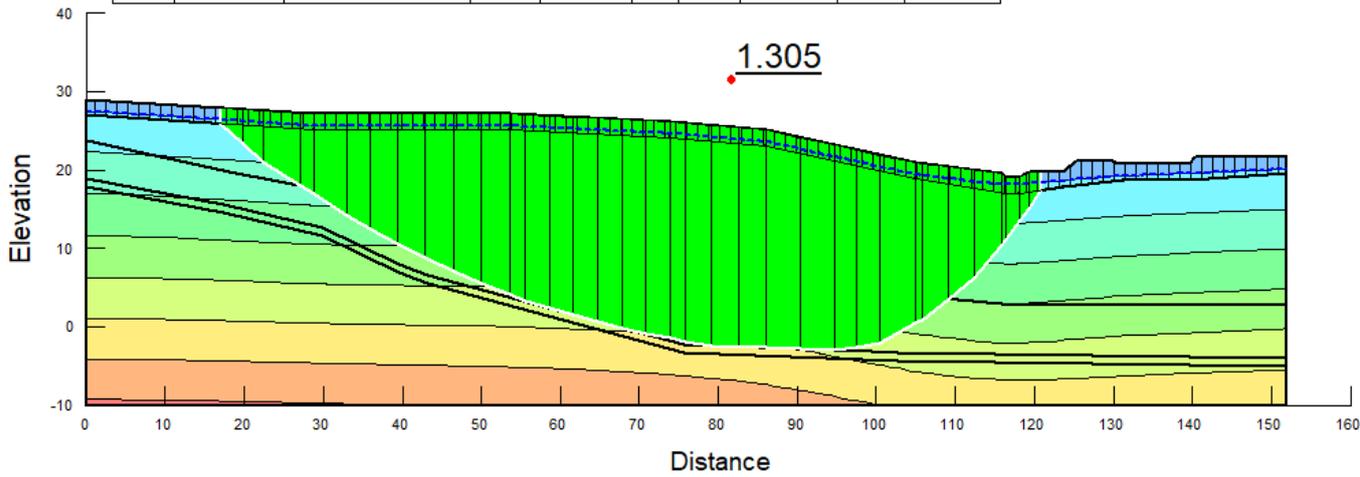
Figure 30: Factor of safety at time = 0 in section C-C

Figure 30 shows the calculated safety factor equal to 1.305 in section C-C before infiltration starts.

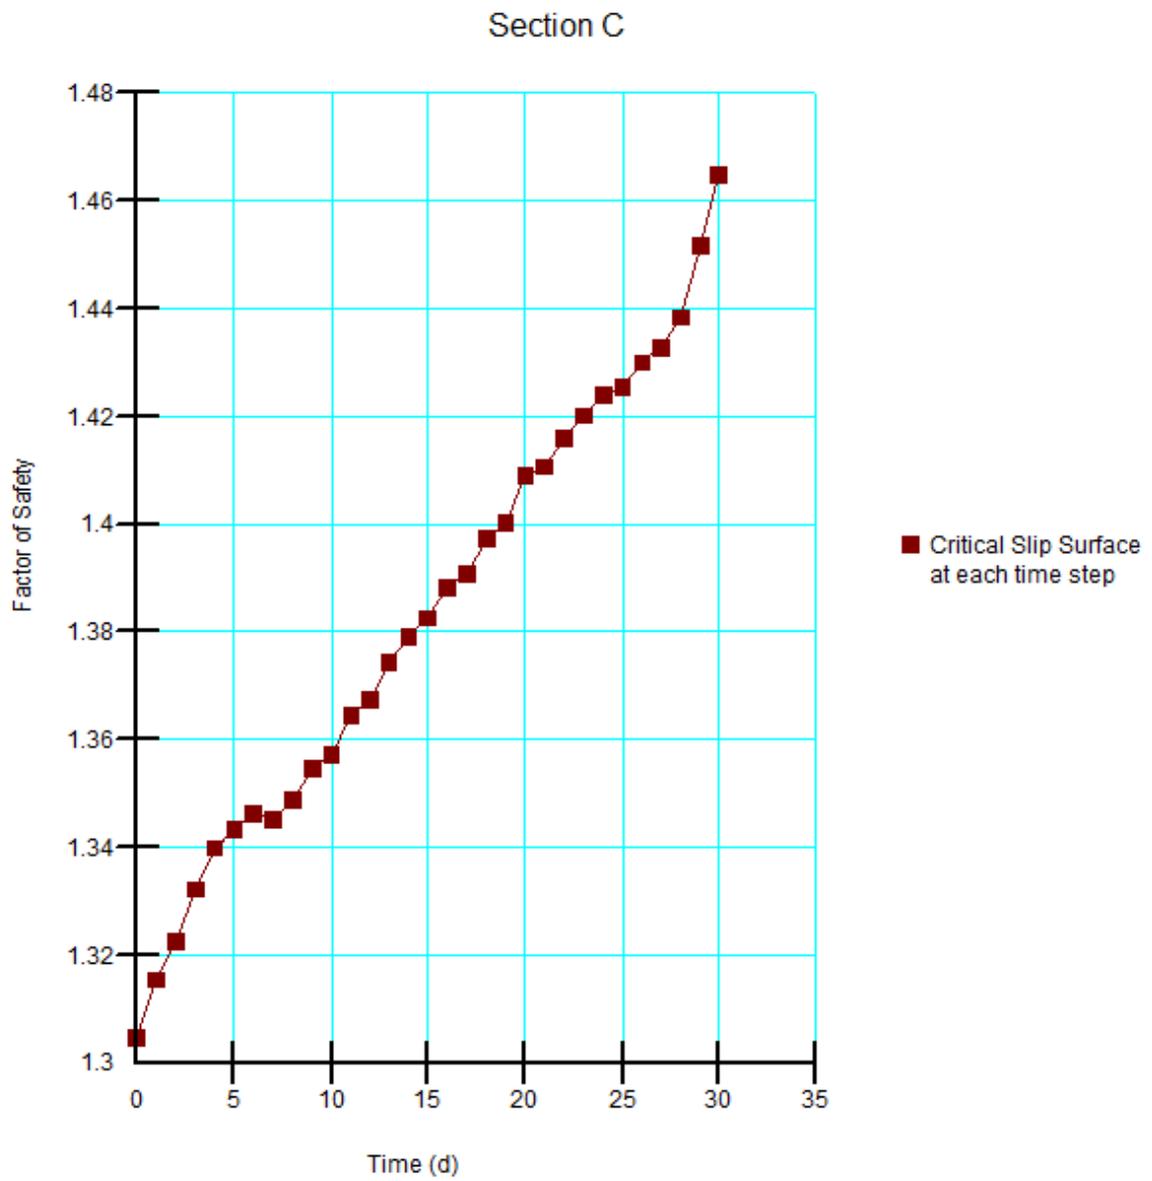
Figure 32: Initial conditions in section C-C.

Figure 32 shows the change in safety factor during the infiltration period from day 0 to day 30.
