Reimagining a Sixties House

- Into a contemporary house with studio spaces for arts
and crafts

Chalmers School of Architecture
Department of Architecture & Civil Engineering

Building Design and Transformation / 2024

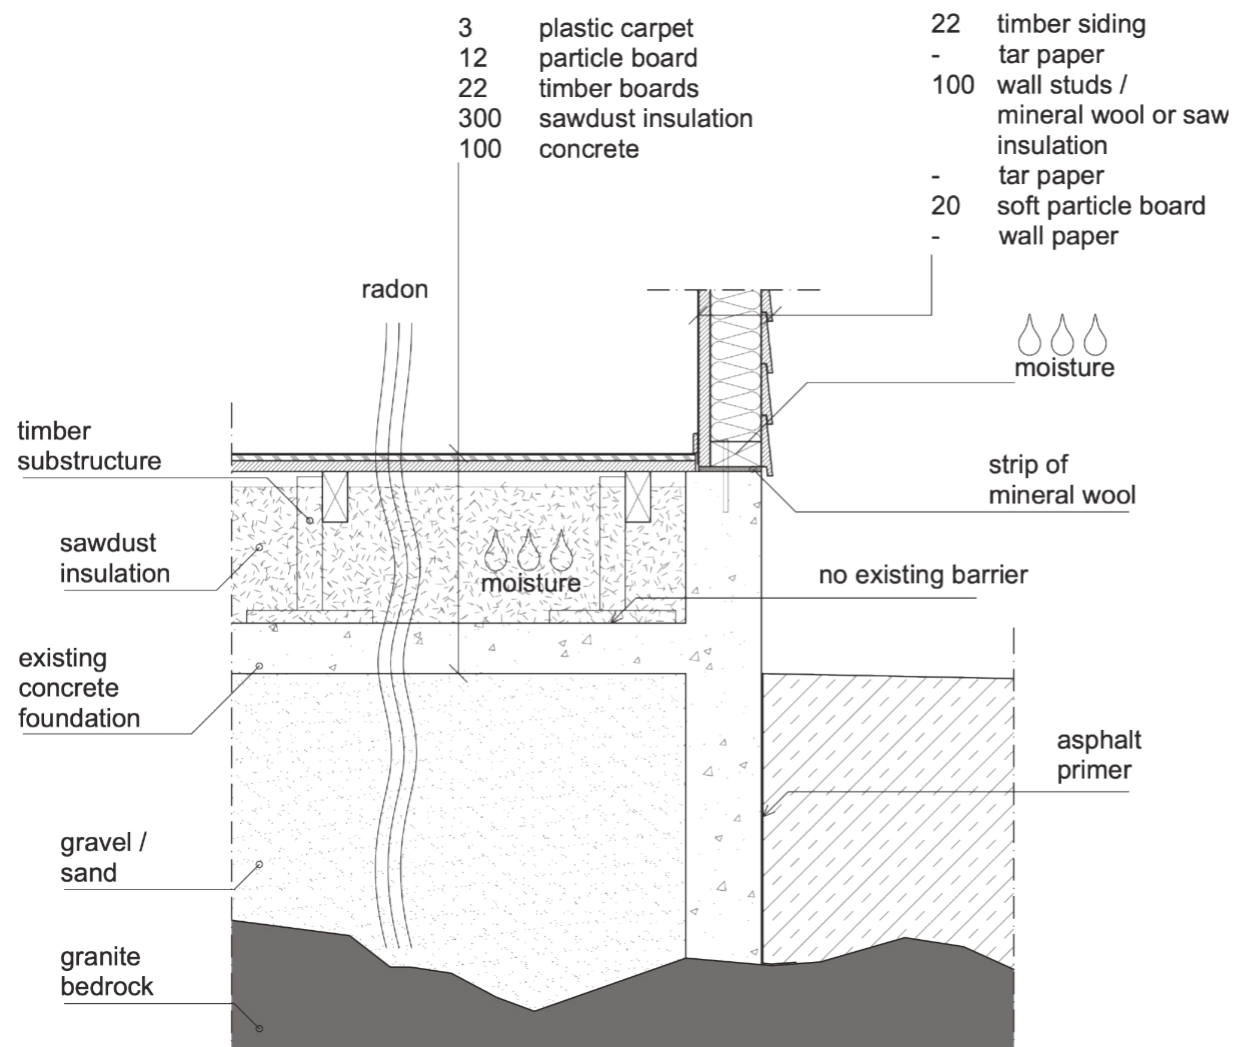
The existing foundation in this thesis project is precisely like the one described earlier, one where the concrete slab is resting on poorly drained ground and is insulated from above with sawdust combined with a wooden subfloor resting against the concrete as seen in drawing below. There is no chance to install new insulation underneath the existing foundation, but with the correct approach where the timber substructure is removed and new protection against moisture is installed one can get a good solution. This is shown in a design proposal in chapter 6.

Section D3-D3 of existing foundation, showing some of the flaws in need of solutions.

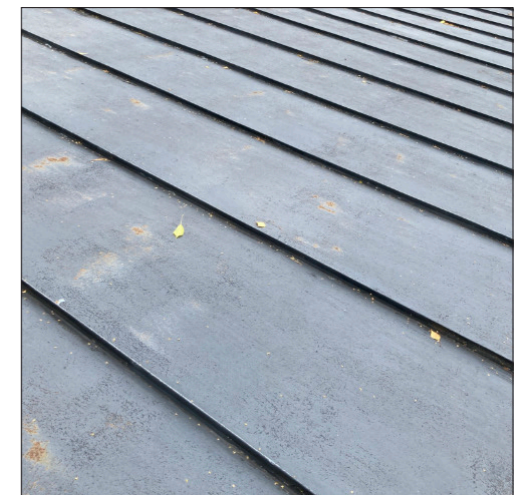
Painted sheet metal was used as roof covering. Spots of rust is visible all over the roof. Sunlight has made an impact on the paint during the years.

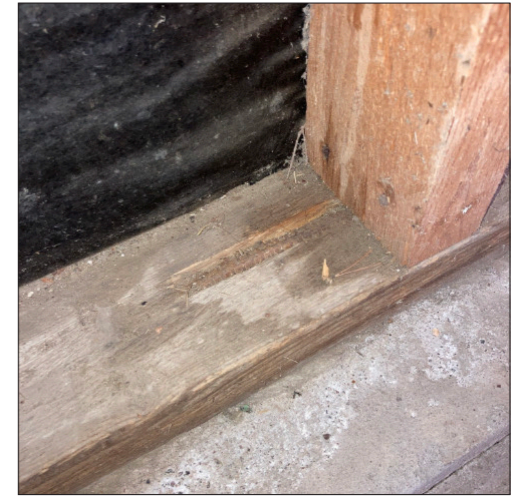
The timber sole plate is anchored to the concrete foundation with a bent 10 mm rebar.

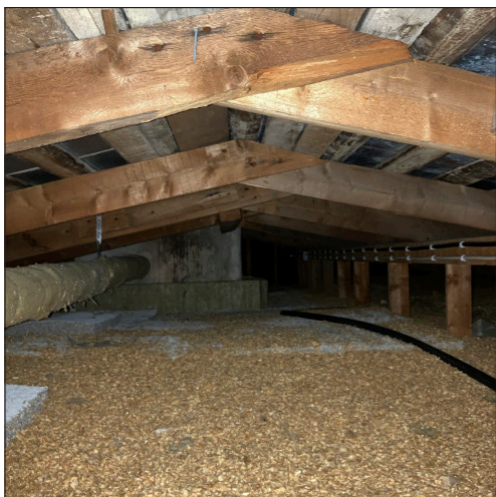
Sawdust was used as primary insulation. Over time some fireproofing insulation and cellulose insulation has been added. The sawdust layer is about 300 mm thick and the roof beams have a 65x130 mm dimension.

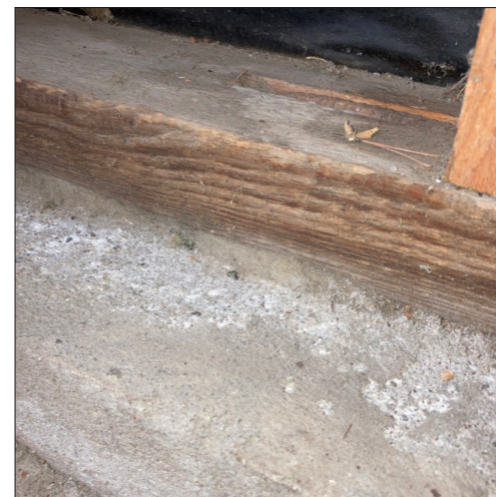
There is no vapor barrier between the concrete foundation and the timber sole plate. Only a strip of mineral wool was used to separate the timber structure from the foundation.

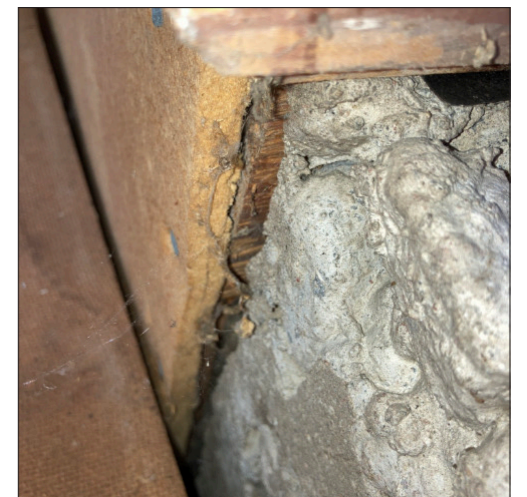
At some points there seems to be nothing separating the timber sole plate from the foundation.

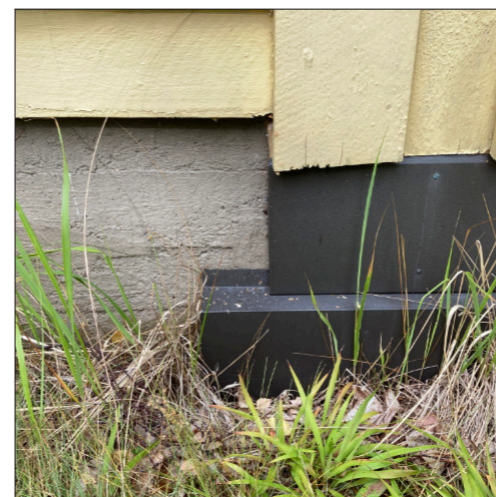
Parts of the foundation have been covered in sheet metal to create a barrier to the ground at parts where the building turns to a souterrain type, no one knows what can be found behind it.

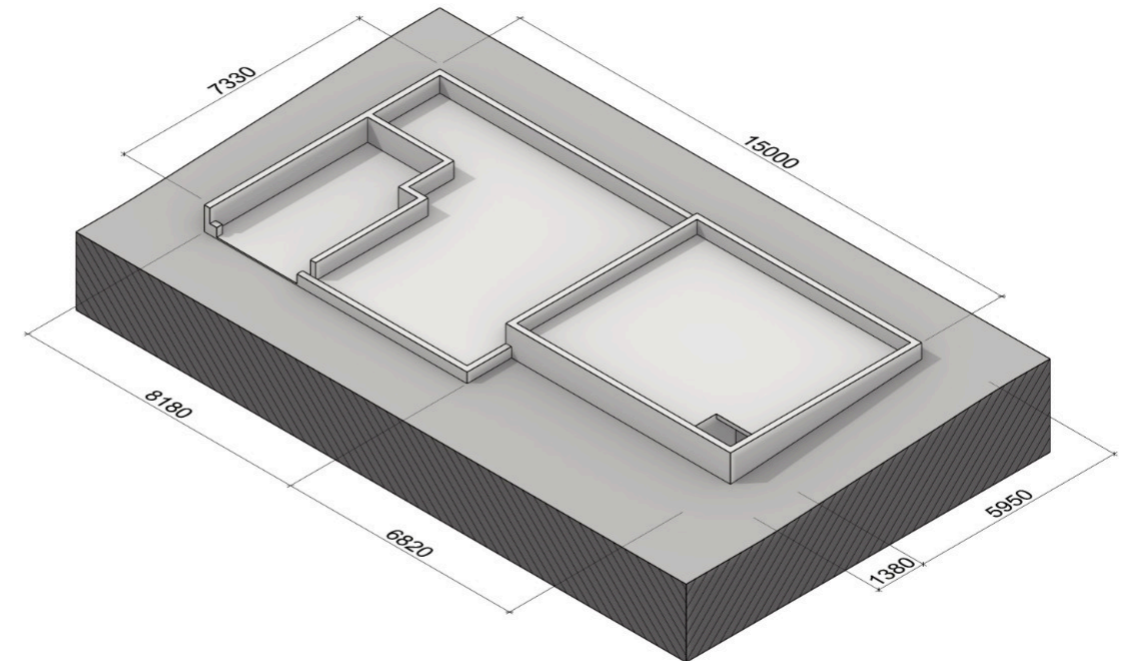
Foundation as it looks today. Isometric 1:200

After reviewing the gathered documentation as shown in earlier chapters, a conclusion was taken that only the foundation would be saved and then corrected to fit an entirely new house. Since concrete is rather co2 intensive, this solution should still saves some resources and emissions even if the house is not entirely saved. Although labor intensive, parts of the wooden structure and facade could be reused in parts of the new building, for example as backing board in the facade siding or custom furniture, flooring or wall covering in the studio spaces. The image above shows the concrete foundation of the existing building which will be the starting point for a design proposal in chapter 6.

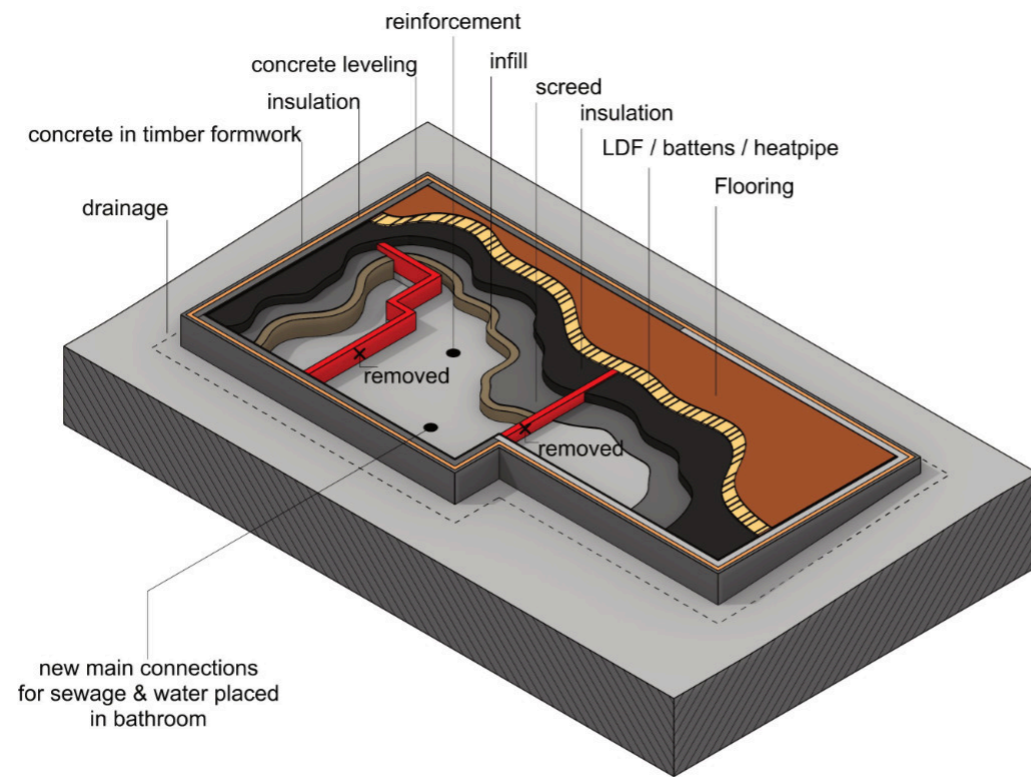
Transformation of the existing foundation. Isometric 1:200

Image above illustrates the multiple changes that could be done to the foundations to better fit the new building. The changes involves removing some parts and casting some new to the old foundation to get a good level to attach the new wall structures to. Externally the foundation is insulated and an additional concrete cast is made to create a sandwich like structure. The form works for this can be made from the same timber boards that was used in original cast in the 60's since some of the boards have been saved as flooring in the attic as seen on page 34. Drainage is installed around the house and the ground is set to the right levels. In the middle of one of the rooms, an reinforcement needs to be done to carry the load of the ridge beam and roof trough a pillar. This could be avoided if the dimension of the ridge beam and pillars were to be larger. The lowest

part is then infilled with Light extruded clay aggregate (LECA) or other material with similar function and a screed is cast to level the entire floor surface which is then insulated with foam glass, creating the base for a floating floor that holds the heating pipes and also the timber floor boards. Water and sewage pipe can be fitted in the insulation. Fortunately there is an inspection spot for the existing sewage right where the new bathroom will be. The foam glass is a sustainable insulation made from recycled glass and it is also not moisture permeable, making good for stopping radon gas. An other less expensive option would be recycled EPS foam combined with a membrane for vapor and radon proofing or a version with foam glass granulate.
