Bond Behaviour of Naturally Corroded Reinforcement in Concrete Structures

Experimental and Numerical Study

Master of Science Thesis in the Master's Programme Structural Engineering and Building Performance Design

Department of Civil and Environmental Engineering
Division of Structural Engineering
Concrete Structures
CHALMERS UNIVERSITY OF TECHNOLOGY
Göteborg, Sweden 2012
Master's Thesis 2012:80

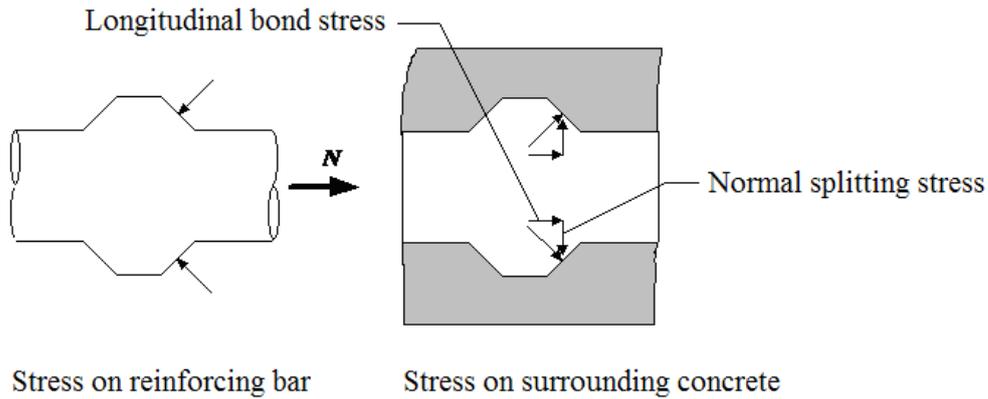
Figure 2.1 Bond between a ribbed bar and the surrounding concrete by mechanical interlocking, from Magnusson (2000) modified by Berg and Johansson (2011).

Stage III is for higher bond values, $\tau > 1-3 f_{ct}$. The stresses and the wedge action rise. The stress component on the rib can be split into two components, longitudinal bond stress component causing the transverse cracks and normal stress component causing longitudinal cracks to form, this is the cause of concrete splitting, it can be seen on figure 2.1. The tensile force is resisted by circumferential tensile stresses in the concrete, see Tepfers (1973). The bond strength and stiffness are assured mostly by interlocking action between the reinforcement and the concrete and secondly by friction, see FIB (2000).

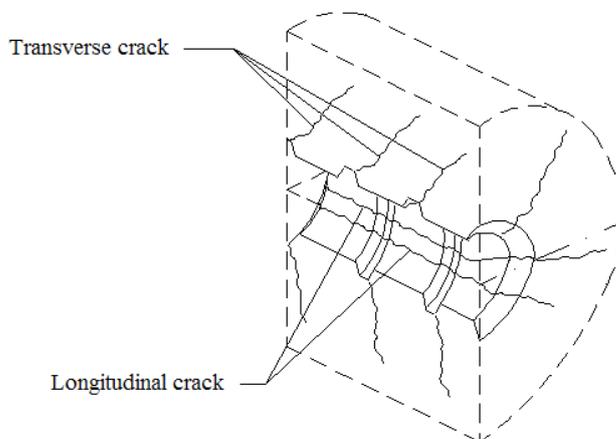
Figure 2.2 Longitudinal and transverse cracks caused by bond, modified from FIB (2000) by Berg and Johansson (2011).

Stage IV leads to pull-out or splitting failure. Many factors can influence the type of failure. They can be: the degree of confinement, transverse reinforcements, and size of concrete cover and diameter of reinforcement bars. Splitting failure occurs when radial stresses causes longitudinal cracks that propagate up to the surface, it is typical when bar diameter is large and/or the concrete cover is small. Pull-out failure is caused by shearing off the concrete keys between the ribs of the reinforcement bars. That usually happens when the concrete cover is thick and/or the transverse reinforcement is sufficient. Splitting failure is weaker than the pull-out failure, see Sæther (2011).

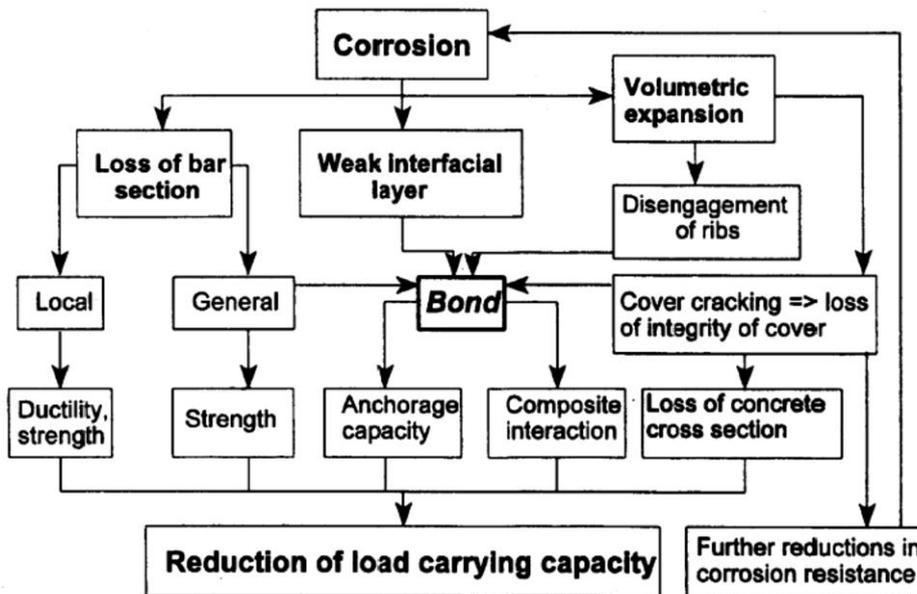
Figure 2.3 Effects of Corrosion on residual strength, from FIB (2000).

Corrosion of the reinforcements leads to loss of cross sectional area of the reinforcement bars, weak interface layer, and volumetric expansion; this is demonstrated in figure 2.3. The latter two affect the bond between the bar and surrounding concrete; tests have shown that the loss of bond is potentially much more severe than loss of cross section, see FIB (2000). The anchorage capacity of the structural member is threatened more by general corrosion rather than localized corrosion, see FIB (2000). Localized corrosion produces ions that have lower volume per unit mass than general corrosion and therefore, cracking is less likely to be caused from localized corrosion, see Val *et al.* (1998). Because the rust products occupy more volume than steel, corrosion can lead to cracking, spalling or even delamination of the concrete, see Figure 2.4.

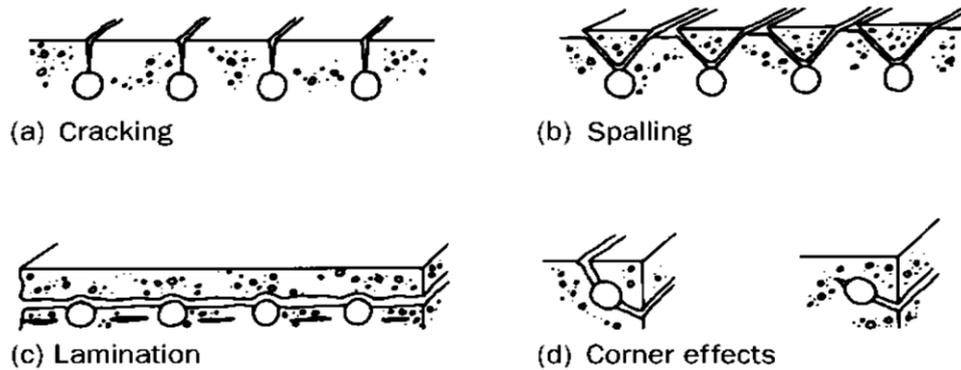
Figure 2.4 Different forms of damage from steel reinforcement corrosion, from Browne (1985).

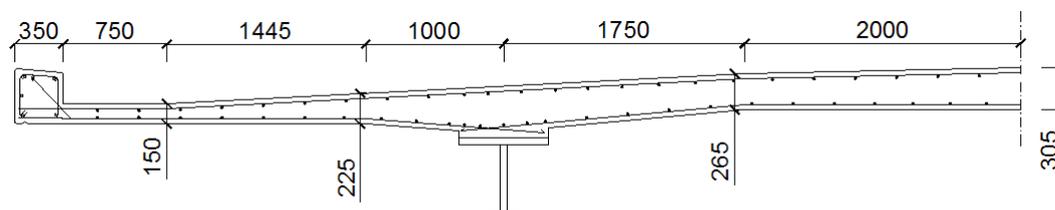
Figure 3.2 Section cut of the bridge deck.

The test specimens are originated from Stallbackabron in Västra Götaland, the bridge is part of road E45 and road 44 and crosses the Göte Älv River in Trollhättan. It is a link between Stallbacka industry area and Överby shopping centre and is the most important link between Trollhättan and Vänersborg. The bridge has been in service since 1981. In 2010 it was recorded that each day 30,000 vehicles travel across the bridge. The bridge is one of the largest bridges in Sweden, 1.392 meters long. It has a navigable height of 26 m and four lanes, total width of 14.95 m. It is a composite bridge the deck is made of reinforced concrete resting on steel beams. A cross section of the bridge deck can be seen in Figure 3.2.

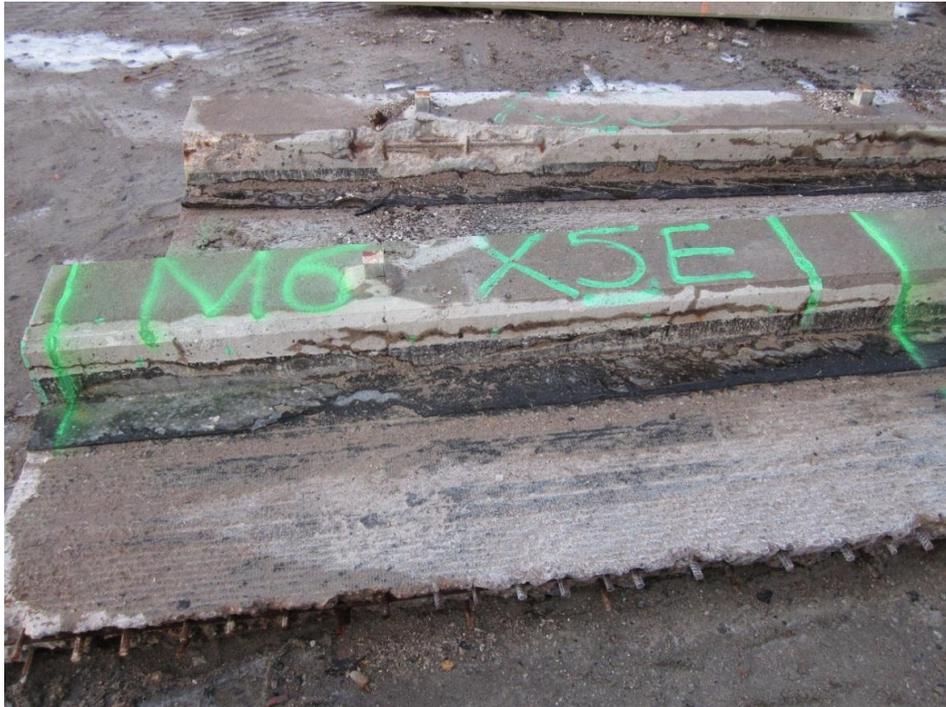
Figure 3.3 Edge beams and part of the slab after being sawn from the bridge.

Even though it had only been in service for 30 years extensive rehabilitations were needed. The reason for that is mainly poor design of the bridge. Edge beams were carrying more load than they were designed for and subsequently they cracked because of that. Another factor is that the steel railing was cast into the concrete and causes stresses in the edge beam. It was noticed that transverse cracks initiated at the

railing sometimes were all across the cross-section. After cracking is initiated corrosion is more rapid because it is easier for the de-icing salts to penetrate through the concrete to the reinforcement. De-icing salts are considered to be one of the biggest causes of corrosion of steel in concrete; however, research has shown that using de-icing salt is still more economical than using the other alternatives, see Broomfield (1997). In order to extend the service life of the bridge, there was a need to replace the edge beams and the outermost part of the slab. The edge beams were suitable for this research since they are naturally corroded and have different extent of damage, from no damage to corner spalling. In Figure 3.3 part of an edge beam can be seen.

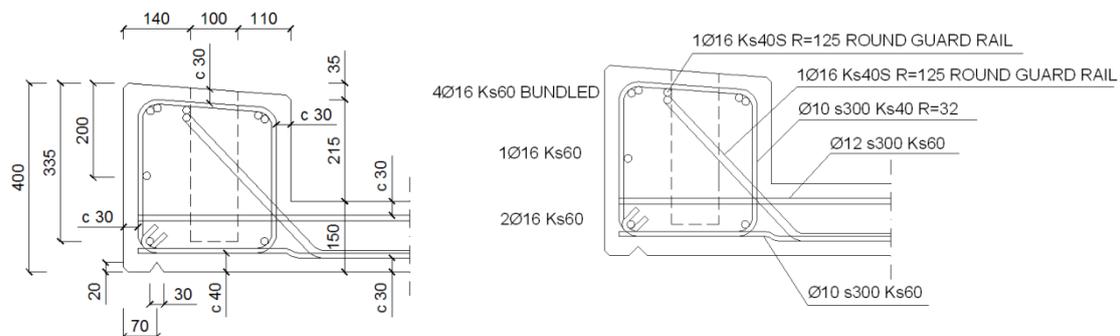
Figure 3.4 Section cut of the edge beams.

Stirrups are made of Ks40 and are of diameter 10 mm and with spacing of 300 mm. Longitudinal reinforcement is made of Ks60 and is of diameter 16 mm. In the bottom there is one bar in each corner and in the top there are two bars bundled in each corner. There is also one longitudinal bar on the outside edge of the beam. The guarding rail is cast into the concrete with additional reinforcement around those rails, as can be seen in Figure 3.4.

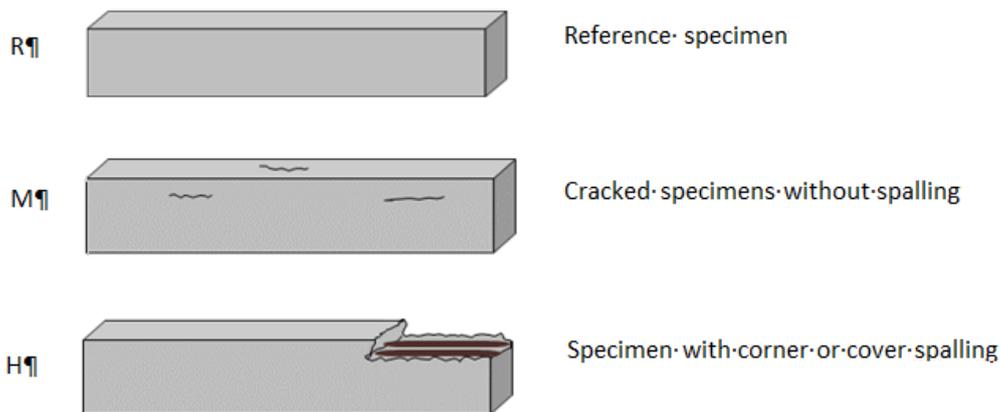
Figure 3.5 Classification for damage of test specimens.

Tests on 8 specimens from the southern part of the bridge were tested by M. Tahershamsi (2012). In this thesis specimens from the northern part of the bridge were tested. Initially it was planned to test 15 specimens but due to problems with measuring device, testing was delayed for five weeks. Therefore, it was not possible to test all the specimens within this thesis project; 10 specimens were prepared but only five were tested. Berg and Johansson established a classification system that Tahershamsi began to use. In that system, the beams were classified based on how much damage they had. There were five classes. That system turned out to be too complicated in practice so a new system was established and is used in this thesis. That system consists of 3 damage classes: reference, without any visible cracking; medium damage where the specimens were cracked but did not have any spalling; and finally a high damage where the specimens showed both cracking and spalling of the concrete cover, see Figure 3.5. The beams were named with a letter according to damage class and a number, for example M5, a medium damaged specimen number five. That is the same naming system used earlier by Berg and Johansson, and Tahershamsi in 2011 and explains why we start with number M4. The five specimens tested in this round were randomly taken from a group of 15 specimens which explains the non-consecutive naming.

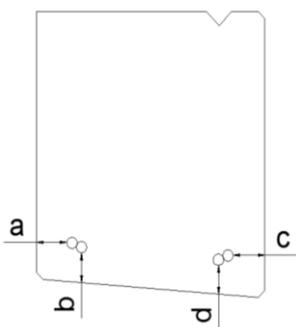
Figure 3.6 Notations for concrete cover.

When working with the specimens deviations from drawings were noticed. Concrete cover was not accurate and there was reinforcement bars in the beam that were not on the drawings. The bars were also spliced; therefore in some of the beams at certain locations there was one extra bar. Deviations of the concrete cover can be seen in Table 3.1 for both ends of each test specimen. Notations are found in Figure 3.6.

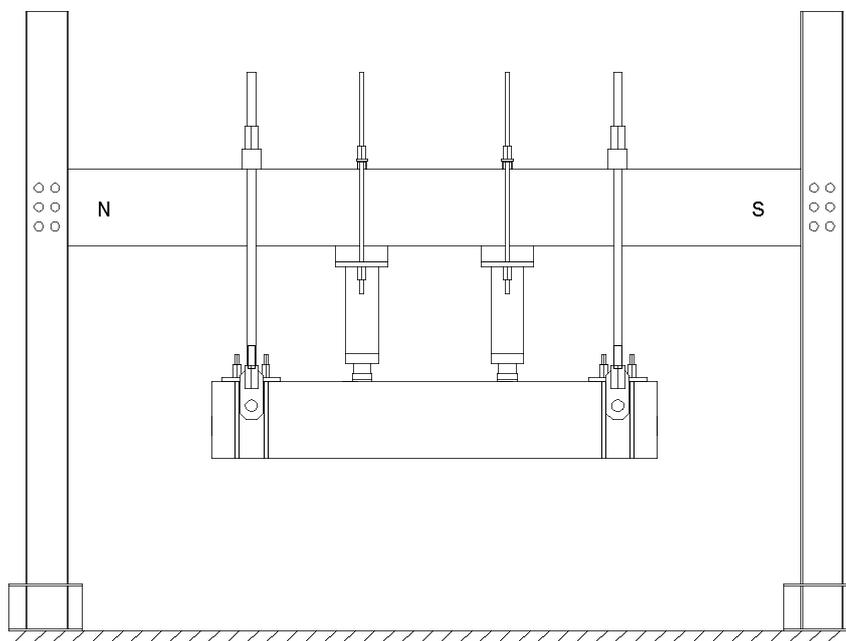
Figure 3.7 Test set up.

Detailed design of the test set up and strengthening of the beams were needed in order to secure that bond slip failure would occur. Test set up and strengthening designed by Berg and Johansson was used. A four point bending test indirectly supported was used, as can be seen in figure 3.7. Directly supported test setup could not be used since the support pressure would improve the bond of the reinforcement over the support.

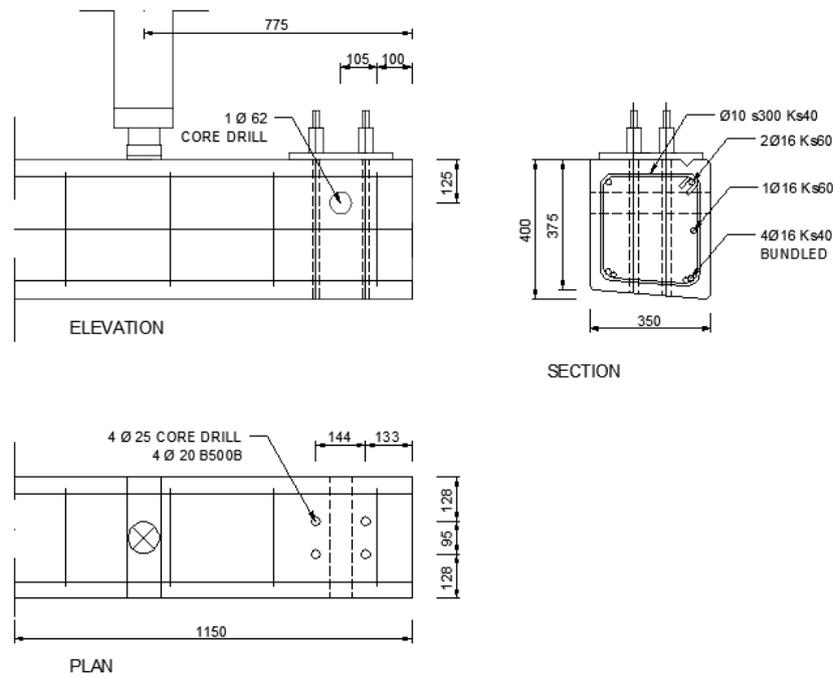
Figure 3.8 Load arrangement, placement of the support and the strengthening bars.

Anchorage resistance of indirectly supported beam is lower than for directly supported beam. To be able to get bond failure the beam needed to be strengthened in order to transfer the shear force up to the support. That was done with four $\varnothing 20$ mm fully thread reinforcing bars of high yield steel glued to the concrete with epoxy and anchored at the top with a steel plate and four hexagonal nuts at each end. The epoxy

used came from Nils Malmgren AB. It is a two component material, injection *NM Injektering INP 32* and hardener *NM Härdare 24 L*. According to the manufacturer, the tensile strength of the component is 20 MPa and the adhesion to the concrete is 3.5 MPa.

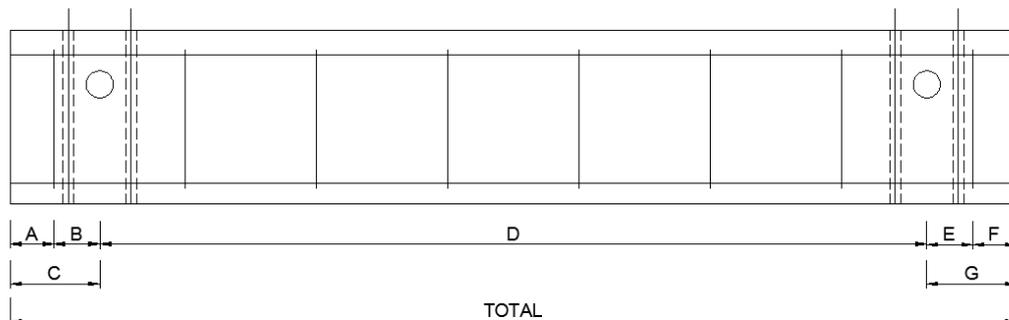
Figure 3.9 Position of the support holes.

Before drilling the specimens, the end stirrup had to be carefully located using a detector Profometer 3 – rebar locator. Next, the position of the support hole was marked, and finally, the position of the strengthening was marked. In few cases it was necessary to move the support hole closer to the centre in order not to drill through the stirrup. In those cases the support hole on both sides was moved closer to the centre in order to keep symmetry, see Figure 3.9 and table 3.2 for variations between specimens.

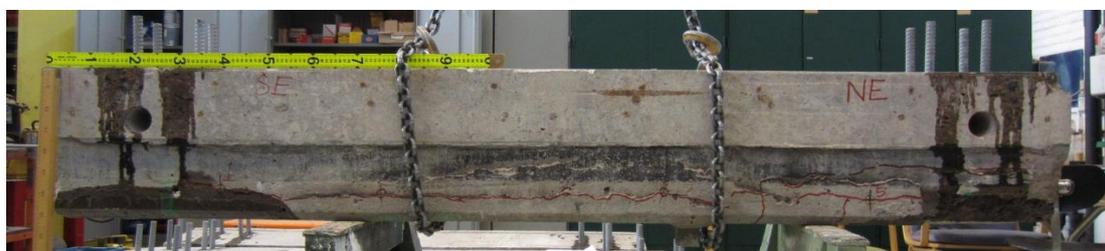
Figure 3.10 Example of documentation of specimen.

Before testing the specimens were documented. All visible cracks were marked and crack widths were measured and compared to old measurements if they existed, see Appendix E and Appendix F. The crack widths were from 0.1 mm to 3.2 mm. The specimens were thoroughly photographed from various angles, to keep the former look of the beams documented, see examples in Figure 3.10 and Figure 3.11 (both from beam M6).

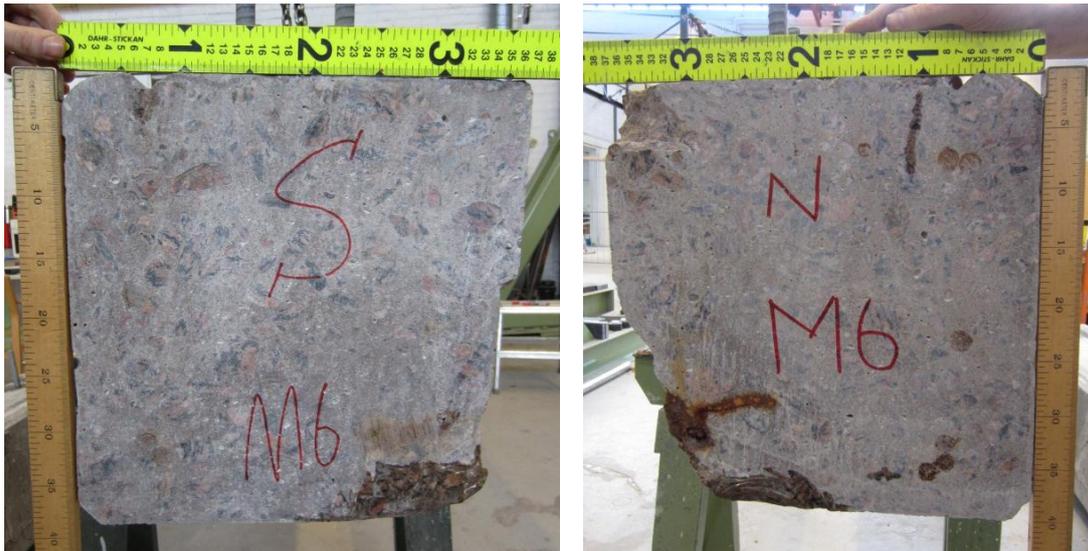
Figure 3.11 Example of pictures for documentation of specimen.

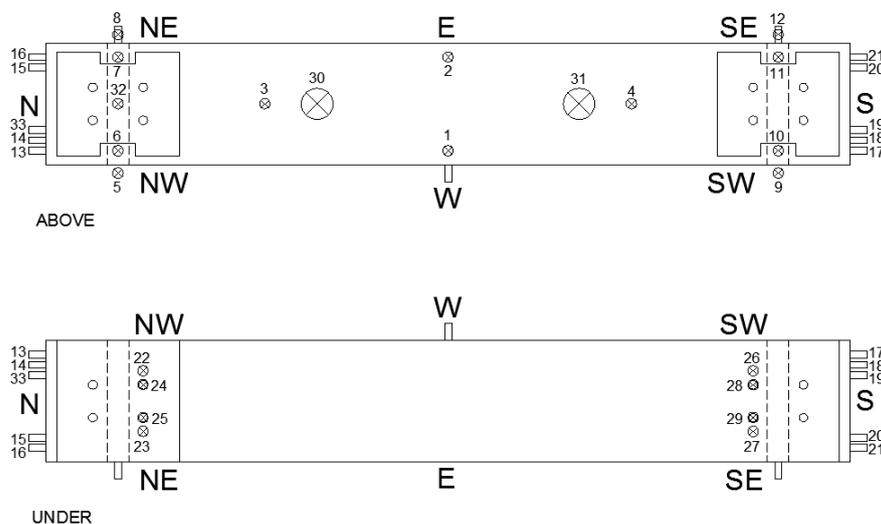
Figure 3.12 Numbering of LVTD:S on the top and bottom of R6, M4 and M6.

Before each test a number of LVTD:s were connected to the beam, 4-5 on each short side, 15 on the top, 8 on the bottom and 3 lateral. The LVTD:s measured the displacements during loading. The position of the LVTD:s for beam M5 is shown in Figure 3.12. The LVTD:s on the short sides measured free end slip of the main bars. Those LVTD:s are put on a steel plate which is drilled to the concrete. The mid of the plate is 185 mm from the top of the beam. The LVTD:s on the bottom measured free end slip of the strengthening bars. Those are connected the same way as the short end LVTD:s, the mid of the plate is 275 mm from the support. The LVTD:s on the top measured mid span deflection, deflection close to the load, and support settlements, both on the concrete and on the steel hanger. Those LVDT's are fastened to stands on the floor. When testing M5 all LVTD:s on the short sides measured displacement of the reinforcement. Next, when testing specimen M9, a LVTD number 33 was added and that and LVTD number 19 measured the displacement of the concrete on each short end. When testing the last three specimens 4 LVTD:s were moved to measure the displacement of the concrete close to the bottom of the strengthening bars, see Figure 3.12.

After two tests it was decided to change the setup of LVDT:s so that it became possible to measure free end slip of the strengthening bars, see arrangement in Figure 3.12. In Figure 3.23 and Figure 3.24 free end slip of the strengthening bars can be seen. Slip of the strengthening bars were observed before ultimate load was reached, the magnitude of the slip for specimens R6 and M4 are very small compared to the free end slip of the main reinforcement. For specimen M4 it is clear that the strengthening bar on SE side started to slip faster at a load level of 150 kN and slips till a load level of 225 kN is reached, then SW side started to slip faster and the force is transferred to the SW bar and the free end slip of the strengthening bar on the SE side decreases.

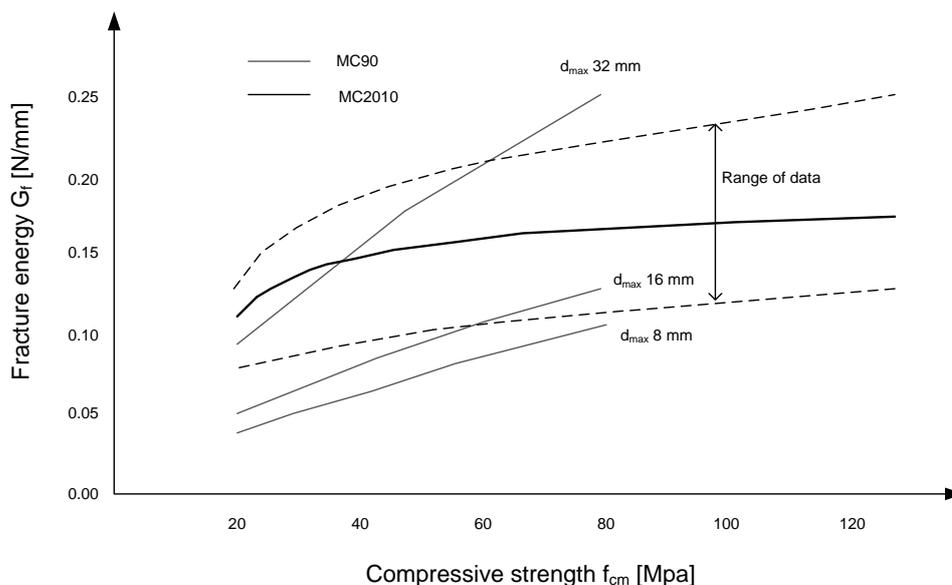
Figure 3.13 Comparison of fracture energy between Model code 1990 and model code 2010, modified from Müller (2009).

Calculated fracture energy for the concrete with mean compressive strength of 48 MPa was 0.147 N/mm. However, from Figure 3.13 it can be seen that the fracture energy varies from 0.10 N/mm to 0.19 N/mm. Since no reliable data regarding the aggregate's specifications of the constructed bridge, could be found, mean value was used, see Table 3.3. This also gave reasons to run analysis with different fracture energy values in order to get better correlation between the experiments and the FE analysis, see 4.3.

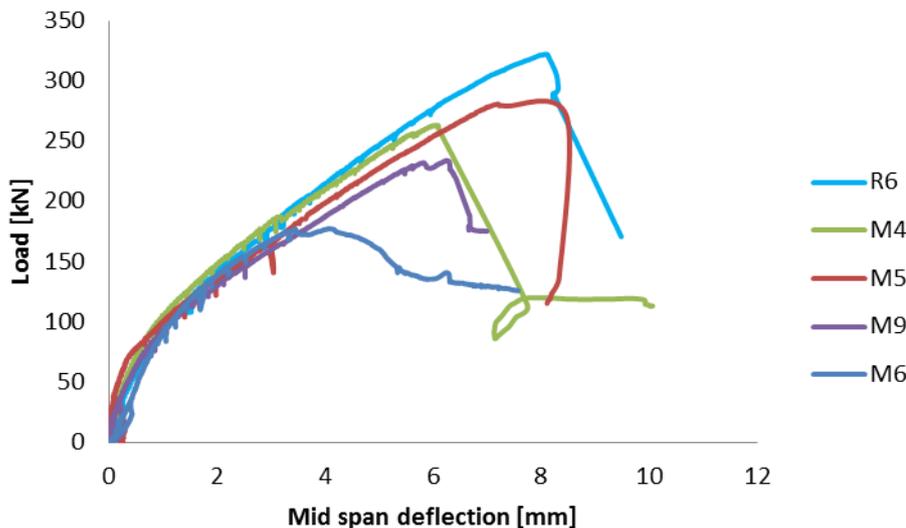
Figure 3.14 Average load as function of mid span deflection for the test specimens.

As can be seen in Figure 3.14 all the specimens had similar behavior up to the failure load. However, the maximum load is quite different for the specimen; it varied from 178 kN to 316 kN. The specimens were first loaded up to 35 kN and then unloaded. Then they are loaded to their maximum capacities. At a load level of approximately 75 kN the loading was stopped and all the visible surface cracks were marked if. This was done in intervals of every 10 kN after the load level of 75 kN; which explains the disrupts which can be seen in Figure 3.14 where the load is plotted versus the mid span deflection. The load is average of the two point loads, and the mid span deflection is taken as the average of the measurements of the two LVDT:s in the mid span, corrected for the deformations of the supports, measured on top of the specimen.

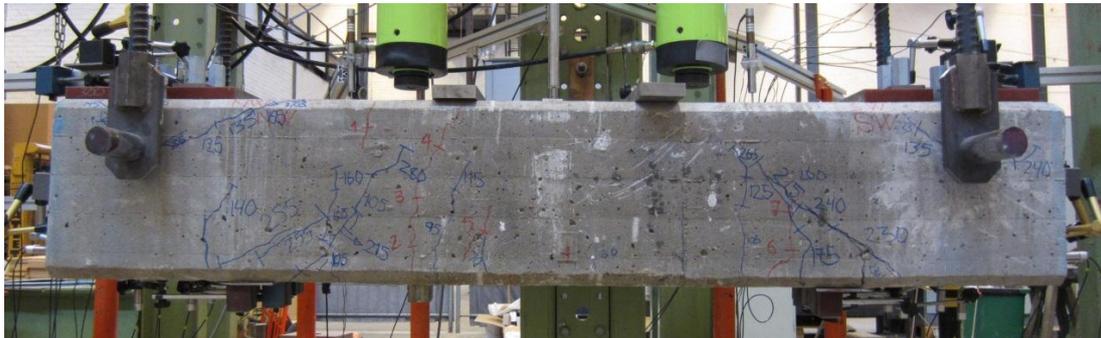
Figure 3.15 Final crack pattern of west side of beam M5.

As can be seen in Figure 3.15 and Figure 3.16, after the shear crack was initiated, the crack propagated upwards and later another shear crack started closer to the support. That crack propagates further upwards and in some cases it intersected the earlier shear crack. When free end slip of the strengthening bars was measured

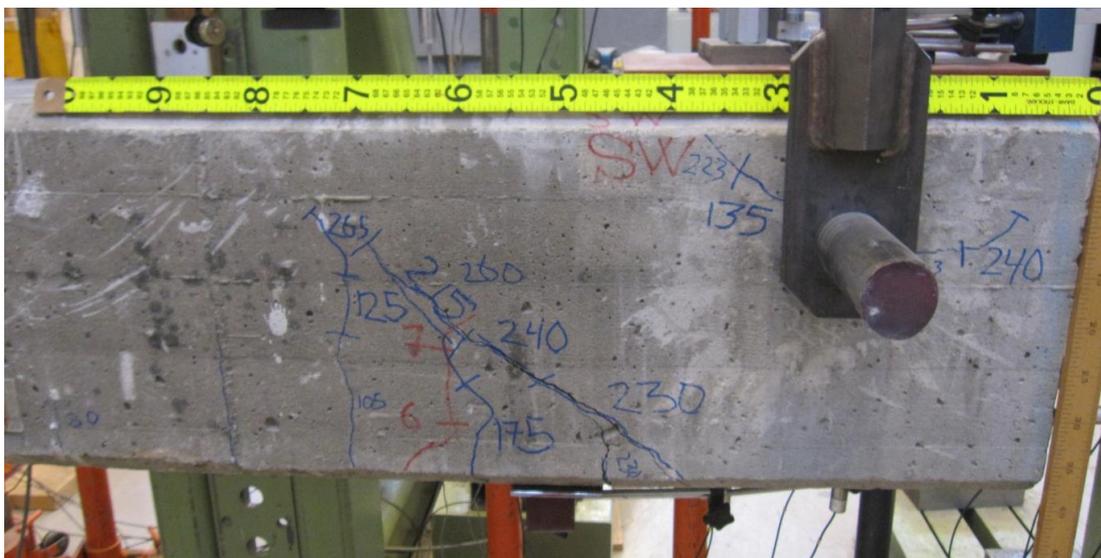
Figure 3.16 Final crack pattern of the failure end on the SW side of the specimen M5.

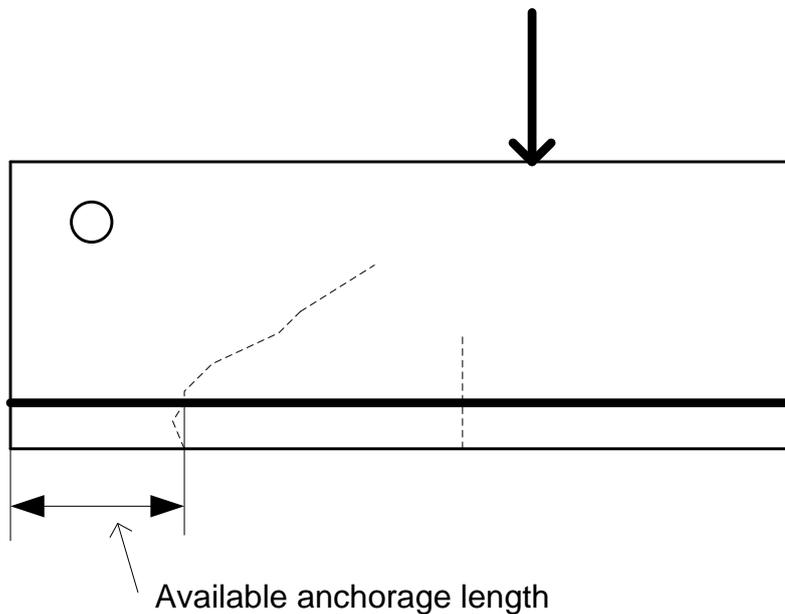
Figure 3.17 Explanation of the available anchorage length.

available anchorage length was 0.91 for M6 compared to 0.62-0.74 for the other specimens, see Table 3.5.

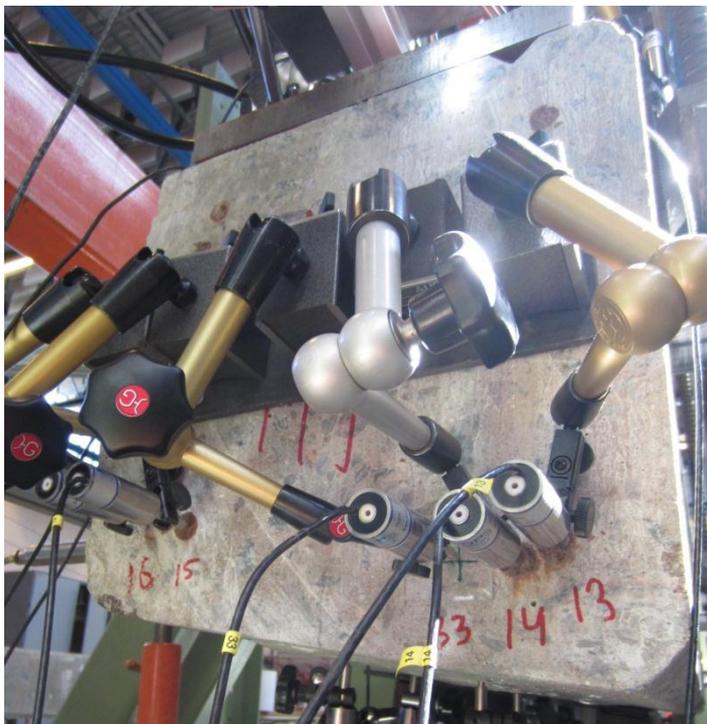
Figure 3.18 LVDT:s on short side of specimens.

On Figure 3.19 the displacement for the bottom reinforcement for specimen M5 has been shown, it can be seen that a negative slip was measured in the tests. These values were not free end slip but caused by deformation of the beam's end section under loading. That was later verified by having one LVDT on each end of the beam measuring the displacement of the concrete and the other four LVDT:s were measuring the displacement of the reinforcement, see Figure 3.18.

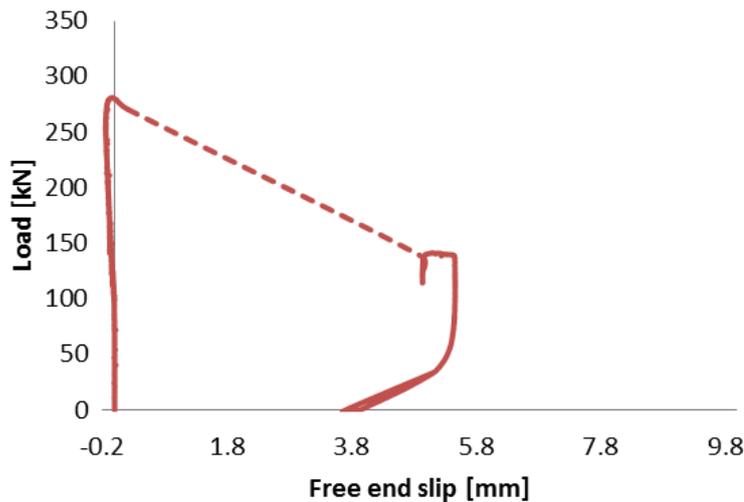
Figure 3.19 Displacement of main reinforcement in test specimen M5.

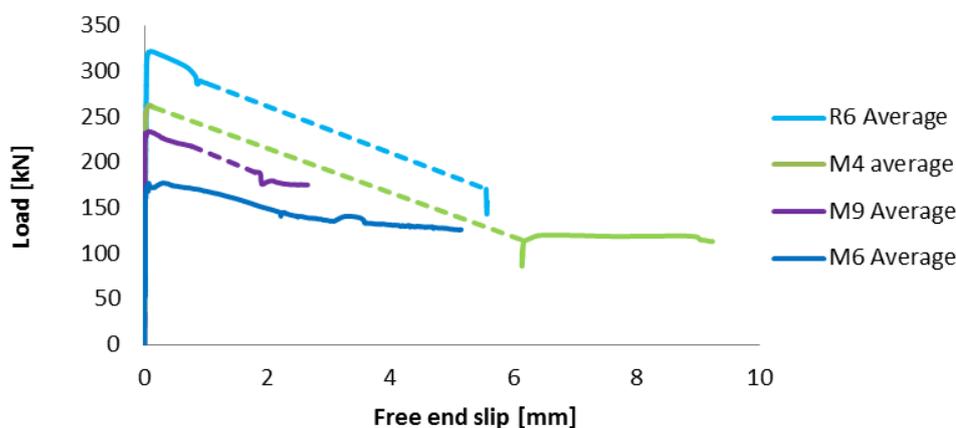
Figure 3.20 Free end slip of main reinforcement, dashed line represents were the measurements are not continuous.

The difference of the displacement of the concrete and the reinforcement can be seen in Figure 3.20. Behavior of the free end slip in the early stages can be seen in Figure 3.21. Those values should be considered carefully since placement of the LVTD on the concrete was not in line with all the main reinforcement bars. Measurable free end slip started for a load between 170 and 307 kN which was 90 to 97 % of the maximum load and the final anchorage failure occurred at the moment of maximum load. However load level of 80 to 140 kN very small free end slips were seen in the analysis less than 0,01 mm, those values are not considered measurable. When the bar started to slip, a crack formed along the bar either on the bottom or on the side, see Figure 3.22. The LVDT:s gave one measurement every second, in Figure 3.19 and Figure 3.20 the dotted line represents only one measurements. From that it can be seen that the failure for specimens M4, M5 and R6 was more abrupt than the failure of specimens M6 and M9.

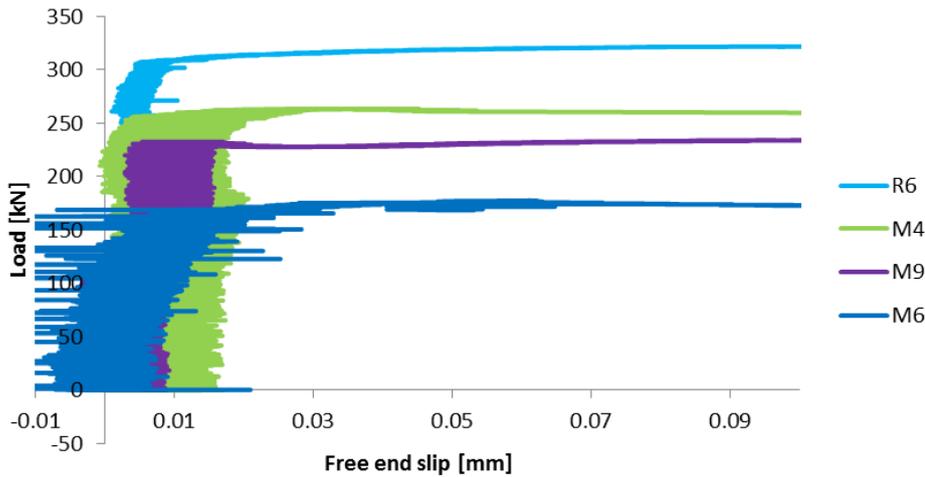
Figure 3.21 Enlarged free end slip of main reinforcement.

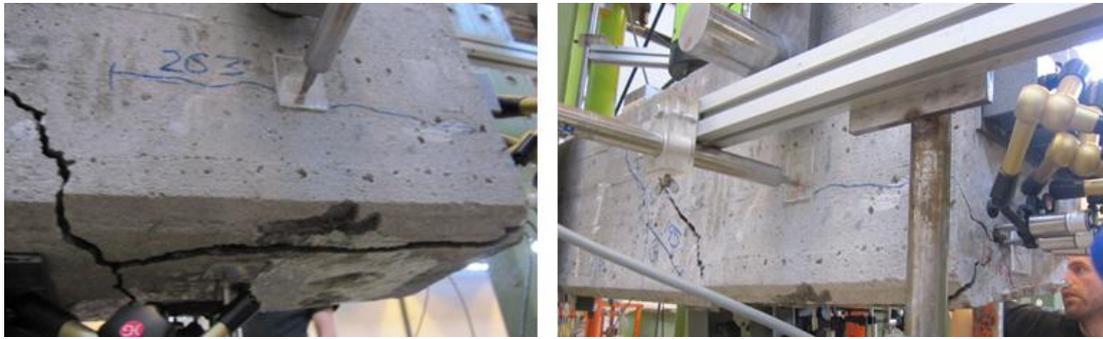
Figure 3.22 Crack along reinforcement on beam M4.

reinforcement but usually smaller slip was observed than for the main reinforcement. After the main reinforcement start to slip a splitting crack forms along the bar in some cases both on the side and on the bottom of the specimen, see Figure 3.22.

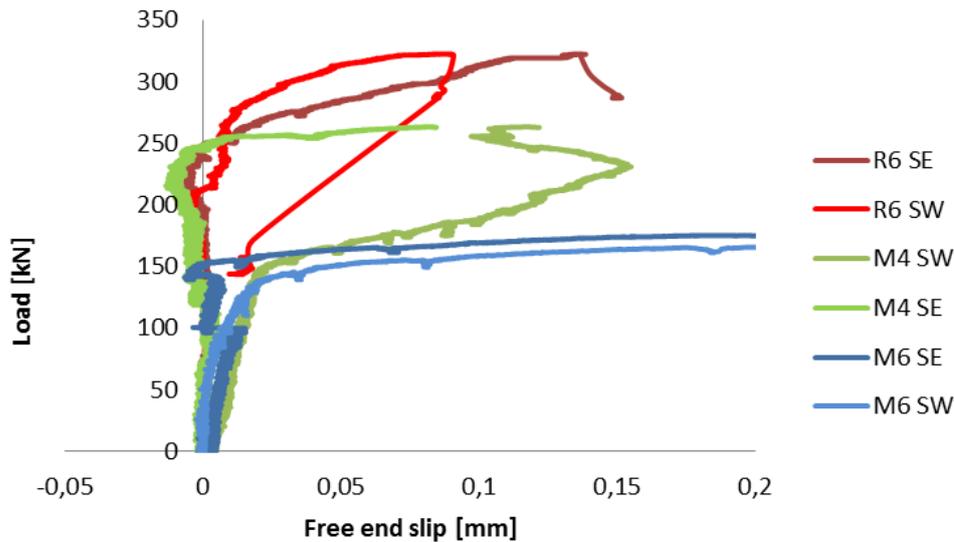
Figure 3.23 Enlarged free end slip of strengthening bars.

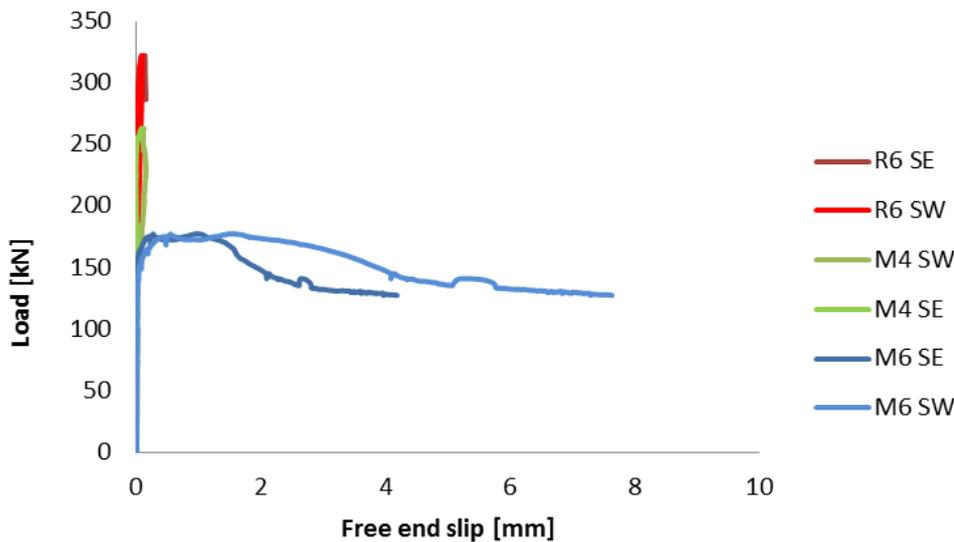
Figure 3.24 Free end slip of strengthening bars.

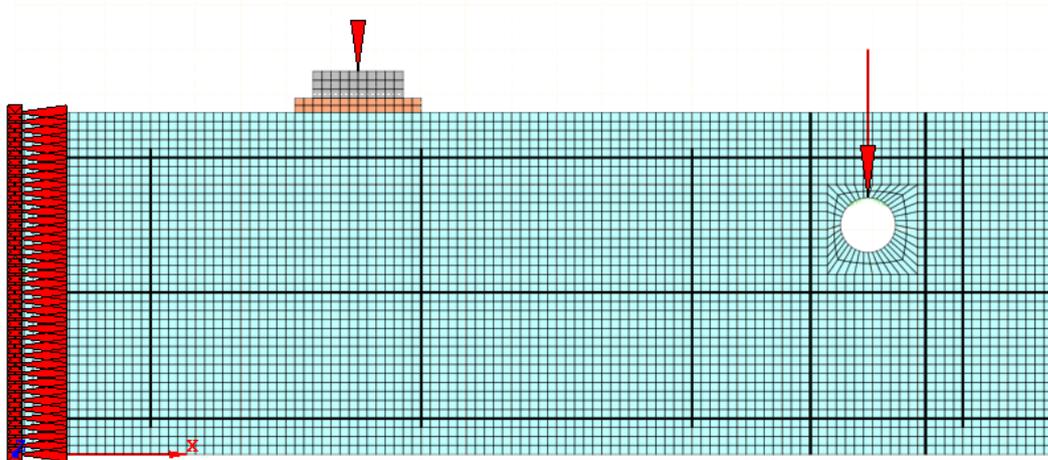
Figure 4.1 Picture of the FE model.

A 2D model was modified from Berg and Johansson (2010). Only half of the beam was modelled with symmetry line on one edge, see Figure 4.1. Non-linear FE analysis based on non-linear fracture mechanics was carried out. The model was created using Midas FX+ version 3.0.0 post- and pre-processor. Results were also analysed in Midas FX+. All the analyses were run by using Diana Version 9.3.0 on a cluster; this was mainly because it was easier to run a phased analysis on a cluster than on Windows. It was also beneficial with regard to the calculation time. All the material data had non-linear response; the material data can be seen in the data file in Appendix B. The model consisted of about 5300 elements and element size was 10 mm. Execution time was around 30 minutes.

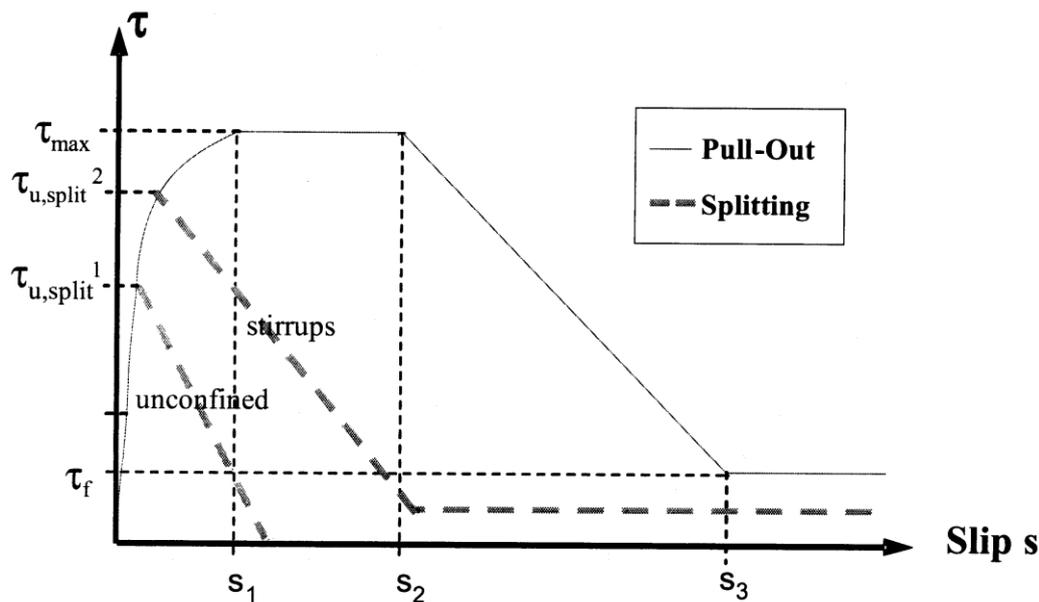
Figure 4.4 Bond slip curve, from FIB (2010).

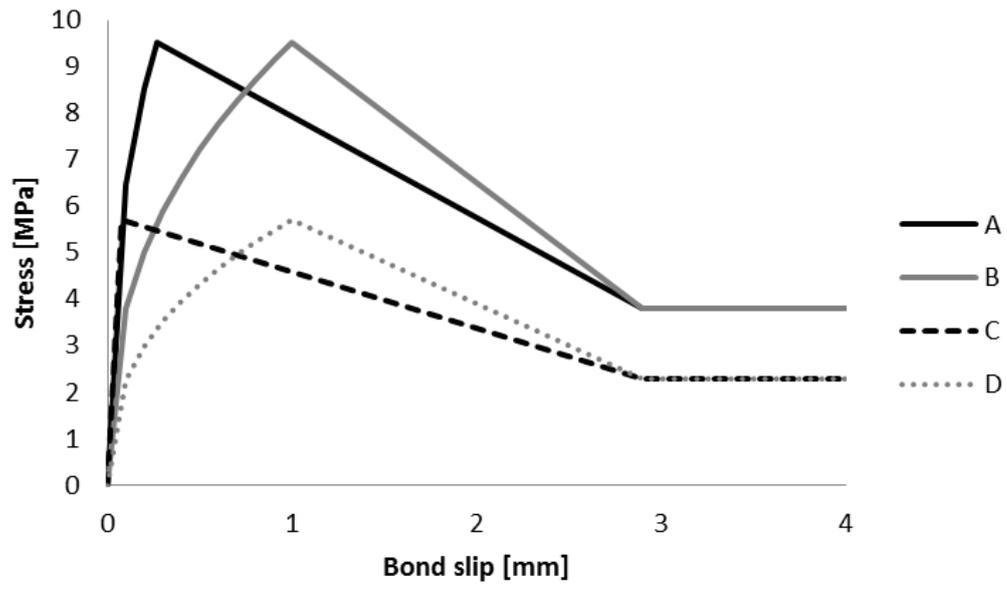
Figure 4.5 Bond curves used for the bottom strengthening in FE analysis.

Both bond curves A and B were reduced for worst corrosion conditions according to Table 4.2. The bond curve used for the analysis can be seen in the Figure 4.5.

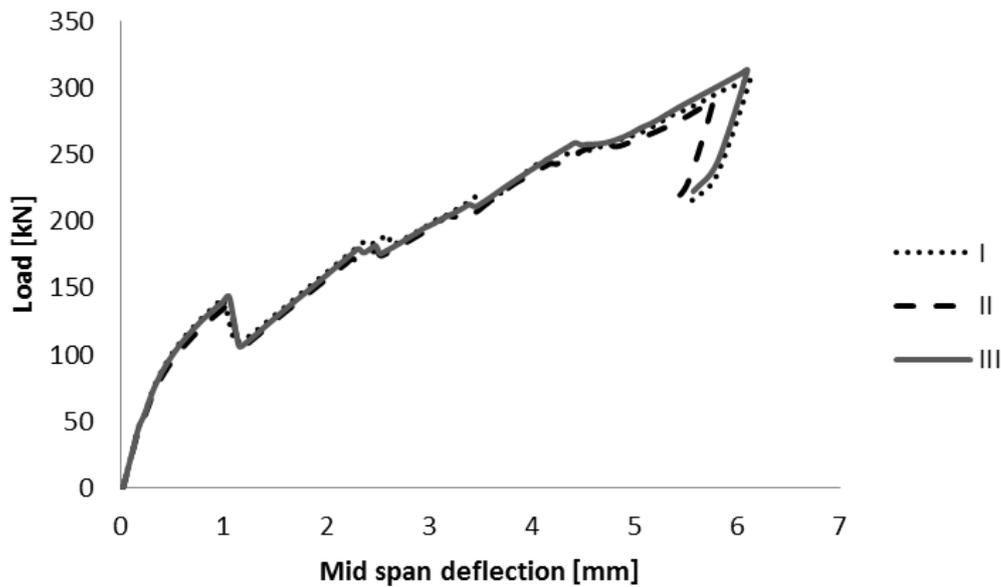
Figure 4.6 Load versus mid span deflection for analyses I, II and III.

In Figure 4.6 and Figure 4.7, the behaviour of analysis I, II and III can be seen. The load deflection for the analyses follows the same behaviour but they have different ultimate load. As described in chapter 3.3.1, there are uncertainties in the material parameters. After consideration, it was decided to have analysis III as a reference analysis.

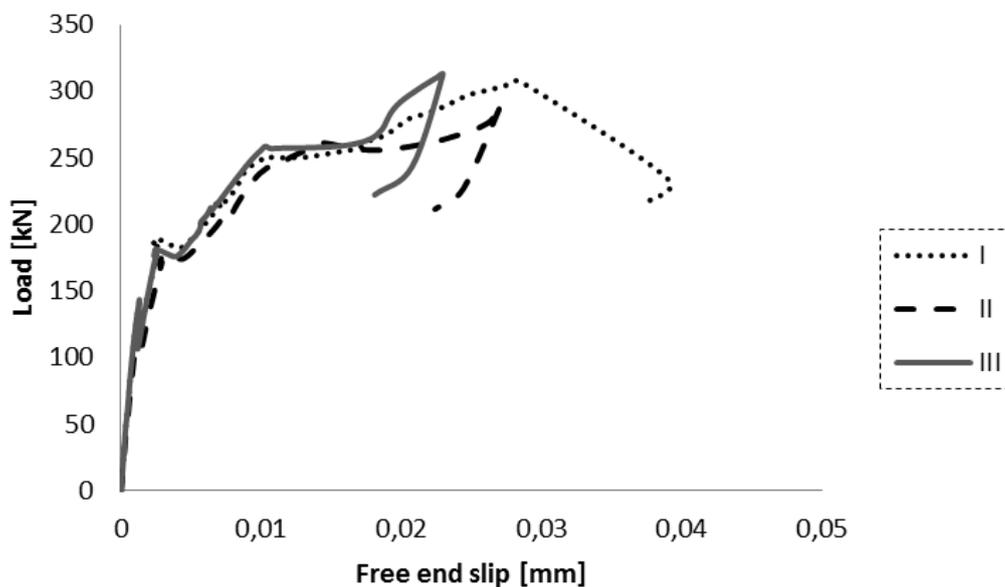
Figure 4.7 Load versus free end slip for analyses I, II and III.

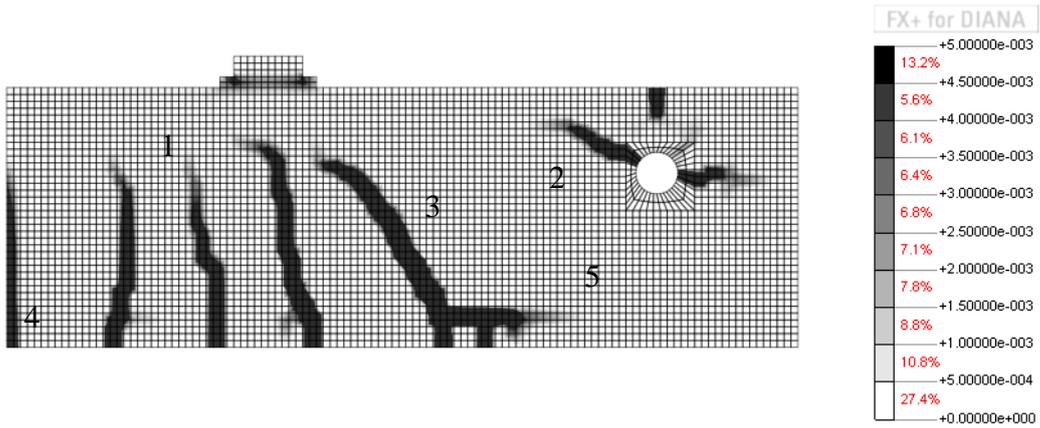
Figure 4.8 Crack pattern in terms of maximum principal tensile strains for maximum load in analysis III.

The crack pattern for the reference analysis can be seen in Figure 4.3 which shows the equivalent total strain in the concrete at maximum load. The crack positions and cracking loads are related to Figure 4.8, Figure 4.9 and Figure 4.10 with numbers.

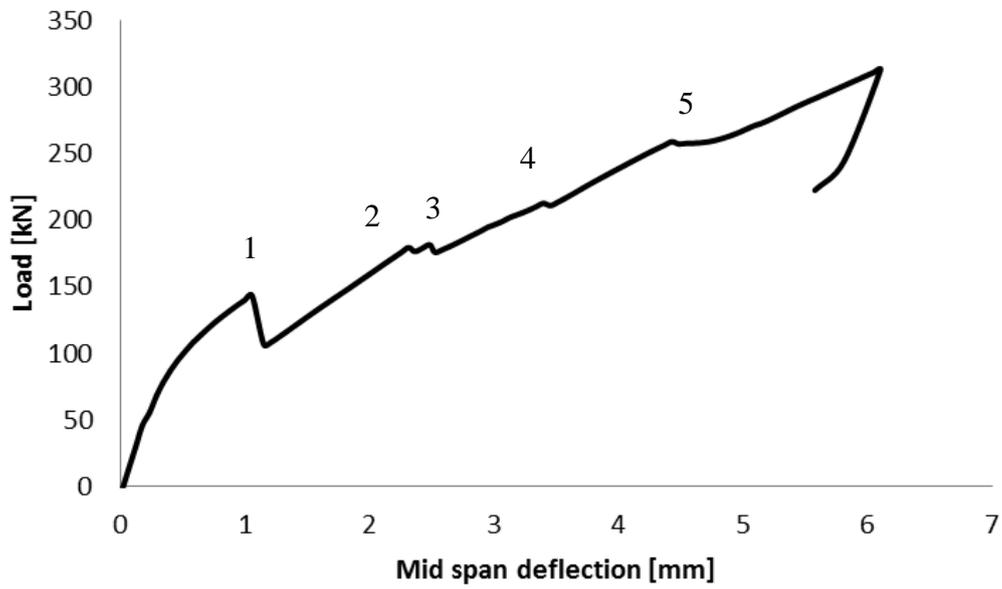
Figure 4.9 Load versus mid span deflection for the reference analysis III.

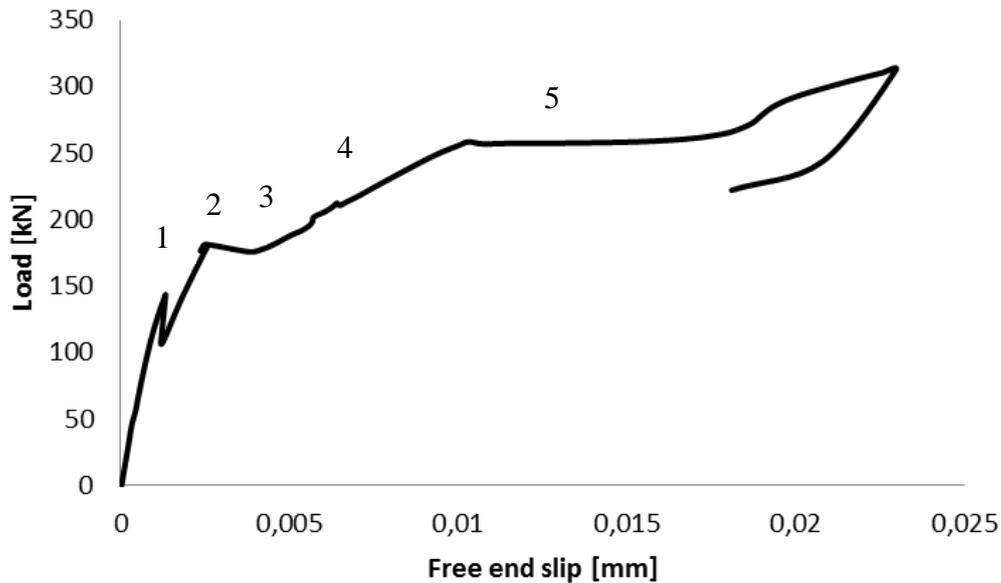
Figure 4.10 Load versus the free end slip for the reference analysis.

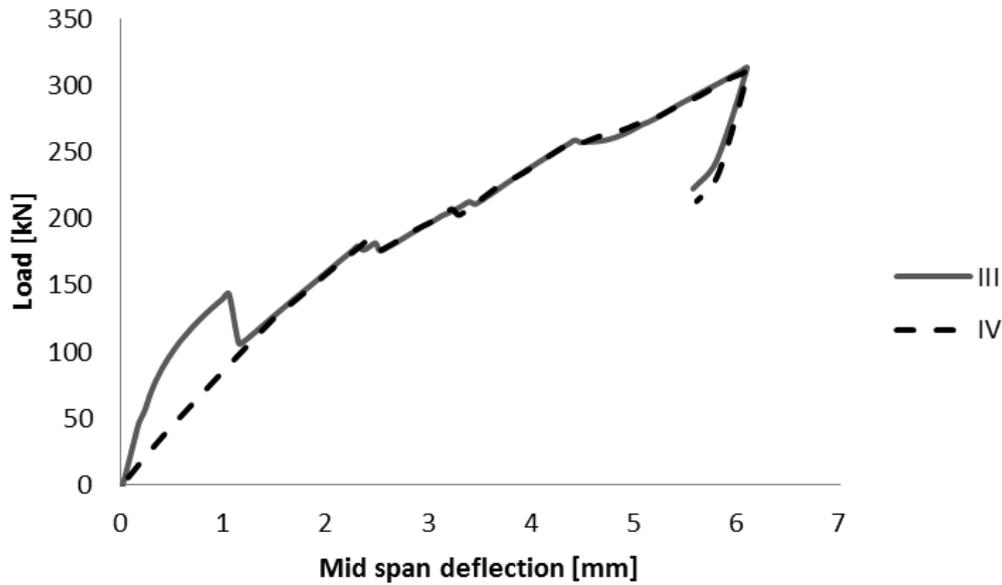
Figure 4.11 Load versus mid span deflection for analyses III and IV.

After the first two bending cracks appeared, the stiffness of the beam was reduced to a great extent. Possibly, some of the test specimens from Stallbackabron already had some bending cracks, and would therefore, show lower initial stiffness. Therefore, analysis IV was run with an unloading phase so it would represent a cracked specimen. When the first two bending cracks had opened, the model was unloaded and then loaded to failure. The result from analysis IV can be seen in Figure 4.11 and Figure 4.12. By analyzing the force deflection graph, it can be seen that analysis IV lost stiffness in the beginning and then followed the same behaviour as the analysis III.

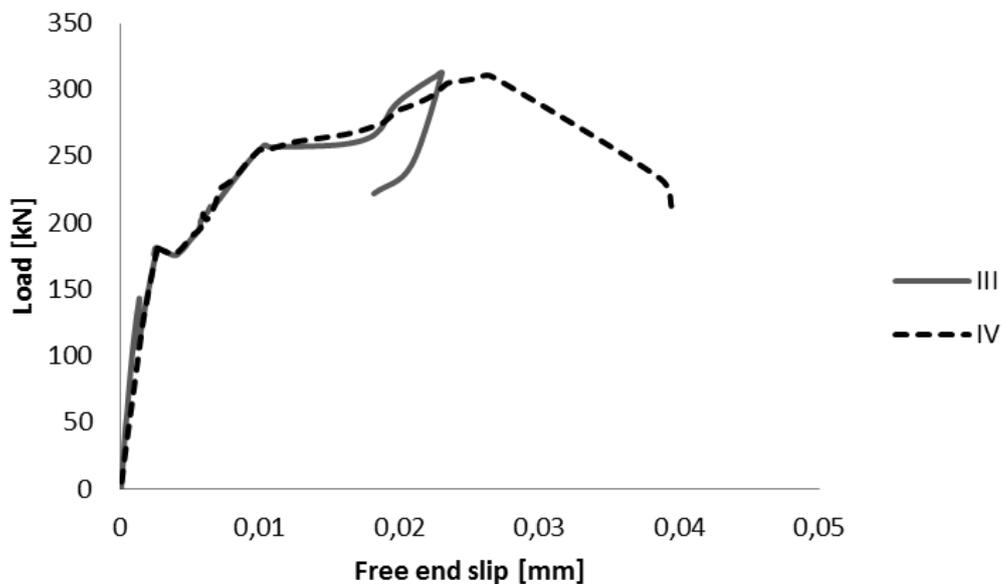
Figure 4.12 Load versus free end slip for analyses III and IV.
