Bond Behaviour of Naturally Corroded Reinforcement in Concrete Structures

Experimental and Numerical Study

Master of Science Thesis in the Master's Programme Structural Engineering and Building Performance Design

Department of Civil and Environmental Engineering
Division of Structural Engineering
Concrete Structures
CHALMERS UNIVERSITY OF TECHNOLOGY
Göteborg, Sweden 2012
Master's Thesis 2012:80

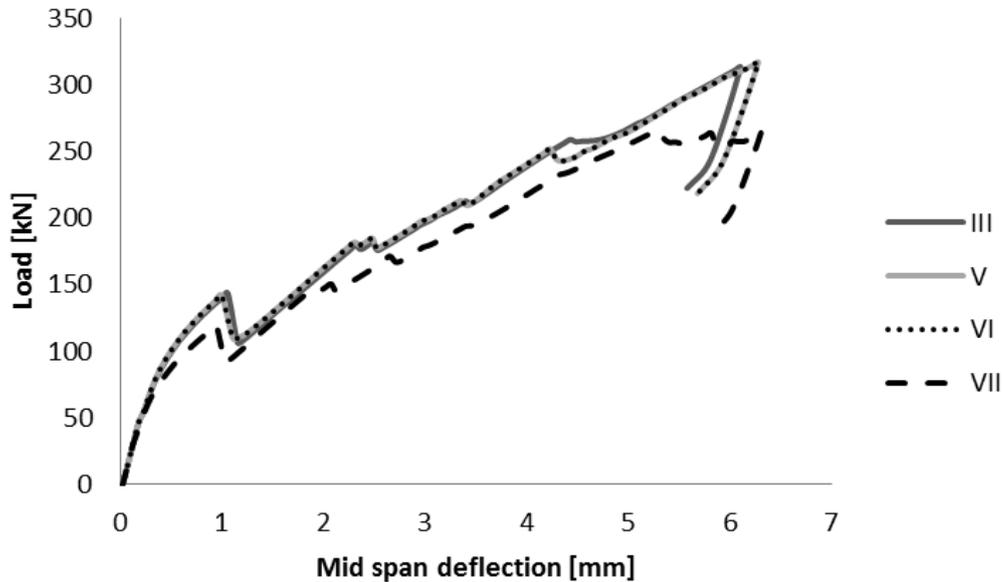
Figure 4.13 Load versus mid span deflection for analyses III and V-VII.

compared to the other analysis. The main difference is that when maximum load was reached, a cracking around the bottom reinforcement started from the shear crack and propagated to the end of the beam. That resulted in a larger free end slip of the reinforcement, 0.13 mm. The ultimate load was also lower in analysis VII than the others, 266 kN compared to around 315 kN for the others. Comparison between analysis III, V, VI and VII can be seen in Figure 4.13 and Figure 4.14.

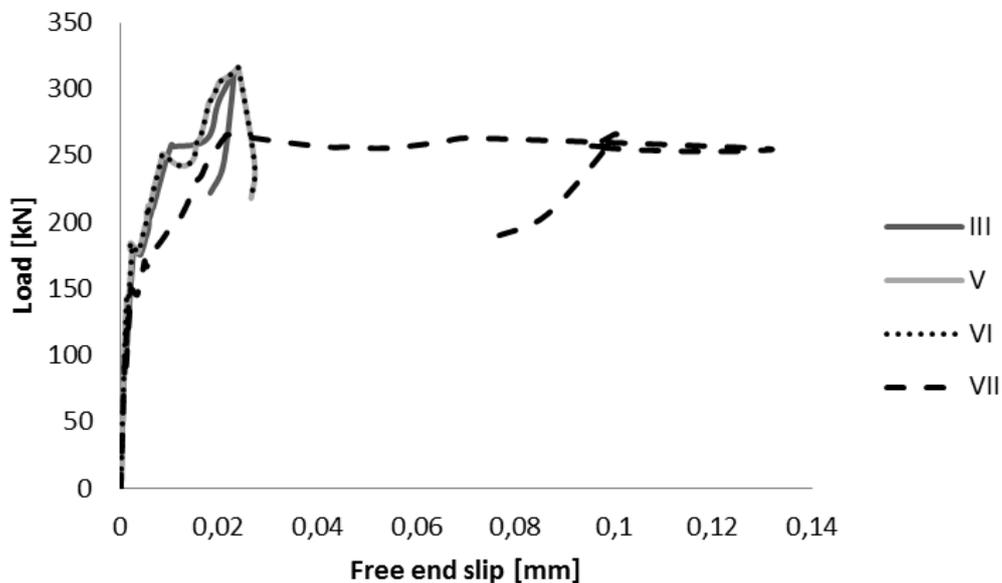
Figure 4.14 Load versus free end slip for analyses III and V-VII.

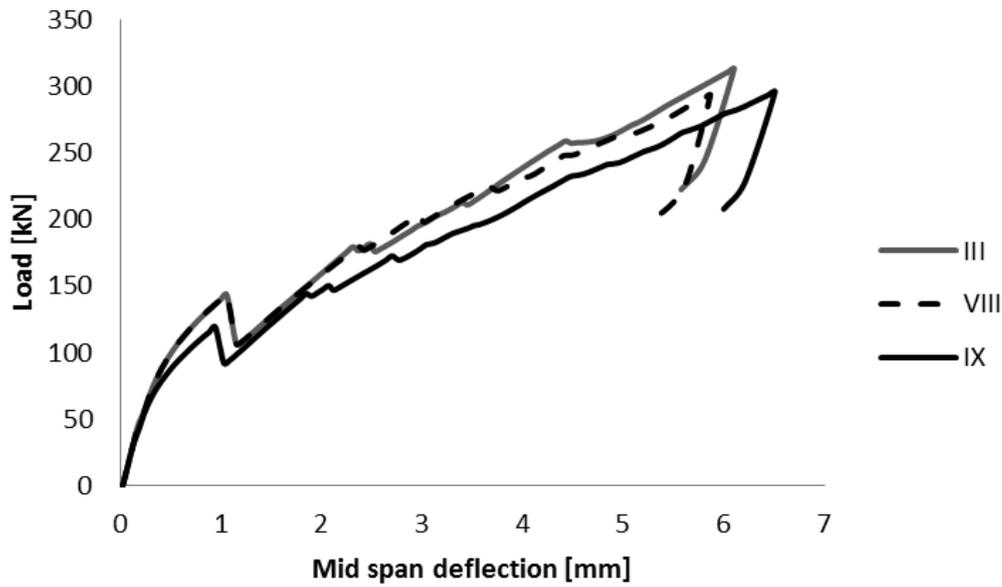
Figure 4.15 Load versus mid span deflection for analyses III, VIII and IX.

analysis VII and VIII, see comparison of analysis III, VIII and IX in Figure 4.15 and Figure 4.16.

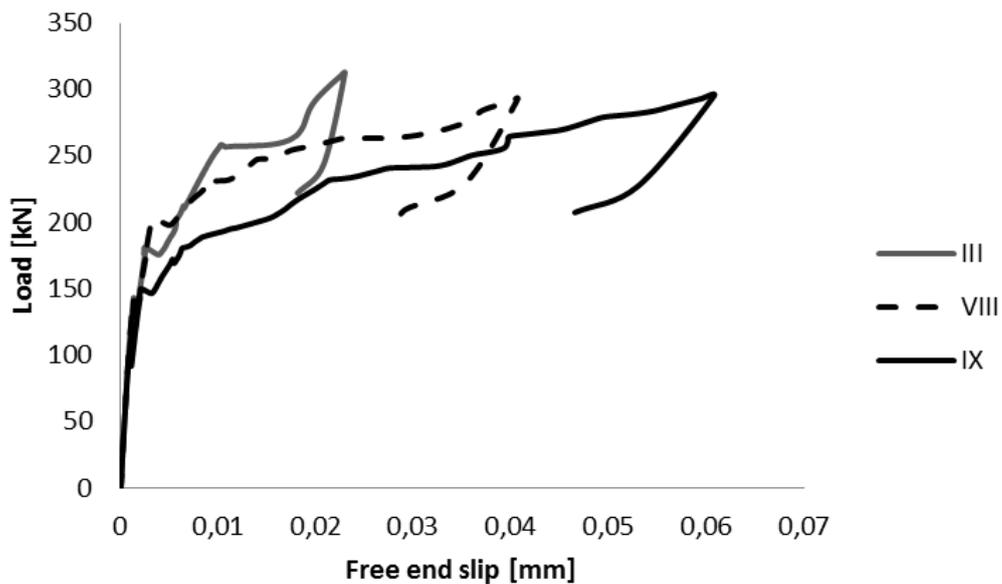
Figure 4.16 Load versus free end slip for analyses III, VIII and IX.

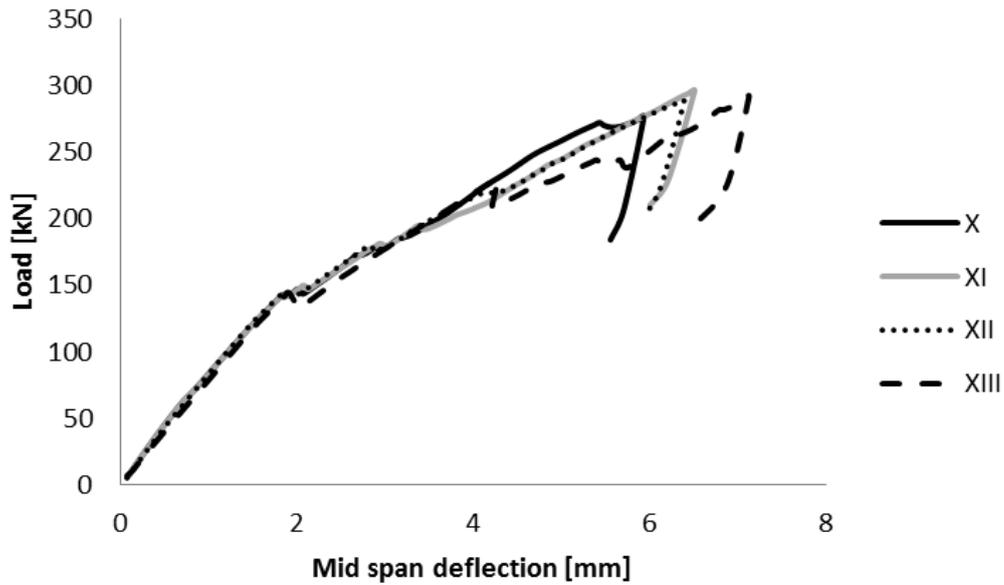
Figure 4.17 Load versus mid span deflection for analyses X-XIII.

Analysis X and XIII were run in order to adjust the bond slip curve in an attempt to get the appropriate behaviour of the bond slip. Comparison can be seen in Figure 4.17 and Figure 4.18.

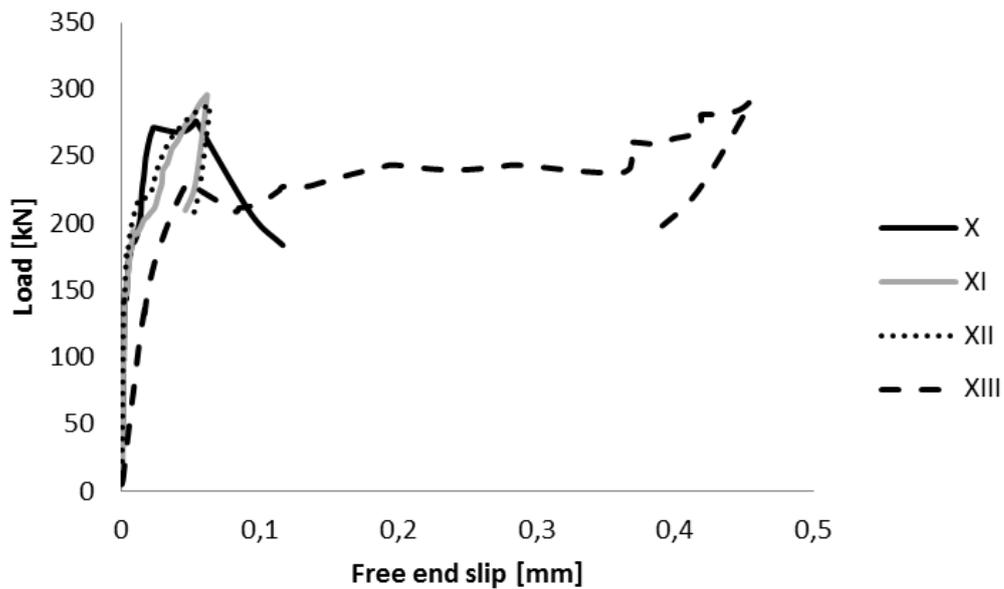
Figure 4.18 Load versus free end slip for analyses X-XIII.

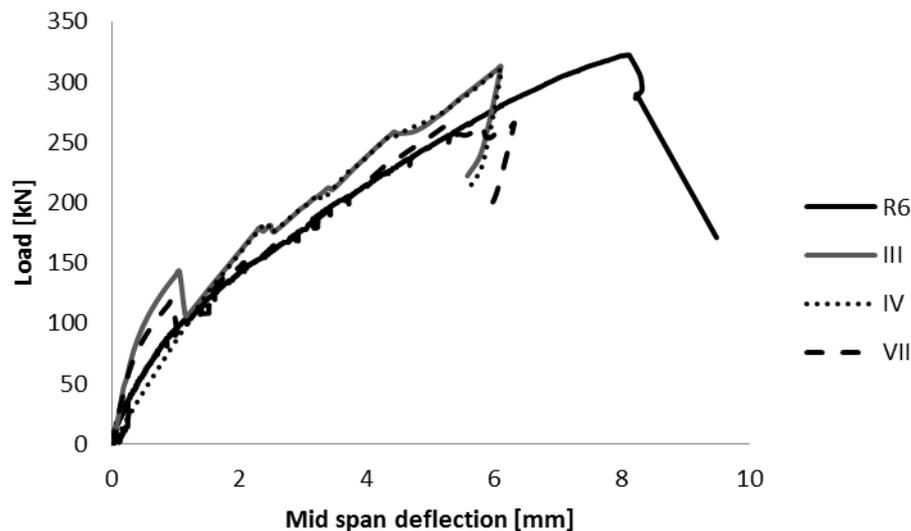
Figure 5.1 Load versus mid span deflection.

By looking at Figure 5.1, it can be seen that there is a very good correlation between analysis VII and specimen R6. In the beginning, analyses VII shows a bit stiffer behaviour, that can be explained by the fact that the specimens are already cracked. After the first crack develops in analyses VII, the curve follows a same trend as specimen R6, the ultimate load is however much lower in analysis VII than in specimen R6. Analyses III and IV have similar ultimate load as specimen R6 but with higher stiffness.

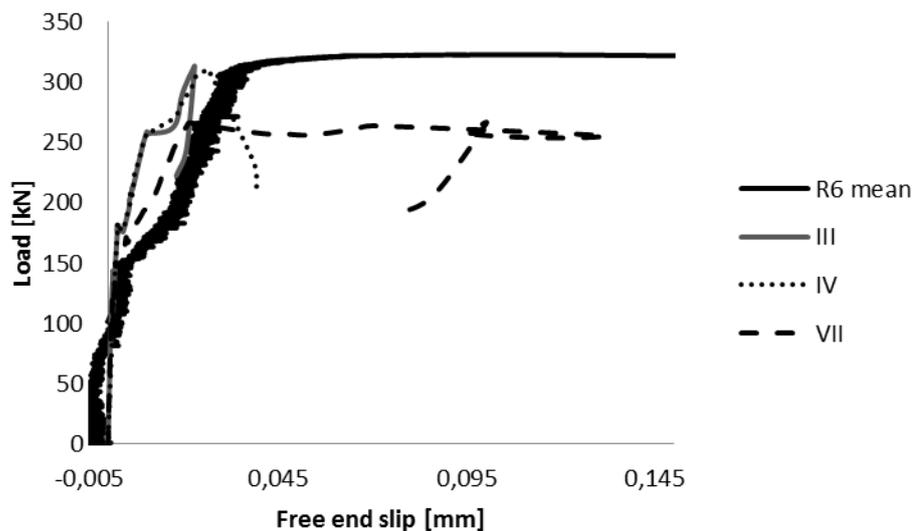
Figure 5.2 Load versus free end slip.

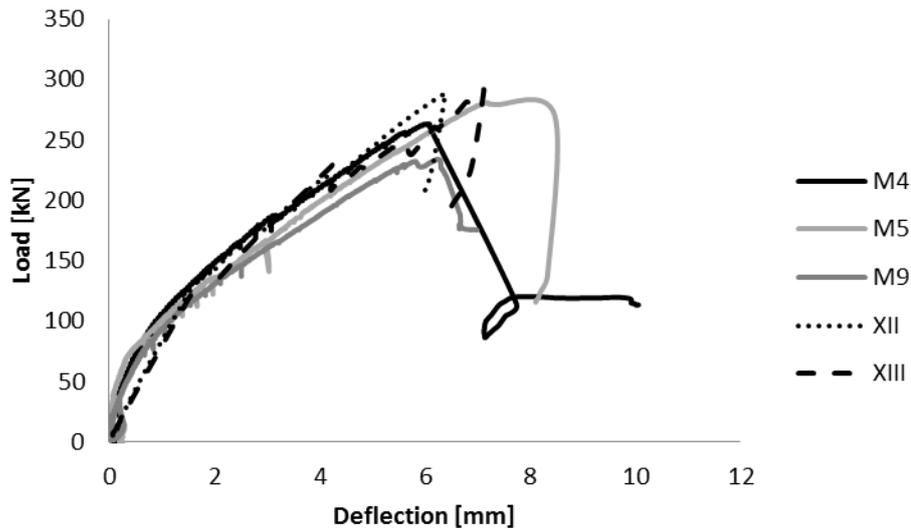
Figure 5.3 Load versus mid span deflection.

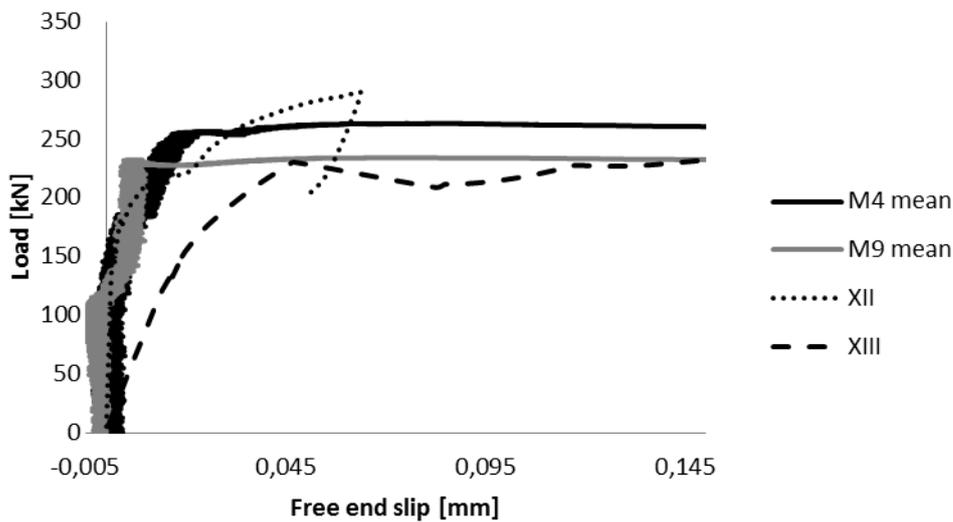
Figure 5.4 Load versus free end slip, enlarged.

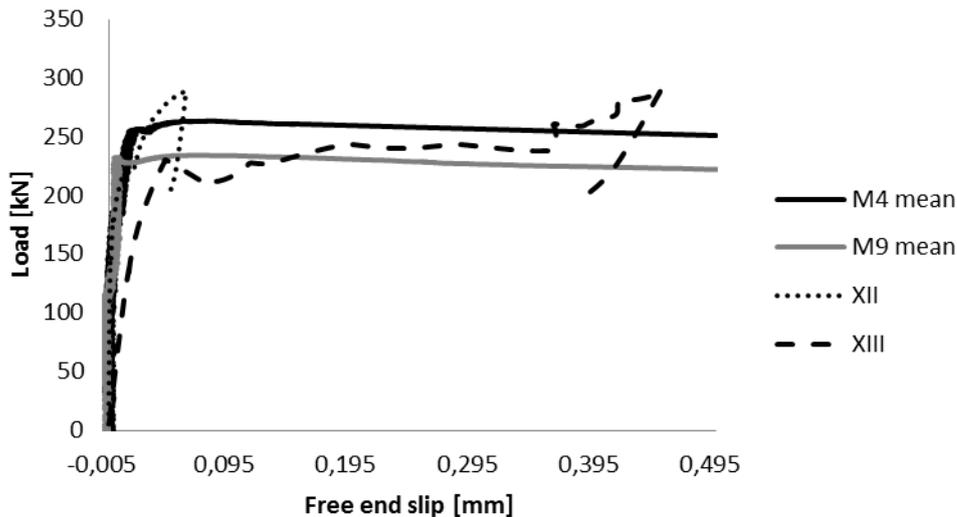
Figure 5.5 Load versus free end slip.

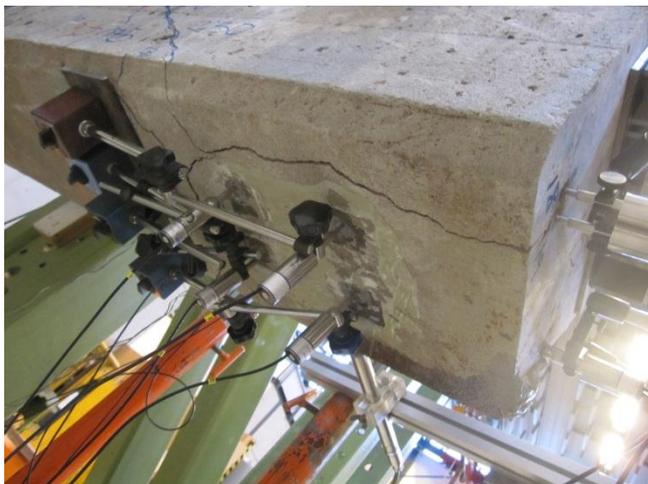
Crack pattern on bottom on south side (failure side)
