Quality assessment of LMD/w Ti-6Al-4V alloy components using conventional NDT techniques

Diploma work in the Master programme Production Engineering

Diploma work No. 155/2015
Department of Materials and Manufacturing Technology
CHALMERS UNIVERSITY OF TECHNOLOGY
Gothenburg, Sweden

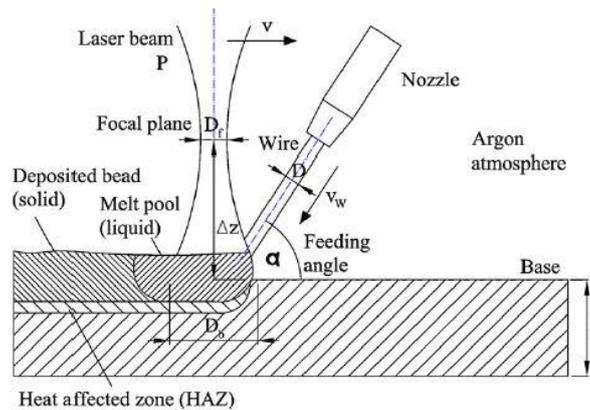
Figure 1: Schematic drawing of wire-feed LMD [7].

Even though the powder feed is most commonly used method, the wire-feed deposition is growing of an interest as it creates parts with less contamination as well as is more robust solution [4]. The basic concept of this technique is presented in Figure 1. The filler material in form of wire is fed into the melt pool where it fuses with base material or previous bead. The energy needed to melt both materials is provided by laser beam. In order to ensure good quality, the process is performed in an atmosphere of shielding gas.

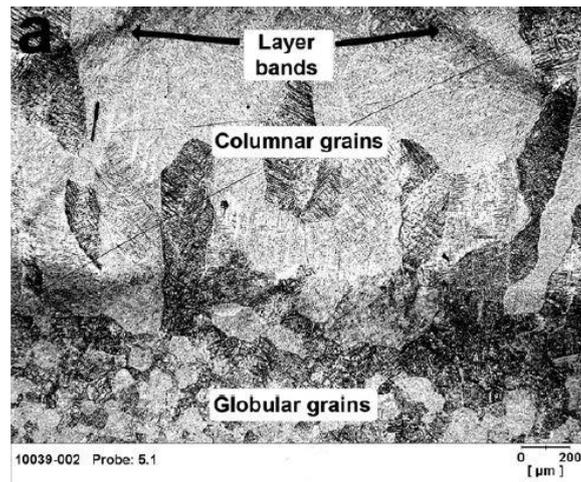
Figure 2: Microstructure of multi-layer LMD sample [7].

Sample titanium alloy blocks produced by LMD tend to be characterized by complex microstructure of α and β grains. Depending on different manufacturing conditions and heat treatment, the hexagonal close-packed (hcp) α -grains and body-centered cubic (bcc) β -grains can develop various forms. Analyzing multi-layer LMD samples, depending on heat treatment, several characteristics can be observed. Considering as-built samples, one of the characteristics is that the prior β -grains have columnar shape that grew epitaxially across several layers in direction of temperature gradient. The long and narrow columnar grains can reach length up to a few millimeters. Heat treatment in the $\alpha+\beta$ region influences only grain size and distribution of α -grains. The layer bands are clearly visible, yet they are correlated to $\alpha/\alpha+\beta$ transus lines rather than to the deposited layers. There are differences between the microstructure of higher and lower layers. General observation is that grains in higher layers are coarser and the grain number is decreasing. Figure 2 shows sample microstructure of as-built blocks. [7]

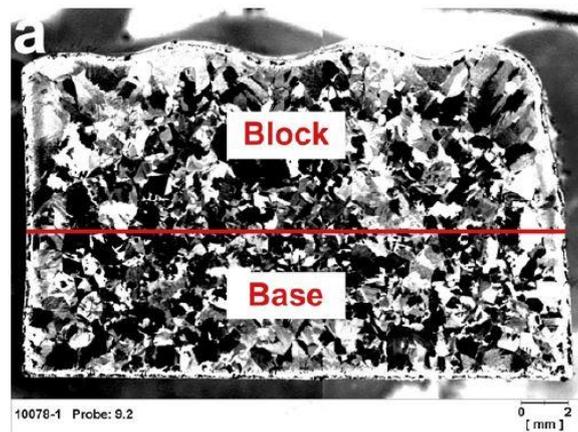
Figure 3: Microstructure of LMD multi-layer block in 1200C/2h/FC condition [7].

The blocks that were heat treated at 1200°C for 2h and then subsequently furnace cooled appear to have a different microstructure (see Figure 3). It is not possible to distinguish between the base and deposited material. There is more homogenous size and distribution of grains. Additionally, no layer bands can be observed as well as columnar β -grains.

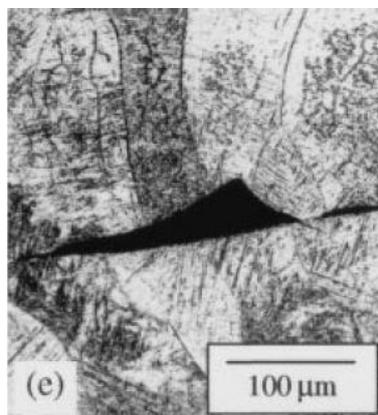
Figure 4: Lack of fusion defect in LMD sample [10].

Despite the fact that multi-layer LMD components are prone to this type of defect, information about characteristics of LoF in LMD samples is very limited. The available document [10] describes lack of fusion as an elongated irregularly shaped pore type of defect. It occurs parallel to the deposition's direction, along the layer boundaries. In the conducted experiment [10], the amount of LoF was much higher than gas porosity. It was also observed that the defect occurs more often in thin-substrate deposits. Figure 4 shows an example of LoF defect in powder-feed LMD block.

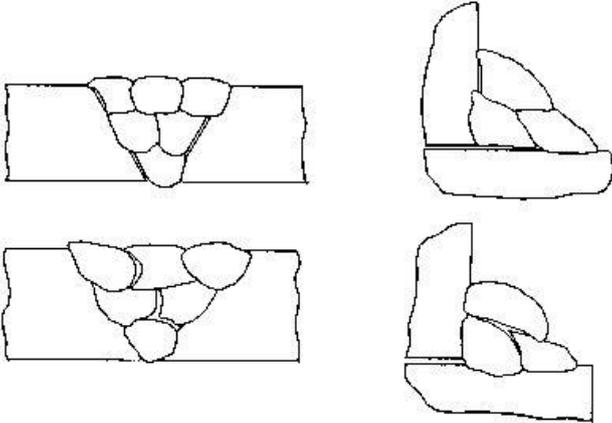
Figure 5: Simplified presentation of two types of LoF: lack of side-wall and inter-run fusion. [12]

Regarding lack of fusion in welds, there are three types of positioning of the defect: lack of side-wall fusion, lack of inter-run fusion, lack of fusion at the root of the weld. The first two cases are presentment in Figure 5 below. Additionally, data obtained in experiments [13] show that despite constant welding parameters and fully automated process there is no repeatability of LoF shape. According to the results of the experiments, the most probable positions for occurrence of LoF are corners of the runs, being the furthest points from the heat source.

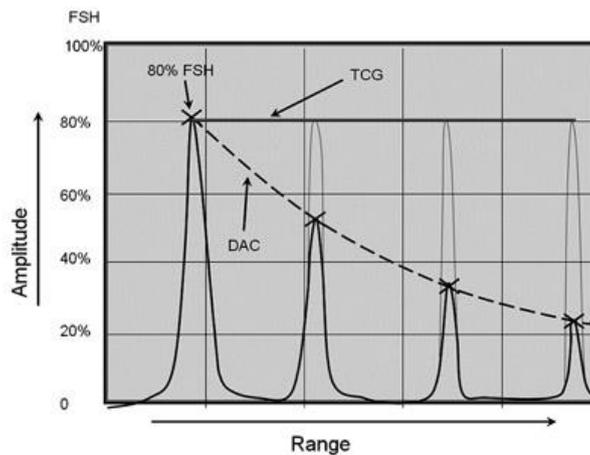
Figure 7: Presentation of a function of TCG curve and DAC curve [17].

It is a common practice to use reference blocks with Flat Bottom Holes (FBH) to create TCG curves. During the calibration, the gain is set so that the indication of each FBH would be 80% of the display screen. This way the inspector can easily assess the dimensions of detected flaw in regard to reference defects. Figure 7 presents the principle of using TCG curve to strengthen the signals of FBH at lower depths.

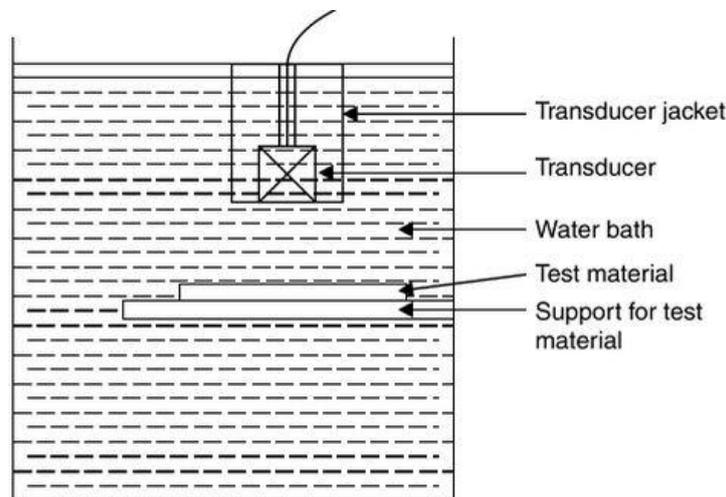
Figure 11: Schematic drawing of immersion testing [14].

For immerse application, the probe is mounted in fixture that usually can move in two perpendicular directions. The movement occurs along the top plane of the tank. In order to obtain valid results the velocity of movement needs to be adjusted to sound wave velocity and the speed of data acquisition. Figure 11 below shows general principle of immersion testing.

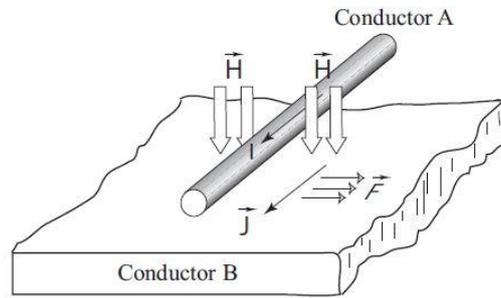
Figure 12: Schematic representation of principles of Electromagnetic Acoustic Testing [15].

In this method the ultrasonic wave is generated by an altering Lorentz force influencing the lattice structure of the material. Electromagnetic Acoustic Transducers (EMATs) uses magnetic induction to generate eddy currents (\vec{J}) in the test piece. As the piece is simultaneously subjected to the influence of permanent magnet (\vec{H}), the Lorentz force (\vec{F}) is created. Figure 12 shows the principles of this method. The characteristic of this type of measurement enables high-speed, contactless testing. However, it limits testing to conductive materials. [15]

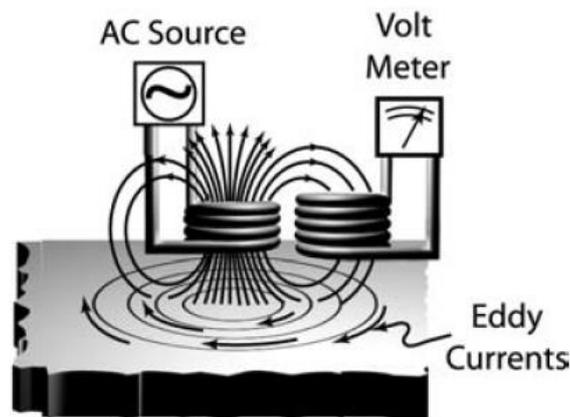
Figure 13: Basic principle of Eddy Current testing [15].

The phenomenon that enables to use ECT as an inspection technique is the electromagnetic induction. To be more precise, when the altering current flows through a coil it generates a magnetic field circulating around the wire of the coil. If the conductive material is influenced by the generated magnetic field, it will produce circle shaped currents in the conductor. Induced eddy currents produce a secondary magnetic field that is opposing to the magnetic field of the coil. If there is change of conductivity of tested material caused by defects or inhomogeneities in material and physical properties of specimen, the magnitude of the secondary magnetic field will change. One of the ways to measure the changes of both secondary and primary magnetic field is to use second coil connected to measuring device. This principle is presented in the Figure 13 below. [15]

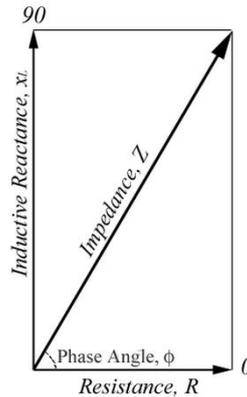
Figure 15: Basic concept of impedance plane created by resistance and inductive reactance [22].

The vector representation of the resistance and inductive reactance is used to display the results of eddy current test on impedance plane. The schematic vector representation of the parameters is shown in Figure 15.

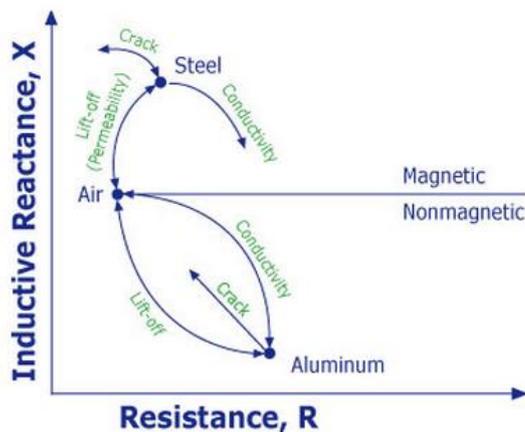
Figure 16: Response of the signal on impedance plane regarding to change of one of parameters: liftoff, crack appearance, conductivity [22].

There are several causes for change in impedance of the coil, e.g. varying conductivity, magnetic permeability, liftoff, sample thickness or layer thickness, influence of the edge of the sample. Additionally, one important factor is the presence of flaws in the material. Figure 16 below presents sample responses of the impedance depending on a change of one of the parameters. As can be noticed in the figure, the positioning of the indication on impedance plane depends also on the material type and its properties.

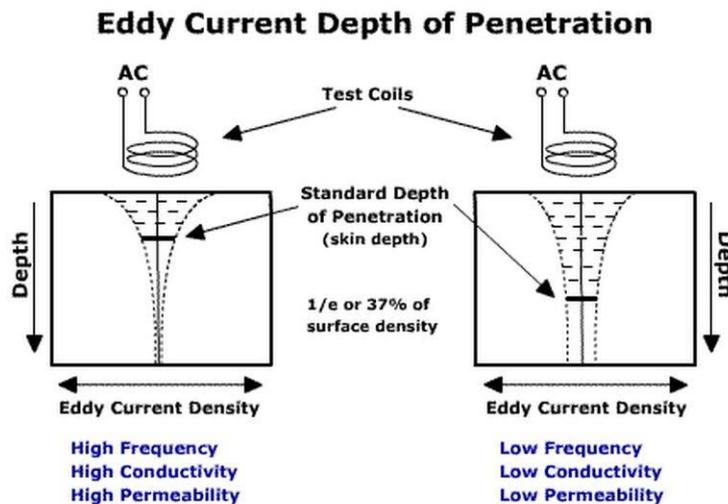
Figure 17: General influence of frequency of measurement, materials conductivity and permeability on the depth of penetration. [22].

Simplified relation between probe frequency, conductivity, permeability is shown in the Figure 17 below.

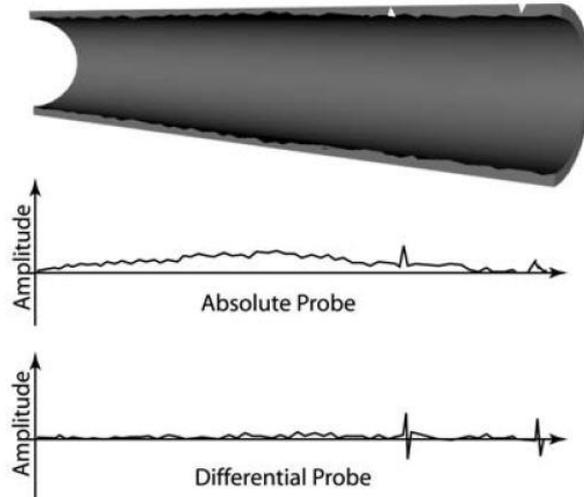
Figure 18: Difference in response of absolute and differential probe for material thinning, void and crack [22].

Depending on the configuration of the secondary coil two types of eddy current probes can be distinguished: absolute and differential. The first type measures changes in the test piece in relation to itself. It is applicable for both detection of sudden changes, i.e. cracks, and slow change of geometry. On the other hand, differential probes base detection of a flaw on comparing responses of two coils. They are commonly used for detection flaws like pores, cracks and voids as they are able to detect sudden, minute changes in magnetic field at the same time being insensitive to slow variations caused by change of materials properties and geometry. Figure 18 shows the difference in response of the probe depending on configuration.

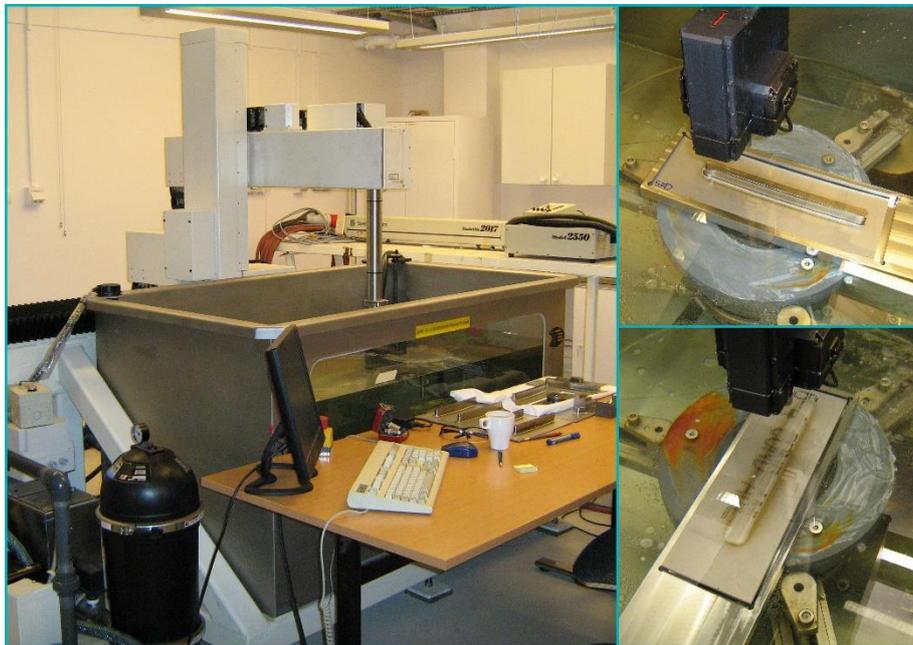
Figure 20: Ultrasonic immersion equipment ScanMaster LS-200.

The immersion tests were performed using LS-200 inspection system produced by IRT ScanMaster. The device consists of a scanning machine with positioning system using 3 linear and 3 angular axes. Automatic scanning can be performed using transverse movement in two axis. The traversing system enables to perform planar scans as well as scans of cylindrical shapes. The machine has built-in accurate motion control system and ultrasonic hardware in combination with a signal processing software. Due to this, it allows not only to obtain real time, good quality B-scans and C-scans, but also advanced post processing of measurements and analysis of signal to noise ratio. The Figure 20 below shows the immersion equipment used for the measurements at GKN NDT laboratory at the Production Technology Centre (PTC) in Trollhättan.

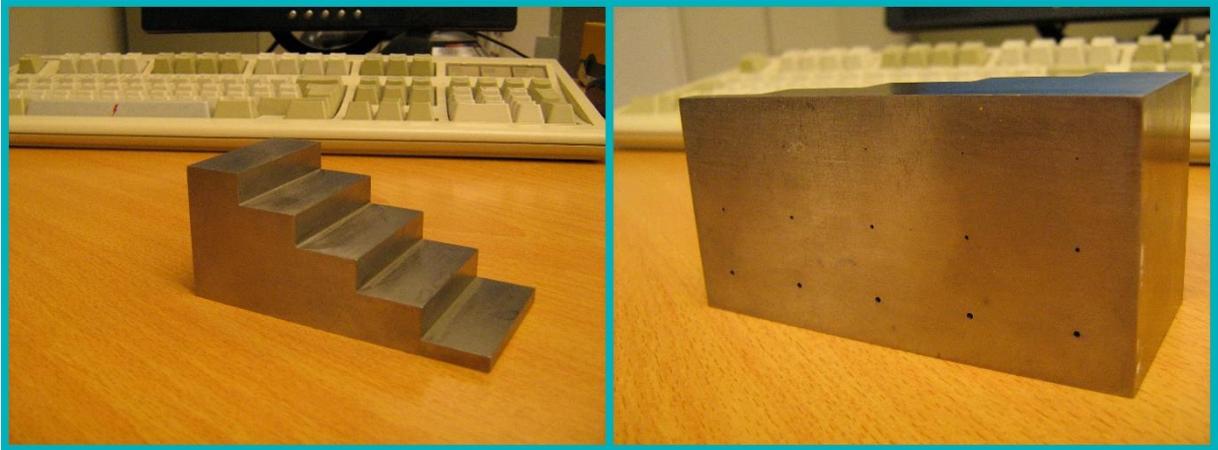
Figure 21: The reference block with flat-bottom holes.

Initially, as the reference for the inspection, a conventional step block was used. It was manufactured from Ti-6Al-4V alloy using LMD of powder metal. The block consists of 5 steps with the lowest being 5 mm high and incrementing by 10 mm. Each of the segments consists of 3 flat bottom holes (FBHs) of different diameters; 1.2, 0.8 and 0.4 mm. The depth of all holes is identical and equals to 3 mm. In this way the reference block was used both as area-amplitude and distance-amplitude reference. The designation ‘step 1, step 2, (...), step 5’ used later in the text refers to step of 5 mm height, step of 15 mm height and step of 45 mm height respectively. The photos of the reference block are presented in Figure 21. The reference block was used to create TCG curves necessary to inspect pieces with natural defects.

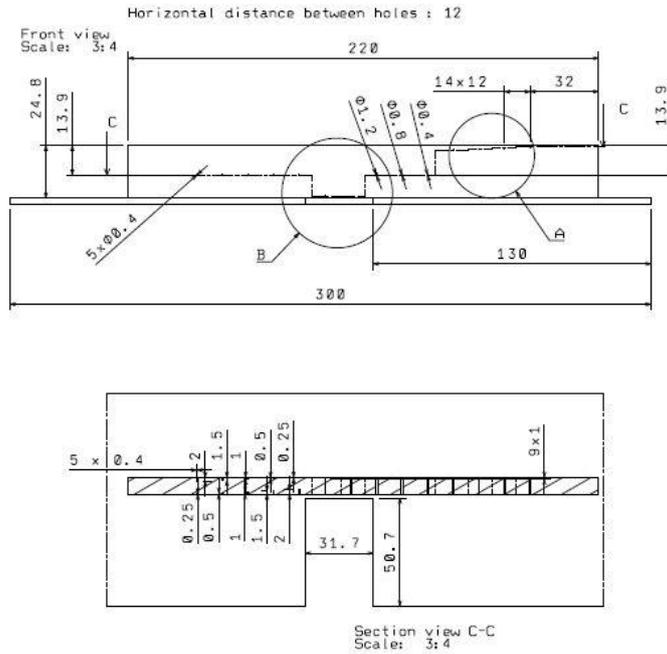
Figure 22: New reference block designed to address issues occurring while inspecting LMD pieces.

As the project progressed, based on observed issues in LMD blocks, new reference piece was designed containing side drilled holes (SDH), see Figure 22. The aim of the new reference was to examine surface sensitivity, detectability of defects close to the edges of the walls as well as assess influence of the surface conditions on the signals produced by internal defects. More detailed drawings of the reference are presented in Appendix 1.

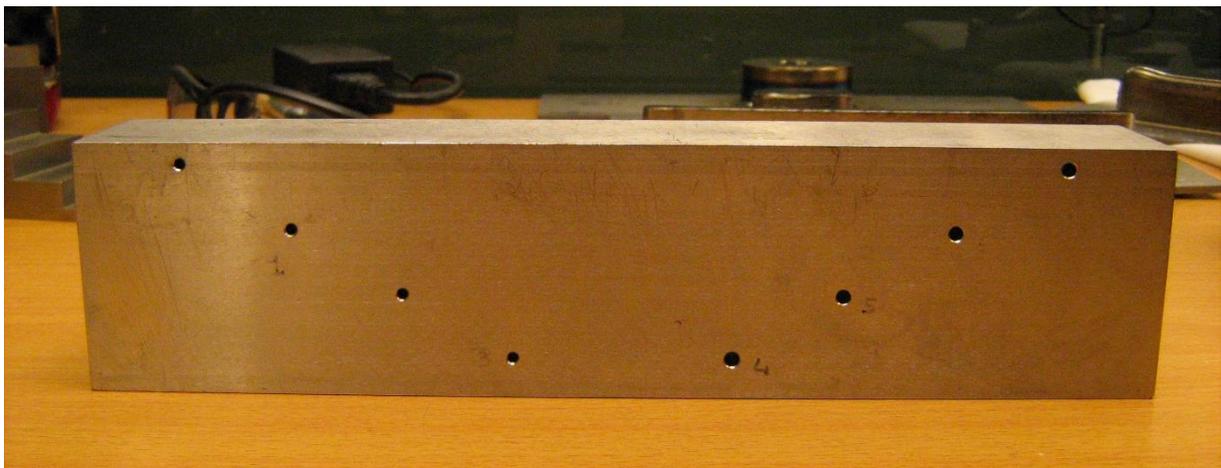
Figure 23: Reference block used to gain signal response from SHDs.

Diameter [mm]	2.4	3.2
Depth 1 [mm]	5	5
Depth 2 [mm]	20	20
Depth 3 [mm]	35	35
Depth 4 [mm]	50	50

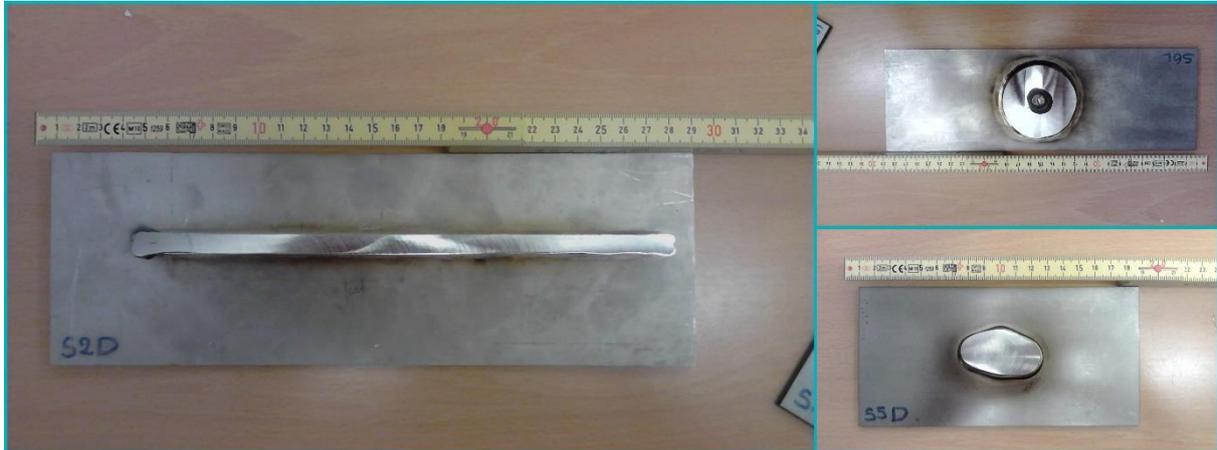
Figure 24: Samples of pieces investigated during experiments.

A number of LMD blocks of different types were manufactured using LMD/w and tested. The initial strategy to produce relevant LMD blocks with natural flaws was to manufacture pieces with 2 beads in width and several layers in height. The thickness was determined by the internal requirements regarding LMD pieces used in a specific application. However, due to complications concerning producing natural defects that would be representative for the investigation, the group of test pieces was extended to bulky samples of various cross-sections as well as walls with more than 2 beads in thickness. Sample pieces are shown in the Figure 24.

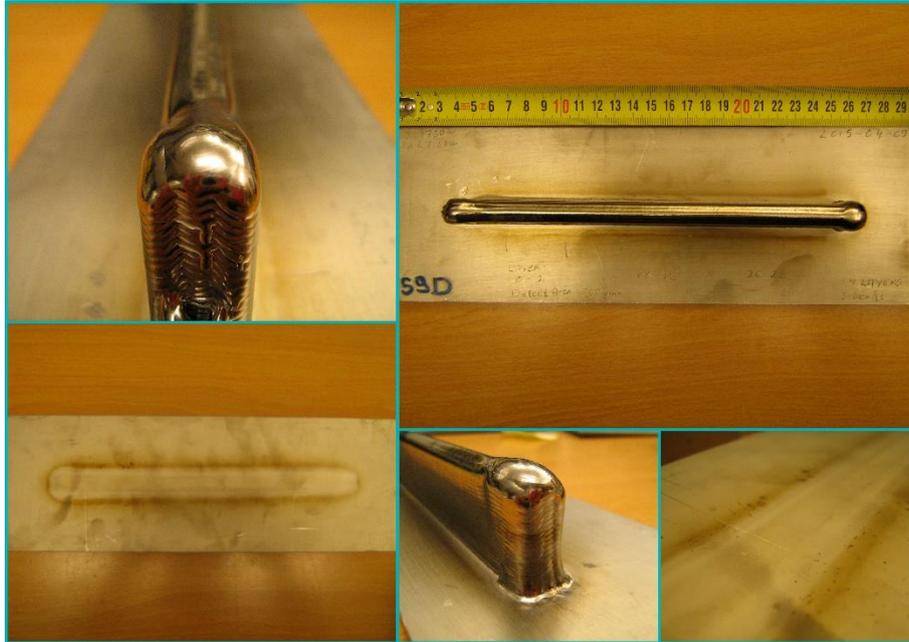
Figure 25: LMD walls in the raw state – rounded top surface (top left), distorted bottom of the piece (bottom left and right).

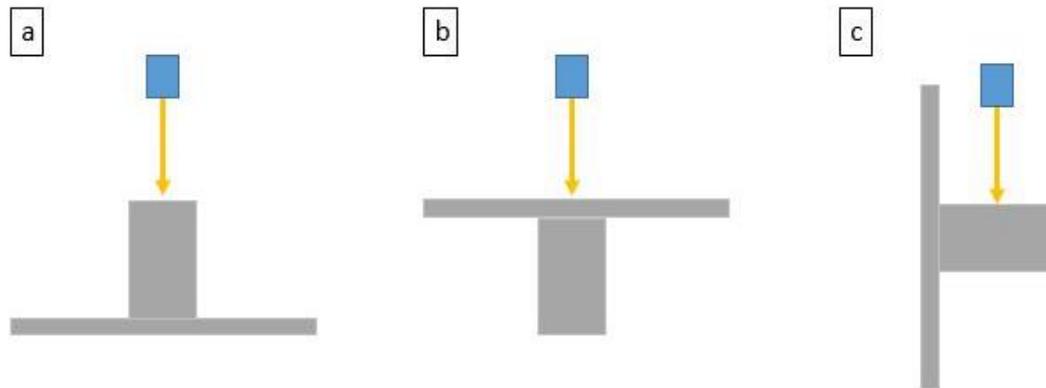
Figure 26: Three different setups: a) top surface as incidence surface; b) bottom surface as incidence surface; c) side of a wall as incidence surface.

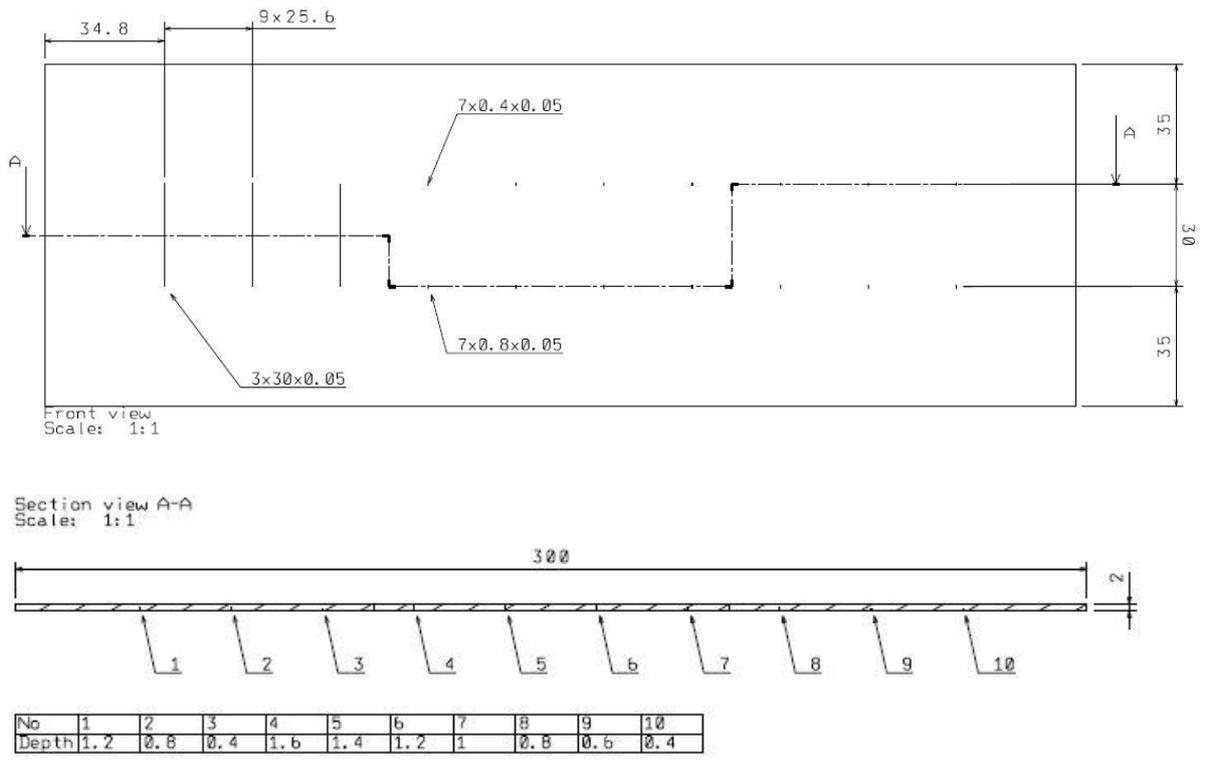
Figure 28: Reference plate for eddy current testing.

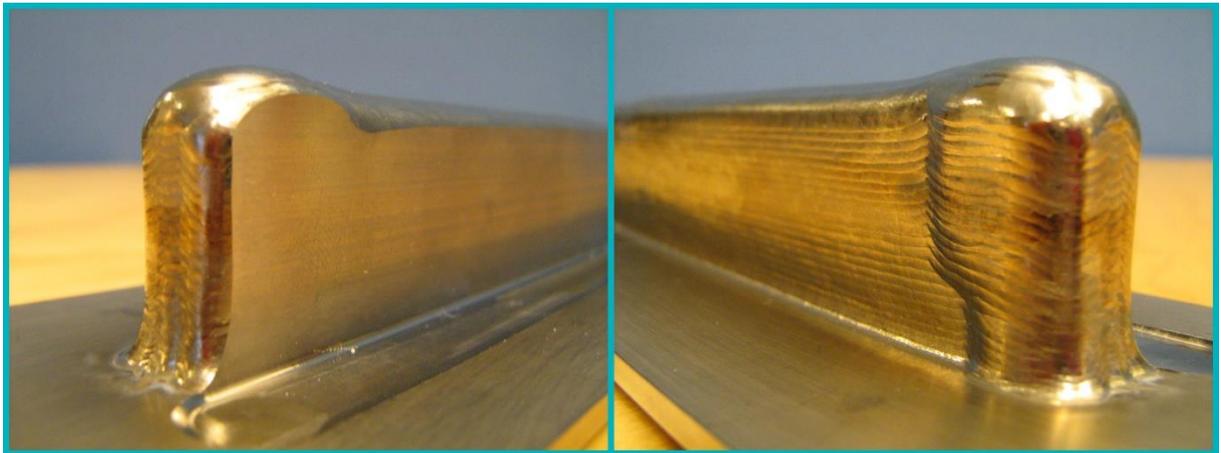
Figure 29: LMD piece prepared for eddy current inspection.

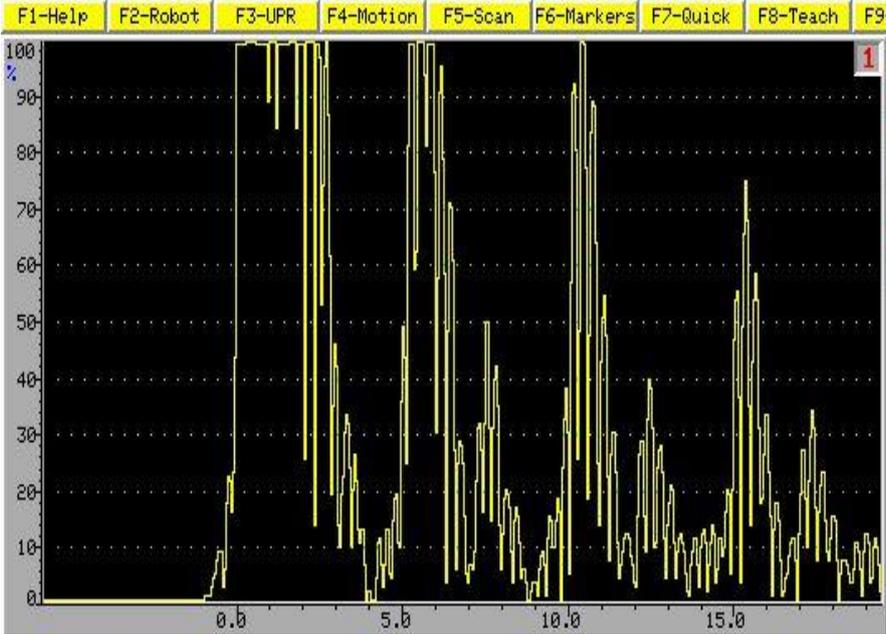
Figure 31: A-scan of the signal generated by probe I7-0512-RG placed over step 1 – the dead zone on about 4 mm.

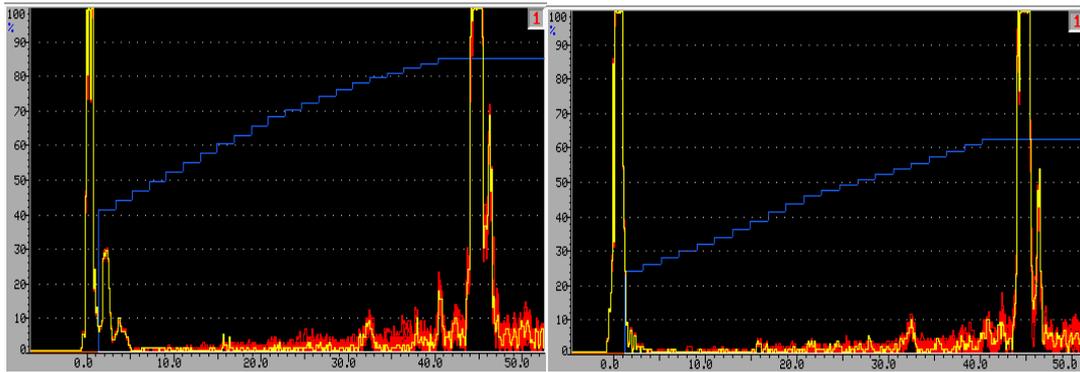
Figure 32: Probe IS1010GA - entire TCG curve: a) TCG1004F - high value of amplitude of voltage, low value of preamplifier; b) TCG1004M - low value of voltage amplitude, high value of preamplifier. Red signal shows the signal within last 3 sec of measurement.

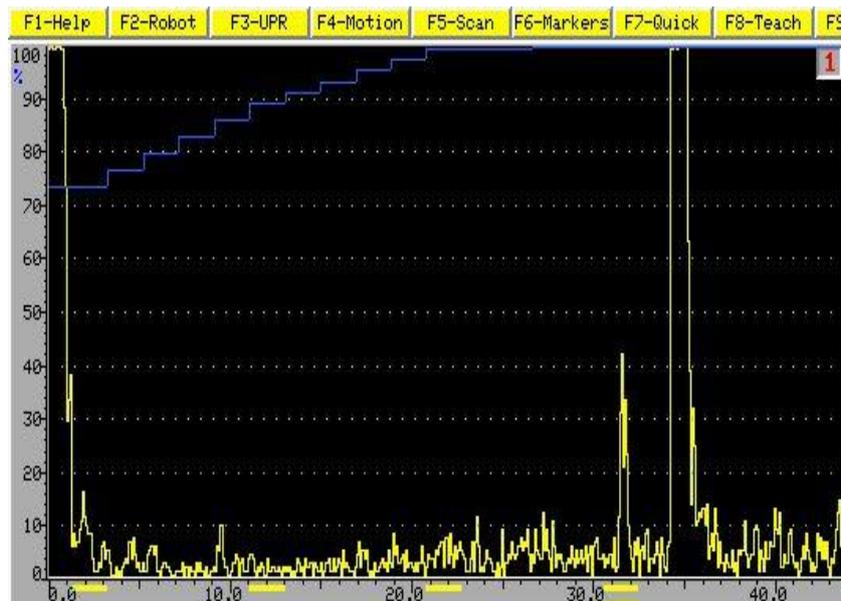
Figure 33: Probe V317 - limit of amplification for 0.4 FBH.

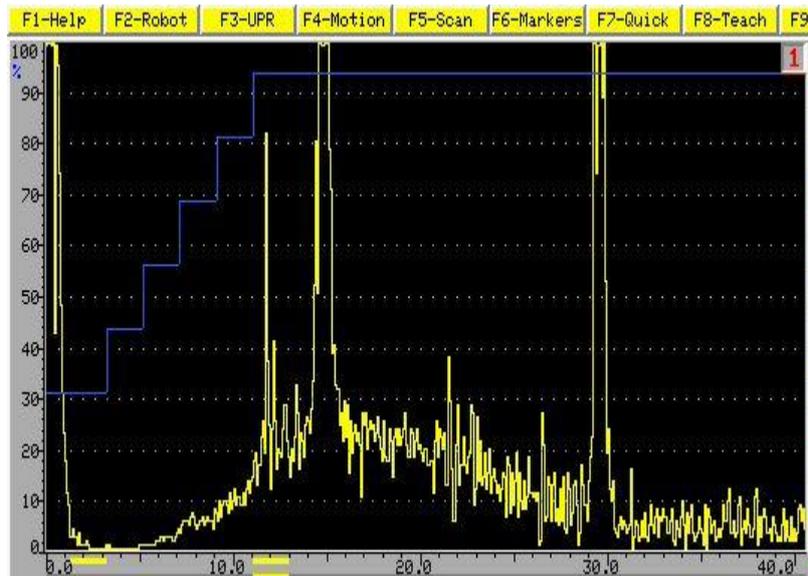
Figure 34: Probe I3-2504-R - high random noise when creating the TCG curve for 0.4 FBH, step 2.

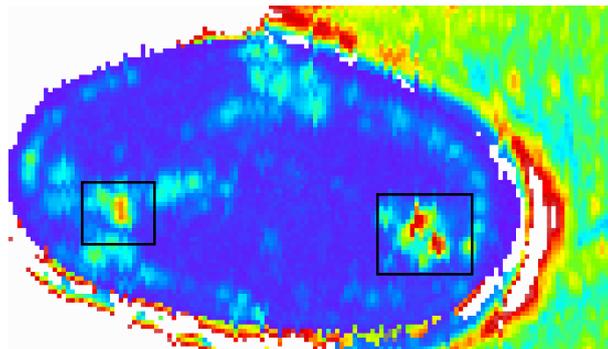
Figure 35: C-scan of part S5D – defects marked by squares. Yellow and red color indicates signal values between 70-100%. White pixels indicate signals over scale.

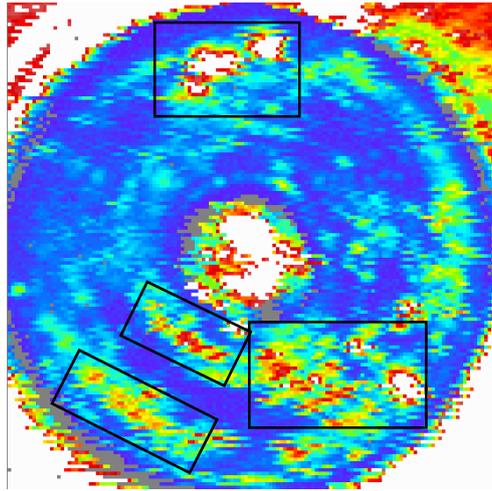
Figure 36: C-scan of part S6D – defects marked by squares. Yellow and red color indicates signal values between 70-100%. White pixels indicate signals over scale.

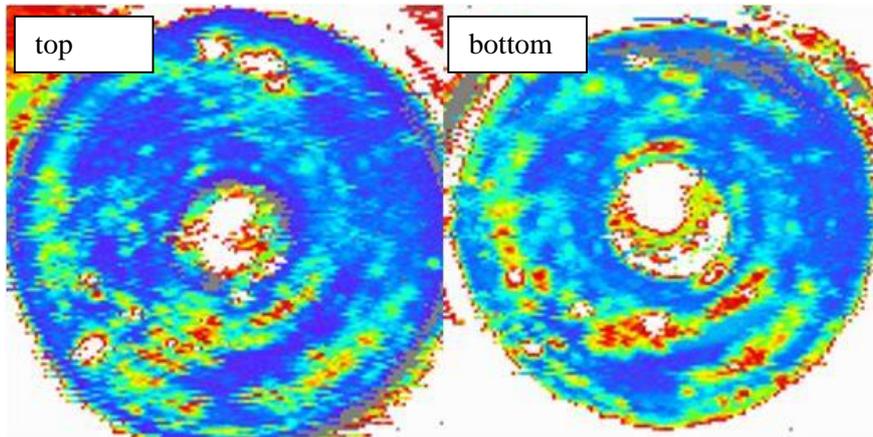
Figure 38: Part S6D scanned from two different incidence surfaces: top – milled surface, bottom - plate side.

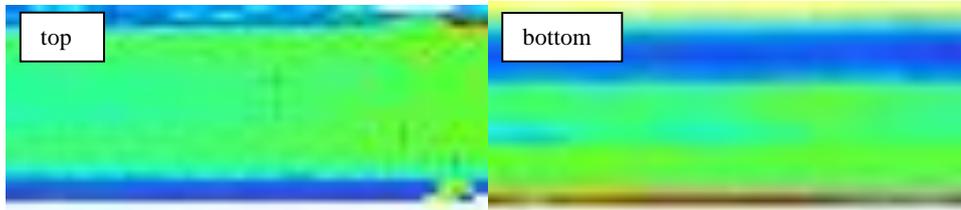
Figure 39: C-scan of the piece S8D, incidence from the milled top surface (top) and raw plate side (bottom).

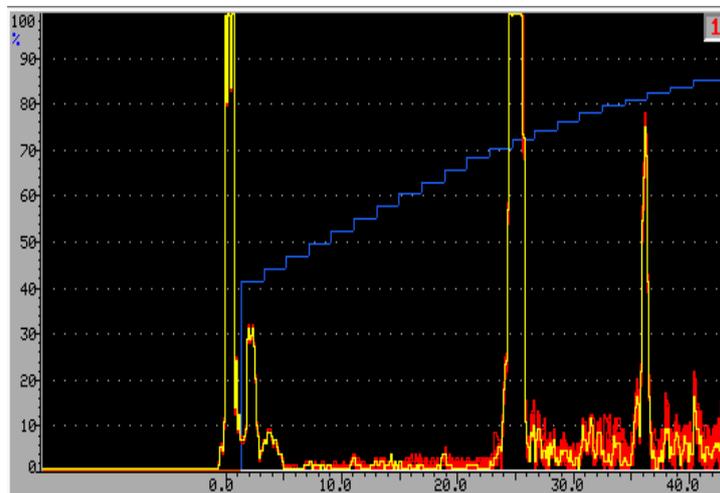
Figure 40: Signal response in form of A-scan. Constant signal of 30% in 2-3 s on the time line. TCG1004F was used for signal amplification – blue step curve.

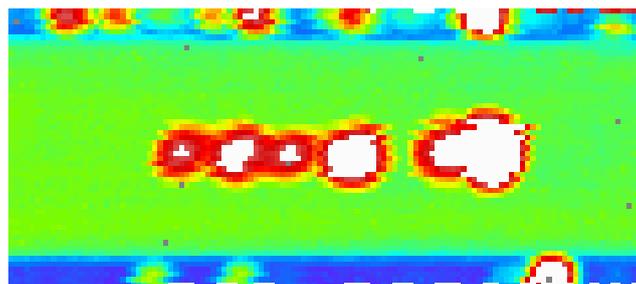
Figure 41: The C-scan presentation of the piece S7D with visible indications by the edges.

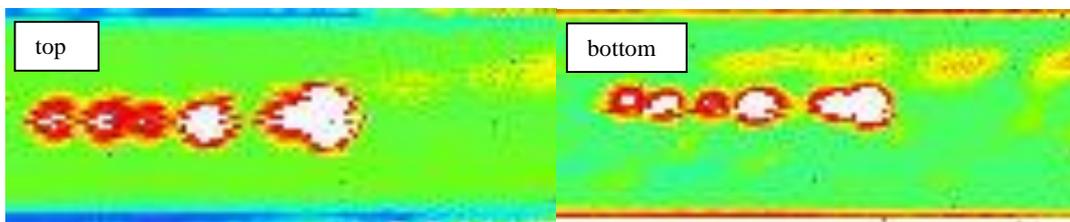
Figure 42: Scan of part S7D in series 6.

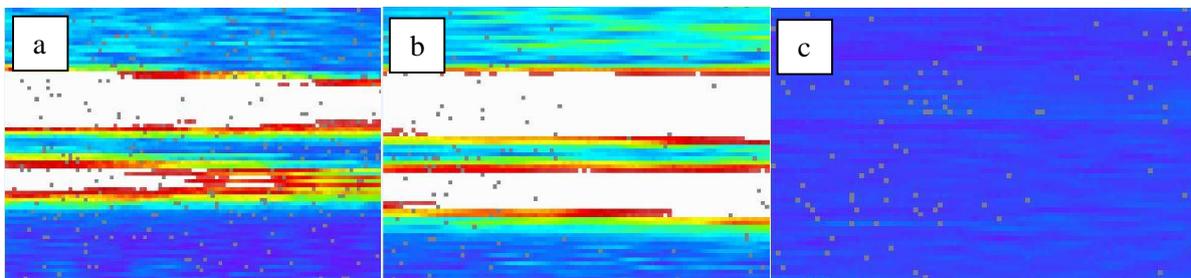
Figure 44: C-scans of the piece S1ND: a) raw plate surface, b) polished plate surface, c) milled plate surface.

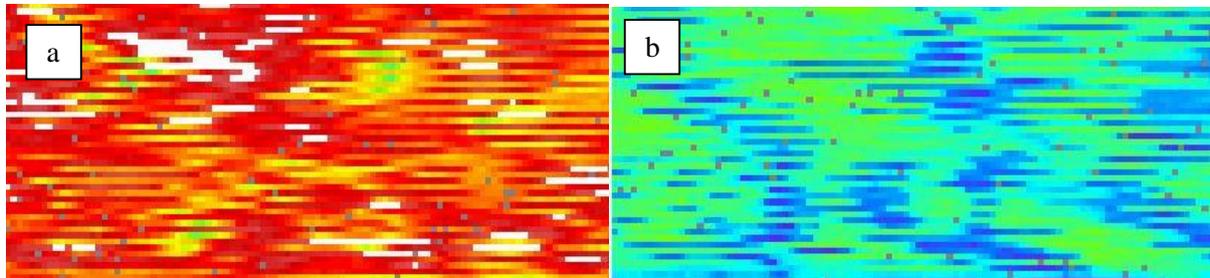
Figure 45: C-scan of the piece S10D with incidence surface being rough side surface of the wall: a) gate on the incidence surface 80% FSH, b) gate between front and back echo TCG1004F.

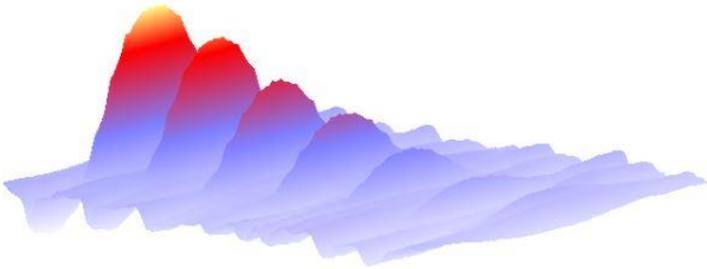
Figure 47: Graphical representation of data obtained from scan of the area containing all seven notches of 0.8 mm length.

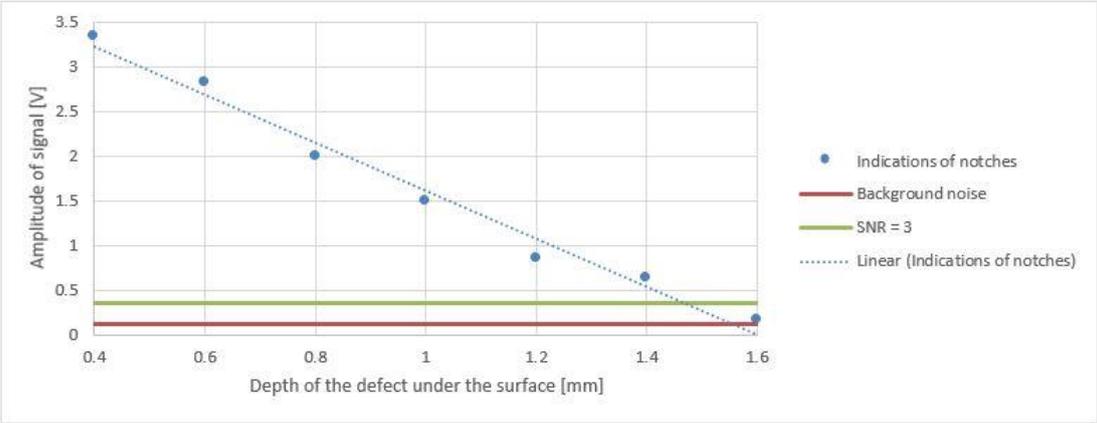
Figure 48: Graph presenting the amplitude decrease with the increase of depth under the surface of inspection of 0.8 mm long notches.

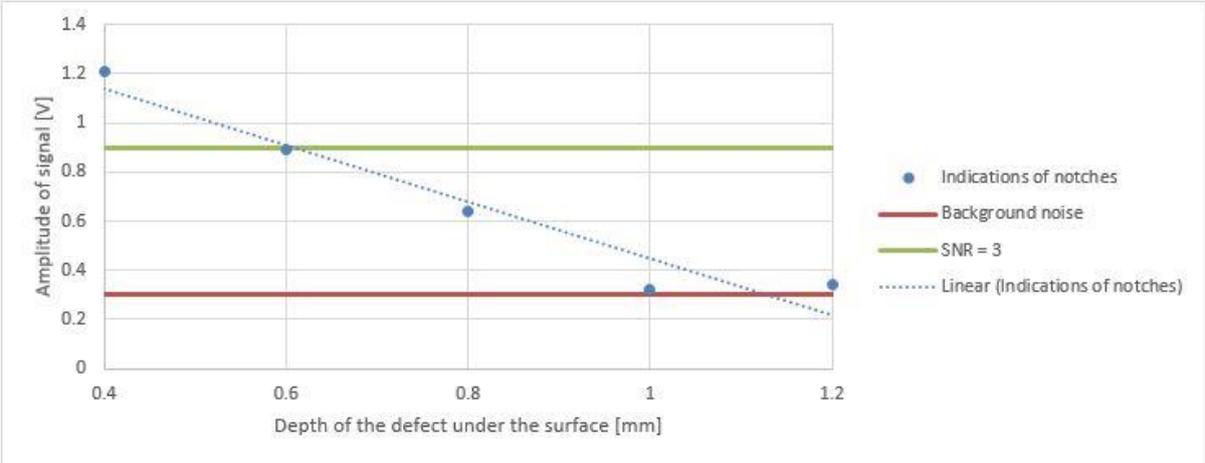
Figure 50: Graph presenting the amplitude decrease with the increase of depth under the surface of inspection for 0.4 mm long notches.

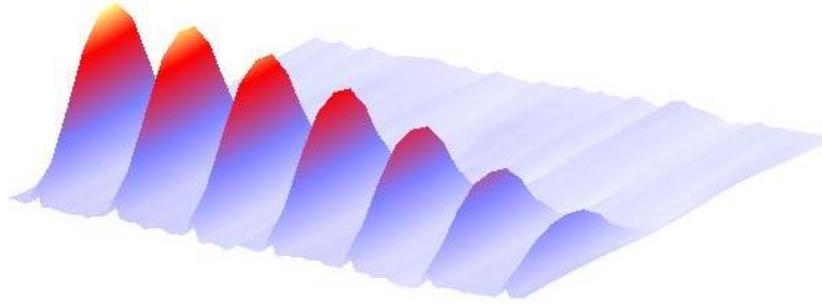
Figure 51: Graphical representation of data obtained from scan of the area containing all seven notches of length 0.8 mm.

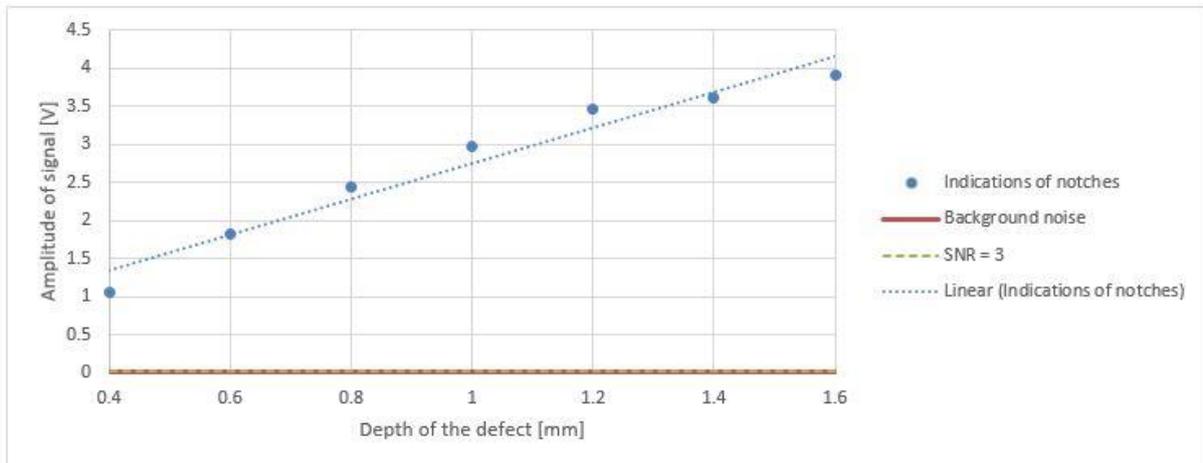
Figure 52: Graph presenting the amplitude decrease with the increase of depth under the surface of inspection for 0.8 mm long notches.

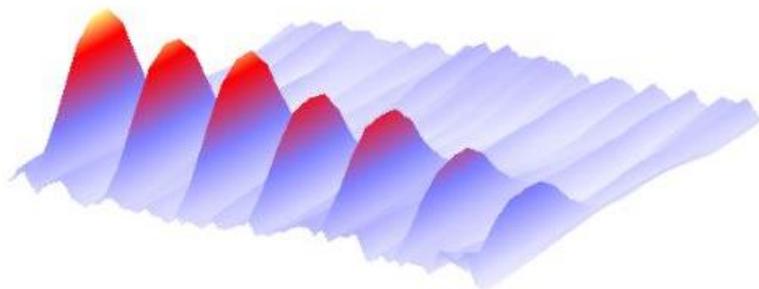
Figure 53: Graphical representation of data obtained from scan of the area containing all seven notches of length 0.4 mm.

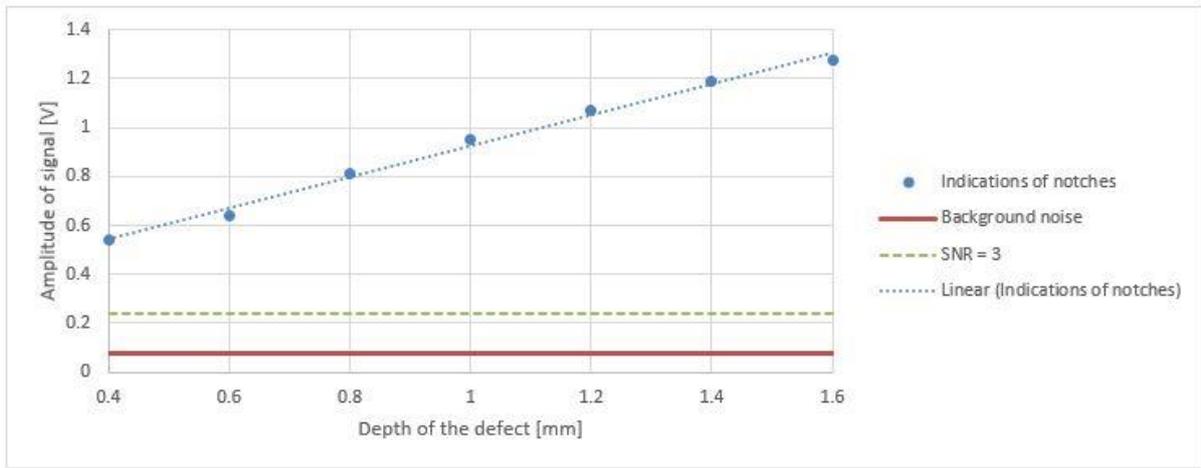
Figure 54: Graph presenting the amplitude decrease with the increase of depth under the surface of inspection for 0.4 mm long notches.

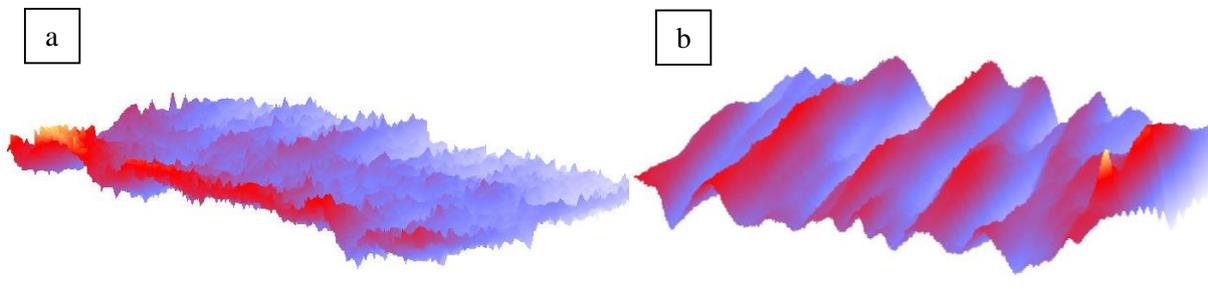
Figure 55: Results of inspection using settings for subsurface detection: a) milled side surface, b) raw side surface.

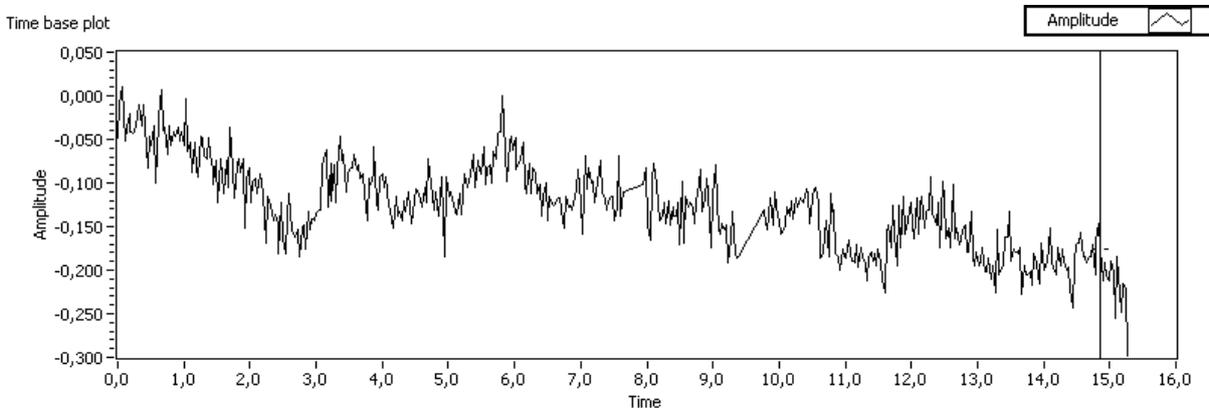
Figure 56: Impedance signal acquired during line scan - milled conditions.

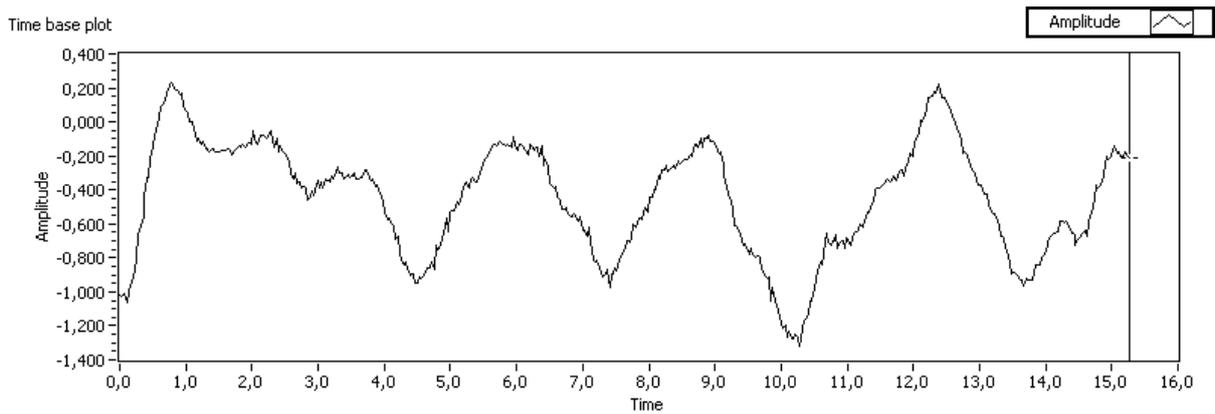
Figure 57: Impedance signal acquired during line scan - raw conditions.

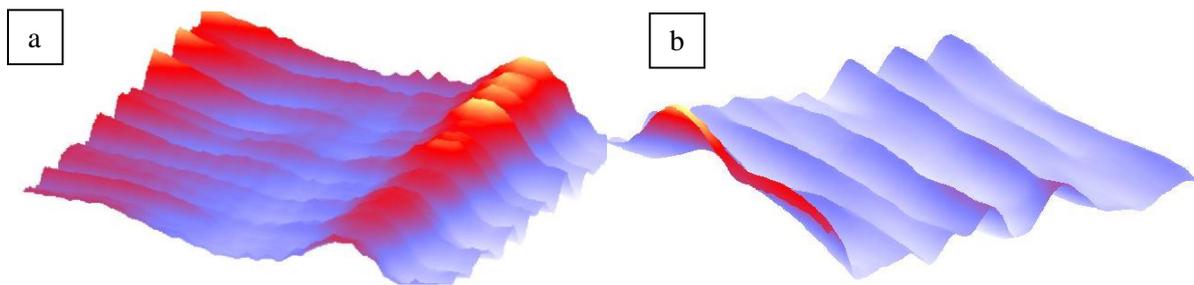
Figure 58: Results of inspection using settings for surface detection: a) milled side surface, b) raw side surface.

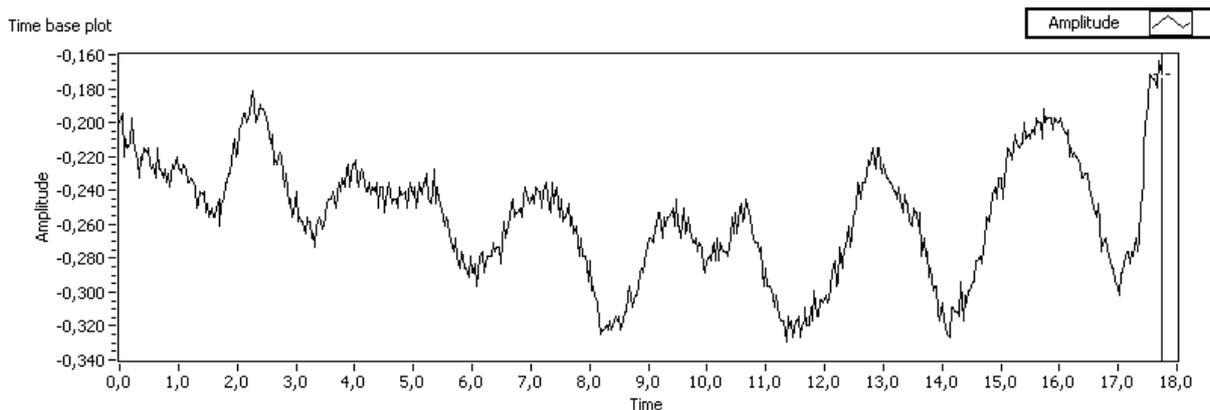
Figure 59: Impedance signal acquired during line scan - milled conditions.

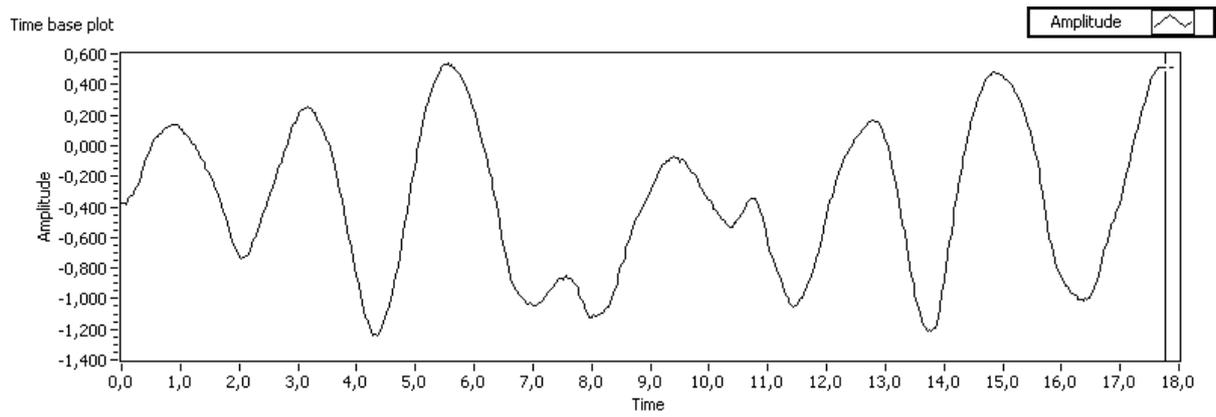
Figure 60: Impedance signal acquired during line scan - raw conditions.

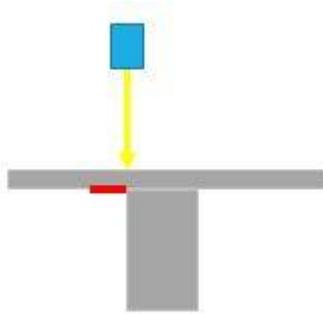
Figure 61: Schematic drawing indicating the surface (marked by red line) generating strong indications close to the edge of a wall.
