Quality assessment of LMD/w Ti-6Al-4V alloy components using conventional NDT techniques

Diploma work in the Master programme Production Engineering

Diploma work No. 155/2015
Department of Materials and Manufacturing Technology
CHALMERS UNIVERSITY OF TECHNOLOGY
Gothenburg, Sweden

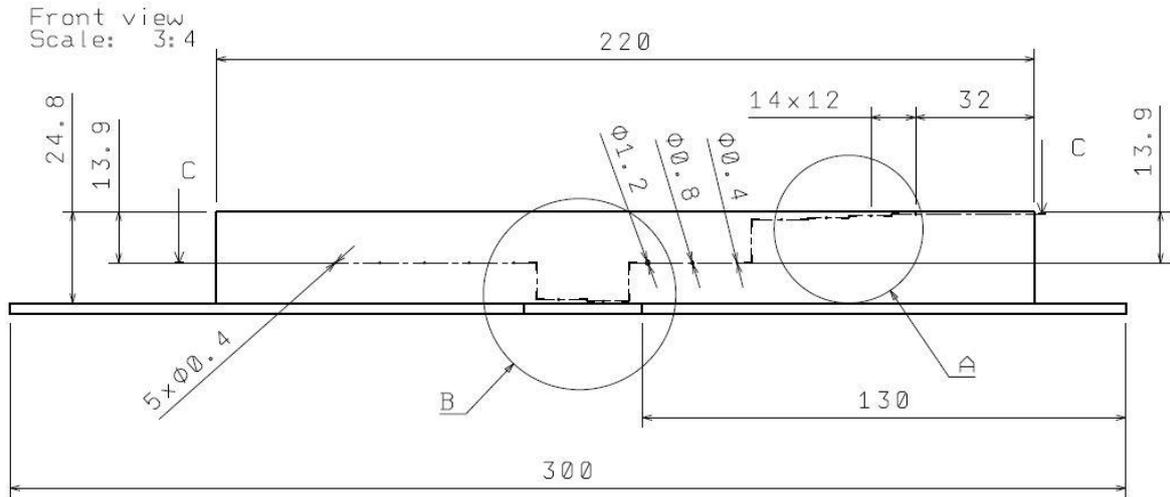
Figure 62: The front view of the reference wall with side drilled holes.

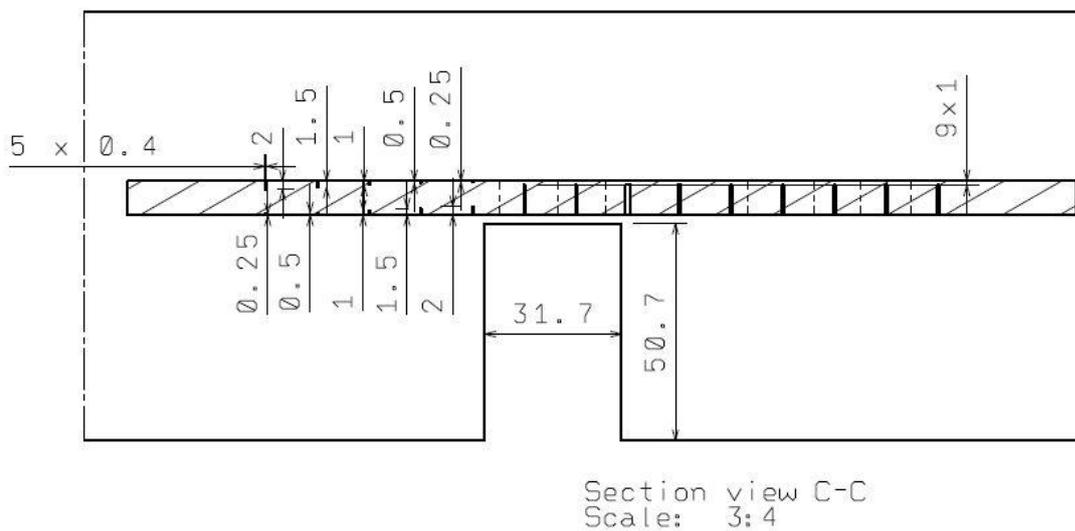
Figure 63: The cross-section C: values of the depth for all holes.

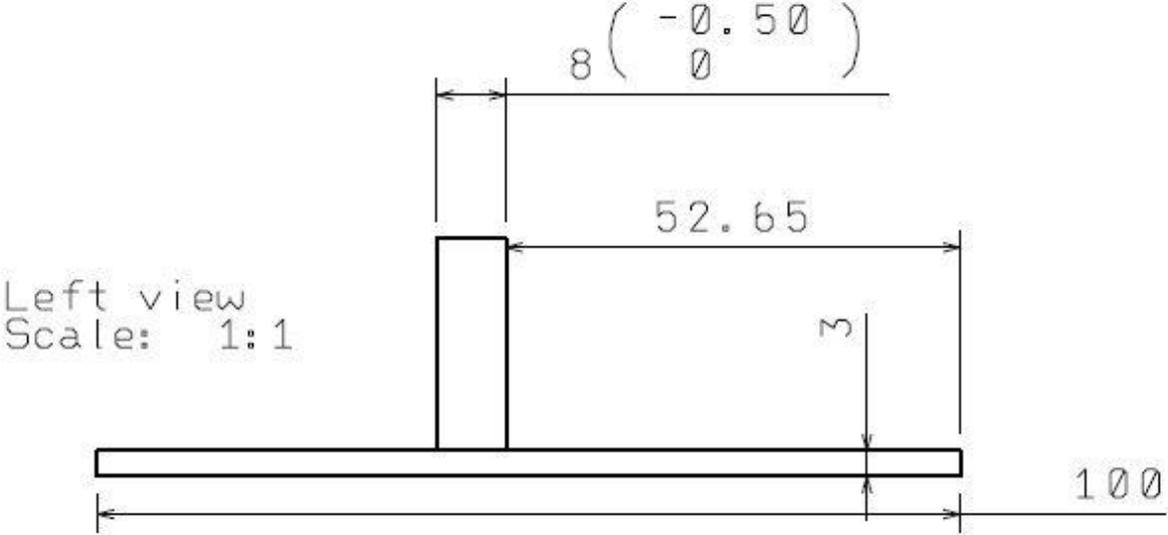
Figure 64: The left view of the new reference – basic dimensions.

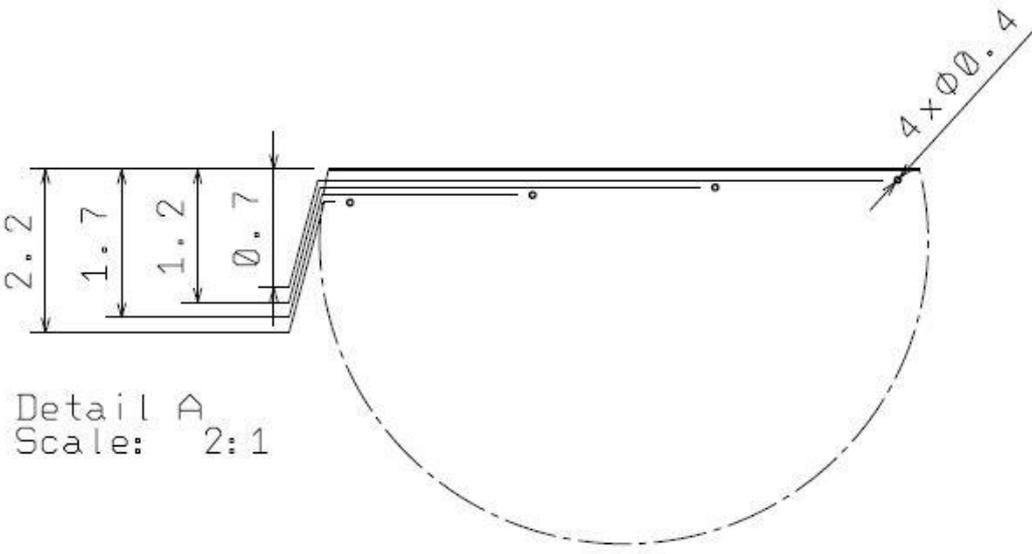
Figure 65: SDHs positioned close to the milled top surface.

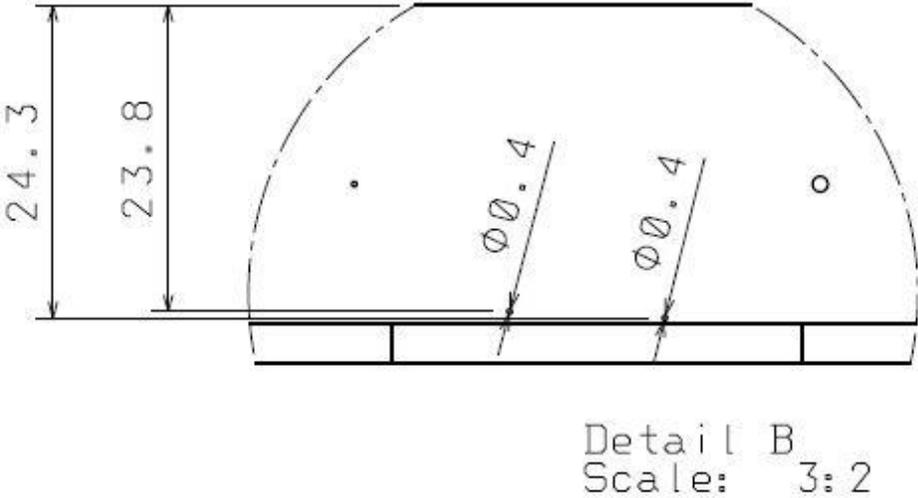
Figure 66: SDHs positioned close to the plate, in the first layer of deposited material.

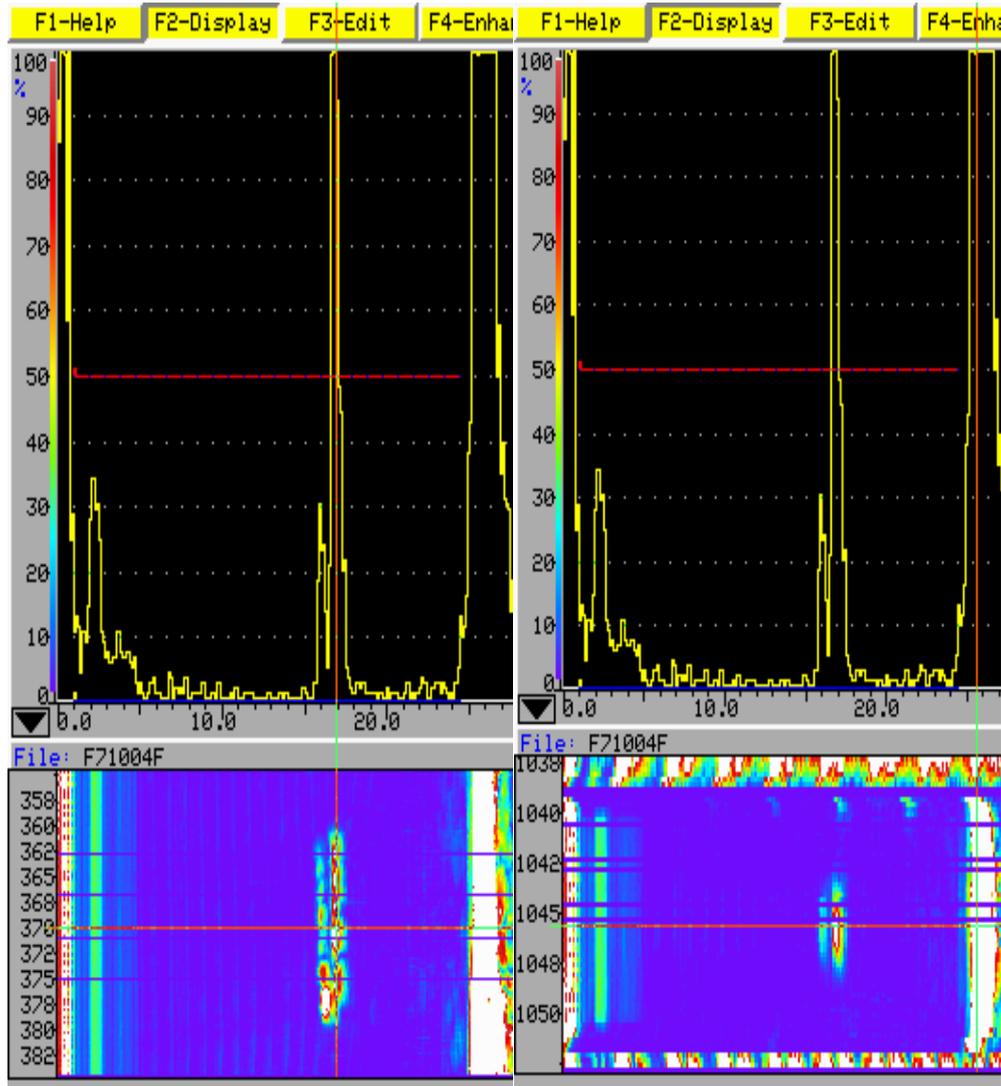
Figure 67: Horizontal (left) and vertical (right) B-scan of the defected area.

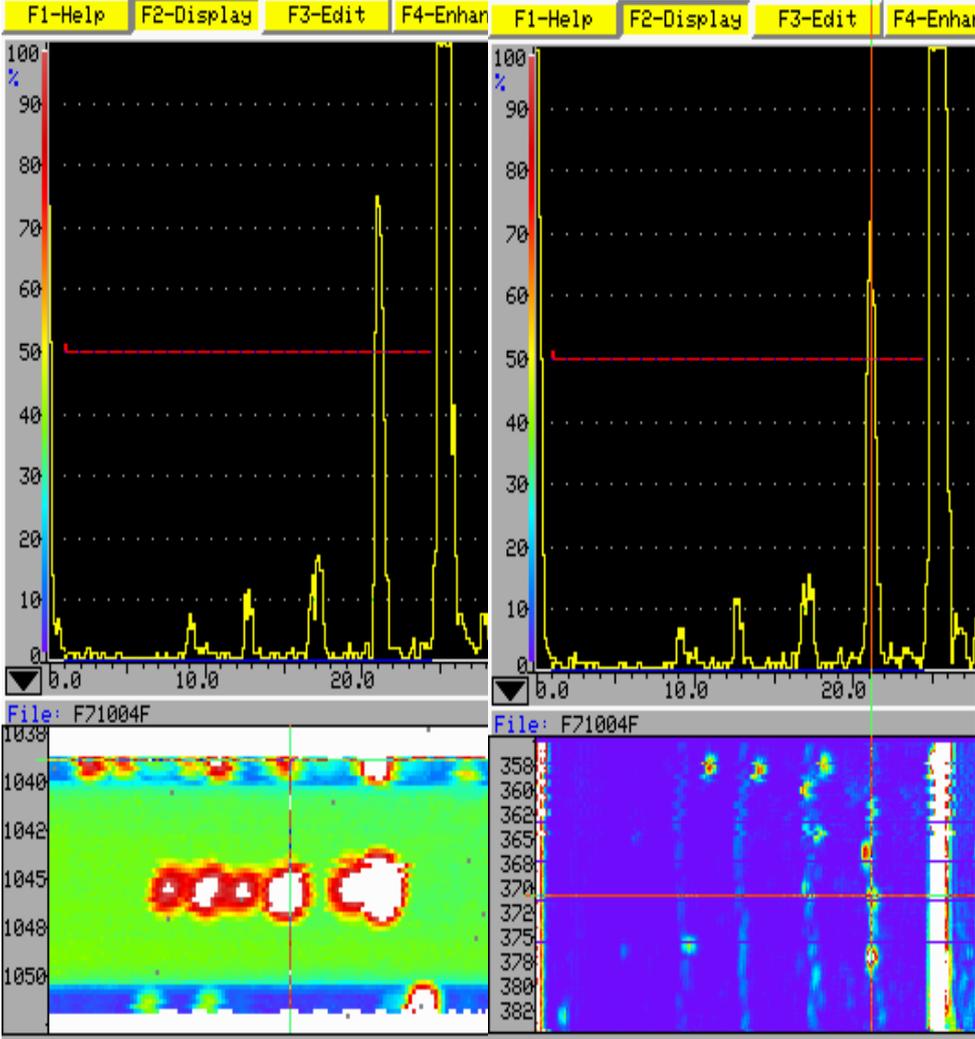
Figure 68: Horizontal B-scan of the area close to the edge of the wall (right).

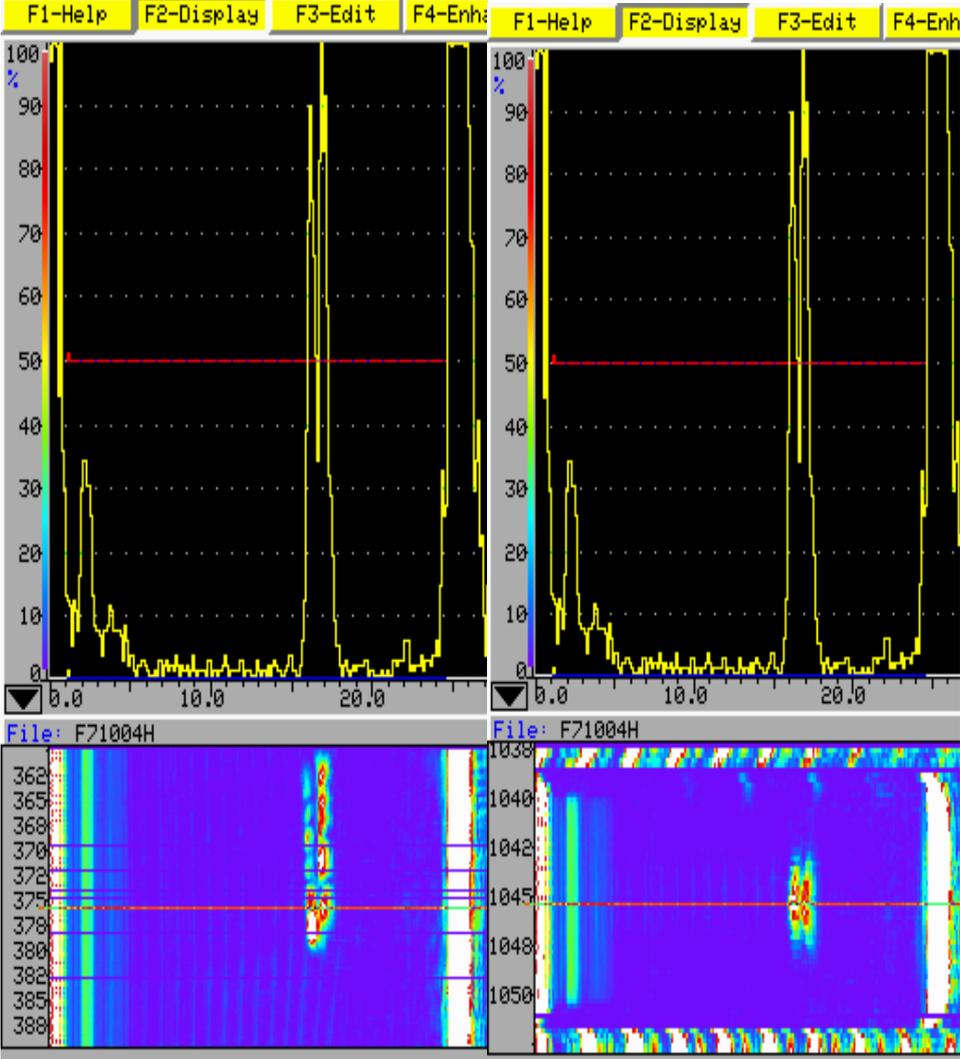
Figure 69: Horizontal (left) and vertical (right) B-scan of the defected area. Scan performed using milled, top surface as incidence.

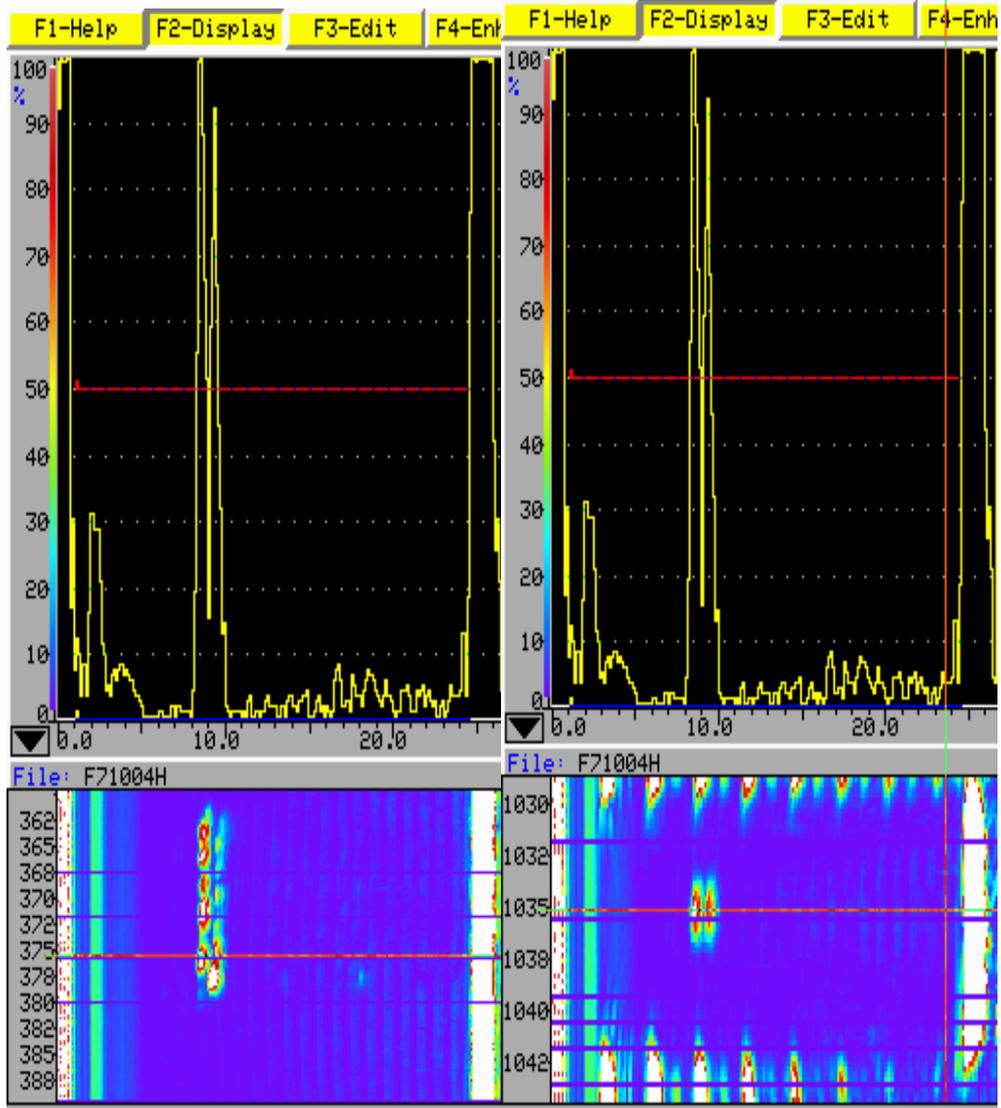
Figure 70: Horizontal (left) and vertical (right) B-scan of the defected area. Scan performed using the milled, plate side as the incidence surface.

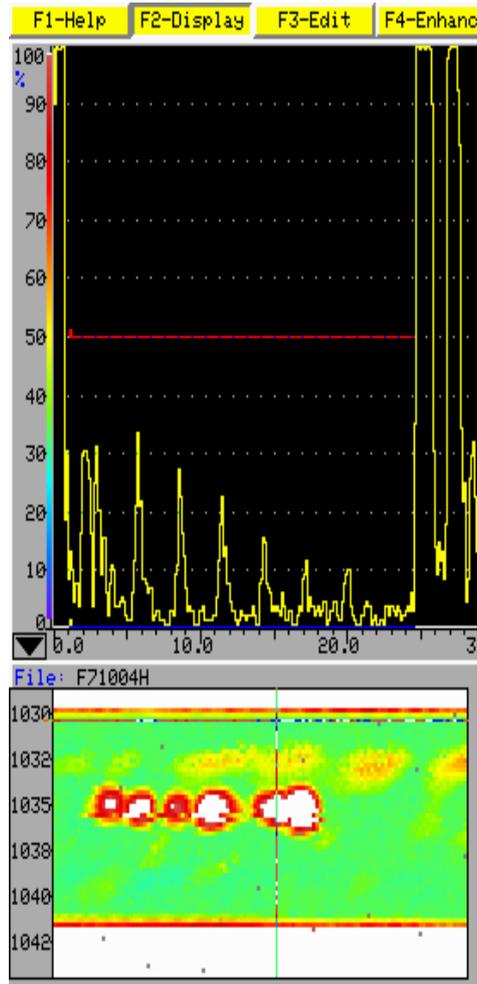
Figure 71: The A-scan of the signal acquired close to the edge of the wall. Influence of signal generated by the plate. Scan performed using milled surface of the plate.

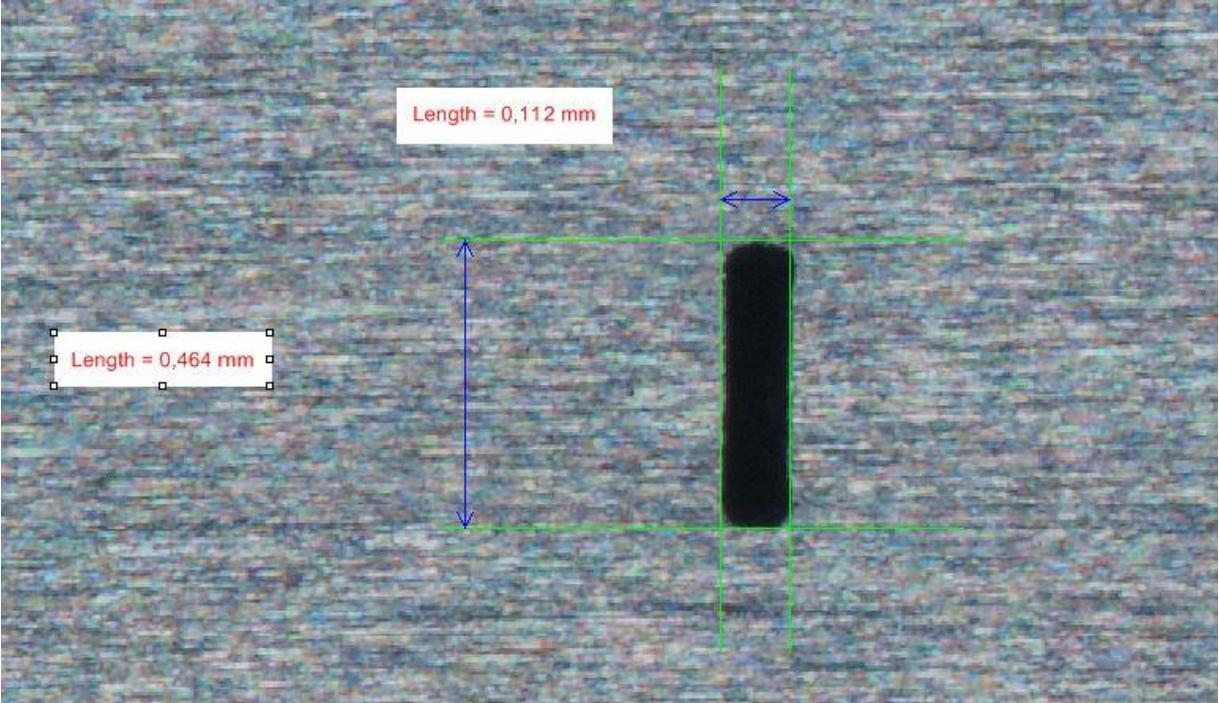
Figure 72: Example of length and width measurement performed on 0.4 mm notch.

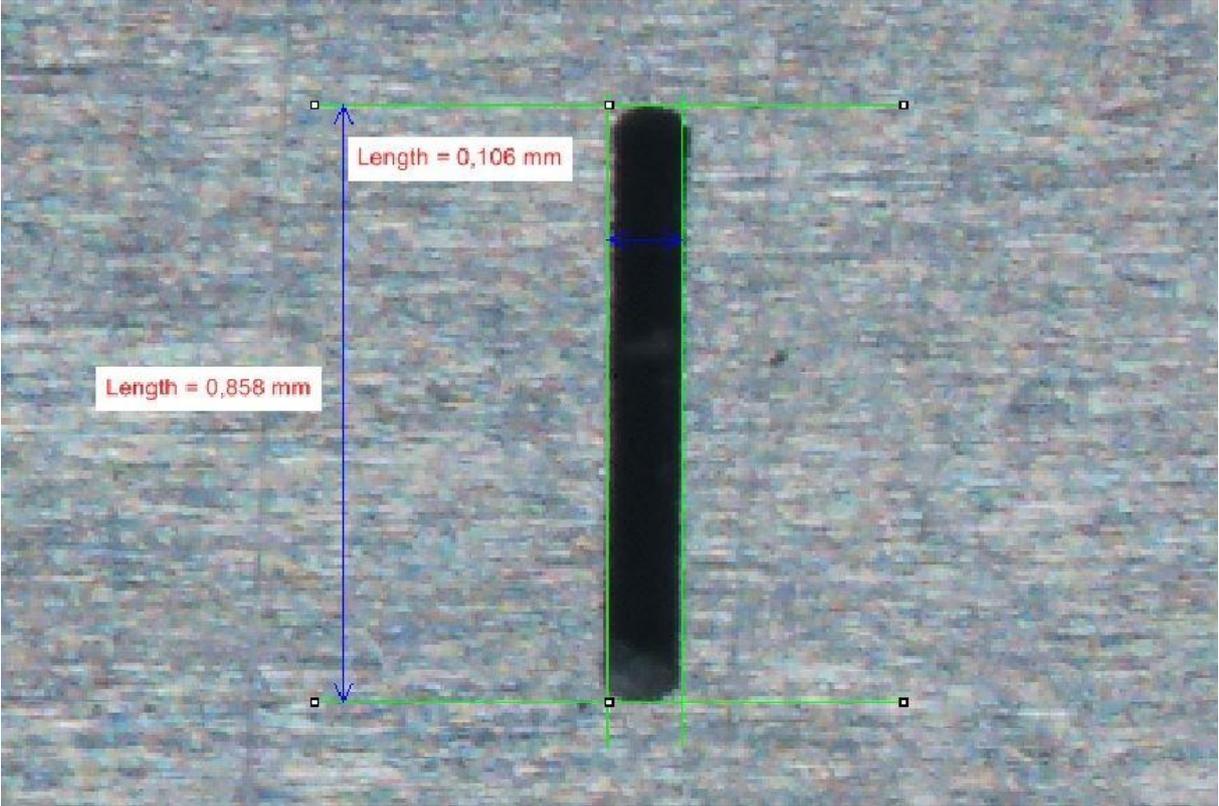
Figure 73: Example of length and width measurement performed on 0.8 mm notch.

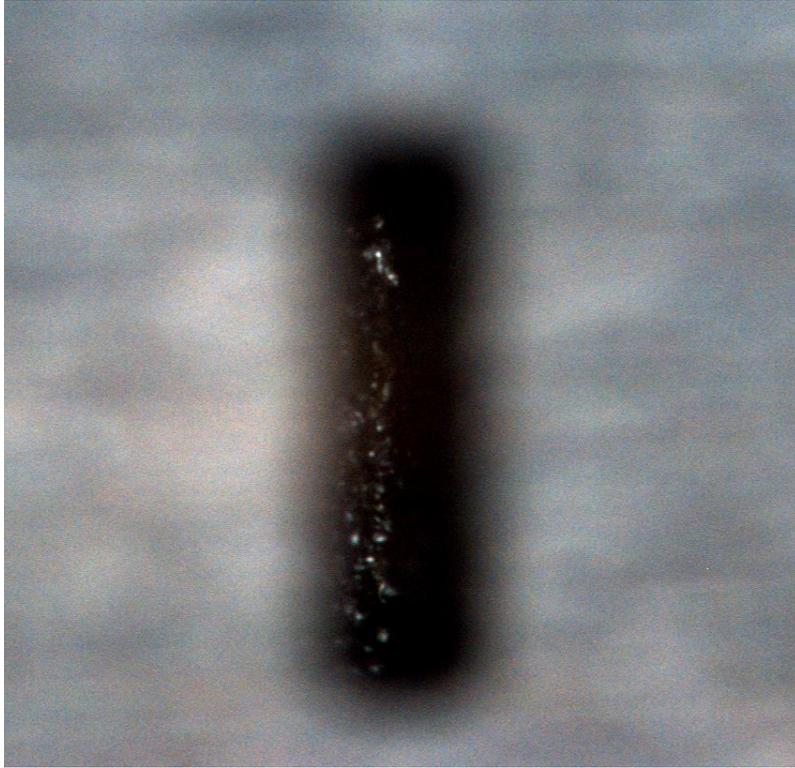
Figure 74: Captured bottom of the notch 0.4 mm at the depth of 0.4 mm.

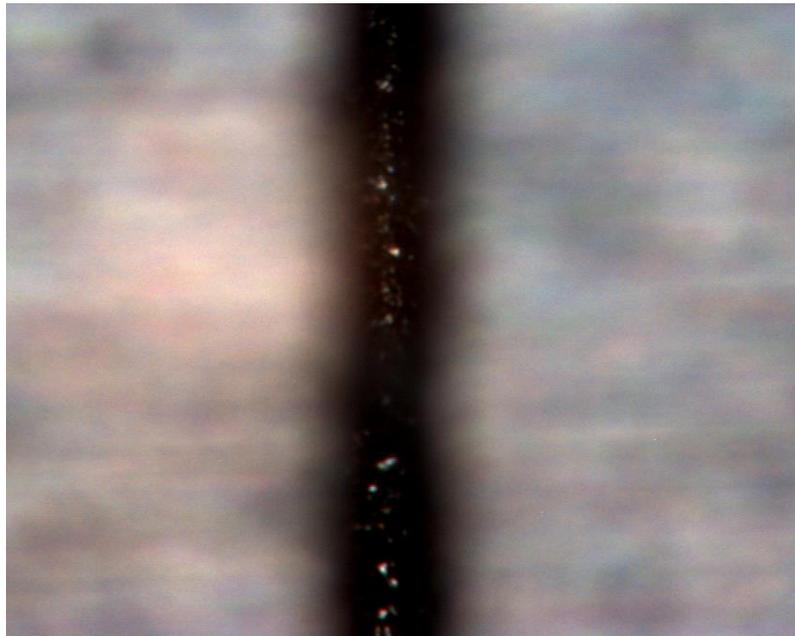
Figure 75: Captured bottom of the notch 0.8 at the depth of 0.4 mm.

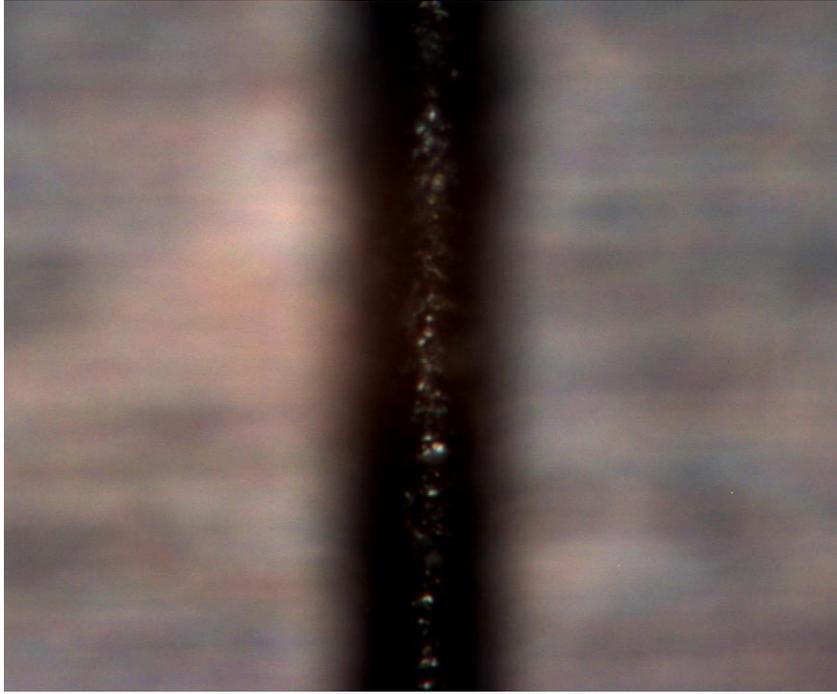
Figure 76: Captured image of the bottom of the 30 mm notch at the depth of 0.4 mm.

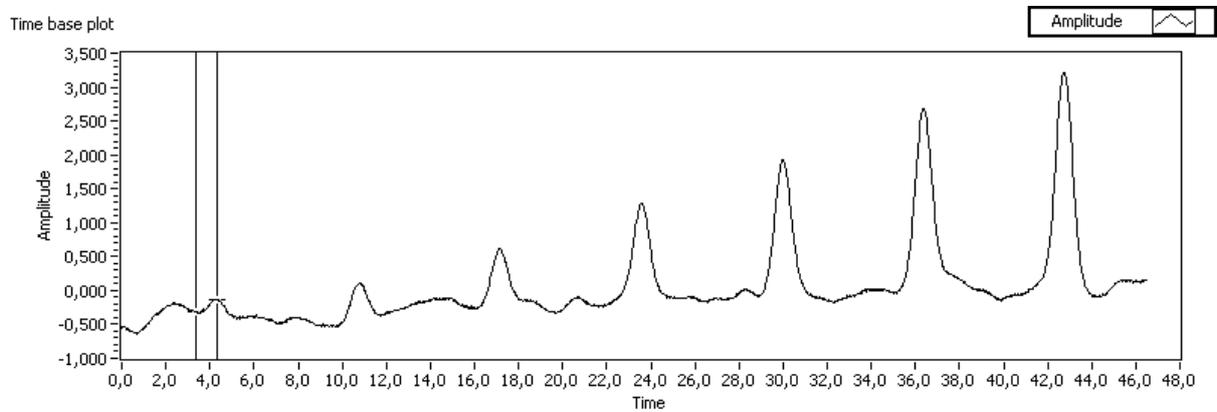
Figure 77: Plot of inductive reactance acquired while scanning area with 0.8 mm notches. Response with highest amplitudes is presented in the figure.

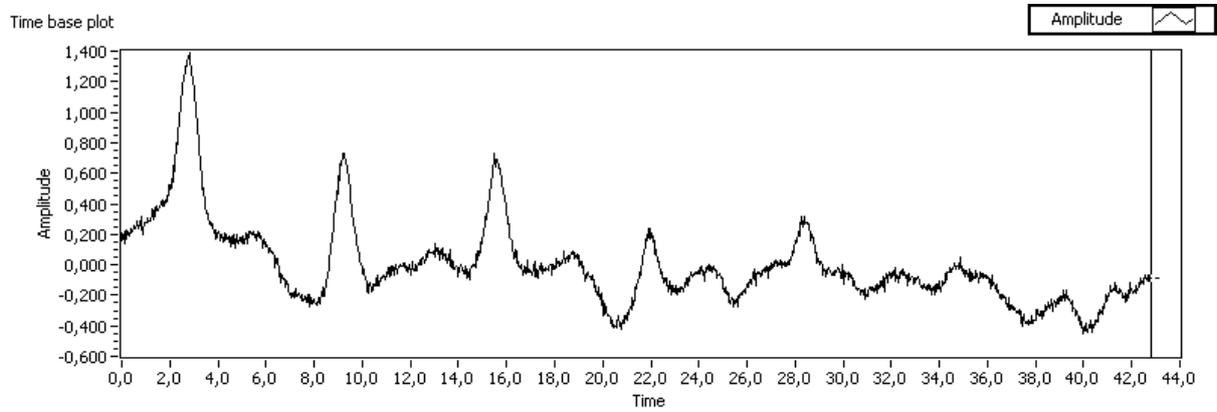
Figure 85: Plot of reactive inductance acquired while scanning area with 0.4 mm notches. Response with highest amplitudes is presented in the figure.

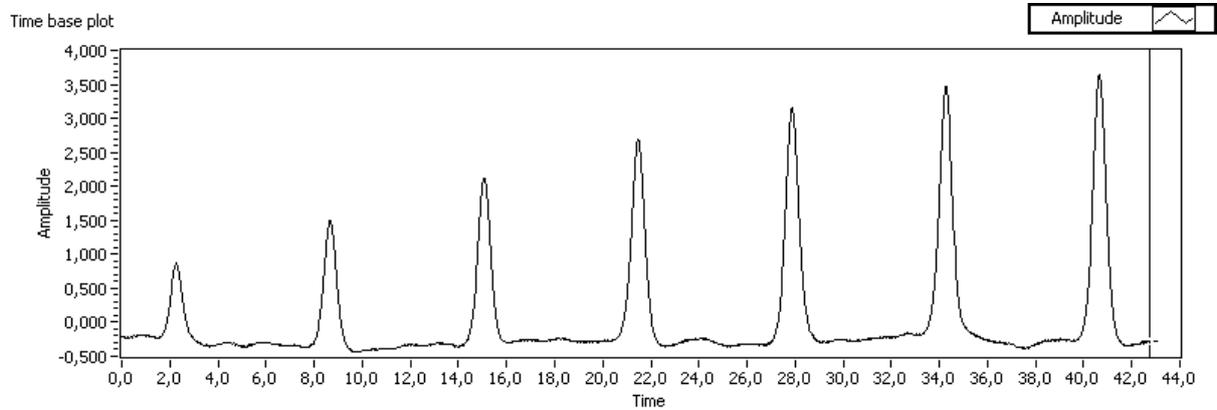
Figure 91: Plot of inductive reactance acquired while scanning area with 0.8 mm notches. Response with highest amplitudes is presented in the figure.

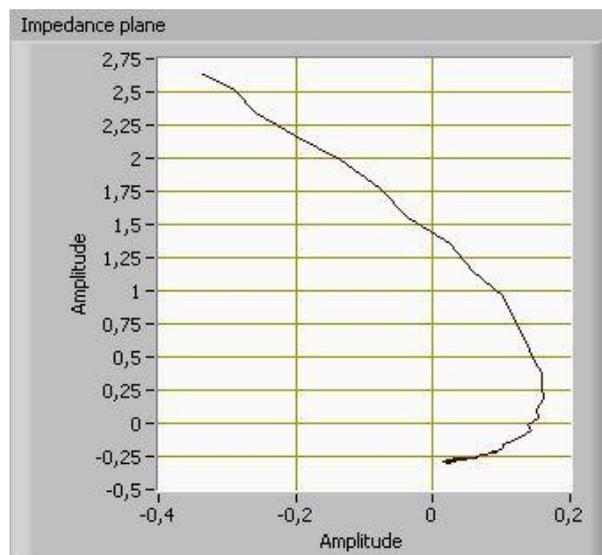
Figure 95: Indication of notch 7 presented on the impedance plane.

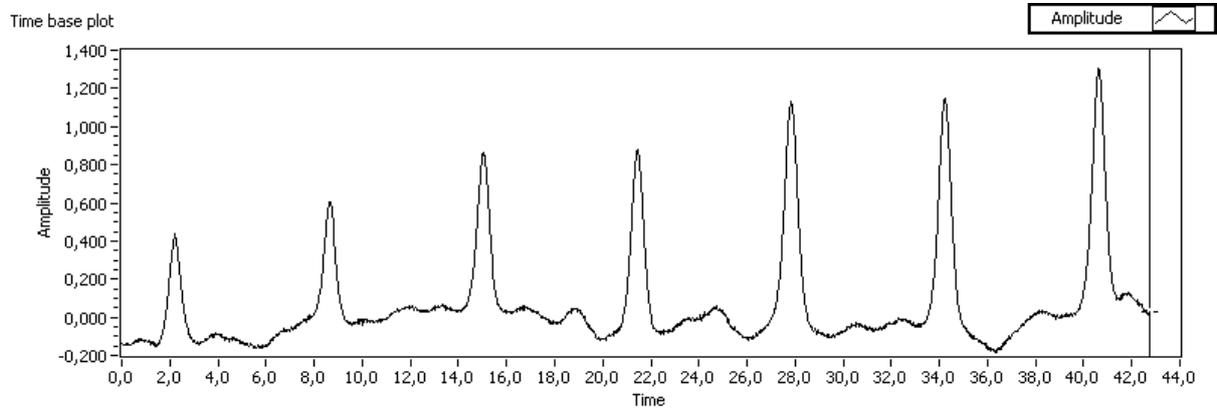
Figure 99: Plot of inductive reactance acquired while scanning area with 0.8 mm notches. Response with highest amplitudes is presented in the figure.

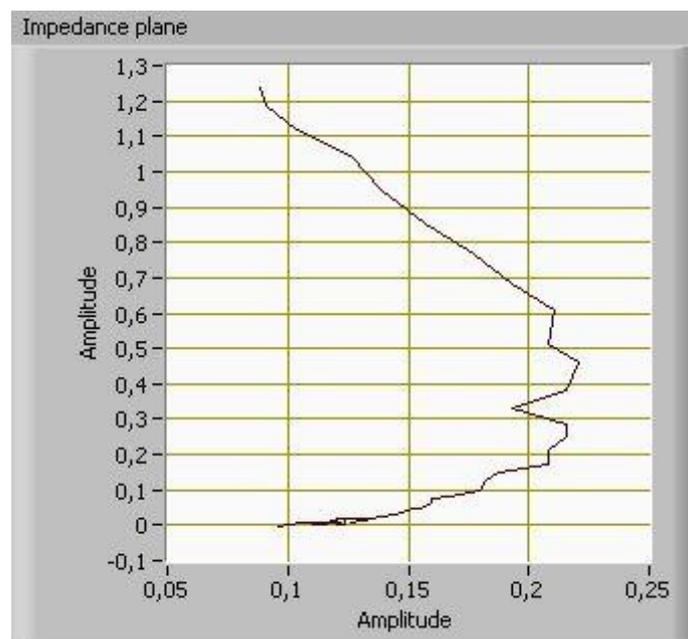
Figure 100: Indication of notch 4 presented on the impedance plane.
