RECONNECTION

context, artefact and history in designing
the restoration of a Zanzibari hammam

Master thesis in Architecture

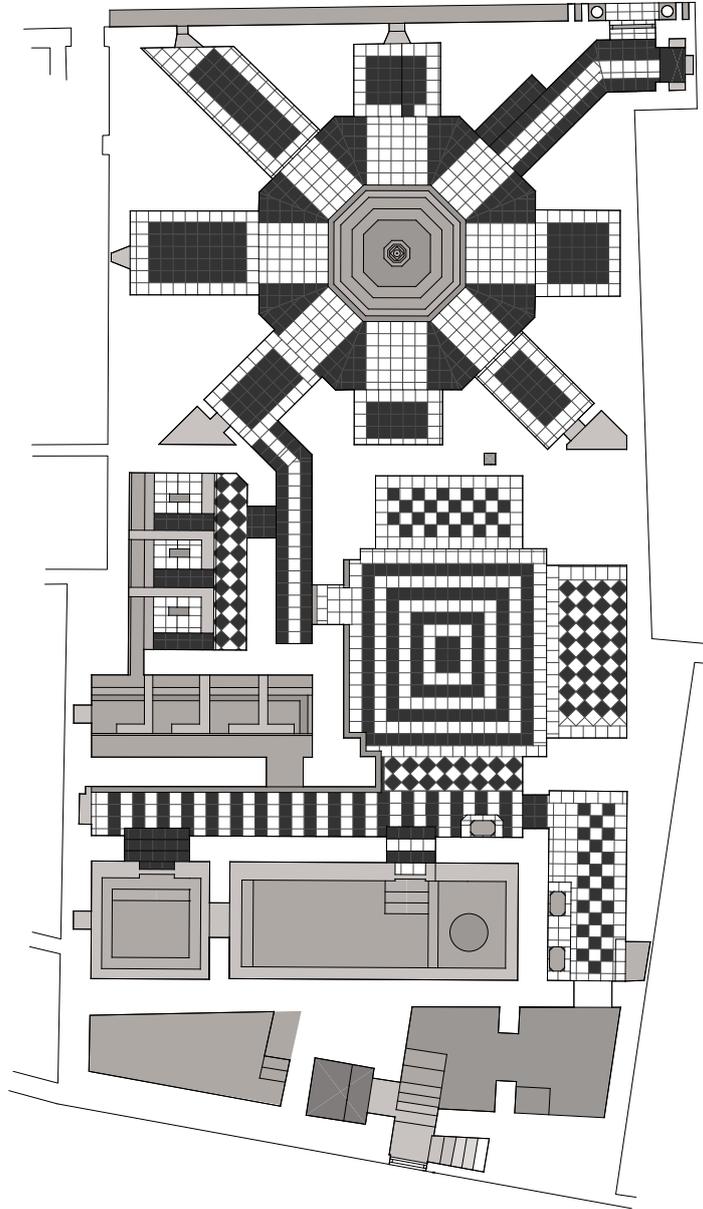
Plan showing the layout of tiles and plaster on floors. Scale 1:200

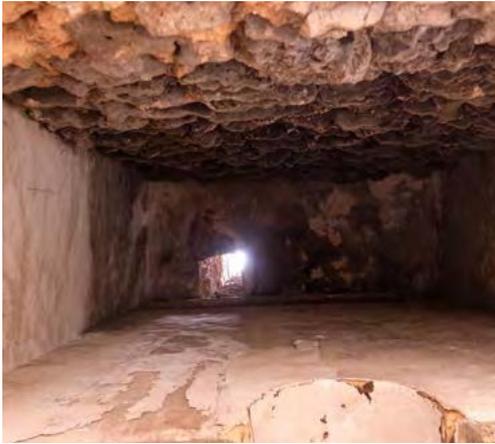
Exposed coral rubble and orig. plaster in coffee niche

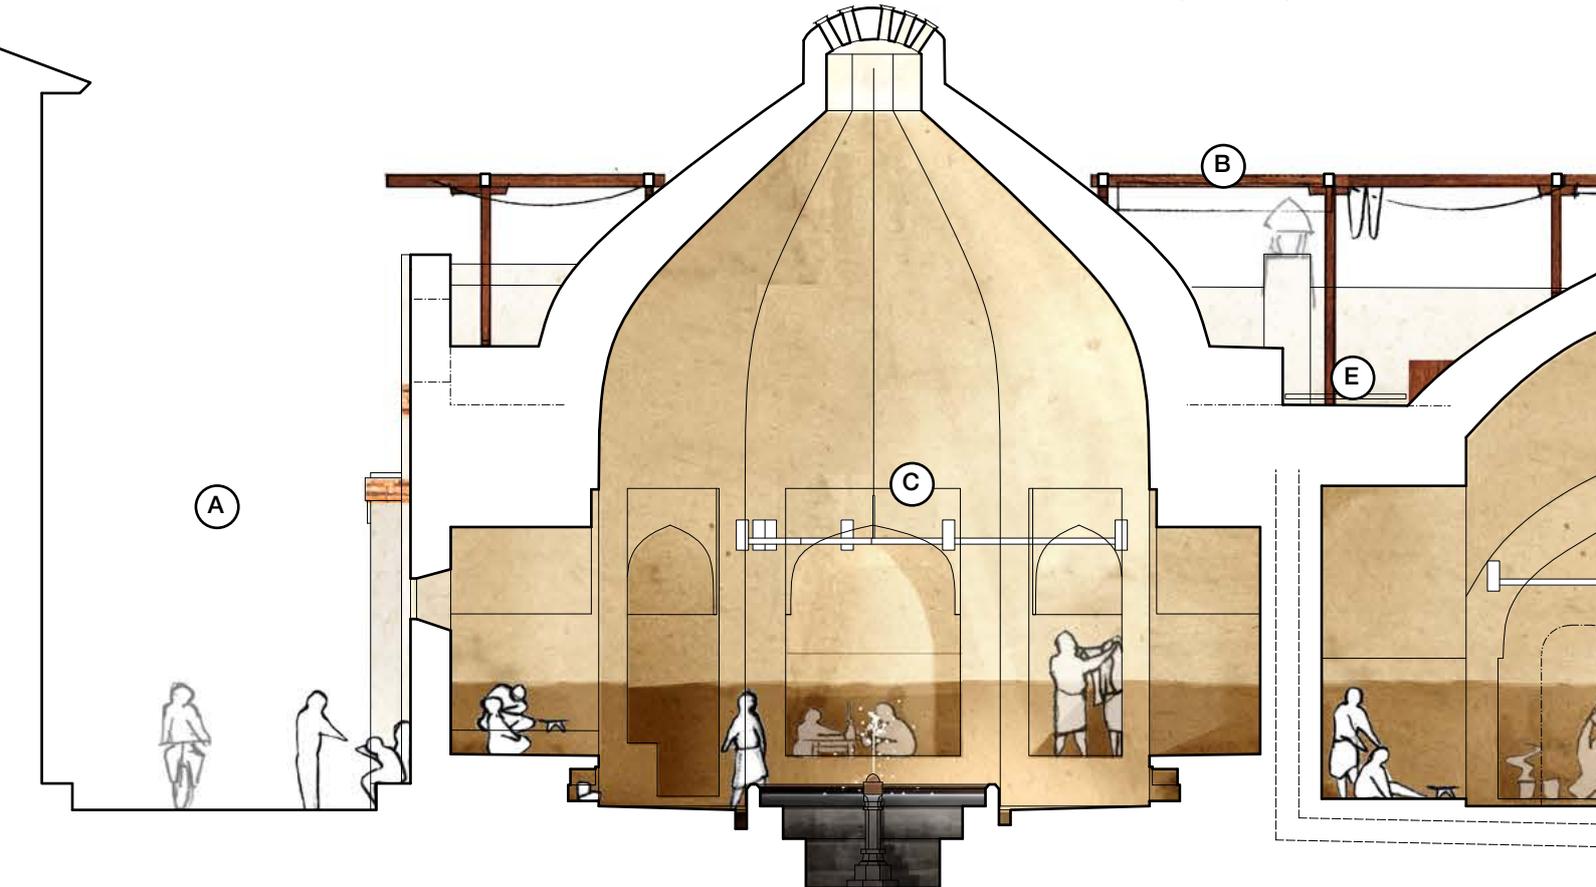
C. Light fittings: The freely rotating lamps of the main rooms have a one long arm traveling around the room in a mimic of the dynamic natural lighting of the passing day. Wiring is done from the roof with only the low-voltage part of the system on the inside, making dangerous or intrusive interior wiring unnecessary.

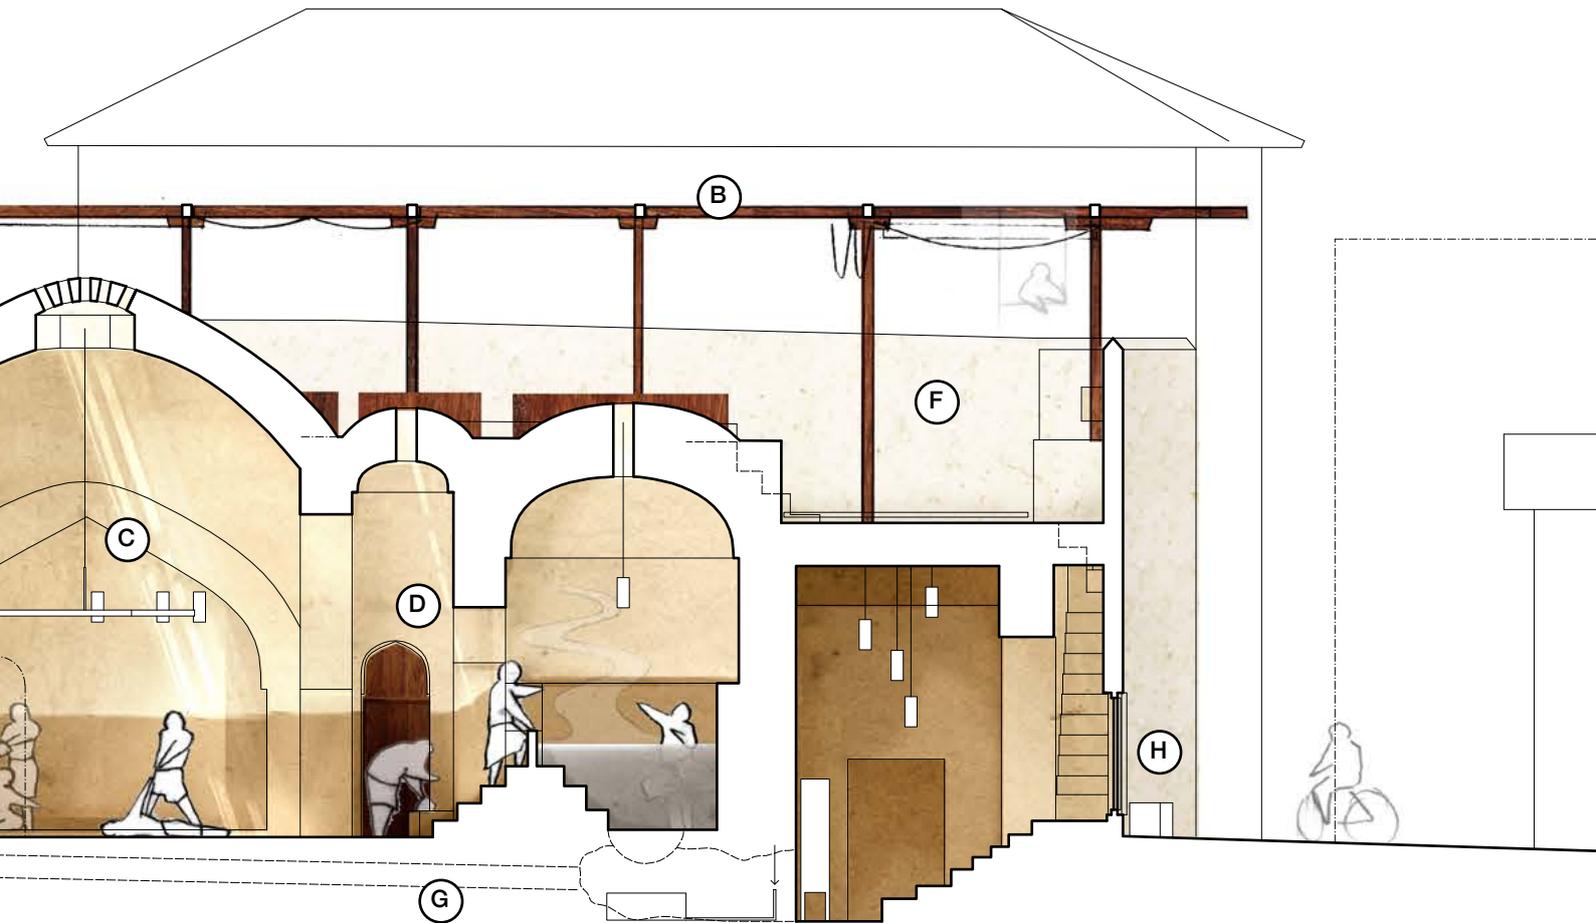
G. The heating system: The original under-floor heating system is restored to use and separated from the heating of water to allow the latter to make use of solar heaters.

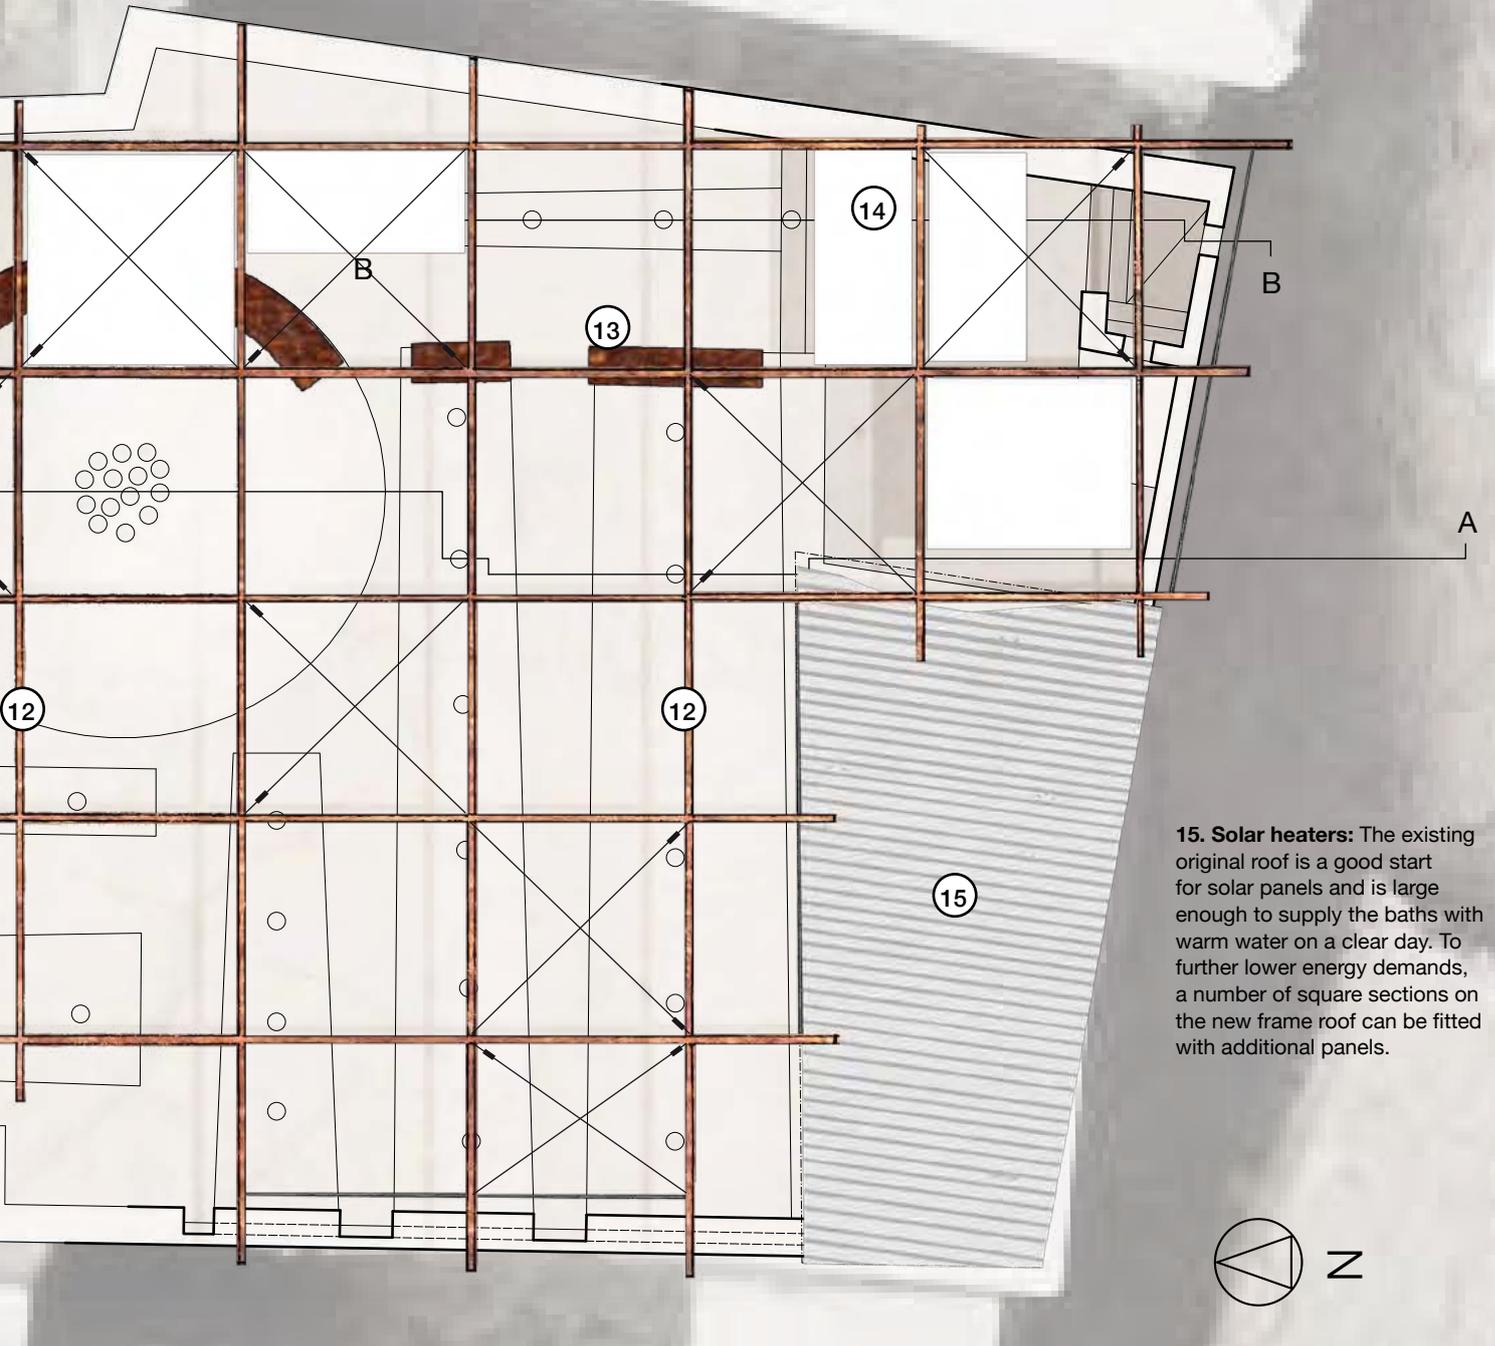
Roof plan with proposed new use and features

15. Solar heaters: The existing original roof is a good start for solar panels and is large enough to supply the baths with warm water on a clear day. To further lower energy demands, a number of square sections on the new frame roof can be fitted with additional panels.

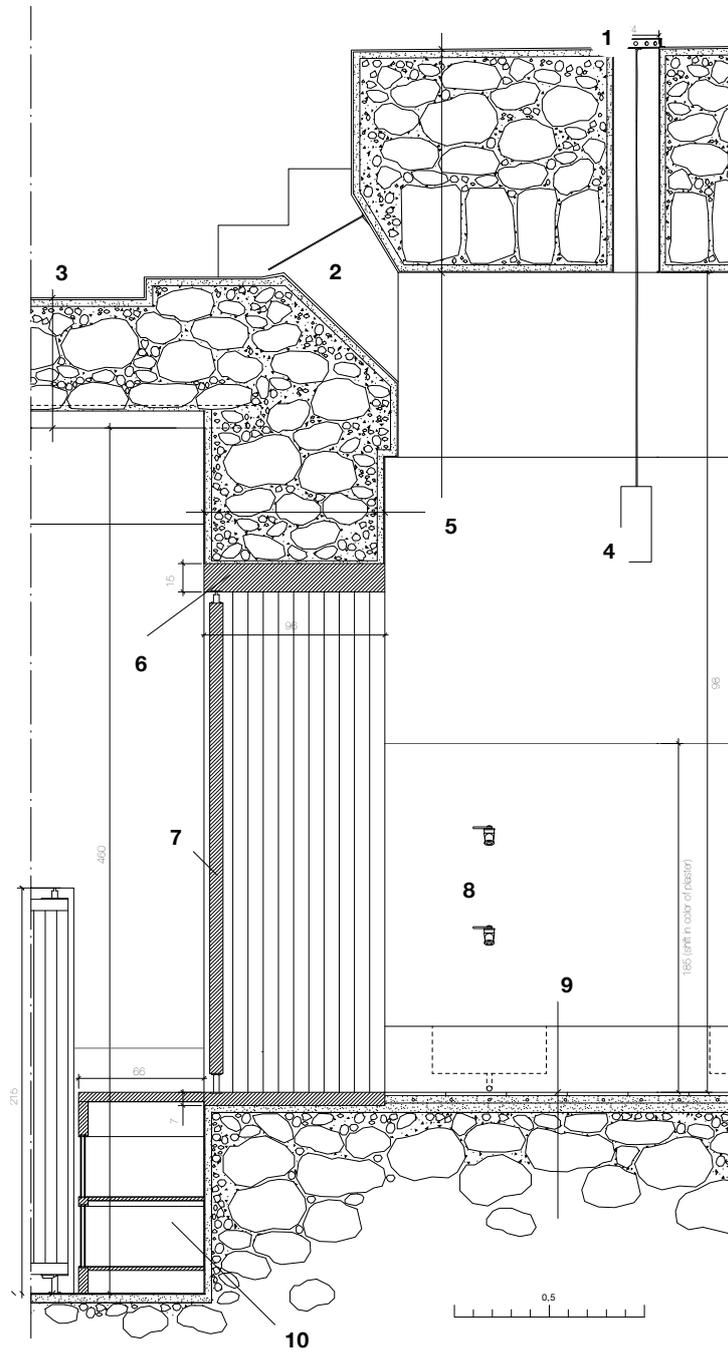
Detail of section B-B. Scale 1:40

- 2 The current design remains while the pane itself is replaced with a tempered equivalent for safety reasons.
- 3 The mangrove poles, boriti, are replaced according to good conservation practice. Replacements are not painted.

- 4 New brass pendants suspended from the new light shaft covers. 12V electrical wiring is carried on the roof, with no interior wiring required.
- 5 Walls and ceilings are repaired according to good conservation practice. Cement fillings around doors remain as well as historical repairs on selected walls, retaining an unbroken line of documentation.

- 10 Stair to new opening, constructed in accordance with other furniture. The back of the integrated cupboard is left open as to allow ventilation of wall.

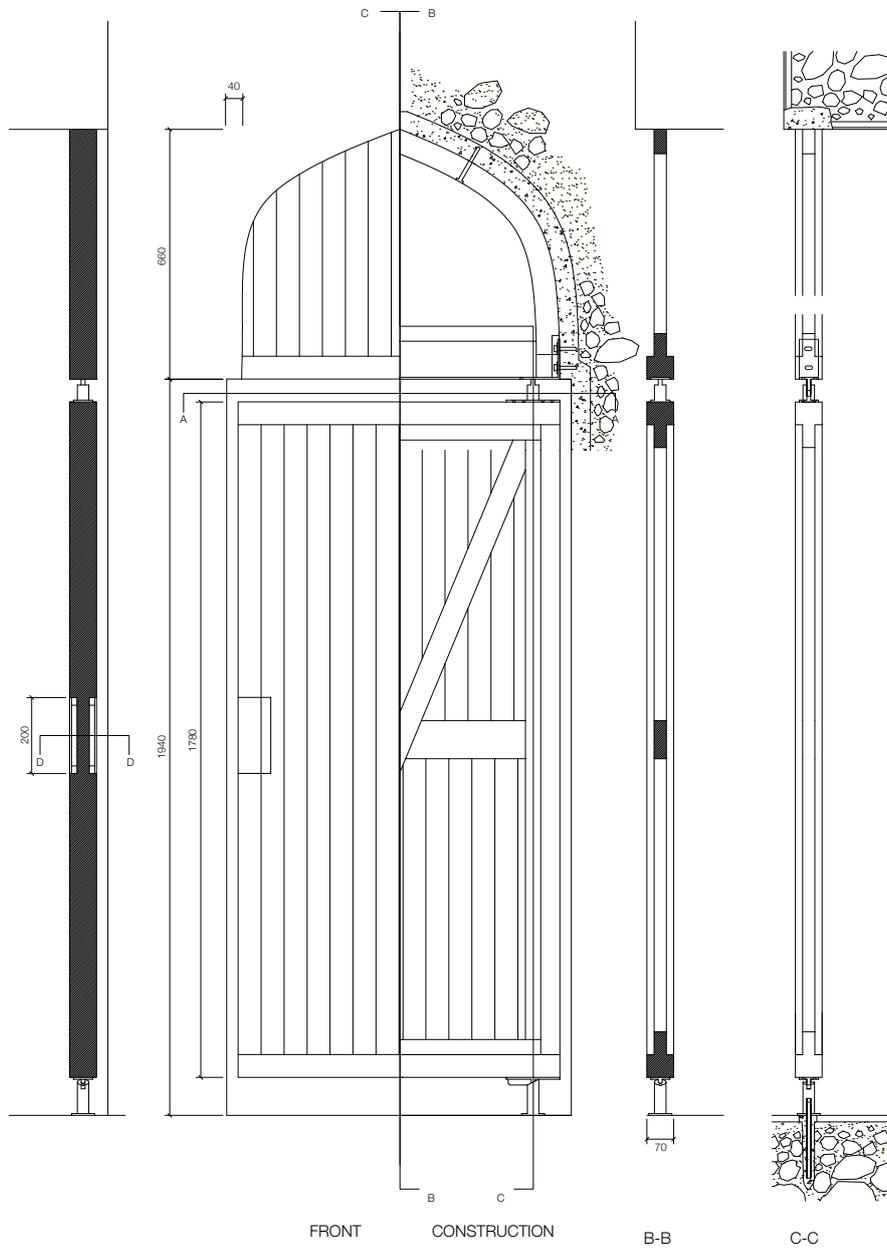
Pivoting door. Scale 1:20

New door, exposing the previous removal of a door frame and replastering. One tile for each door has to be drilled through, irreversibly damaging it. On the other hand, this approach leaves the walls more or less intact and has the benefit of not leaving organic material in direct contact with the damp wall behind the plaster.

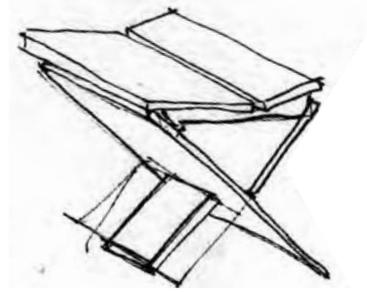
An example of a collapsible chair for those who minds sitting on the floor. The seat itself is made of two pieces of the same marble as the floor. A gesture in a sense, to those same visitors, who can enjoy the cool of the smooth floor from a convenient height.

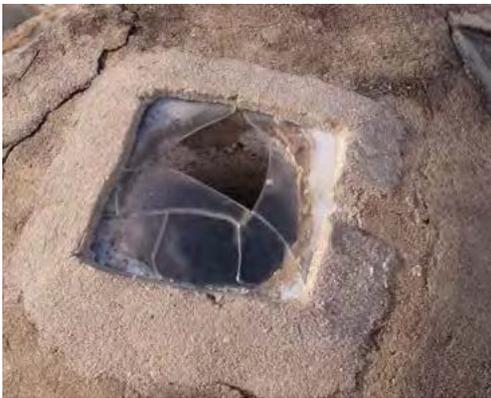
Ventilated cover for light shafts. Scale 1:4

Many of the existing panes are broken.

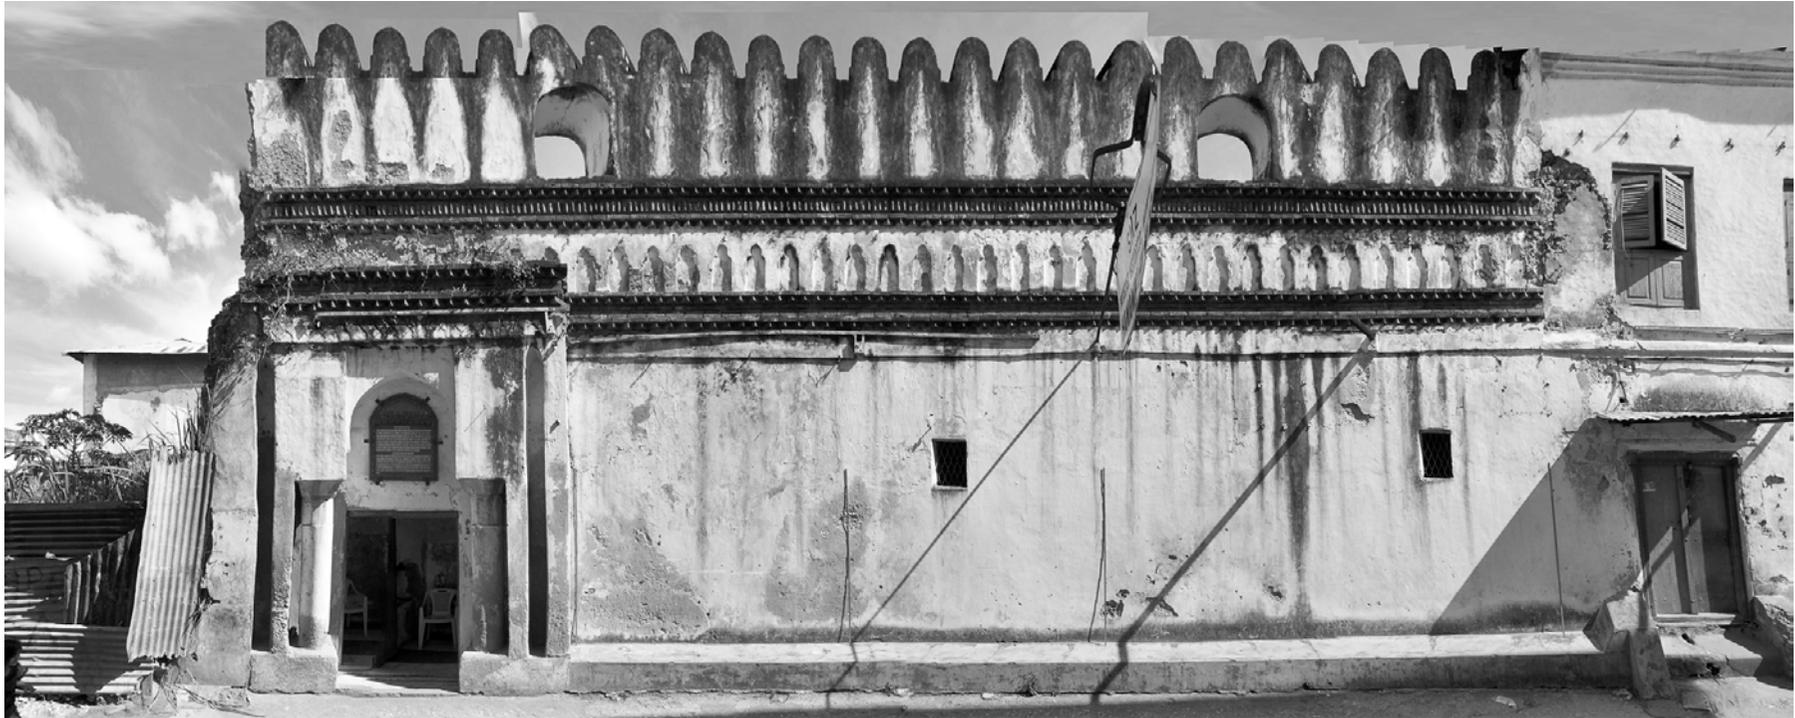
Collage of facade towards Hamamni Street. (original photos: Magnus Persson, 2013)

9 A set of pictures of the facade towards Hamamni Street shows this cycle of an advanced state decay (1983), repairs (1993) and new deterioration following the current disregard (2013).

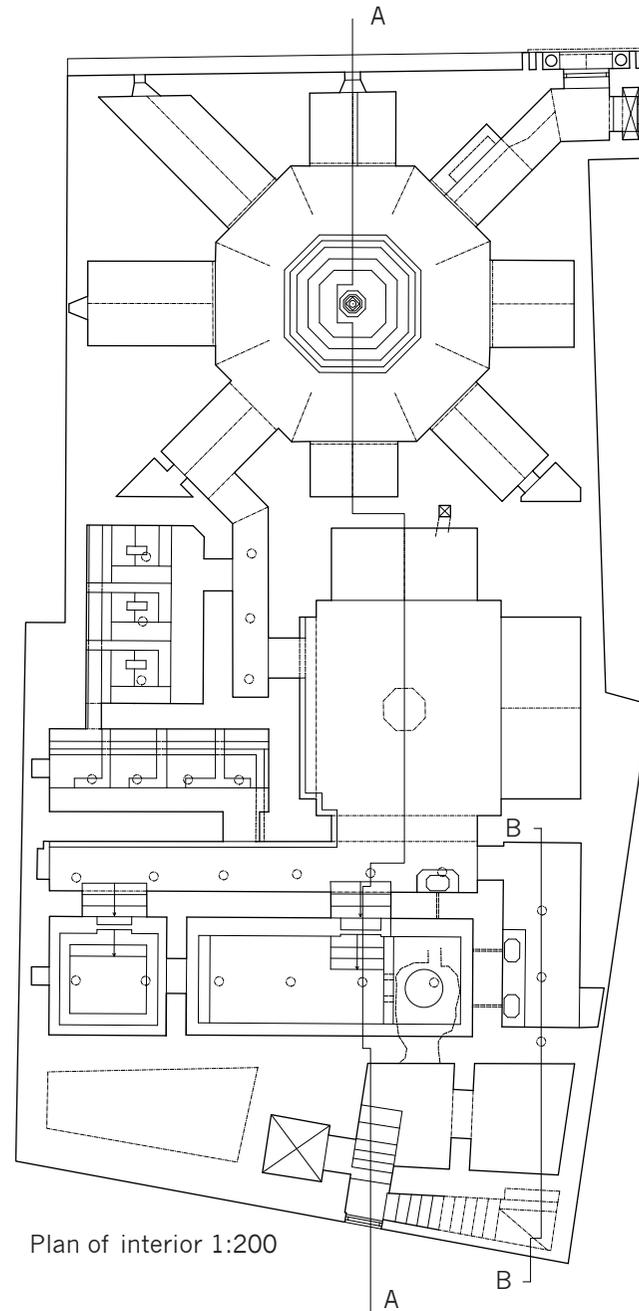
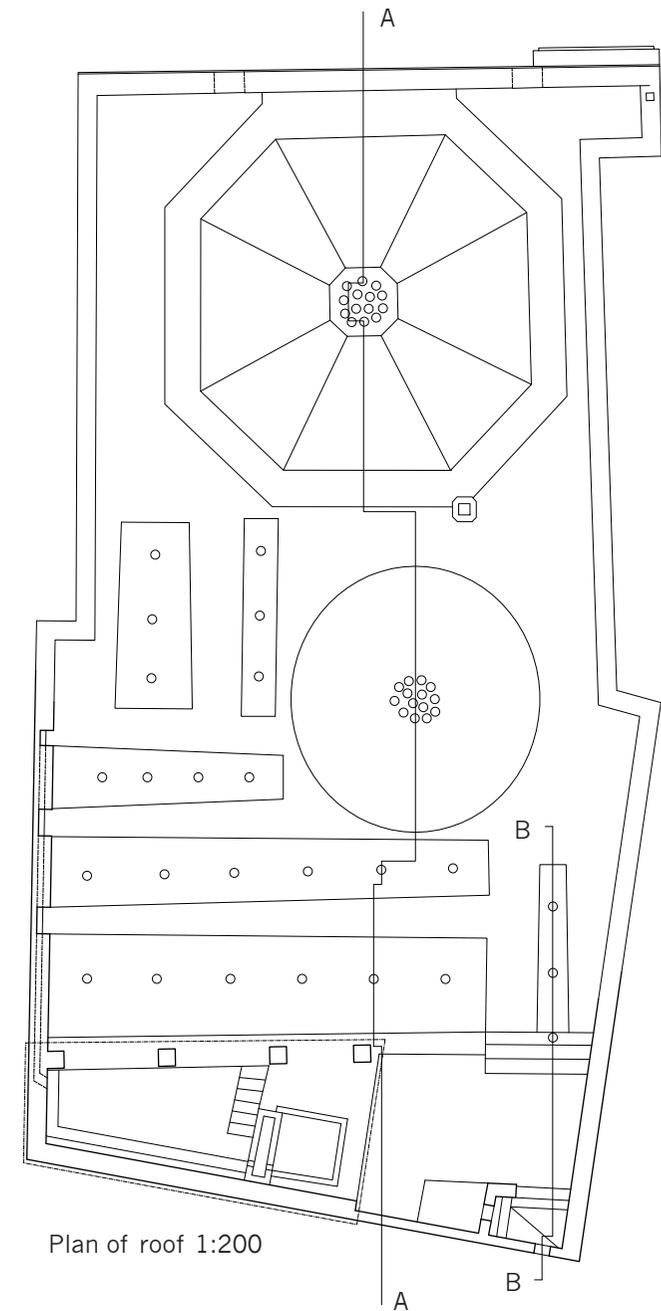
Section B-B 1:200

Since no complete set of drawings have been accessible and the accuracy of the existing floor plan is not consistent, a new mapping of the building was done. The drawings shown here are the result of the mapping.

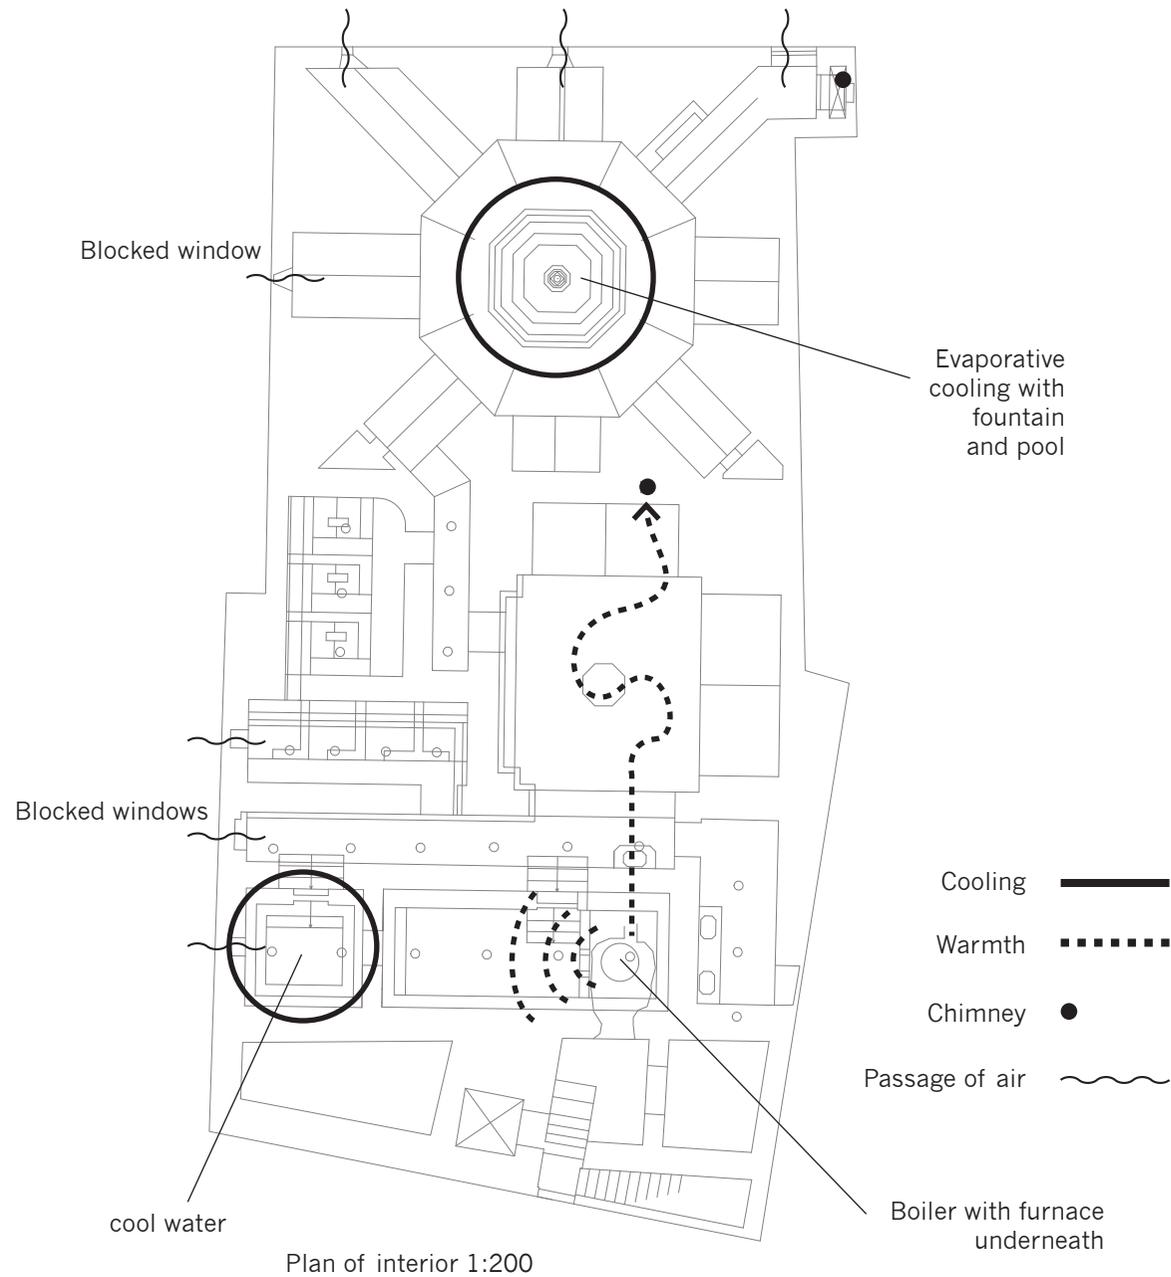
The cool room ought to have held a lower temperature than that of the outside. Both due to being shaded and because of the fountain placed in the middle of the room. Especially before the windows along the western wall of the baths were blocked by other buildings.

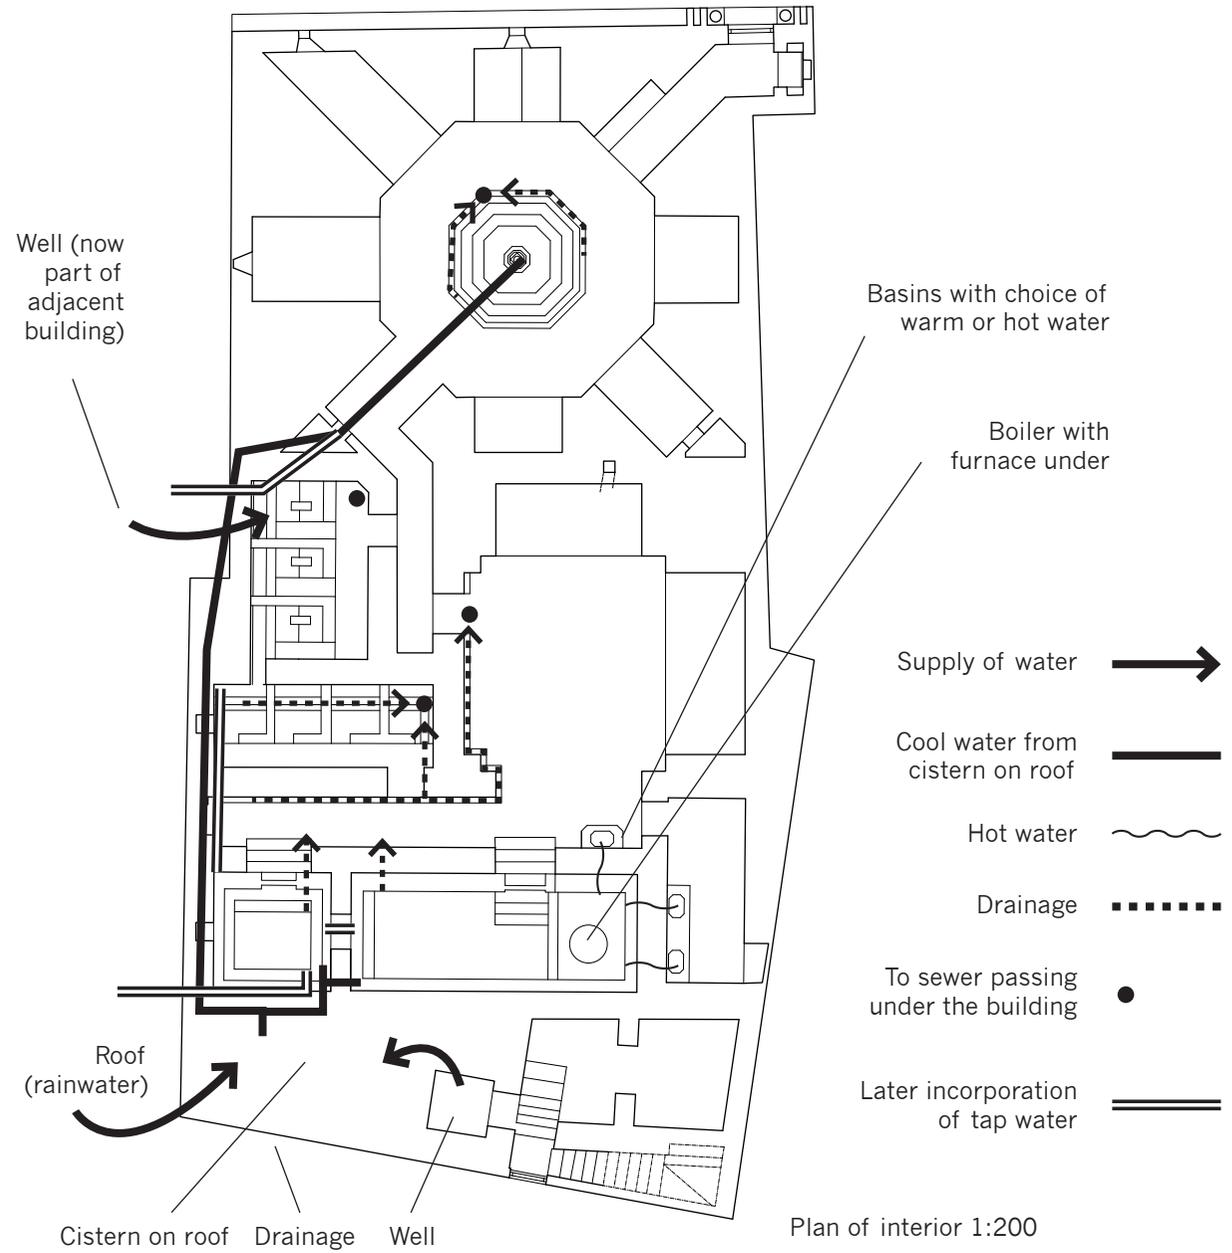
When tap water was introduced in Stone Town, new pipes were installed, carrying water to and within the bath house. The illustration shows an interpretation of how the flow of water was changed.

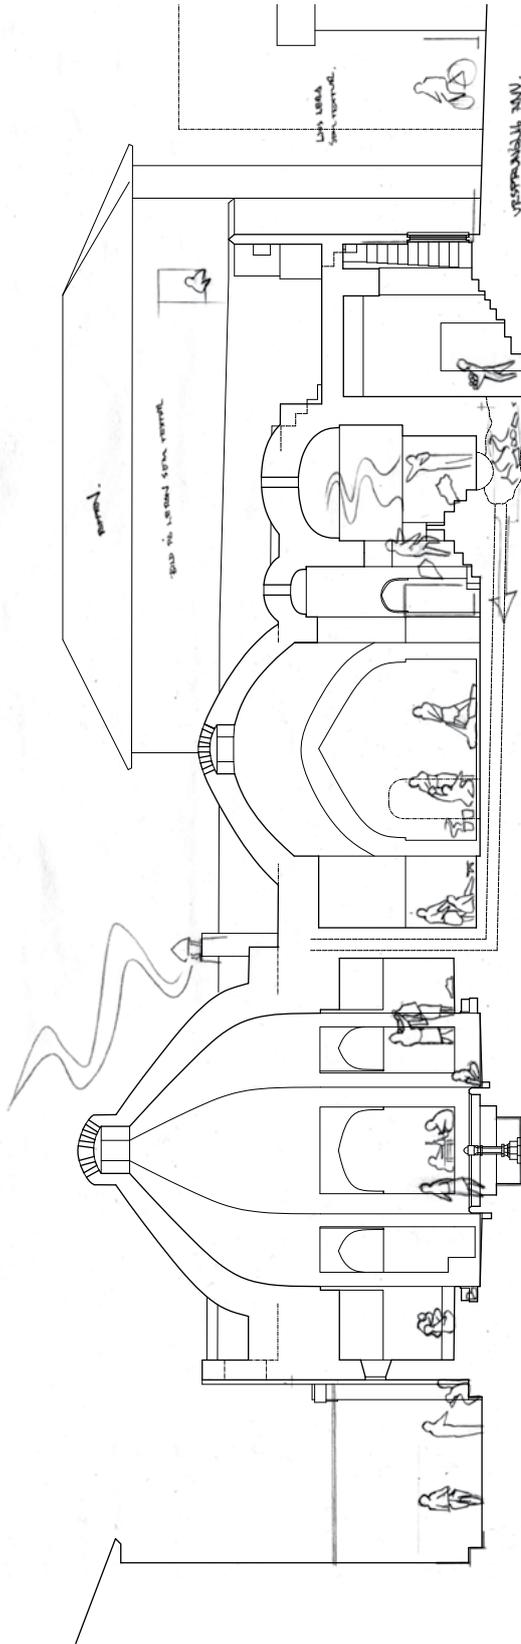
Illustration of original use, sections

Section A-A through the entire building including Hamamni Street to the left and the back street.
