Renovation of brick buildings constructed 1870-1930

Investigation of the thermal envelope in renovated and re-renovated dwellings

Master's Thesis in the Master's Programme Structural Engineering and Building Technology

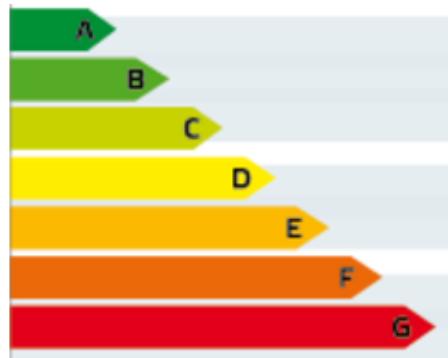
Figure 2.1 Rating scale of energy class based on energy consumption (Boverket, 2016).

According to the Energy Performance Certificate (EPC), the energy consumption of the building is 109 [kWh/m²/year], which gives grade E in Figure 2.1 and Table 2.1.

According to the EPC, the energy consumption is 135 [kWh/m²/year], which gives grade E in Figure 2.1 and Table 2.1.

According to the EPC, the energy consumption is 145 [kWh/m²/year], which gives grade F in Figure 2.1 and Table 2.1.

According to the EPC, the energy consumption is 126 [kWh/m²/year], which gives grade E in Figure 2.1 and Table 2.1.

According to the EPC, the energy consumption is 172 [kWh/m²/year], which gives grade F in Figure 2.1 and Table 2.1.

If all possible combined renovations would be made (windows, 100 mm on all walls and attic apartments) showed in Figure 7.2, the average EPC would decrease from 138 to 67 kWh/m²/year. According to the rating scale from Boverket in Figure 2.1 and Table 2.1 this means that the grade would go from F to C for the average EPC.

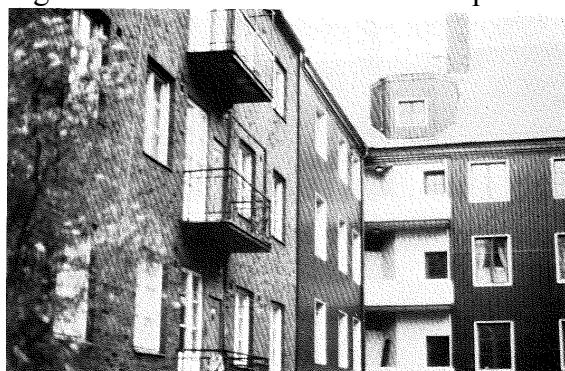
During the seventies it was popular to add insulation to the buildings. Antell and Paues (1981) believe that a lot of the extra insulation was a result from the energy saving contribution by the government during the seventies. The renovations during that time were made with very cheap and time efficient methods, which did not always follow the architectural design of the buildings (Antell and Paues, 1981). Figure 4.1 below illustrates an example.

Figure 4.1 Façade facing court yard covered with metal sheets (Antell and Paues, 1981).

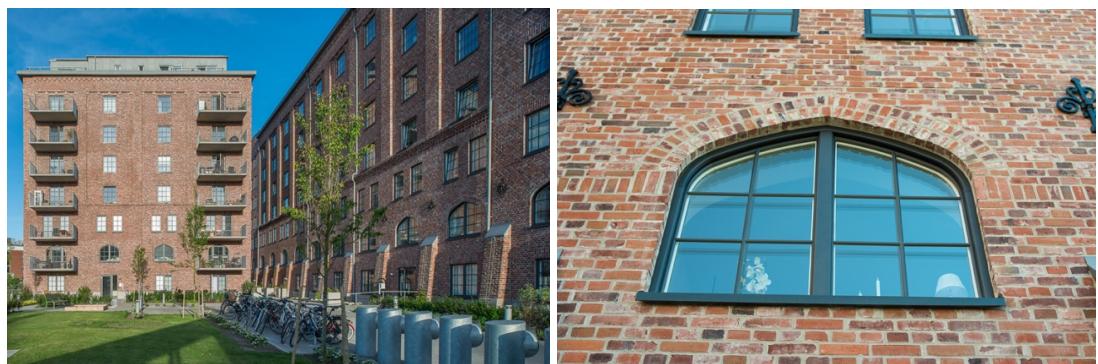
Strängbetong has rebuilt some warehouses in the area Eriksberg in Gothenburg. It was important to keep the old appearance of the area and the buildings were supposed to be converted into residential buildings (Strängbetong, 2016). The warehouses were demounted and the brick remounted in concrete sandwich elements, see Figure 4.3 and 4.4. The old appearance of the bricks was re-made in walls constructed in the factory of Strängbetong.

Figure 4.4 Example of a new sandwich element with remounted bricks. Photos: Strängbetong (2016).

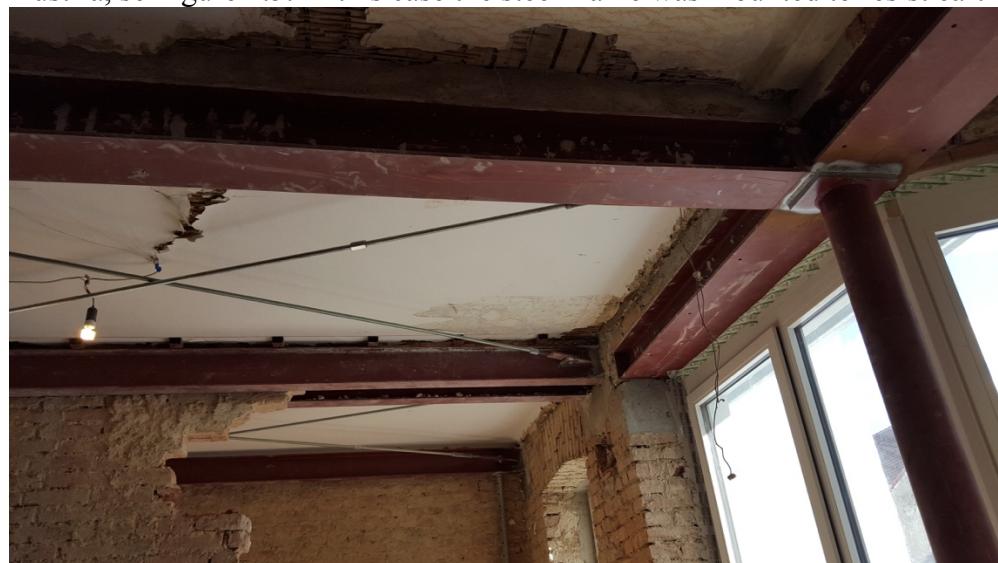
Figure 4.5 New steel frame in an old brick building in Vienna. Photo: Pär Johansson.

If all the wooden load bearing parts are not enough when a building is changing the function for example, it is possible to keep the brick walls and replace the wooden columns and the beams with steel. This method was used in a project in Vienna in Austria, see Figure 4.5. In this case the steel frame was mounted to resist earthquakes².

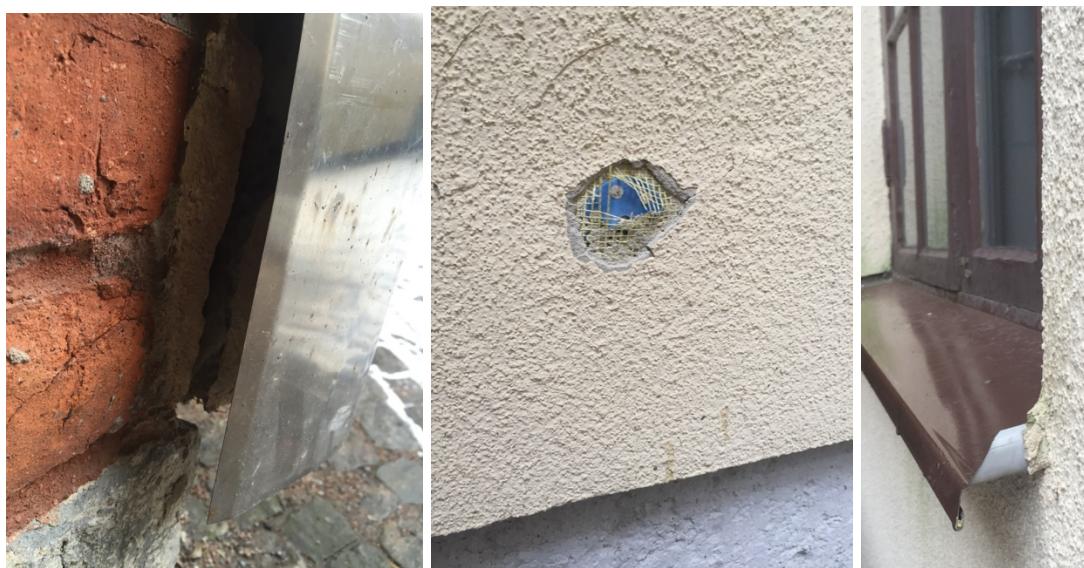
Figure 5.2 Left: Added insulation layer behind covering steel plate in a corner. Middle: External stucco and fastening of the insulation visible through a damage. Right: Window ledge connection to the façade.

Otherwise, also the wall facing the inner court yard consists of brick. The windows in this wall are original wooden windows consisting of two panes. New window ledges are integrated into the stucco, see the picture to the right in Figure 5.2.

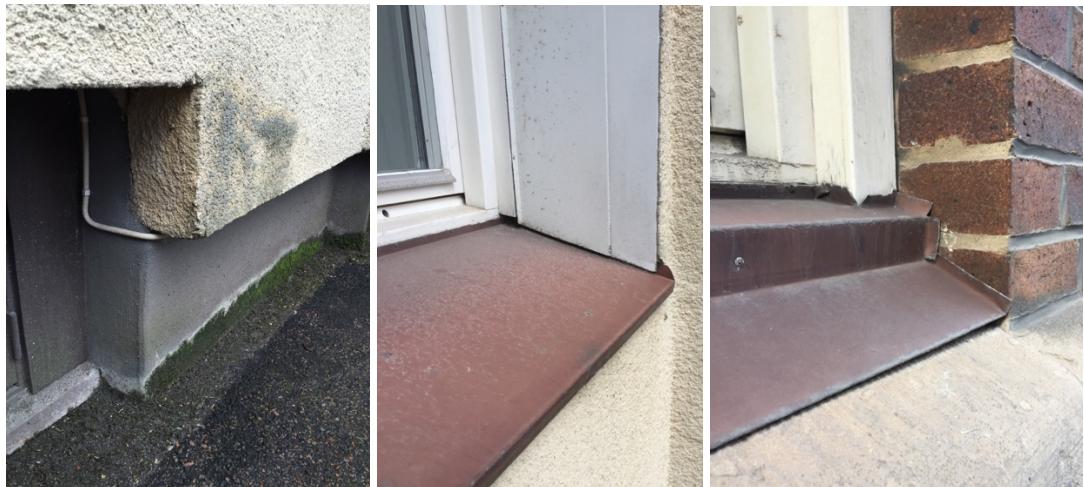
To the side of the street the façade has not been changed since the year of construction, which means that the original brick wall remains. The brick which has been used is red brick. The windows were changed around 1980, but the original windows were kept in the stairwell. To the side facing the yard 100 mm of mineral wool has been added to the façade with a coat of stucco, see picture to the left in Figure 5.4. The windows were kept in the same depth in the wall construction after the insulation was added, illustrated in the middle picture in the same figure. The picture to the right shows that window ledges of the windows facing the street have also been replaced. The corners of the ledges have not been folded, but cut.

Figure 5.4 Left: Added insulation on the wall facing the yard. Middle: Window and wall connection facing the yard. Right: Window and wall connection facing the street.

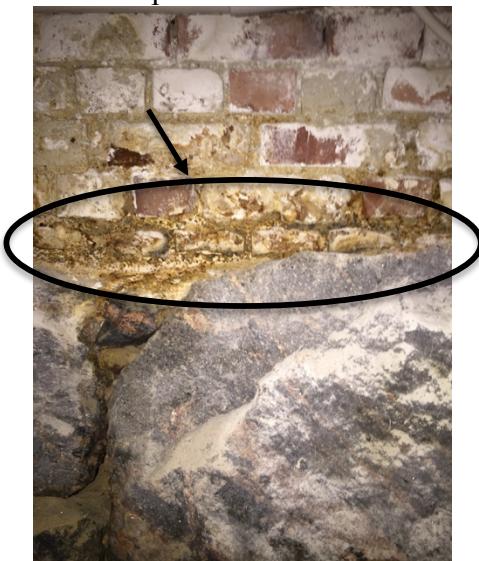
Figure 5.5 Design and construction of the foundation wall with discolorations.

The foundation walls are made with brick and dry stone wall combined, see figure 5.5 below. The figure also shows discolorations. It is possible that they origin due to moisture problems.

In some areas of the foundation wall discolorations could be observed, see figure 5.5 above. This was not the case everywhere, see Figure 5.6 below.

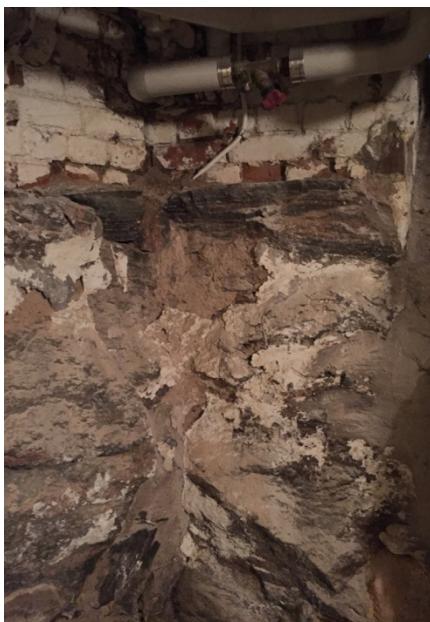
Figure 5.6 Areas of the foundation wall free from discolorations.

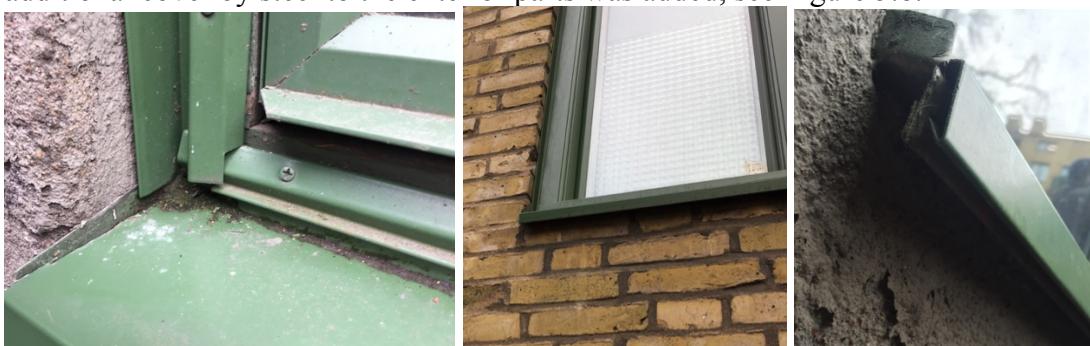
The walls towards the street are unchanged, they are brick walls with different thickness depending on floor level. The walls towards the yard are similar, no insulation has been added in this case. The original gates have been kept. The windows are built-on, and an extra window pane was added on the inside, as described in Chapter 4 and Section 4.1.2 – Windows. The original frame was kept and additional cover by steel to the exterior parts was added, see Figure 5.8.

Figure 5.8 Left: Added cover to a window in the basement wall. The wooden frame is visible beneath the cover plates. Middle: Added cover to a window of an apartment. The wooden frame was less visible than in the previous figure. Right: New and old window ledge.

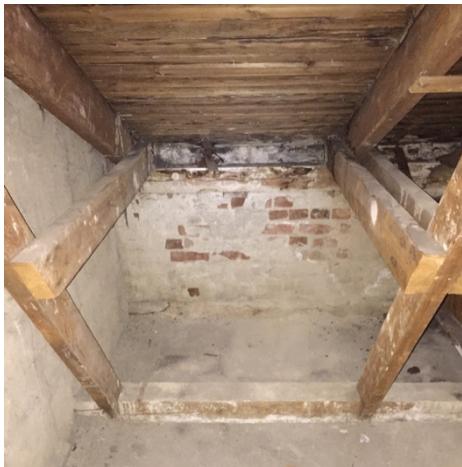
Figure 5.9 Design of roof trusses and connection of roof and exterior wall. Notice the brick wall.

The roof was renewed. The original structure was kept and was slightly improved with a double layer of roofing felt. The tiles are made of slate. Figure 5.9 below illustrates the design of the roof trusses.

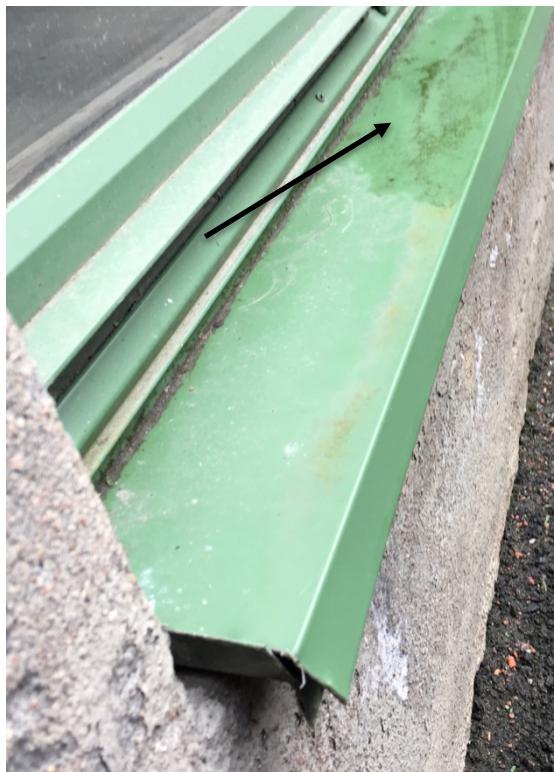
Figure 5.10 Difference in inclination of window ledges resulting in standing water.

Since an extra window pane was added and the frame was kept unchanged there are no new moisture risks in the connection wall-frame. Extra weather protection was added on the exterior of the frame, which at least should not worsen the situation, if this cover could work as a rain coat. Although, to guarantee quality or function, could be difficult¹. Figure 6.10 below illustrates that the inclination of the mounted ledge was not necessarily follow the original and can even be less than the original inclination in some places. This resulted in standing water on the new window ledge.

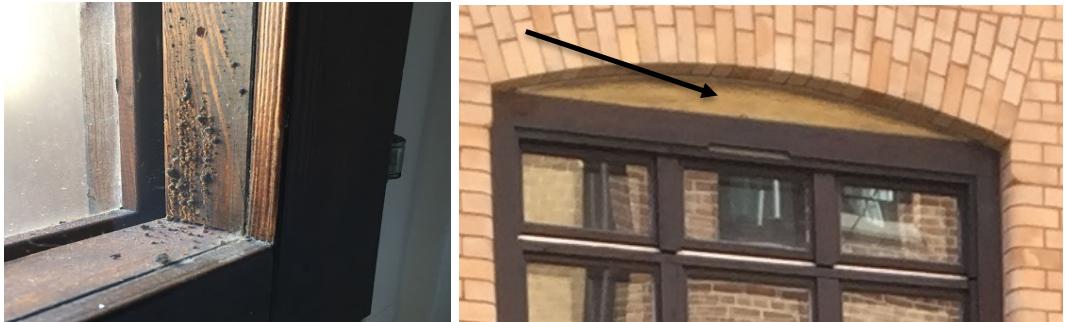
The façades towards the streets are entirely original. The thickness of the brick walls differs with the height of the building. The windows have probably been changed around 1970. The new windows are 2-glassed windows, see figure 5.12 below. They probably have energy performance comparable to the original windows. The openings in the walls that are reserved for the windows do not always have the same shape as the installed windows. The extra volume is covered by a wooden plate, see Figure 5.12.

Figure 5.12 Left: Corner of installed windows. Right: Difference in shape of window and opening in façade.

To the side facing the street the façade is close to original. When the windows were changed, the rounded top of the window probably became straight, see Figure 5.12 above. The changes to the façade of the yard are illustrated in Figure 5.14 below.

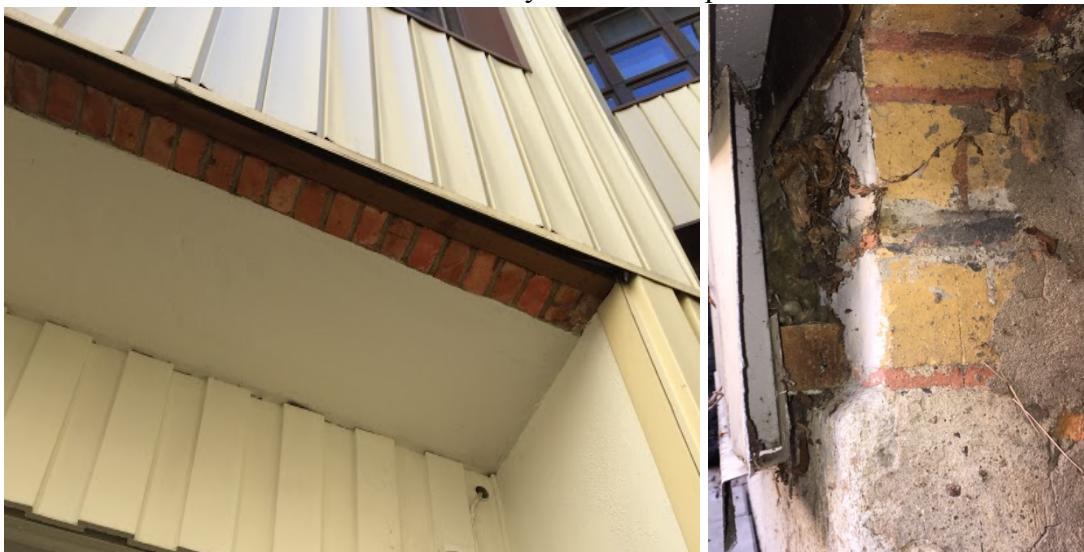
All the façades facing the yard is clad with 50 mm mineral wool with wooden frame. The insulation is covered by painted, corrugated steel, see Figure 5.13. Figure 5.13 also illustrates how the addition of the layers has been performed.

Figure 5.13 Left: Façade facing to the yard. Right: Added corrugated steel and mineral wool.

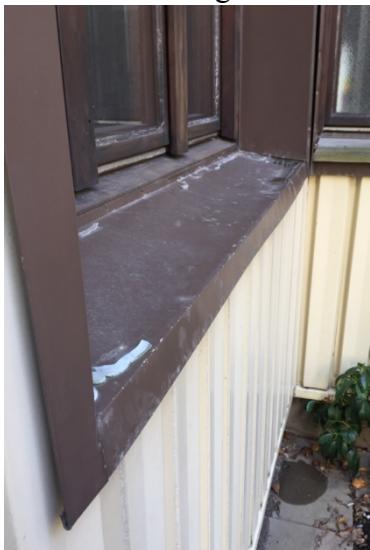
Figure 5.14 Changed window and its connection to the corrugated steel.

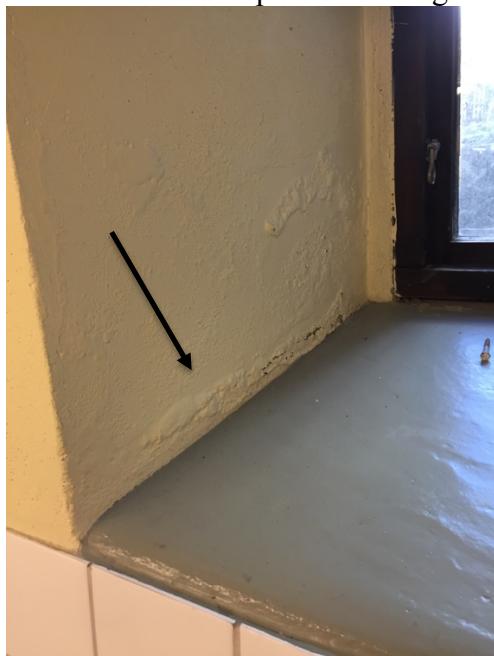
Figure 5.15 Flaking paint on foundation wall.

Figure 5.15 below illustrates that indications of moist foundation walls can be identified since the paint is flaking.

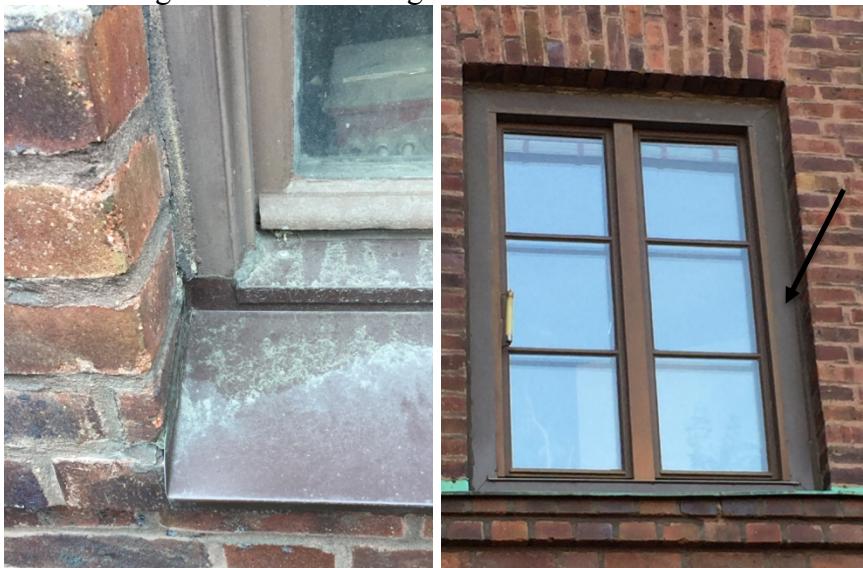
All exterior walls consist of brick and are in original shape. The thickness differs with the height of the building. The majority of the windows have been changed, but some original windows are still in use, see Figure 5.17. The windows of the shops on street level are original as well as the gates and doors.

Figure 5.17 Left: Original wooden window. Right: Frame-in-frame window.

When changing the windows, the original frame was kept and a new window frame was probably installed into it, see figure 5.17.

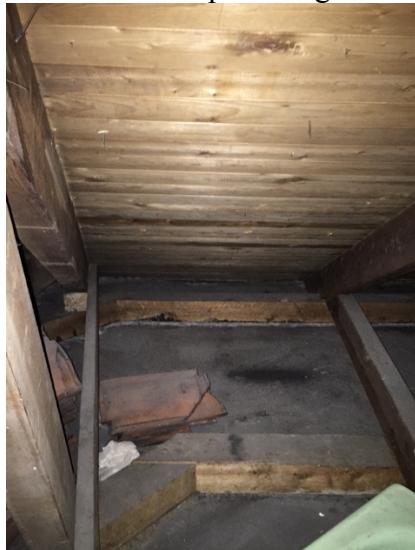
Figure 5.18 View of attic and structure of the roof.

The attic has kept its original design and is illustrated in Figure 5.18 below.

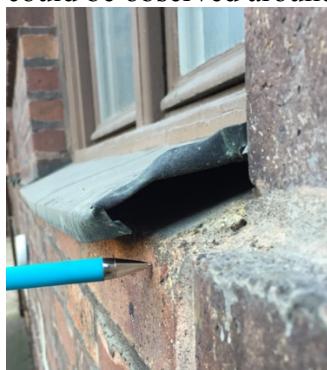
Figure 5.19 Original window ledge.

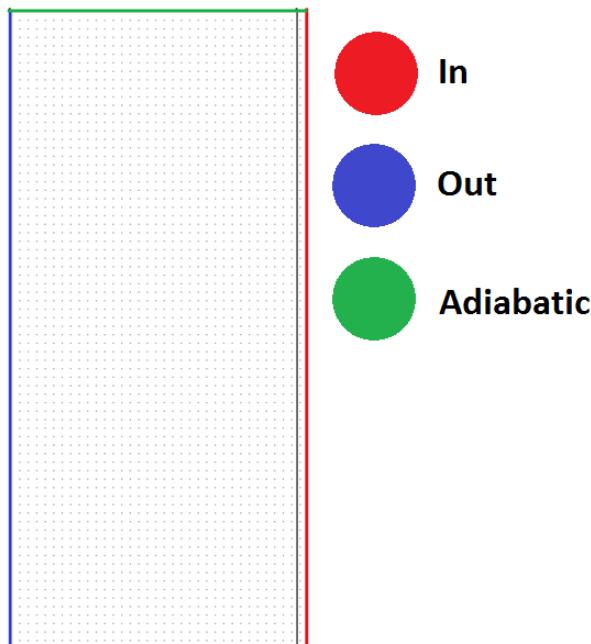
Figure 3, basic geometry with boundary conditions

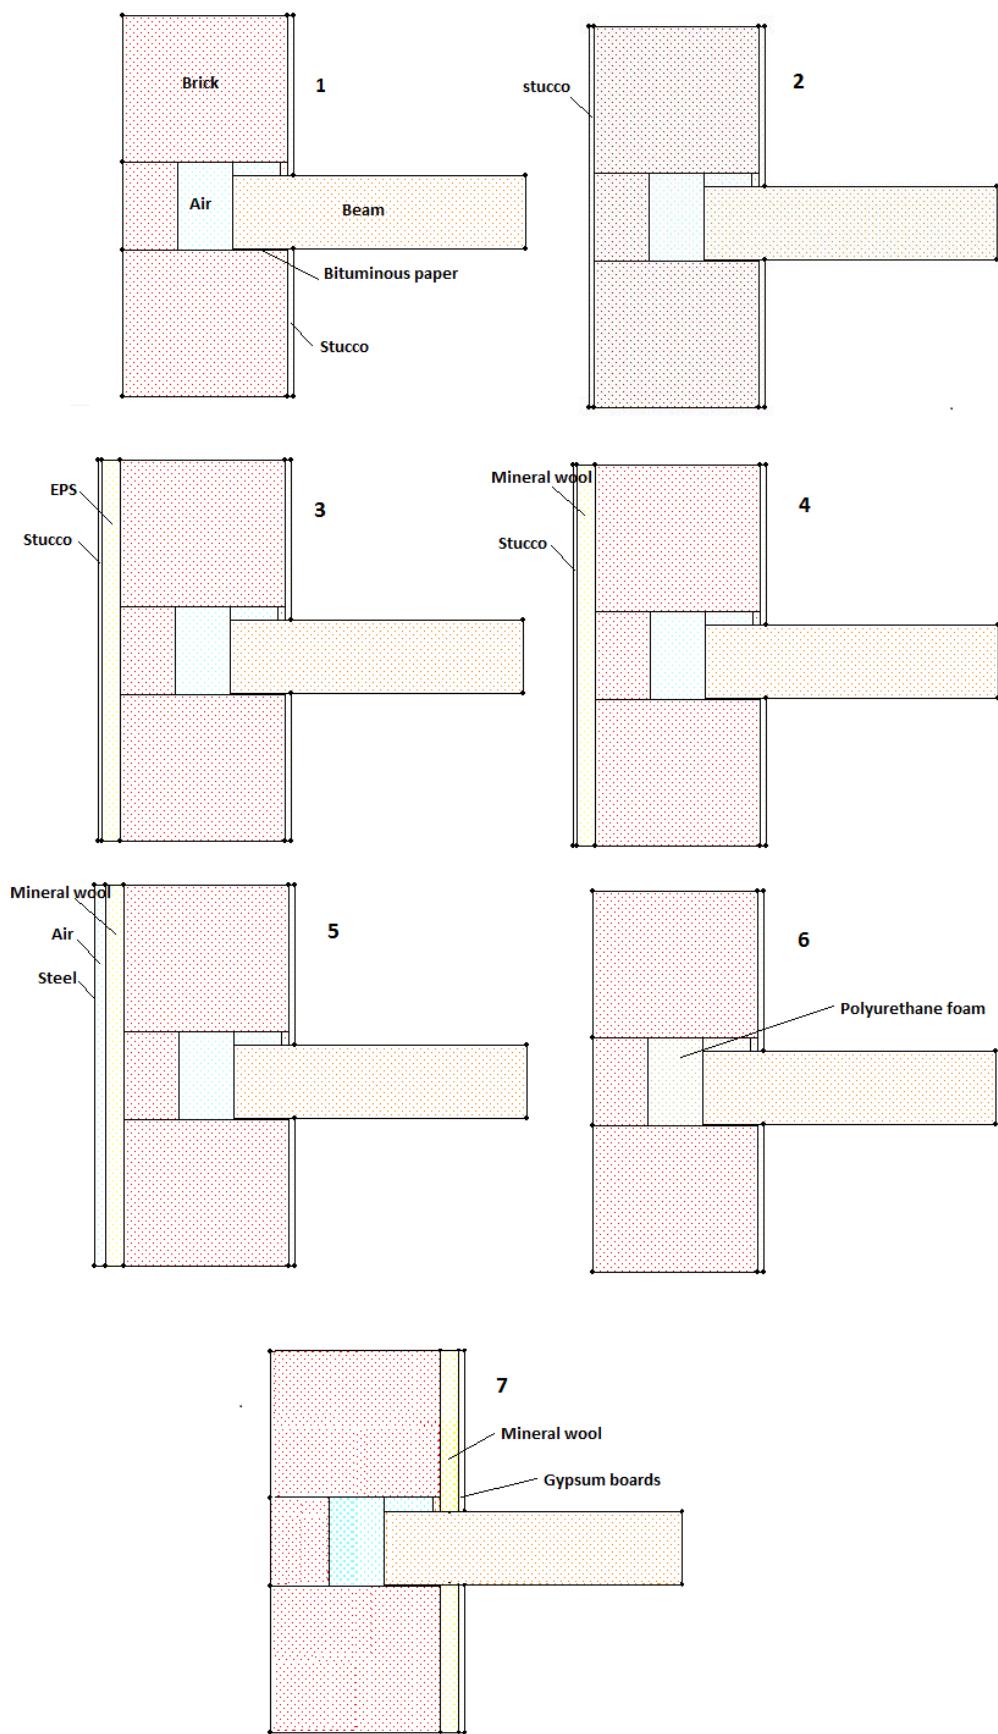
Figure 3 shows the five different geometries with each materials marked.

Figure 3, types of geometries, 1-7

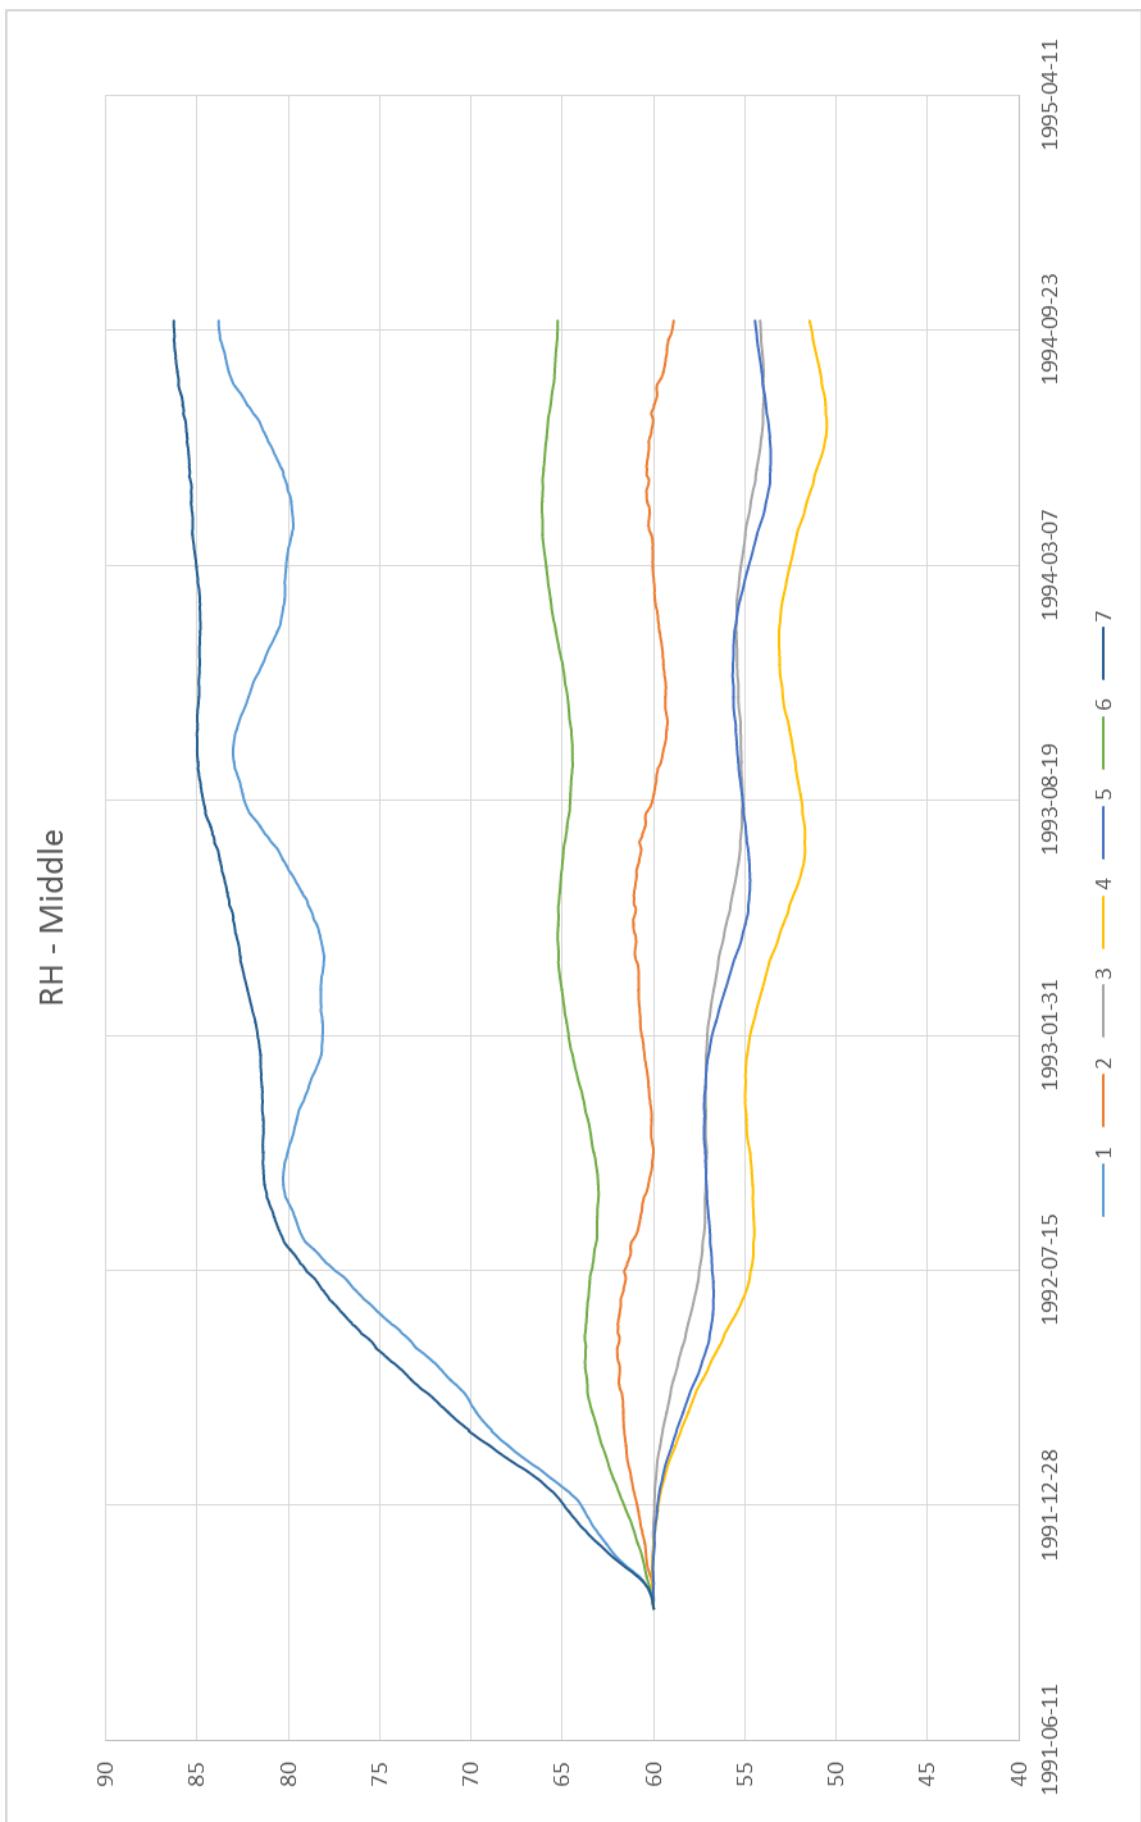
Figure 5 and 6 show the relative humidity over the three calculated years in the points marked in figure 1 for each of the seven types of beam supports.
