Performance Evaluation of a Drinking Water Treatment Plant in Samaipata, Bolivia

Master's Thesis in Infrastructure and Environmental Engineering

A drinking water treatment plant for a population of 4,935 inhabitants in Samaipata in Bolivia was evaluated in terms of performance, design, operation, and maintenance. The thesis aimed to identify technical problems and deficiencies in operation of the plant, and to introduce suitable treatment measures for the source El Fuerte and the well La Carretera to the responsible Water Cooperative of the village. The risk of contamination for both sources was assessed by a protocol for sanitary facilities. Water samples were taken to identify whether suitable treatment technologies for the types of water source are provided. The performance of each treatment step in the plant was studied by inspection and water analyses at different points in the treatment chain. Jar tests were performed with $Al_2(SO_4)_3$, $Al_2(SO_4)_3$ and lime, $FeCl_3$ and $FeSO_4$. The plant was operated for 4.5 h with an increased dosage of 15 mg/l of Aluminum Sulfate. A Microbial Barrier Analysis (MBA) and Quantitative Microbial Risk Assessment (QMRA) were performed t

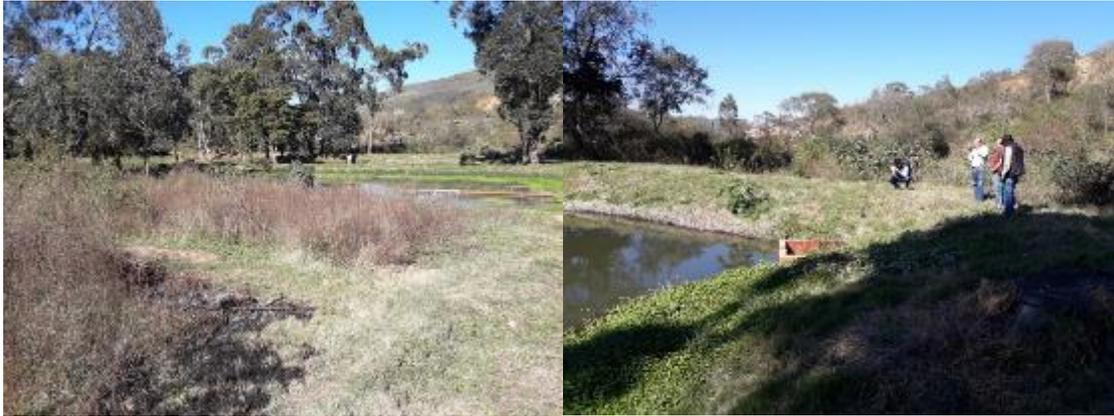
The sewage system has been implemented since 1991 in a part of the town known as Casco Viejo (central zone of Samaipata). It's a typical wastewater treatment method in Bolivia: The wastewater is stored in four oxidation lagoons forced by gravity. Triggered by sunlight and complex microbial mechanisms, the biochemical oxygen demand (BOD), total suspended solids (TSS), and pathogens are reduced (Symonds et al., 2014). The lagoons are unlined and working at full capacity. The wastewater is discharging directly into the river and affects the downstream users. One of the goals of the Water Cooperative is to enhance the sewage water situation in future (Ho & Sotelo, 2018).

Figure 17 (left) & Figure 18 (right) Oxidation pond of Samaipata August 2018 (Author's own copyright)

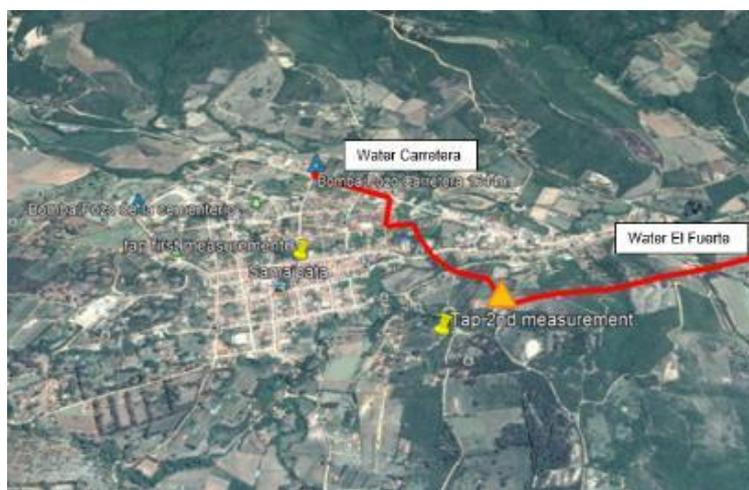
Figure 20 Location of WTP (two red pipes La Carretera and El Fuerte mixing in the WTP, orange rectangle is the WTP) (Google earth (28th of January 2017), scale 1:3,77 km) (Data provided by the Water Cooperative, 2018)

The source El Fuerte and the well La Carretera have been chosen to be treated in the plant, due to their poor water quality and because both are contributing each with approximately 30 % to the system (El Fuerte up to 15 l/s and La Carretera up to 10 l/s) (Water Cooperative 2018, personal conversation, 8th April). Other sources like Chorrillos or Tambillo have not been recommended to connect to the plant in regard to lower evaluation and pressure problems (Ho & Sotelo, 2018).

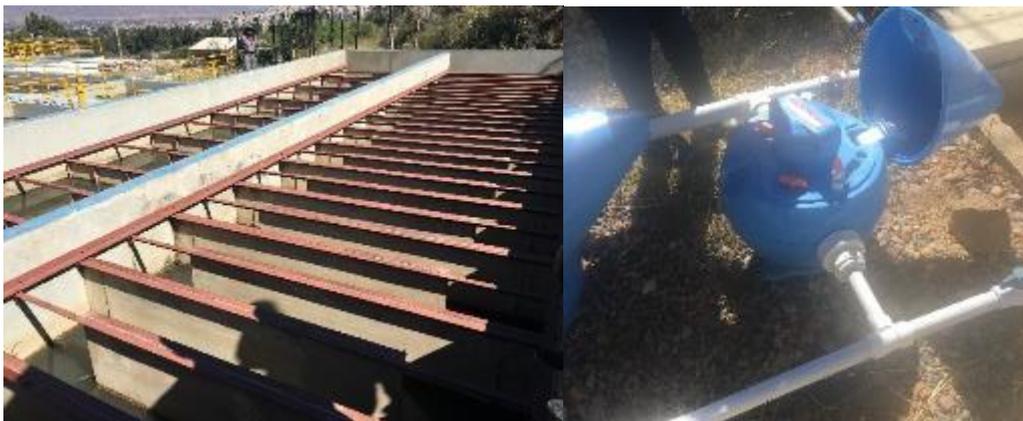
In the municipality Sacaba located 13 kilometers eastward from Cochabamba in Bolivia, a treatment chain of coagulation, flocculation, and disinfection is used to provide drinking water states the engineer of the plant (2018, 17th May). Water is coming from a river and lagoons draining over aeration stairs in the flocculation gravity forced basin consisting of two parts (rapid mixing chamber and a slow mixing chamber). The coagulant poly aluminum chloride (PAC) (25 kg used for 3 days) is added at the inlet of the plant. Two sedimentation basins in a row separating the sludge from the water over an overflow installation and four rapid sand filters are followed. Finally, the water is disinfected with Trichloro in a 'GOOD AGUA' system and stored in two tanks. Turbidity is reduced in the treatment plant from 10-11 NTU to 2-3 NTU in the rainy season (personal conversation with the engineer of the plant of Sacaba, 2018 17th May) .

Figure 21 Flocculation basin in Sacaba (Author's own copyright) & Figure 22 'Good Agua' Disinfection system in Sacaba 2018 (Author's own copy right)

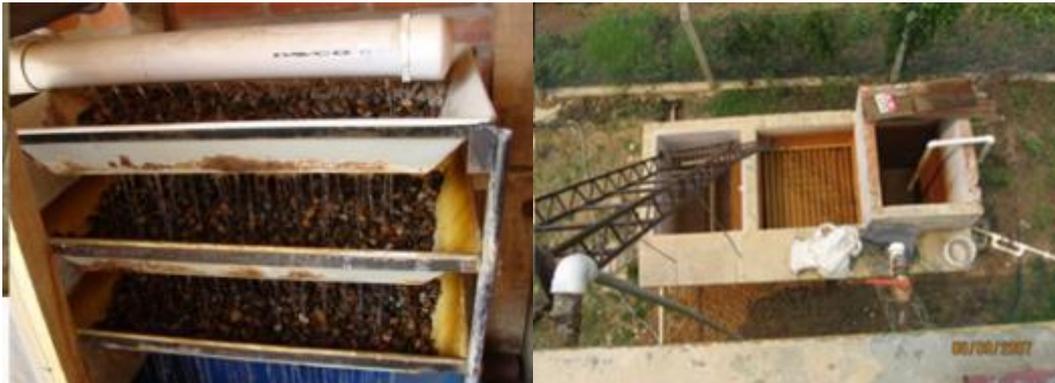
Aeration oxidizes and precipitate iron, manganese and sulfur, volatile organic compounds and some taste and odor compounds (Sobsey, 2002). High-performance aeration is applied for the removal of radon in groundwater supplies and can achieve up to 99.9 % removal (WHO, 2011). Four different types of aerators are usually used: gravity aerators, spray aerators, diffusers and mechanical aerators (Shammas & Wang, 2016b). According to Sobsey (2002), the technical difficulty in use by locals is low and the costs for a household level are less than \$ 10. Aeration is a common used method in a conventional treatment chain in Latin America, due to the country's problems with high arsenic content (Litter, Morgada, & Bundschuh, 2010).

Figure 24 (left) Oxidation in a WTP in Bolivia (CASA, 2017) & Figure 25 (right) Aerator in Bolivia (CASA,2017)

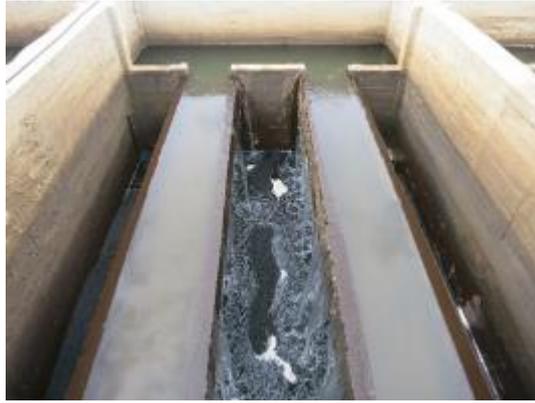
Silica sand and anthracite coal used alone or in multi-media combination are the most common types of granular media bed filters. More layers in filters have been shown to function more efficient in the use of the whole bed depth for particle retention and can be operated at higher flow rates (WHO, 2011). Porosity is formed by the grain size. The grain size distribution has important impacts on particle removal, head loss, and backwashing requirements for media filter (American Water Works Association, 2011). Tanks (<math> < 100 \text{ m}^2 </math>) are mostly open rectangular designed and generated at a $4\text{-}20 \text{ m}^3/\text{m}^2\cdot\text{h}$ flow rate. The purified water is collected via nozzles at the bottom of the tank and solids are removed by backwashing with treated water (WHO, 2011). Effective backwashing is essential for long-term service to eliminate solids, to clean the media and to avoid problems of mudballs and filter cracks (American Water Works Association, 2011). Pressurized filters in mostly cylindrical shell treat up to $15 \text{ m}^3/\text{h}$. This kind of filters is necessary when the water head needs to remain in order to avoid the need for pumping (WHO, 2011). Filter material granular activated carbon (GAC) can replace parts of the sand proportion in rapid sand filters. GAC filters are often considered in cases where a removal of biodegradable organic matter (BOM) is desired. GAC filter perform better in challenging environments of lower temperature and oxidants in backwash water (Shammas & Wang, 2016 b). In India the construction of a small and medium sized RSF has shown that the initial expenses for the construction were high, however, operation and maintenance costs are in comparison to other types of treatment (Visscher, 1990).

Figure 26 Sand filter in the WTP in Santa Clara in Cuba 2015 (Author's own copy right)

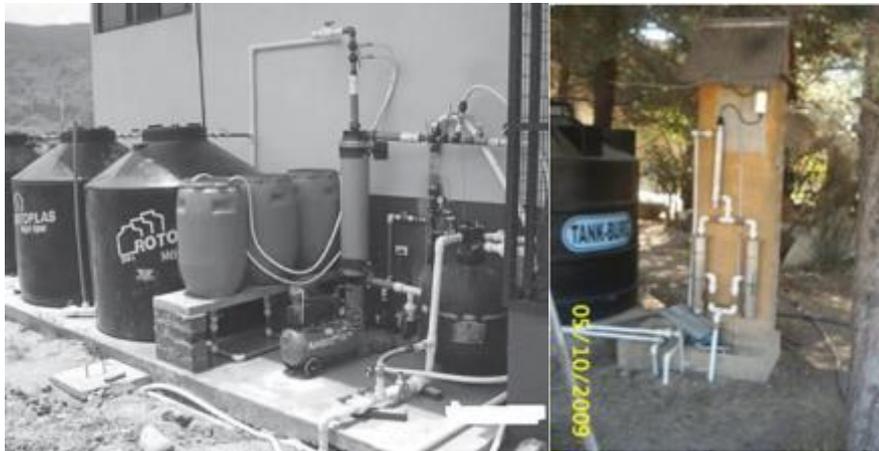
Figure 27 (left) UF membrane in use in Ecuador (Arnal, 2007) & Figure 28 (right) MF in use in Bolivia (CASA, 2017)

A successful installed UF technology in a rural area of Ecuador (>500 inhabitants) has shown that this technology is easy to install, is compact, and works with a constant production, however maintenance and replacement costs are high and electricity is needed (Figure 27) (Arnal, et al. 2007).

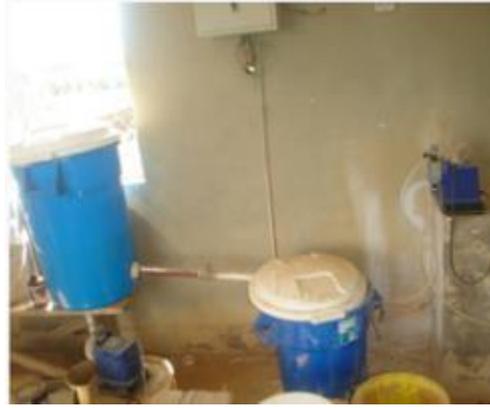
Chlorine is applied as a disinfectant in developing countries, next to bromine and iodine (Kausley, 2014). Chlorine breaks the cell membrane of a pathogen, interrupt the transmission way of food to energy and inhibits the reproduction (Drinan, 2001). In emergency cases, it was found as the most effective disinfectant because it can inactive high concentration of pathogens in a short time. Additionally, chlorine is used to prevent regrowth and recontamination of the system. A dose of 0.25 mg/l free residual chlorine is recommended for a TOC value of <25 mg/l. One side effect of using chlorine is the potential of the formation of chlorine by-products with organic compounds such as trihalomethanes (THMs) and halo acetic acids (HAAs). Aeration or activated carbon adsorption is used to remove natural organic material (NOM) in a previous step in the treatment chain in these cases (Drinan, 2001).

Figure 29 Inlet of disinfectant in the pipe of a WTP in Bolivia (CASA, 2017)

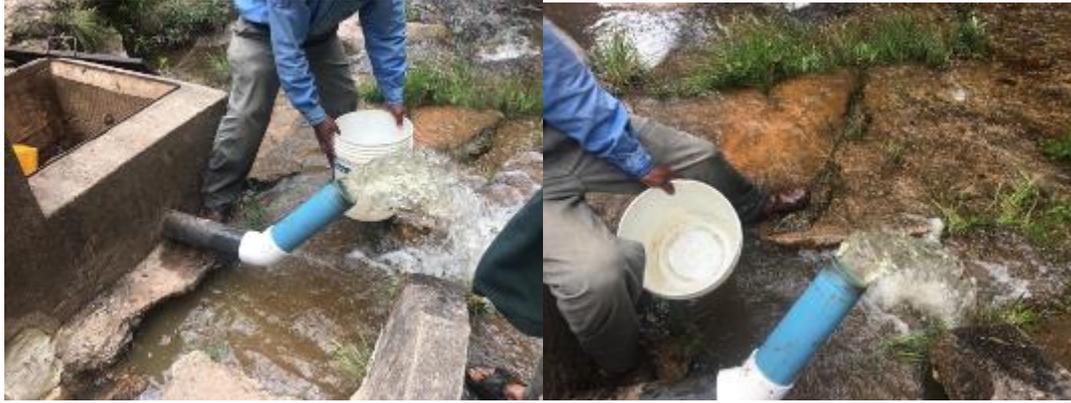
The flow from the sources was measured with a bucket and a watch three times and the average was calculated. The flow from El Fuerte was determined at the outlet of the lower reservoir on the 8th of April 2018 in the morning and from La Carretera direct at the outlet of the well on the 2nd of May 2018 in the afternoon.

Figure 32 (left) & Figure 33 (right) Flow determination El Fuerte 8th of April 2018 (Authors own copyright)

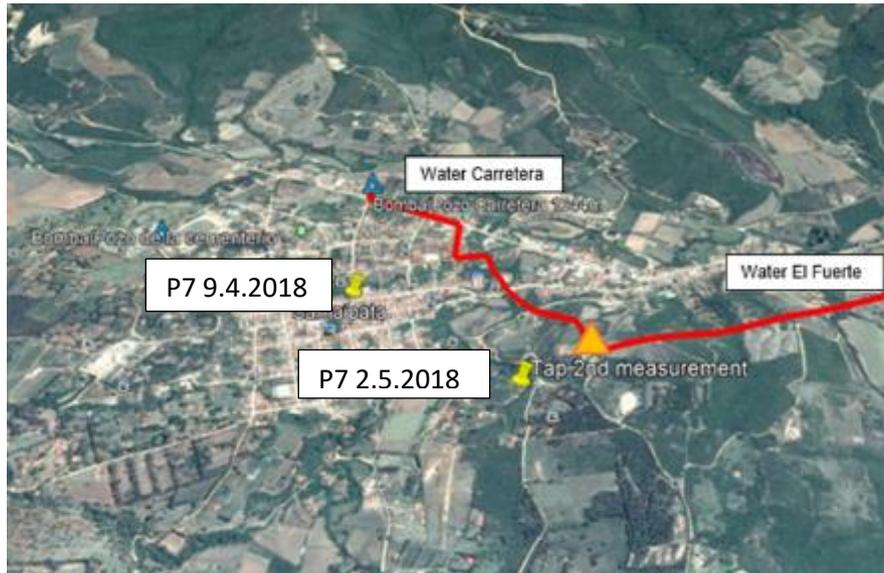
Samples from seven locations were taken before and after each treatment step in the plant (see Figure 35). In a first sampling only a few parameters were measured considering the problem description from the Cooperative and the citizens. In a second sampling, some parts were studied more in detail. On the 9th of April 2018, at seven places were sampled. On the 2nd of May, a sample of the total effluent (P5) was repeated due to the lack of clarity of the value of pH and the Permanganate Index. Additionally, it was decided to choose a larger spectrum for this analysis. The analysis at the end of the distribution system (P7) was also taken a second time at a different tap because the water at the sampling point was mixed with water of other sources. Thus, a house was chosen 1-2 km after the plant which has only supply from the WTP (see Figure 34).

Figure 34 The yellow pins are the locations of sampling of P7. The two red pipes are La Carretera and El Fuerte mixing in the WTP. The orange triangle is the location of the WTP (Data provided by the Water Cooperative, 2018)

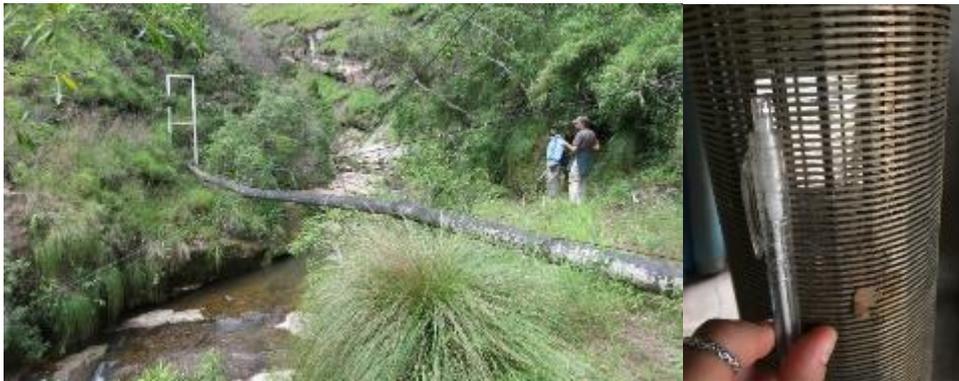
Figure 39 (left) Distribution system to the intake of El Fuerte April 2018 (Author's own copyright) & Figure 40 (right) Pretreatment: 2 layers of unoxidized steel filters 2018 (Author's own copyright)

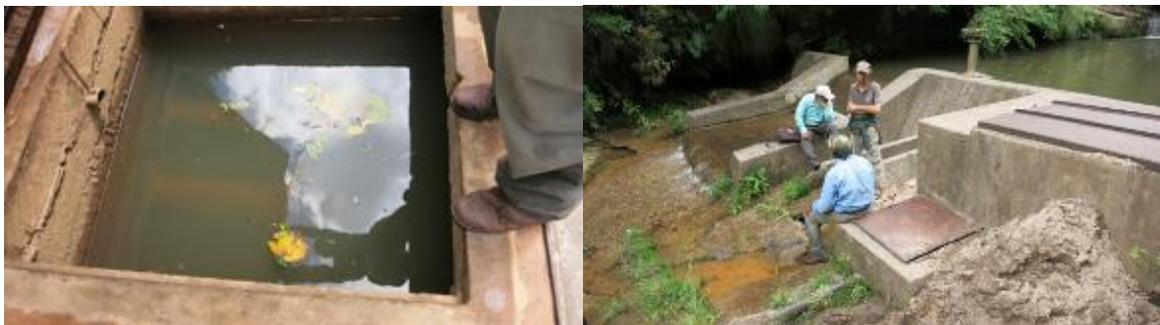
Figure 41 (left) Pretreatment at the intake el Fuerte April 2018 (Author's own copyright) & Figure 42 (right) Intake El Fuerte: Lower concrete reservoir April 2018 (Author's own copyright)

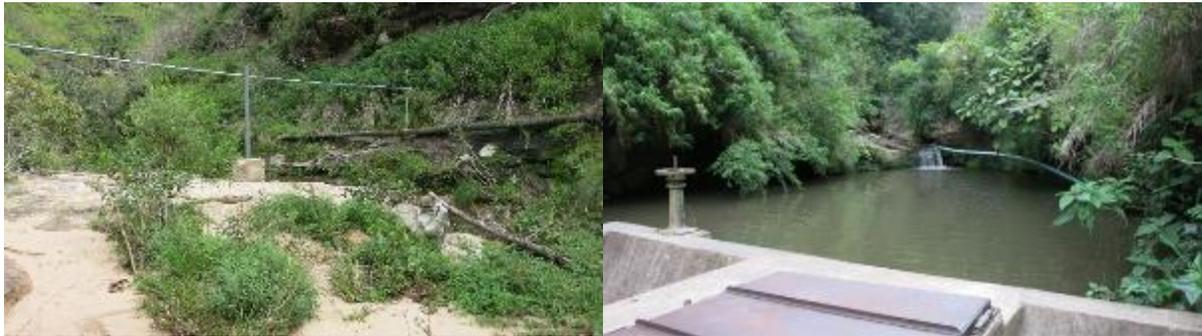
Figure 43 (left) Pipes from Los Alisos contributing the flow of El Fuerte (2-3 l/s) April 2018 (Author's own copyright) & Figure 44 (right) Intake El Fuerte: In the background the upper reservoir April 2018 (Author's own copyright)

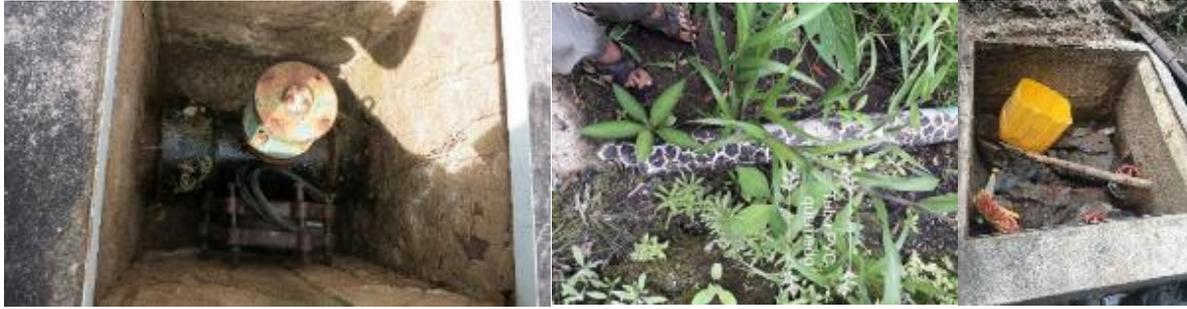
Figure 47 (left) Valve in the distribution system April 2018 (Author's own copyright) & Figure 48 (middle) Damages on the pipes from fire April 2018 (Author's own copyright) & Figure 49 (right) Chamber of inspection April 2018 (Author's own copyright)

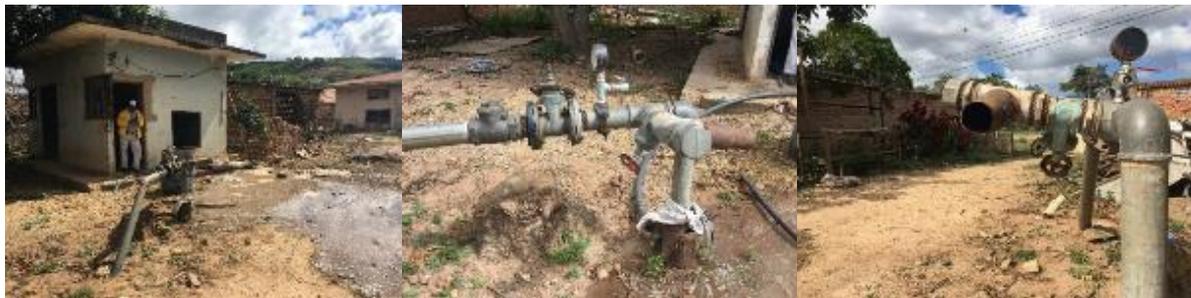
Figure 50 (left) Territory of the Water Cooperative May 2018 (Author's own copyright) & Figure 51 (middle) Well La Carretera May 2018 (Author's own copyright) & Figure 52 (left) Inspection outlet well La Carretera (Author's own copyright)

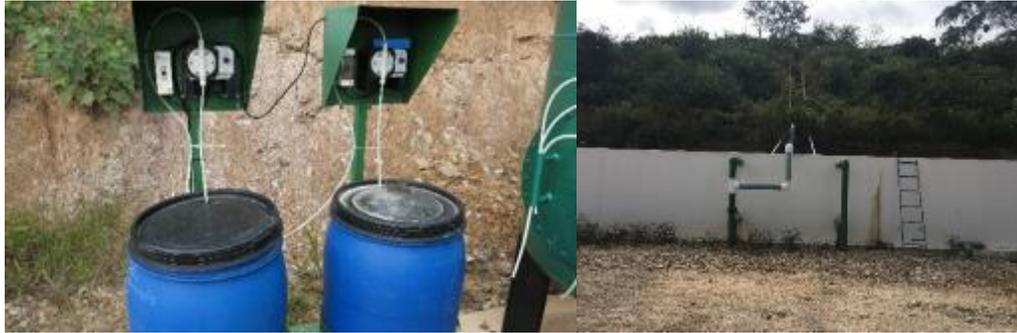
Figure 53 (left) Mixing of Aluminum Sulfate 2018 (Author's own copyright) & Figure 54 (right) CFS tank 2018 (Author's own copyright)

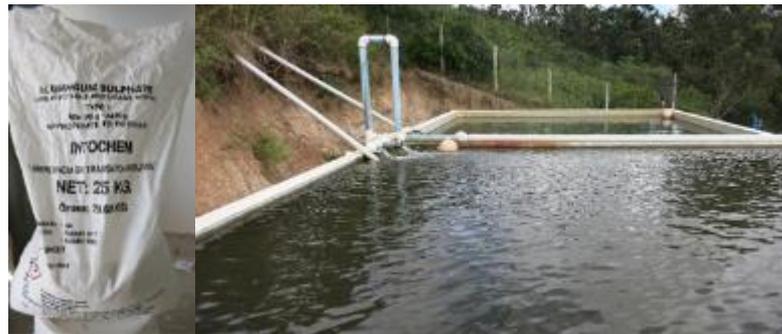
Figure 55 (left) Stored Aluminum Sulfate 2018 (Author's own copyright) & Figure 56 (right) Filled CFS tank with two chambers 2018 (Author's own copyright)

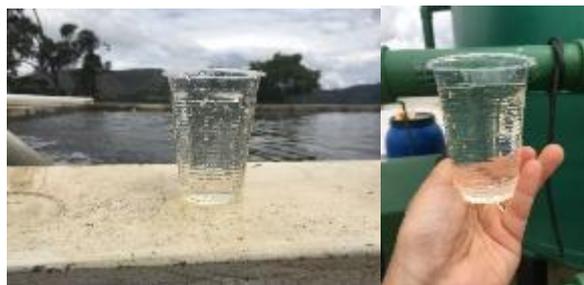
Figure 57 (left) Sample close to the inlet of the CFS tank 2018 & Figure 58 (right) Sample close to the outlet 2018 (Author's own copyright)

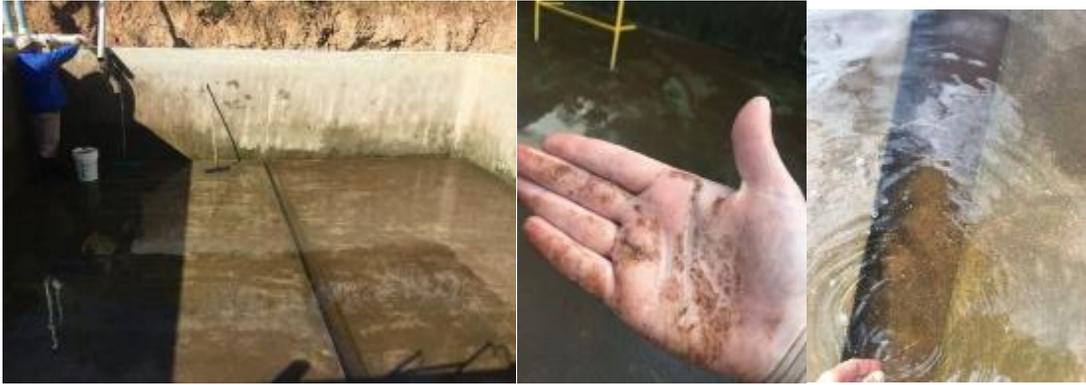
Figure 59 (left) Empty CFS tank 2018 (Author's own copyright) & Figure 60 (middle) Sediments on the basin bottom 2018 (Author's own copyright) & Figure 61 (right) Outlet of collected sediments 2018 (Author's own copyright)

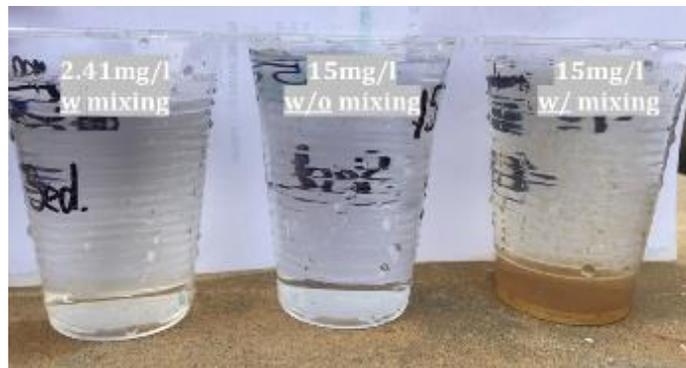
Figure 62 Floc formation in the mixture with 15mg/l with mixing after t=14h 2018 (Author's own copyright)

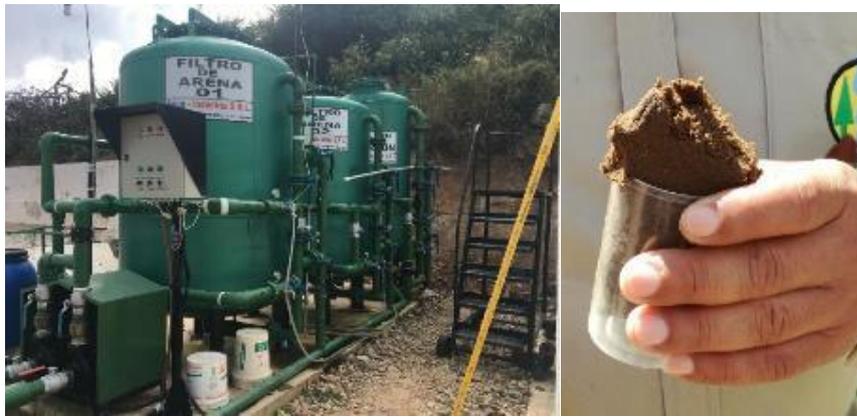
Figure 64 (left) Sand filter in a row (the first 2 unit tanks in the picture) (Author's own copyright) & Figure 65 (right) Sample of the sand (first sand filter) 2018 (Author's own copyright)

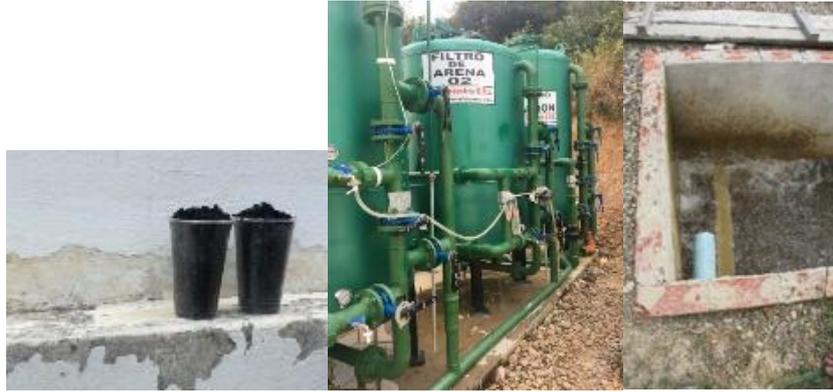
Figure 66 (left) Sample of activated carbon 2018 (Author's own copyright) & Figure 67 (middle) The last filter in the row is the activated carbon filter 2018 (Author's own copyright) & Figure 68 (right) Effluent after backwashing the filters 2018 (Author's own copyright)

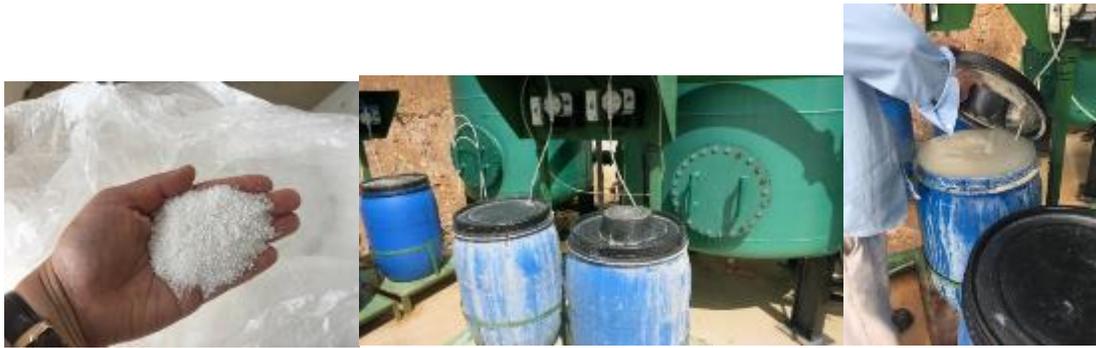
Figure 69 Sample of Calcium Hypochlorite 2018 (Author's own copyright) & Figure 70 Mixing of the disinfectant 2018 (Author's own copyright) & Figure 71 Inspection of the mixing routine of the technician 2018 (Author's own copyright)

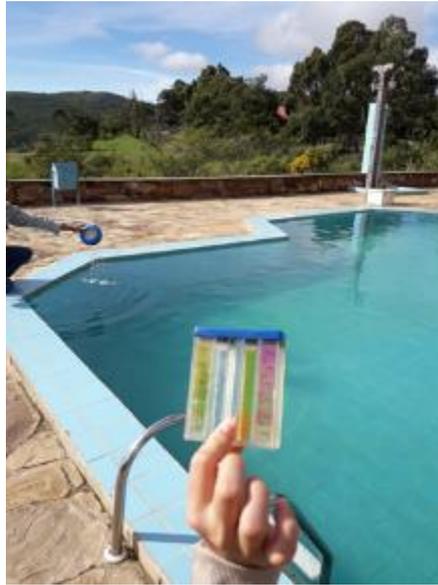
Figure 73 Appendix B Residual Chlorine test pool in Samaipata (2018) (Author's own copyright)

- a. Residual chlorine is not reaching the end of the distribution system: Residents have measured the residual chlorine value of zero in their houses (see Appendix B Figure 73).

- c. Residents have reported depositions of sediments in the sinks in their houses coming from the tap water. An investigation of CASA has referred that there is no visible reduction of turbidity within the treatment processes of the plant (CASA, 2018) (see Appendix b Figure 73 until and Figure 76).

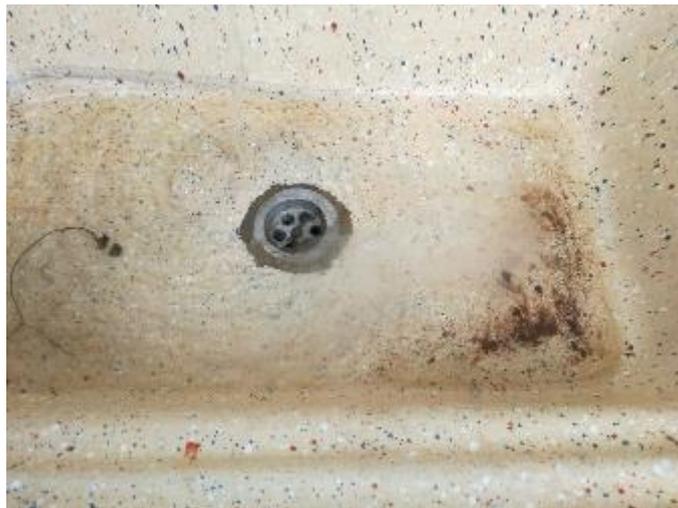
Figure 74 Appendix B Sediments from the tap water (2018) (Author's own copyright)

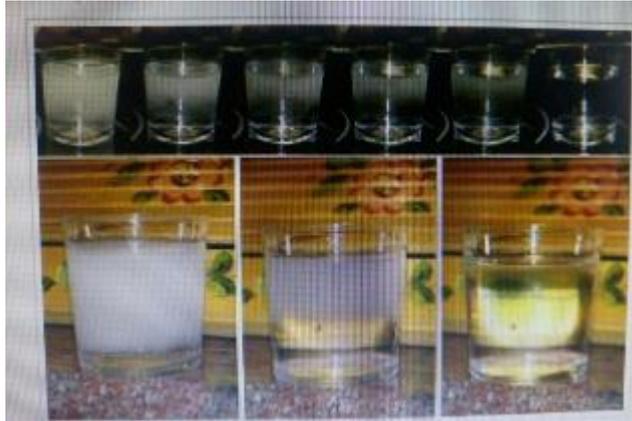
Figure 77 Appendix B Water bubbles after filling a glass with tap water. They are disappearing after 20 seconds (2018) (Author's own copyright).

- d. Distribution system: Not all parts of Samaipata are supplied (see Appendix B Figure 77). and pressure problems in the system are noted (small air bubbles)

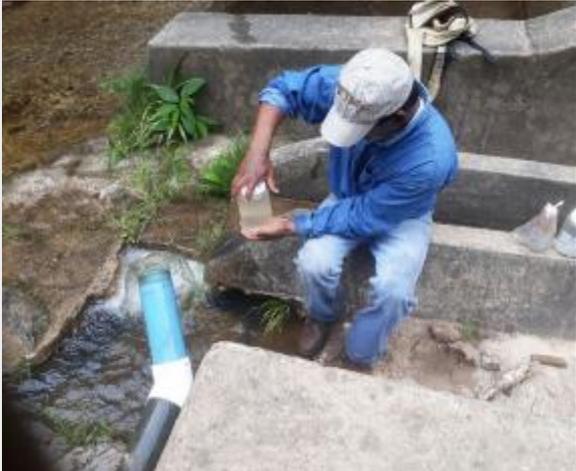
<p><i>Figure 80 Appendix C Sample taking at the source (Author's own copyright)</i></p>
<p>Source El Fuerte 2.5.2018</p>	<p>pH [-] Turbidity [NTU] P. Index [mg/l] Conductivity [$\mu\text{S}/\text{cm}$] Total Solids [mgST/l] TDS [mgSTD/l] TSS [mgSS7l] Acidity [mgCaCO₃/l] Alkalinity [mg/l] Calcium [mgCa²⁺/l] Hardness [mgCaCO₃/l] Chloride [mgCl./L c.l] Total Iron [mgFe/L] Magnesium [mgMg²⁺/L] Mangan [mgMn/L] Potassium [mgK/L] Sodium [mgNa⁺/L] Sulphates [mgSO₄/L] Ammoniacal Nitrogen [mg/l] Carbonates [mg/l] Bicarbonates [mg/l] E. Coli [UFC/100 ml] Total Coliform [UFC/100 ml]</p>	<p>-Time: 11.30 am cloudy - Place: Control outlet of the lower reservoir/ inlet in the pipe to the WTP -Appearance: turbid -Outlet from a PVC tube (10.16 cm) -Appearance of the collection point: bad-normal -Pretreatment exists after the small reservoir</p>

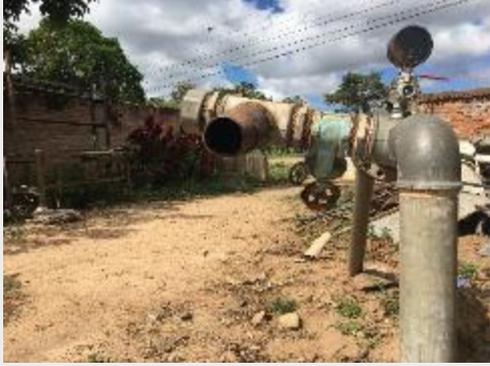
<p>La Carretera 2.5.2018</p>	<p>pH [-] Turbidity [NTU] Permanganate Index [mg/l] Conductivity [μS/cm] Total Solids [mgST/l] TDS [mgSTD/l] TSS [mgSS7l] Acidity [mgCaCO₃/l] Alkalinity [mg/l] Calcium [mgCa²⁺/l] Hardness [mgCaCO₃/l] Chloride [mgCl./L c.I] Total Iron [mgFe/L] Magnesium [mgMg²⁺/L] Mangan [mgMn/L] Potassium [mgK/L] Sodium [mgNa⁺/L] Sulphates [mgSO₄/L] Ammoniacal Nitrogen [mg/l] Carbonates [mg/l] Ferrous Iron [mgFe²⁺/l] E. Coli [UFC/100 ml] Total Coliform [UFC/100 ml]</p>	<p>-Time: 11:10 am, cloudy, rainy -Sampling point: Direct from the well (casted iron pipe) -Appearance of the collection point: very bad (waste, fire, animals, etc.) -Appearance of the sample: clear, hints for iron in the water</p>

<p><i>Figure 81 Appendix C Extraction La Carretera (Author's own copyright)</i></p>
<p>Inlet in the plant 9.4.2018</p>	<p>pH [-] Turbidity [NTU] Conductivity [μS/cm] Fe [mgFe/L] Mn [mgMn/L] Permanganate Index [mg/l] E. Coli [UFC/100 ml] Total Coliform [UFC/100 ml]</p>	<p>-Time: 11:20 pm sunny/humid -Place: tube inlet in the plant -Appearance: turbid -Outlet from a PVC tube -Appearance of the collection point: normal</p>

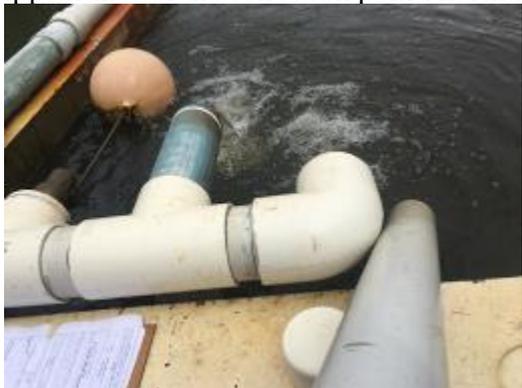
<p><i>Figure 82 Appendix C Inlet in the plant, sample taking from the right pipe (Author's own copyright)</i></p>

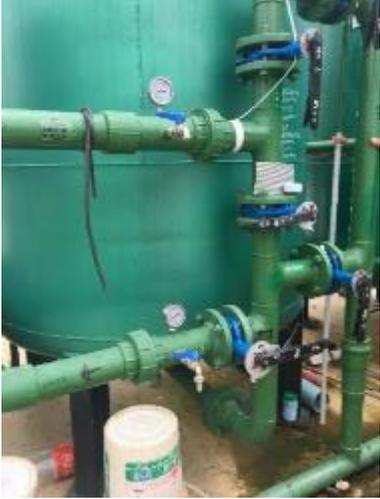
<p>Outlet CFS Tank</p> <p>9.4.2018</p>	<p>pH [-] Turbidity [NTU] Conductivity [μS/cm]</p>	<p>-Time: 10.39 am sunny/humid -Place: Tap in the treatment system -Appearance: turbid, no flocs -Outlet from a FG tube -Appearance of the collection point: normal</p>

<p><i>Figure 83 Appendix C Point of sample before the sand filters, the upper tap was used to take a sample (Author's own copyright)</i></p>
<p>Inlet Activated Carbon Filter</p> <p>9.4.2018</p>	<p>pH [-] Turbidity [NTU] Conductivity [μS/cm]</p>	<p>-Time: 10.48 am sunny/humid -Place: tap in the treatment system -Appearance: turbid -Outlet from a FG tube -Appearance of the collection point: normal</p>

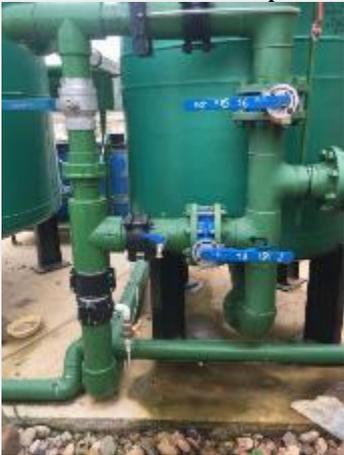
<p><i>Figure 84 Appendix C Extraction point before activated carbon filter (Author's own copy right)</i></p>
<p>Outlet of the Treatment Plant</p> <p>9.4.2018</p>	<p>pH [-] Turbidity [NTU] Conductivity [μS/cm] Permanganate Index [mg/l] E. Coli [UFC/100 ml] Total Coliform [UFC/100 ml]</p>	<p>-Time: 10.59 am sunny/humid -Place: after disinfectant dosage, before tank, tap in the treatment system -Appearance: turbid, acid smell -Outlet from a FG tube -Appearance of the collection point: normal</p>

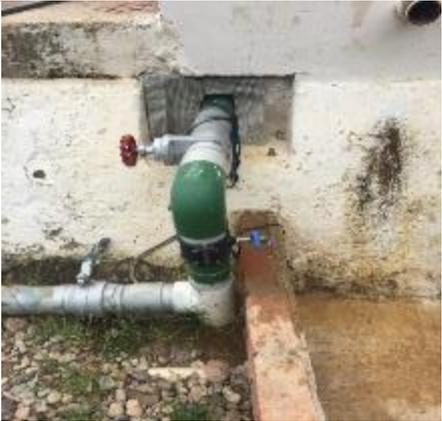
<p data-bbox="791 609 1326 667"><i>Figure 85 Appendix C Extraction point outlet of treatment plant (blue tap) (Author's own copy right)</i></p>
<p data-bbox="236 696 424 792">Outlet of the Treatment Plant</p> <p data-bbox="236 831 363 864">2.5.2018</p>	<p data-bbox="443 696 751 1547"> pH [-] Turbidity [NTU] Conductivity [μS/cm] Total Solids [mgST/l] TDS [mgSTD/l] TSS [mgSS7l] Acidity [mgCaCO₃/l] Alkalinity [mg/l] Calcium [mgCa²⁺/l] Chloride [mgCl./L c.l] Hardness [mgCaCO₃/l] Total Iron [mgFe/L] Magnesium [mgMg²⁺/L] Mangan [mgMn/L] Potassium [mgK/L] Sodium [mgNa⁺/L] Sulphates [mgSO₄/L] Aluminum [mg/l] Ammoniacal Nitrogen [mg/l] Permanganate Index [mg/l] E. Coli [UFC/100 ml] Total Coliform [UFC/100 ml] </p>	<ul data-bbox="791 696 1342 898" style="list-style-type: none"> -Time: 12:15 am, cloudy, rainy -Place: after disinfectant dosage, before tank, tap in the treatment system -Appearance: turbid, acid smell -Outlet from a FG tube -Appearance of the collection point: normal

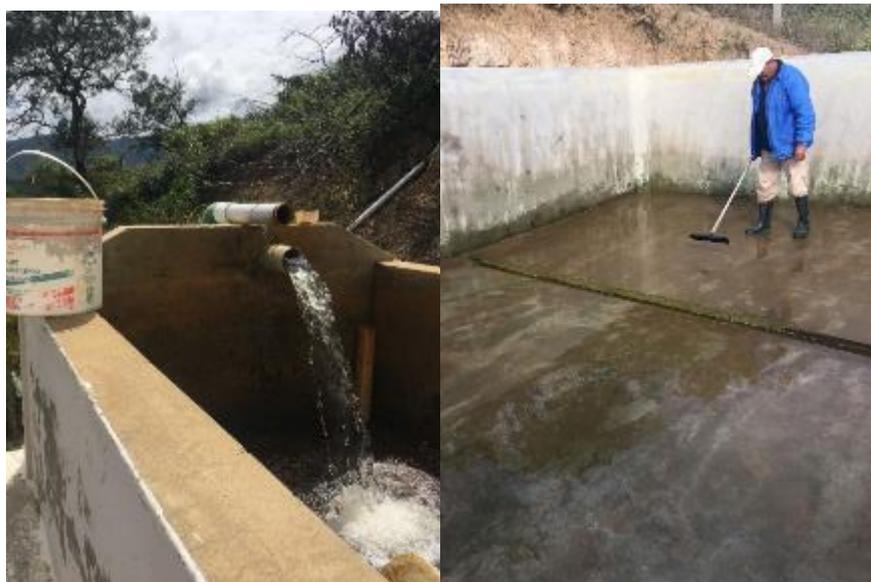
Figure 90 (left) Appendix C Flow determination of the inlet of the plant (Author's own copyright) & Figure 91 (right) Appendix C Cleaning the basin 4th of June 2018 (Author's own copyright)

The flow into the plant was measured with a bucket (volume = 18 l) and a watch three times and the average was calculated on the 9th of April 2018 (see Chapter Results 5.2.1). The value has been compared to the measured inflow from El Fuerte to determine the water losses from source to plant (Appendix C Figure 90).

Due to the fact that most of the information of the plant was collected by conversations of the technicians and that some statements differed from one to the other worker, these statements have been verified by attending the technician's routine at the plant. Therefore, the cleaning procedure of the CFS and mixing procedure of the coagulant was accompanied (Appendix C Figure 90 and 91).

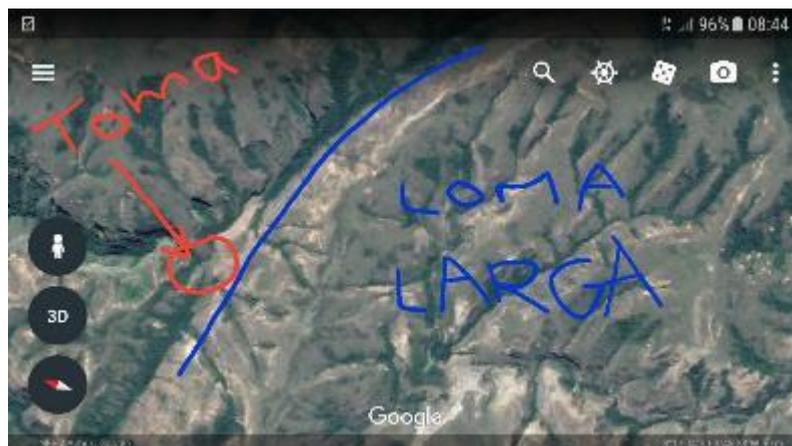
Figure 93 Appendix C Area of the expected free cows (Author's own copyright)

Once that the main contamination sources in the catchment have been defined, the pathogen concentration has been estimated. The evaluated area, the assumptions and calculations can be found in Appendix (see Appendix C Figure 93, Table 45 and Table 46) and the results can be found in Chapter 5.5. E. Coli was analyzed during the water sampling already and therefore excluded in risk assessment.
