## **Sustainable renovation projects of residential buildings**

### **5 examples in Austria**

*Master thesis at Chalmers Architecture*

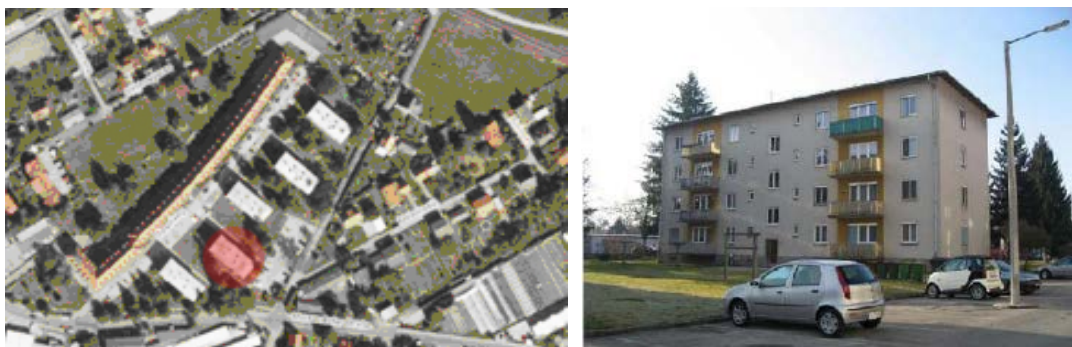
*Figure 4.3: The site plan to the left shows the five free standing buildings and one building row. The red-marked building is our research object, Dieselweg-4. The photo to the right shows Dieselweg-4, the entrance façade. (Square, 2010, pp 1)*

There are five free standing buildings (built in the 1960s and 1970s) and one long building (built in the 1950s) in this residential district, and totally, 204 apartments. Dieselweg-4 is our research object, which is one of five free standing residential buildings (Figure4.3).

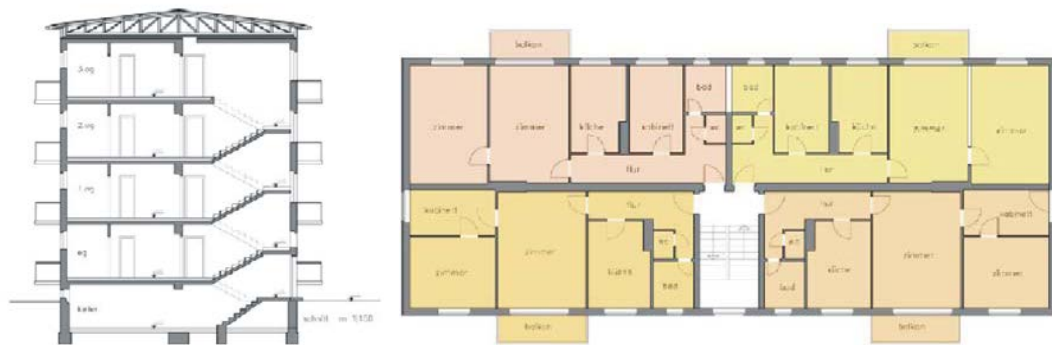
*Figure 4.4: Section and plan of Dieselweg-4.  
(Square, 2010, pp 3)*

Dieselweg-4 is a free standing building with 4 stories, including a basement. 4 apartments are grouped around the staircase in each floor. The apartments are in the size of about 90 to 100 m<sup>2</sup>. (Figure 4.4)

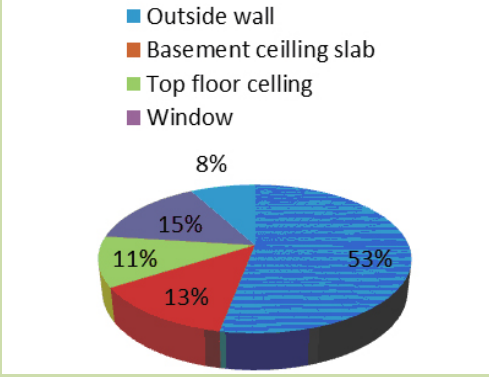
| Basic information about "Dieselweg-4" before renovation | |
|---|--|
| Transmission heat losses of the thermal envelope | <p>■ Outside wall ■ Basement ceiling slab ■ Top floor ceiling ■ Window</p> |

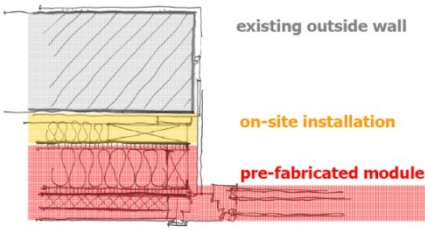
| <b>Old stock</b> | 300 mm Existing exterior wall | |
| <b>Compensation insulation site applied</b> | 100 mm Rock wool | |

One key measure in this project was a solar-thermal facade, which integrates heating and mechanical heat recovery ventilation (MHRV), as well as high-performance windows, by employing a patented honeycomb technology. As shown in Figure 4.4, the façade was constituted of three main parts: the original wall, compensation insulation and the prefabricated solar wall.

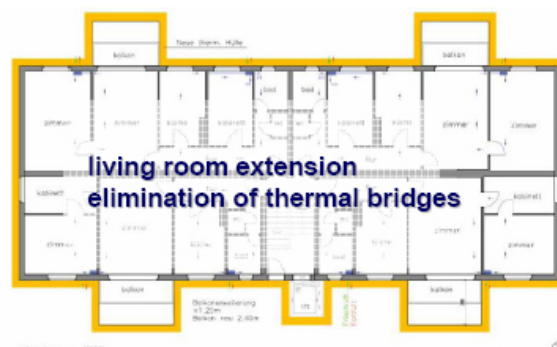
*Figure 4.7: Enclosed balconies. (Square , 2010, pp 3)*

3) The third factor is the extension of living area by enclosing the original open balconies (Figure 4.7). This formed a buffer zone between inside and outside, warmed up by the sunshine, and extended the using time of balconies throughout the year. Well enclosed and insulated balconies can eliminate thermal bridges and improve the usability of the dwellings and increase the comfort of living.

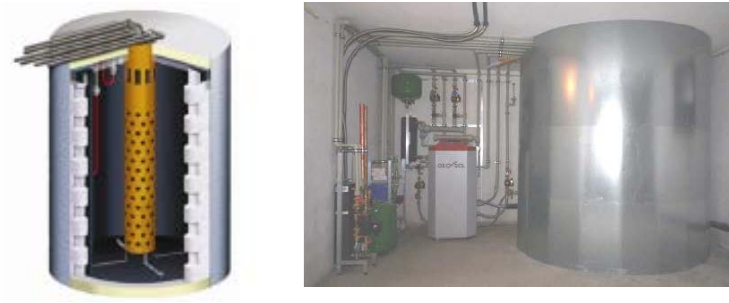
*Figure 4.8: Square, 2010, pp 4)*

The total energy supplied for hot water and heating is collected by solar façade. A generously sized solar heating system (about 3 m<sup>2</sup> / flat) is installed on individual homes. The honeycomb in the outer wall will be warmed by the sunshine to ensure a comfortable temperature for the building. A large storage tank (*Figure 4.8*), which is designed with "insulating bricks", ensures that the heat is available when it is needed.

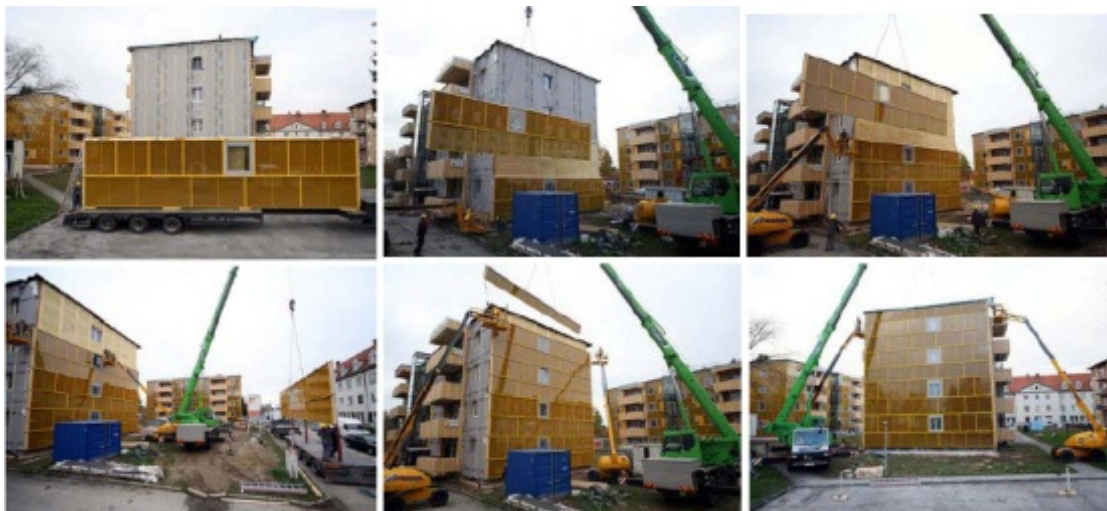
*Figure 4.9: Process of installing the pre-fabricated façade.  
(Square, 2010, pp 6-7)*

To minimize environmental impact and disturbance to residents, the envelope is constructed in prefabricated modules, of approximately 12 x 3 m. the detailed design of the modules were based on the laser of each façade. The pre-fabricated modules are brought to the site by a truck and trailer. Afterwards they are lifted by a truck-mounted crane. Two additional mobile-cranes are positioned on each side (Figure 4.9).

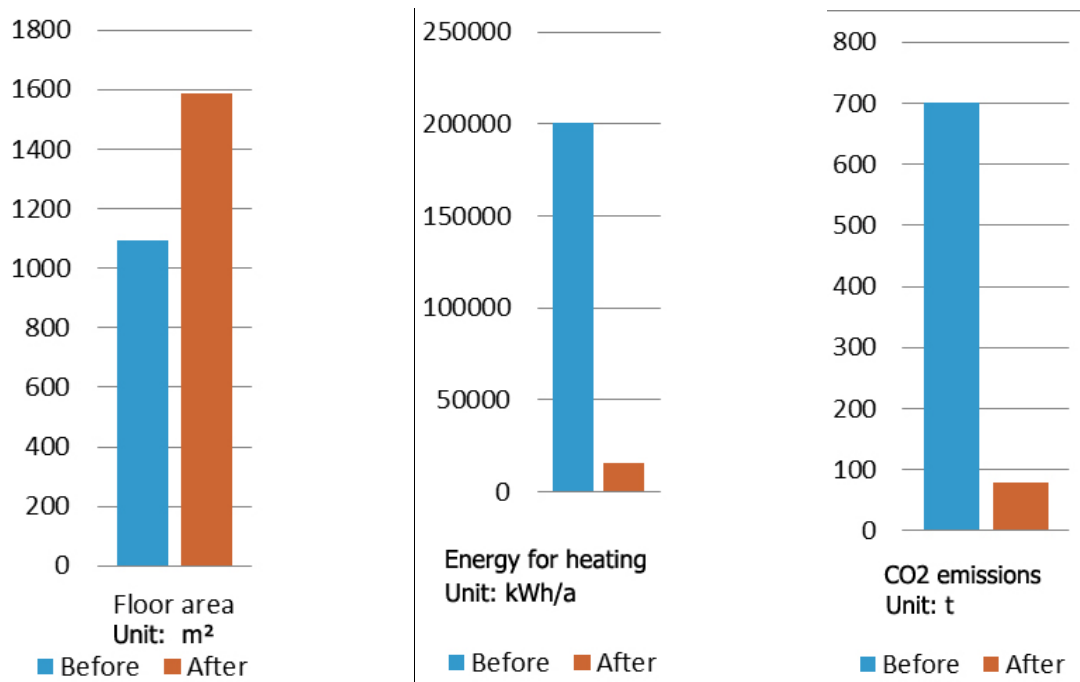
Figure 4.13: Floor area (left), Energy for heating (middle), CO2 emission (right)

The result of renovation is positive. The floor area was enlarged from 1091 m<sup>2</sup> to 1589 m<sup>2</sup> (Figure 4.13); the total energy demand for heating was decrease from 200.855 kWh/a to 15.258 kWh/a; and the CO<sub>2</sub> emissions reduced to 80 t / year from 700 t / year since renewable energy sources was used (Figure 4.13). What is more, after renovation, the U-value of façade, top-floor and ground-floor are all less than 0.2 W/m<sup>2</sup>K; and U-value of window is approximately 0.85 W/m<sup>2</sup>K (Figure 4.14). Sonja Geier (2010) of AEE (The Association of Energy Engineers) claims that "even in winter days with low solar radiation, the efficient U-value shows an improvement of approximately 21% ..." Moreover, amount of heating cost also goes down to €0.11 per m<sup>2</sup> /month from €2.00 per m<sup>2</sup> /month.

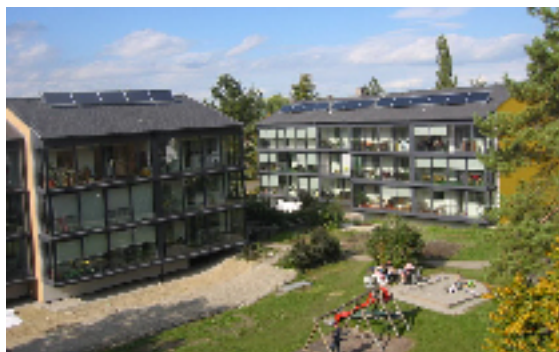
*Figure 4.23: solar collectors  
(Omoregie, 2008)*

Before renovation, the energy for hot water was only supported by gas burning. Through renovation, on the roof, the 150 m<sup>2</sup> solar collectors (*Figure 4.23*) on the south-facing roof were installed, which can achieve an annual solar fraction of 60% for domestic hot water preparation. In other words, solar energy partly replaced the fossil fuse energy. After renovation, the hot water supply system depends on both gas (40%) and solar energy (60%).

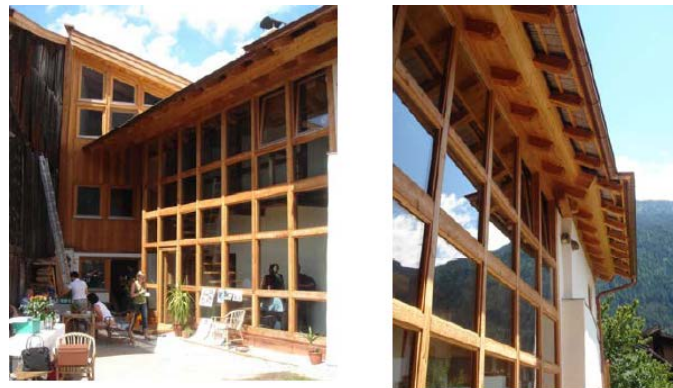
*Figure 4.32: the new wooden-glass box. (Heiß et al, 2009)*

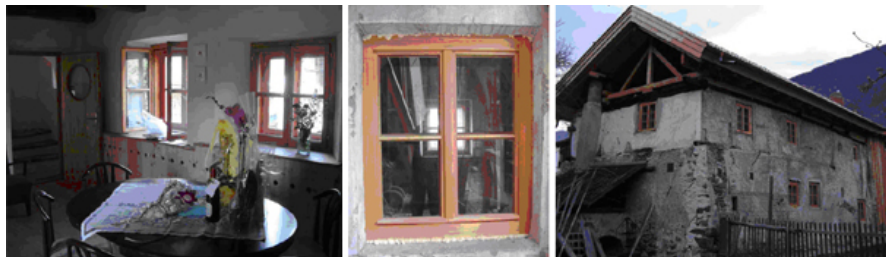
*Figure4.34: The new windows  
(Heiß et al, 2009)*

3) Windows are replaced with new ones which actually have two layers of window. In between, there is an air area, which can act as an air insulation to reduce indoor heat losses as well as a sound insulation (Figure4.34).

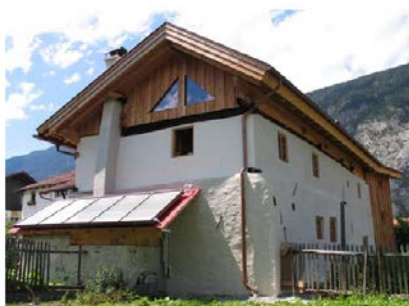
*Figure 4.35: solar collectors. (Heiß et al, 2009)*

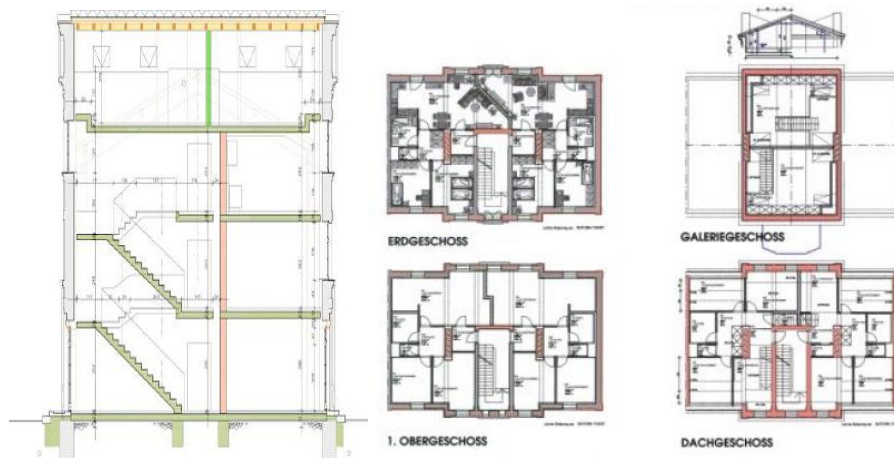
Figure 4.38: section (left), plan (right). (Wohnhaussanierung “Tschechenring”, 2008)

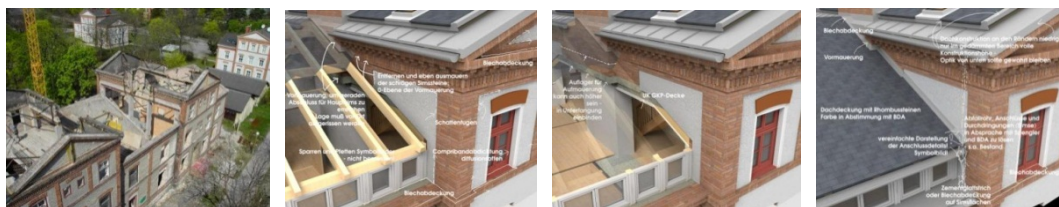
Figure 4.40: roof renovation. (*Wohnhaussanierung "Tschechenring"*, 2008, pp 48)

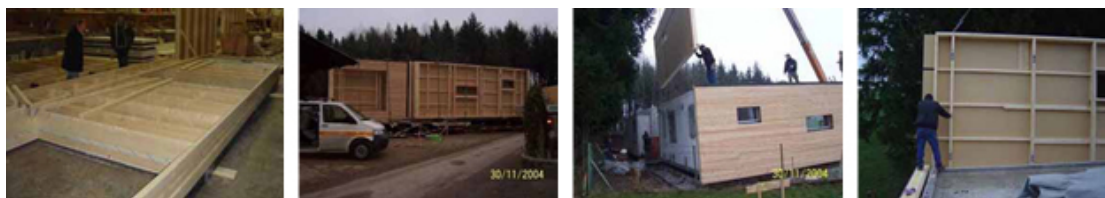
Figure 4.47: *Process for installing the pre-fabricated façade*  
(Lang, et al, 2007)

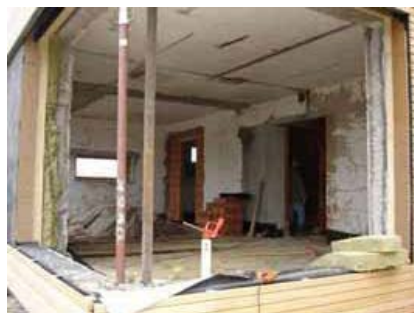
Figure 4.48: *Insulation.* (Lang et al, 2007)

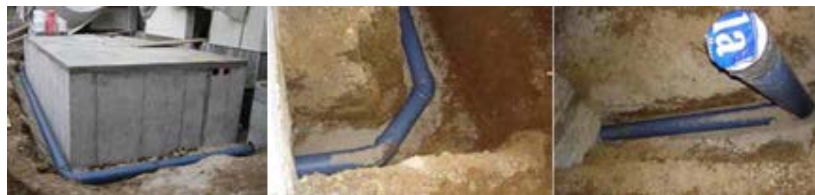
*Figure4.52: Pipes for fresh air  
(Lang, et al, 2007)*
