# Structural Evaluation of Defects in Bolt Hole Threads

Master's Degree Thesis Report

Master's thesis in MSc Product Development

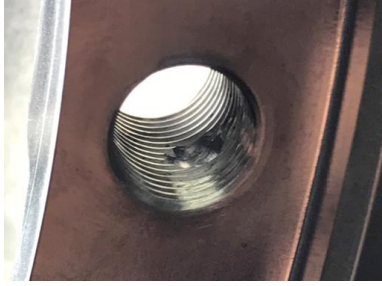
*Figure 3.1 – Defect 1: actual photograph (left) and CAD model (right).*

**Defect 1 - Missing Piece of Thread Material:** In this defect, a small section of the thread inside the hole has broken away, leaving a visible gap. As shown in the photograph, one localised area of the thread is damaged and a piece of material is no longer present. This kind of damage can occur during machining, assembly, or due to an impact on the part. In the CAD model, this is represented as a rectangular block of material removed from one section of the thread turns.

*Actual defect*

*CAD representation*

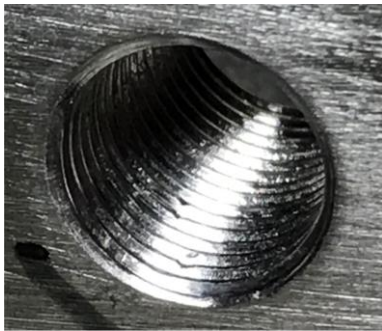
*Figure 3.2 – Defect 2: actual photograph (left) and CAD model (right).*

**Defect 2 - Breaks on the Thread Flanks:** This defect involves visible cracks on the surface of the thread. As seen in the photograph, there are two areas where breaks are present in the thread face. These breaks sit on the side surfaces of the thread and change how contact is made between the bolt and the hole. In the CAD model, this is represented as a small U shaped slot cut into the surface of one of the thread flanks.

*Actual defect*

*CAD representation*

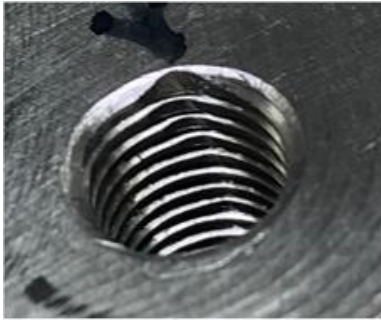
*Figure 3.6 – Defect 6: actual photograph (left) and CAD model (right).*

Defect 6 - Small Breaks on Multiple Thread Flanks: This defect consists of small breaks appearing on the face of several thread turns. Unlike Defect 2 where cracks are concentrated in one area, here the breaks are spread across a number of threads. The photograph shows cracks visible on the thread surface at the top of the hole. In the CAD model, these are shown as small diamond-shaped slots on the faces of several thread turns.

*Actual defect*

*CAD representation*

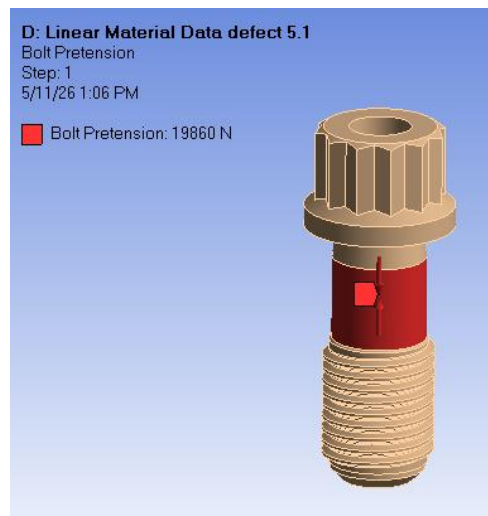
In ANSYS, the pretension was applied using the Bolt Pretension feature available in Mechanical, which introduces a cut plane in the bolt shank and applies the specified preload as force. This approach correctly captures the elastic interaction between bolt and joint members during the loading sequence. The pretension step was completed before any external loading was applied, following the recommended two-step analysis procedure.

Figure 3.3. Pretension loading procedure in ANSYS.
