Evaluation of slouched sitting postures of rear seated car passengers

A study of parameters with a focus on influence over time

Master's thesis in Product Development

MASTER'S THESIS 2021

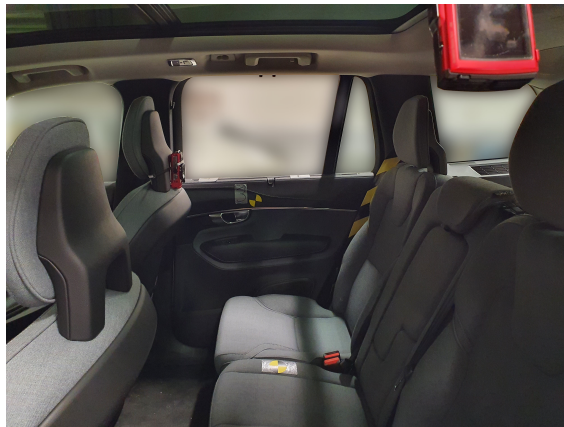
Figure 4.8: Image of the wool mix interior

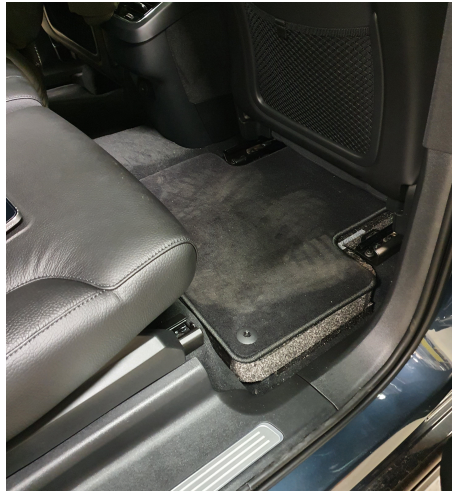
Figure 4.9: Image of the lowered sitting height modification

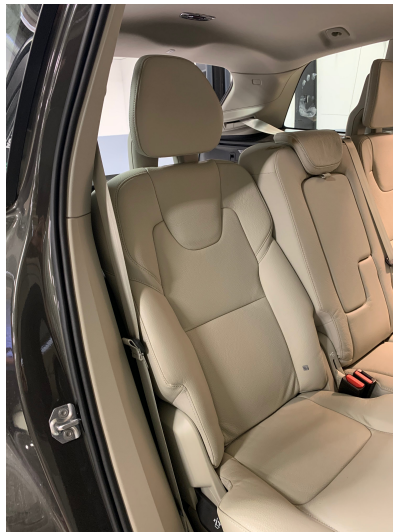
Figure 4.10: Image of the reclined backrest

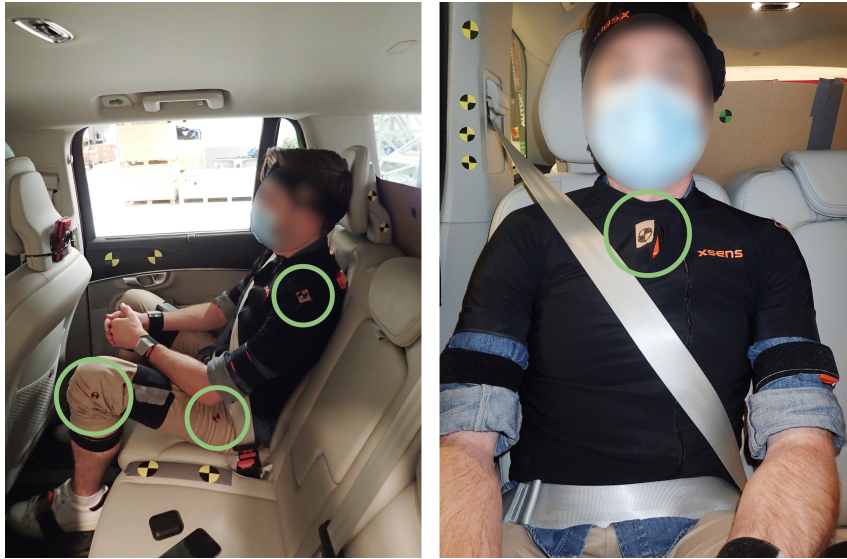
Figure 4.11: The stickers placed on the test persons used in the photo analysis

When the test person has filled in and signed the consent form, they were informed about the comfort evaluation form, see appendix D.1. When done, the Xsens system was attached to the test person, see figure 4.12. Before the calibration of the system could be done, two measurements needed to be taken. These were the shoe length and their body height which gave the system input to create a realistic manikin. Measurement point stickers were put on shoulder, sternum, and knee, these images can be seen in figure 4.11. For the first three test persons, stickers were also put on their ASIS points, but it was found that the shirt moved too much making these measurement stickers unusable.

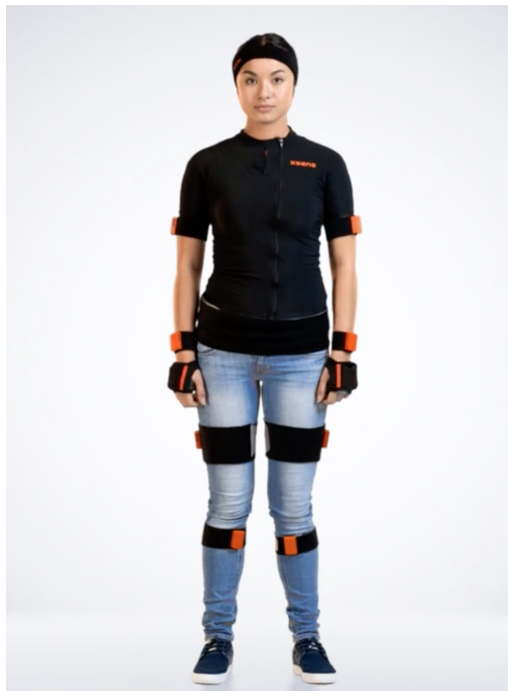
Figure 4.12: Image of a Xsens sensor placement on the test person (Source: Xsens.com)

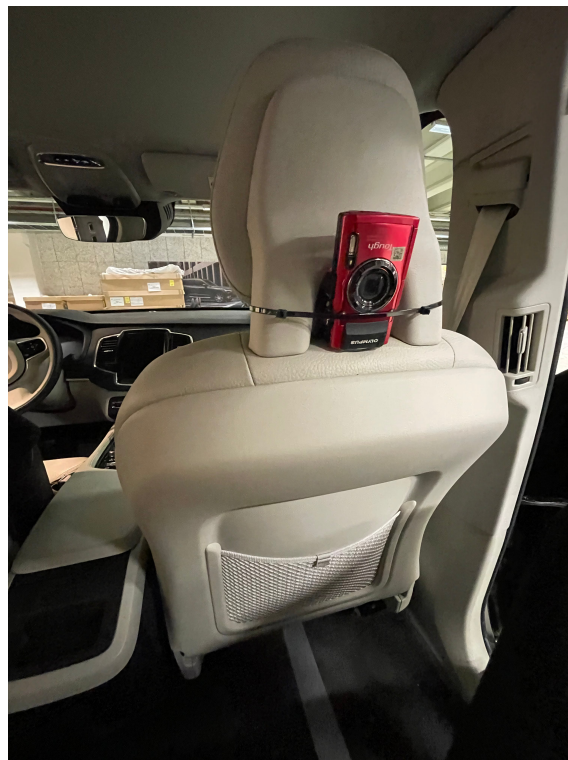
Figure 4.13: Image of the front facing camera

The mounting point for the front camera was changed and improved. This was done to avoid accidental button presses on the camera and to decrease variation between images. This also made it possible to more precisely angle the camera and capture points of interest. The camera placement can be seen in figure 4.13

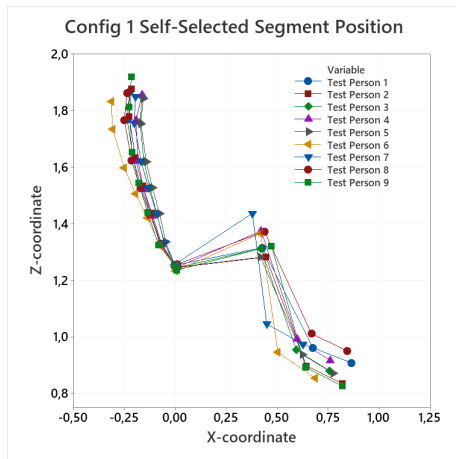
Figure 5.11: The position of each segment of every test person in the self-selected position for configuration 1.

The Xsens data is presented as diagrams of segment position and pelvis orientation. Test person 10 has been excluded from all graphs due to poor quality.

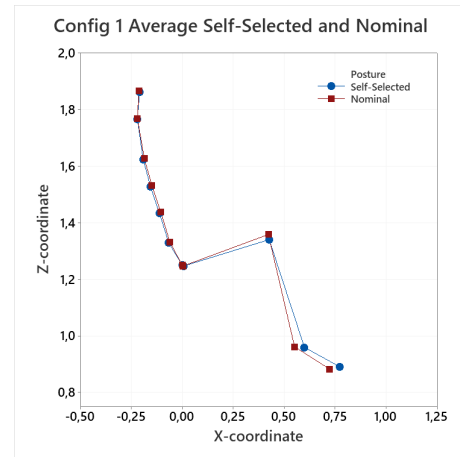
Figure 5.12: The average values of self-selected and nominal position for configuration 1.

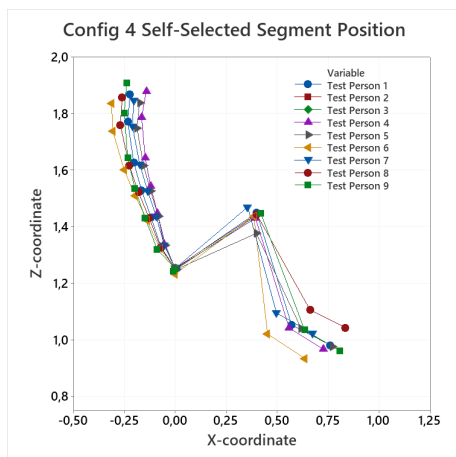
Figure 5.17: The position of each segment of every test person in the self-selected position for configuration 4. Test Person 2 and 3 has been excluded due to poor quality.

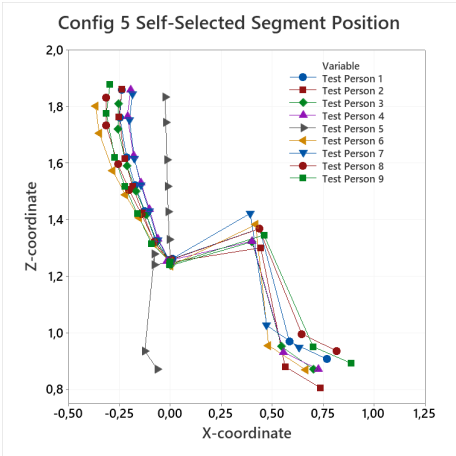
Figure 5.19: The position of each segment of every test person in the self-selected position for configuration 5.

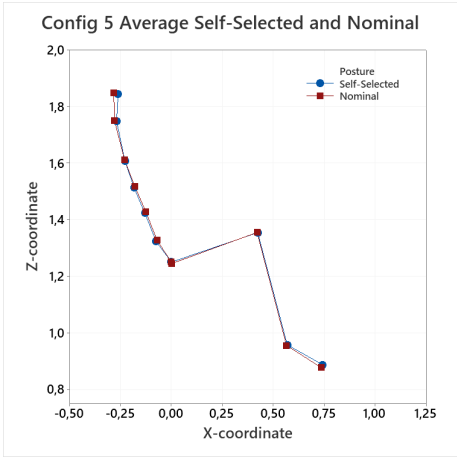
Figure 5.20: The average values of self-selected and nominal position for configuration 5. Test person 5 has been excluded due to poor quality.

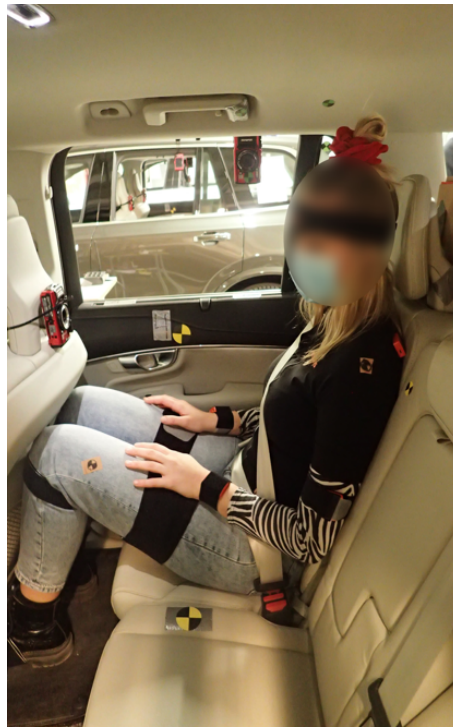
Figure 6.1: An example of how taller people would hit their knees in the from seat. This example is of test person 8 for configuration 4.

Configuration 4 is somewhat different from the other configurations since it's the one that changed the sitting posture the most in the lower body with the lower seats to mimic a V60 or S60. The conclusion of the data for configuration 4 is that although it seems to be the most uncomfortable, most people do not initially slouch as much in this seat compared to configuration 1. This is a surprising result since the theory was that with higher knees, it would be easier for the back so slide down and rotate the pelvis. By looking at the taller test people, it could be seen that most of them would hit their knees in the front seat and were not able to slouch down without putting even more pressure on the knees. An example of this could be seen in 6.1 and was also mentioned in the interview highlights in appendix F. This would make it harder to sit different than the nominal position, since that would be the optimal one to not put pressure on the knees, However, since discomfort most likely will lead to different sitting positions over time, this configuration is the most interesting one to look at for longer rides.

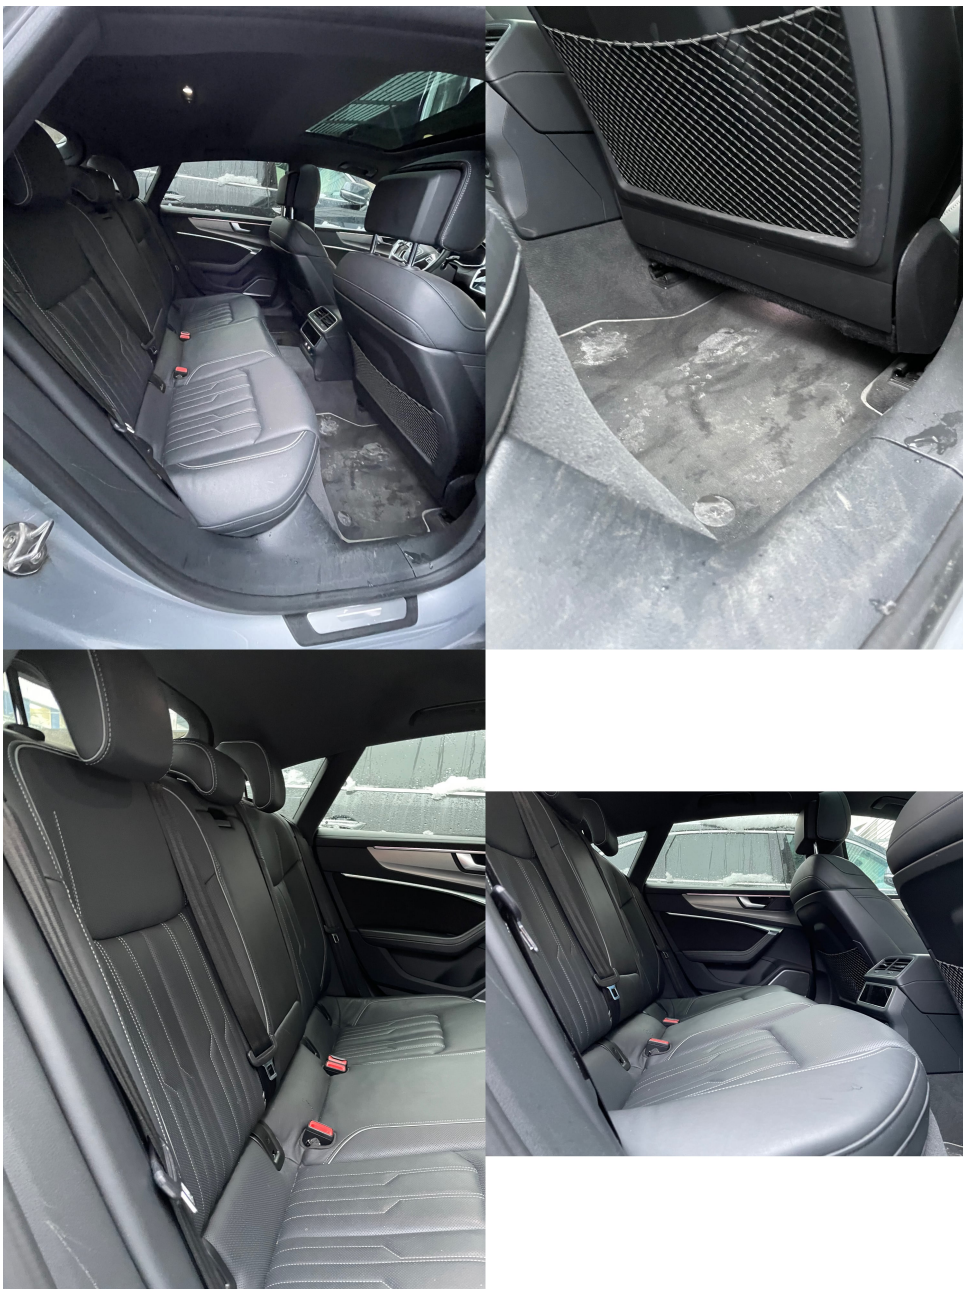
A.1 Rear seat of the Audi A7

Figure A.1: Photos of the rear seats of an Audi A7 MY20

The Audi A7 is a big sedan with a sloping roof line. This makes it feel more cramped in the rear seat for longer passengers. The sitting experience is overall good with comfortable seats and good legroom. The main problem found is the lack of thigh support and limited space underneath the front seat, making it difficult to move your feet. It was also found that the roof height was acceptable but the interior feels cramped because of small windows. This car was studied when it was cold outside which might affect the upholstery but the leather felt hard and slippery.

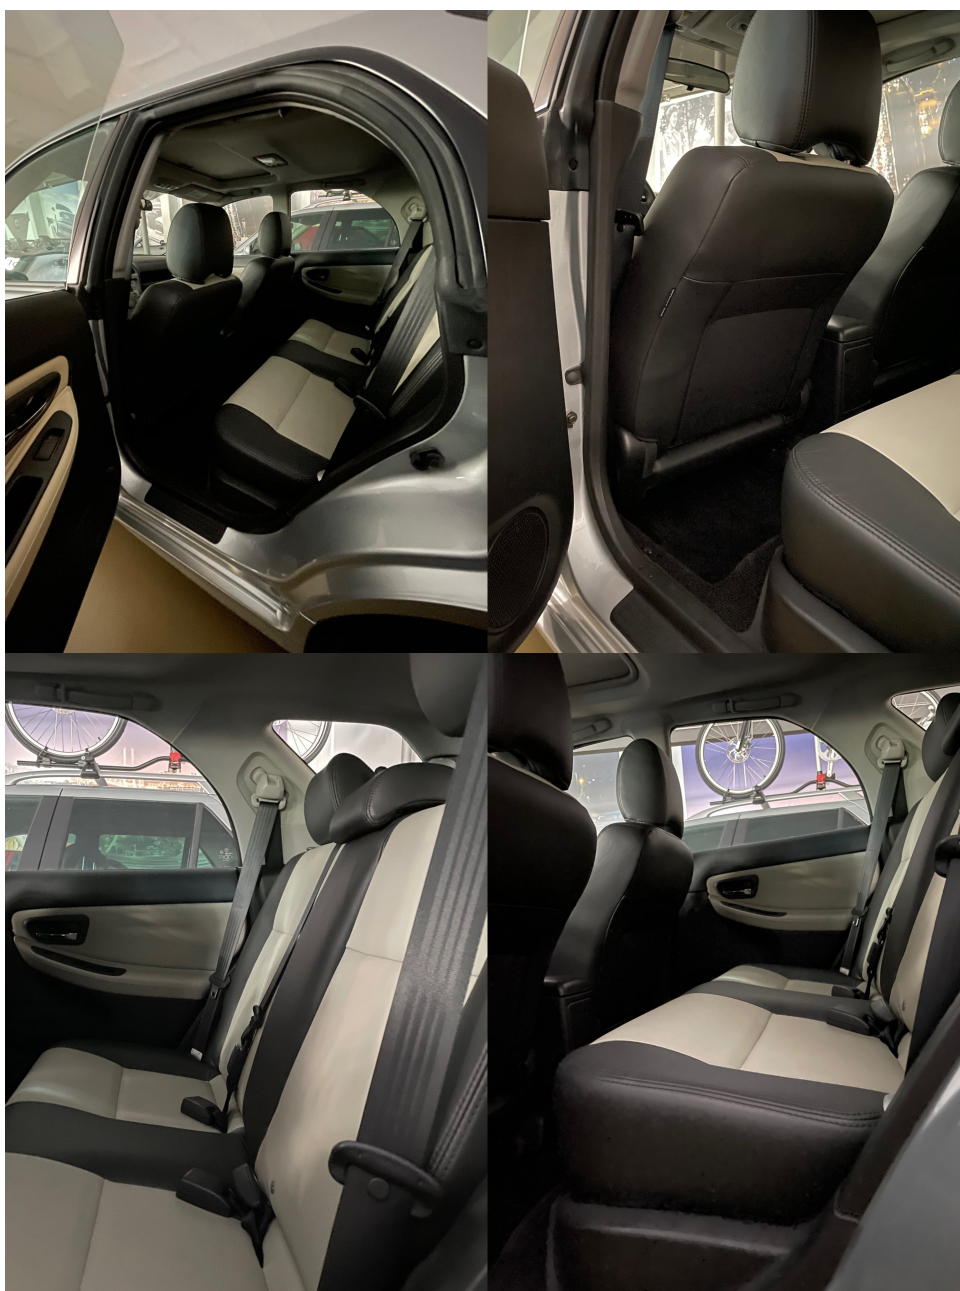
A.6 Rear seat of the Saab 9-2x

Figure A.6: Photos of the rear seats of a Saab 9-2x MY05

The Saab 9-2x is an ICE combi produced from 2005 to 2006. This interior was found to be a mixed experience. Overall, it had an okay seat with okay support. It also had okay headroom, good foot space but a bit tight legroom. The seat still felt cramped, something that can not be completely explained while looking at the measurements taken. A theory is that it can be affected by how close the passenger sits to the door, a measurement that was not recorded.

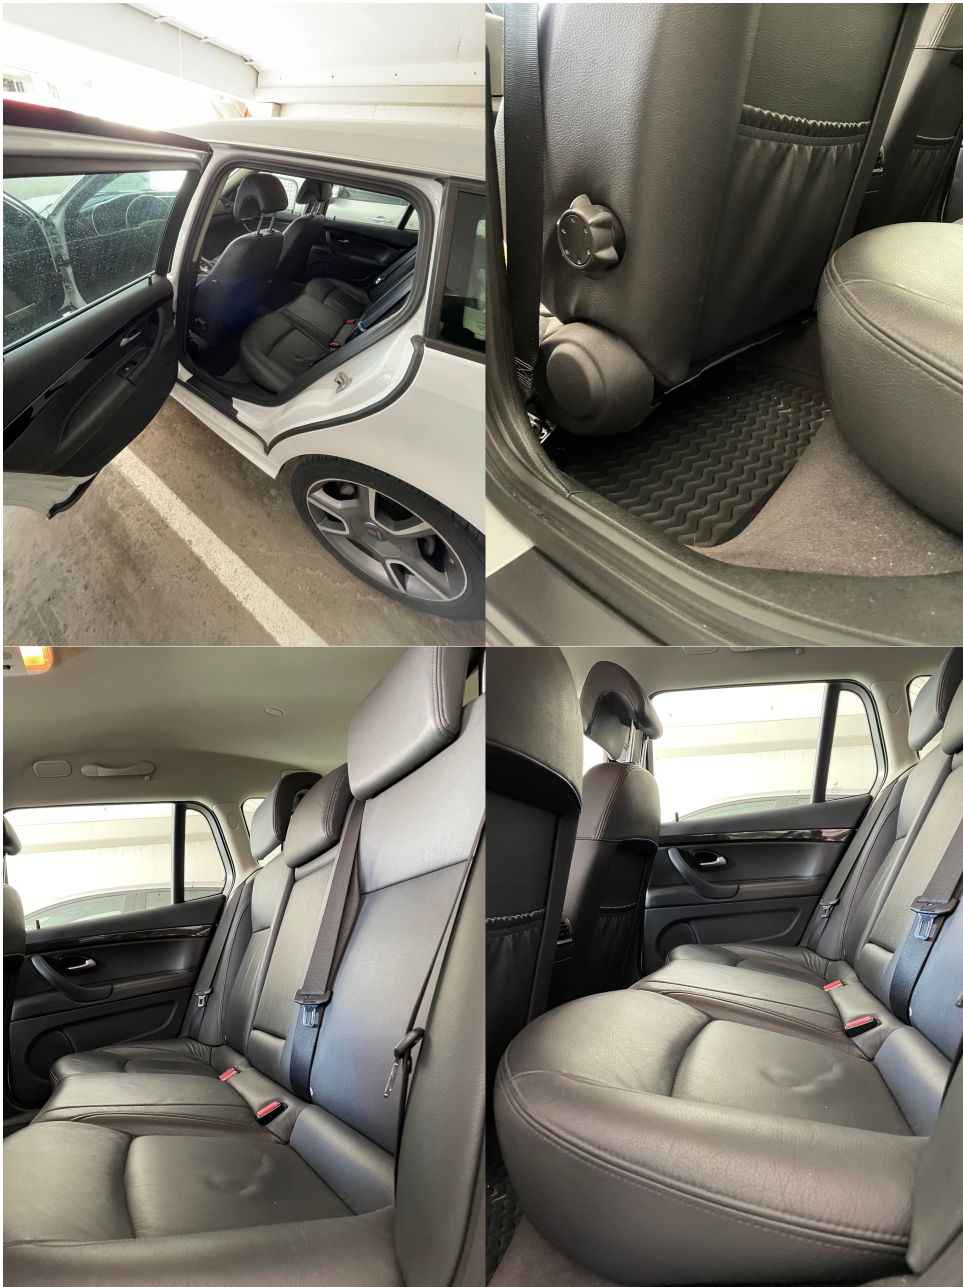
A.7 Rear seat of the Saab 9-3 SportCombi

Figure A.7: Photos of the rear seats of a Saab 9-3 SportCombi MY10

Saab 9-3 is an ICE combi produced between 2002 and 2011. This model had comfortable seats with a lot of support. The leather was soft but had a high friction coefficient making it harder to slouch. It was also found to have extra ordinary headroom which makes the interior feel spacious. Unfortunately, it has a very limited legroom. The floor- to seat-distance together with a angled seat cushion provides a lot of thigh support, if the passenger is able to fit.

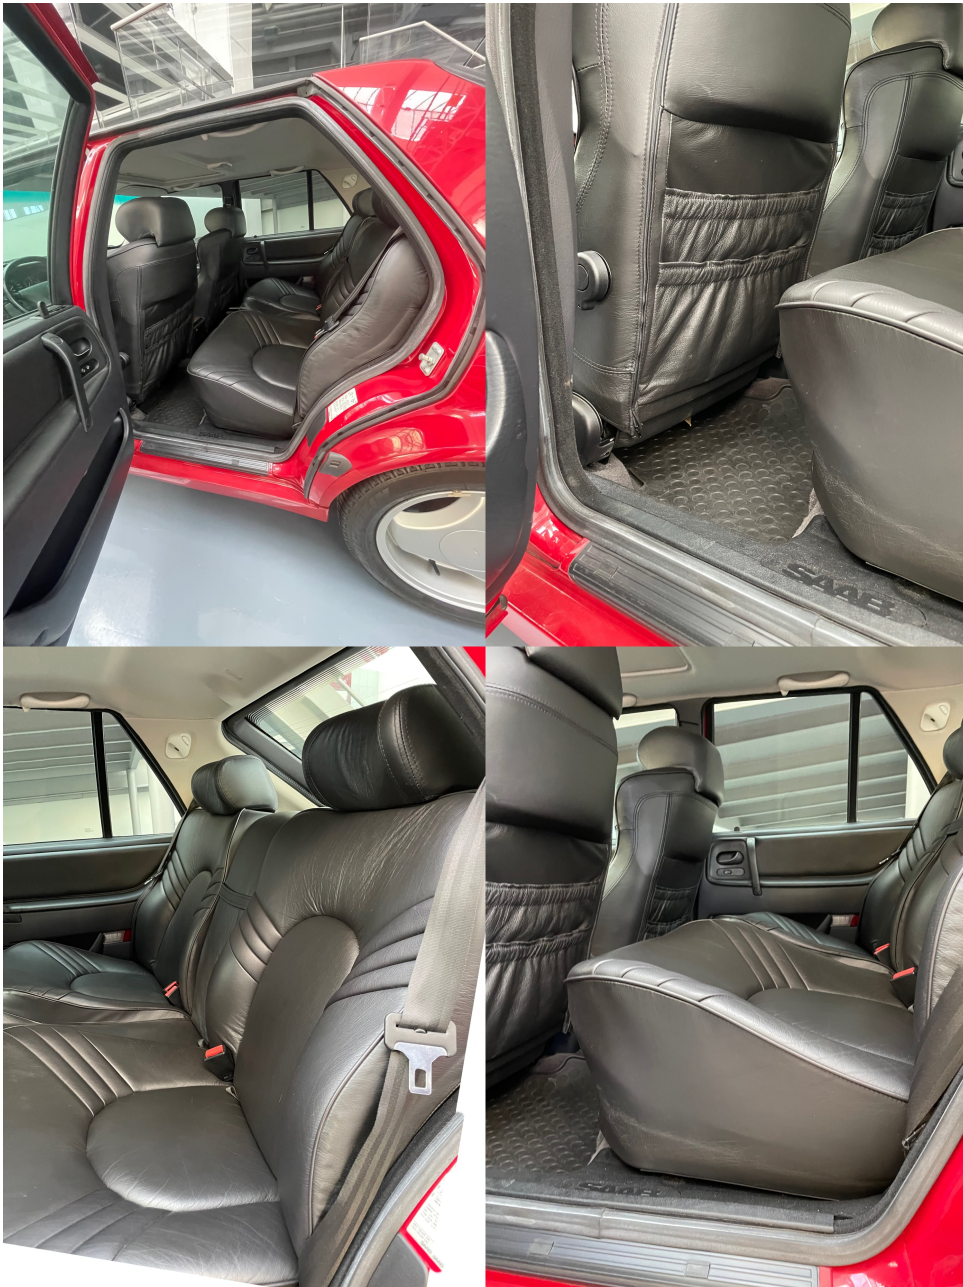
A.9 Rear seat of the Saab 9000 Aero

Figure A.9: Photos of the rear seats of a Saab 9000 Aero MY96

Saab 9000 is an ICE sedan produced between 1984 and 1998. The Aero-package adds, among other things, a sporty leather interior with improved side supports. The seat was very comfortable and supportive. The very soft leather upholstery was quite slippery, something that may be caused by the age of the car. It was found

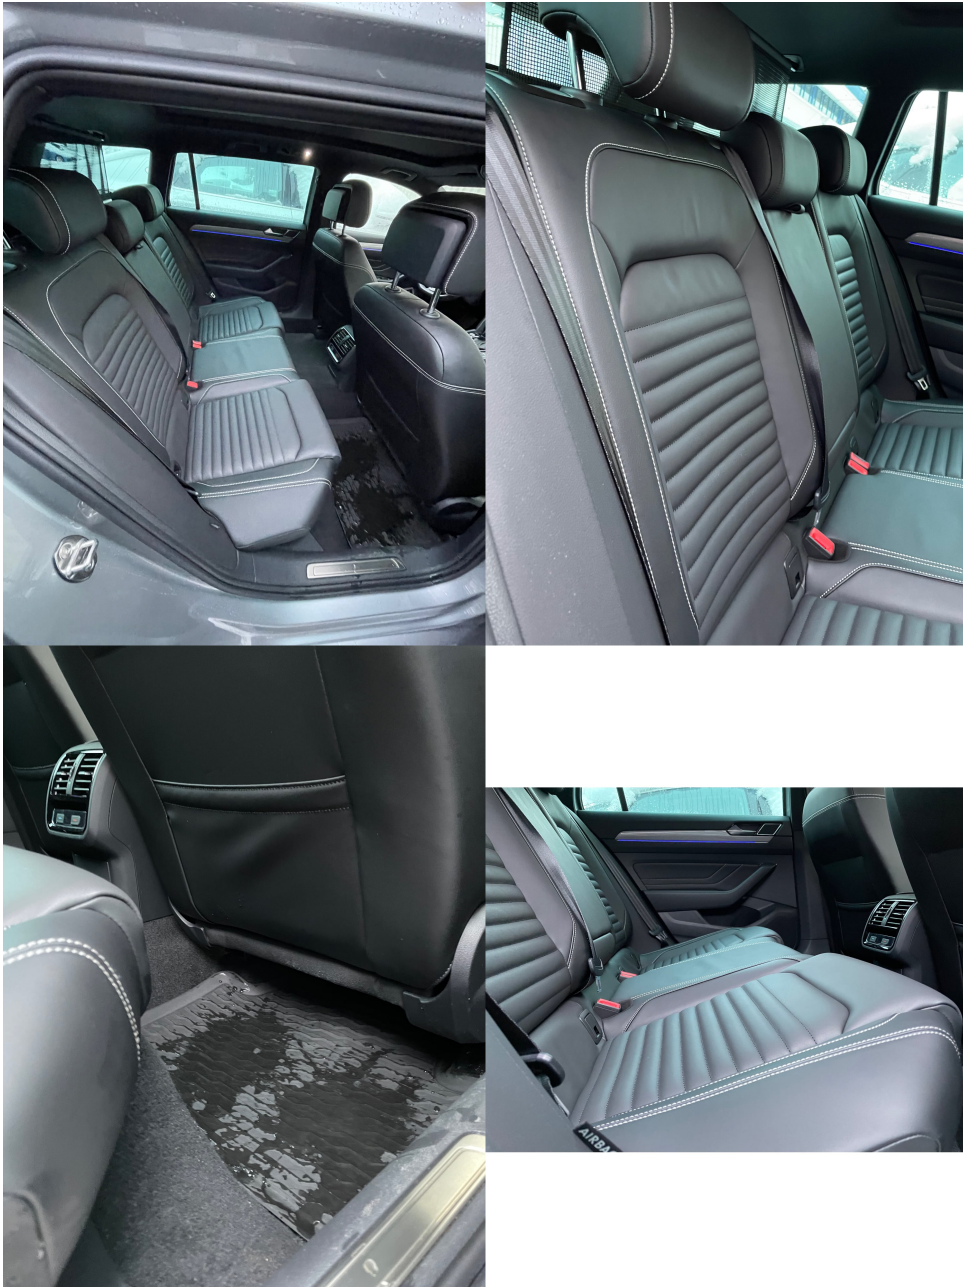
A.13 Rear seat of the Volkswagen Passat Variant

Figure A.13: Photos of the rear seats of a Volkswagen Passat Variant MY19

Volkswagen Passat Sportscombi is a ICE combi. This car is one of the most spacious cars benchmarked. It was also found to have very little tendency to slouch. This is mainly due to the comfortable seats and the less slippery leather. This was attributed to the way the upholstery is sewn as well as the leather used. There was also plenty of room for feet under the front seat, making it easy to move feet around. The small angle on seat cushion was compensated for by the floor- to seat-distance, which provided good support for the thighs.

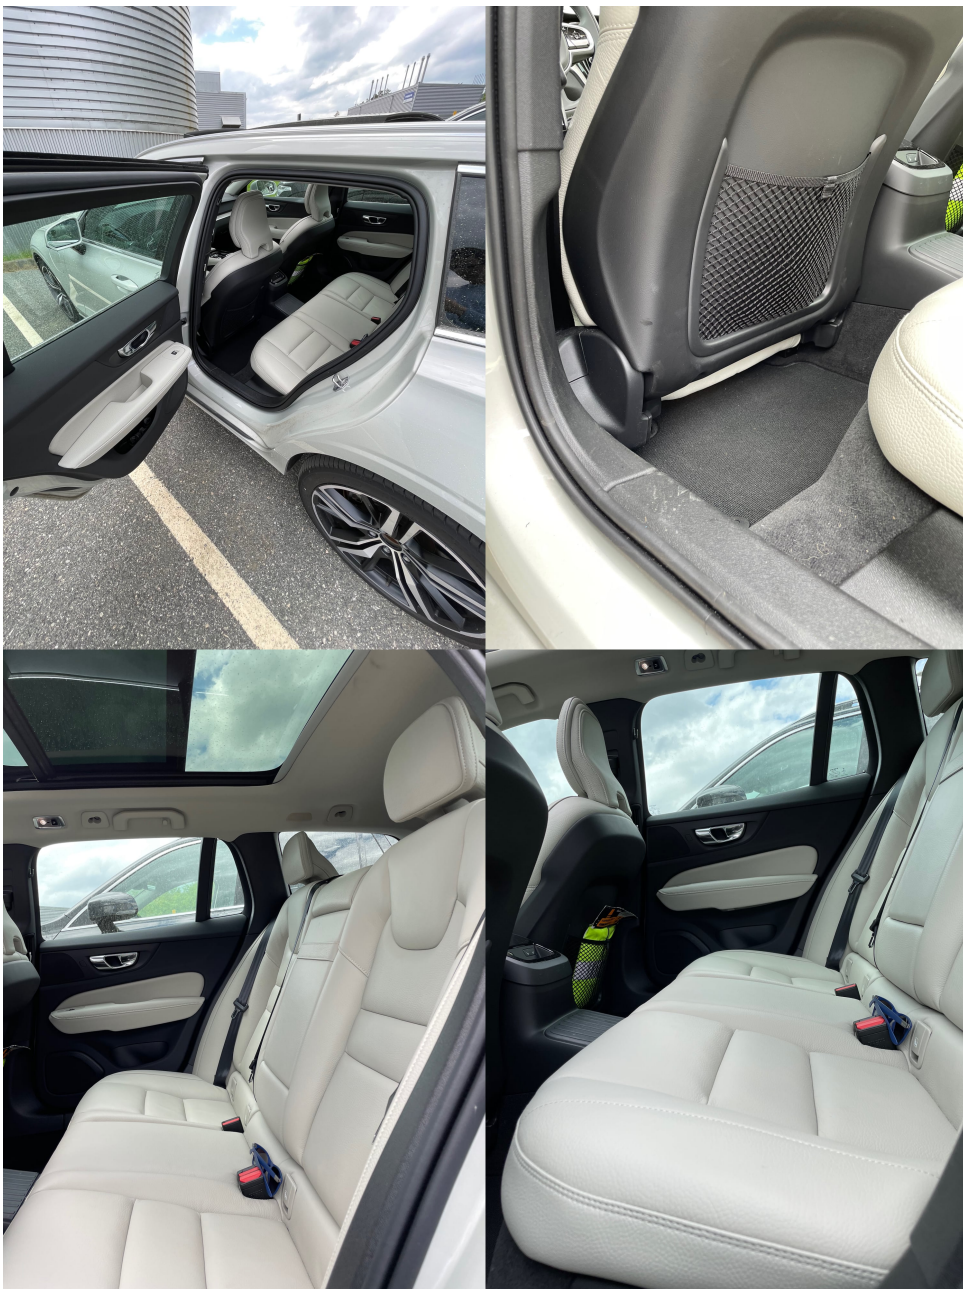
B.1 Rear seat of the Volvo V60

Figure B.1: Photos of the rear seats of an Volvo S60 MY20

Volvo V60 is an PHEV combi. The rear seat of this car was a bit cramped. This was mainly due to the limited headroom, legroom and small windows. Other factors for discomfort was the small seat cushion angle together with a short floor- to seat-distance giving limited thigh support. It was also found that this car have a limited amount of foot space without the ability to push your feet forward making it hard to change sitting position.

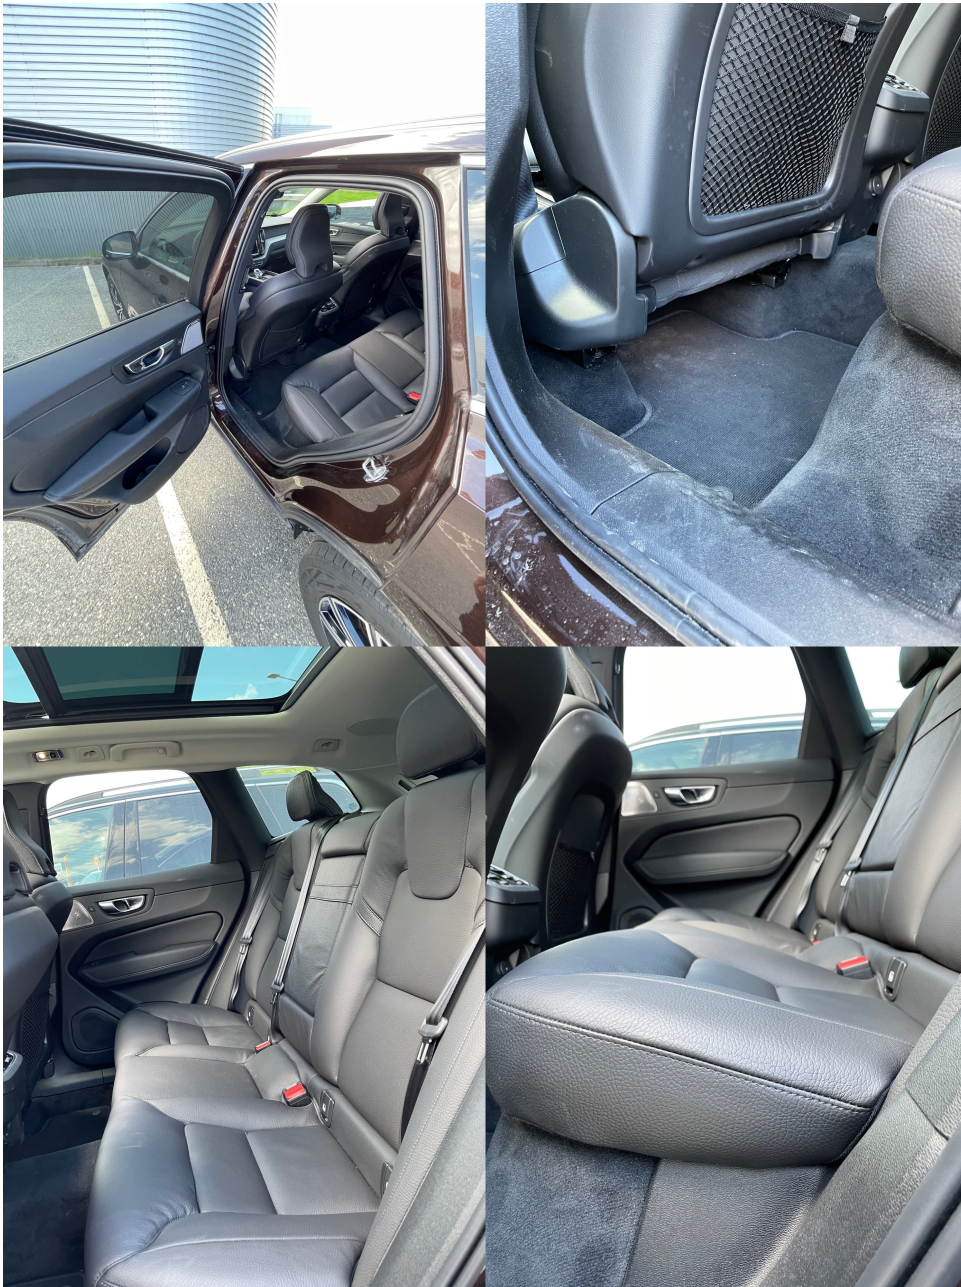
B.4 Rear seat of the Volvo XC60

Figure B.4: Photos of the rear seats of an Volvo XC60 MY20

The Volvo XC60 is a crossover and the tested configurations was a PHEV. This car was overall very comfortable with good headroom and foot space. The legroom and thigh support was found to be okay.

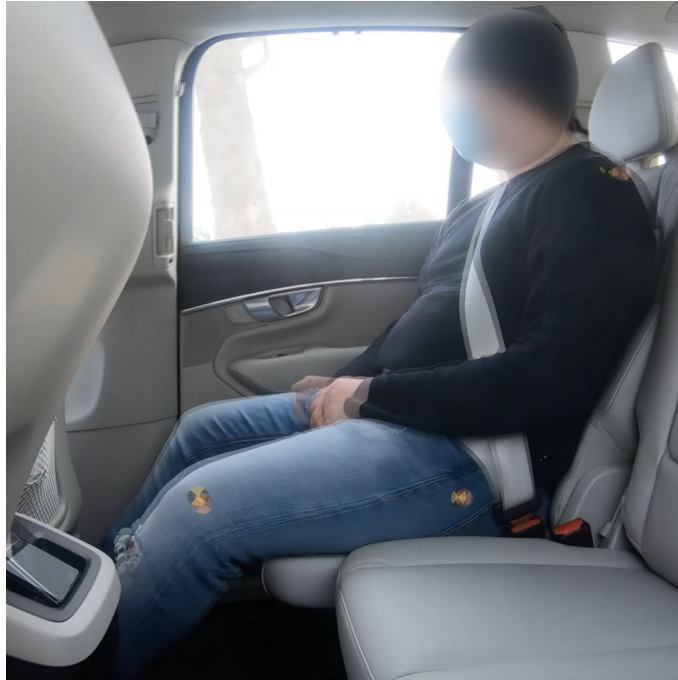
Figure E.1: Image of passenger movement for pre-test person 1 with angled backrest

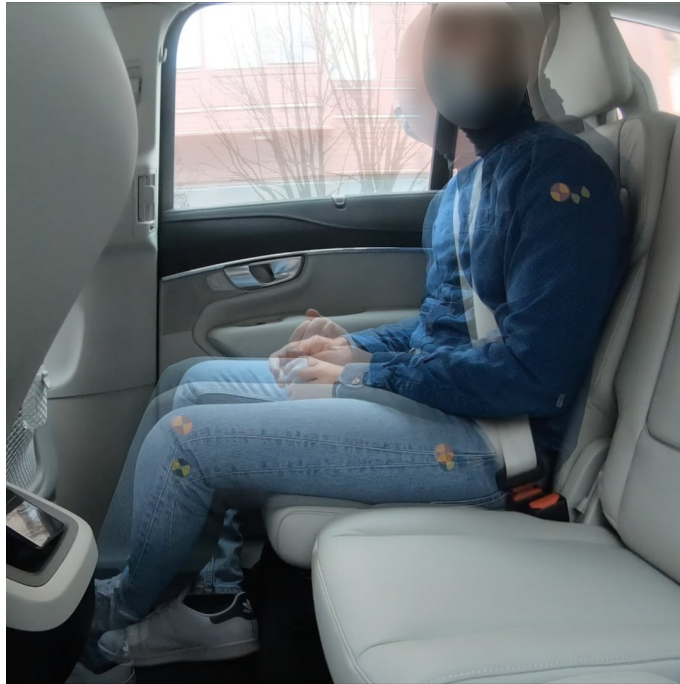
Figure E.2: Image of passenger movement for pre-test person 2 with upright backrest

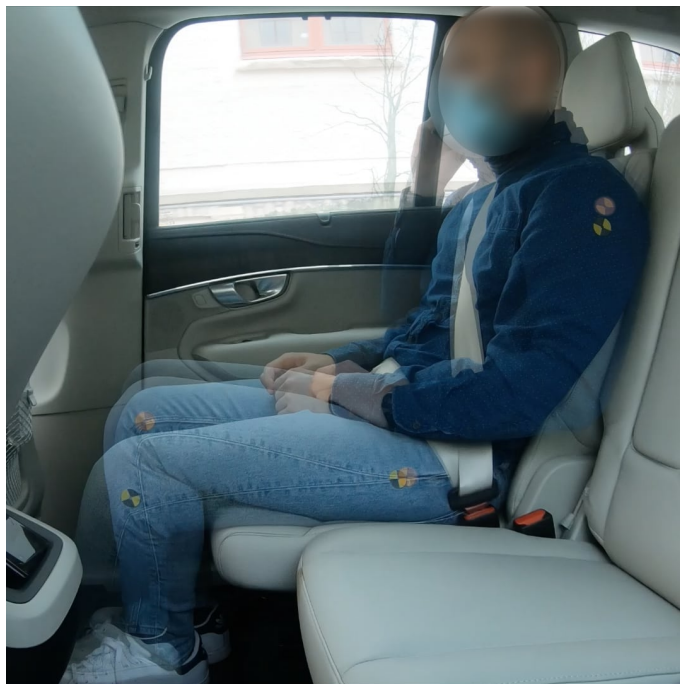
Figure E.3: Image of passenger movement for pre-test person 2 with angled backrest
