# Relationship between Fatigue Properties and Surface Treatment of Aluminum Alloy

Master's Thesis in Materials Science and Technology

Gothenburg, Sweden 2023

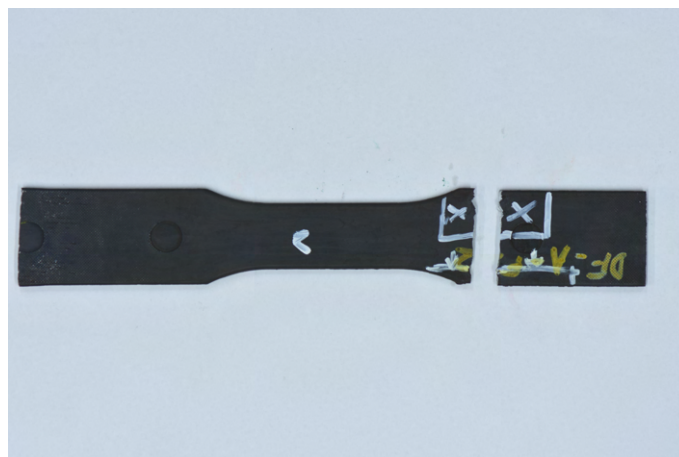
**Figure 2.7:** DF-A-F2 sectioned

After achieving successful results, further research on the grain structure surrounding the crack required proper sectioning. In the figure ??, two symbols were used for sectioning: **X** and  $\uparrow$ , which pinpointed the selected areas for the next steps. The **X** symbol was used to indicate a perpendicular direction to the surface, while the  $\uparrow$  symbol indicated a perpendicular direction to the sectioned area.

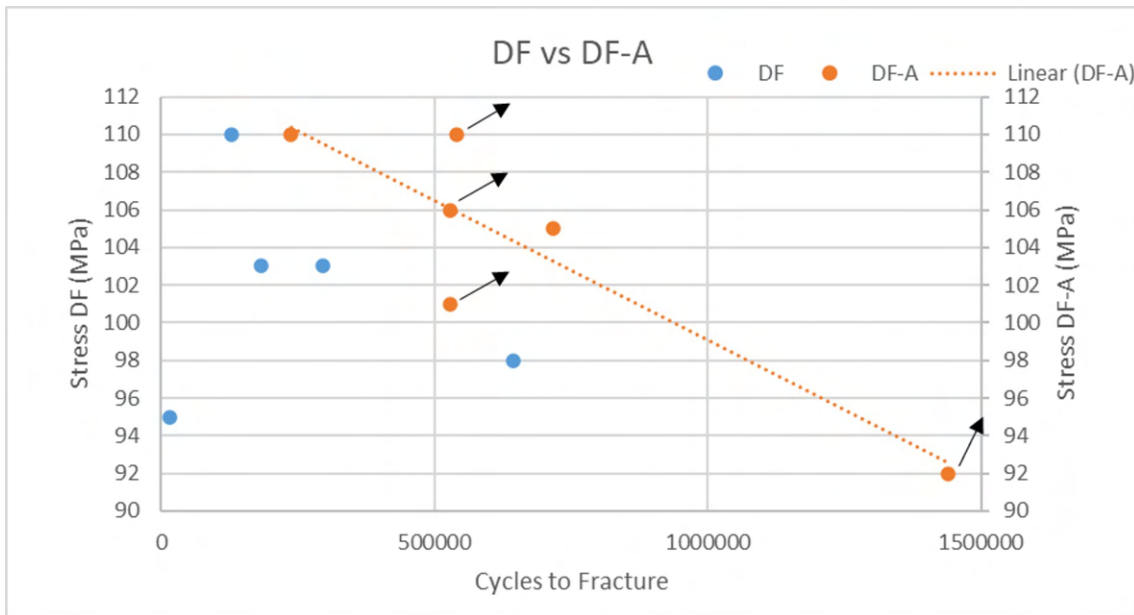
**Figure 4.1:** Data Plot HPDC

Figure ?? shows the data points plotted for the HPDC test samples both before and after amortization along with a trend line for the later batch. The small arrows seen here are the samples that did not break after achieving the threshold value of 500000 cycles. The test was manually stopped for these samples. It is clearly seen that the anodized samples show a higher fatigue strength than the unanodized samples at a prescribed stress level. This trend can also be noted in table ?? previously.

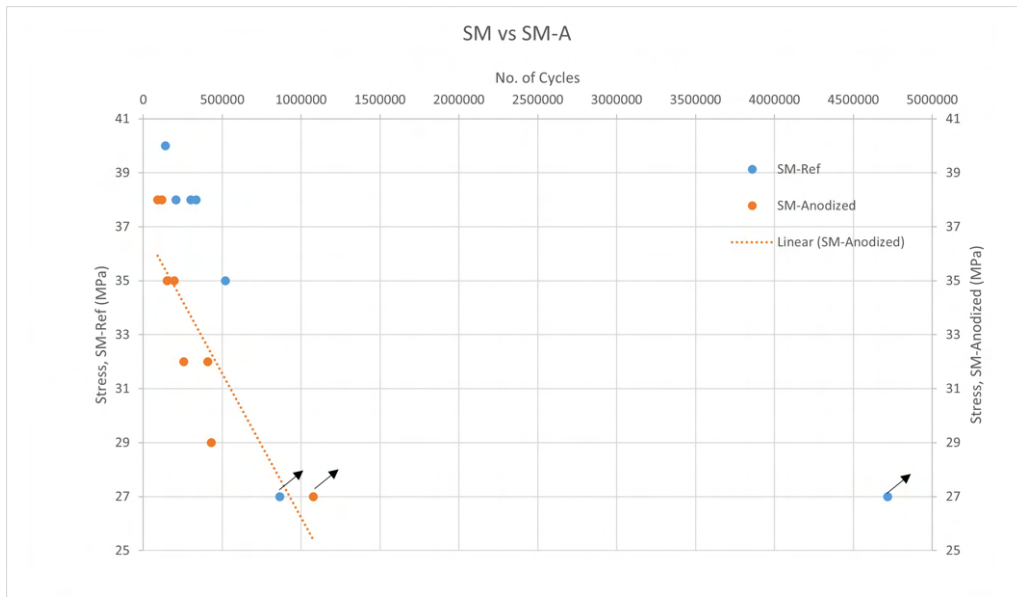
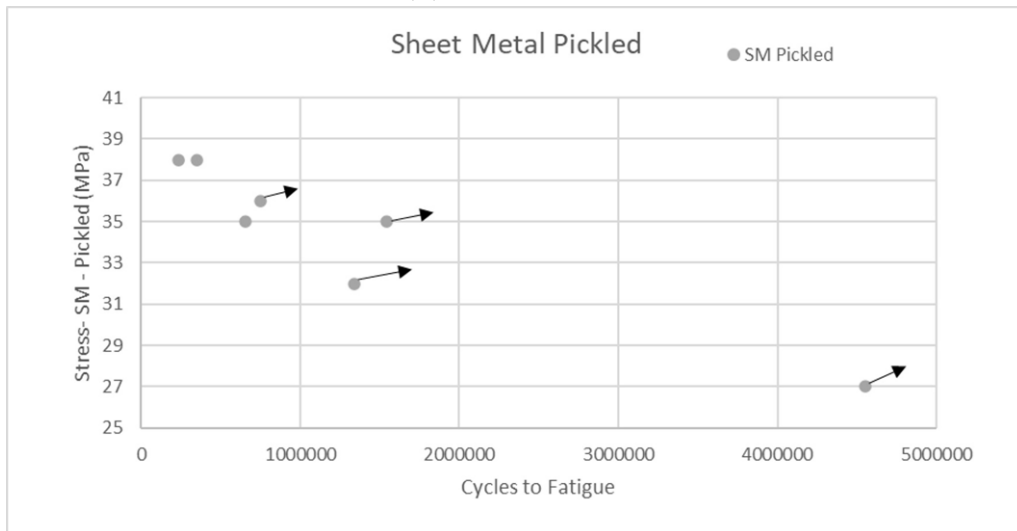
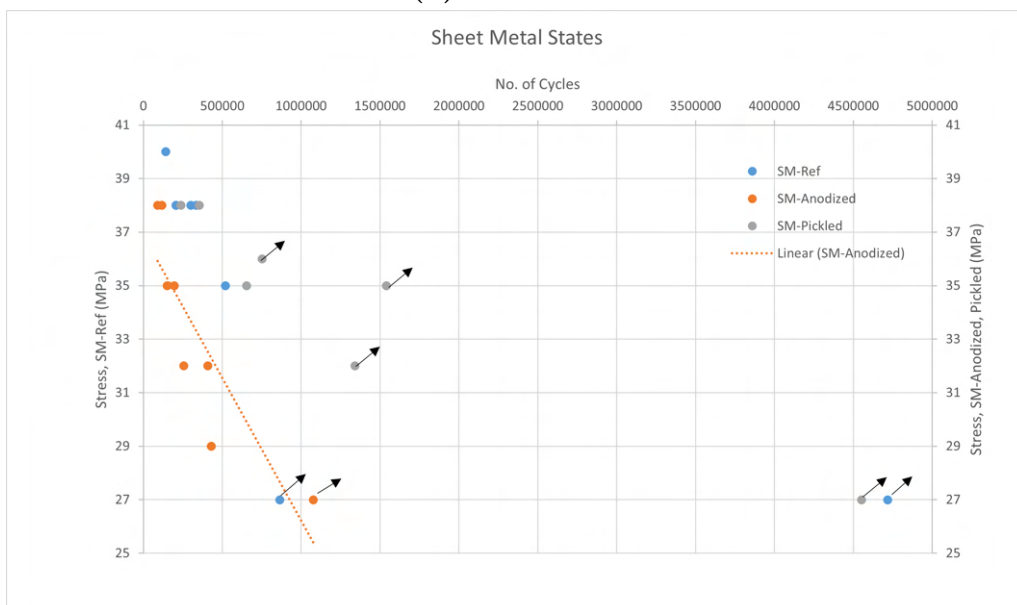
Figure 4.2: Data Plot Sheet Metal

Figure ?? here shows three plots for sheet metal. The first plot ?? depicts the comparison of sheet metal samples before and after anodization. Similar to the previous figure, the arrows here also show the samples that did not break and the tests were stopped manually. It is evident that at lower stress levels, the samples showed the best fatigue behavior. Such behavior was expected as the sheet metal displayed the lowest tensile strength out of all the alloys as seen in figure ?. The pickled samples displayed the best fatigue characteristics out of the three states for sheet metal samples. As seen in table ?? and figure ??, most of the test runs were successful and had to be manually terminated in order to start a new test. Pickling not only rids the metal of any undesired oxides, or scale build-up but leaves the surface with corrosion pits that prove to be the cause of future fatigue failure. The reason why these test samples behaved the way they did was attributed to the lack of such pits on the surface post-treatment. Once more the arrows point out the samples that did not break. Figure ?? shows the comparison of reference, pickled, and anodized sheet metal samples. It is fairly evident that the pickled samples show the best fatigue properties out of the batch staying consistent with the assumption that anodization alone does not cause a decrease in fatigue strength. However, it is evident that amongst the three states of sheet metal samples, there is a significant decrease in fatigue strength in the anodized samples.

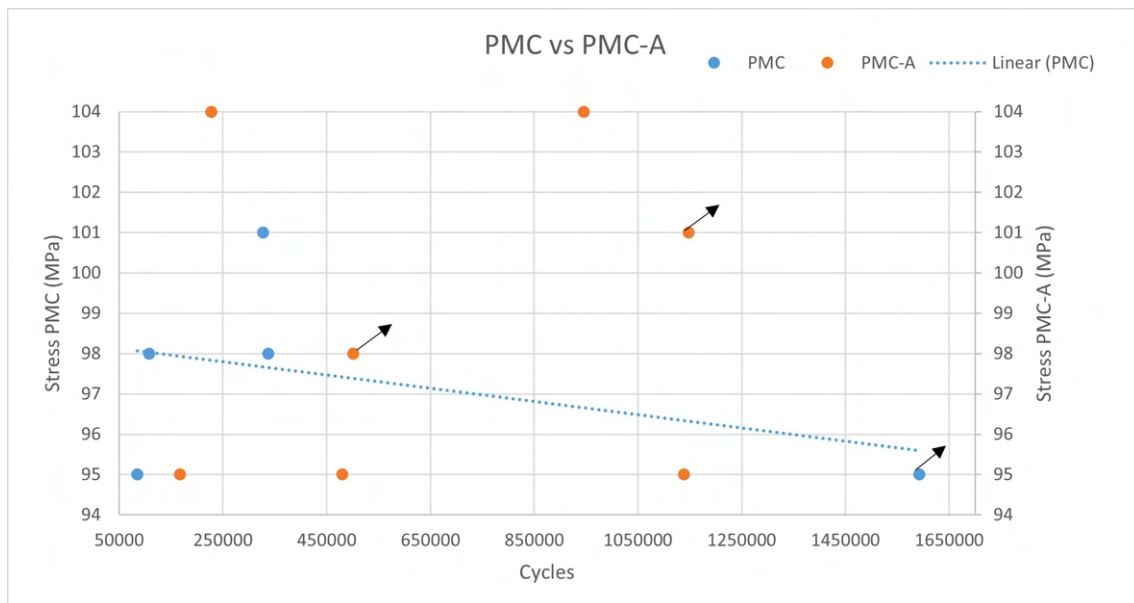
**Figure 4.3:** Data Plot PMC

Figure ?? and tables ?? and ?? show a spread of data across the various stress levels for permanent mold cast samples. As always the threshold was set at 500,000 cycles for a successful high-cycle fatigue run, and the sample had to fracture in the testing area for the test to be valid. The failed samples also display a spread of data owing to the contribution of the presence of pre-solidified material defects, shrinkage porosity, and internal stresses. The in-depth analysis of both the cast materials, i.e. HPDC and PMC, showed a similar pattern of defects causing the samples to fail well before the threshold. Figure ?? is an overview of both the cast alloy's anodized

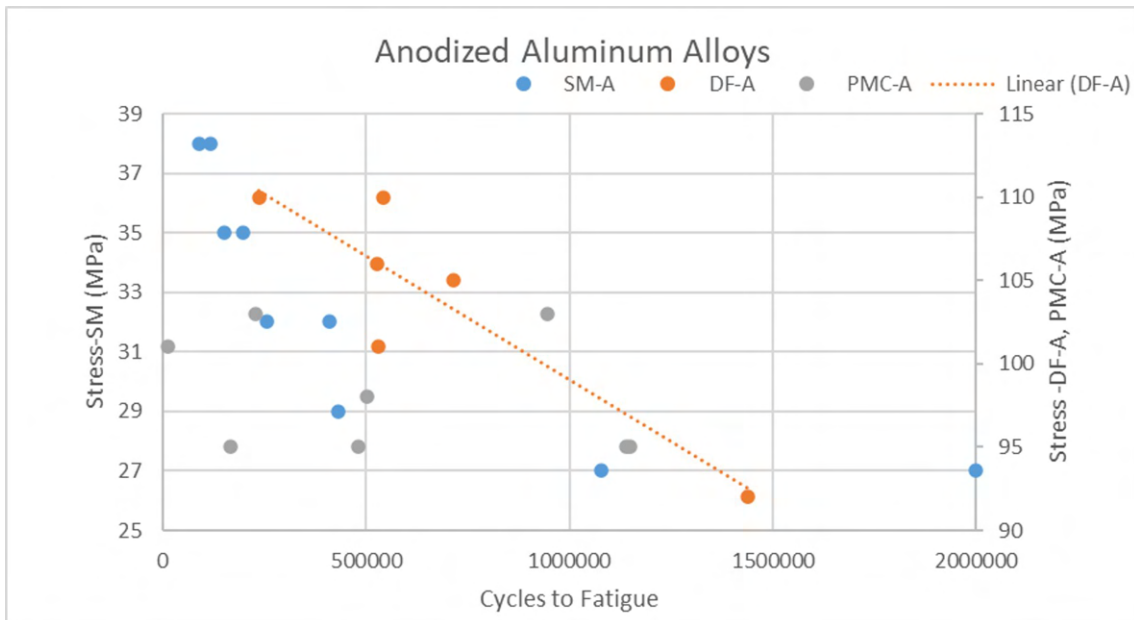
Figure 4.5: Data Plot Anodized Alloys

sample. It is seen here that quite a few samples had a successful test run with the HPDC samples having a higher fatigue strength than the PMC samples.

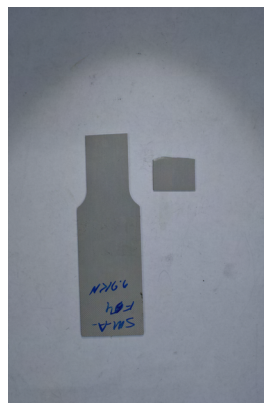
**Figure 4.7:** SM Test Samples

Sheet metal samples were visually inspected as well. Figure ?? shows how sheet metal samples looked after their respective test runs. One sees that both the unanodized (reference) and anodized SM samples fractured, however, the pickled sample did not break but showed some signs of physical distortion at the position marked by the arrow. The reference sample fractured very close to the clamping section while still remaining valid. The anodized sample fractured in the middle of the testing region and was also valid. The sample ?? showed a rather unusual surface defect post-test. One sees waves, torsion, and buckling effects in the testing area as marked by the arrow. The sample survived 1540529 cycles and did not fracture. The surface defects could be attributed to misalignment of the test top and bottom jaws by applying slight shear along with the designated tension force. Since there was no compression load applied in any of the tests, buckling was ruled out as a possible cause of the defect. The test, however, remains valid.

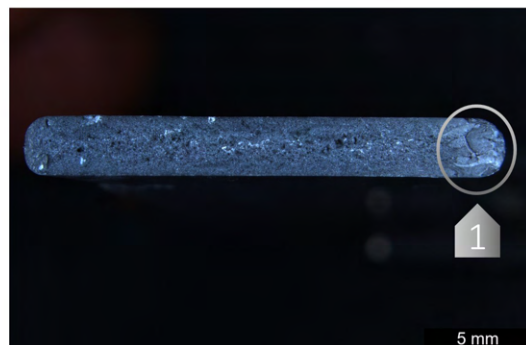
The figures ?? and ?? show the overview and closeup, respectively, of the fracture surface from the other half of the HPDC reference sample DF-F9. Furthermore, the second peculiar sample in the HPDC reference batch is shown from figure ?? to figure ??. The connotations "-1" and "-2" represent two halves of the fracture surface. An overview and a closeup of the marked spot is shown for both halves.
