# Microstructural Investigation of Solder Joint Failure in Heavy Duty Trucks

Master's thesis in Materials Engineering

MASTER'S THESIS 2026

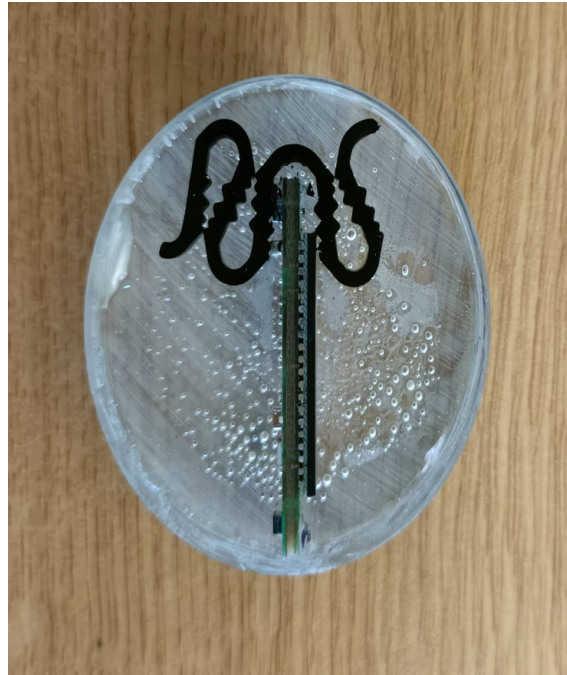
**Figure 3.5:** Sample cold mounted in Epoxy

After sectioning, the samples were mounted in epoxy resin using a cold-mounting process as seen in Fig 3.5 . Cold mounting was selected because elevated temperatures used during hot mounting may alter the solder joint microstructure, increase intermetallic compound growth, or modify existing fatigue cracks. The mounting orientation was selected to ensure that multiple solder joints could be observed simultaneously during microscopy.
