# Project Management challenges that affect lifespan of constructions in development aid project

A Case Study through Healthy Hospital Project in Tanzania

*Diploma Thesis in the Engineering Programme*

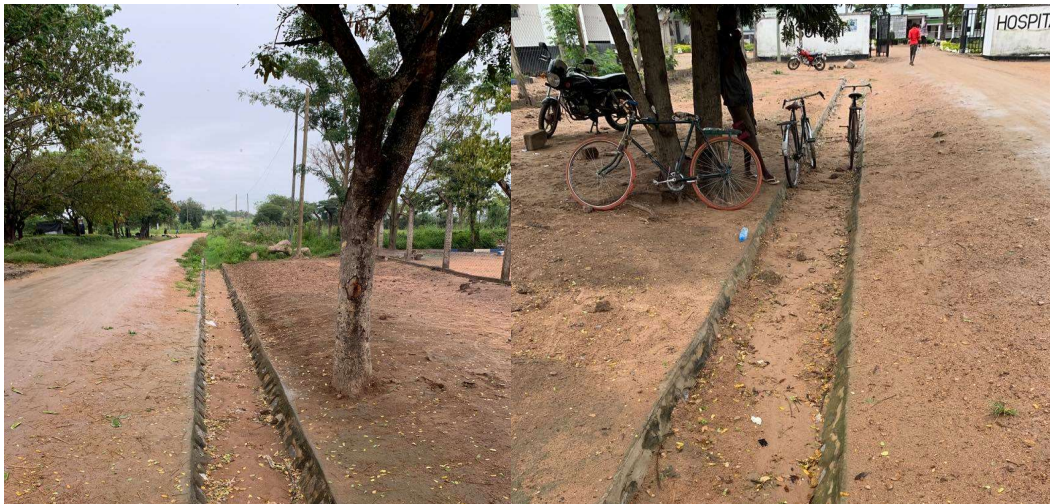
*Figure 3.9 Clogged gutter at Kolandoto Hospital 2020.*

During the end of the week we went for a study visit to Kolandoto Hospital accompanied by the HMT. EWB have had a long last cooperation in Kolandoto and conducted several projects throughout the years (Axelsson & Schön, 2019). The purpose was to investigate the infrastructure improvements that had been done in order to increase our knowledge of how infrastructural challenges have been dealt with. The hospital had a drainage that reached along the ails along the hospital area, connecting all buildings. This prevented water masses from penetrating into construction. However, we noticed that the slight slope at some points caused sand masses to settle in the gutter which made it clogged as visualised in Figure 3.9. The depth was also lower which filled up the gutter faster with sand and soil. This was an observation that could be useful for our drainage project in Mkula.

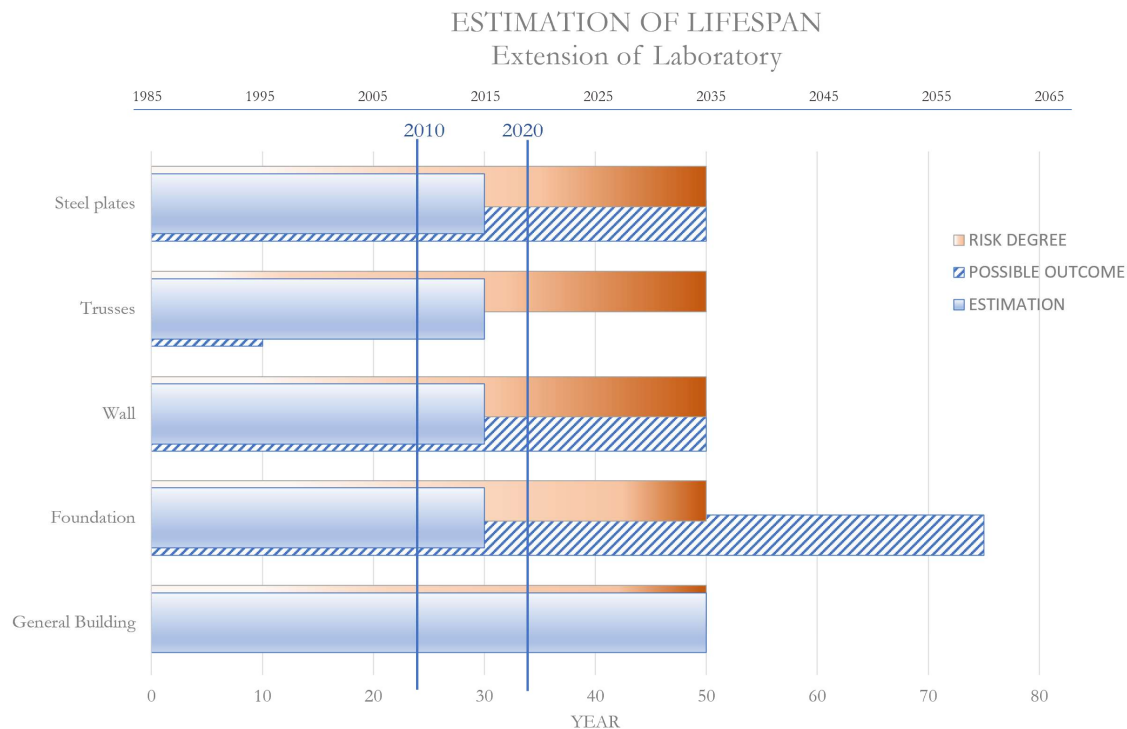
Figure 3.10. Estimation of lifespan for the extension of laboratory.

Figure 3.10 is created during our case study as a way of understanding durability when considering different options for the extension of the laboratory. The roof consists of steel plates without ceiling, leaving empty space between already existing walls and the roof. We discussed if it would be enough to only do maintenance on the steel plates. The roof could be considered as an independent construction as it has individual bearing columns. Everything but the foundation could be demolished in order to keep the roof. The foundation was beneficial to keep since it was one of the larger expenses. As shown in Figure 3.10, the lifespan of the foundation can moreover be expected to last longer.

We conducted the estimation of lifespan for different parts of the building from previous experience and studies. Broader research was made to create an understanding of durability of the old RCH. According to Celadyn (2014), the general building durability for concrete constructions is 75 years, while the European standard is 50 years. The need of renovation and maintenance would probably be required after at least 25 years. The author claims that following main factors affects the average durability of buildings: building function, applied technology, environmental conditions, local culture, and economic and political situation. Among these factors, Celadyn (2014) points out environmental conditions as an overall building destructor. Dry, cold climates are mentioned as satisfactory conditions while hot humid climates could lead to complications for concrete components. The lifespan varies depending on climate zone and geographical location.

Steel construction with general paintings of today is considered to last in 30 years according to International Conference on Construction Materials and Structures (2014). Hot dipped American galvanized plated steel could last for 70-100 years whereof this is not an option in this case scenario. Trusses made of timber could last for only eight years if not maintained, based on studies in Mozambique (Schittich & Sauer, 2012). Brand’s diagram has been used as a source of information whereof foundation and load-bearing elements could last for 30-300 years, in average 50 years(Brand, 1997). Exterior surfaces are considered to be endured for 20 years by Brand.

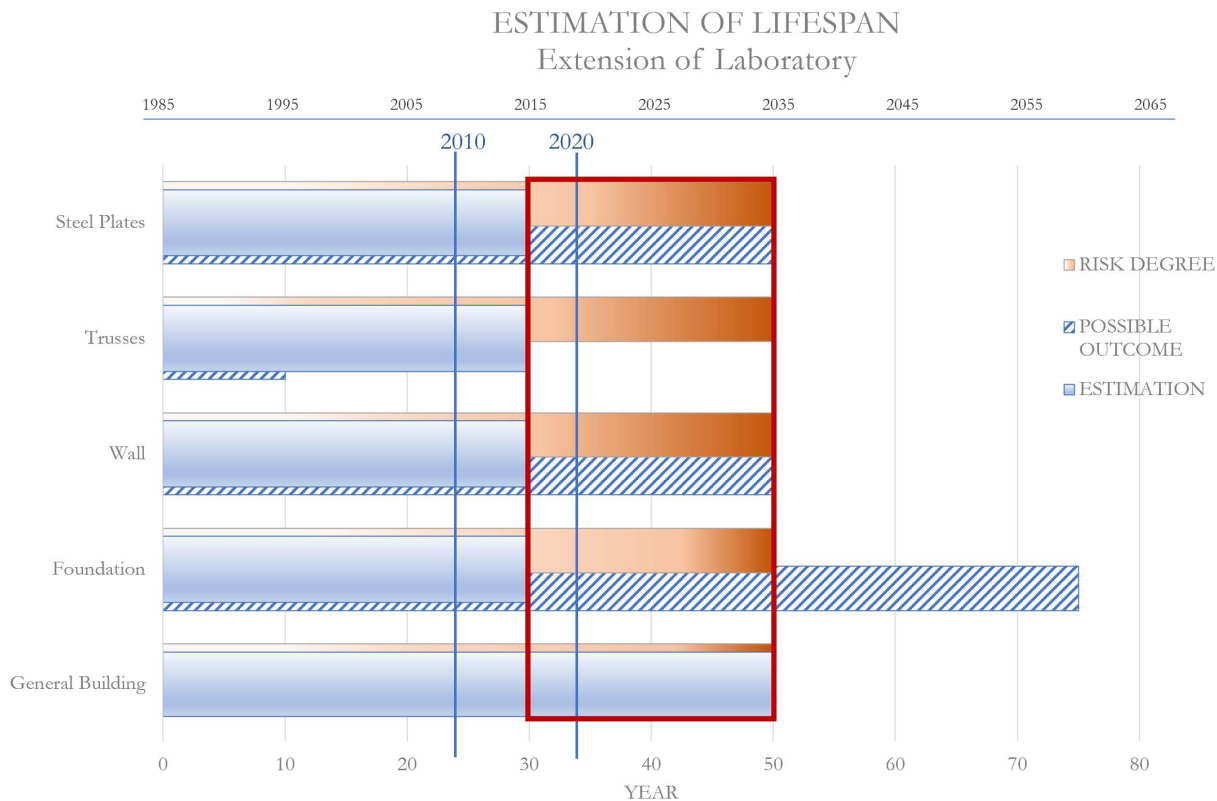
Figure 5.2. Estimation of lifespan for the extension of laboratory showing risk degree.

As illustrated in Figure 5.2 the likelihood of the roof being intact decreases over time. The box shows the time span where risk of urgent maintenance is considered high. General life length for all construction parts are arbitrarily assumed to be 30 years without maintenance (Dias, 2003). The year of construction is also an assumption which makes the condition of different construction parts uncertain. Some parts, for instance the trusses, can have shorter lifespan due to variations of weather conditions as shown in Figure 5.2 by the hatched boxes. Furthermore, the joint connecting the extension with the main building indicates that extension might have been built later on (Chapter 3.2.4). This is another factor of uncertainty. Thus, the year of estimated maintenance is fluctuating with an unknown range. Considering all mentioned factors of uncertainty, we believed that any damage on the roof in the near future, would be a likely outcome. Additionally, consequences of any leakage of rainwater due to flaws are expected to cause severe damage on new components and equipment. The likelihood of the event to occur and the degree of damage are both considered high risk factors. Thus, keeping the existing roof would rely on external resources in order to fix any urgent future maintenance. This makes *risk degree of quality* a constraining factor since it is likely to cause future dependency.

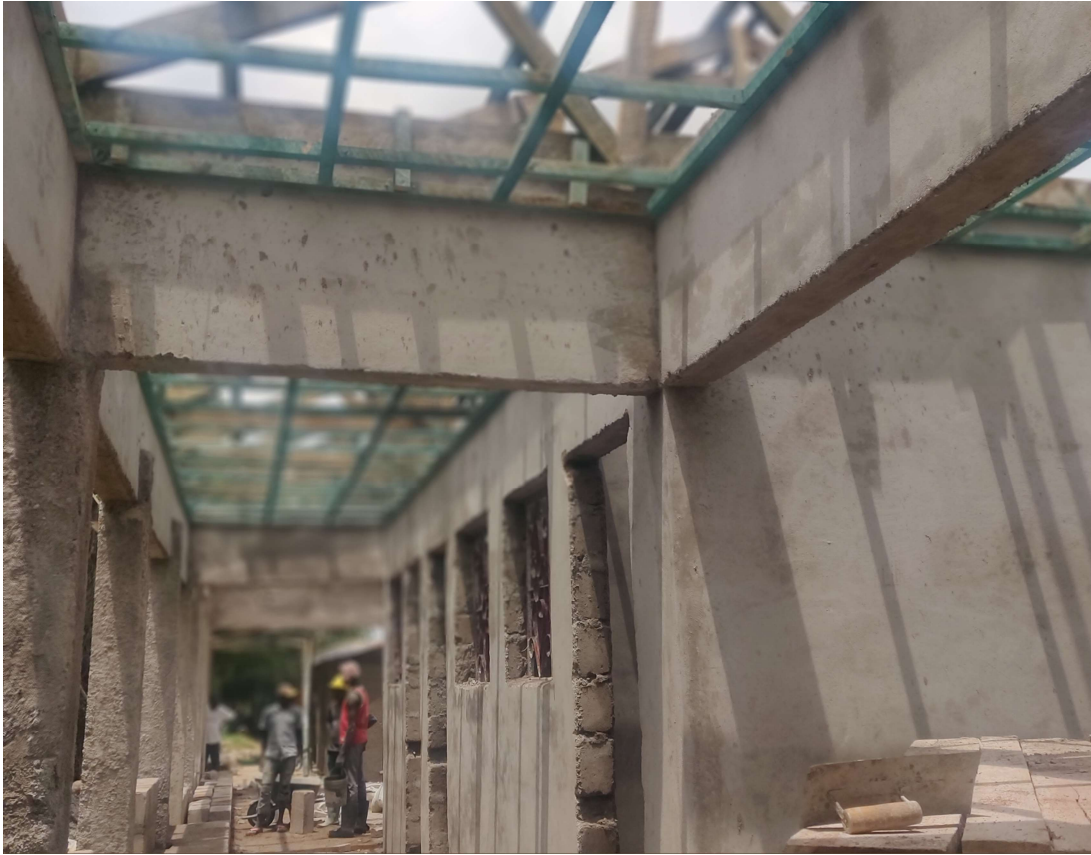
Figure 5.3. The implementation phase of the new RCH.

The construction of the new RCH can be seen in Figure 5.3. We will present some examples of how issues have been dealt with, by addressing project management challenges for the RCH. We will partly address constraining factors which are mentioned in chapter 5.2.2. These will be described as numbers within parentheses. Previous chapter principally addressed measures that could be done during *planning phase* (Timeline is visualized in Figure 3.2). Following analysis will present examples on measures that were done during *implementation phase*. This, in order to analyse the circumstances how quality and maintenance has been balanced to strive for project success.

As for the new RCH, the communication between us and the contractor was difficult due to the language barrier. We noticed that the casted concrete columns were not properly done due to lack of equipment. As they casted the columns, they did not vibrate the concrete which created air bubbles. Some columns showed up to 20 centimetre of reinforcement exposure. Since the roof was lightweight, the bearing function would most likely not be jeopardized. Although, it could cause the reinforcement to rust when exposed to precipitation. We sent the pictures to the EWB team for them to evaluate whether it was necessary to re do the casting of the exposed areas. They told us to ask the HMT to inform the contractor to cover exposed areas with concrete addition as soon as possible.
