## Design of Test Set-up using FEM

### Pilot Tests on Anchorage of Naturally Corroded Reinforcement

*Master of Science Thesis in the Master's Programme Structural Engineering and Building Performance Design*

Department of Civil and Environmental Engineering  
Division of Structural Engineering  
Concrete Structures  
CHALMERS UNIVERSITY OF TECHNOLOGY  
Göteborg, Sweden 2011  
Master's Thesis 2011:33

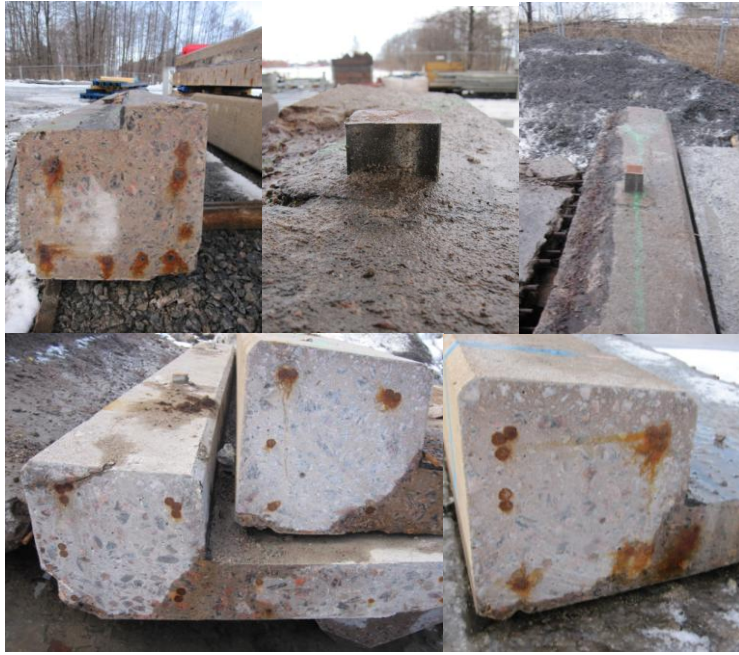
*Figure 3.6 The actual specimens from Stallbackabron.*

The longitudinal reinforcement bars, closest to the upper inclined surface of the edge beams, were more damaged than the other longitudinal bars and therefore more interesting in the investigation of bond and anchorage behaviour. The higher extent of corrosion induced damage is reasonable since the upper bars during its service life time were most exposed to de-icing salts. In the experiments, described in Chapter 5, the beams were positioned upside down so that the most corroded bars were loaded in tension. The rotation of the edge beams facilitated the loading, since the load worked on a flat surface instead of a surface with an inclination.

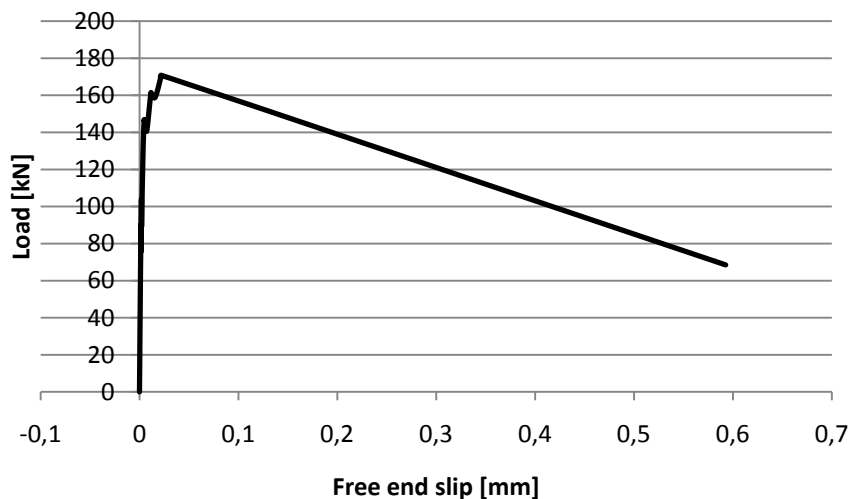
Figure 4.8 Applied load vs. free end slip.

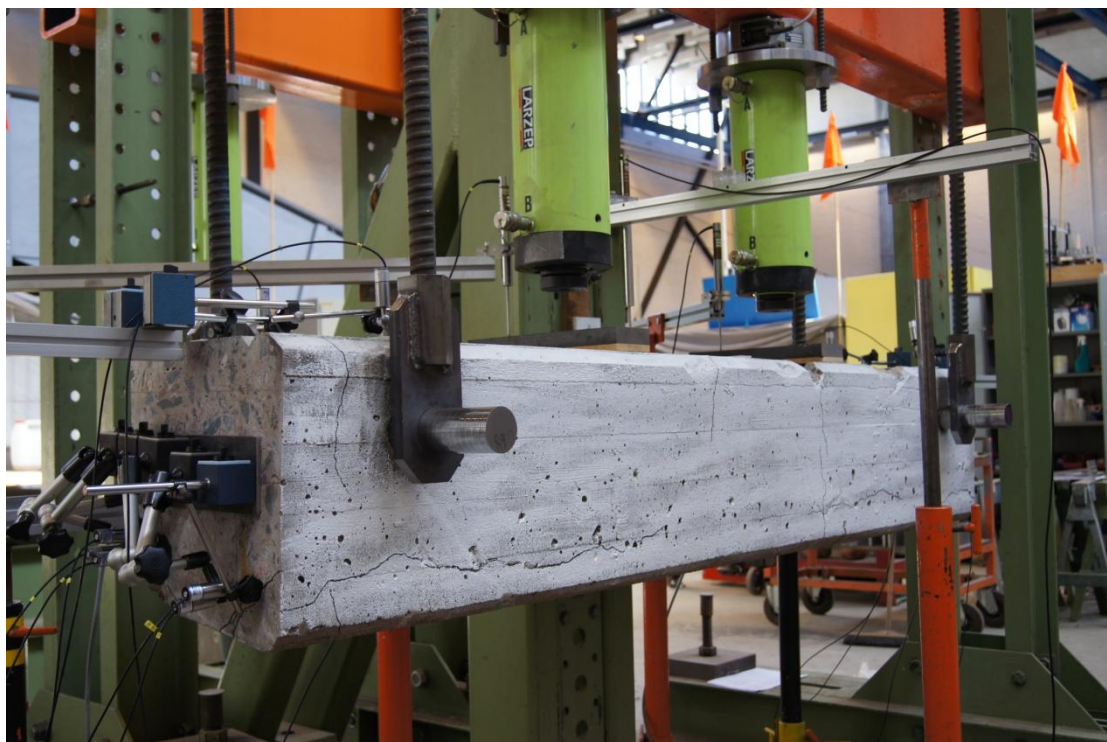
Figure 5.2 Actual test set-up.

In addition, the crack development was continuously registered and the lateral mid-span displacement was plotted against transverse mid-span displacement on a xy-recorder. Two other displacement transducers, in the sections of the suspensions and in lateral direction, were connected to volt-meters in order to indicate if the beam tended to rotate or move in a rigid body motion. From the analyses it was shown that the beam tended to move in lateral direction. For safety reasons, in case of extensive displacements, heavy supports were placed in the mid span on each side of the beam. The actual test set-up is depicted in Figure 5.2.

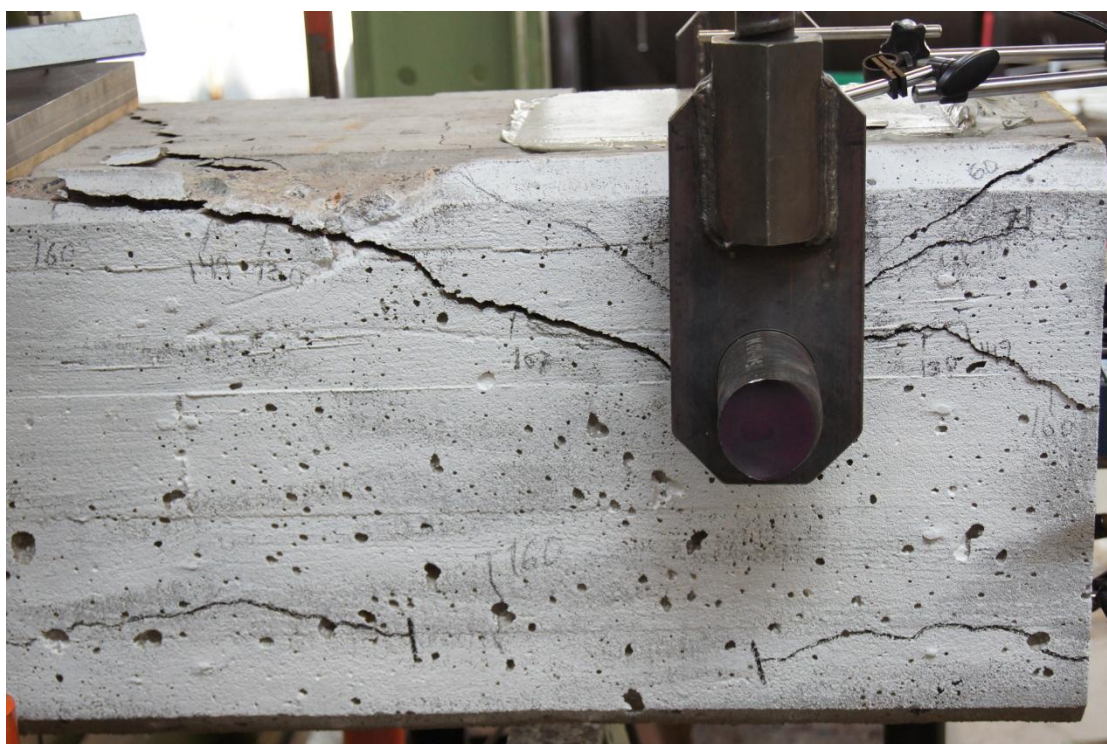
*Figure I.7. Elevation: West (front). Critical inclined shear crack.*

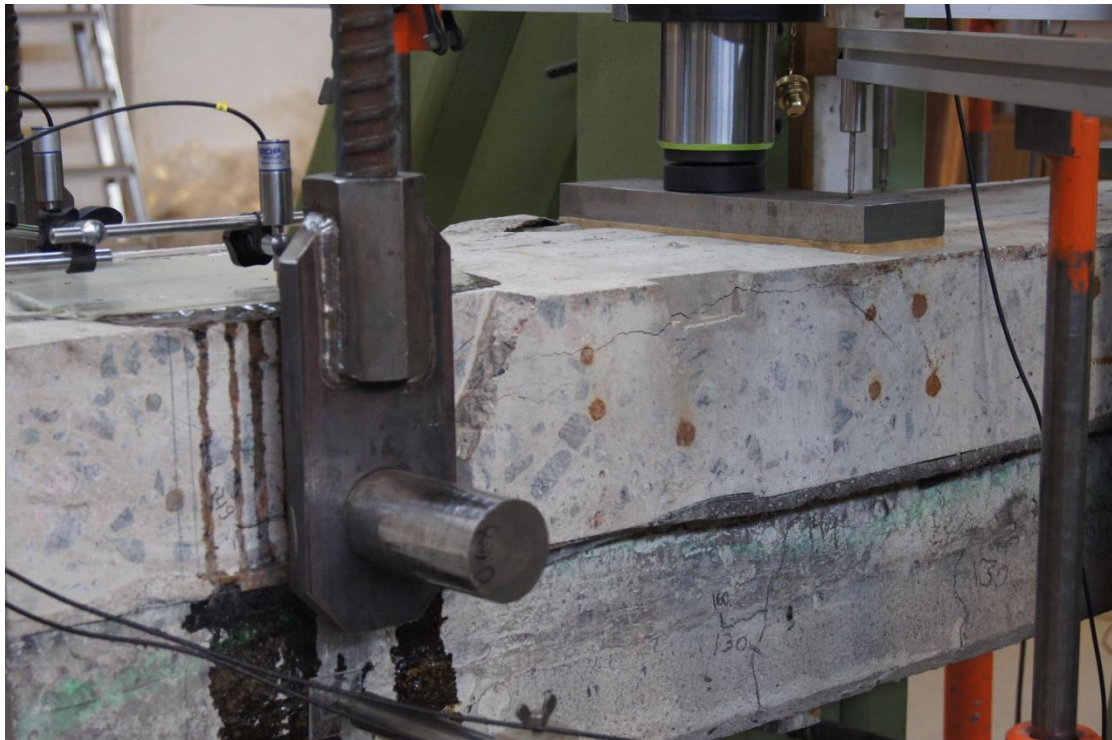
*Figure I.8. Elevation: East (back). Critical inclined shear crack.*

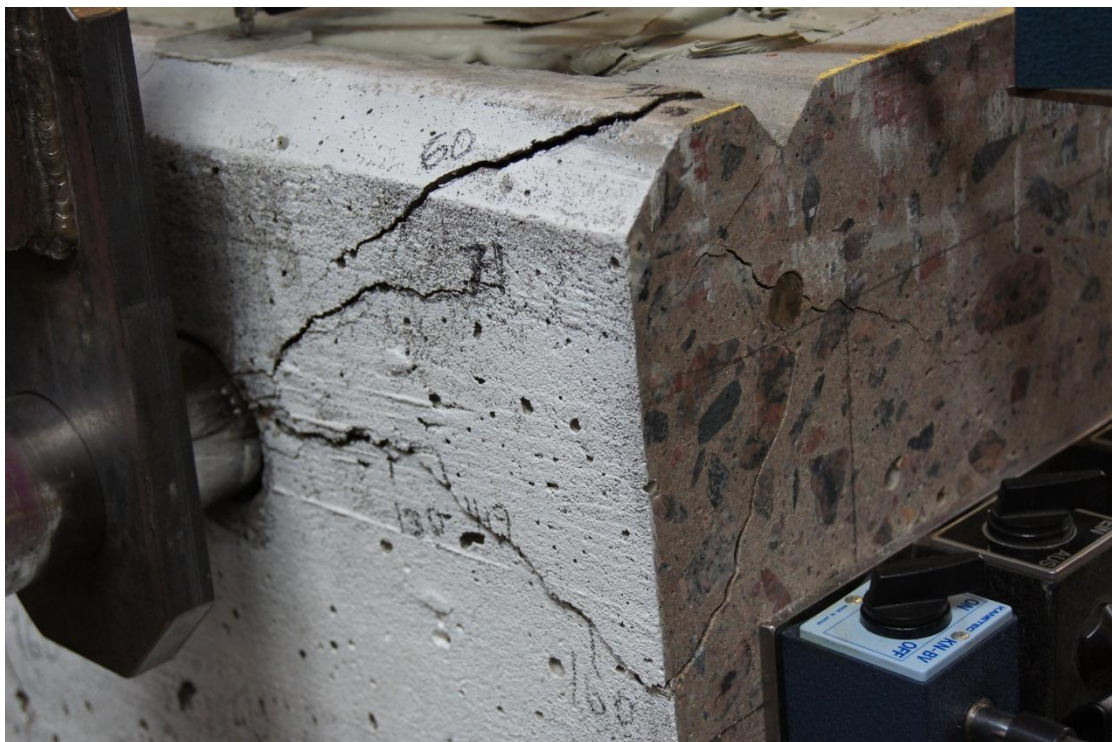
*Figure I.9. Section: South short face. Critical splitting cracks radiating out from the compressive reinforcement.*

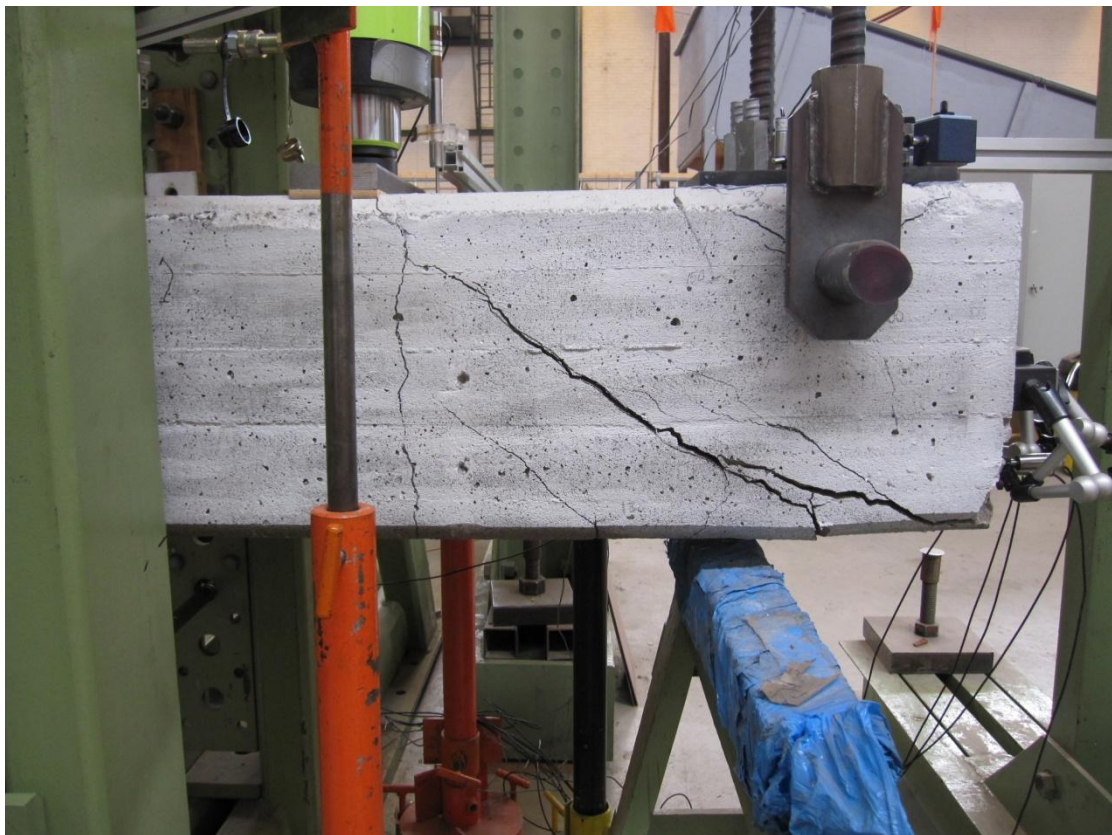
*Figure K.7. Elevation: West (front). Critical inclined shear crack.*

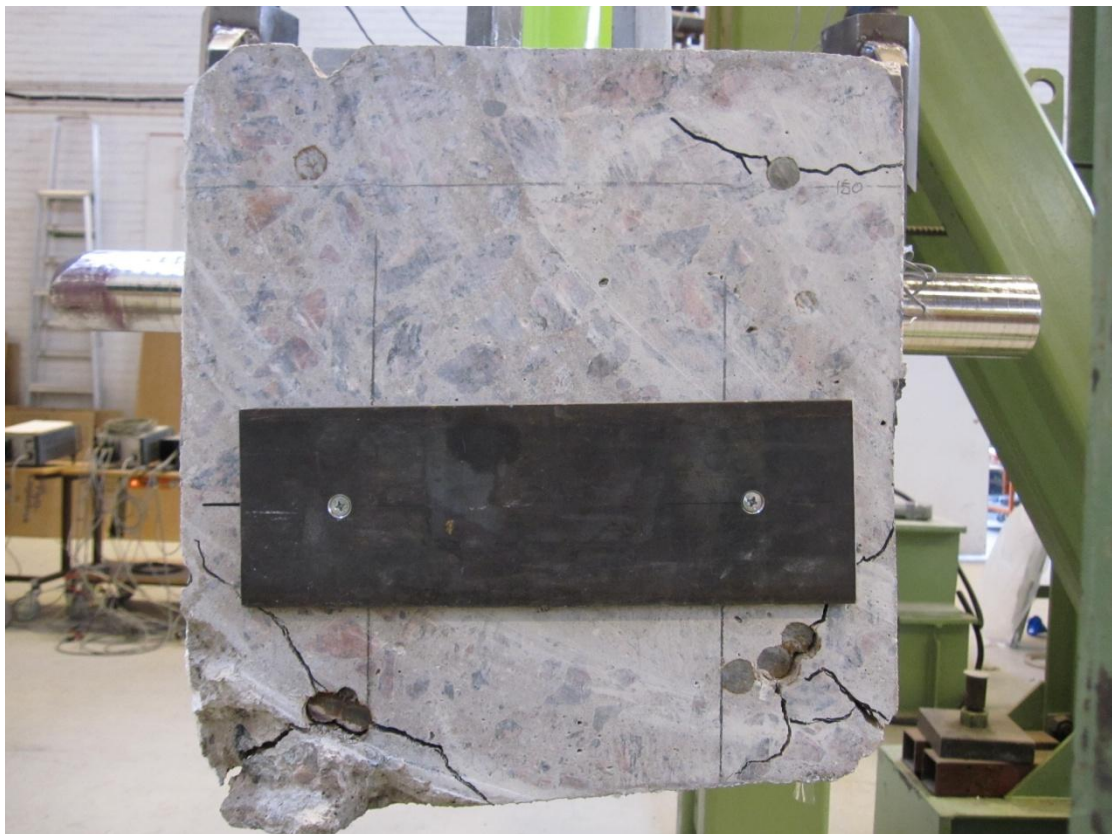
Figure K.9. Section: South short face. Critical splitting cracks.
