# **Interlocking CSEB buildings in Nepal**

## **Performance and failure behaviour investigated by masonry prism and triplet shear testing**

Master's thesis in the Master's Programme Structural Engineering and Building Technology

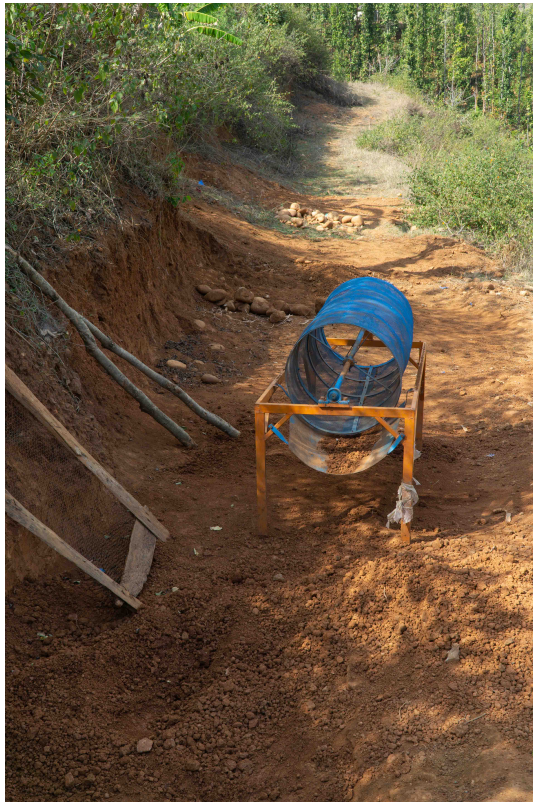
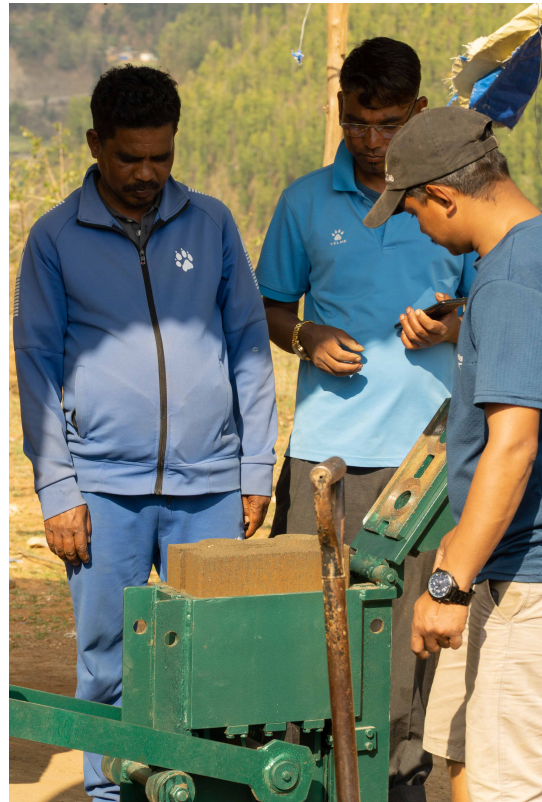
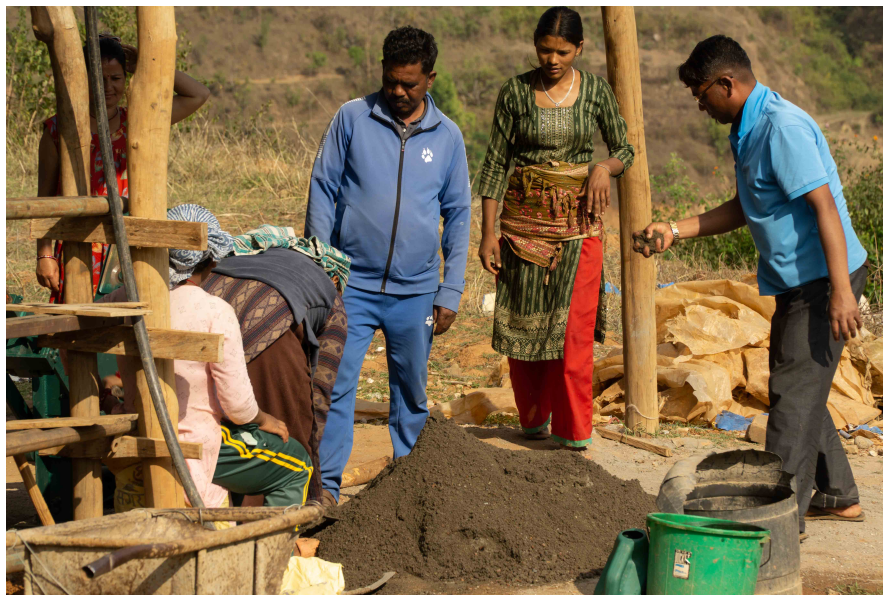
**Figure 3.2:** Overview of the block production.

Unlike conventional kiln-fired bricks, CSEBs are not subjected to high temperature firing. Instead soil, sand, cement and water are mixed and pressed to blocks before being water cured and air dried, this procedure takes around 40 days in total. Removing the need for kiln-firing lowers CO<sub>2</sub> emissions. With a single manual press approximately 400 - 500 blocks can be produced in a working day. Sourcing of soil, mixing of materials and pressing of CSEBs can be seen in Figure 3.2.

(a) Soil procurement and soil sieving machine.

(b) Block pressing machine with block being pressed.

(c) Soil, sand, cement and water mixing.

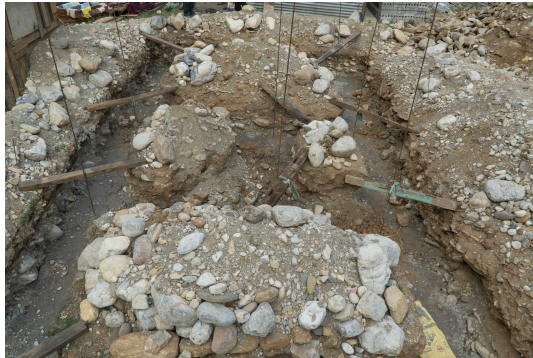
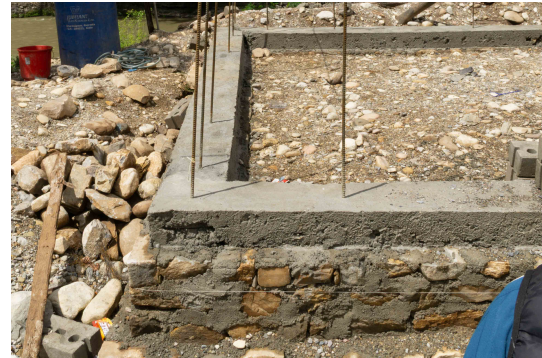
When constructing a house a foundation is first dug out before being filled with large aggregate concrete. Reinforcement is anchored in foundation and extends vertically. A reinforced concrete plinth band is cast before the interlocking CSEB is laid on top. The foundation dug out and plinth band are shown in Figure 3.3.

(a) Foundation dug out of house. Vertical rebar prepared for anchoring.

(b) Foundation and plinth band cast with vertical rebar sticking up.

**Figure 3.3:** Foundation preparation and casting of plinth band with vertical rebar.

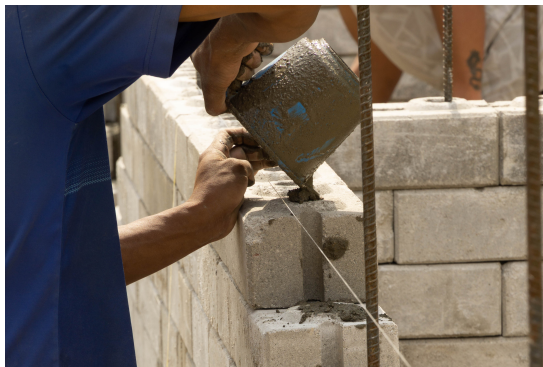
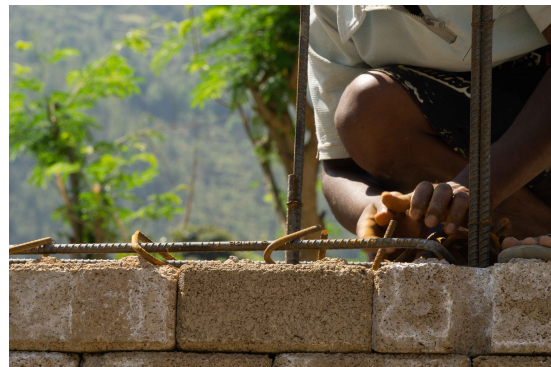
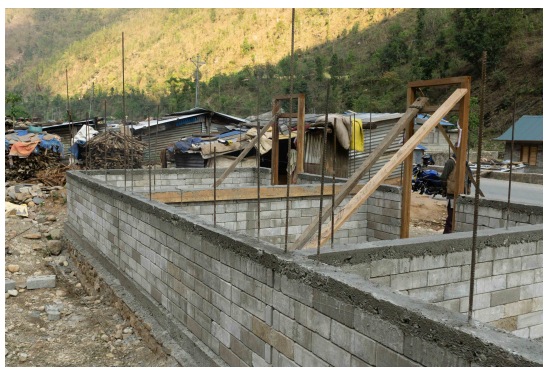
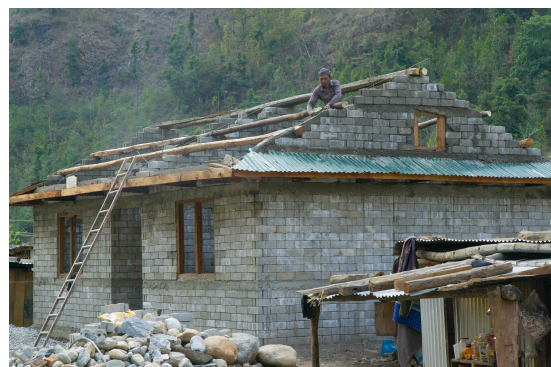
(a) Grout pouring in CSEB voids.

(b) Rebar preparation for lintel band.

(c) Casting of sill band.

(d) Laying of roof beams on gable wall.

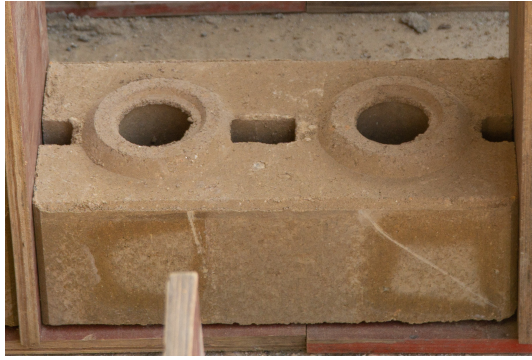
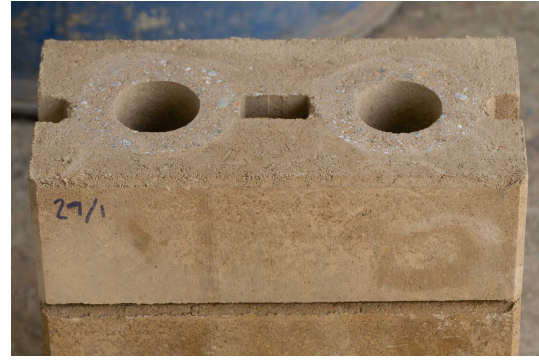
Three units were tested in their standard (non-ground) state, and three units had their keys removed via grinding. Grinding was performed using a machine powered hand tool. All units were tested using a plate with holes to account for grout voids, resulting in a net compression area of 25 510 mm<sup>2</sup>. The results of the ultimate compression tests are summarised in Table 5.3.

(a) CSEB with keys left intact.

(b) CSEB with keys ground off.

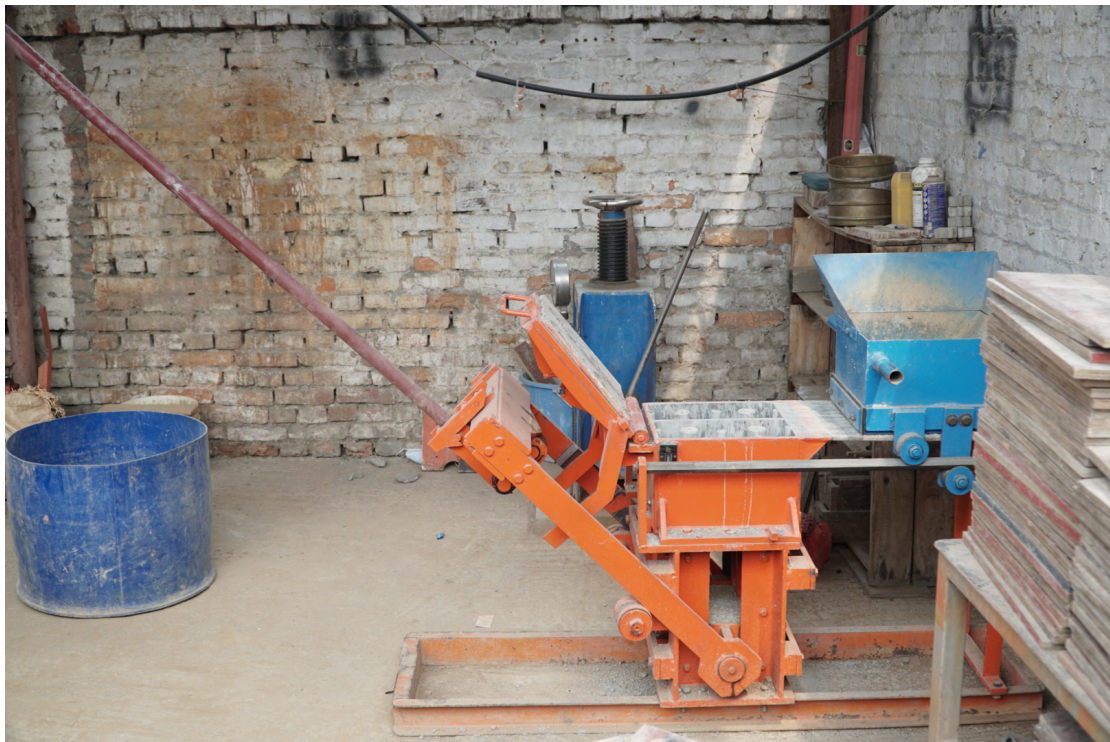
Prior to the block production, the soil was sieved to retain particles within a certain size range. Additional sand was added with a ratio of 1.2 kg sand per 1 kg soil in order to achieve the recommended particle grading. The mix proportion between the soil-sand mix and cement was 1:8 by dry weight. The required quantities of each material were determined based on dry mass using a scale with an accuracy of  $\pm 5$  g. The soil and cement were dry mixed in a pan mixer until a homogeneous mixture was obtained. Water was then gradually added while mixing to ensure uniform distribution throughout the mixture. The final water to cement ratio was 0.29. An interlocking compressed earth block machine, provided by BUN, was used to produce the blocks, as shown in Figure 6.3.

**Figure 6.3:** Interlocking Compressed Stabilised Earth Block machine built and produced by BUN.

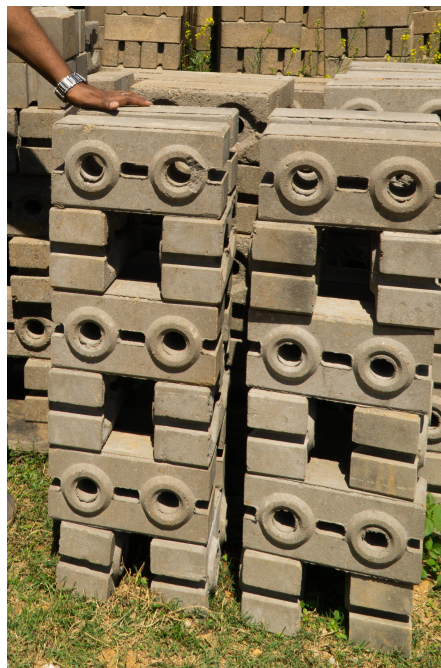
After the initial drying period, the blocks were stacked according to the pattern shown in Figure 6.4, and the curing process was initiated. During the curing, the blocks were watered three times per day to maintain adequate moisture content. The curing conditions varied throughout the curing period, with ambient temperatures ranging approximately between +10 °C and +25 °C and exposure to both sunny and cloudy weather. In cases where rainfall was expected, the specimens were covered with plastic sheeting to prevent uncontrolled wetting. After 22 days, the curing period was completed, and the specimens were allowed to dry under ambient conditions.

**Figure 6.4:** Stack of CSEB units curing/drying in field in Jajarkot.

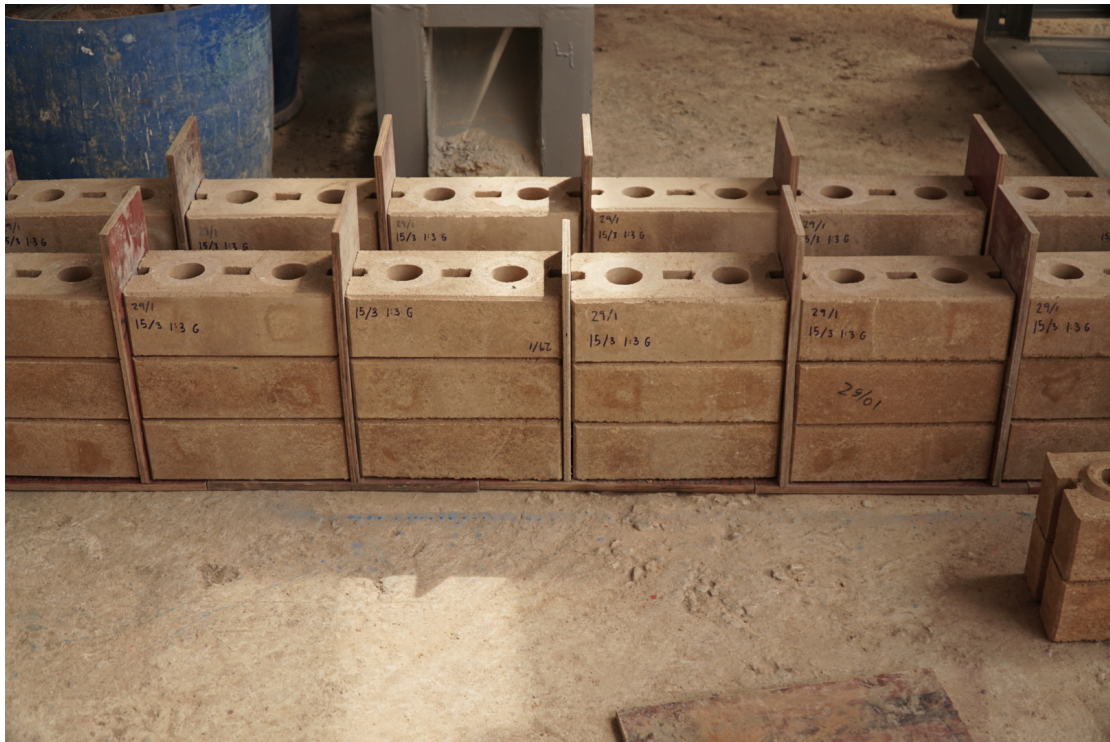
**Figure 6.5:** Triplet specimen production with phenolic coated plywood between triplets.

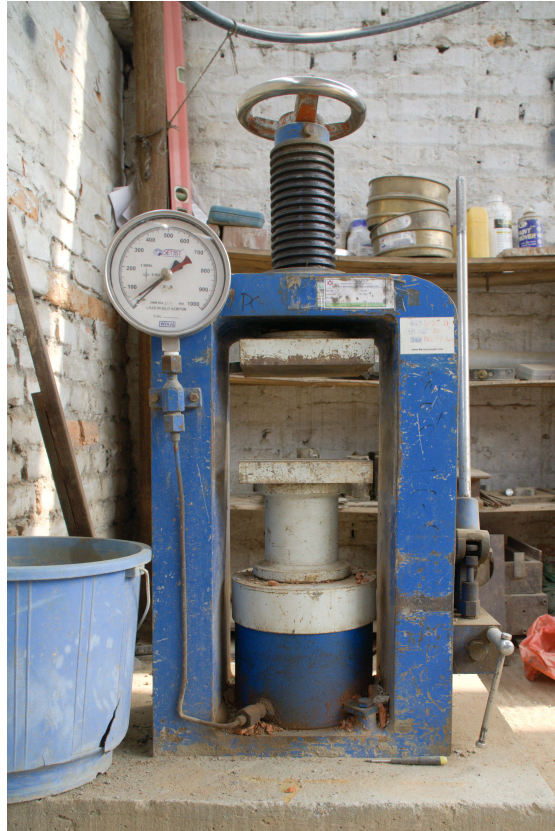
**Figure 6.7:** Hydraulic Compression Testing Machine (CTM) located at the workshop.

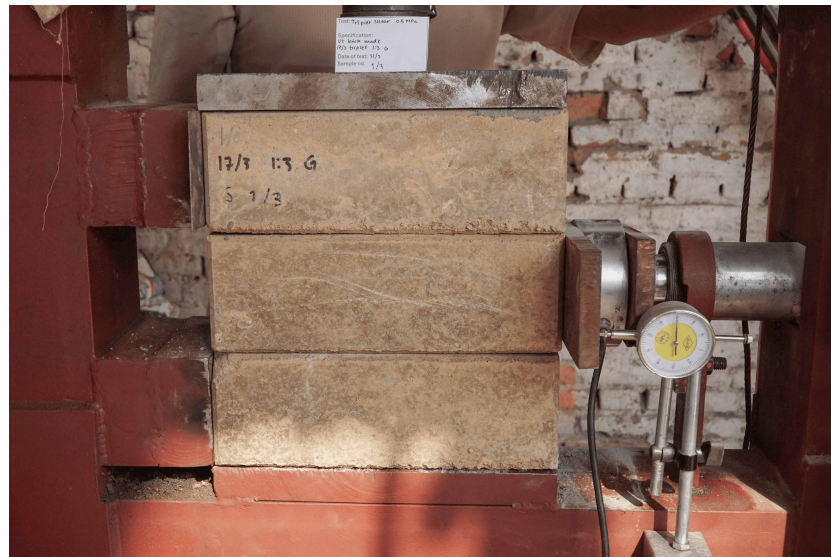
Calibration by an external expert was performed, adjusting the pressure dial. The calibration was deemed accurate for pressure levels of  $400 \text{ kg/cm}^2$  resulting in about 77 kN. This was sufficient for an initial set of the tests but showed to be insufficient during the testing phase. The solution was to use a load cell (with a capacity of 15 tonnes) in series with the piston. This showed to give accurate results correlating well with the pressure dial, when this correlation was established the tests were altered to to use the load cell as load indicator and the horizontal piston was used up to load levels of 14 500 kg (142 kN). The final test set up is shown in Figure 6.10.

**Figure 6.10:** Final test setup for triplet shear. Load cell and dial gauge to the right in series with hydraulic piston.

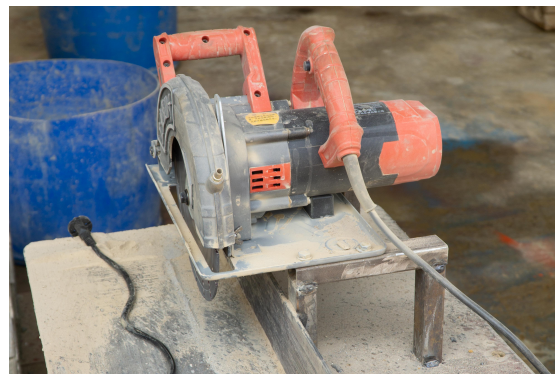
As part of the additional testing, the internal structure of the blocks was examined to evaluate the compaction and dispersion of the grout within the channels. To achieve this, the specimens were marked along the perimeter of the grout channel and sectioned using a stone cutter, thereby exposing the internal core of the grouted sections for visual inspection. See Figure 6.13 for the setup of block sectioning.

**Figure 6.13:** Stone cutter and setup used for block sectioning.

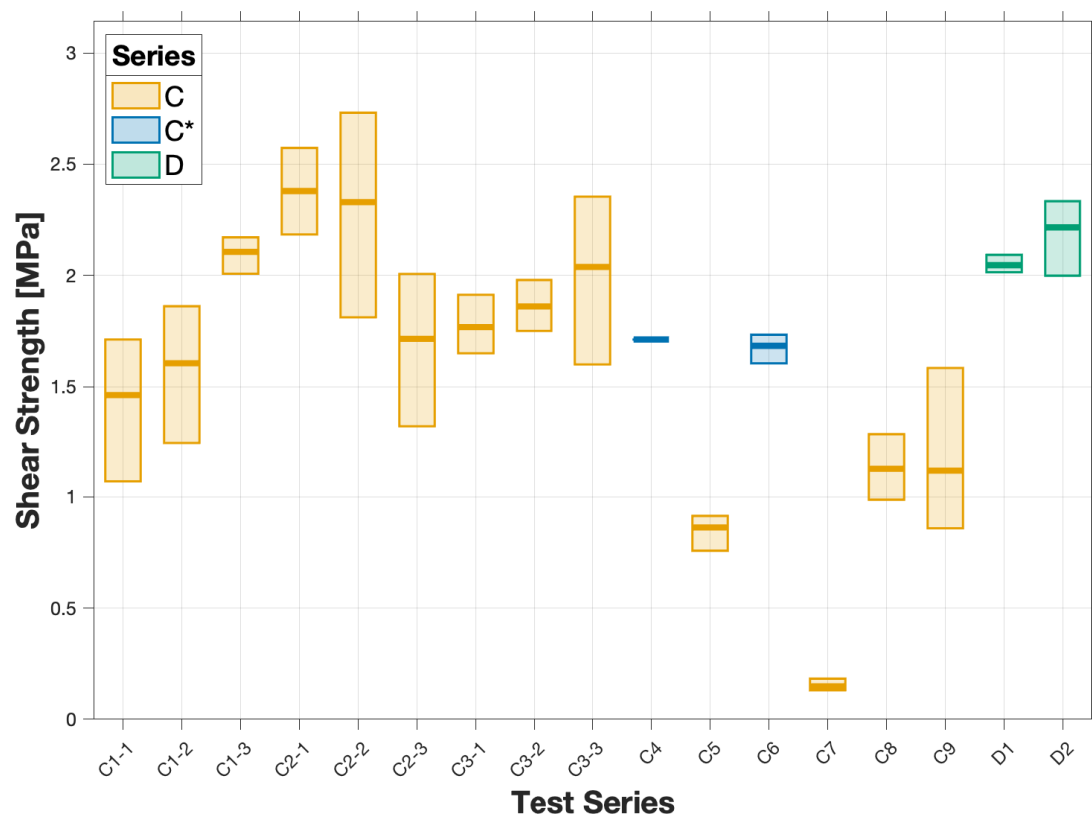
A general summary of the peak horizontal loads of the triplet shear tests, corresponding shear strengths, and data variance is presented in Table 7.2. As visually indicated by the data spread in Figure 7.2, the shear response varied significantly depending on the specific joint composition and applied pre-compression. A detailed comparative analysis of a selection these specific parameters and their corresponding failure mechanisms is provided in the following section. For each test series a figure describing the relevant test data is presented, for a reference on how the figures are to be read see Figure 6.14. The typical behaviour of progressively increasing pre-compression load can be read from the presented figures of each test.

**Figure 7.2:** Comparison of shear strengths across all test series showing mean values and spread of each series. **\*Note:** For series marked with C\*, the maximum capacity of the calibration equipment was reached, and the test was terminated prior to ultimate failure.

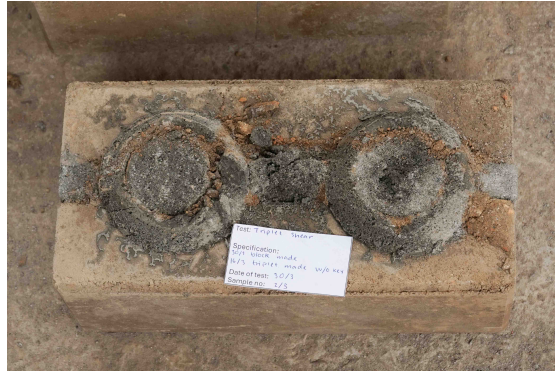
**Figure 7.10:** View of the grout key formed within the interlocking void post testing.

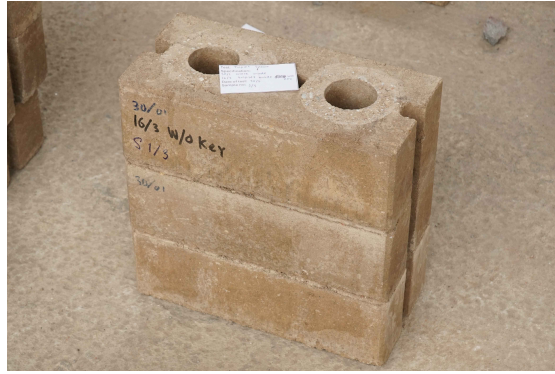
**Figure 7.13:** Series C7 - dry stacked triplet without keys showing no damage after testing.

Series C7 consists of dry stacked specimens without interlocking keys, representing a friction dominated interface response. As shown in Figure 7.12 the specimen exhibited sliding at low load levels, approximately 4.8 kN. Due to the early onset of sliding, only a limited number of stable data points were obtained within the applied loading scheme. Despite this, the scatter between individual specimens remained relatively small, and all samples initiated sliding at comparable load levels. Units showed close to no damage showing that the failure occurred only in sliding friction, see Figure 7.13.

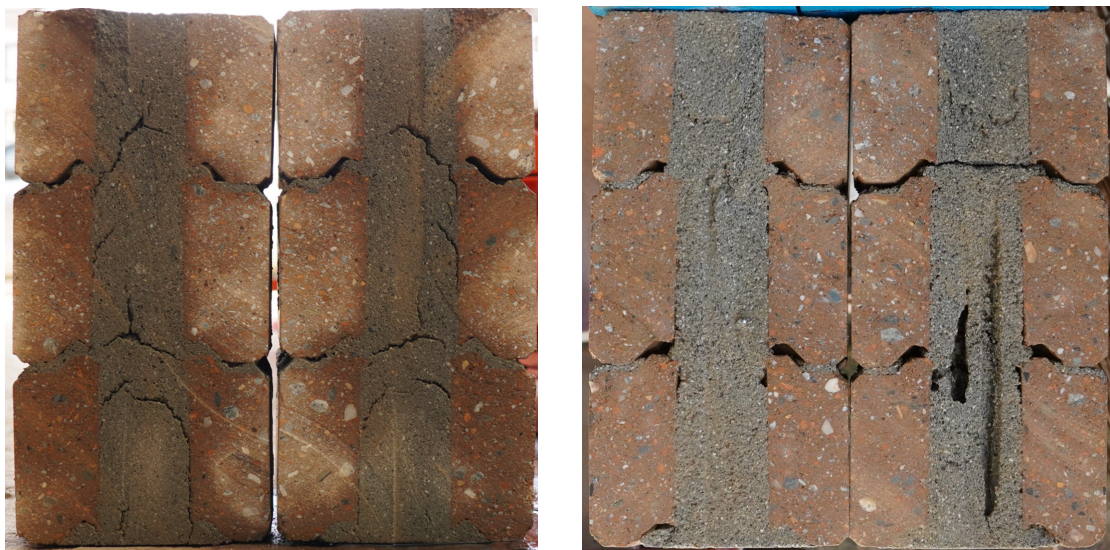
Cutting open the block revealed defects in the grout even before testing as seen in Figure 8.1. The defects are in key areas, in the interface between two blocks where shear resistance is crucial. The two different grout strengths show different defects, the 1:3 mix have partly flowed out in the key voids and subsequently developed cracks while the 1:6 has major voids from compaction rods.

**Figure 8.1:** Block cut without being tested. 1:3 grout mix left and 1:6 grout mix right.
