## **Usage of Highly Accelerated Stress Test (HAST) in Solar Module Ageing Procedures**

*Master of Science Thesis*

**TOMAS HULKOFF**

Department of Electrical Engineering  
*Division of Energy and Environment*  
CHALMERS UNIVERSITY OF TECHNOLOGY  
Göteborg, Sweden, 2009

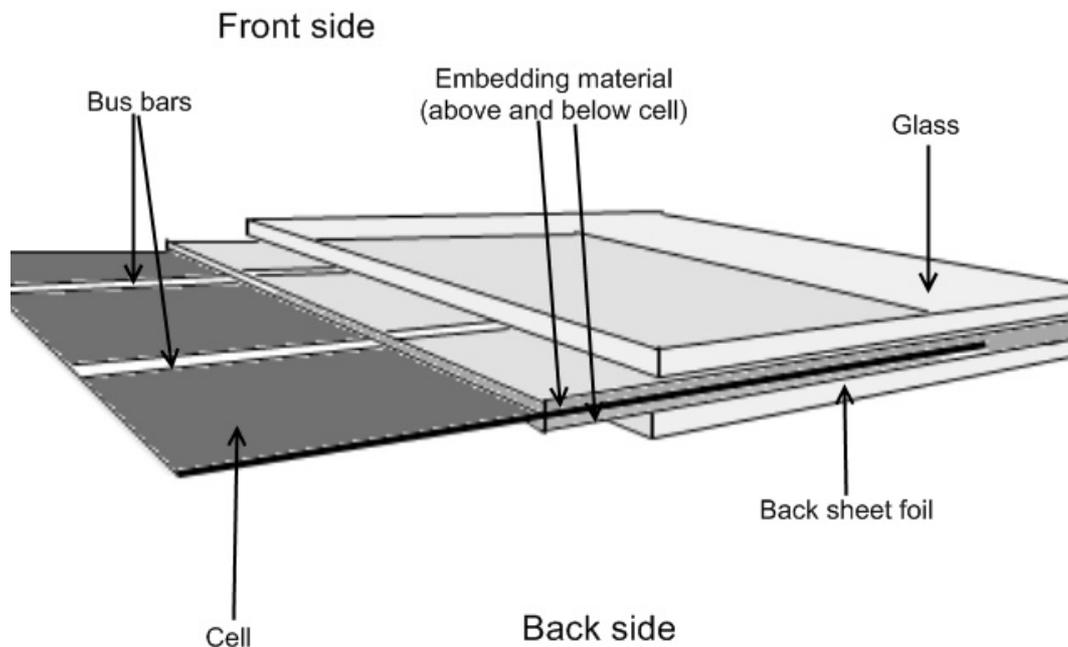
Figure 1. A standard module composition

Absorption of moisture is to be expected since the embedding materials are sensitive to water. Even though the construction with glass and back sheet foil, Figure 1, have been developed to withstand the water penetration, the aging of the protective materials are supposed to cause a loss of their good features and let more and more damp through. Glass is considered to be a stable material thus the degradation times are very long, it is not expected to see the transparency decrease within the glass. However the glass might dim, especially in the contact area to the embedding materials, thus causing a lower transmittance.

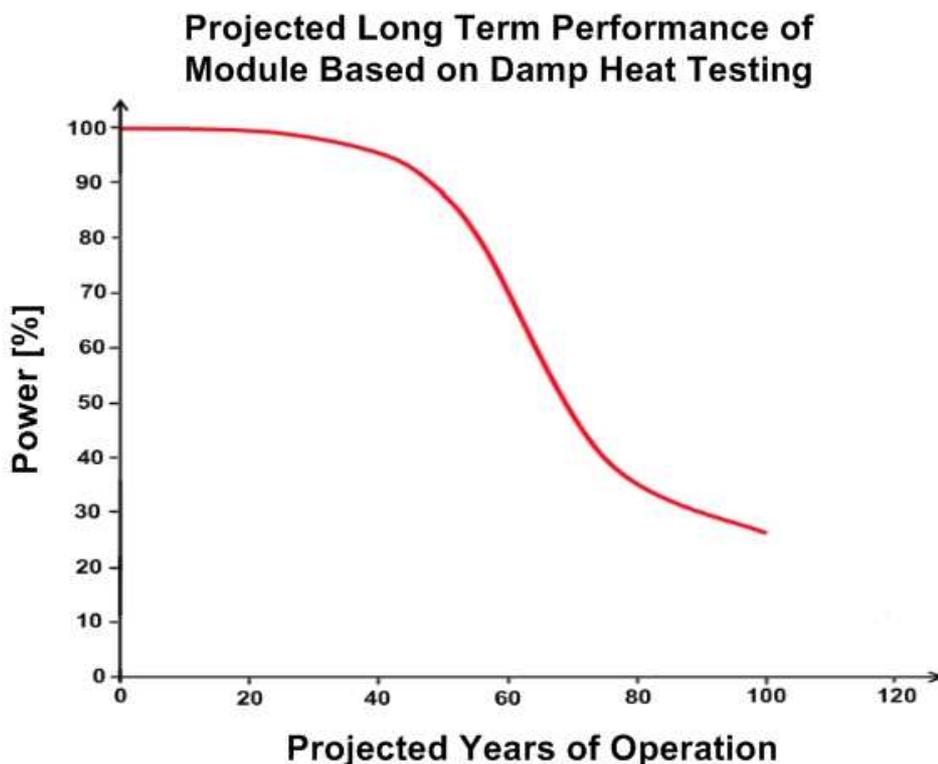
Figure 2. Projected Long Term Performance of Module Based on Damp Heat Testing

The DH is the part of the IEC 61215 [6] test that takes the longest time and there can be a lot of savings in the test phase with shortening this step. However 1000 hours of DH does not make a large difference regarding power loss in normal modules today. Therefore much longer testing times are needed in order to establish when the module would fall out of warranty. As most modules need at least 2000 hours to fall under the failure criteria of 5% power loss it would respond to 40 years exposure of Miami's climate, Figure 2.

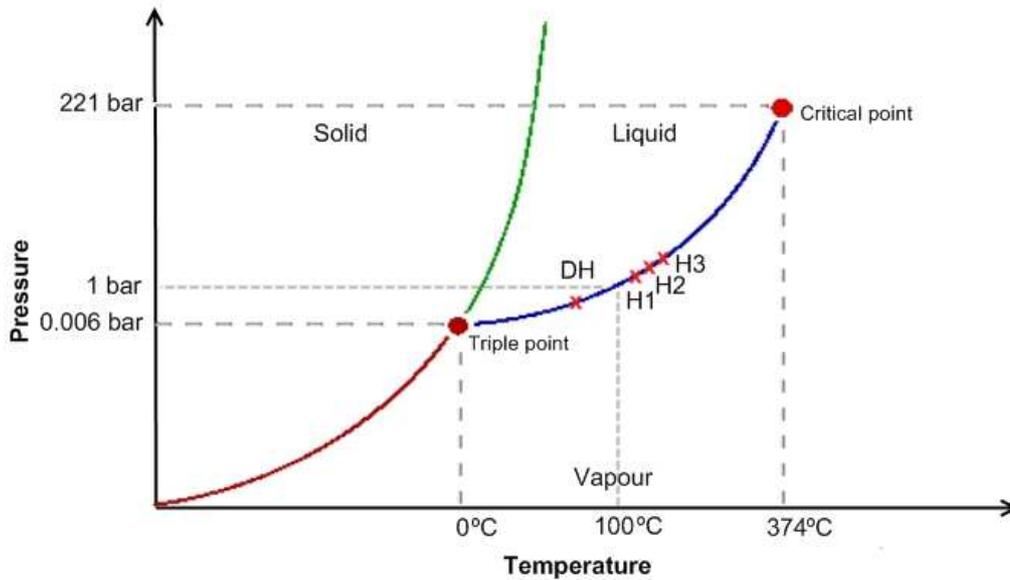
Figure 3. Phase diagram over water states according to pressure and temperature.

The water absorption in the HAST is much higher than in the DH, this is due to the higher pressure in order to make it possible to work with temperatures over the boiling point. In Figure 3 the relation between temperature and pressure is showed. The three HAST tests, at 110°C, 120°C and 130°C, are needed to work over the water boiling point and therefore a higher pressure is needed to keep the same vaporization level, 85 % RH, as in the DH at 85°C

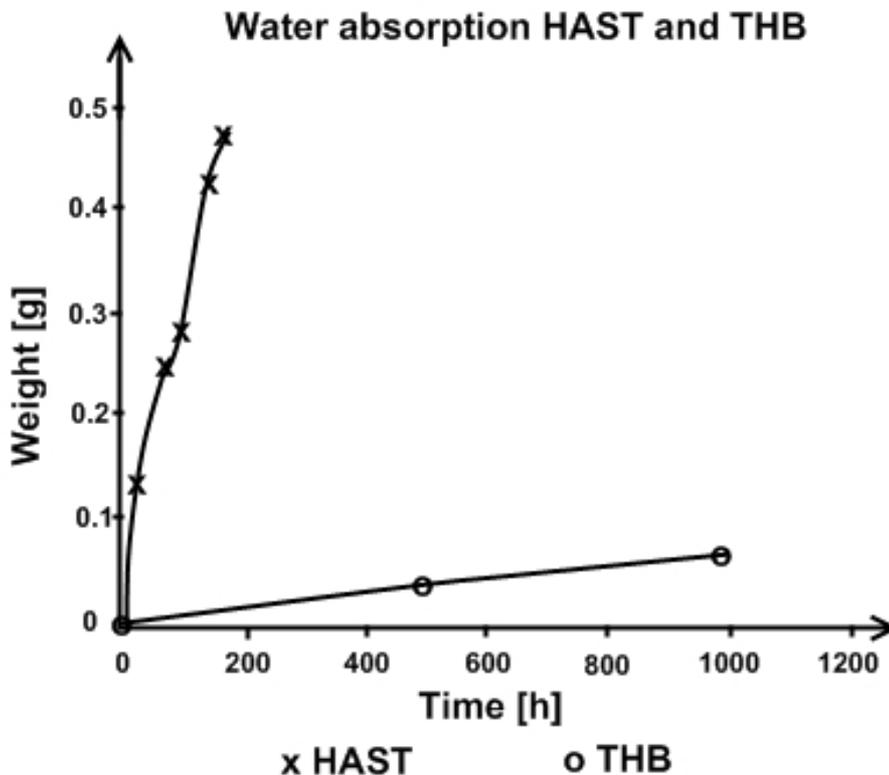
Figure 4. The HAST relative THB water absorption over time.

The HAST test is known to have a higher rate of moisture absorption compared to Temperature Humidity Bias (THB) test, basically the DH with an added bias, the relationship between THB and HAST is seen in Figure 4 [10]. Corrosion, bubbles, degradation of embedding materials and cracks can increase the amount of water absorption. However, this was outside the focus of this work..

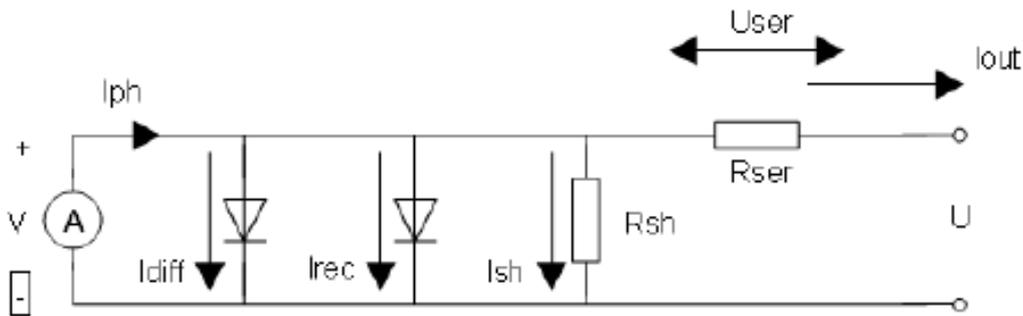
Figure 5. The 2-diode model describes the inner characteristics of a solar cell.

Changes in the relationship between produced current and voltage of the cell (I-V characteristics) are shown as performance losses when the cell is being flashed. In order to estimate the aging, the power changes are decisive. The major part of the power losses can be derived to optical degradation of the glass, degradation of cells and/or embedding materials. They occur in combination with each other and it can be difficult to estimate exactly which loss is caused by what degradation process.

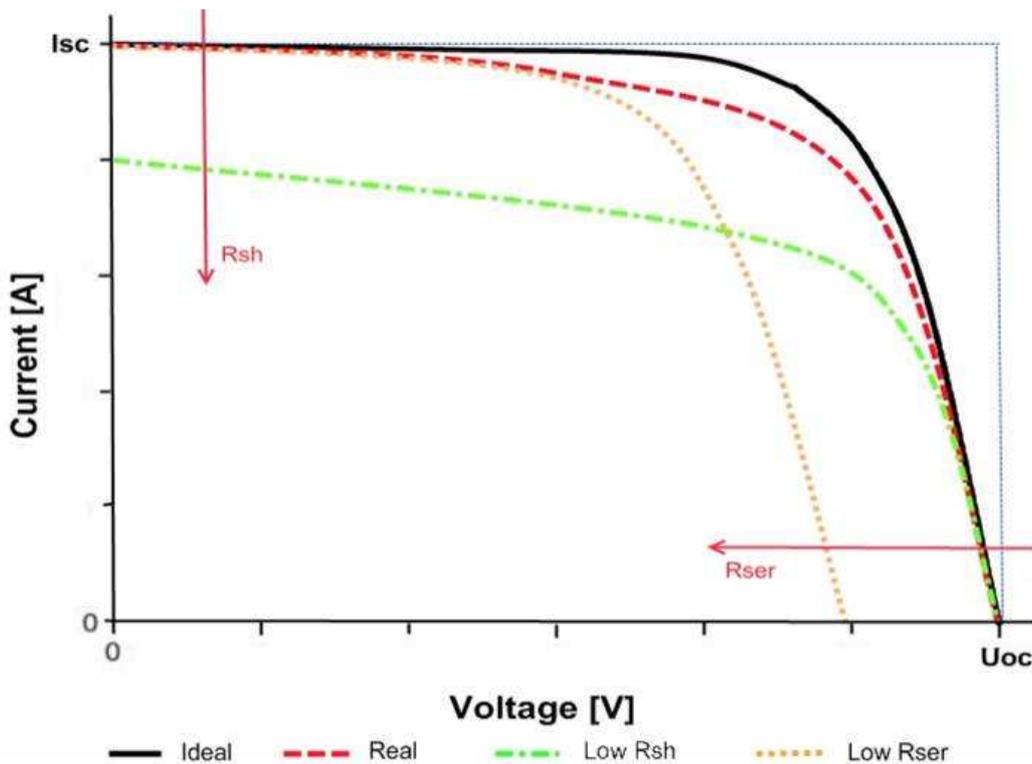
Figure 7. An exaggerated relation between the FF,  $R_{sh}$  and  $R_{ser}$  to  $I_{sc}$  and  $U_{oc}$ .

In Figure 7 the red/dotted curve is an example of what happens when  $R_{ser}$  and  $R_{sh}$  are altered. The resistances deform the FF resulting in a lower  $P_{mpp}$ . A decreased shunt resistance lowers the  $I_{sc}$  and an increased series resistance lower the  $U_{oc}$ . The arrows showing the  $R_{ser}$  and  $R_{sh}$  decrease are exaggerated examples just to show the principals. The current  $I$  and voltage  $U$  are affected and not the  $I_{sc}$  and  $U_{oc}$ .

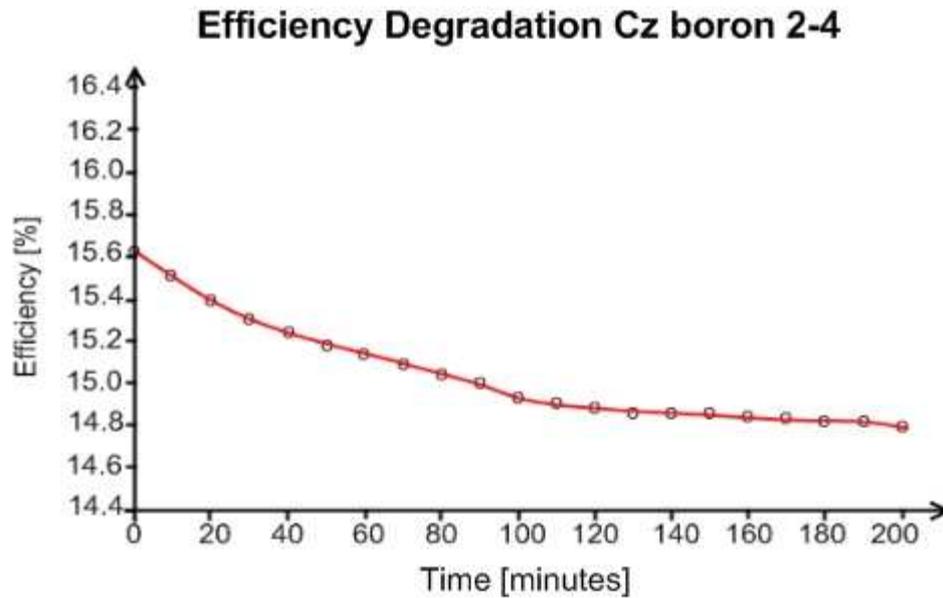
**Figure 8. Efficiency degradation of Cz boron cells.**

In this work the LID and regeneration is not considered giving a major influence over the results which are searched. The description is however needed in order to explain the initial increase in power during the first test rounds. The LID follows from the physical properties of the silicon. When a silicon cell becomes illuminated with long wavelength light, the response of the cell decreases and gives lower open circuit voltage ( $U_{oc}$ ) and short circuit current ( $I_{sc}$ ), see Section 2.2.1, together with lower cell efficiency. Therefore the effect of the cell decreases, the percentage depends on the content of boron and oxygen within the silicon, and this is related to the manufacturing methods and environments. With a temperature treatment of the cell at approximately 175°C, the LID process is reversible; the cell is regenerated.

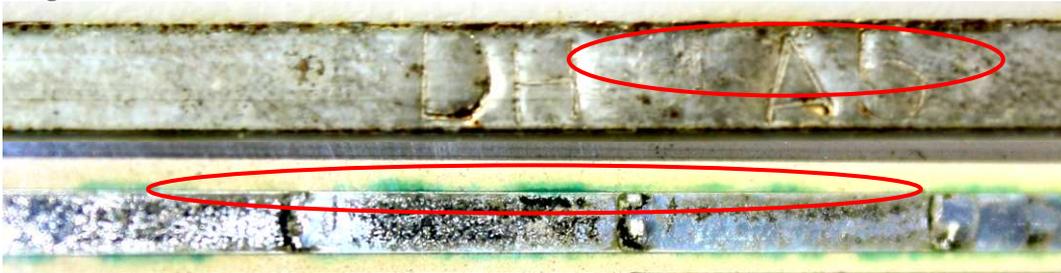
**Figure 16. DH-A5 at 2000h front side corrosion and at the back side bus bar also green copper corrosion is to be seen.**

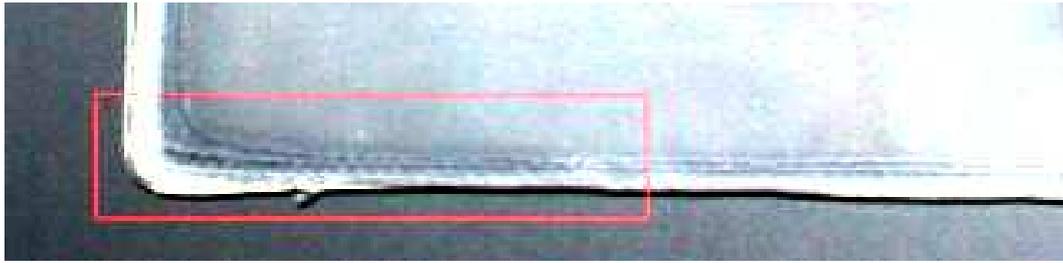
**Figure 17.** The sample A show a proceeding de-lamination at the corners at 1000h, it is seen that the back sheet foil no longer grips the glass.

There are de-lamination signs showing on the A sample in the edge region of the glass. They appear after 1000 hours of testing and look like the back sheet foil is being drawn towards the middle of the module. This leaves a strip of de-laminated back sheet foil at the corners where the embedding no longer grips to the foil. After 2000 hours it has expanded, now covering all the edges of the module with an up to 8 mm loose area, Figure 17 - Figure 19.

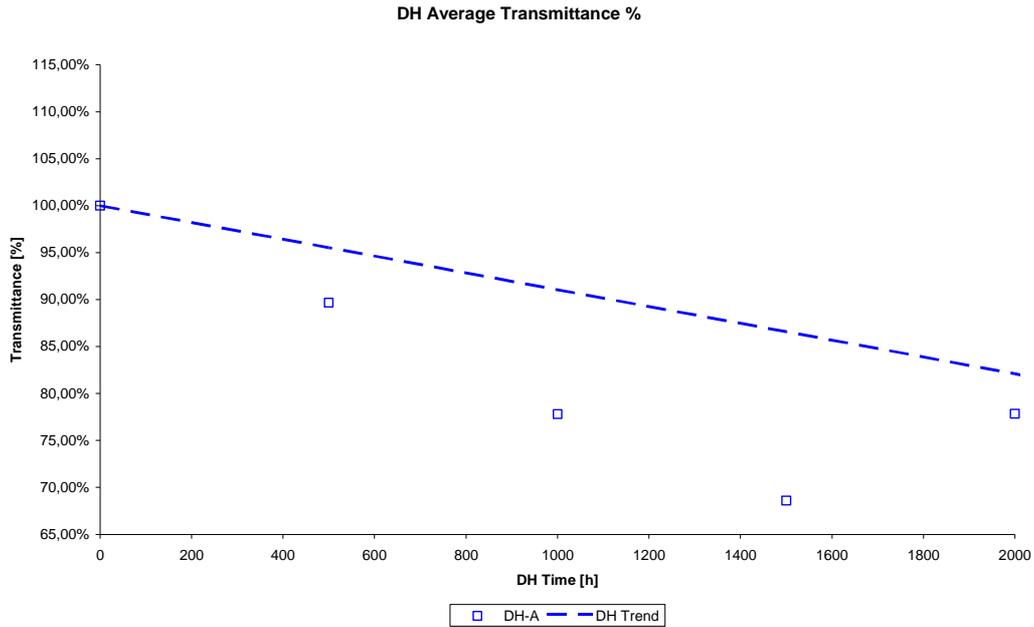
Figure 20. Transmittance average for DH over test time.

Due to the haze, the transmittance features had naturally changed. It was a clear reduction of the transmittance features of the non aged modules; Figure 20 show an integrated average of the transmittance development over the time together with a trend line. The value decreased from 0.88 at 0 hours to 0.80 at 500 hours, which is with almost 10 %. Figure 21 show the transmittance spectra at the different measurement points. The transmittance degradation continues over the test time until 2000 hours when an improvement is seen, where the transmittance suddenly increases from 0.61 to 0.69, with 13 %. From the figure a 5 % loss of transmittance appears after 500 hours, that gives a 1% loss every 100 hours. Considering the DH test time of 1000 hours to correspond to 20 years it can be interpreted as 1 % loss every 2 years or 0.5 % per year or 50 hours. A base of the degradation can therefore be set at 0.5 % per year. The average trend line is placed higher than the measurement points, this because the transmittance improves itself at 2000 hours, and the line is calculated on the average slope.

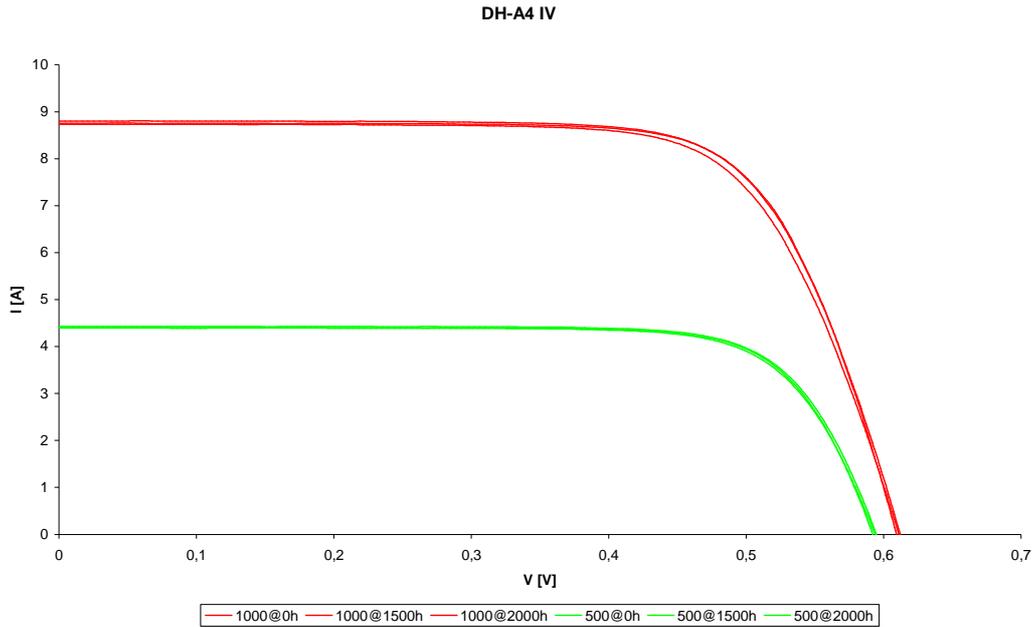
Figure 22. IV-characteristics at 0, 1500 and 2000 hours of DH for DH-A4

Since there are no large differences in the IV-curve of a typical DH-A sample seen in Figure 22, taken at the transmittance extreme values at 0, 1500 and 2000 hours. The conclusion is that the change in transmittance rather lies behind the cell in the embedding material or in the transition between embedding material and back sheet foil.

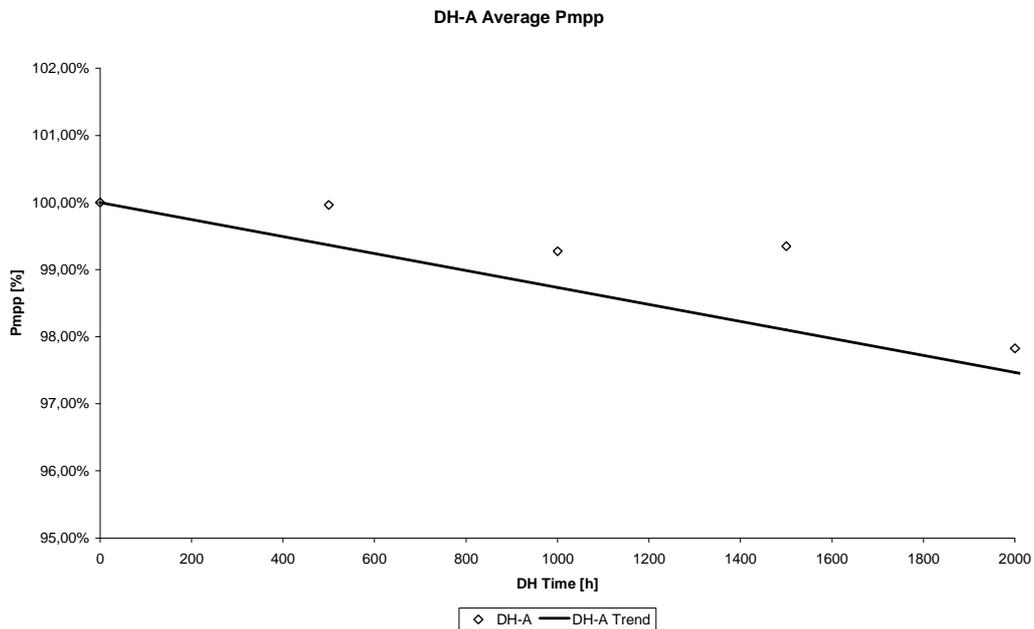
Figure 23.  $P_{mpp}$  degradation over DH test time

The power degradation of the modules are as expected relatively small as seen in Figure 23 showing the  $P_{mpp}$  development. A 1 % decreases every 800 hours leads to 400 hours of testing in order to achieve 0.5 %

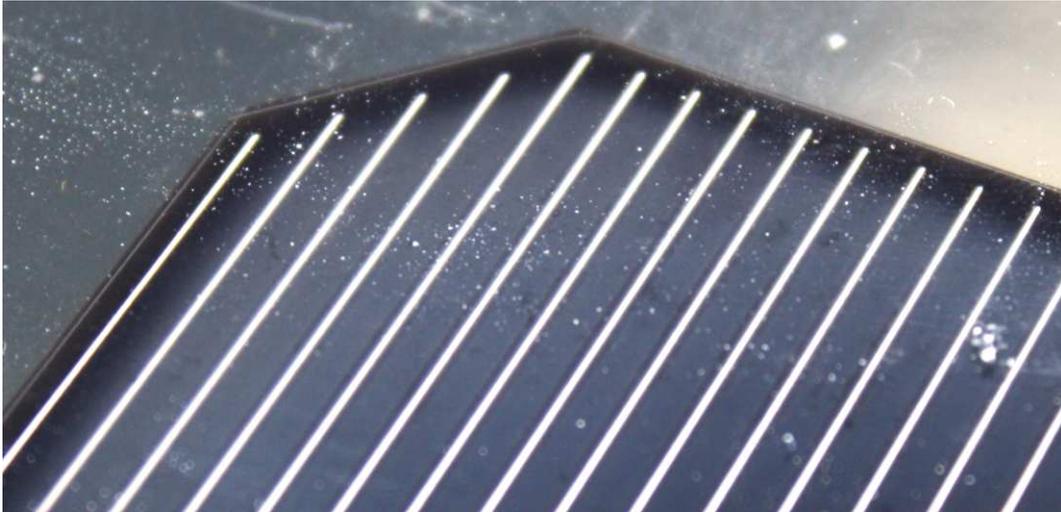
**Figure 24. Pale area on the front side of the H3-A cells at 48 hours.**

In difference to the Damp Heat the HAST does not cause a white haze in the embedding material. A reason is that the higher temperature, close to the laminating temperature about 140°C, suits the sample A materials better than the lower DH temperature. However, in the case of HAST testing, a white haze appear over the cells. At 48 hours a light browning could be seen in the transparent embedding, but not in the same extent as with the DH samples. There was no recognisable change to the bare eye over the test time.

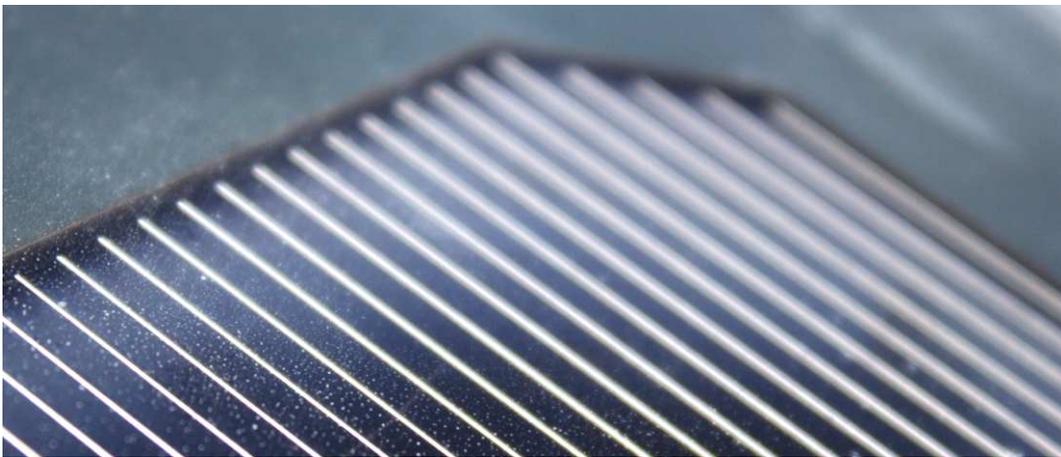
**Figure 25. The H1-A samples also show a clear discolouring above the cell after 72 hours.**

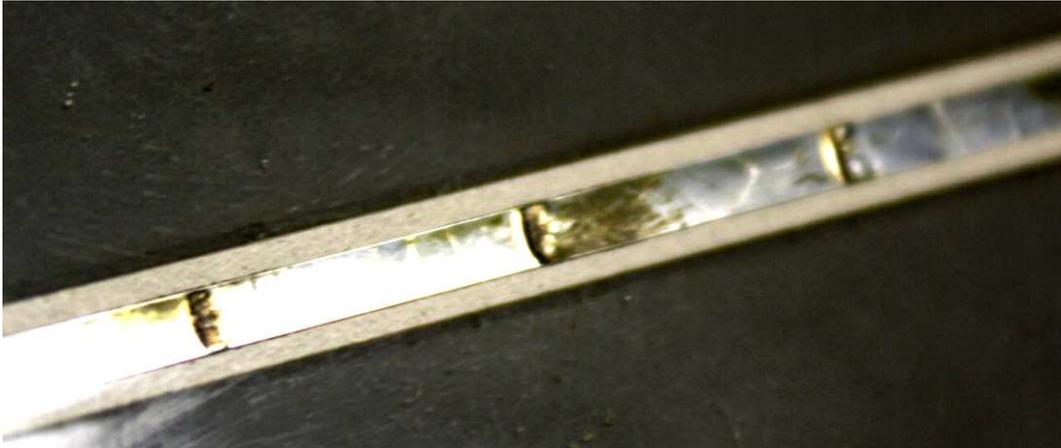
**Figure 30. Corroded back side bus bar in the H3-A samples at 72 hours, this occurred at 96 hours for the H2 samples.**

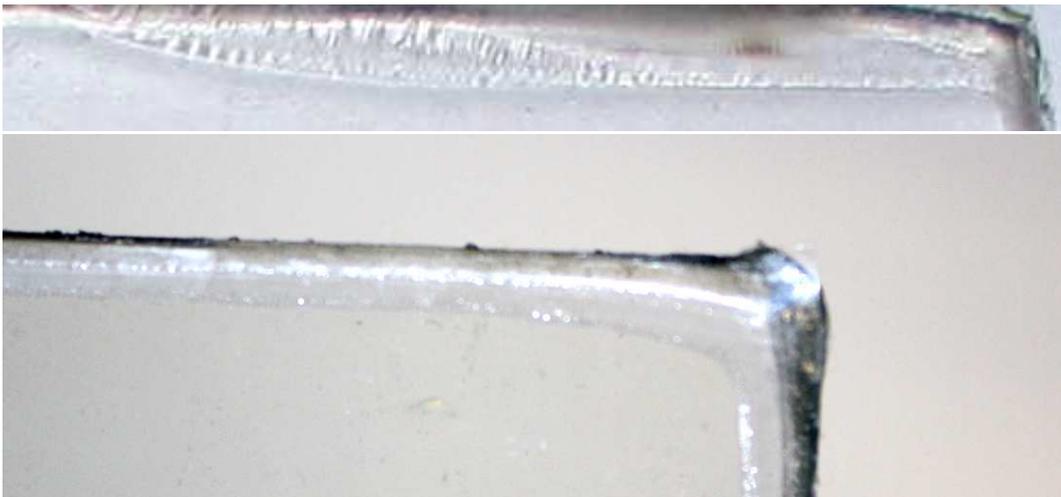
**Figure 31. HAST 24 hours: A samples show some de-lamination at the edges similar to DH.**

Regarding de-lamination at the edges, the back sheet foil was not gripping already after 24 hours. In the A sample a small area could be seen on the H2-A2 sample above the cell; a group of small bubbles between glass and cell Figure 33. These bubbles were however not expanding over the test time, so it does not seem like it is a degradation de-lamination.

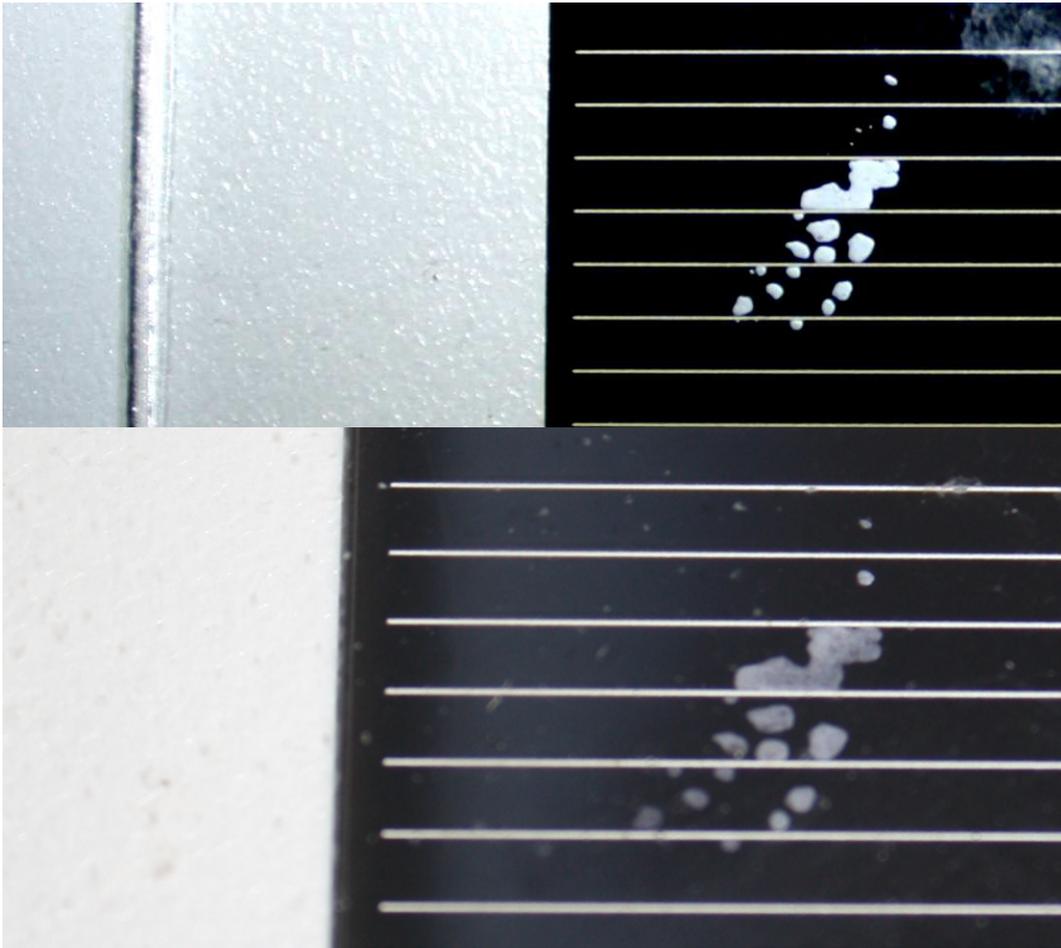
**Figure 33. The A modules are still transparent (left part) in difference to in DH and some bubbles between cell and glass at 24 and 48 hours.**

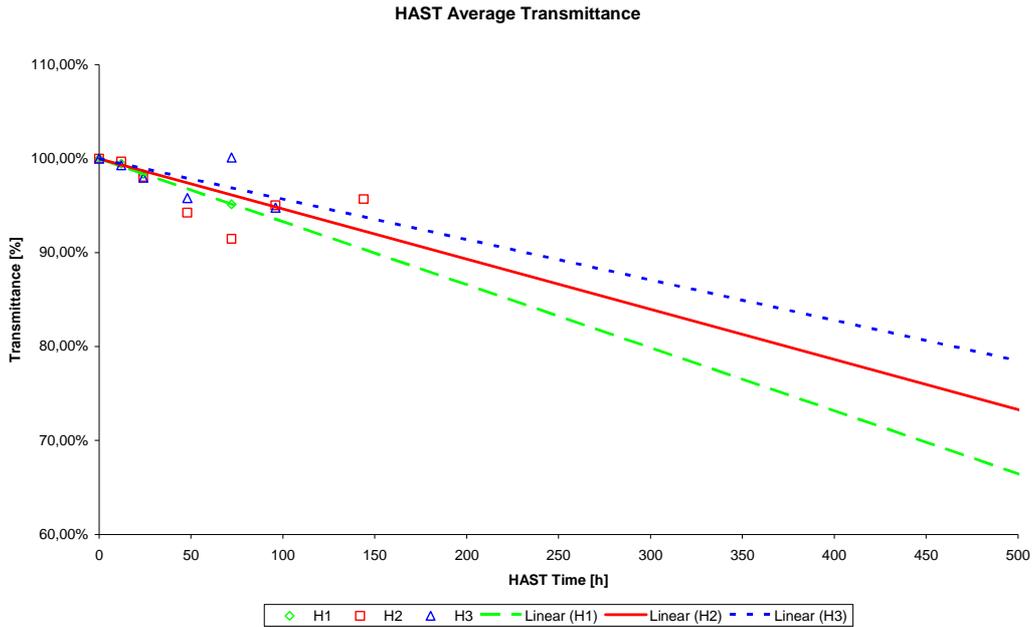
**Figure 34. Transmittance average for HAST (H1: 110°C, H2: 120°C, H3: 130°C) over test time.**

In Figure 34, it is seen that a similar process takes place in the transmittance for the H2-A samples. It reaches the lowest curve at 72 hours and then improves itself up to 144 hours. This could suggest approximate 70 hours of HAST correlation to each 1000 hours of DH. 144 hours would then be around 2000 hours of DH, where an improvement in transmittance was seen.

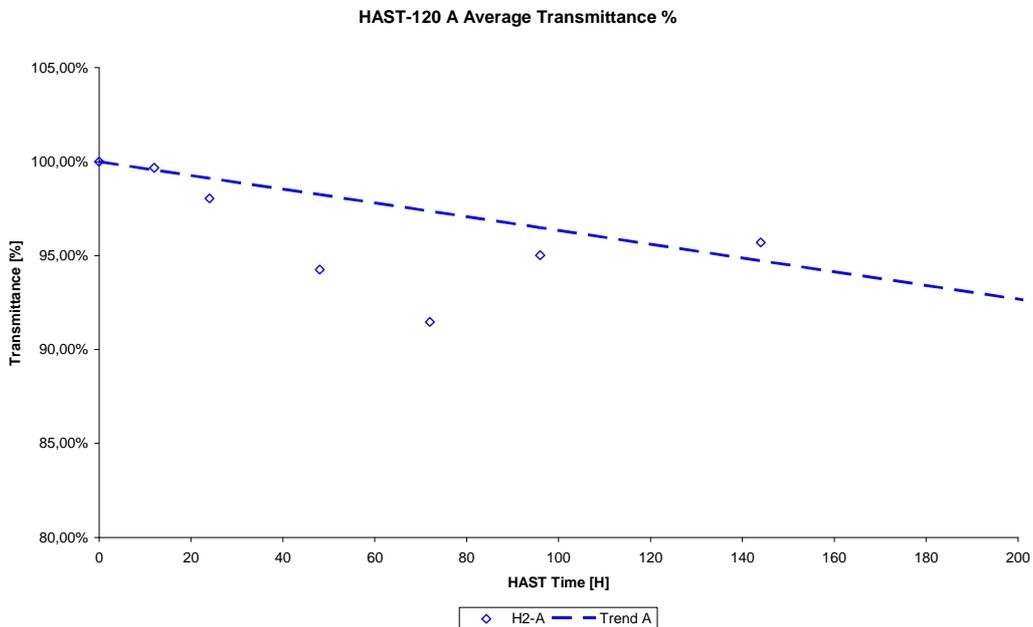
**Figure 35. HAST 120°C A sample transmittance degradation with trend line.**

In the Figure 35 the integrated average of the transmittance curves is shown. A 5% reduction can be read out at approximately 130 hours. This gives 1 % every 26 hours and the 0.5 % rate at 13 hours. A lowest measurement is made at 72 hours and then the transmittance recovers according to Figure 36. The IV curves at the extreme values at 0, 72 and 144 hours are basically constant and does imply that the transmittance reduction have not taken place between cell and glass Figure 37.

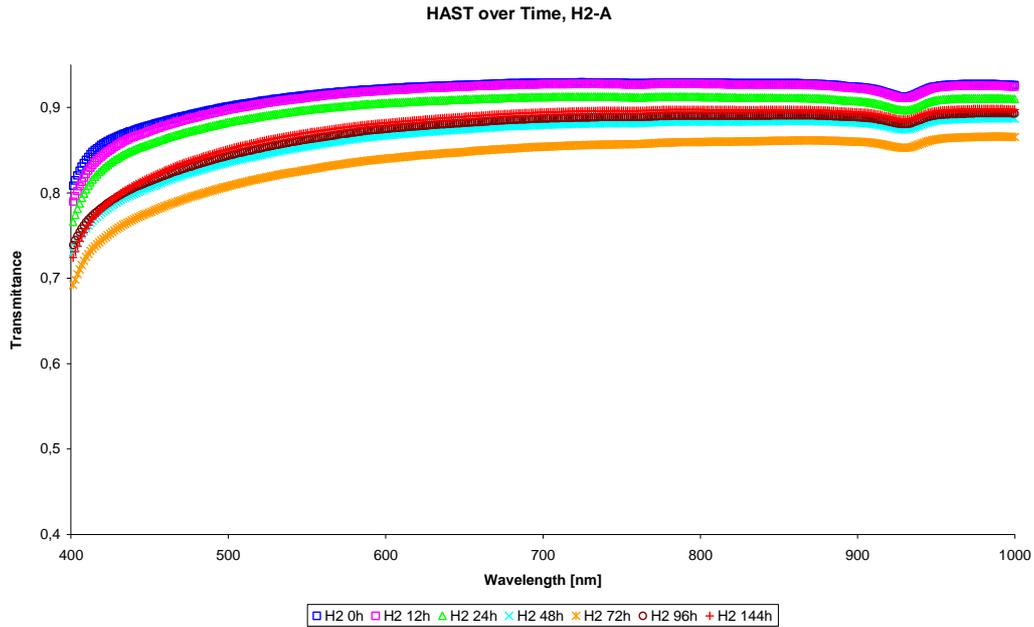
**Figure 36. The time variation of the HAST sample A at 120°C.**

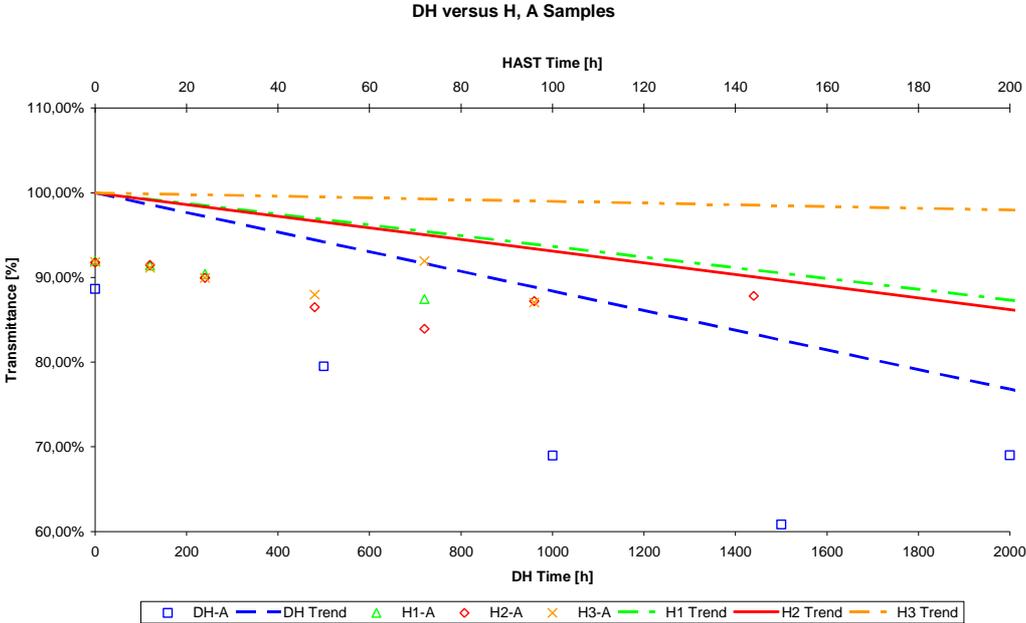
Figure 39. The different test types, DH and HAST, compared in transmittance development.

Figure 39 shows all the integrated average transmittance values for DH and HAST samples. The HAST time scale has been corrected to 500 hours and it shows an almost parallel degradation in 110°C, the other two were close as well. Although not meeting the expectation of reducing the time it shows that there is a connection between the two tests and the materials tested have to be considered regarding the results and the test type.

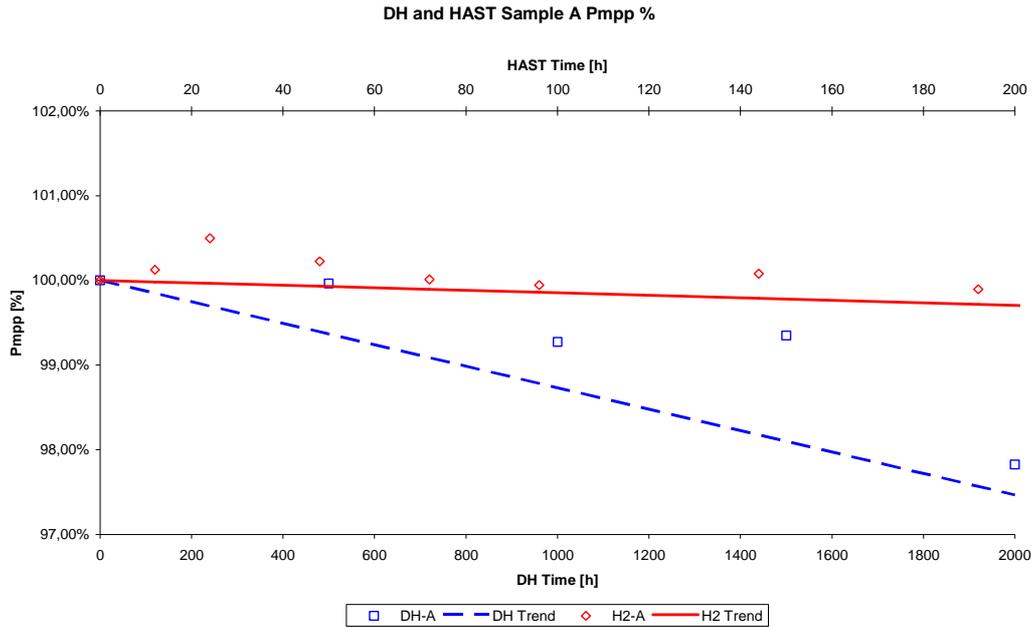
**Figure 40.** The measured values and the trend lines corrected of the top value after regeneration with base of 100 % for DH and HAST.

Due to the initial power increase the trend of the HAST power is also increasing, since the effect of this is much smaller in the DH the trend is not influenced. Figure 40 shows the trend lines in both cases. The figure show that the degradation for the A samples seem to go far slower than with 10 times the speed, giving the AF of 4 from the transmittance more relevance. However it is needed to remember that the power degradation normally work slower in artificial aging compared to real life experience. The heavier degradation in DH have also been supported by the lower temperature HAST being more similar to the 85°C DH. If assumed that the transmittance degradation would be equal in both tests the power trends would also close in on each other.

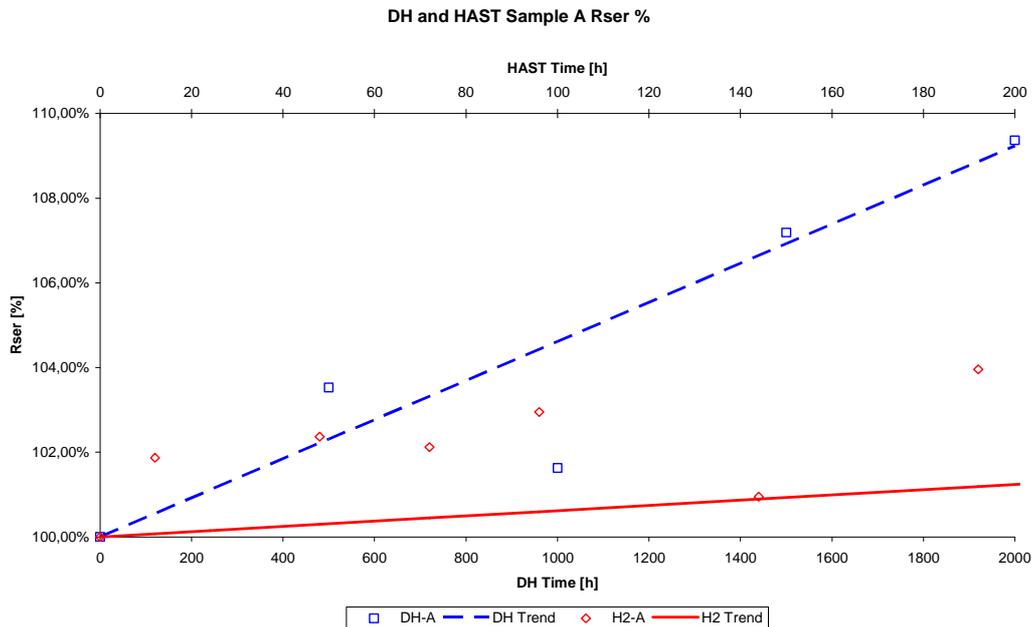
**Figure 41.**  $R_{ser}$  of DH and HAST.

The series resistance grow at a rate of about 5 % every 1100 hours in DH and 1 % every 180 hours HAST, Figure 41. The relationship in the  $R_{ser}$  development gives a 110/90 correlation, that is the A samples  $R_{ser}$  increases only 1.2 times faster in HAST.

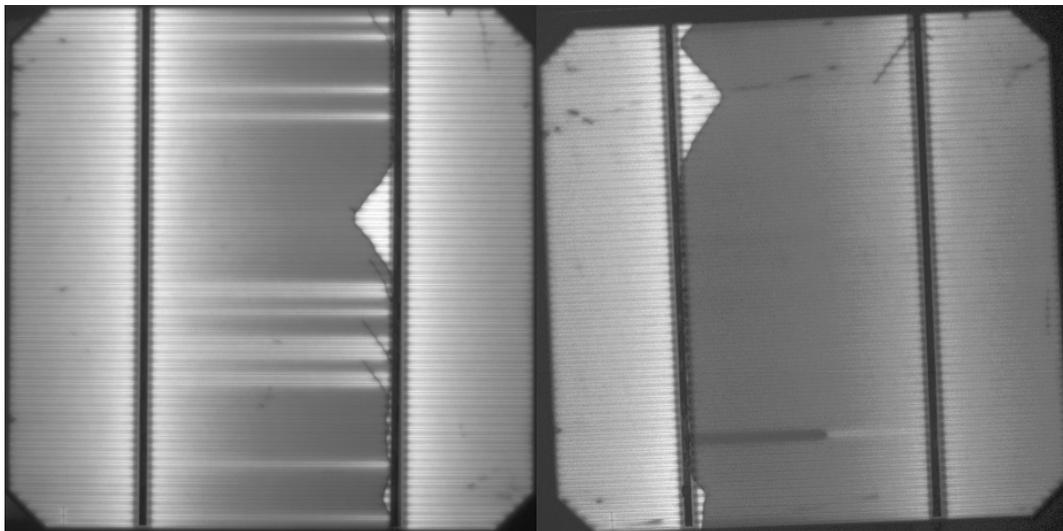
Figure 42. DH-B3 and H2-B3, completely cracked after lamination.

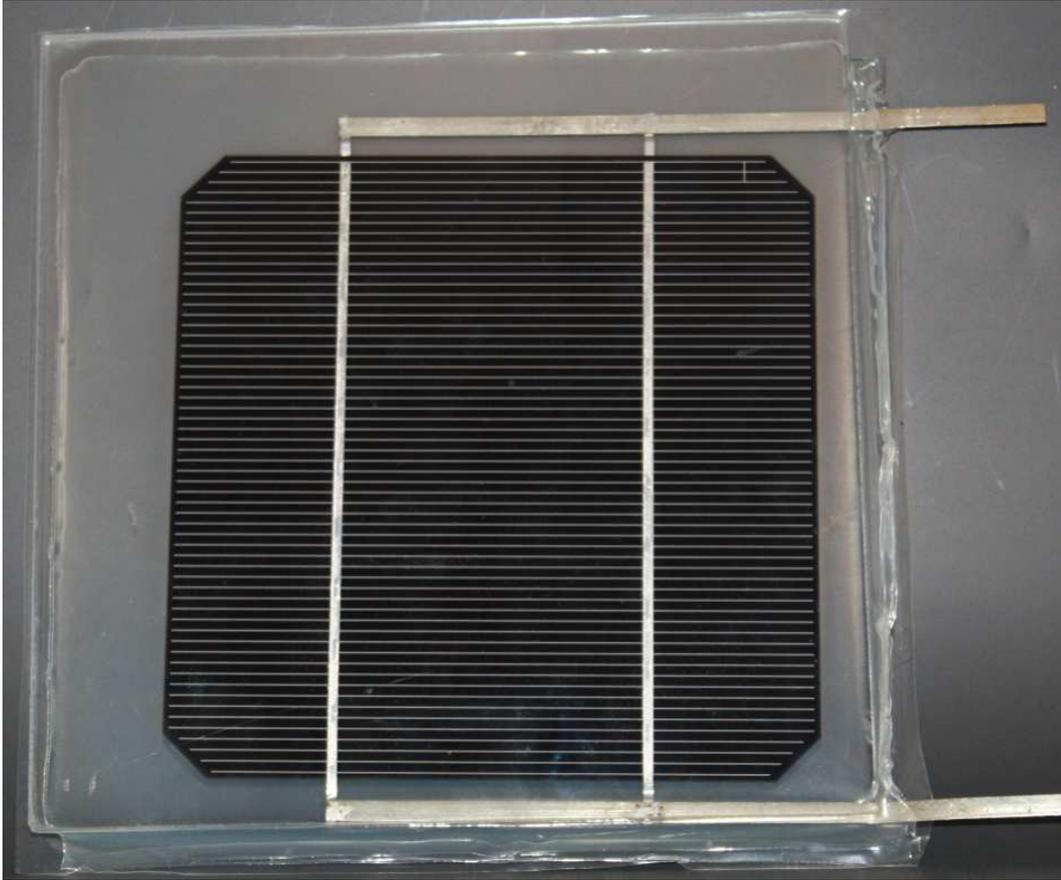
**Figure 43. The back sheet foil slipped on the DH-B4.**

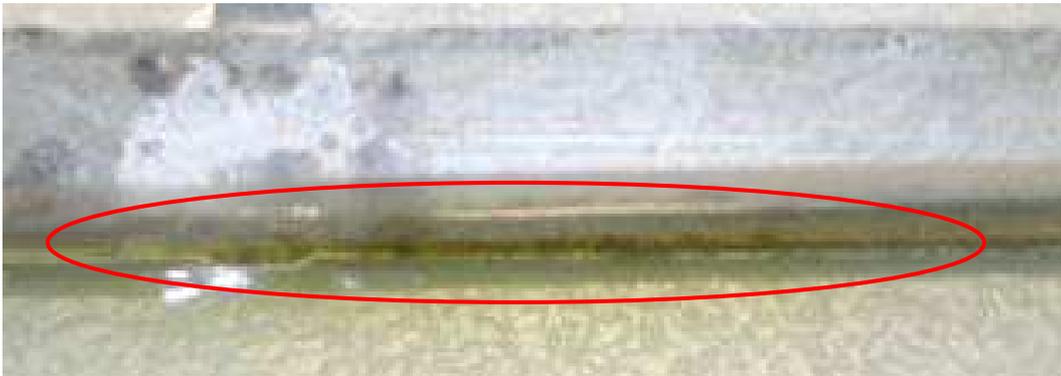
**Figure 45.** B sample corroded only at the skew cell DH-B4

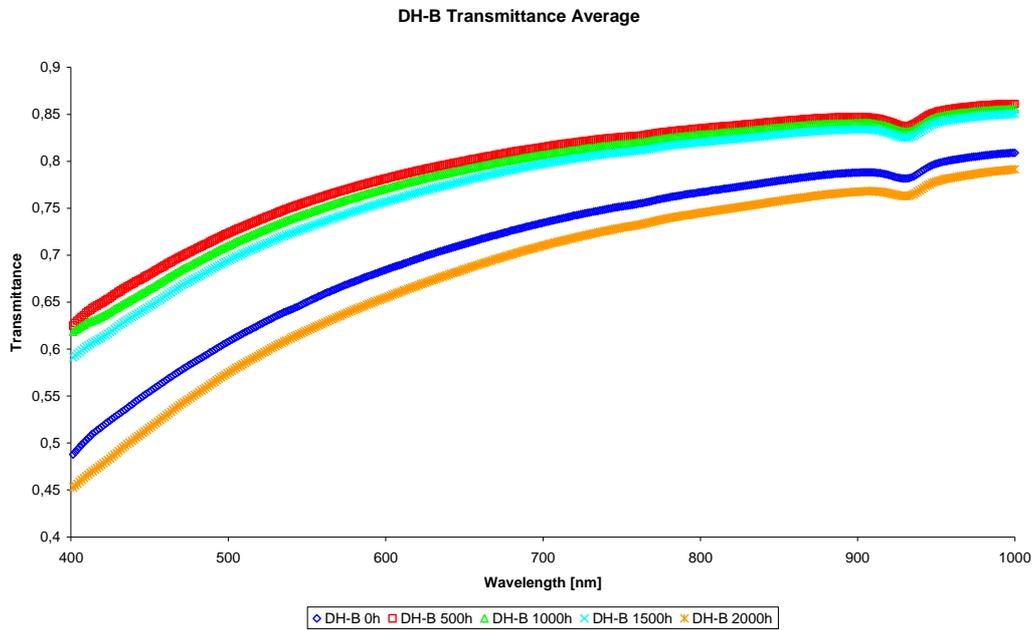
Figure 48. DH-B transmittance development over test time.

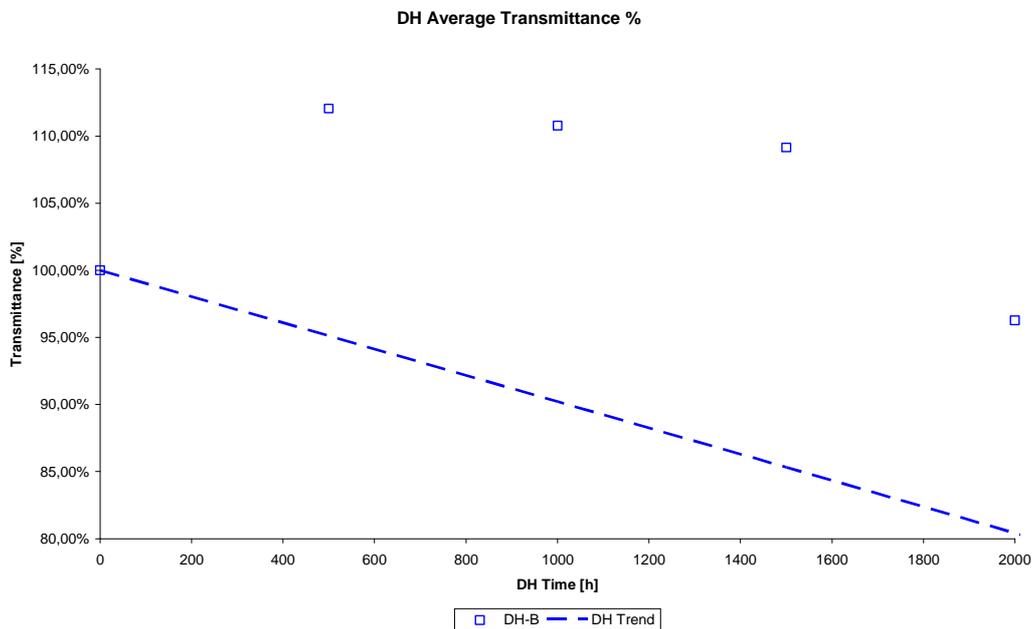
Figure 49. The transmittance average, regarding only degradation and not the initial improvement, shown over the DH test time.

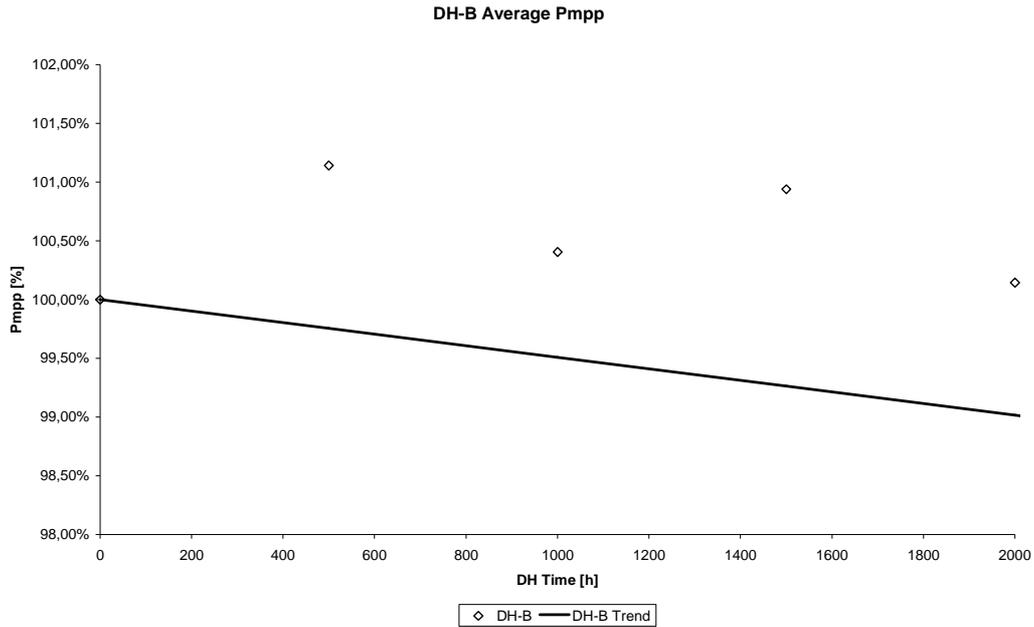
Figure 50. Average P<sub>mpp</sub> for DH-B samples

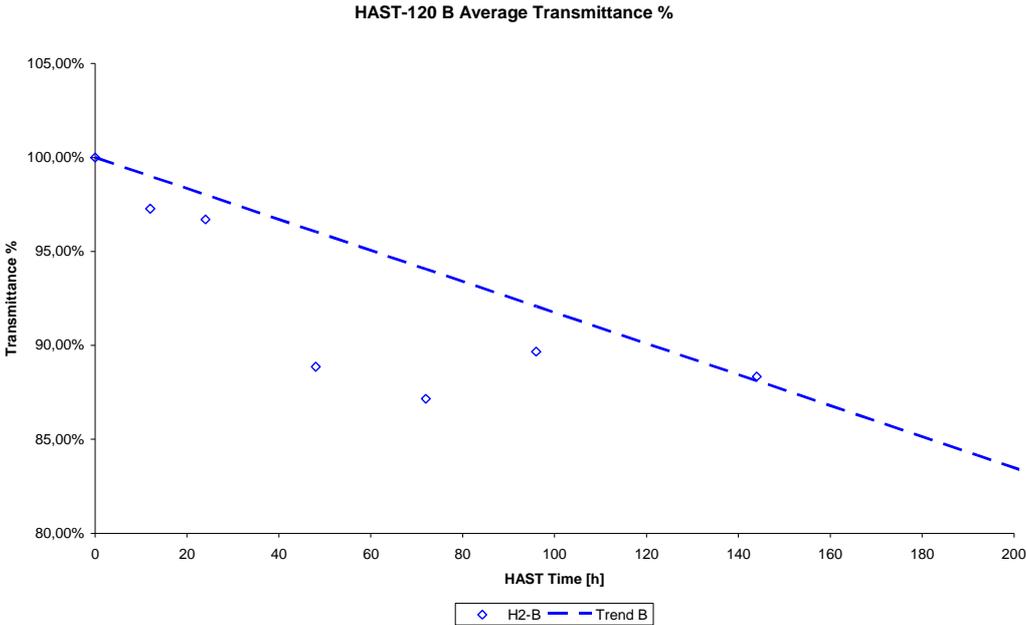
Figure 55. The Transmittance measured values and the trend for H2-B samples over time.

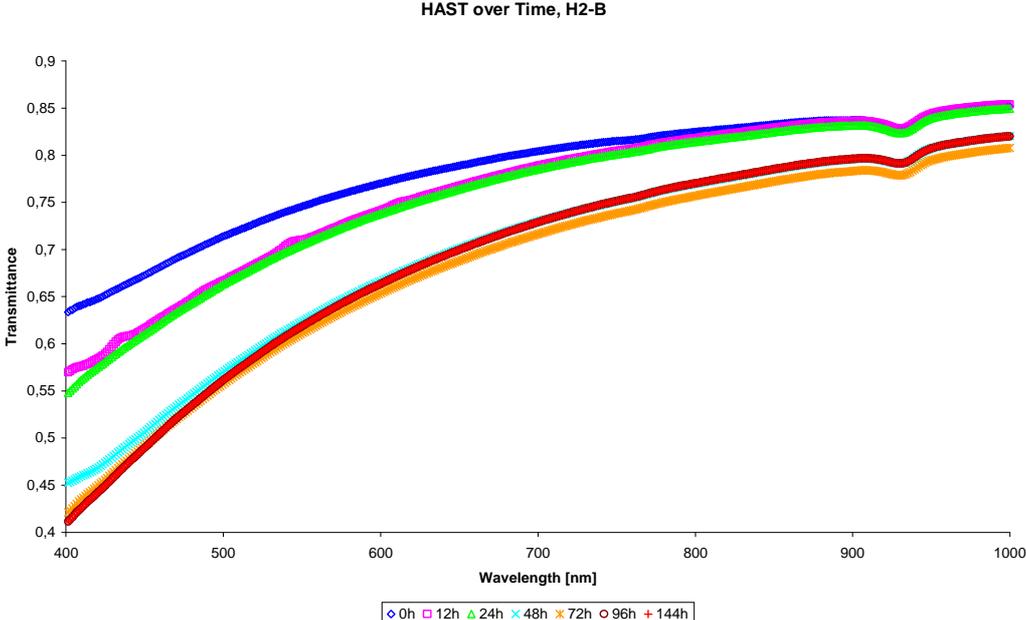
Figure 56. DH-B transmittance development over test time.

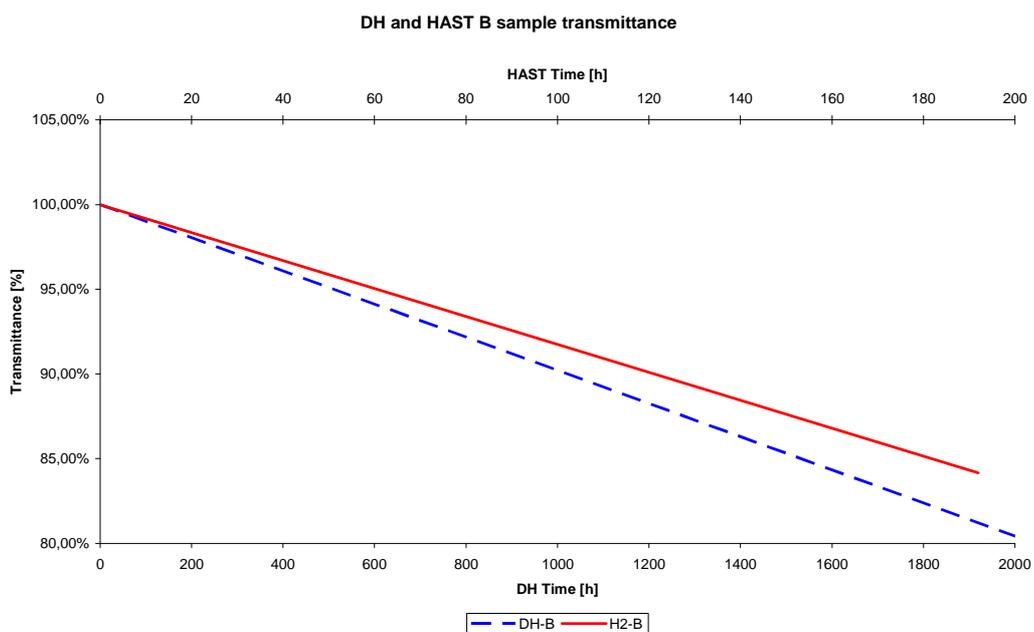
Figure 58. Transmittance over time in both DH and HAST for the B samples.
