## **Usage of Highly Accelerated Stress Test (HAST) in Solar Module Ageing Procedures**

*Master of Science Thesis*

**TOMAS HULKOFF**

Department of Electrical Engineering  
*Division of Energy and Environment*  
CHALMERS UNIVERSITY OF TECHNOLOGY  
Göteborg, Sweden, 2009

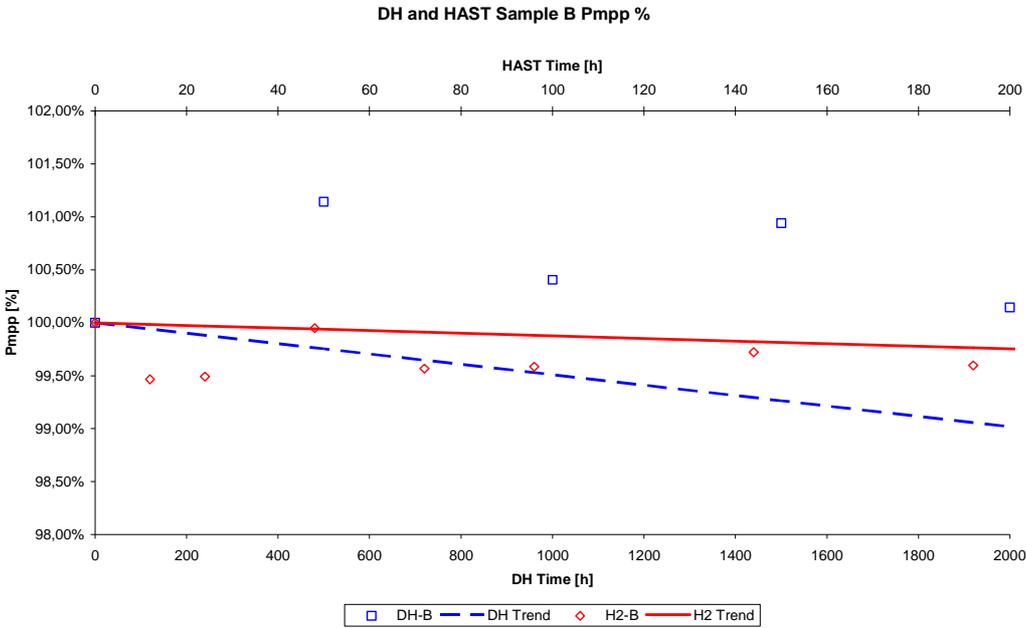
Figure 59. DH and HAST 120°C in relation to each other over test time. Trend line calculated from top value after regeneration.

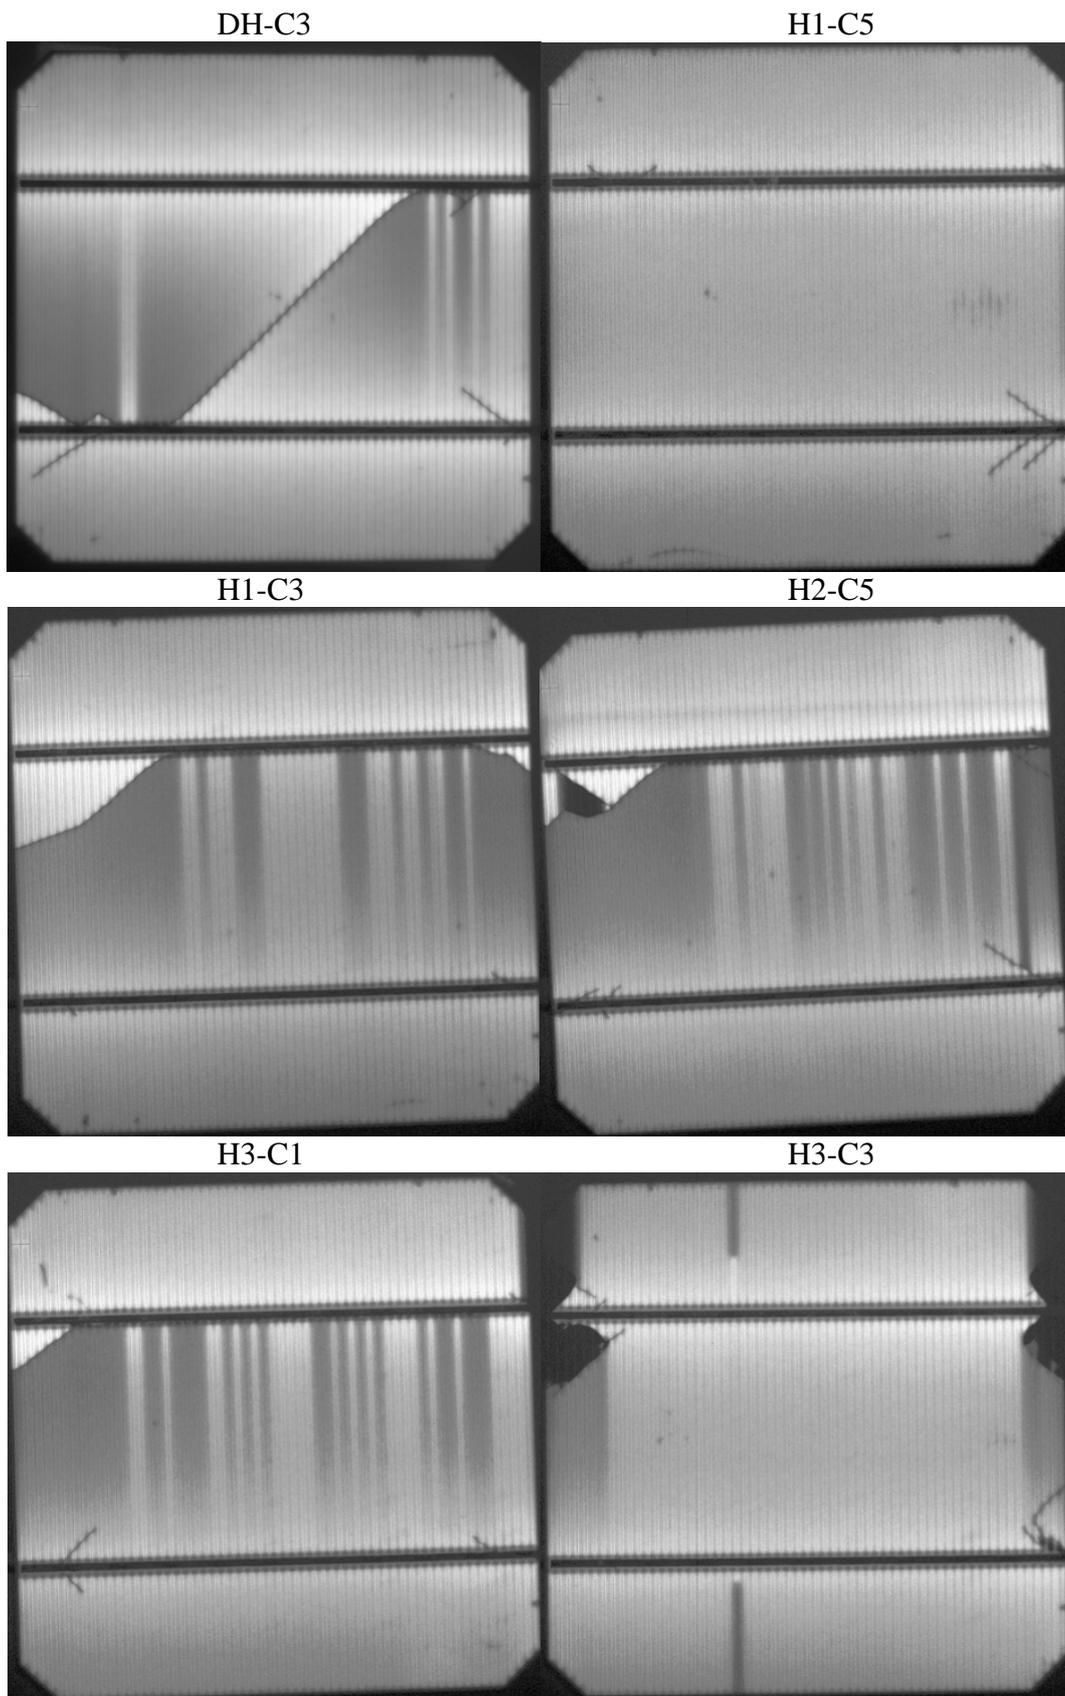
**Figure 61. The broken cells and a cell with large cracks, H1-C5**

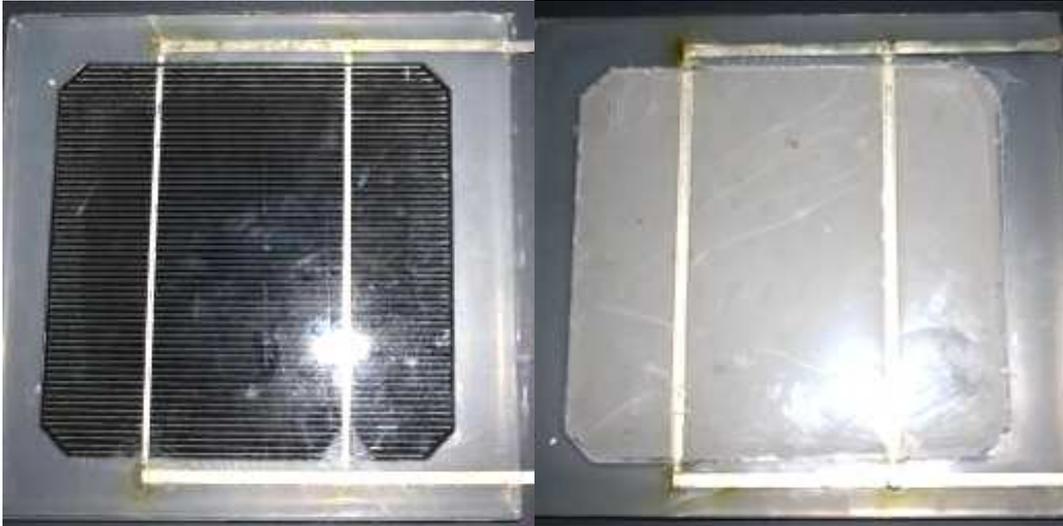
**Figure 64. The DH-C at 1000 hours, it shows a growing de-lamination on front side close to the bus bars.**

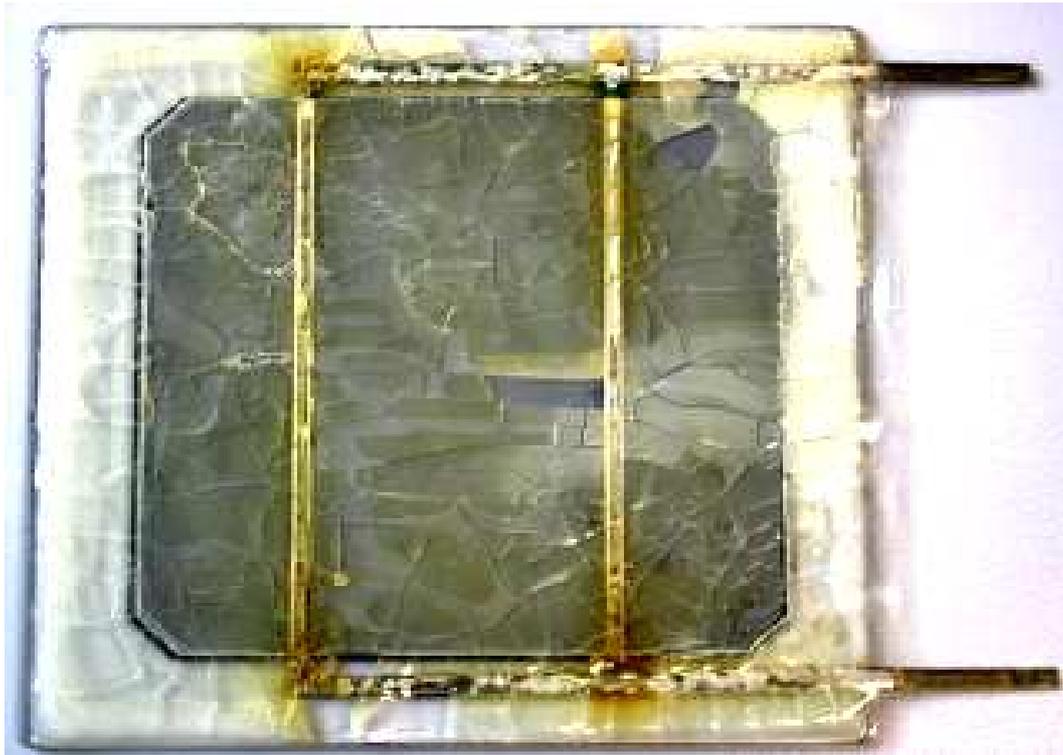
**Figure 67. The heavy de-laminated and corroded back side of the 2000 hours C sample.**

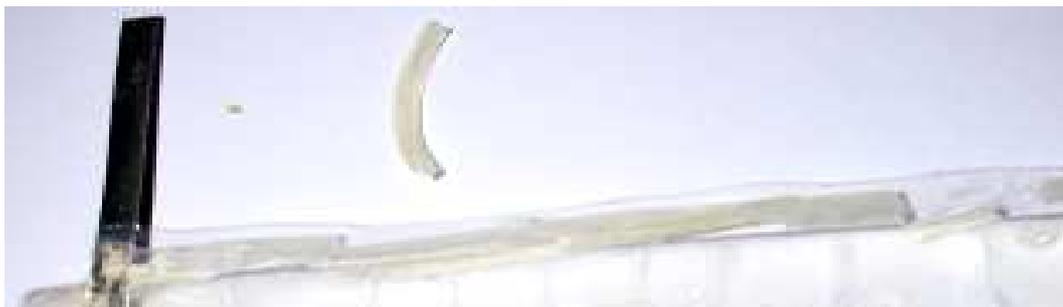
**Figure 68. The thermoplastic falling out of the C samples.**

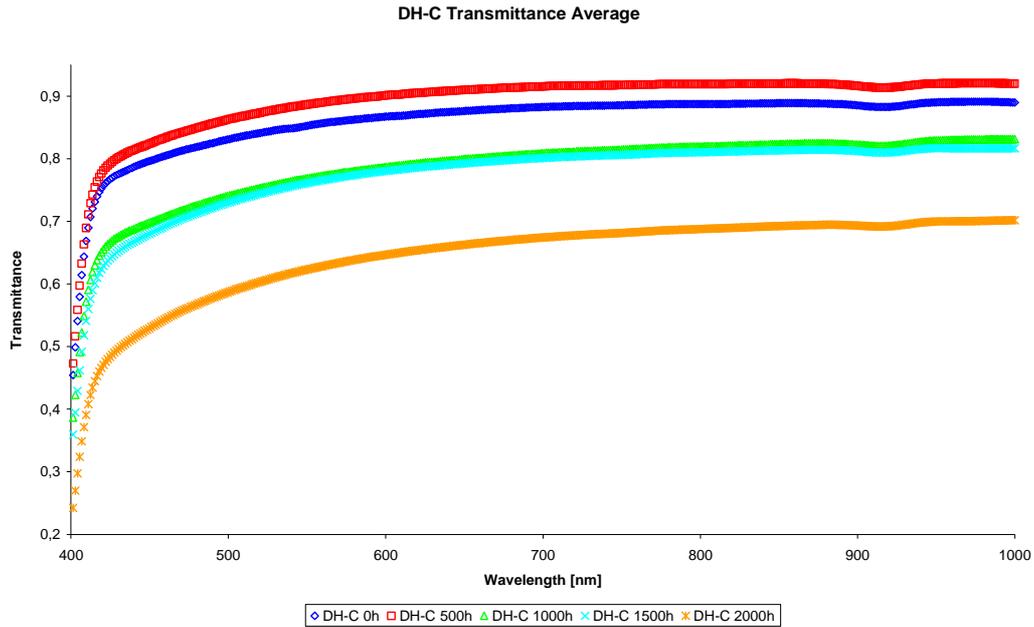
**Figure 69. Transmittance average over DH testing time**

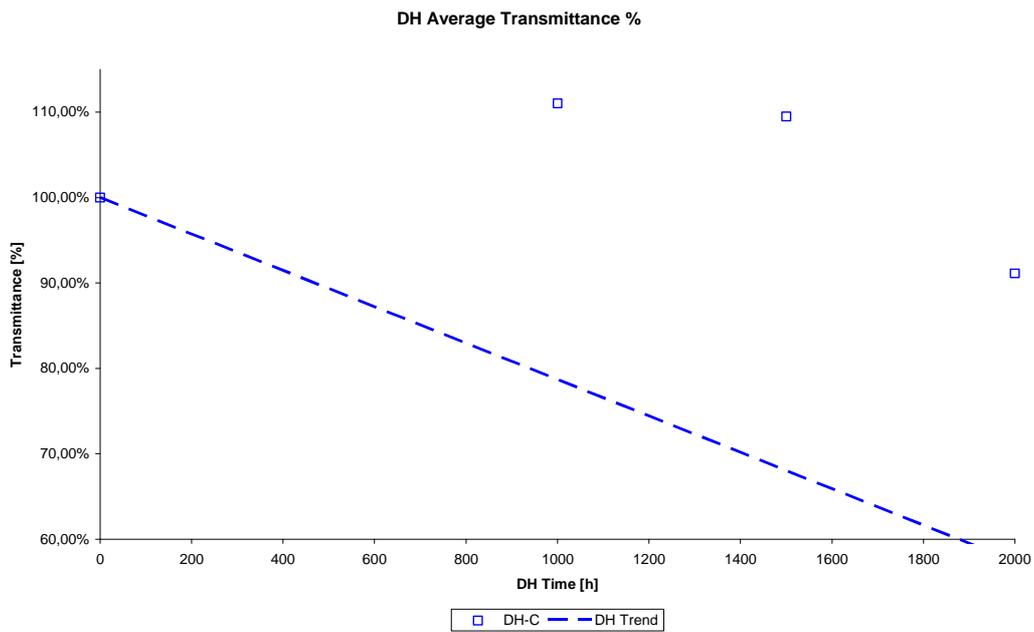
**Figure 70. Average transmittance degradation in DH over testing time with initial improvement removed and only considering degradation.**

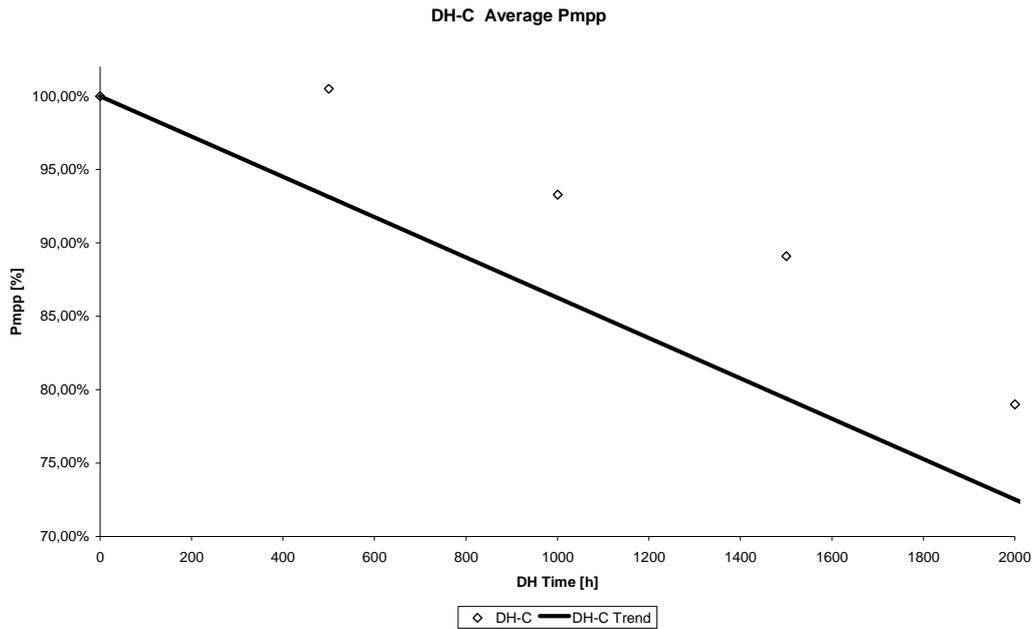
**Figure 71. DH-C average power over DH test time.**

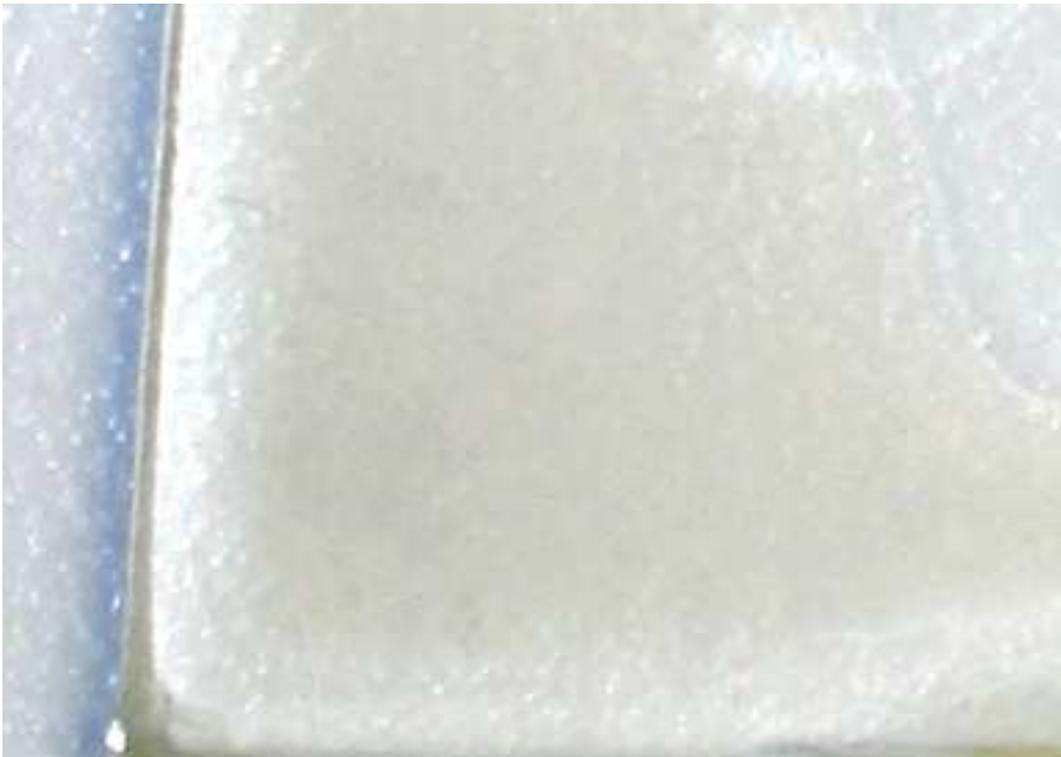
**Figure 74. Browning and bubbles of H2-C samples at 48 hours.**

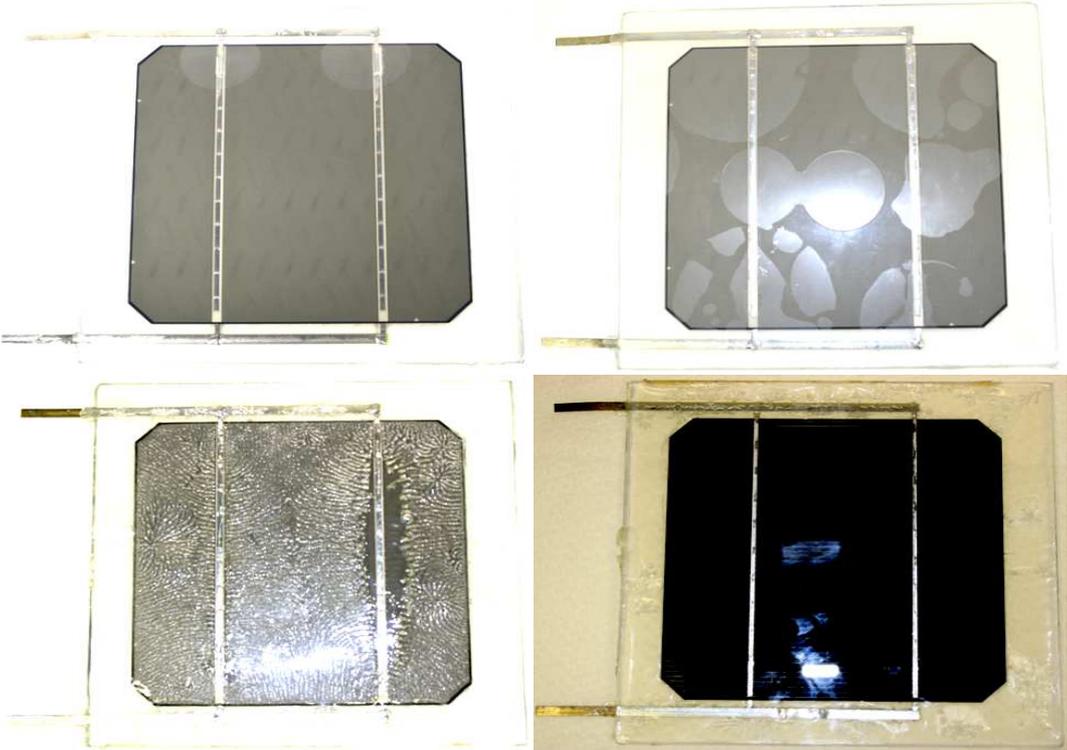
**Figure 76. The back side of each H-C sample at 12 hours of HAST, H1, H2 and H3, with different stages of bubbles and de-lamination, also the front of the H3-C1 is seen. The already corroded leads show a brown discolouration outside the modules.**

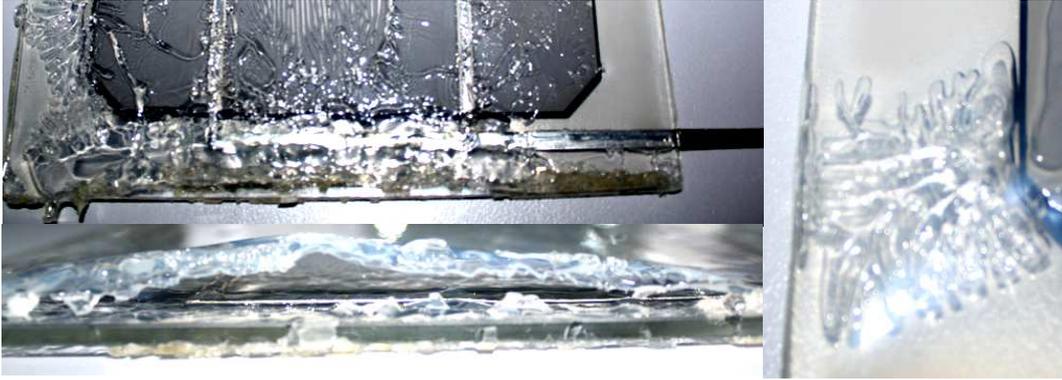
**Figure 77.** The melted embedding in the C samples after 24 hours at 130°C.

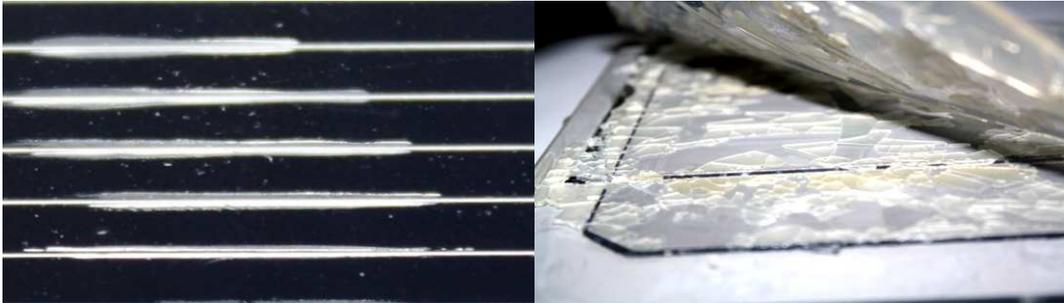
Figure 81. Increasing front side de-lamination after 96 hours. H2-C sample, back side is completely de-laminated as the back sheet foil can be removed without any resistance from the glue.

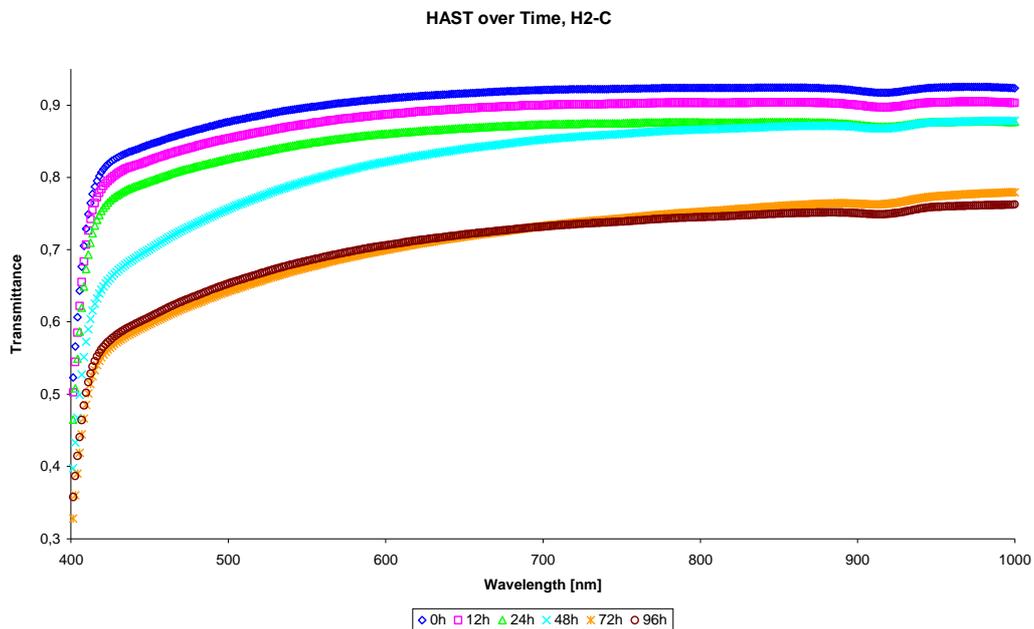
Figure 82. HAST transmittance for H2-C samples at 0, 12, 14, 48, 72 hours of testing.

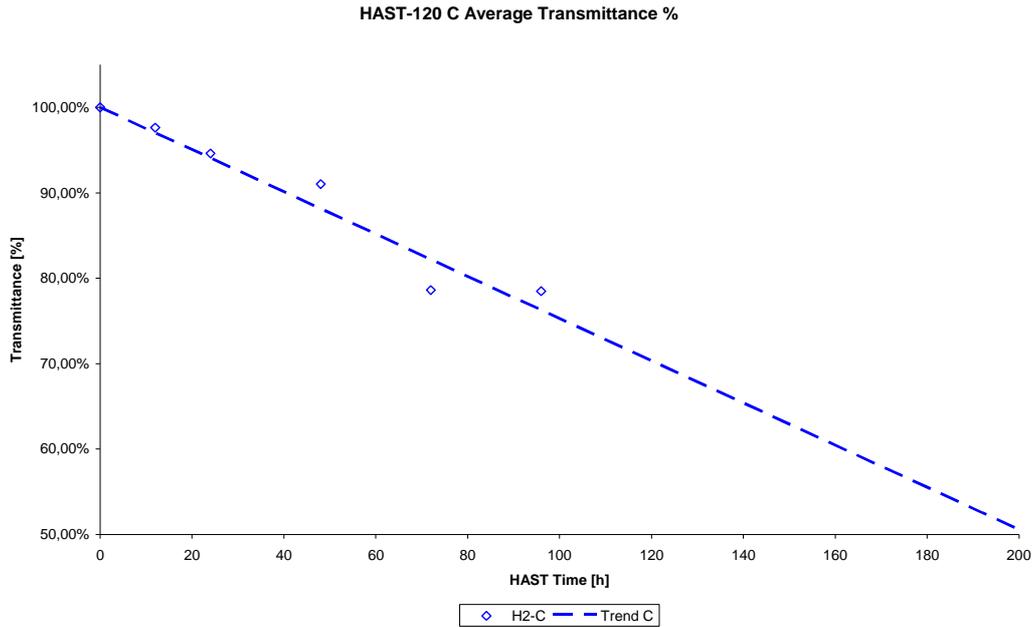
Figure 83. Transmittance degradation for H2-C samples.

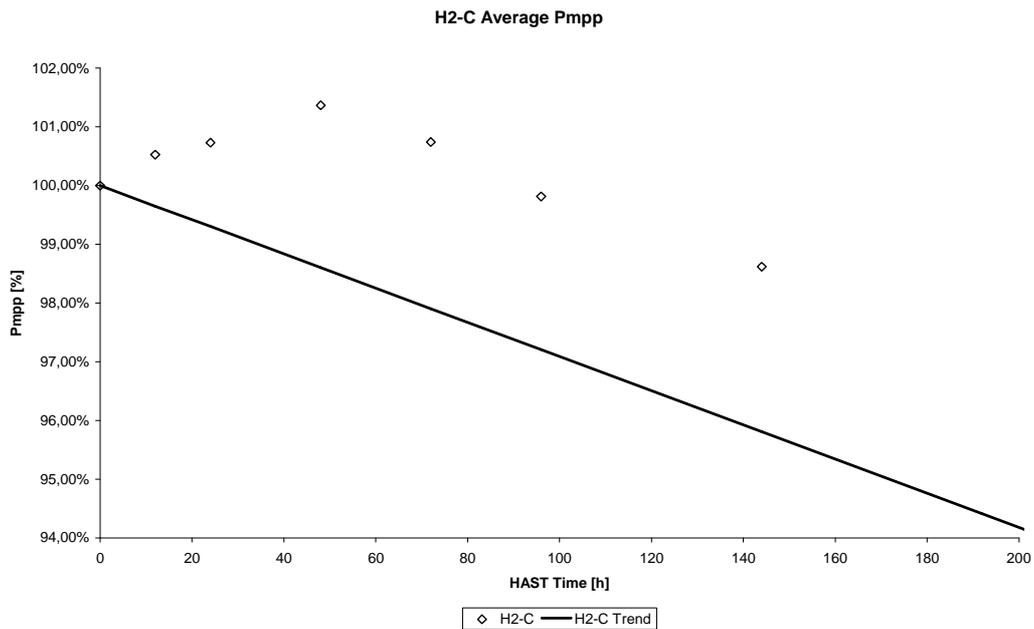
Figure 84. Average P<sub>mp</sub> for H2-C samples

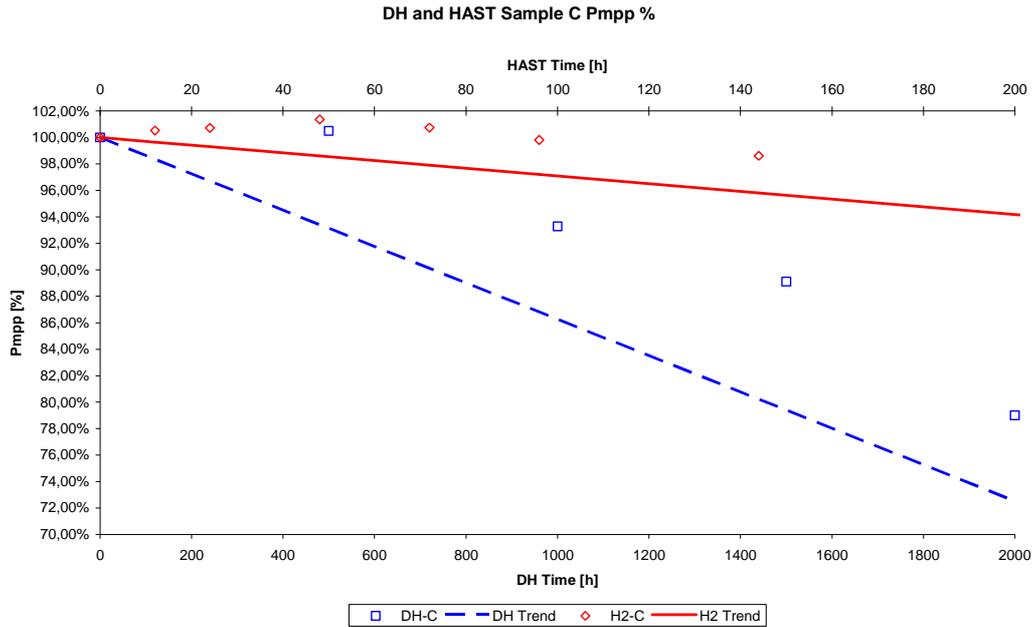
Figure 85.  $P_{mpp}$  for DH and HAST with measured values and corrected trend lines.

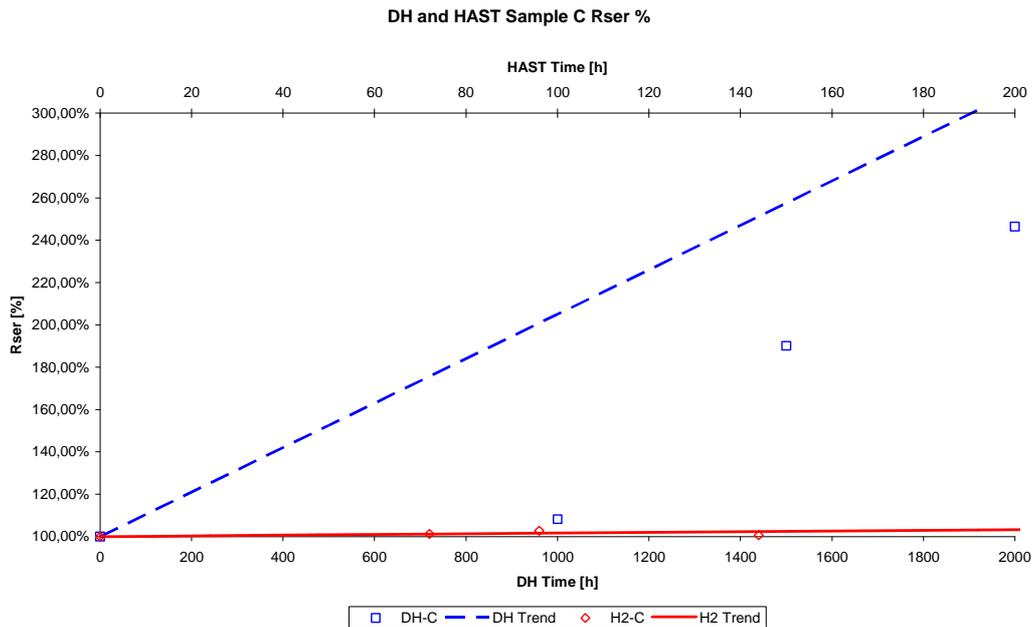
Figure 86. HAST and DH series resistance development over time.

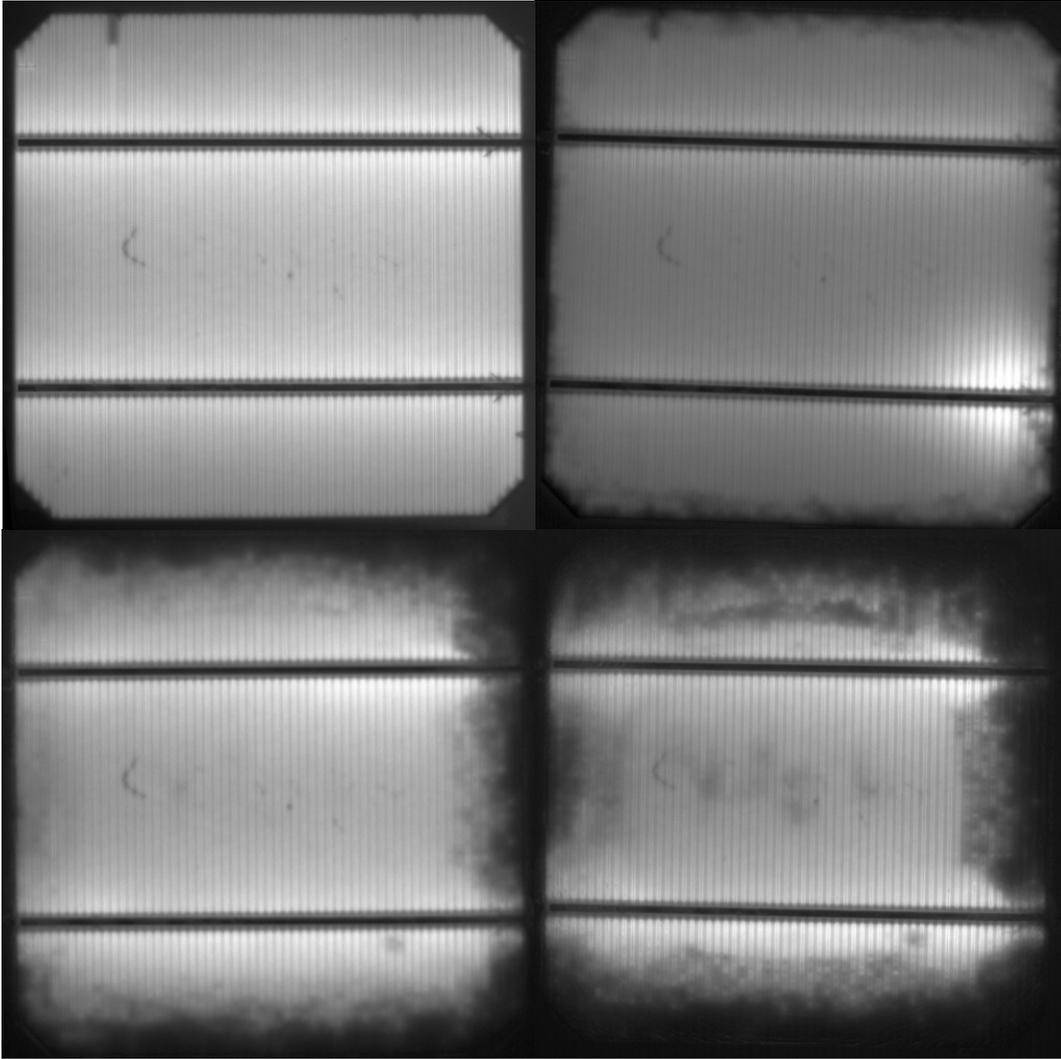
**Figure 87. The DH-C2 at 0 hours of testing at the top left, at 1000 hours during EL testing top right; dark clouds at the cell edge implies higher series resistance. The bright area at the bus bar low left is probably due to a bridge over the cell edge causing a short circuit. Bottom left; the same DH-C2 at 1500 hours. The de-lamination influence is becoming clear to see due to the darkened areas. Bottom right; finally at 2000 hours.**

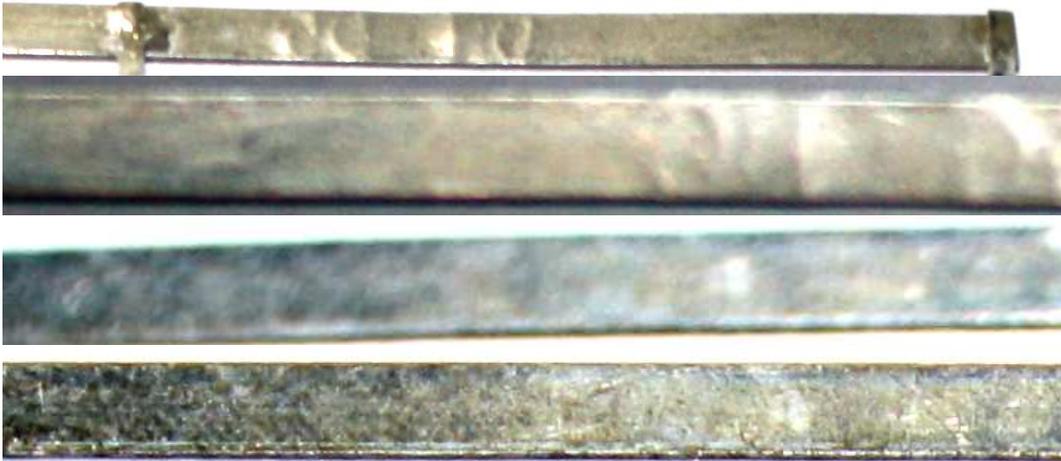
Figure 89. Corrosion after 500, 1000, 1500 and 2000 hours of DH, DH-D5.

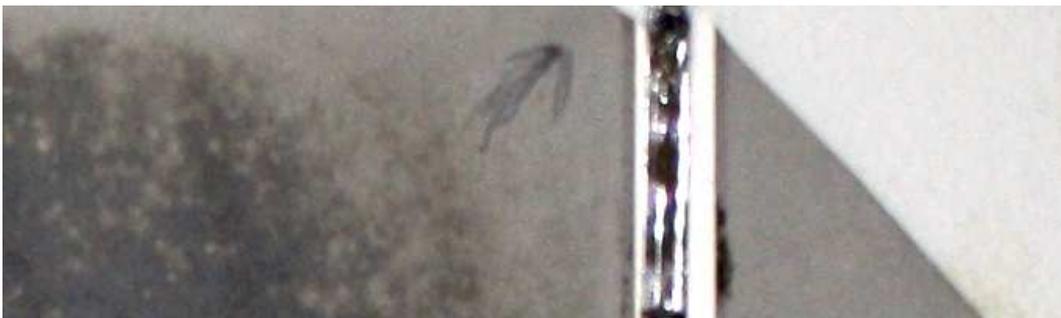
Figure 90. Discoloured back side and corrosion on the back side bus bar, DH-D5.

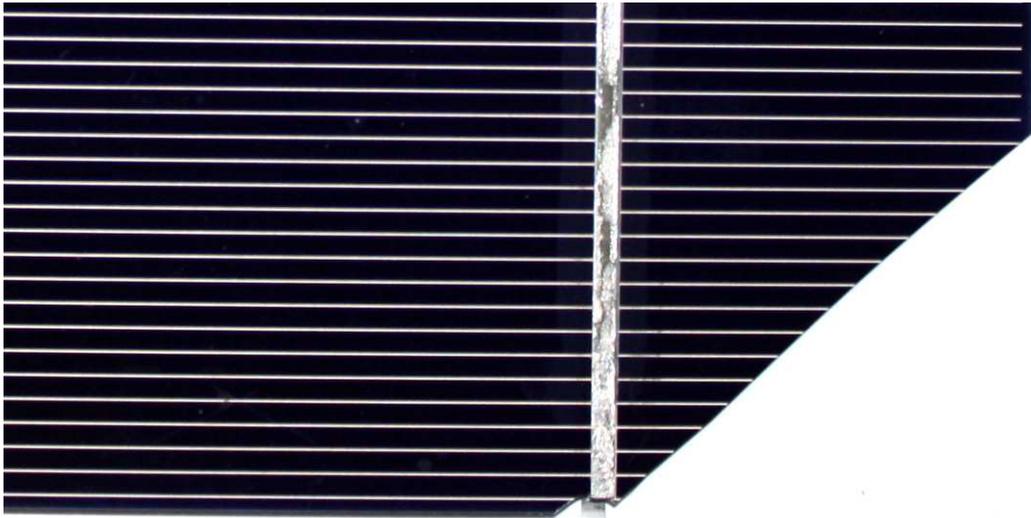
**Figure 91. The broken off corner and front side similar to an untested cell, from the DH-D5 after 500 hours.**

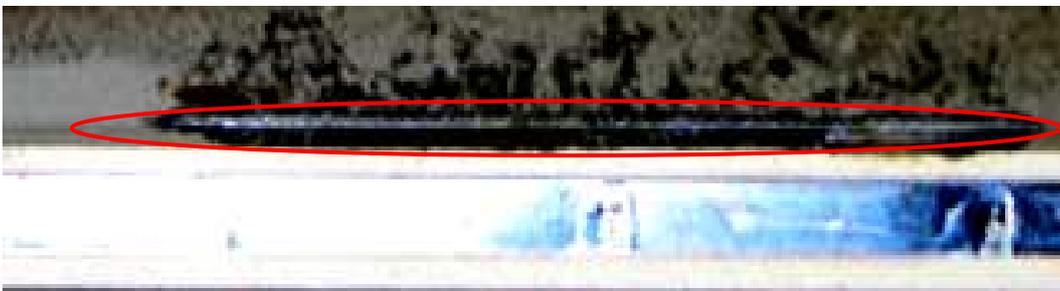
**Figure 92. DH-D4 sample show signs of corroded copper after 2000 hours DH (the small strip above the bus bar).**

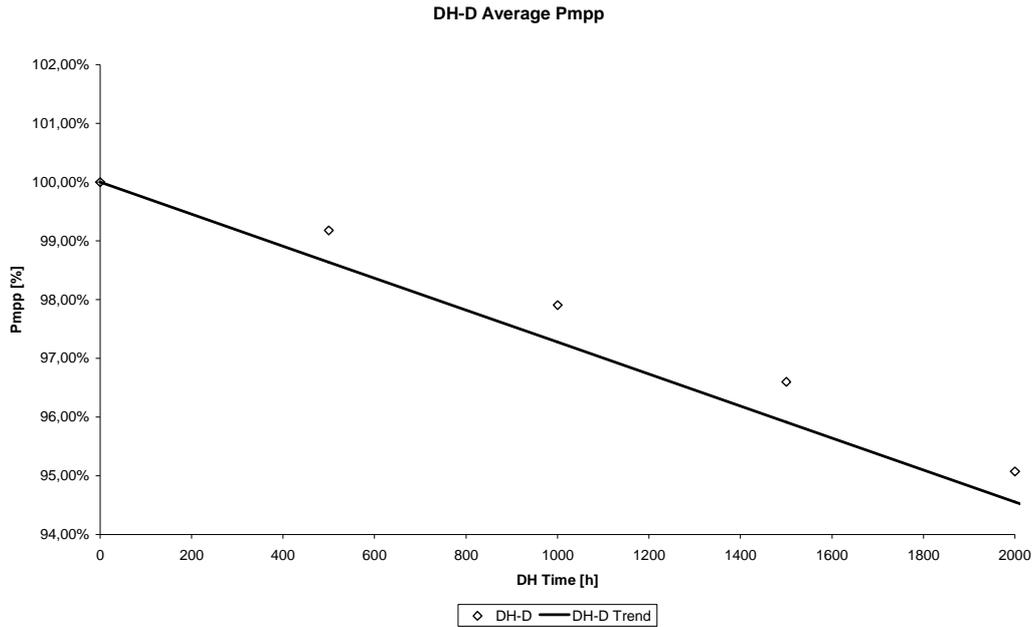
Figure 94. Average  $P_{mp}$  for DH-D samples.

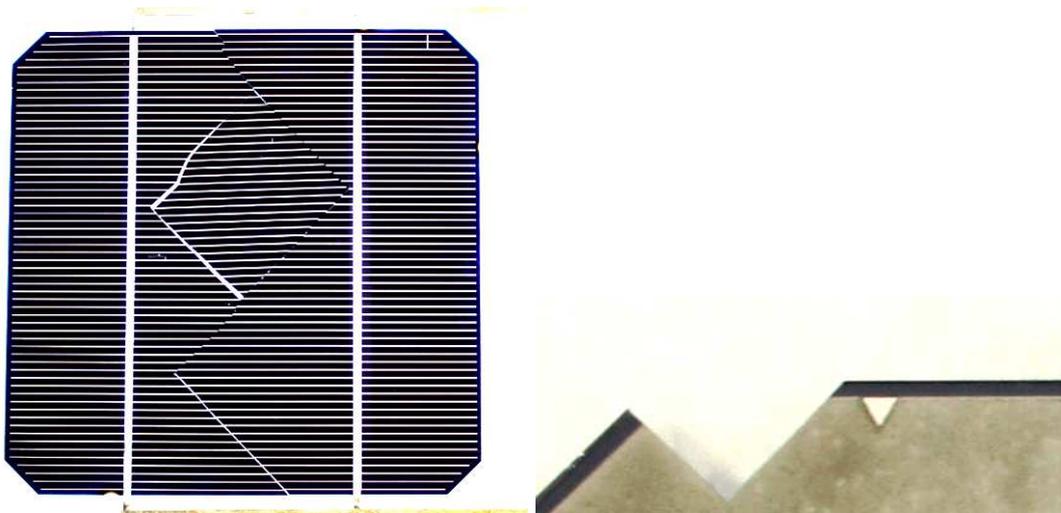
Figure 95. The broken H2-D1 after it was dropped. Cracked of part of H1-D4

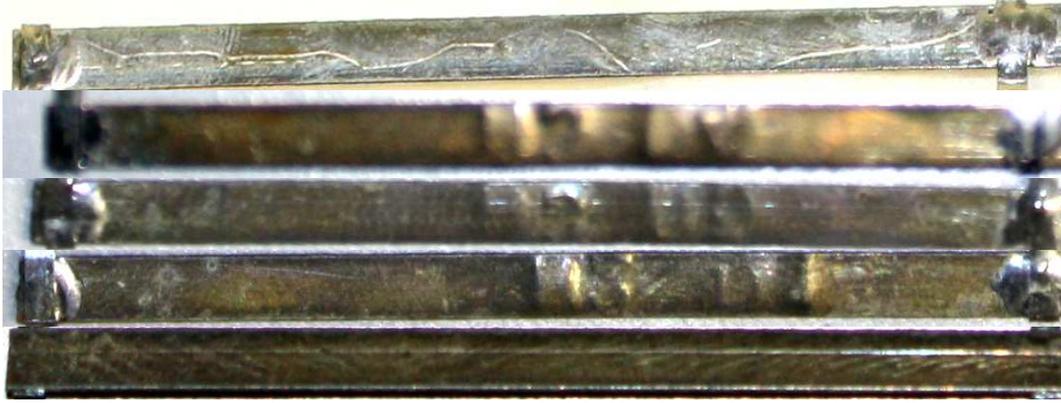
Figure 97. The corrosion development over 12, 24, 48, 72 and 96 hours in HAST

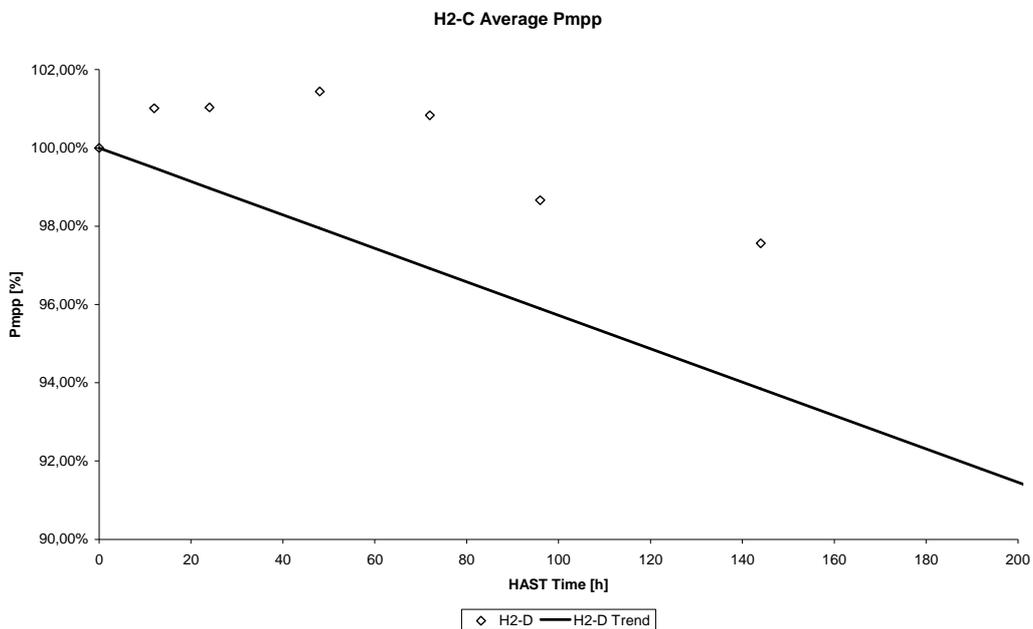
Figure 98. Development of average  $P_{mpp}$  for H2-D samples.

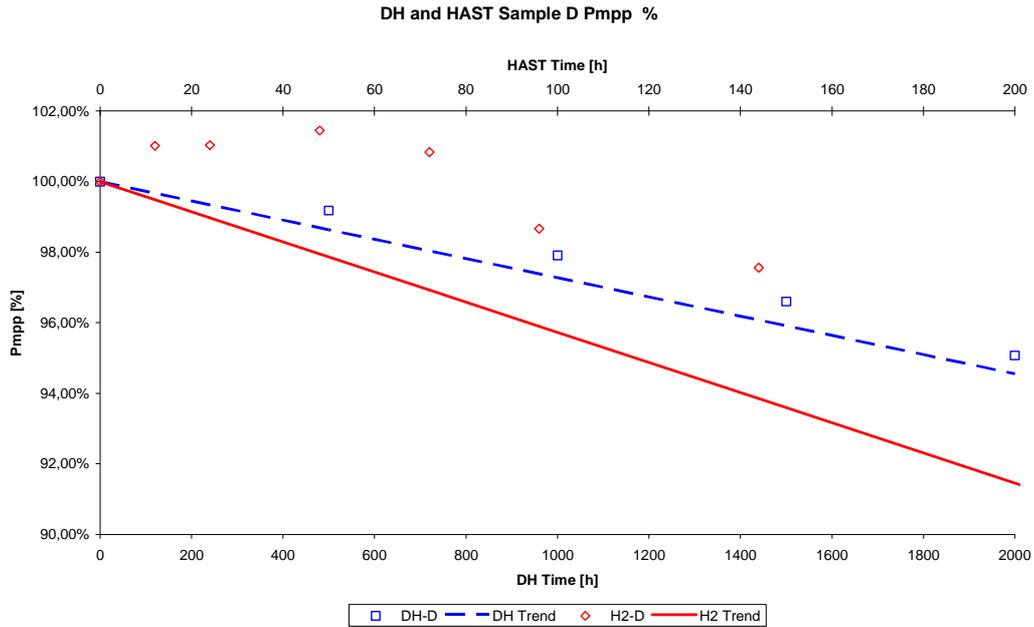
**Figure 99. DH and H2  $P_{mpp}$  over testing time. The initial measurements removed and starting the degradation of the HAST samples at the top power measured. Measured values plotted.**

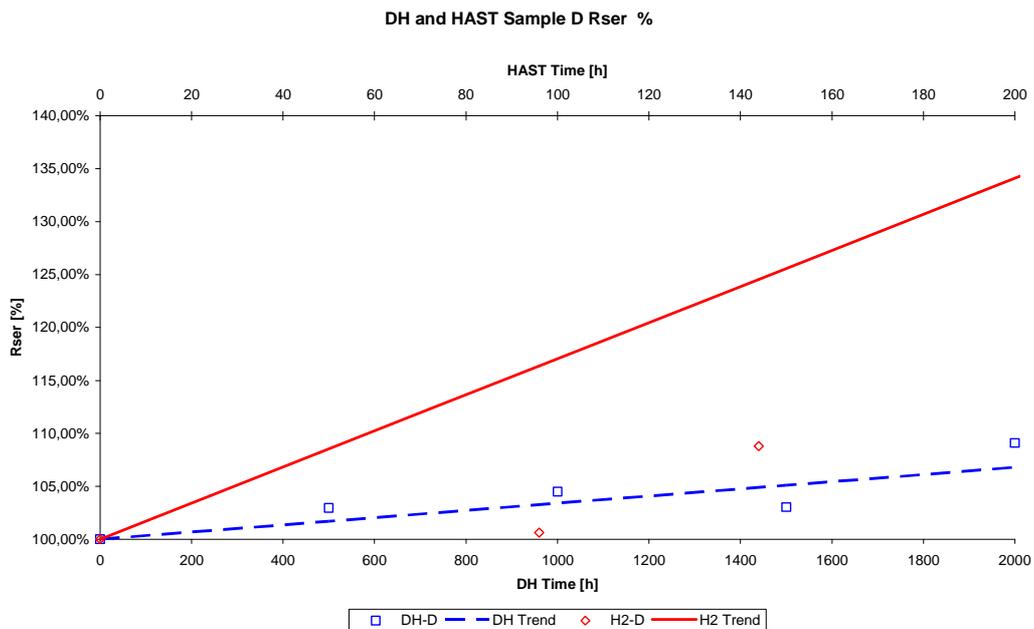
**Figure 100. Series resistance development showed for the H2 and DH over testing time.**

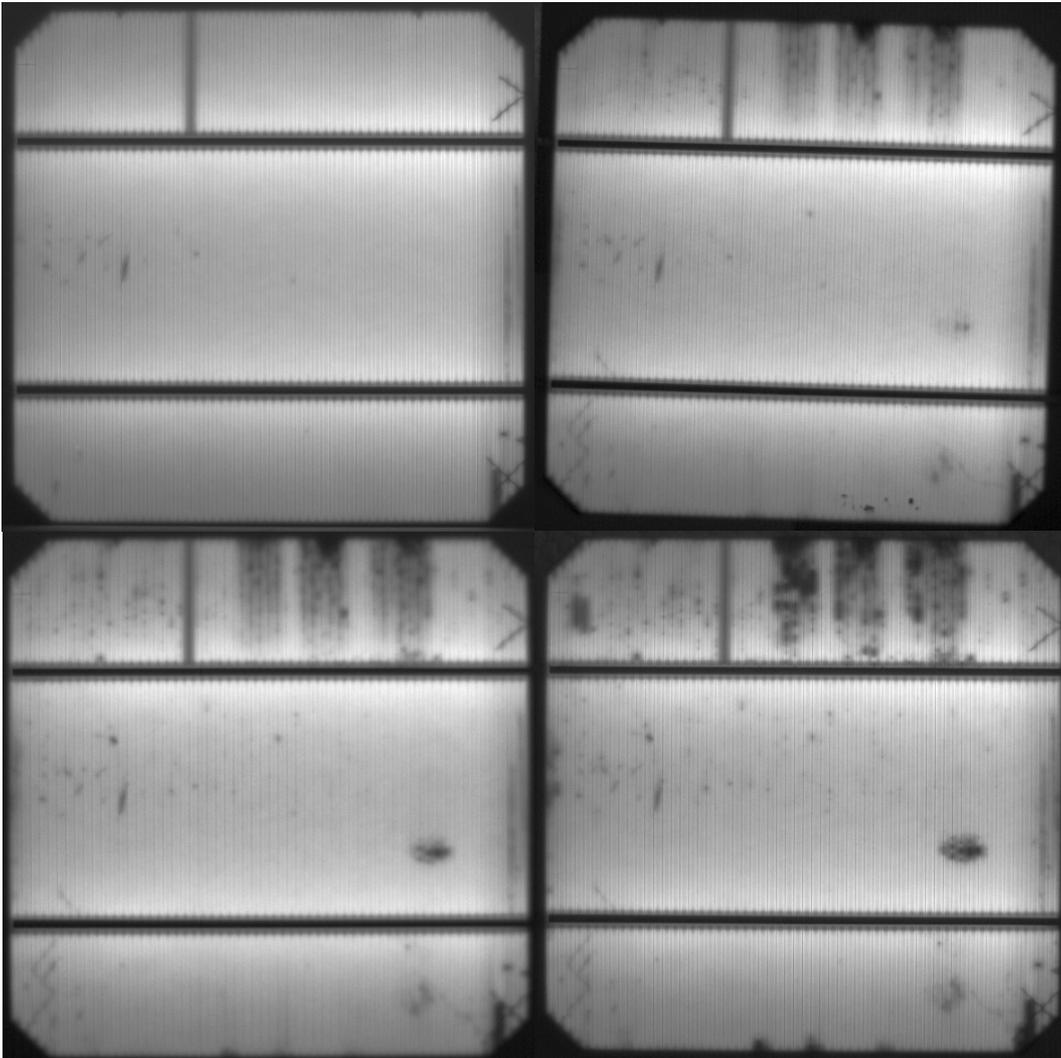
**Figure 101. Top left, DH-D3 at 0 hours. Top right; DH-D3 show increased dark areas at the top, after 1000 hours. Some small cracks are also to be seen but they are at the same level as at the beginning of the test. Bottom left; at 1500 hours the development continues. Bottom right; DH-D after 2000 hours**

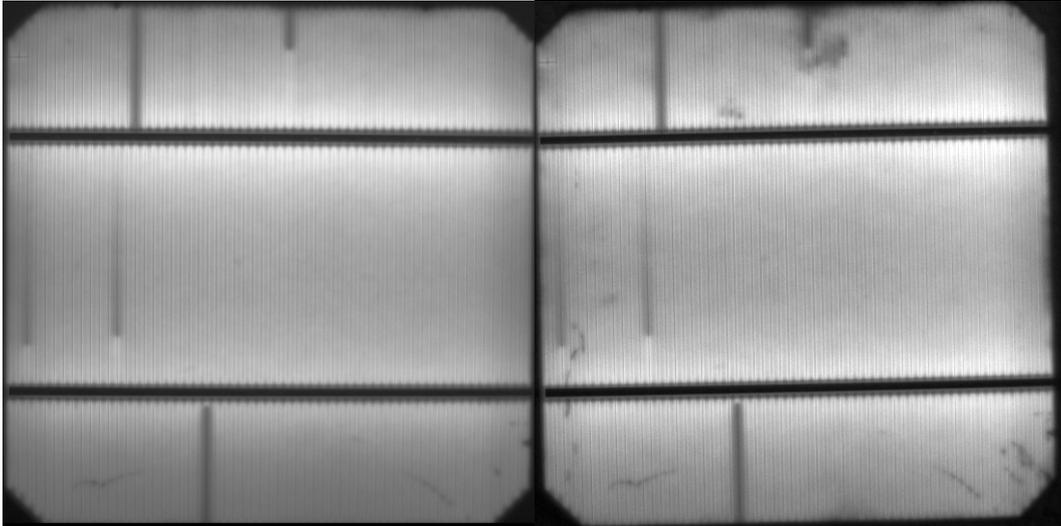
**Figure 102. Left; H2-D3 at 0 hours. Right; after 96 hours HAST, at the top some growing darkened areas can be seen.**

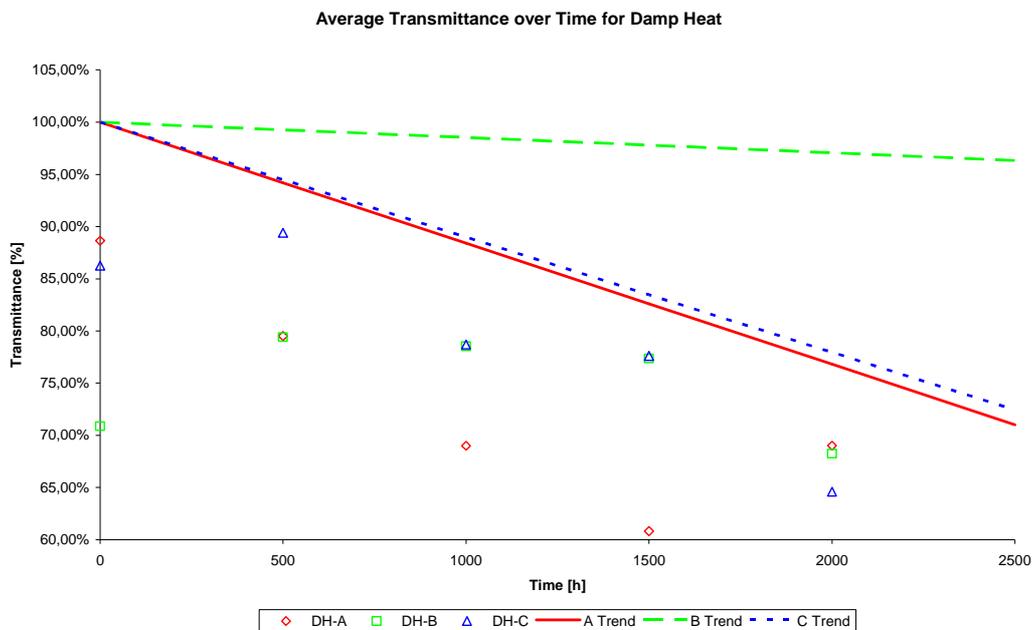
Figure 103. Transmittance for all three samples over time. Trend lines corrected to 100 %.

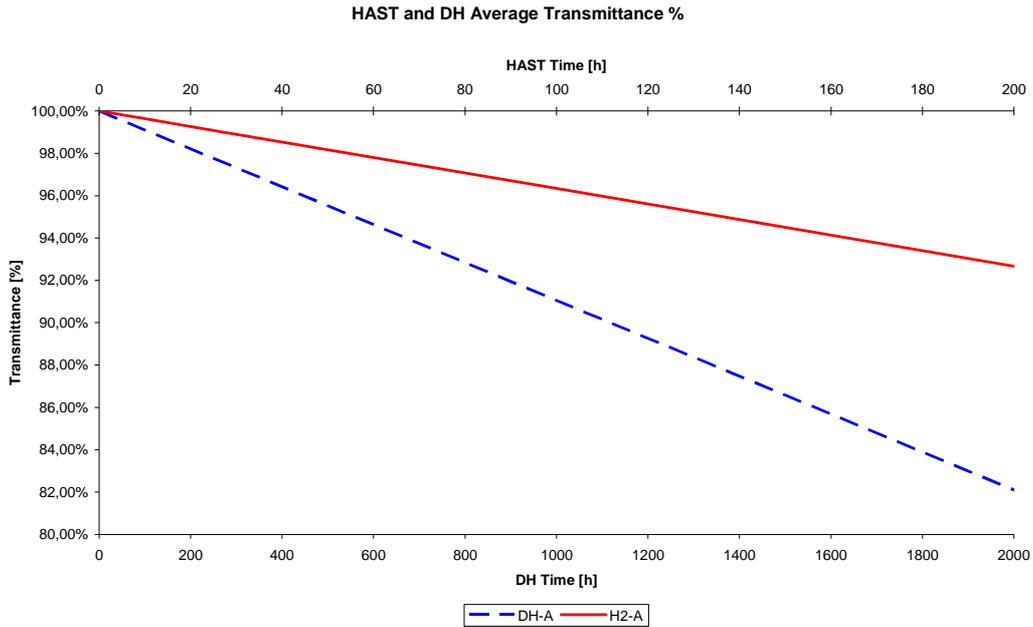
Figure 104. DH and HAST average transmittance degradation for A sample.

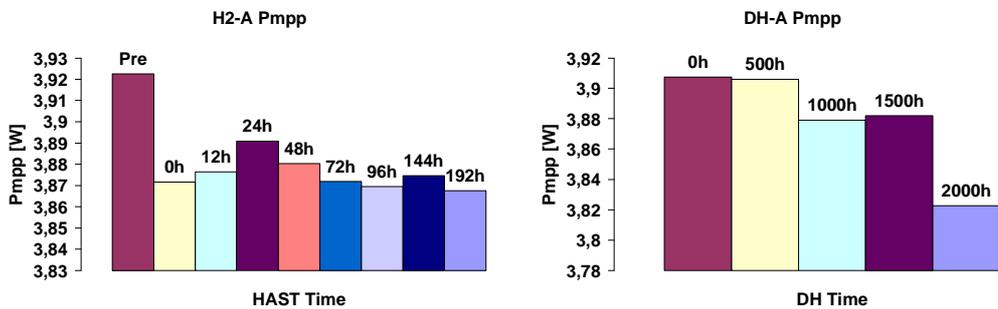
Figure 105. HAST and DH Average  $P_{mpp}$  values in W for sample A.

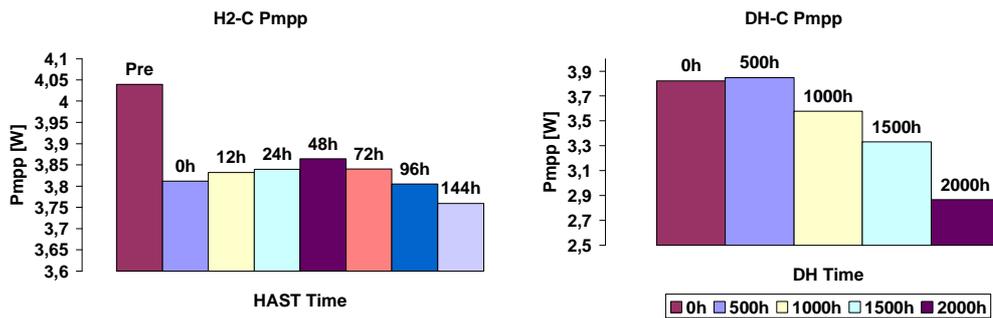
Figure 107. HAST and DH Average  $P_{mp}$  values in W for sample C.

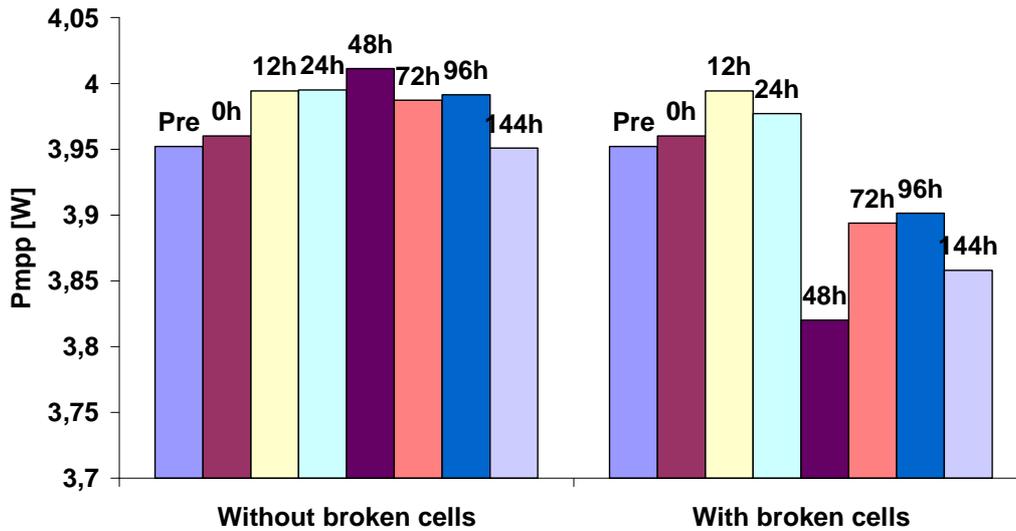
Figure 108. HAST sample D cells, with and without the broken cells
