## **Usage of Highly Accelerated Stress Test (HAST) in Solar Module Ageing Procedures**

*Master of Science Thesis*

**TOMAS HULKOFF**

Department of Electrical Engineering  
*Division of Energy and Environment*  
CHALMERS UNIVERSITY OF TECHNOLOGY  
Göteborg, Sweden, 2009

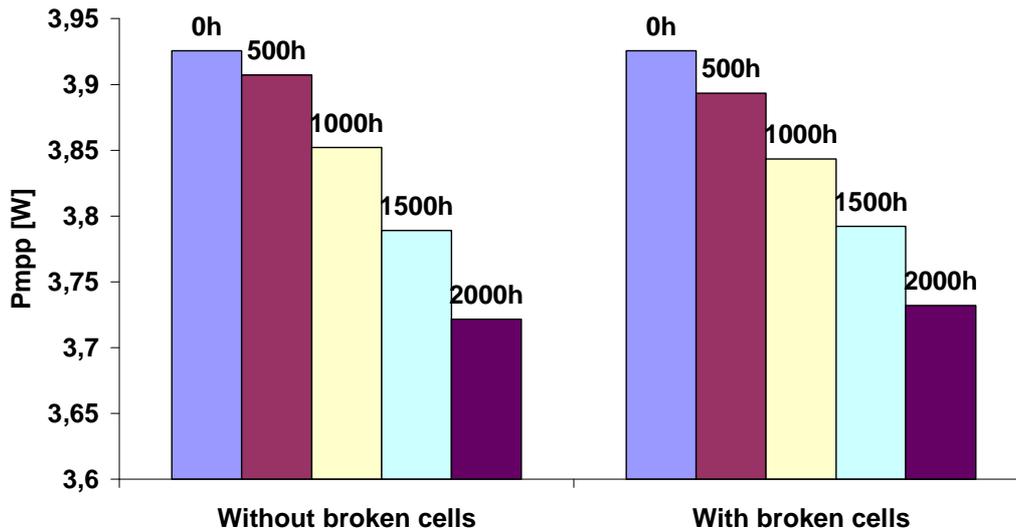
Figure 109. HAST sample D cells, with and without the broken cells

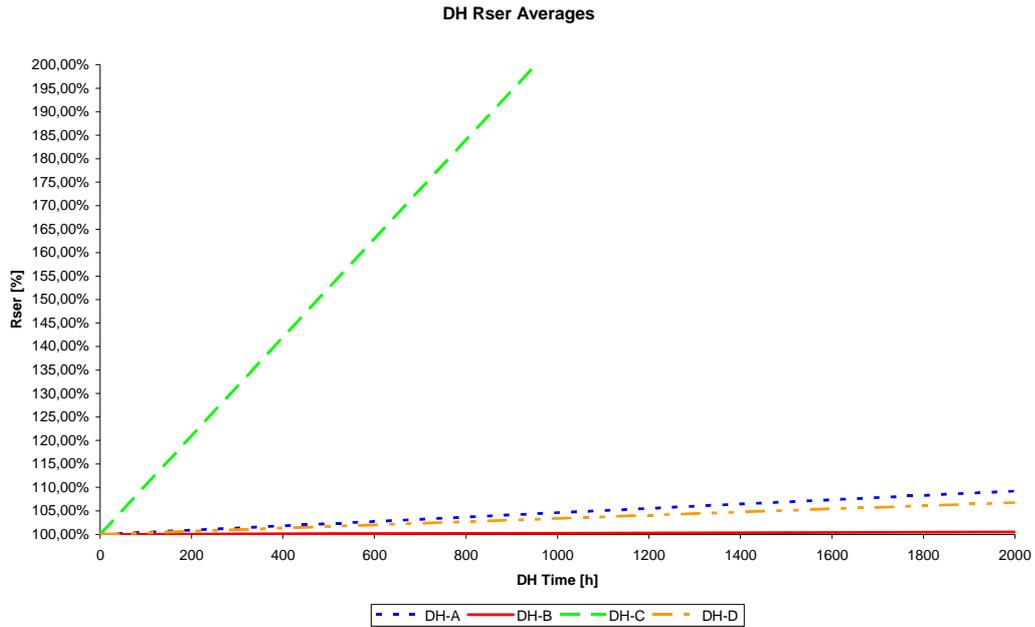
Figure 110. A comparison of DH average  $R_{ser}$  for each sample.
