## Resurrecting Håby church

*Communicating a millennium of alteration and rehabilitation through conservation and adaptive reuse*

Master's Thesis

Chalmers School of Architecture  
Department of Architecture & Civil Engineering

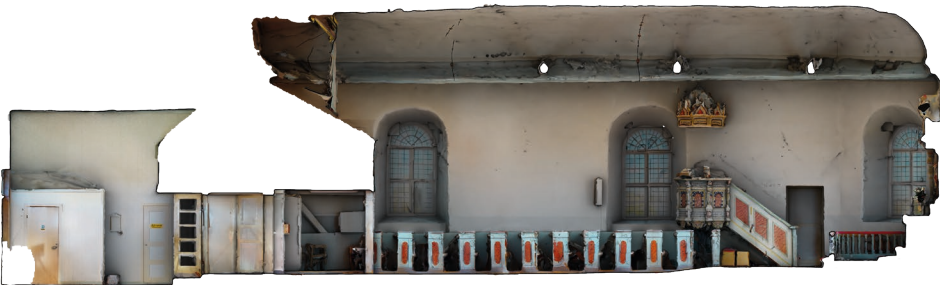
Fig. 57  
Section C-C of the  
photogrammetry of the nave and  
porch.  
Photogrammetry: Carl-Johan  
Claesson, used with permission

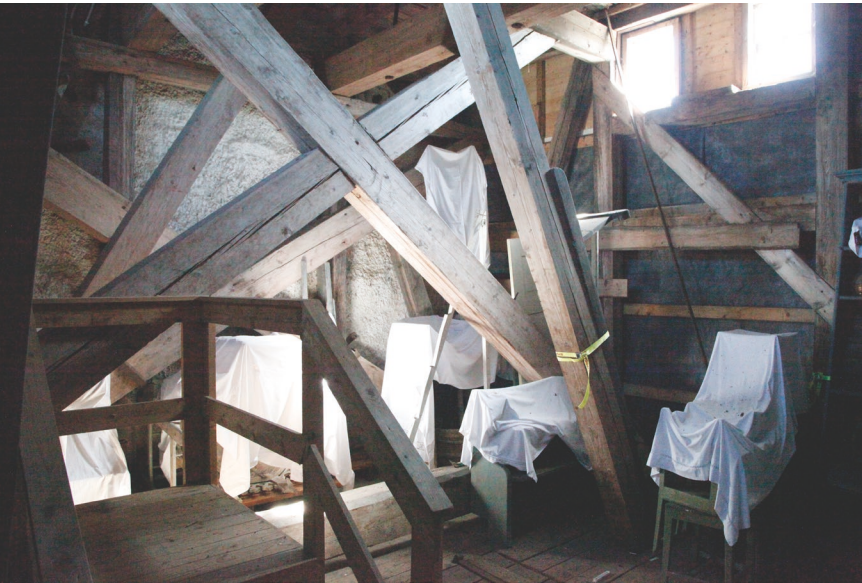
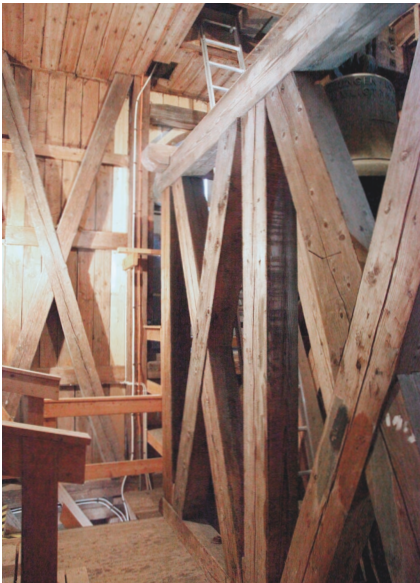
The third floor of the tower where the church-bells are mounted.

The tower is a timber structure with several layers of redundancy in the horizontal bracing to safely carry the loads of the swinging church bells (Fig. 61). The second floor of the tower (Fig. 59-60) is mainly used for storage of unused inventories but is quite obstructed by the bracing members. Clad with copper, the roof was repaired in 2016.

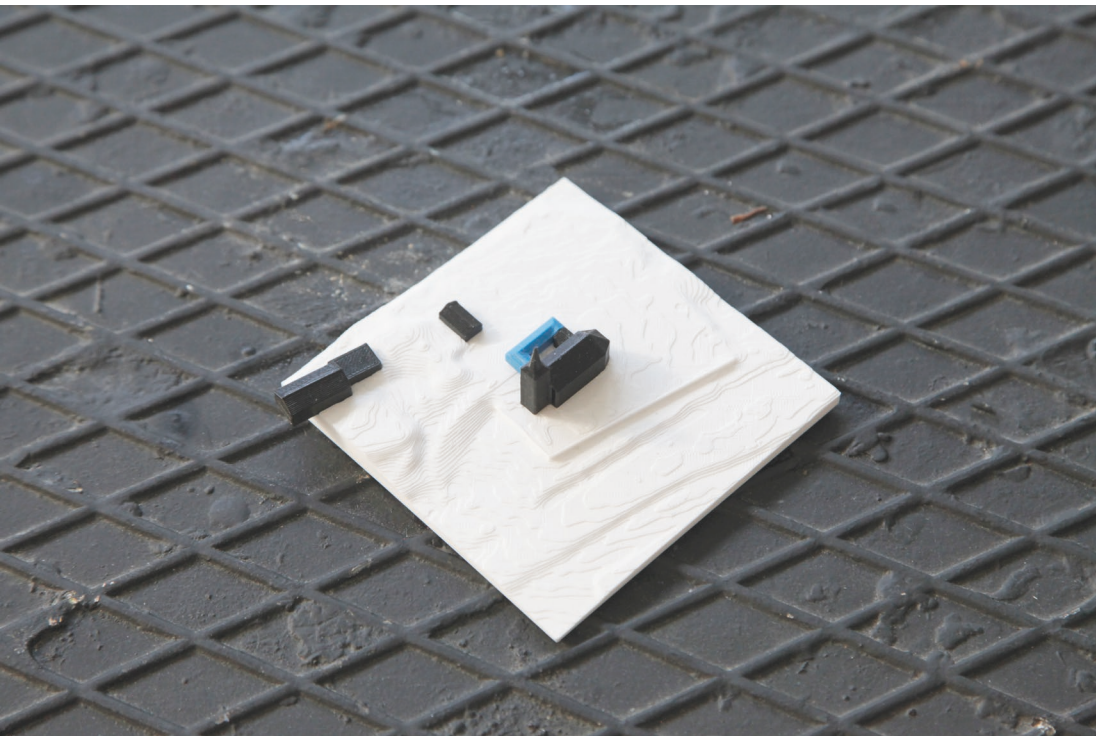
Fig. 73

The chosen volume for the addition, photographed from the 3D-printed model of it on the site.  
Model scale: 1:1000

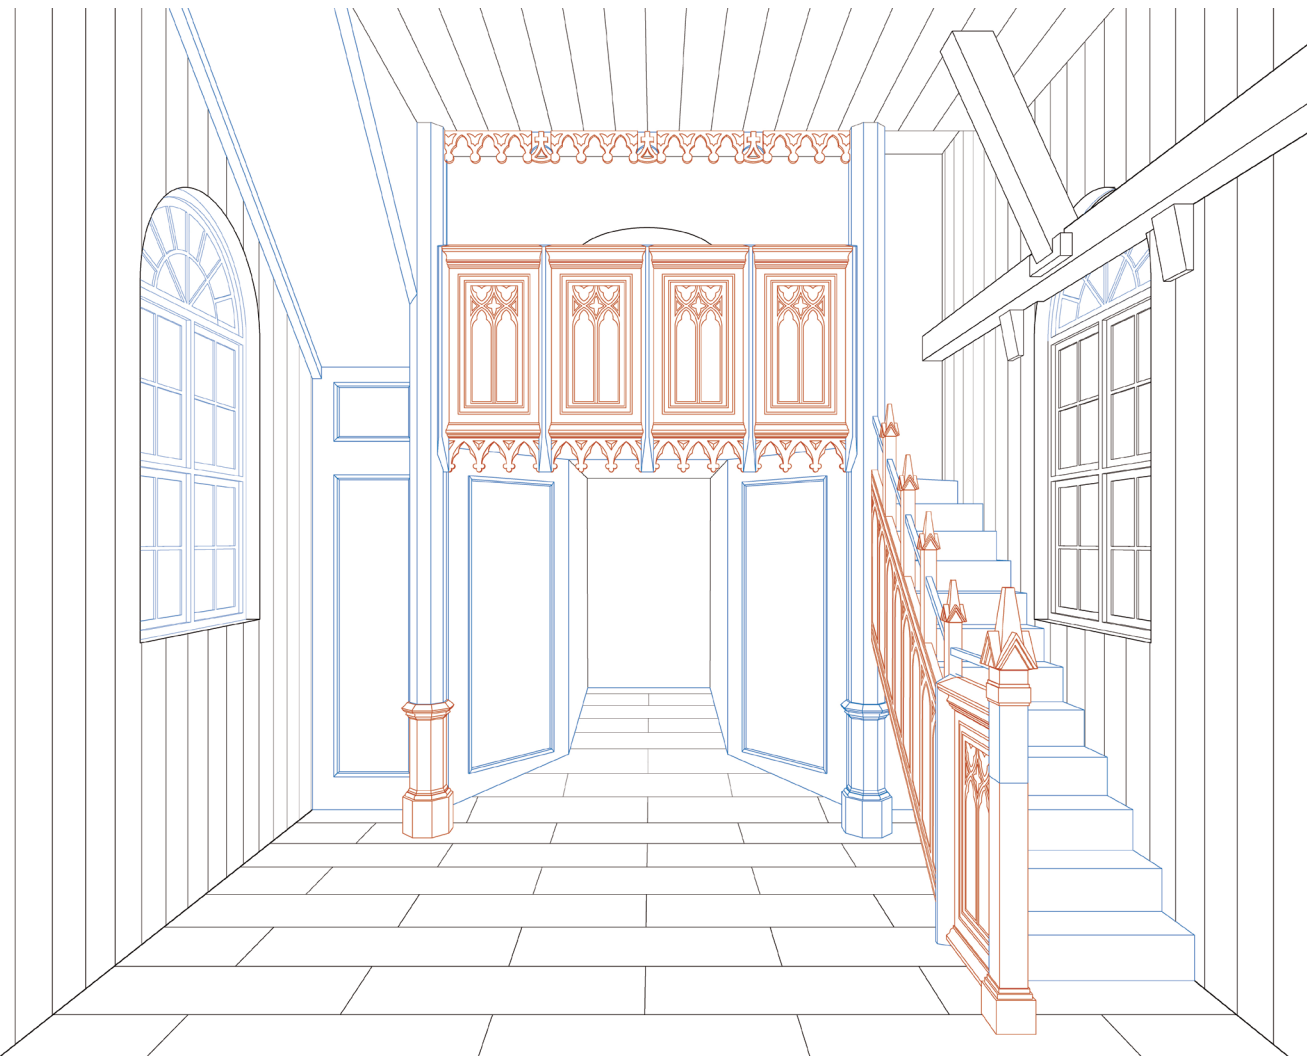
Linedrawn perspective of the new staircase showing where the different elements of the pulpit have been reused

The existing staircase has been changed in many stages and the access to the upper floors of the tower gives the impression of an improvised solution. Since the tower as well as the decommissioned pulpit stored in the tower are both from the 1870s, the design proposes a reversible disassembly of the pulpit (Fig. 109). The parts are then used in the making of the new staircase, restoring the style of the room to something closer to the 1870s appearance (Fig. 110). The currently blocked and false-window to the north is reopened (Fig. 108) which further restores the light and space in the room to its original qualities. The current limestone floors are reused in the making of the permanent accessible ramp into the nave.
