Condition of bicycle paths

The importance of full-width measurements

Master's thesis in Infrastructure and environmental engineering

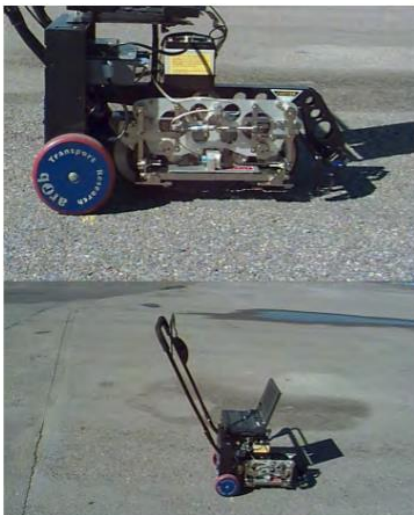
Figure 2.2 ARRB TR Walking Profiler (Niska & Sjögren, 2007).

The unevenness can be measured with manual equipment. The manual equipment does not provide heavy loads that damage the bicycle paths and can be used where the width is narrow. Some techniques used for manual equipment can be scaled up or mounted on measurement vehicles. The Dipstick equipment plots the profile by measuring the height difference and inclination between two points (Niska & Sjögren, 2007). The Face company manufactures equipment with about 30.48cm between the measuring points (FHWA, 2008). The ARRB TR Walking Profiler was developed in Australia, the equipment can be seen in Figure 2.2. The profile can be read from the variation in inclination of a 23cm long plate pushed along the path surface (Niska & Sjögren, 2007). To measure the surface roughness at a local spot the “Sand Patch-method” can be used (Viman, 2017). The Sand Patch-method is performed by pouring out 25ml of sand with specific particle shape and size in a pile on the pavement surface (CEN, 2019). The sand is then smoothed out in a circle on the surface until it is flat, and the sand is filling the space between grains in the pavement. The sand volume is divided by the area of the circle to get the texture depth, see Figure 2.3.

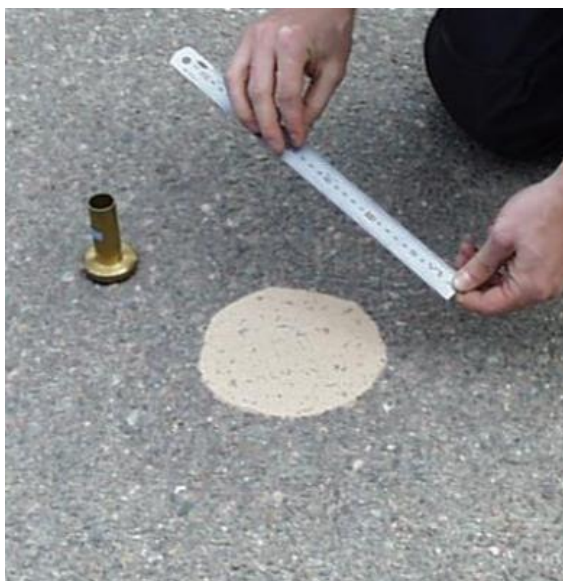
Figure 2.3 Sand Patch-method, photo by Andreas Waldemarson (Viman, 2017).

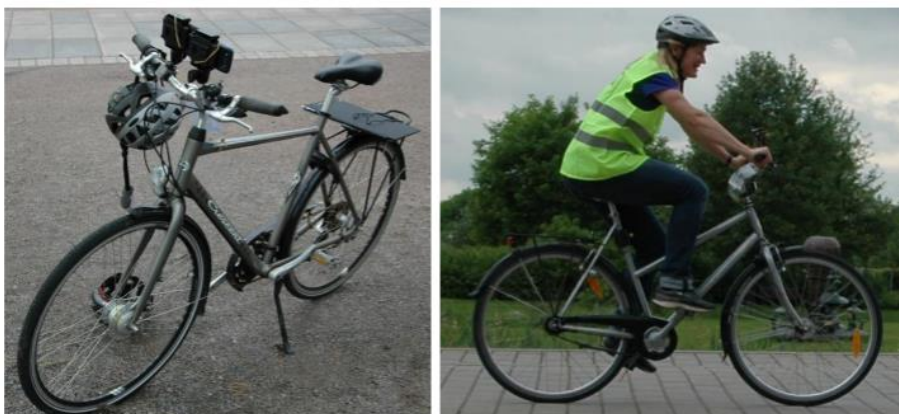
Figure 2.4 Measurements with an accelerometer in a smart phone mounted on a bicycle (Niska & Sjögren, 2014).

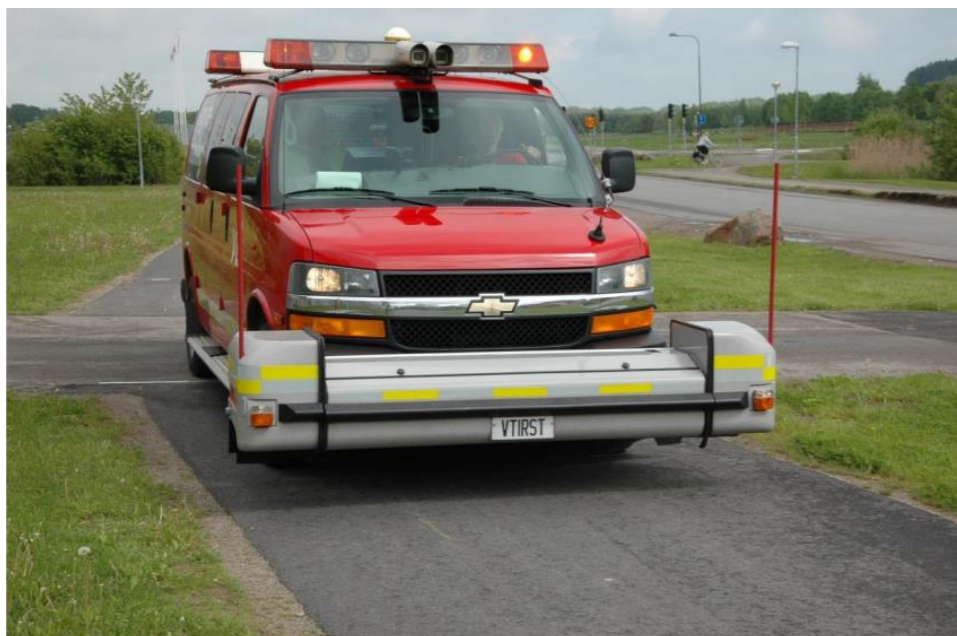
Figure 2.5 Measurement with VTI's laser RST (Niska & Sjögren, 2014).

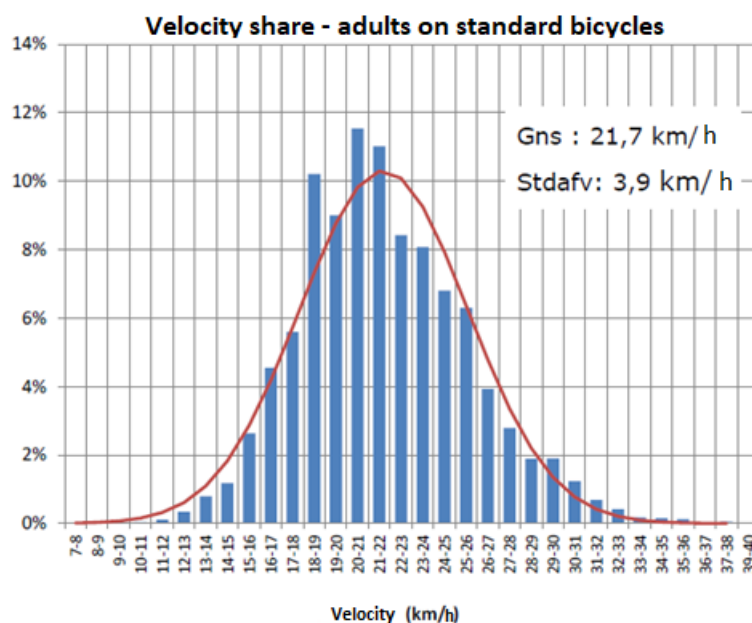
Figure 2.6 Velocity distribution on bicycle paths, adults on standard bicycles (adapted from Greibe & Skallebæk Buch, 2013).

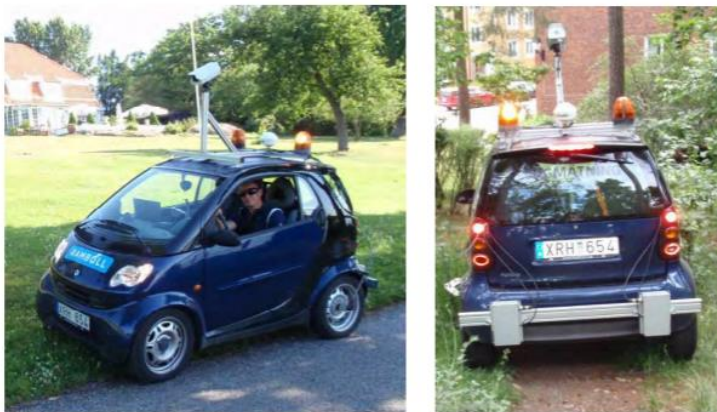
Figure 2.8 Smart car, equipped with two laser sensors (Niska, Sjögren & Gustafsson, 2011).

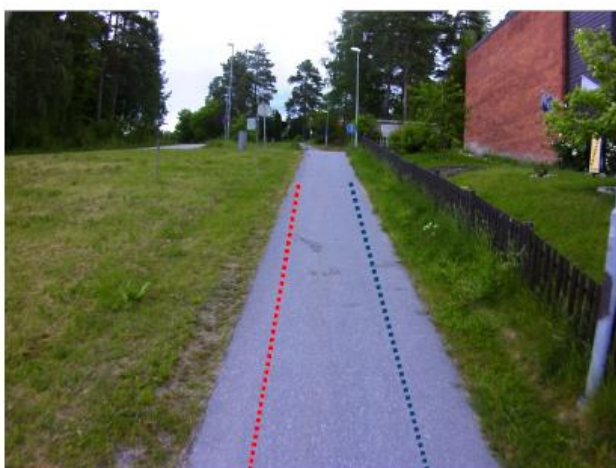
Figure 2.9 Comfort measurement of Unevenness in two paths (Sveriges Kommuner och Landsting, 2011).

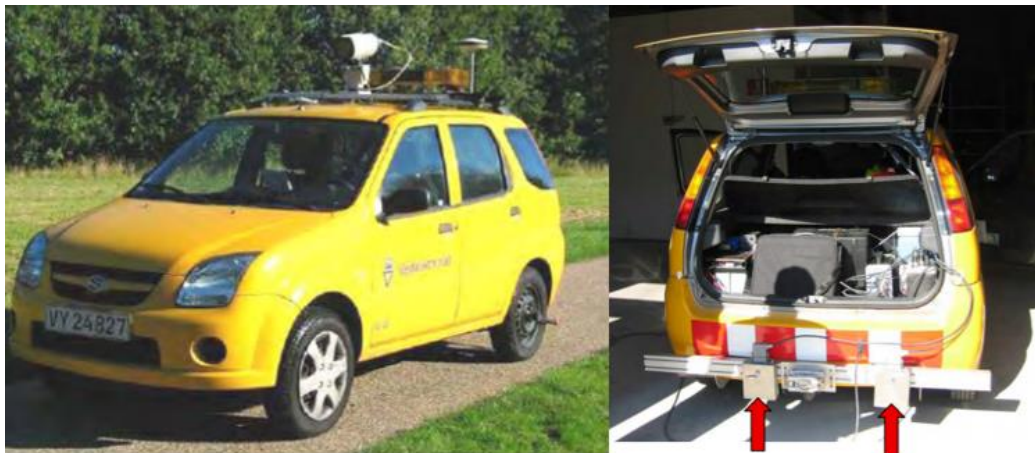
Figure 2.10 Measurement vehicle at the Danish Road Directorate (Niska & Sjögren, 2007).

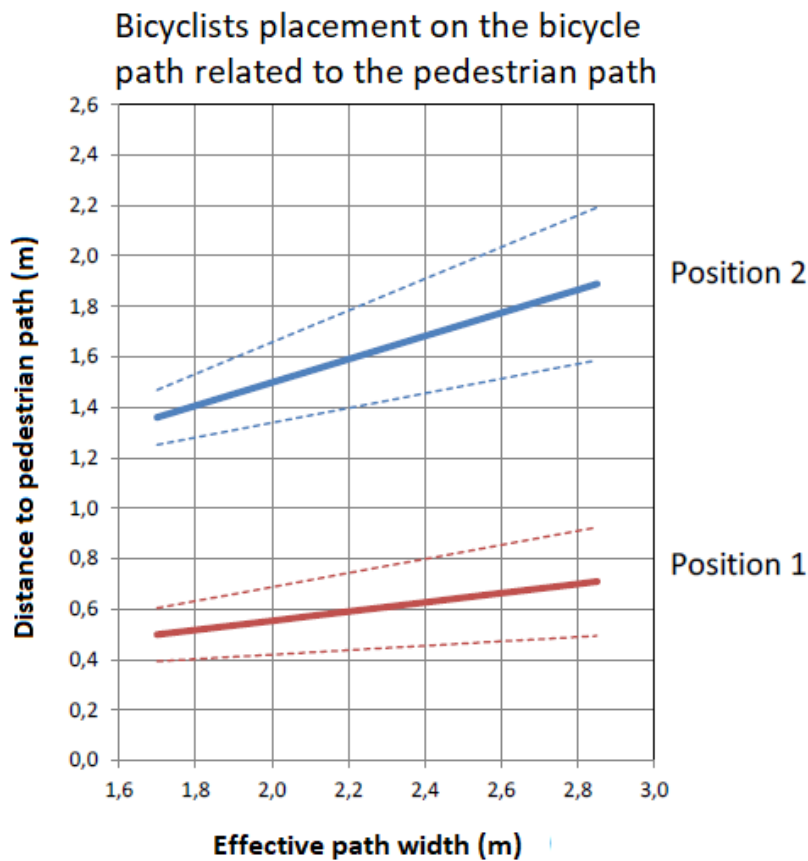
Figure 2.12 Placement on bicycle paths (adapted from Greibe & Skallebæk Buch, 2013).

In Danish bicycle path regulations, the maximum capacity of a 2 meters wide path has a capacity of 2000 bicyclists/h (Greibe & Skallebæk Buch, 2013). Investigations were performed to suggest updates on these regulations. The data collection was measured with video cameras on eight locations around Copenhagen with different prerequisites. 97.8% of the observed bicycles were ordinary bicycles and 1.5% was special bicycles, like bicycles with trolleys etc. the rest were mopeds or other vehicles. Bicycles with trolleys are around 10-20 centimetres wider than a standard bicycle and occupy around 1.3 times more space on the bicycle path. Suggested path width from this study can be found in Appendix A, Table A3. The investigation also considered the location of the bicyclists on the bicycle path which is represented in Figure 2.11 and 2.12.

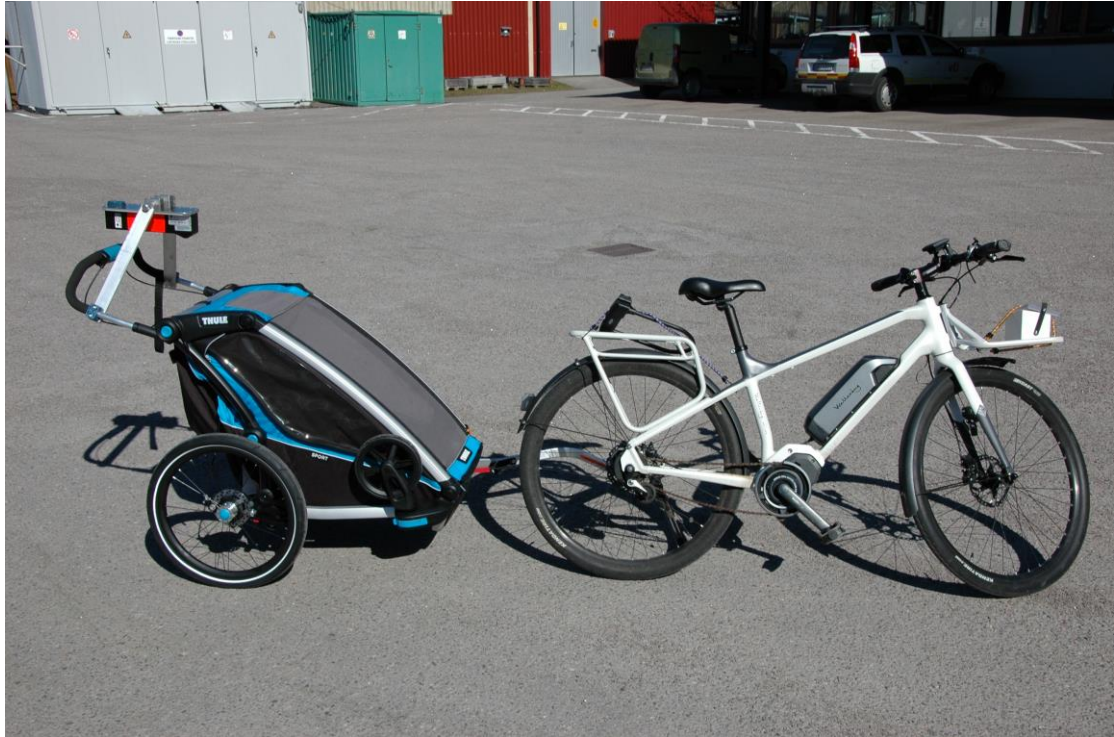
Figure 3.2 Bicycle and trolley with mounted equipment, left side (Leif Sjögren, 2019-04-01).

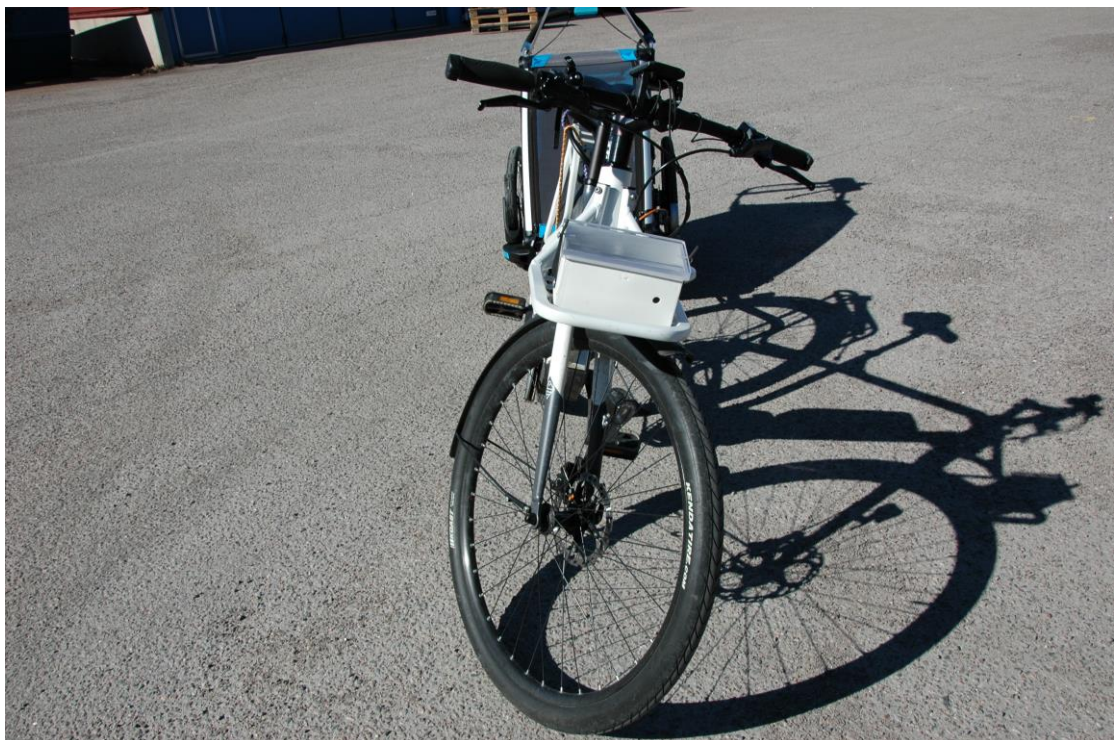
Figure 3.3 Bicycle and trolley with mounted equipment, front view (Leif Sjögren, 2019-04-01).

The smart phone is mounted in a box, placed on a front mounted luggage carrier on an electric bicycle which is also carrying the bicycle trolley, see Figure 3.3 and 3.4. The smart phone has an installed application developed by VTI which is measuring the acceleration along three axes, lateral, vertical and horizontal acceleration. The position of the measurement will be detected by the GPS in the smart phone. The smart phone will take pictures of the path every 10th meter through the hole in the box in Figure 3.3. Data from the app can be unreliable in curves where the bicycle is inclined at high speeds. The bike trolley will in the future also be equipped with light sensors to be able to detect direct and reflecting light on the bicycle path.

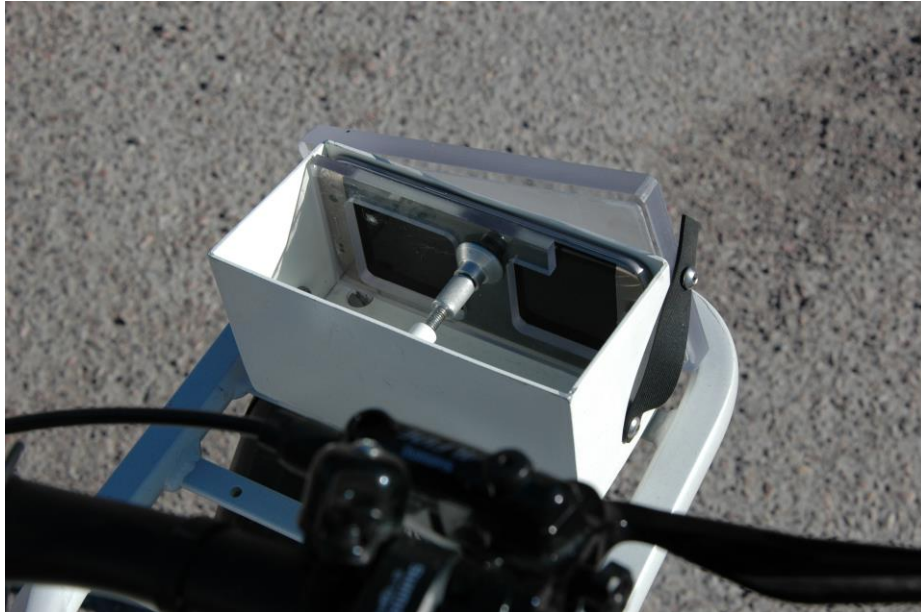
Figure 3.4 Box for mounting of smart phone (Leif Sjögren, 2019-04-01).

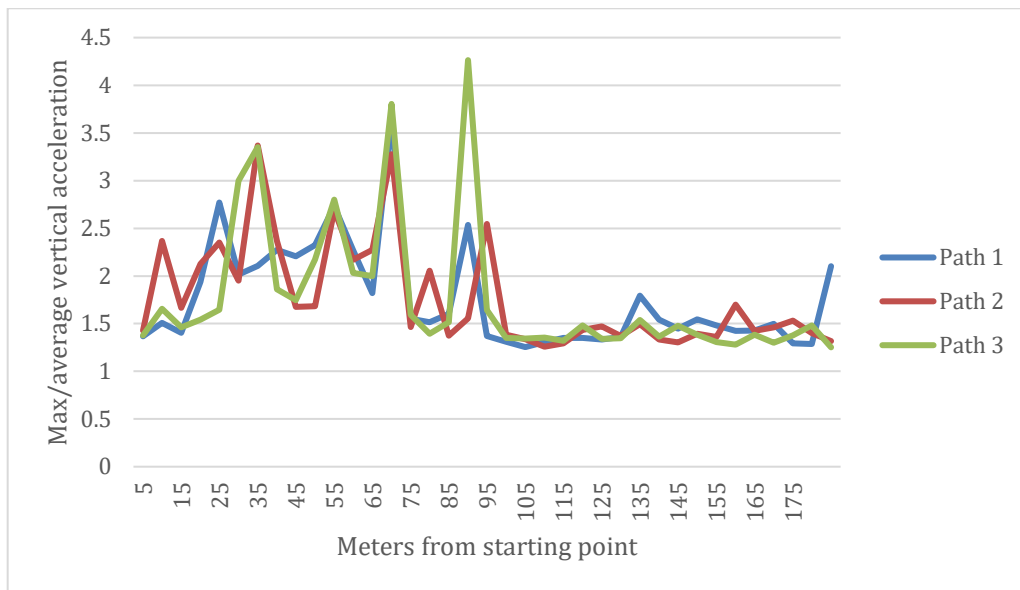
Figure 4.2 Measurements Path 1, Path 2 and Path 3

There is a difference in measurements in different wheel paths on the same bicycle path, as can be seen in Figure 4.2. There is a peak in Path 3 at 90 meters which is larger than in the other paths. At 72 meters into the stretch, there is a horizontal crack on the bicycle path, which all measurements indicate. The result from the application values shows that the first part of the stretch is less smooth than the last 70 meters. Measurements in the same wheel path, Path 2 also shows a difference between the different measurement runs (see Figure 4.3). Some correlation can be seen between Run 1 and Run 3.

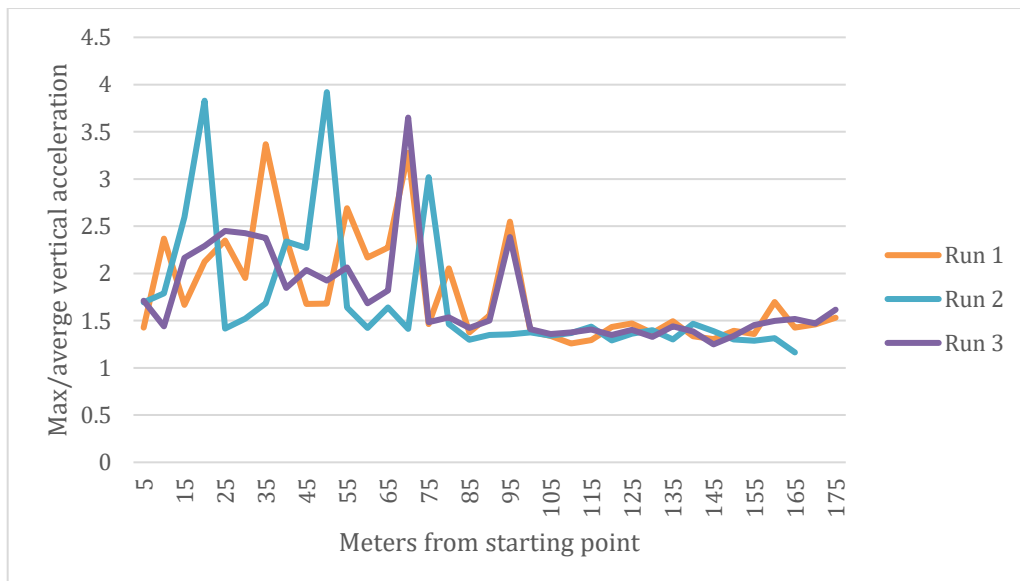
Figure 4.3 Measurements Path 2, three different runs

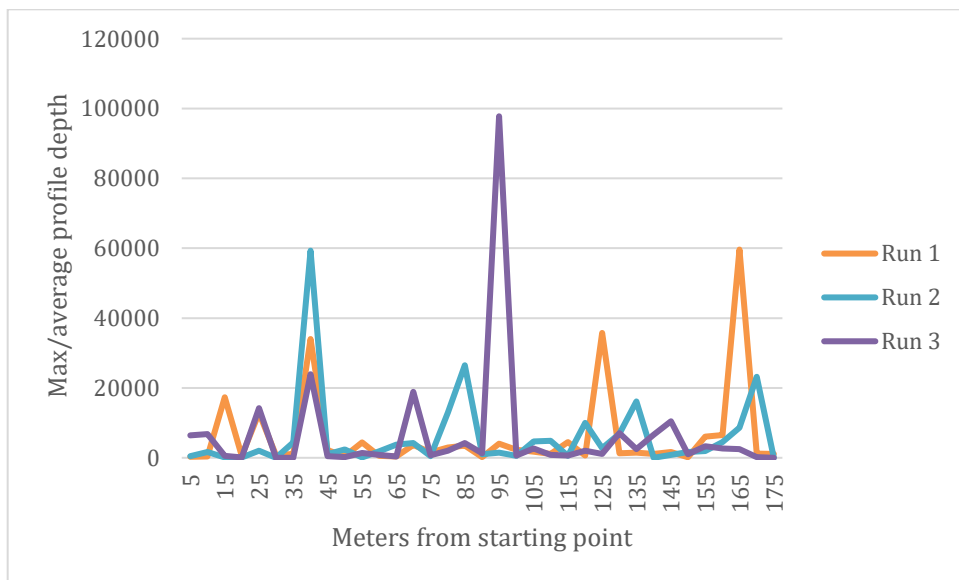
Figure 4.5 Measurements Path 2, three different runs

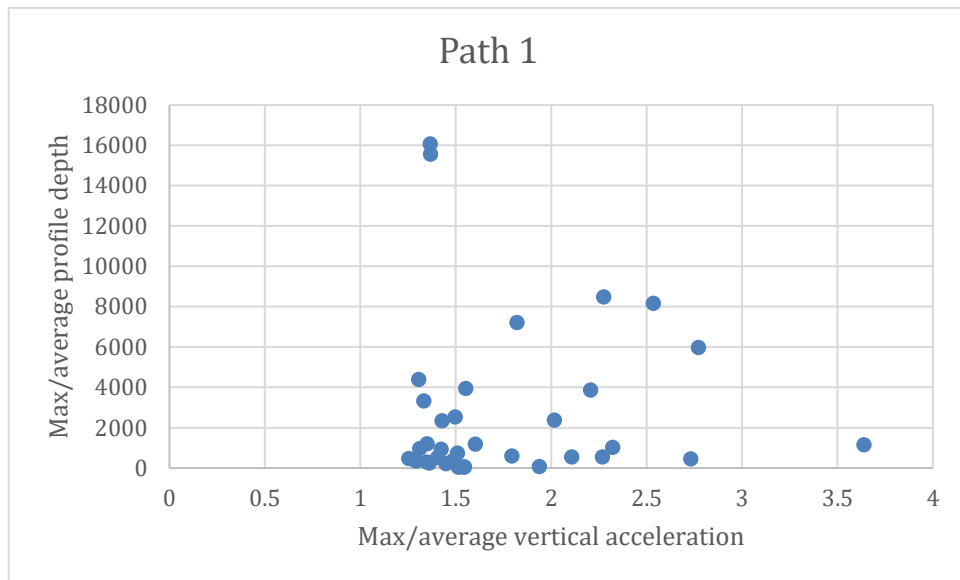
Figure 4.6 Measurements Path 1 with different measurement methods

When comparing the result from both accelerometer and profilometer measurements no functional relationship can be found for any of the paths, see Figure 4.6 – Figure 4.8. The recalculated values from the profilometer are plotted on the Y-axis and values from the accelerometer on the X-axis.

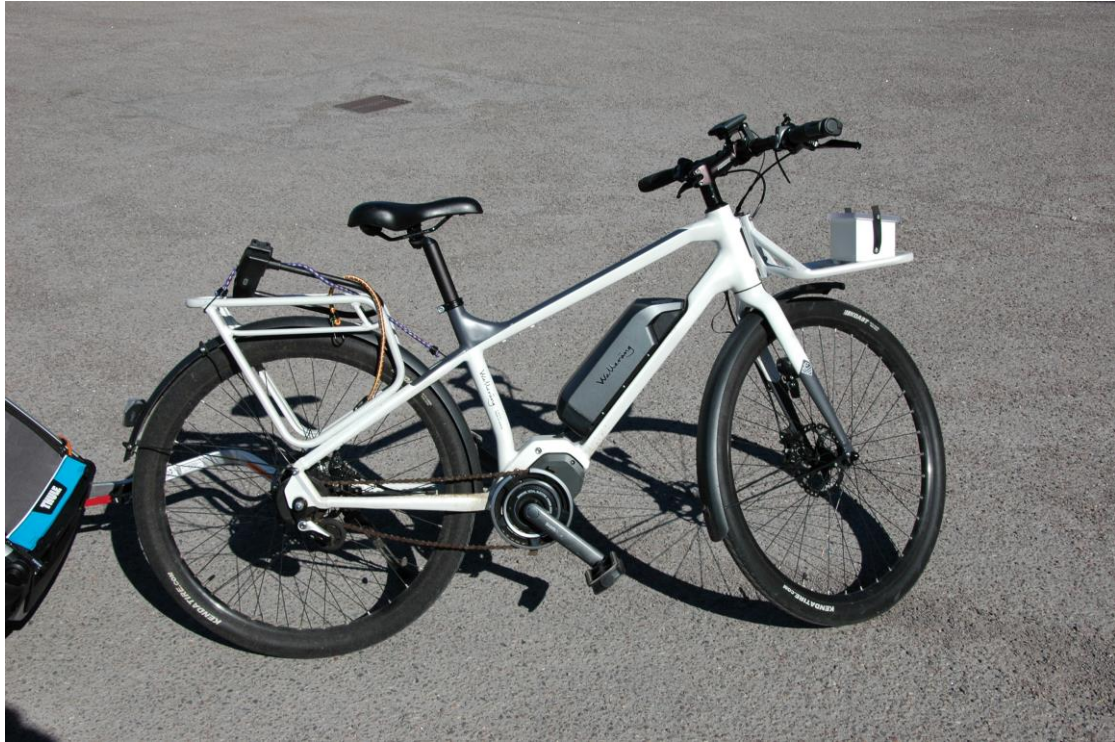
Figure B1 Bicycle used for measurements (Leif Sjögren, 2019-04-01).

The bicycle is of the brand Walleräng, model M01, see Figure B1. During the measurements, the bicycle computer was set on [A] HIGH. On the luggage carrier in the front, a box is mounted where the smart phone is placed during the measurements.

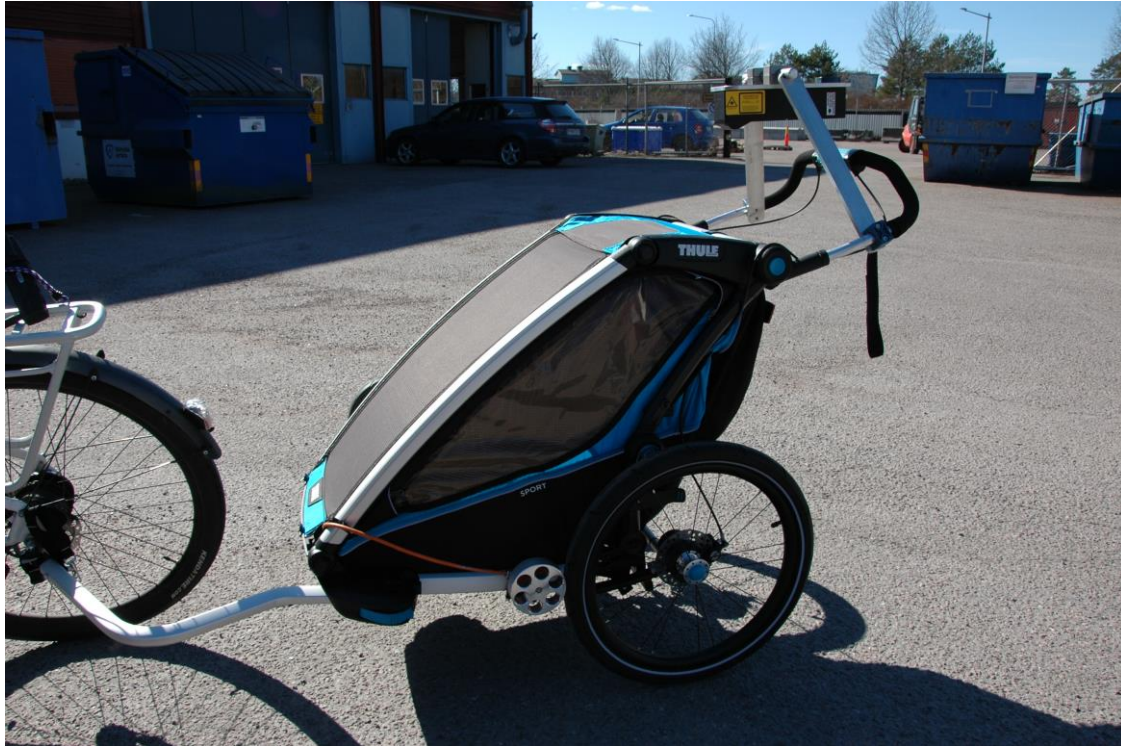
Figure B2 Trolley used for measurements (Leif Sjögren, 2019-04-01).

The trolley is of the brand Thule, see Figure B2. The damping of the trolley is disabled. A distance meter mounted on the right wheel is detecting the distance from the starting point. The laser sensor is mounted on the handlebar. The trolley is carrying a battery and electronic components to transfer the profilometer data from the laser sensor to a computer also placed in the trolley beside the battery during the measurements.

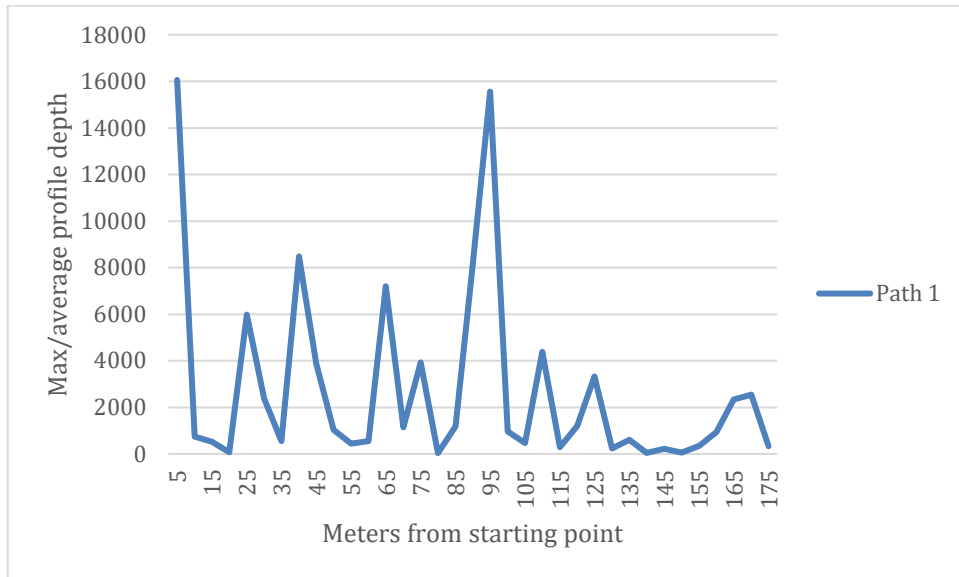
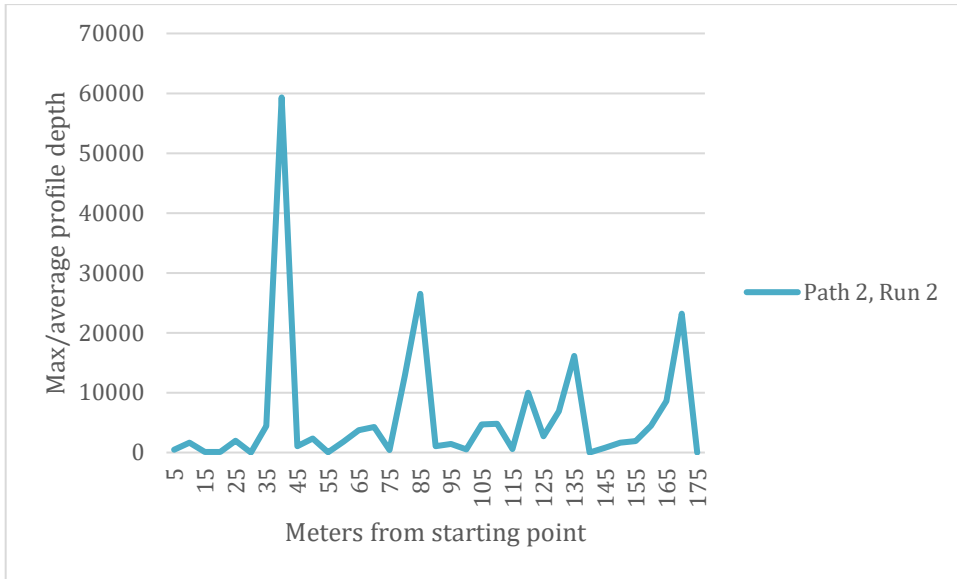
Data collection on the stretch in Linköping measured with the Gocator laser sensor 2375A-3B-N-11. The sensor registered the profile consistently over a width of 520 mm. The measurements were recalculated by zeroing the horizontal profile and for every 5 meters, divide the maximum with the average value. Figure C1 shows the result from the calculation, based on the measurement on Path 1. The result in Figure C2-C4 are based on the measurements on Path 2 and Figure C5 is based on Path 3.
