How can corrosion damages be estimated based on surface observations?

Master's thesis in Master Program Structural engineering and building technology

MASTER'S THESIS ACEX30 2024

Department of Architecture and Civil Engineering
Division of Structural Engineering
Research group: Concrete Structures
CHALMERS UNIVERSITY OF TECHNOLOGY
Gothenburg, Sweden 2024

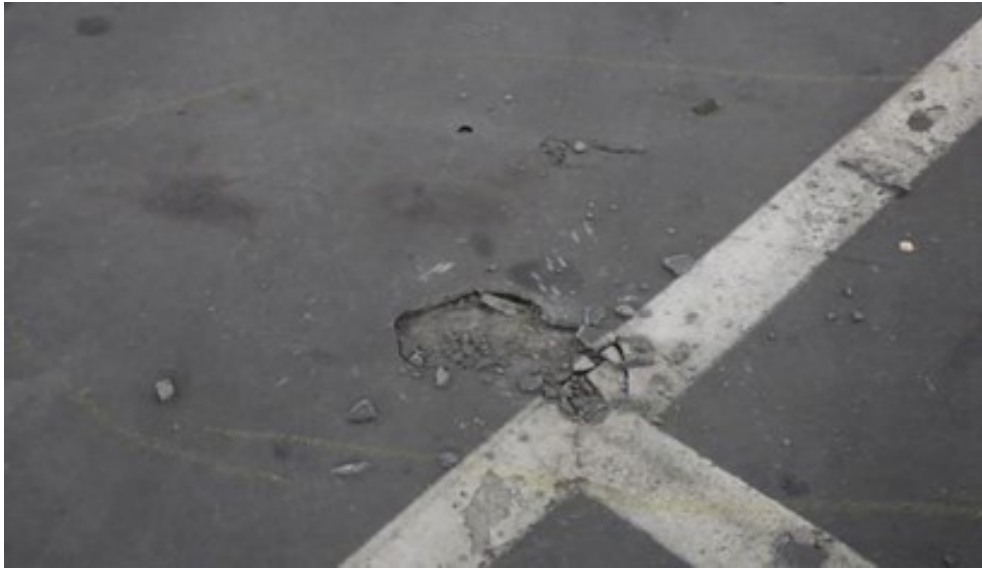
Figure 3.2: Cracks and concrete spalling in the upper section from Afry reports.

Chlorides primarily reach the rebars through two pathways: one via vehicle tires and de-icing salts, and the other due to chloride content present in the cement, depending on the construction time of the parking lot. Inspections covered upper and lower concrete slab sections as shown in figure 3.2. The upper section exhibited corrosion-related damages such as cracking, concrete spalling, reinforcement corrosion, and accumulation of corrosion by-products. In the lower section, there was less damage, likely due to the lower proximity of harmful materials from passing vehicles.

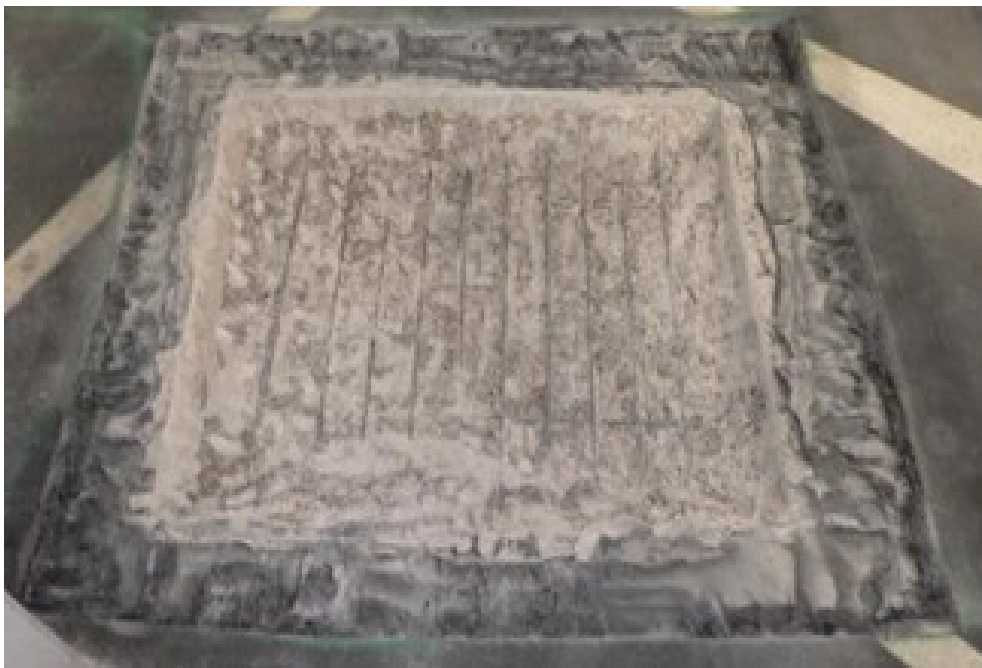
Figure 3.4: Reinforcement status in window F3 from Afry reports.

In this window, the impact of the protective surface layer is clearly visible. This layer prevents harmful substances from reaching the rebar surface, resulting in the rebar remaining in good condition. Additionally, the thickness of the concrete cover is appropriate, which is another reason for the delay in harmful substances reaching the rebar surface and initiating the corrosion process. In fact, the surface layer acts as a shield against corrosive materials and potential damage, ensuring the structural concrete remains intact.

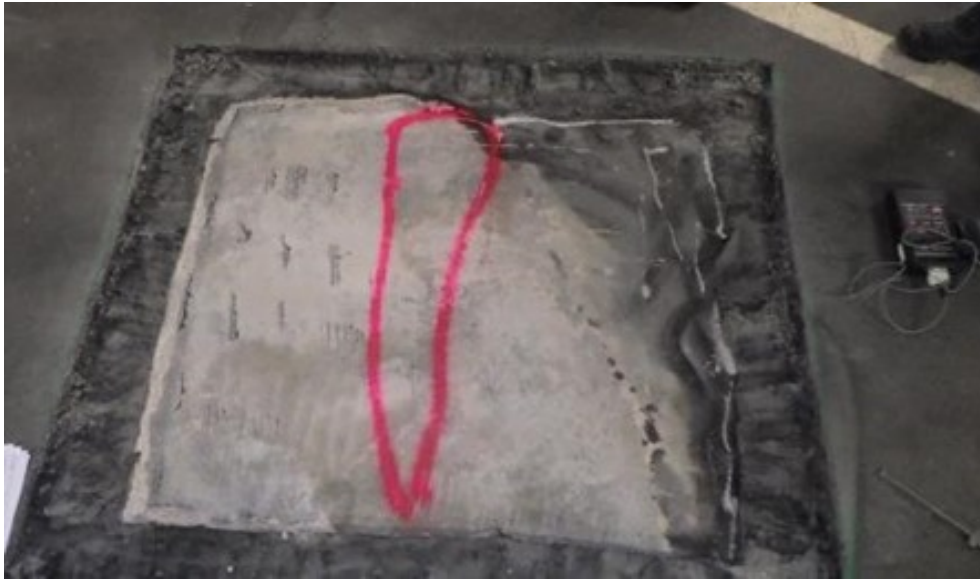
Figure 3.5: Location of window F4 from Afry reports.

Similarly, Window F4 was positioned in a comparable location near a column where delamination of the road surface was observed. Excavation through the road, insulation, and covering layers until reaching the concrete substrate is conducted, as illustrated in Figure 3.5. The outcomes of the investigation are detailed in Table 3.4.

In this window, the overlay thickness is less than in window F3, which could be one of the reasons harmful substances have reached the rebar surface, causing corrosion. Additionally, damage to the structural concrete has provided an easier path for more harmful substances to penetrate, accelerating the corrosion process. The impact of cracks is also clearly visible in this window, with corrosion occurring precisely near the cracks.

Parameter	Measurement notes from examination of F4
Cast asphalt + Insulation mat	Thickness 35-40mm
Overlay (hard concrete)	Unreinforced, thickness 0-25 mm. Probably executed for slope buildup. The overlay was delaminated and lacked adhesion to the structural concrete.
Structural concrete surface	Fine crack in the structural concrete, 0.1 mm. Delamination indication was directly adjacent to the crack. Delamination area approximately 0.1-0.2×0.95 m.
Concrete cover layer	30 mm. measured with a cover meter
Other	Based on all window inspections, it is likely that localized corrosion exists on the reinforcement mesh beneath the crack area. Corrosion attacks in the window are probably not extensive as only a weak and localized delamination indication could be heard.

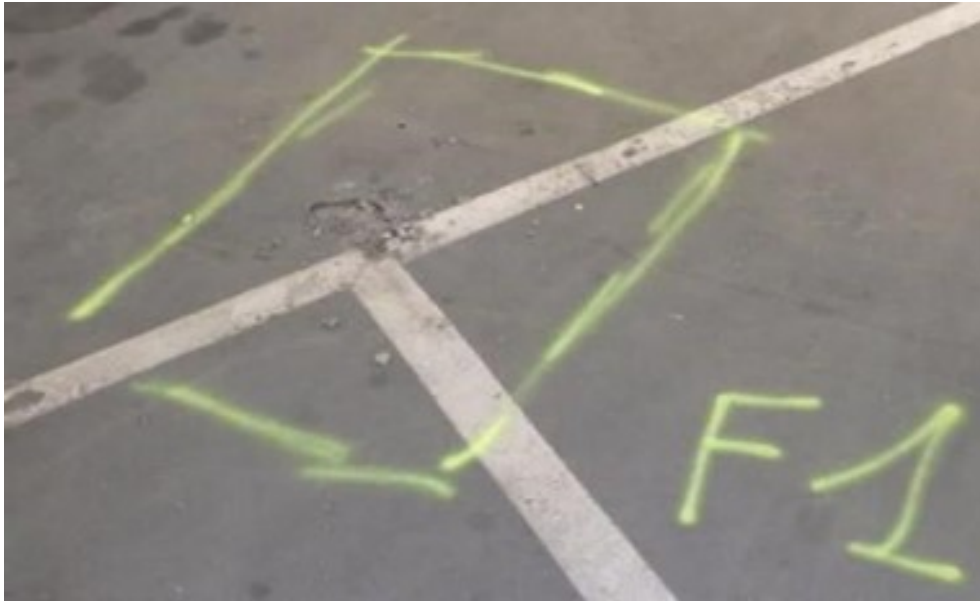
Figure 3.6: Location of window F1 in the second floor from Afry reports.

As previously described, considering visual signs such as the extent of corrosion cracking, and concrete spalling, and also conducting the hammer test to diagnose delamination, two windows with dimensions of 1x1 m were opened on this floor, based on the visual condition for inspection. Window number one, as illustrated in Figure 3.6, was opened in the section where concrete spalling and surface cracks were present on the main beam and at the lower part.

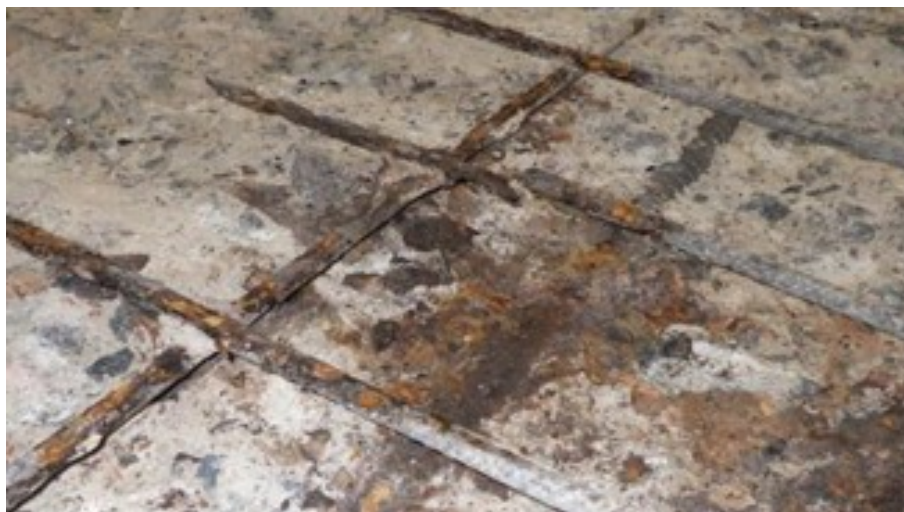
Figure 3.7: Condition of the reinforcement in the Window F1 from Afry reports.

Figures 3.7 depict the condition of rebars in the opened window.

Information regarding the condition of concrete and rebars has been compiled in Table 3.5. As expected, given the width of existing cracks and the thickness of the concrete cover, the corrosion rate of rebars in this section is high.

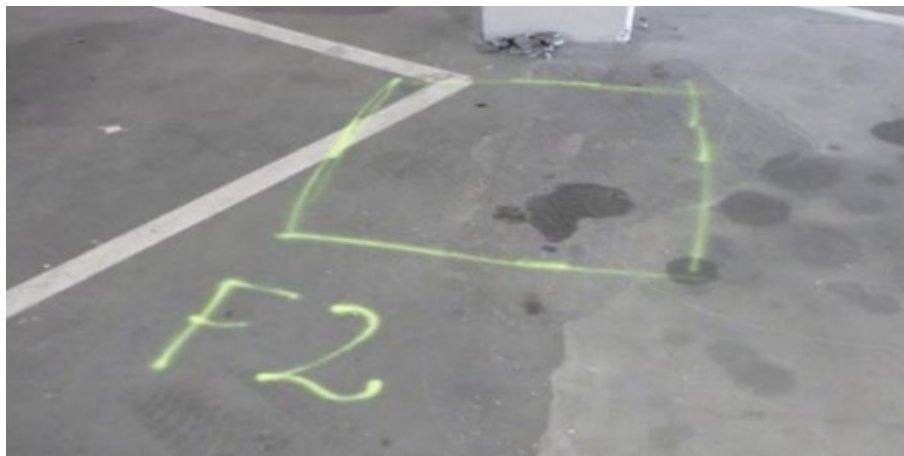
Figure 3.8: Location of window F2 from Afry reports.

Window F2 was positioned at a lower elevation next to a column and above a main beam. Its surface exhibited partial delamination, extending into an area that had previously undergone repairs, as illustrated in Figure 3.9

Detailed findings from the measurements and examination conducted on F2 are outlined in Table 3.6

Parameter	Measurement notes from examination of F2
Overlay (hard concrete)	Thickness 14mm
Reinforcement $\phi 8, S100$ (<i>upperlayer</i>)	Corrosion level: Several reinforcement bars with severe corrosion. At least 6 mm remaining diameter.
Main reinforcement $\phi 16, 1$ <i>piece</i>	Corrosion level: locally 12 mm remaining.
Concrete Cover layer (including overlay)	Approximately 30 mm
Other	Repair concrete did not fully encase the reinforcement (not underneath).

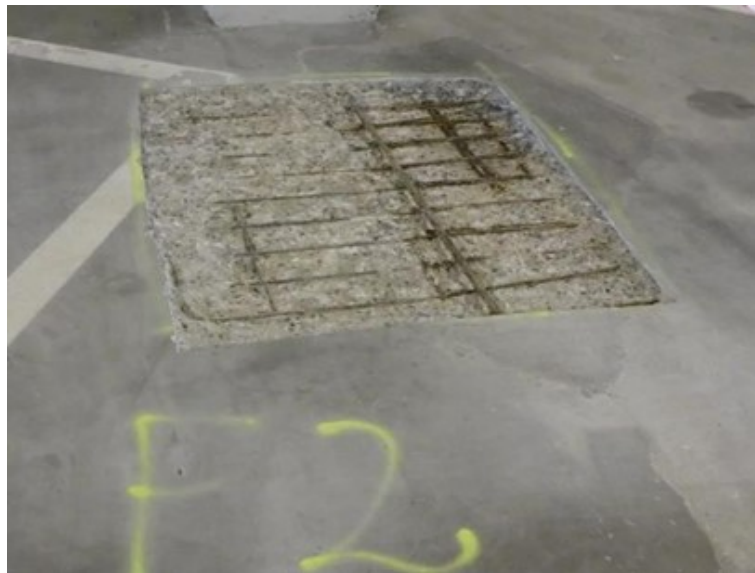
**Figure 3.9:** Status of the bars in the window F2 from Afry reports.

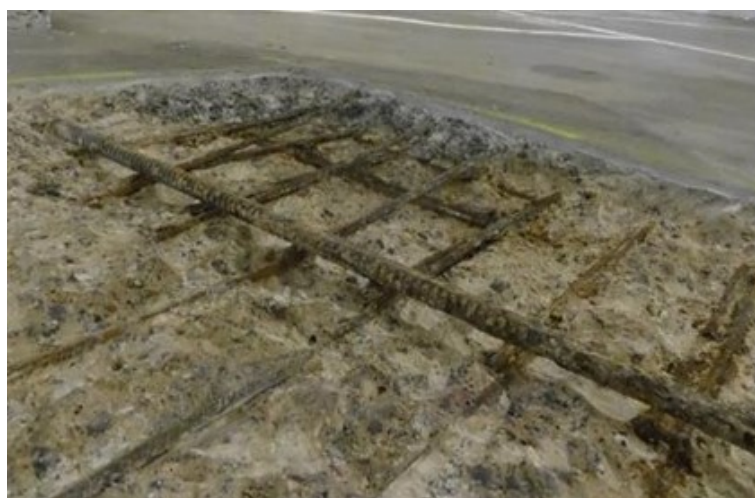
**Figure 3.10:** Status of the bars in the window F2 from Afry reports.

The status of the bars can be observed in Figures 3.10 and 3.11.

The conducted window inspections confirm that the identified delamination areas and cracked surfaces at the top of the floor slabs are caused by reinforcement corrosion. Considering the nature of the corrosion attacks, it is highly likely that the damage is caused by chloride ingress. The inspection reveals severe corrosion attacks on the mesh reinforcement but also significant attacks on the main reinforcement. It cannot be ruled out that there are areas with even more severe corrosion attacks on the main reinforcement.

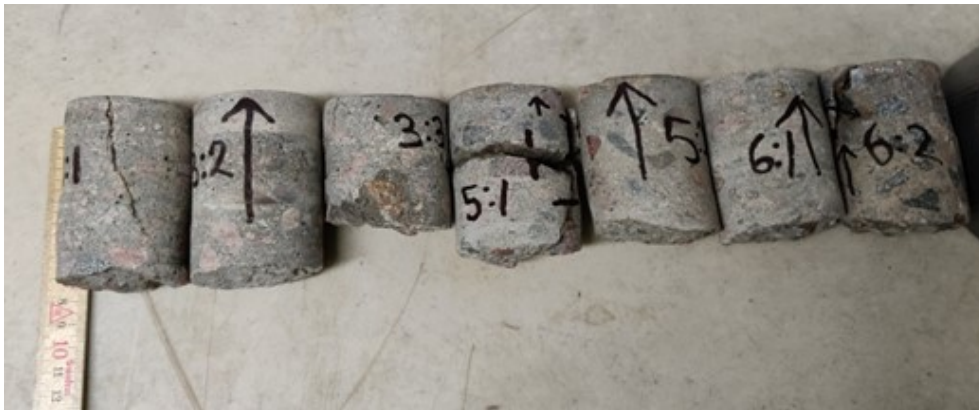
Figure 3.11: Crack width in different samples from Afry reports.

These findings underscore the importance of crack width and concrete depth in assessing chloride penetration and its impact on reinforcement corrosion. In this case, based on visual inspections and observation of some corrosion signs, sampling was conducted at various points on different floors to examine the depth of cracks and the chloride content present in concrete. The cracks are, in several instances, significant at the surface, exceeding 1 mm in width. The maximum crack width measured at core sample position 5:1 was 2.5 mm, as shown in Figure 3.11.

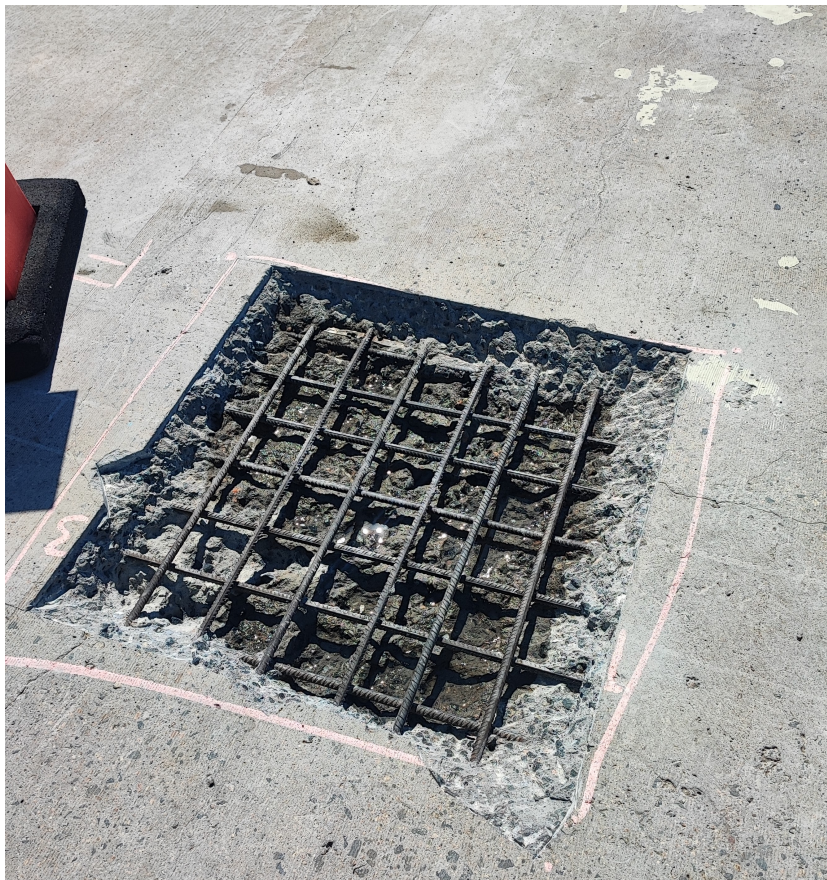
Figure 3.13: Reinforcement statement in window F1 from Afry reports.

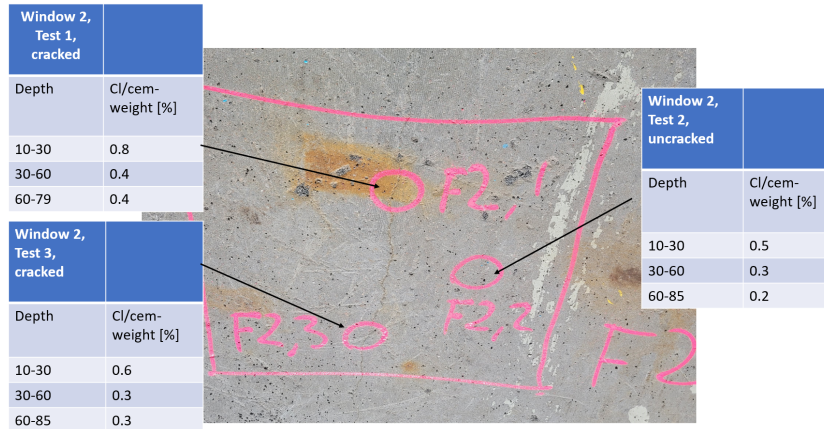
Figure 3.14: Chloride content through depth in window F2 from Afry reports.

Figure 3.14 shows window 2 with results from chloride analyses for each core sample and depth. For two positions, the ratio of chloride to cement at the rebar surfaces was 0.3-0.4%, which is assessed to pose a moderate risk of reinforcement corrosion. Additionally, the observed discoloration on the surface of the concrete, which may result from the reaction of corrosion products with water, further supports this probability.

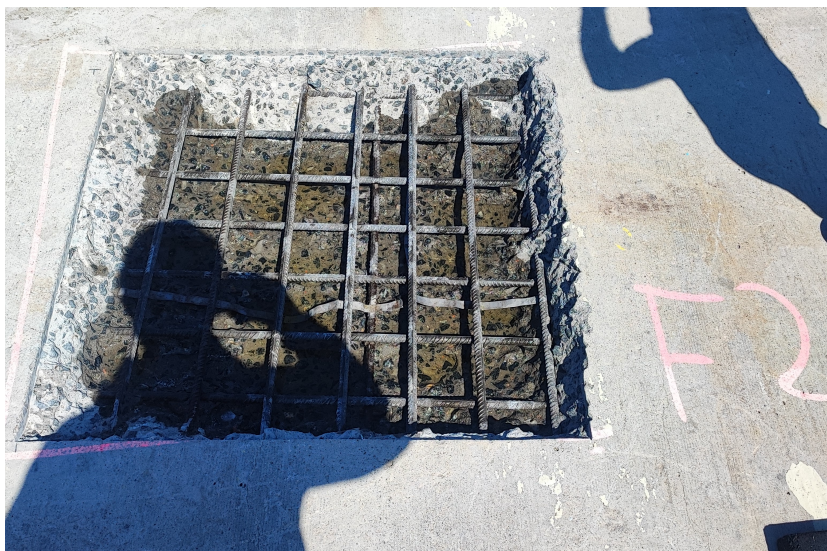
Figure 3.15: Bars status in window F2 from Afry reports.

As expected, considering signs such as discoloration, the presence of cracks, and the measurement of the chloride-to-cement ratio, a reinforcing bar located at the level of a crack near sample F2.1 showed some pitting corrosion of a few millimeters, as shown in Figure 3.15 and Figure 3.16. Otherwise, the reinforcement was unaffected.

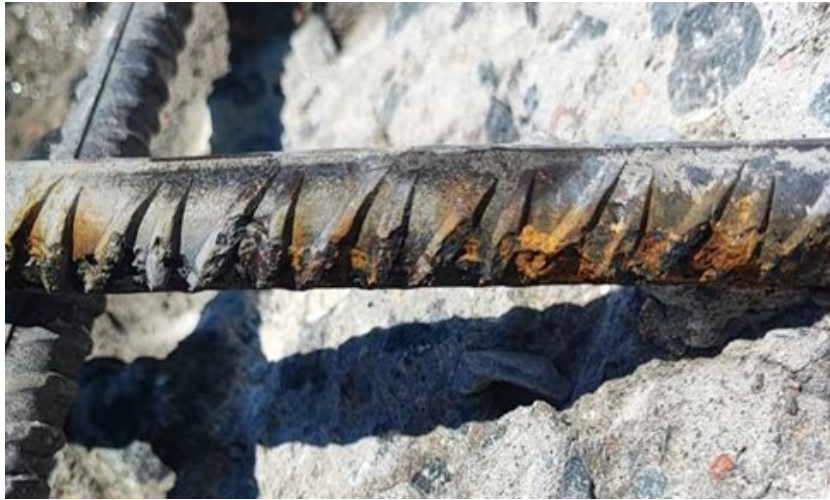
Figure 3.16: Localised corrosion close to the cracks in window F2 from Afry reports.

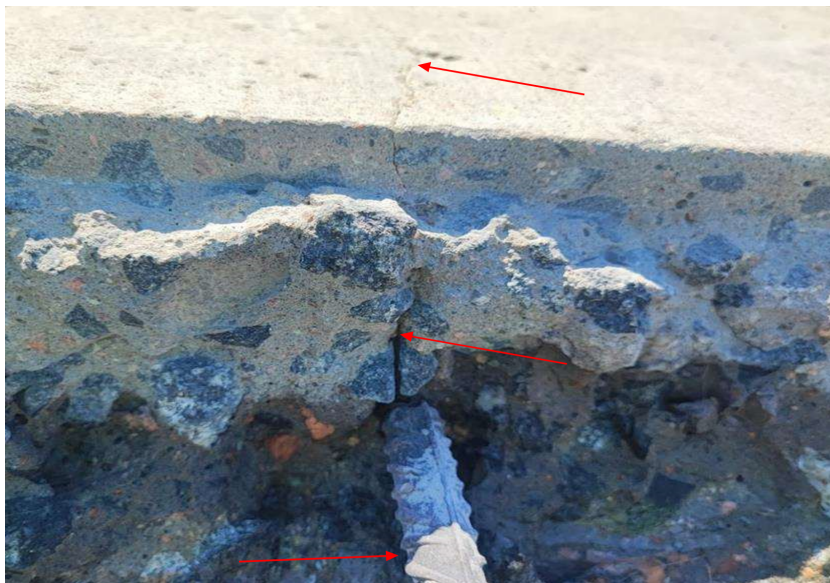
Figure 3.17: Close up of the crack extending to the bar surface from Afry reports.

A close-up of the crack extending below the level of the reinforcement is shown in Figure 3.17. The significance of the cracks is once again evident. A crack that has penetrated the depth of the concrete facilitates the access of harmful substances to the rebar, and corrosion has been observed at this location.

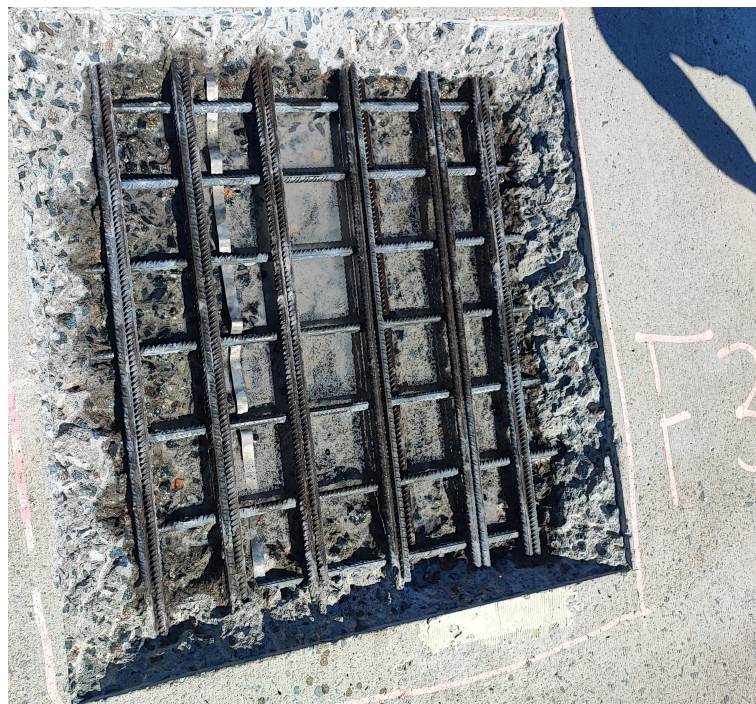
Figure 3.19: The bars status in window F3 from Afry reports.

In window F3, the existence of cracks and their proximity to an area likely to experience corrosion warranted further investigation, prompting the opening of this section for closer inspection. Figure 3.19 included in the report shows no evidence of corrosion. This finding indicates that the cracks might have been caused by factors other than corrosion, as mentioned earlier.

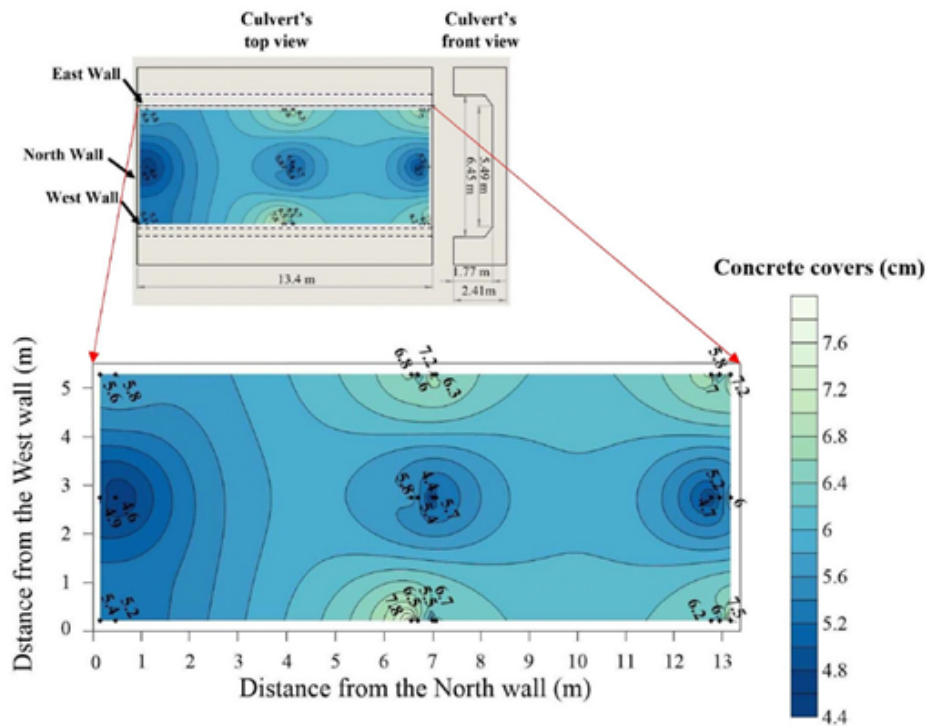
Figure 3.21: Measured concrete cover thickness in different places from [25]

In a separate study [25], they examined the condition of an existing bridge in one of the cities in Canada using this method. Visual inspections were conducted on this bridge in 2017, and areas prone to corrosion were identified based on observable changes such as discoloration, crack formation, and spalling. Furthermore, specific points were selected for sampling to measure the concrete quality, cover thickness, and determine its chloride content, as illustrated in Figures 3.20 and 3.21.

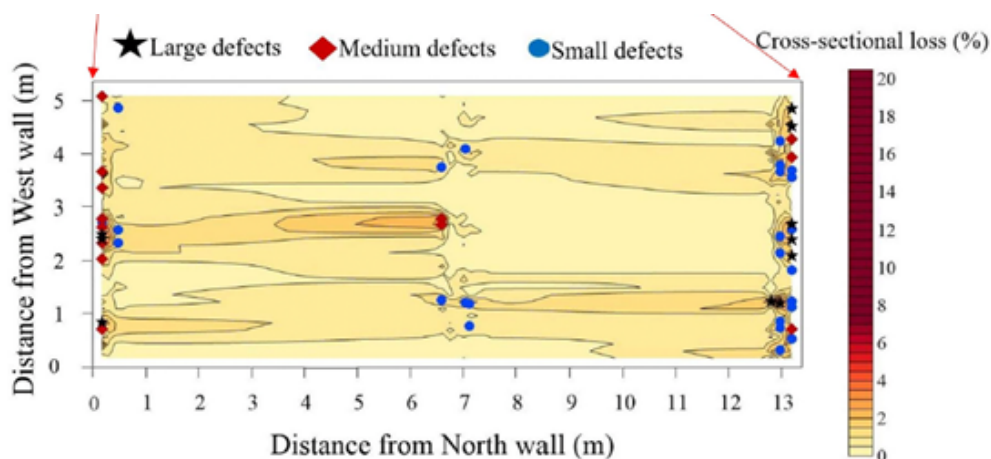
Figure 3.22: Different types of defects in the scanned area from [25]

As previously mentioned, several parameters influence the extent of corrosion, including concrete cover thickness, concrete quality, and rebar size [15]. Additionally, the presence of cracks and chloride levels also significantly affect corrosion rates [5]. The analysis of samples indicated that areas with thinner concrete covers, lower-quality concrete, and higher chloride content are more susceptible to corrosion. These observations are supported by results obtained from this method and are illustrated in Figure 3.22.

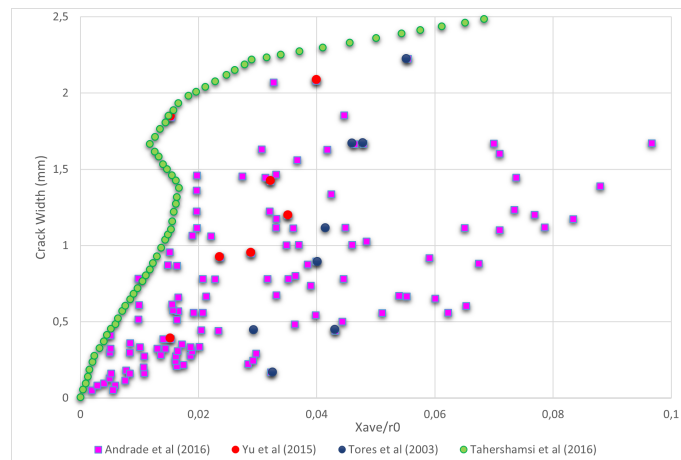
Figure 4.3: Crack width versus average corrosion penetration to initial bar diameter, compile of natural and artificial corrosion [36]

Figure 4.3 present compiled data with artificial data by Tahershamsi et al (2016). The predicted corrosion from artificial method results exceeded that in natural conditions, which can be attributed to various factors such as impressed current rate, self-healing, freezing-thaw cycles, etc.

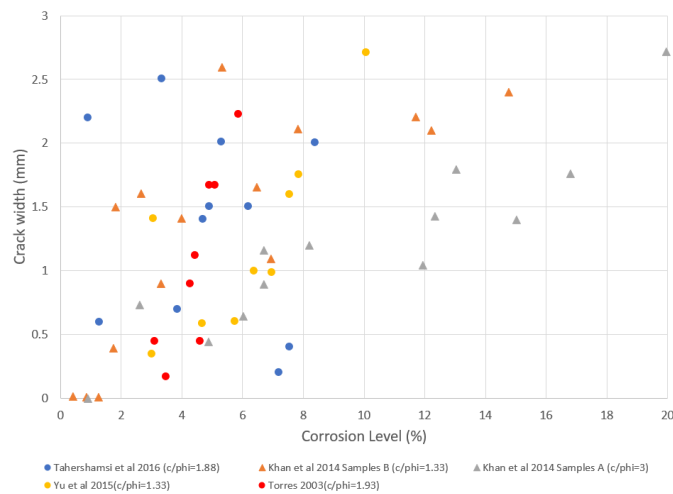
Figure 4.5: Crack width versus corrosion level for natural corrosion

Also, the results obtained from the work carried out by Khan et al (2014), which studied samples exposed to chloride for 27 years under natural conditions, Yu et al (2015), and Torres et al (2003), were combined with the results from Tahershamsi et al (2016) as presented in Figure 4.5.
