# A Transformation of Thordéns Ladugård

Chalmers School of Architecture

2025

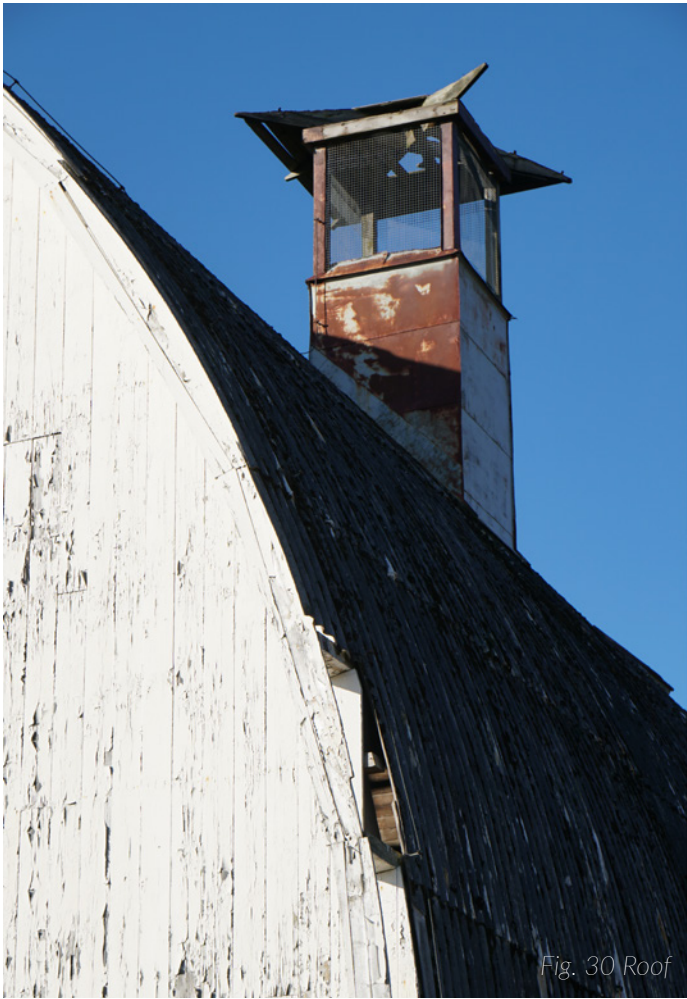
Fig. 30 Roof

Many of the facade materials are original and have gained a natural patina, some more gracefully than others. Most concerning is the roof on the eastern side, with large amounts of moss buildup which has lead to frost shattering damages.

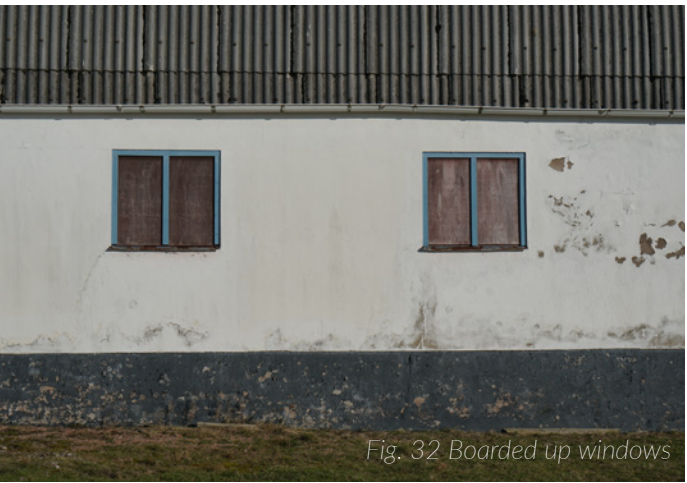
Fig. 32 Boarded up windows

Multiple windows on the ground floor have been either boarded up or replaced. Those that are still original are visibly worn with wooden frames.

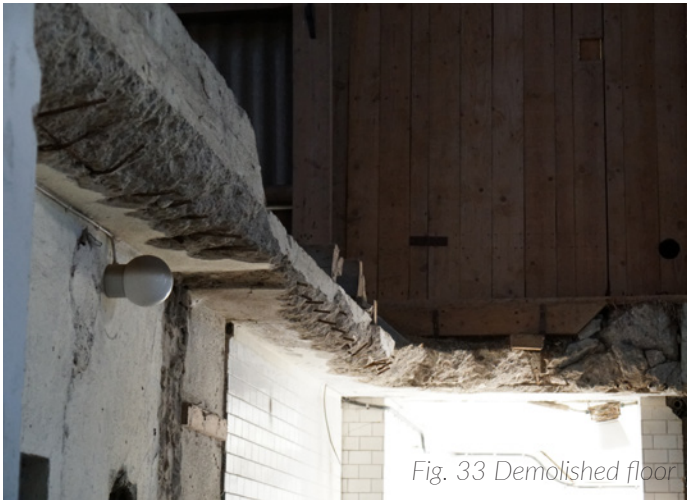
Fig. 33 Demolished floor

To be able to fit even larger machines, one of the laminated wood beams was relieved to make room for a larger gate. The cow stable used to extend a bit into the machine hall, but the extension has since been demolished.

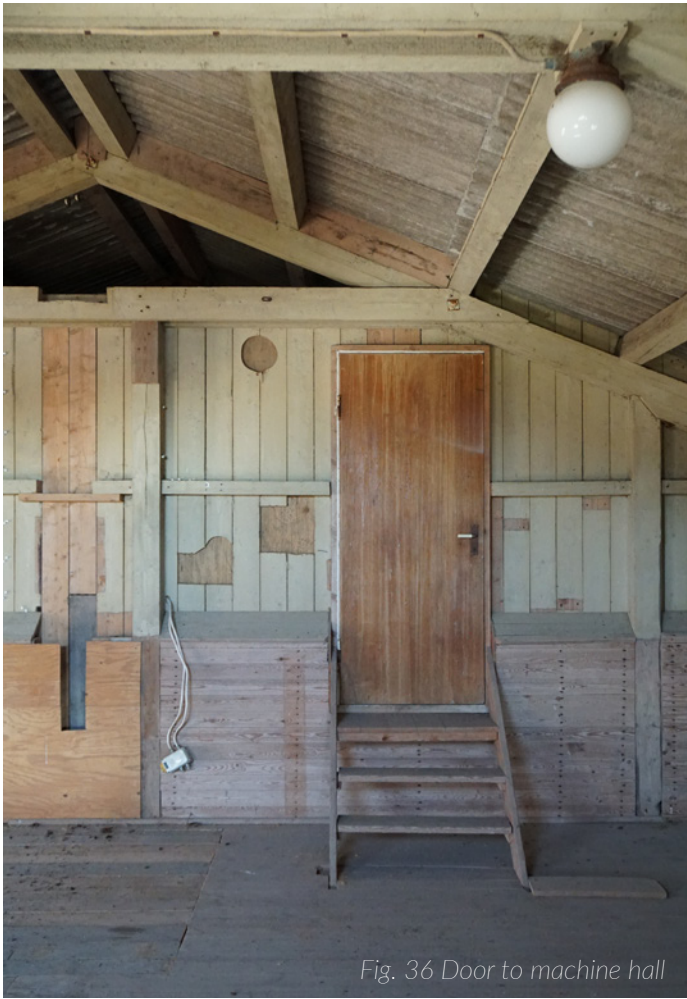
Fig. 36 Door to machine hall

Each floor has doors facing the machine hall, telling a story of how these zones were once connected through elevated walkpaths.

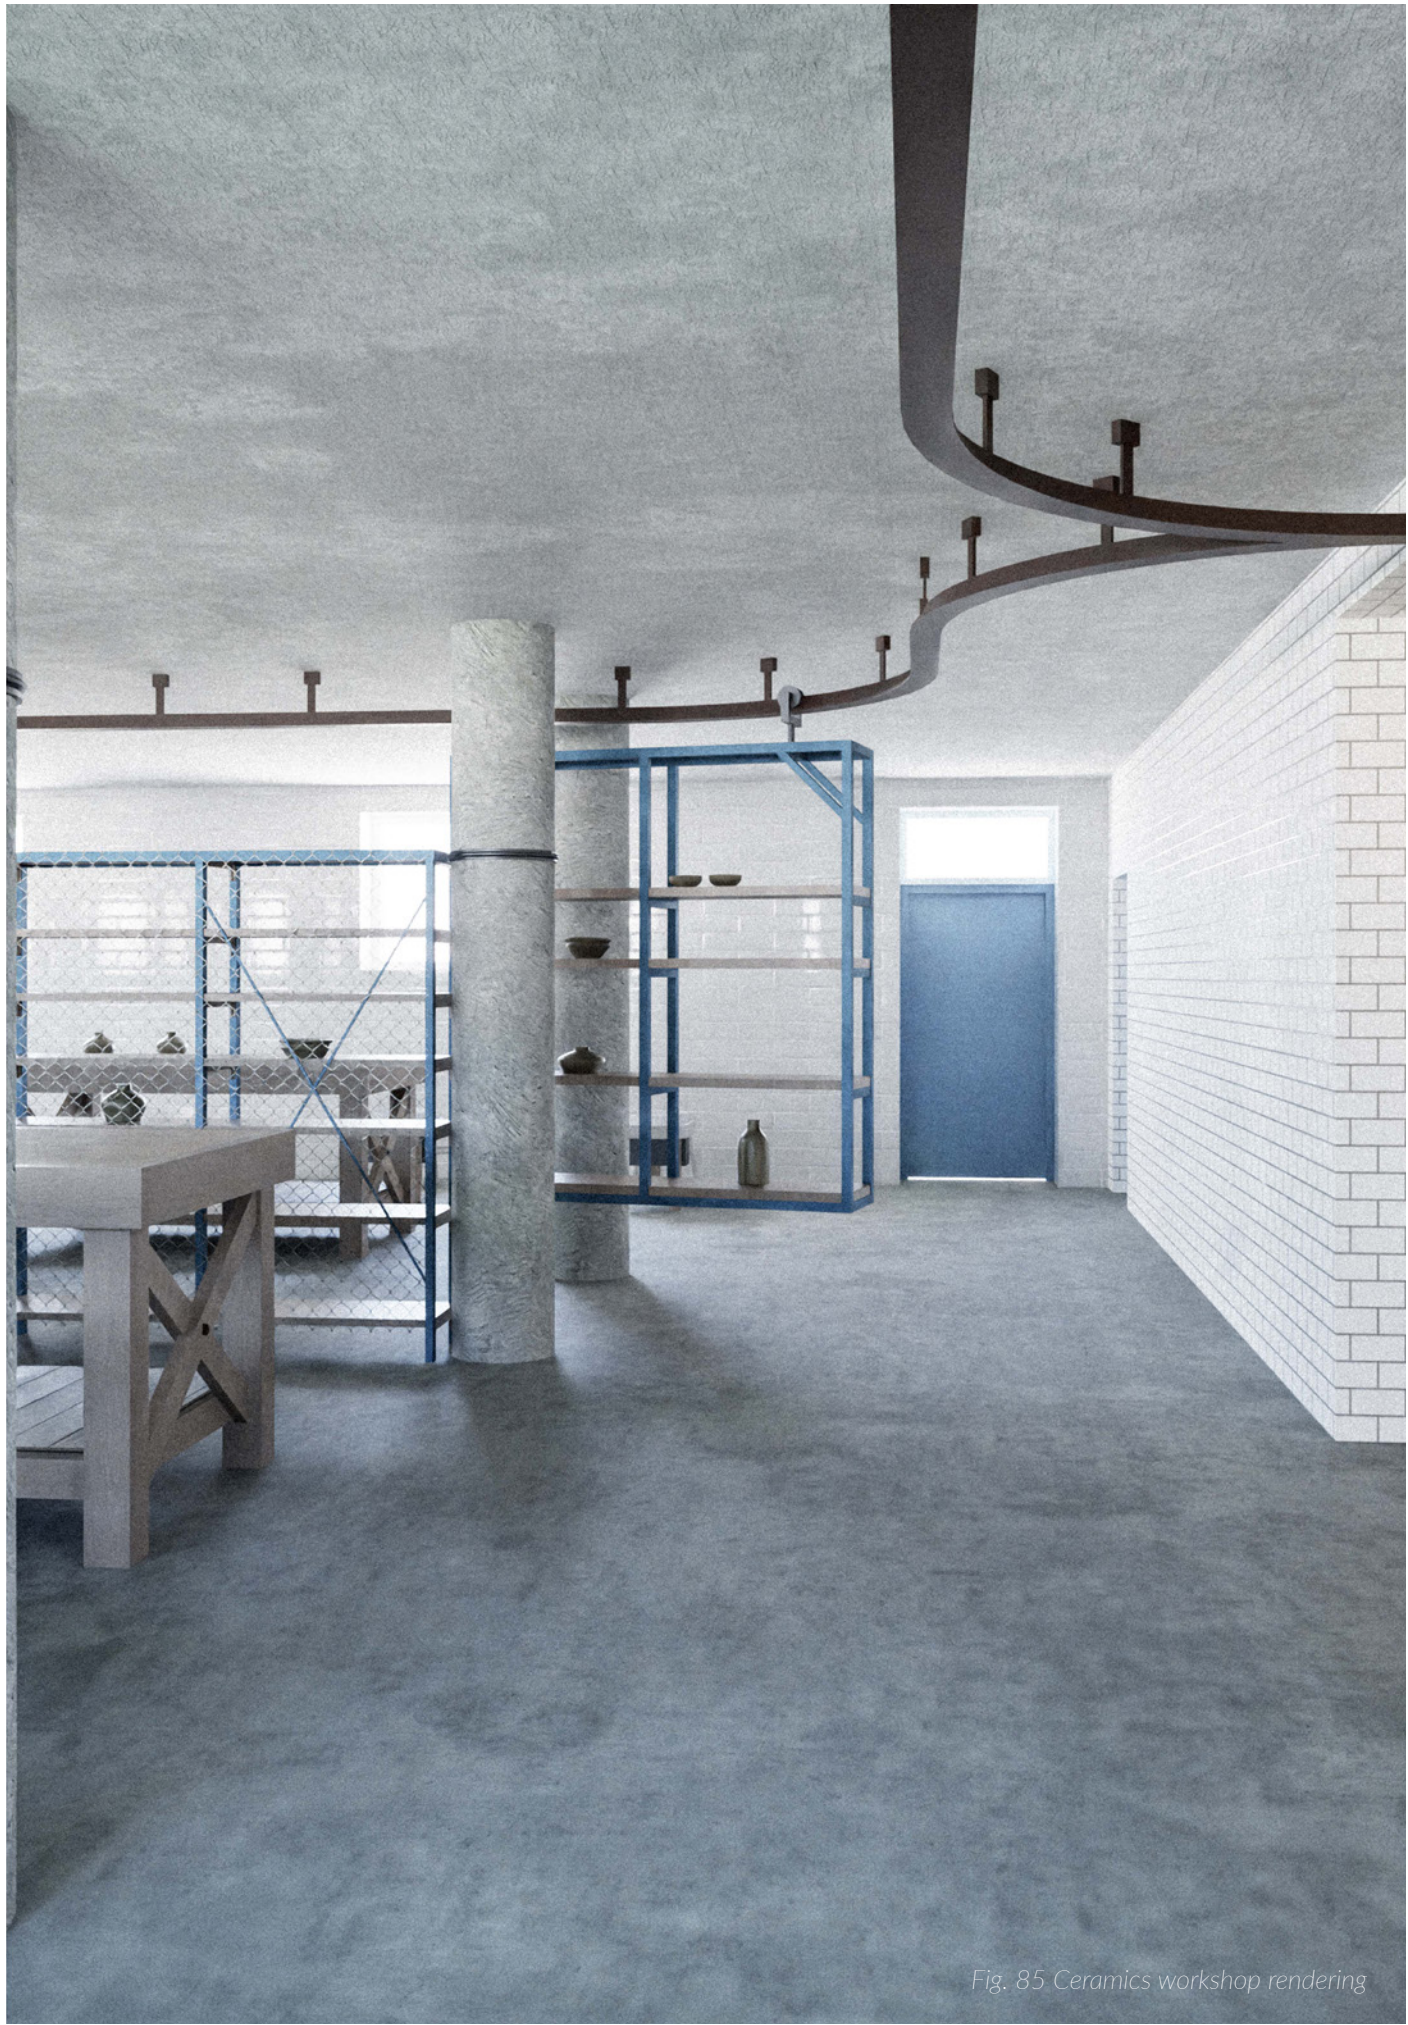
Fig. 85 Ceramics workshop rendering

The ceramics workshop utilizes the existing columns to create spatial division through integrated shelves.
