A STUDY OF WATER SUPPLY AT
NKINGA HOSPITAL
AND THREE VILLAGES IN IGUNGA DISTRICT, TANZANIA

Master Thesis 1992:1

A Study of Water Supply at Nkinga Hospital and three Villages in Igunga District, Tanzania

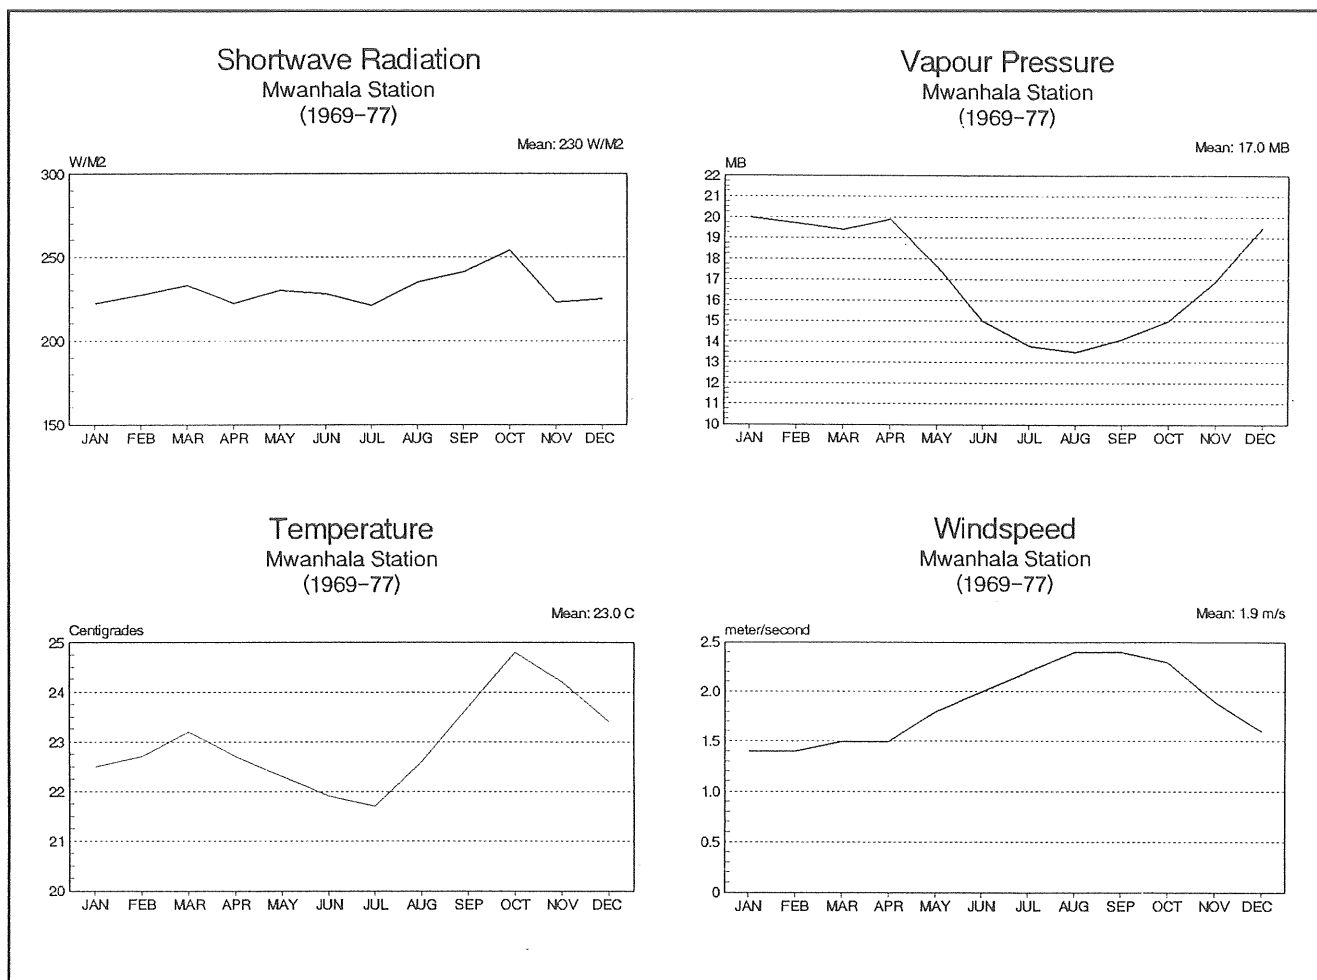
Figure 3.9. Shortwave radiation, temperature, vapour pressure and wind speed at Mwanhala station (1969–1977), [6].

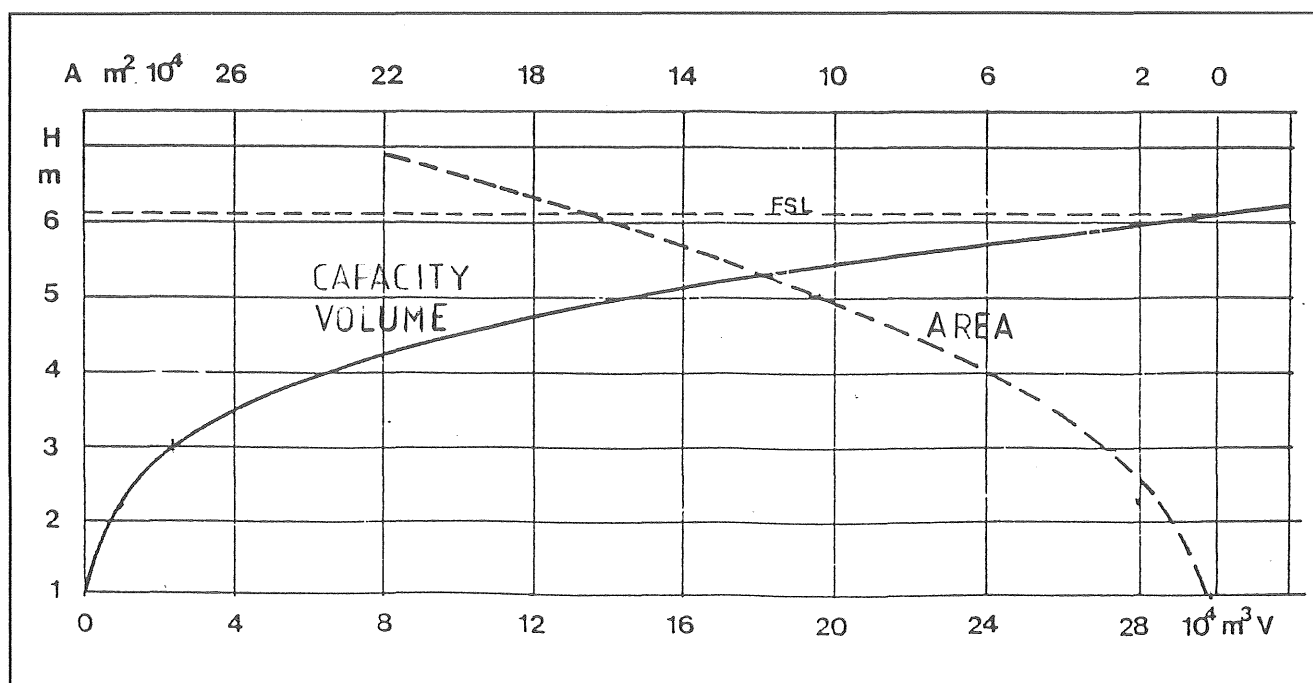
Figure 5.5. Fitted depth—capacity and depth—area function for the Ulaya Dam.

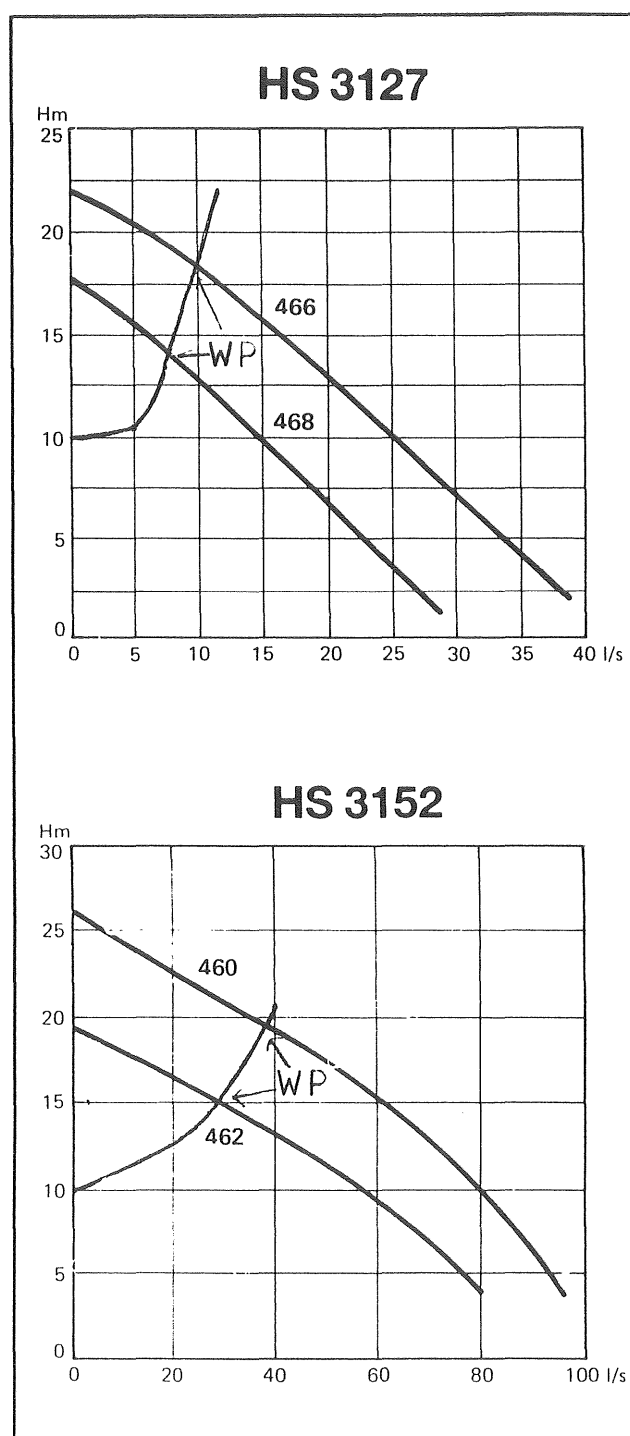
Figure 5.13. Capacity for the sludge pump type HS, ITT Flygt.

Assuming that the sludge content in the water varies between 0 and 30 percent with an average of 10 percent, between 20 and 115 cubic meters of sediment is removed from the reservoir in 8 hours. If about 50 percent of the sediment in the reservoir is to be removed, it will take the biggest pump more than six months of 8 hours of work each day.

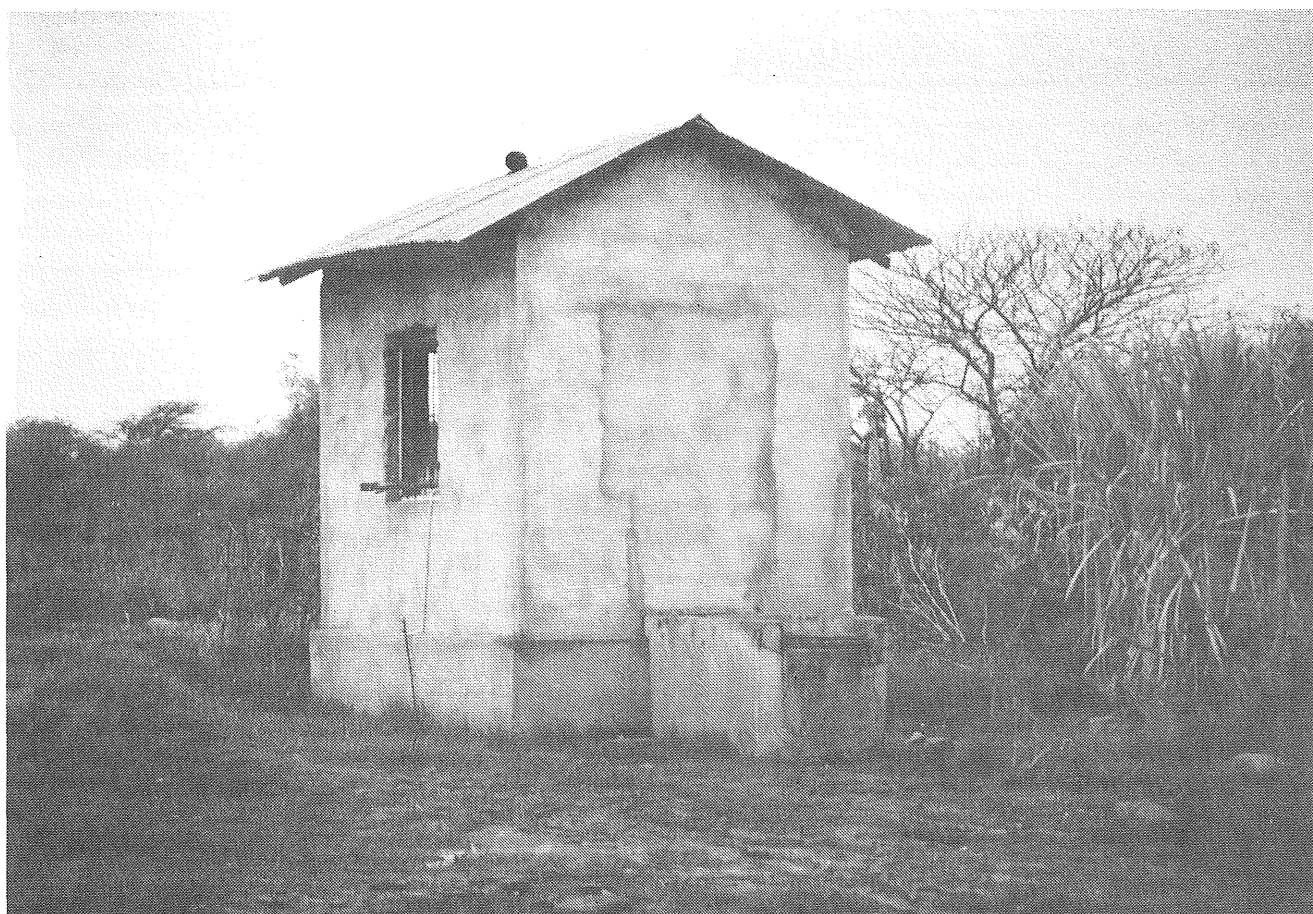
Figure 6.1. Pumphouse above the Borehole 1/79.

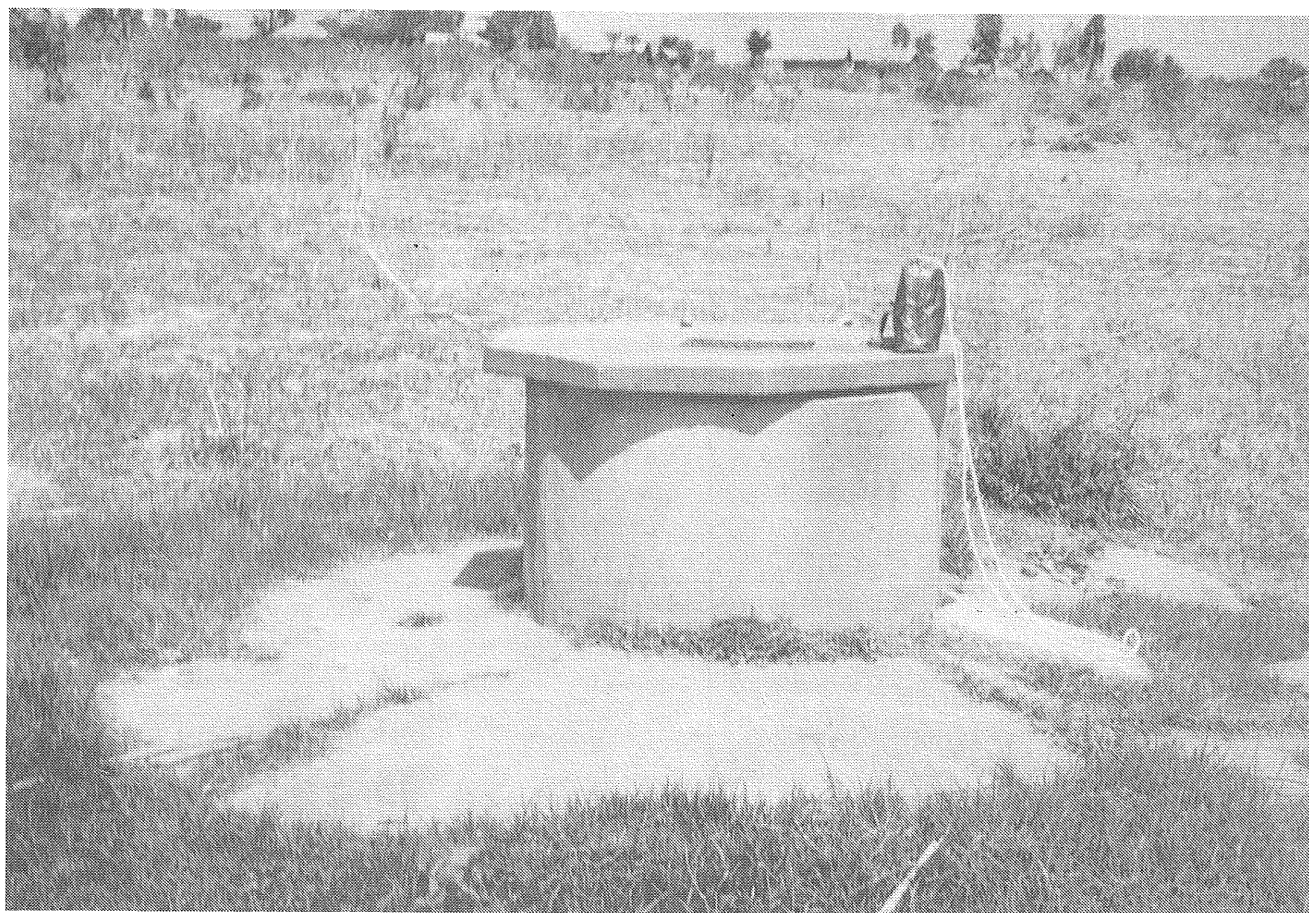
Figure 8.1. Shallow well Ndembezi I.
