Novel Nanomaterial Surface Treatments within Subsea Processing

An investigation of a novel surface treatment, analyzing its capability to improve subsea cooling

Master's thesis in Materials Chemistry

MASTER'S THESIS 2023

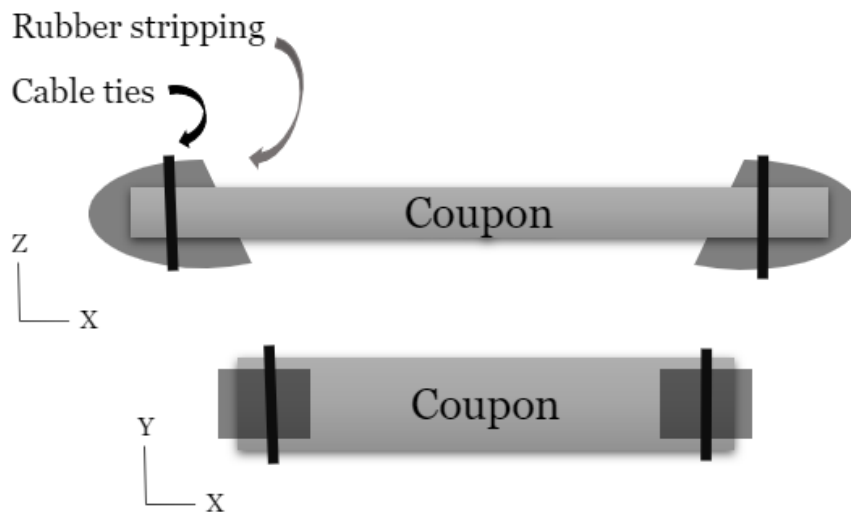
Figure 3.2: A visual representation of the fouling test coupon set up.

The coupons were furthermore adhered to the frame without any additional metallic materials to prevent the frame from acting as a cathodic protection to the coupons. Plastic cable ties and self adhesive rubber stripping were used to be the last component in the fouling setup, and were utilized as illustrated in Figure 3.2.

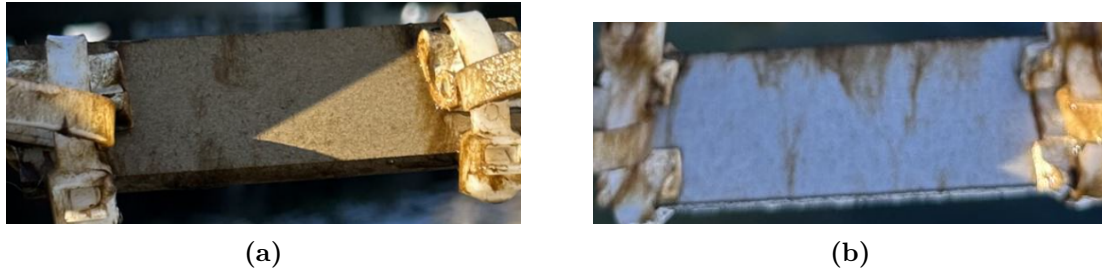
Figure 4.12: Picture taken of (a) Alloy 1 - Coating 1 and (b) Alloy 1 - Bare after 20 days of submersion.

The coupon which showed the least amount of fouling after 20 days however is Alloy 1 - Coating 1, Figure 4.12 (a). There is no signs of corrosion as expected but also a very low amount of fouling. In Figure 4.12 (b) there is evidently fouling occurring at the edges, proving that it is the surface treatment that decreases the amount of fouling.

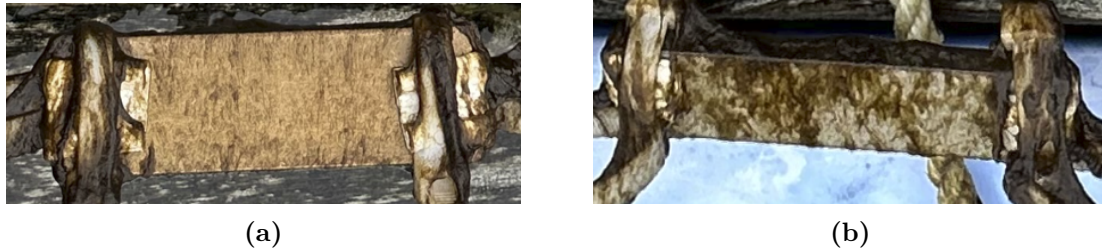
Figure 4.14: Picture taken of (a) Alloy 2 - Coating 2 and (b) Alloy 2 - Bare after 49 days of submersion.

Another result showing low amounts of fouling is Alloy 2 - Coating 2, Figure 4.14 (a). Alike Alloy 1 - Coating 2 some fouling adheres to the relevant surface, but significantly less than the bare Alloy 2 coupon, Figure 4.14 (b).

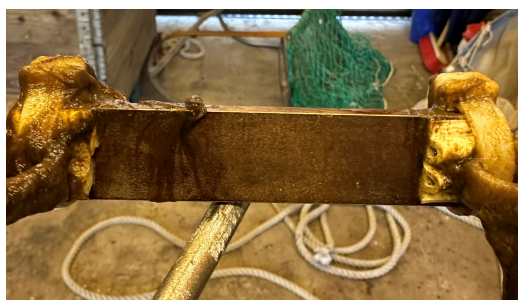
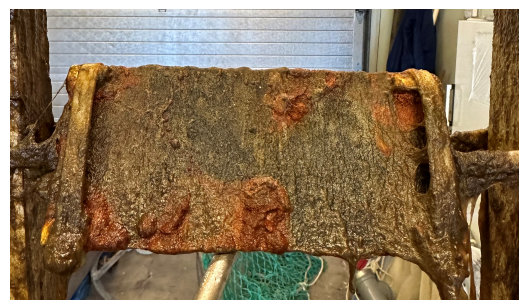
In Figure 4.15 (a), the copper based Alloy 5 is exhibiting clear signs of fouling, yet mainly originating from a specific place as opposed to the figures presented in previous Sections 4.5.1 and 4.5.2. On the contrary, the regular carbon steel, Alloy 4 Figure 4.15 (b), has obvious problems in regards to both fouling and corrosion.

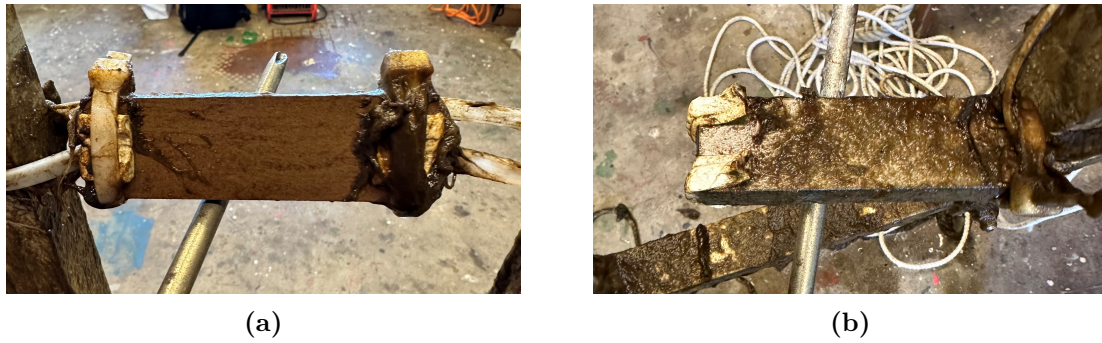
Figure 4.16: Picture taken of (a) Alloy 1 - Coating 2 and (b) Alloy 1 - Bare after 76 days of submersion.

Since stainless steel Alloy 1 - Coating 2 is the material system with the lowest average ξ , after Alloy 5, it is presented along with its bare sample in Figure 4.16. The bare sample, Figure 4.16(b), has clear signs of fouling all over the surface as opposed to Coating 2, which does not have nearly as high amounts of fouling.

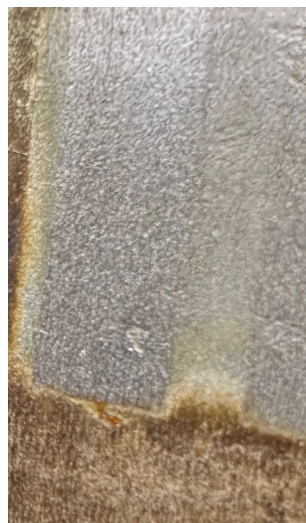
Figure 4.22: Small, visual, local corrosion attacks on Alloy 5.

Additional comparison between the above stated coupons shows a minimal initiated local corrosion attack on Alloy 5, which is demonstrated in Figure 4.22. This could furthermore be compared and equated with the crevice corrosion attacks on Alloy 2 and Alloy 3 demonstrated in Figure 4.20, but in less extent. This indicates that the environment is indeed very harsh and the superiority of Coating 2 is obvious.

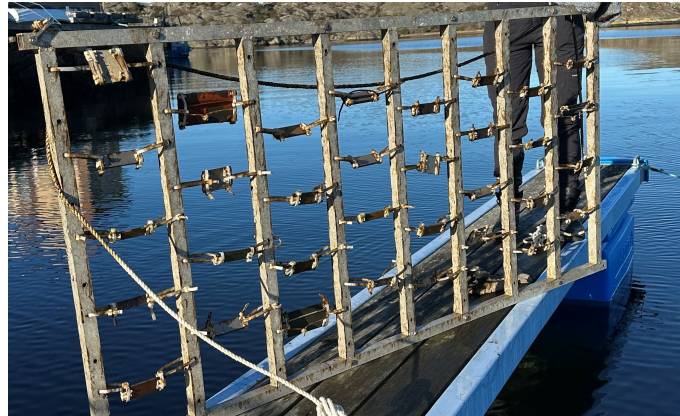
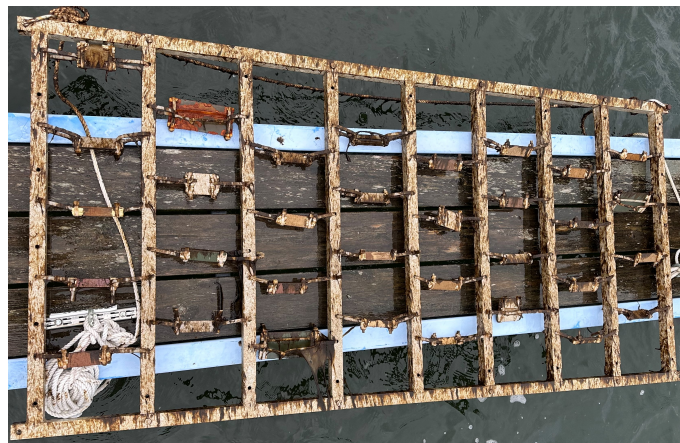
Presented below in Figure B.2 are the subsea module (a) during the first inspection and (b) during the second inspection.
