# **Robust heating in crisis - Evaluation of the FirePipe emergency stove for indoor environments in cold climates**

Master's thesis in Structural Engineering and Building Technology

MASTER'S THESIS 2026

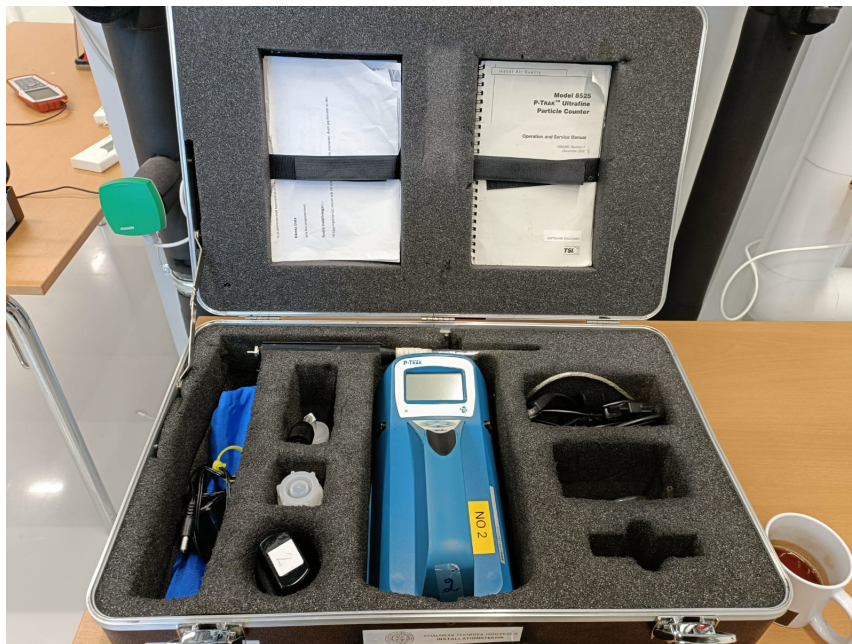
The results are expressed in particles per cubic centimeter ( $\text{particles}/\text{cm}^3$ ), which represents the number of particles present in a small volume of air. This allows the variation in particle concentration to be observed over time.

**Figure 3.1:** TSI P-Trak Ultrafine Particle Counter

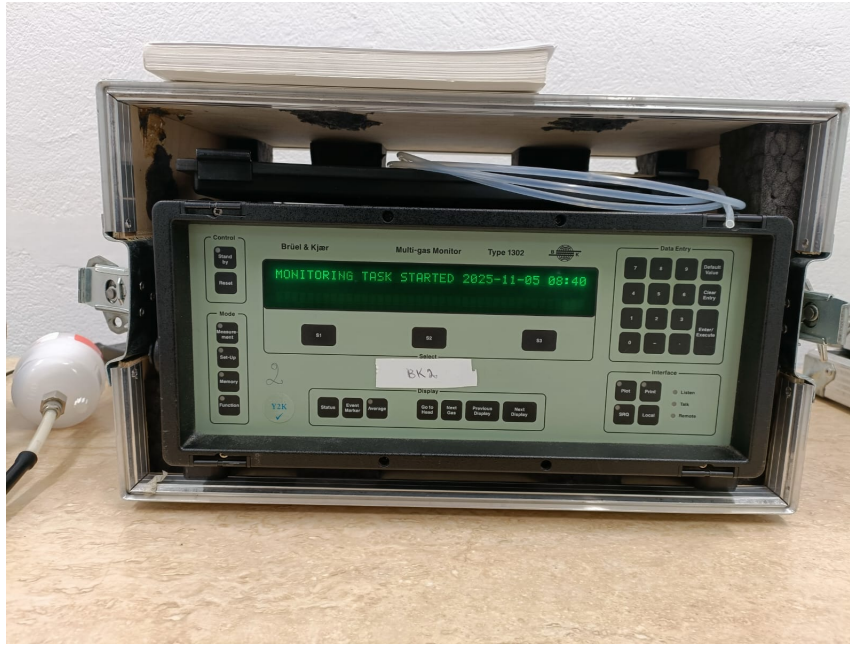
In this study, the instrument is used to measure gaseous emissions produced during the operation of the FirePipe stove. These measurements are important for evaluating indoor air quality under realistic conditions.

**Figure 3.2:** Brüel & Kjær Multi-Gas Monitor

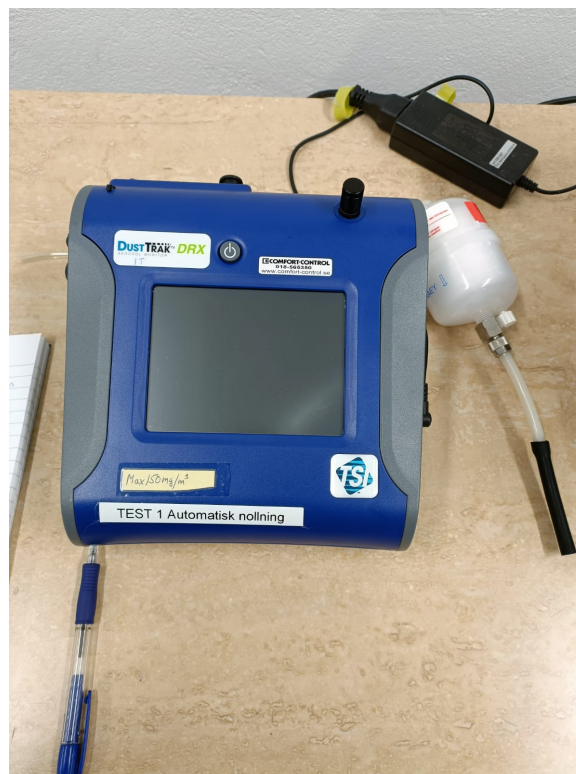
The instrument provides continuous measurements across different particle size ranges, allowing changes in particle levels to be observed over time.

**Figure 3.3:** DustTrak DRX Aerosol Monitor

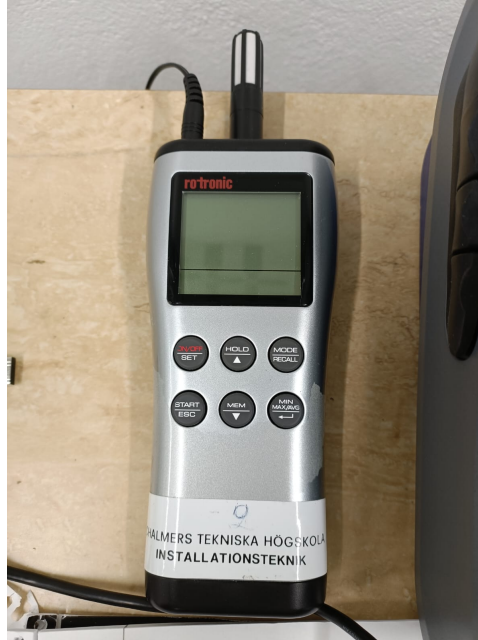
the concentration of CO<sub>2</sub> in the air. This method enables reliable, continuous measurement of CO<sub>2</sub> levels in indoor environments.

**Figure 3.7:** Rotronic CP11 CO<sub>2</sub> Meter

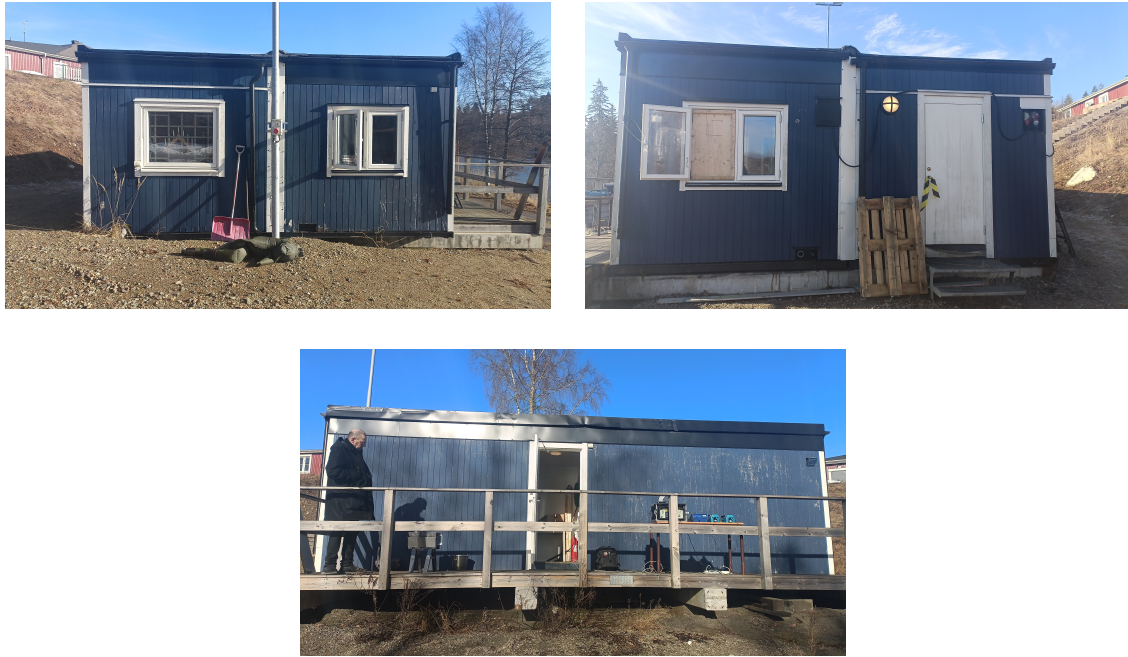
The experiments were conducted within a small, house like test structure located at the training facility. A comprehensive representation of the test environment is provided through floor plans shown in figure: 4.3 and external views, including front and rear perspectives of the structure as shown in figure: 4.2.

**Figure 4.2:** Views of the experimental building environment: Top-left shows the left side view of the building, top-right shows the right side view, and the bottom image shows the front side view of the building.

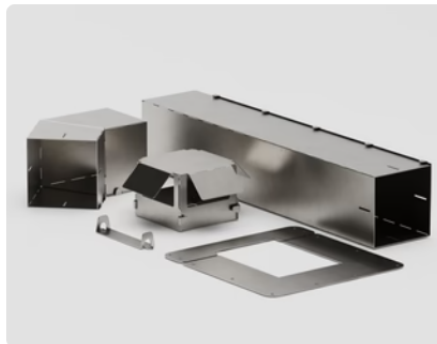
**Figure 5.3:** Some of the components of the stove during assembly

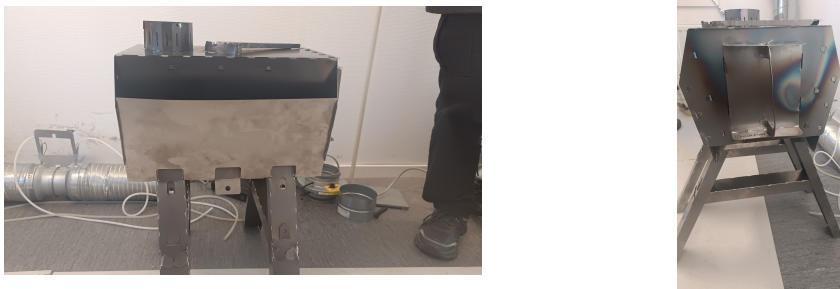
**Figure 5.6:** Stove assembly views: Left shows the stove side view and right shows the stove front view.

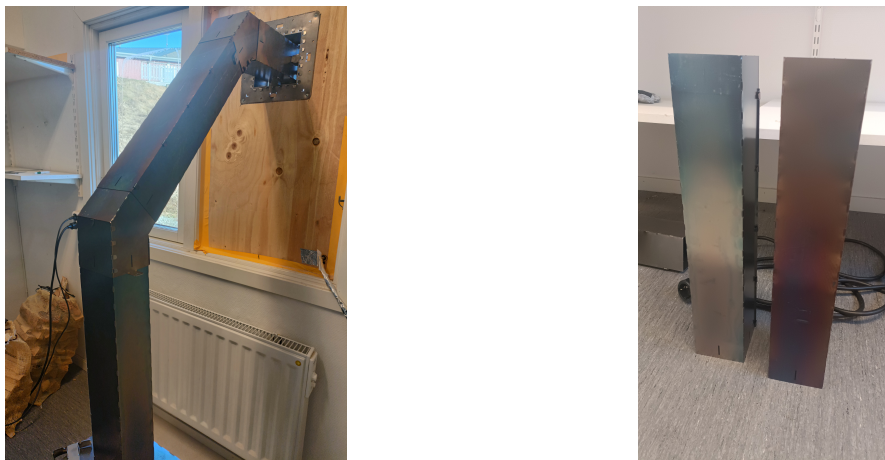
According to the instruction manual, the chimney components should be mounted onto the window board prior to installing the board onto the window as shown in figure 5.7, after which the system is assembled from inside the room. However, due to spatial constraints within the room, this procedure was not feasible. Instead, a modified approach was adopted in which the window board was installed first, followed by attachment of the chimney components. This method proved more practical under the given conditions. Once all components were assembled, the stove was prepared for operation.

**Figure 5.7:** Chimney installation and components: The left shows the stove with the chimney mounted to the window board, and the right shows the chimney components.

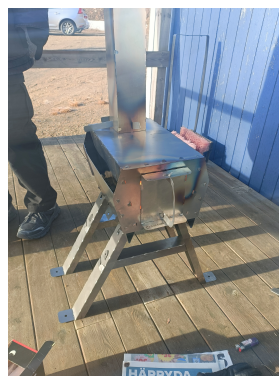
**Figure 5.8:** Outdoor burn OFF of residual oil.

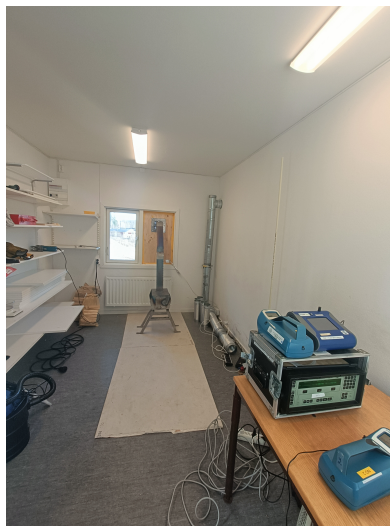
**Figure 5.10:** Interior view of the experimental setup showing the stove mounted onto the window board, with the chimney passing through the board. The ducting system is positioned to the right of the stove, while the extract fan is located below the duct and connected to a damper positioned in front of the fan. The measurement instruments placed on the table are also visible in the figure.

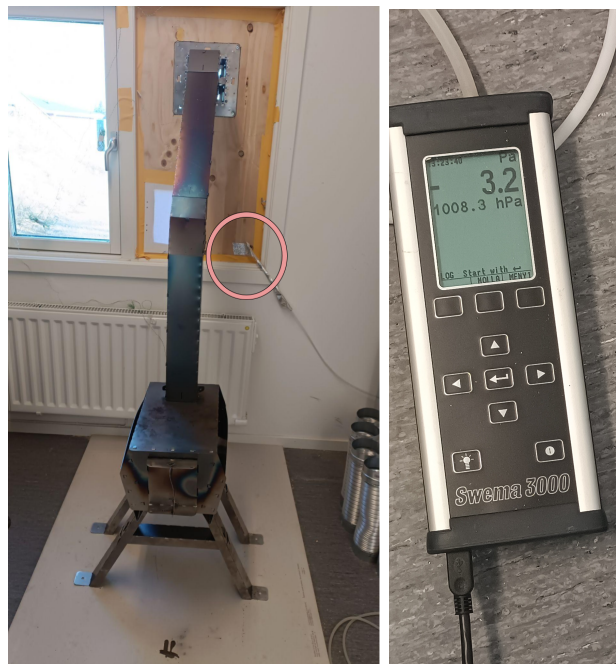
The differential pressure measurement instrument shown in figure 5.11, also called a pressure transducer, was used to monitor pressure differences between indoor and outdoor environments. To avoid localized disturbances, the indoor outdoor pressure difference was measured near the bottom of the window rather than directly at the chimney opening. The location of the pressure measurement point can be seen on the lower right side of the window board in figure 5.11.

**Figure 5.11:** View of the tube located at the lower right corner of the window, connected to the pressure transducer for measuring the differential pressure between the indoor environment and the outside.

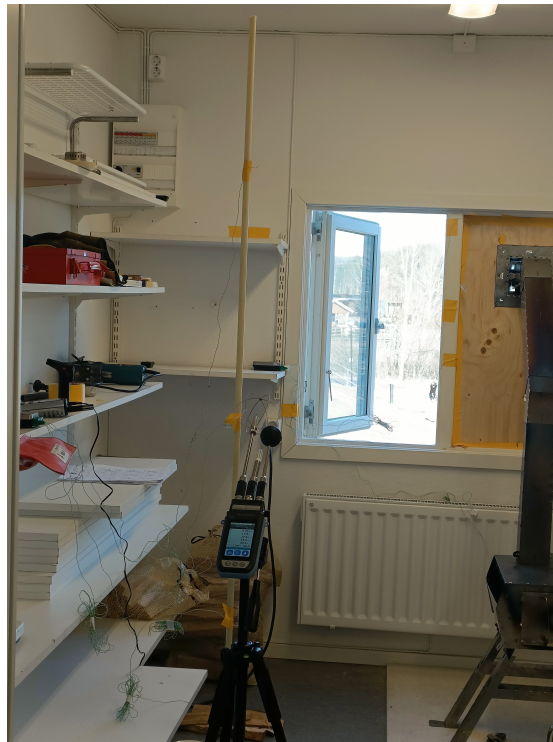
A vertical measurement pole was installed approximately 1 meter from the stove to measure temperature stratification. Thermocouples were positioned at heights starting from 1 meter, with intervals of 0.5 meters, in accordance with ISO 7730, which is shown in figure 5.12.

**Figure 5.12:** Thermocouple mounted on a vertical pole with measurement nodes N1, N2, N3, and N4, positioned in accordance with ISO 7730 guidelines.

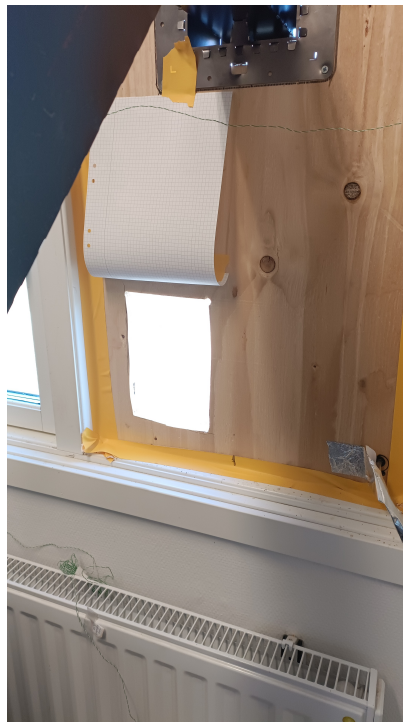
**Figure 5.16:** Opening on the window board below the chimney

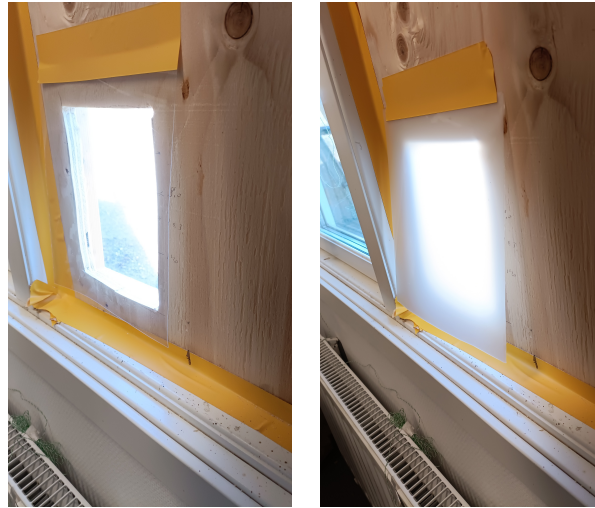
(a) Prototype 1

- Prototype 1 (P1): Plastic sheet type 1
- Prototype 2 (P2): Plastic sheet type 2
- Prototype 3 (P3): Laminated photo paper
- Prototype 4 (P4): Plastic sheet type 1 (reduced thickness)

**Figure 5.17:** Images of flap prototypes P1 & P2.

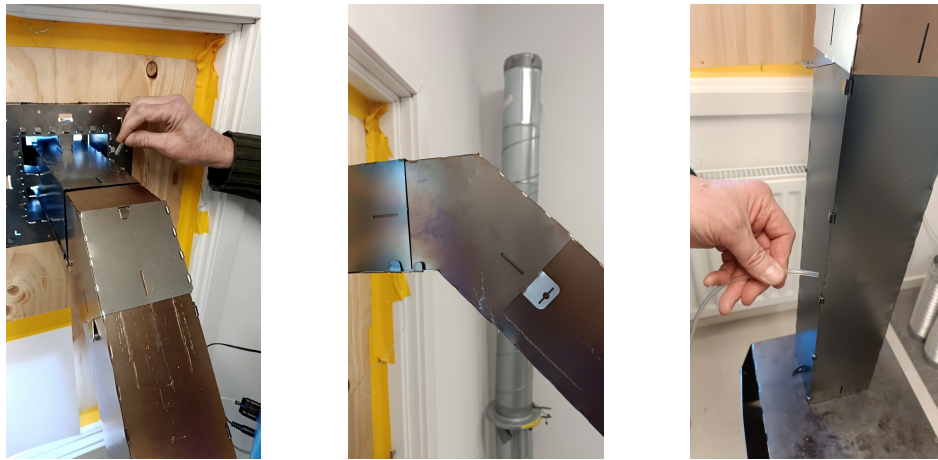
**Figure 6.1:** Chimney components where ultrafine particle (UFP) measurements were conducted: The left shows the horizontal chimney component, The centre shows the angled chimney component, And right shows the vertical chimney component.

cleaner outdoor air to enter the room. Overall, the results suggest that the horizontal chimney section and its joints represent critical locations for particle leakage.

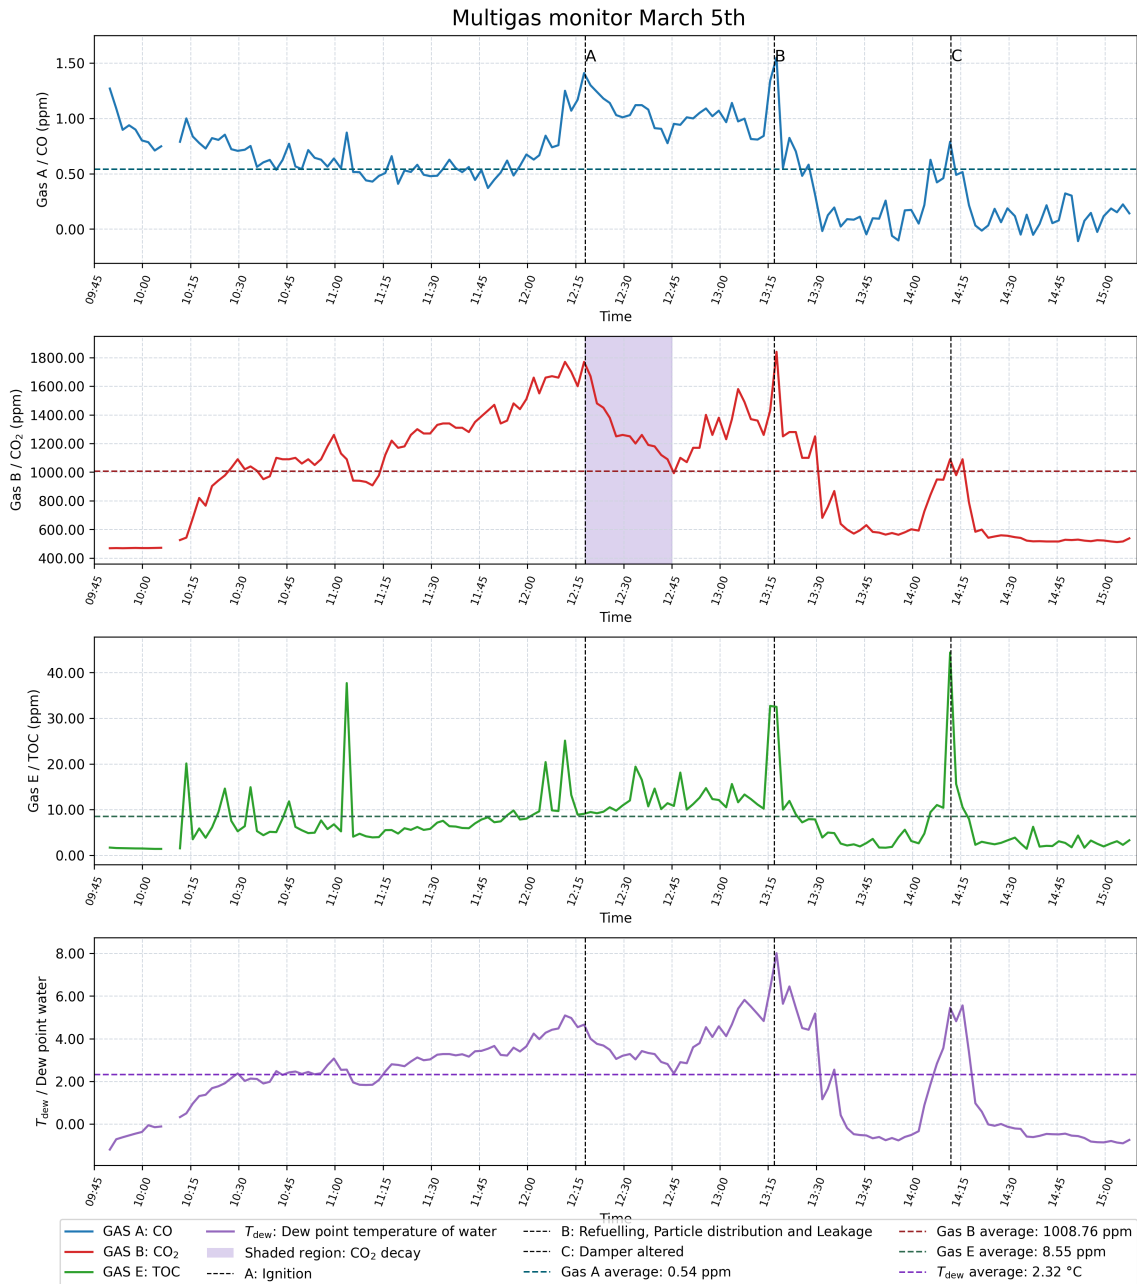
**Figure 6.16:** Mutligas monitor readings March 5<sup>th</sup>

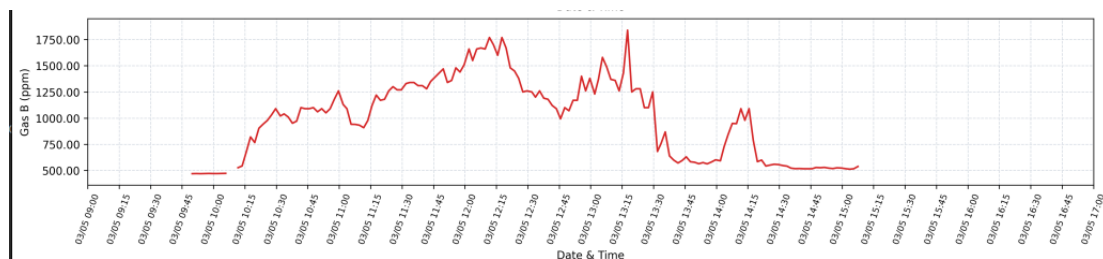
**Figure A.5:** CO<sub>2</sub> Decay Curve Measured Using Multigas Monitor
