# The biocarrier escape routes

Identifying leaks through a Product Chain Organisational study

Master's thesis in Industrial Ecology

CHALMERS UNIVERSITY OF TECHNOLOGY Gothenburg, Sweden 2021 www.chalmers.se Report no. E2021:143

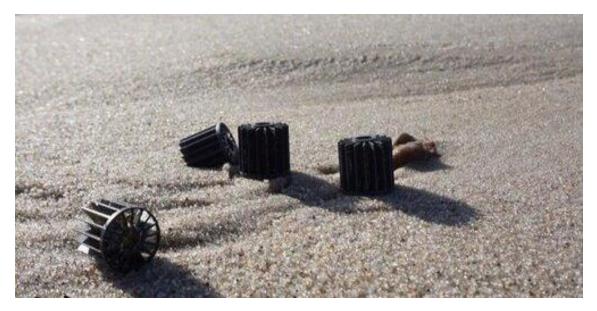
Figure 1.1: Biocarriers found on a beach after leakage from a salmon farmer in Hvide Sand, Denmark (Kruse, 2021)

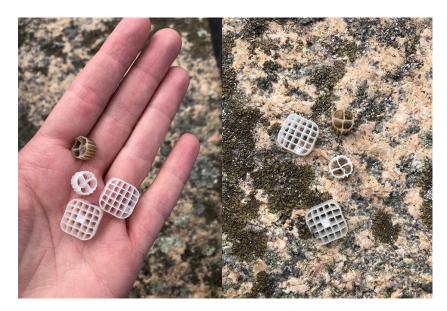
Figure 1.2: Biocarriers of type K1 (AnoxKaldnes) and BWT 15 (Biowater technology) found at a beach-cleaning activity outside Lysekil, Sweden in September 2021.

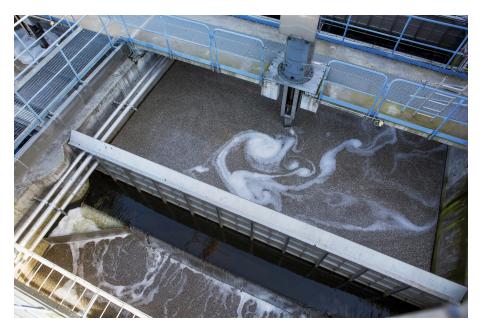
Figure 2.2: Moving biocarriers in the step after denitrification at Ryaverket, Sweden. Photo by Emelie Asplund via Gryyab.

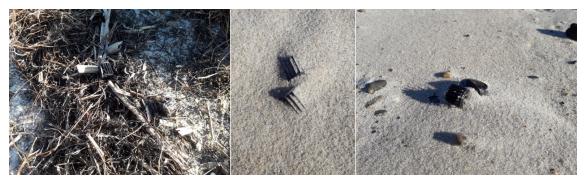
Figure 4.1: Danish findings of biocarriers on beaches (Kryger, 2021)

During the reparation, a large portion of the biocarriers kept in the tank unintentionally blocked the outflow of the water, causing them to slip out with the outlet. The description of the reason is unclear with no further explanations given when contacting the salmon farm or the installation company. Still, it was stated that this was not meant to happen but did not stir any alarm since the system was equipped with additional mesh at the outlet endpoint. This endpoint was situated slightly above the ocean surface, usually releasing treated spill water into the Ringkøbing fjord. The mesh at the endpoint had the purpose of capturing escaped carriers in case of an incident solely and was put in place at the initiative of Ringkøbing-Skjern municipality but operationally by the company itself, as it was not a part of the original design and implementation of the RAS facility. It, therefore, had no purpose for the daily operations of the business and was left out of frequent supervision.

Due to the recent ice-breaking after the Nordic winter, the mesh had been torn down by the ice and therefore failed its purpose as security net. So at the reparation of the bottom plate, approximately half a million of the facility's black little biocarriers leaked into the fjord (Kryger, 2021).

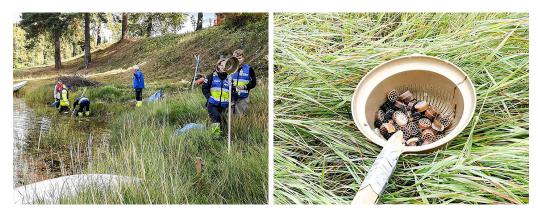
Figure 4.3: Recovery in progress. Photo by private/Älvräddarna (Lundin, 2018)

The remediation was estimated by the responsible company Dala Vatten & Avfall to have recovered approximately 97-98% of the released biocarriers with the help of 30 volunteers from a local group called FRG and from Dala Vatten & Avfall after a month of work. The estimated cost of managing and executing the recovery was 1-1,5 million SEK. FRG put in 3950 hours during 33 days to collect  $42 m^3$  of carriers according to Eriksson (2020), which is a larger amount than the initially stated leak. The environmental NGO Älvräddarna (the river rescuers) later filed a police report of the incident against the treatment plant since they disagreed on the success of the recovery and claimed that 20 of the original 50 ton released was left in the river (Forssell, 2018).

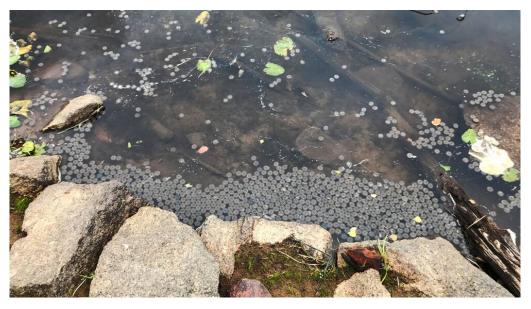
Figure 4.4: Biocarriers found after the leakage in Sweden in 2018. Photo by Niclas Jolhammar/Vansbro räddningstjänst (Forssell, 2018)

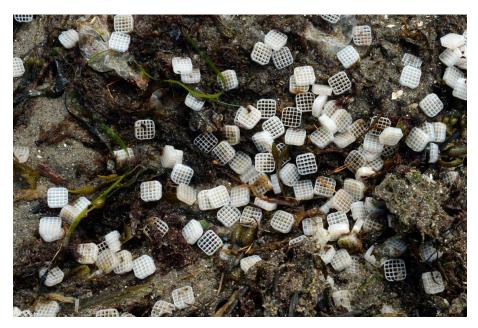
Figure 4.5: Biocarriers found after the leak in Norway (Aas, 2015)

They considered several causes and concluded that a capacity overload due to the recent heavy rainfalls in the region along with clogged pipes and water levels sensors that were out of order had failed to alarm that unfiltered wastewater had filled up in the bioreactor. Then two valves closed too slowly so that water had the time to escape through a valve that should not have been open (Stavelin, 2017).
