# Project in railway technology

Damage from electric discharge in axle bearings on trains

PROJECT REPORT 2023

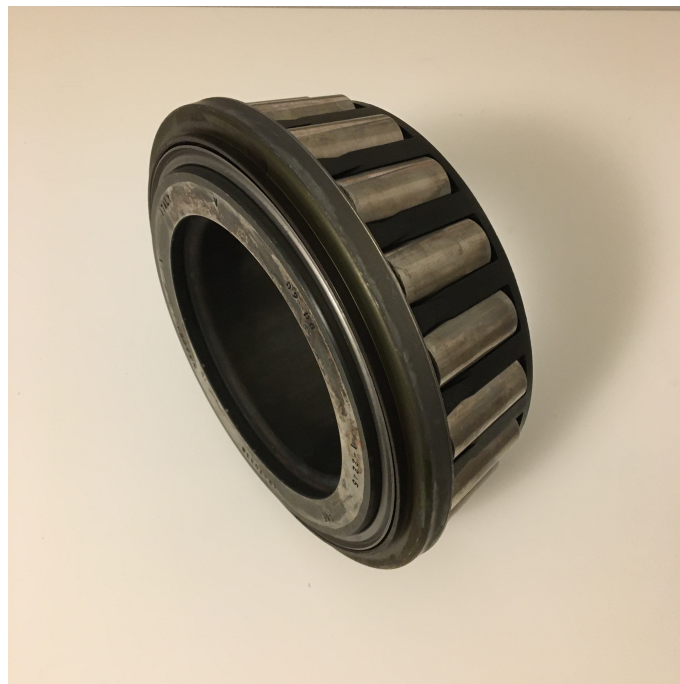
**Figure 4.2:** Roller elements of CTBU

From SweMaint, we have obtained a bearing of type CTBU (see below, figure 4.2). Although this bearing does not show any apparent signs of wear or electrical damage, neither on the outside nor inside, it was replaced by SweMaint. As mentioned above, a large portion of these bearings had been deemed to be damaged after external testing, with a majority of them being declared to possess some kind of damage due to electrical erosion. Of three used bearings of the same type, one was taken for further evaluation. Although the chances that at least one bearing would have signs of electrical damage were high, none of the bearings on display had any damage due to electrical erosion visible to the naked eye. After a good and thorough look at each bearing, the one with the most visible wear was taken for evaluation.

As said before, at first sight, there are no imperfections visible on the roller elements of the bearing. Although it is possible to see thin lines (or rims) running in circles around all the roller elements, these are not connected to electrical damage but rather form through some kind of mechanical process. These lines however should not have any influence on the performance of the bearing and can therefore be neglected in our further inspections of the involved elements.

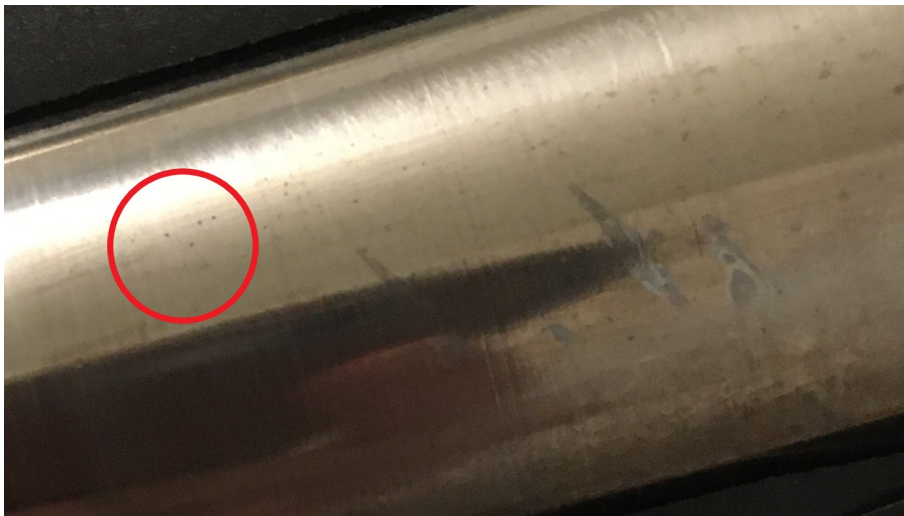
**Figure 4.3:** Found damage on the roller elements

Another even closer look however shows extremely tiny holes (or pits/craters), highlighted below in figure 4.3, which could potentially be the result of electric influence on the bearing, in this case as before mentioned the process of electrical pitting. There is (at least up to now) no systematic development of this phenomenon, and it has not processed as far as to create periodical depressions (electric fluting). Unfortunately, it is not possible to see anything more than the tiny holes, so in order to detect other features of electrical damage like rehardened material around the edges of the pits, some rims around the craters or a flattening of those, further up defined as glazing. Therefore, another investigation of the rolling elements using microscopic resolution would be very much useful to better describe the detected indents.

Regarding the obtained information about the state of the bearing elements it can be said that these pits, just as before the lines from mechanical influence, cannot (yet) affect the performance of the bearing. Testing to find out how these impurities develop if the bearing is further used is necessary. An additional hint would be comparing the time that this bearing had been in utilisation with the time that it might be used onwards from this replacement. Evaluating all of these facts against each other would help to make a prognosis about the safety of further usage of that bearing and also the time until replacement is necessary to avoid any dangers.
