## Evaluation of the effect of impact under installation on the performance of concrete cover for protection of ductile iron pipe

– Analysis of the possible corrosion caused by the Göteborg ground

*Master of Science Thesis in the Master's Programme Structural Engineering and Building Performance Design*

Master's Thesis 2012:146

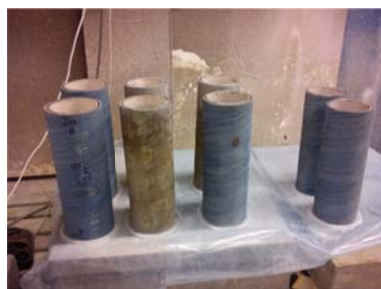
Figure 4.6. VRS-ZM specimens before put in the salt bath.

The first thing done for developing this test was to make the lower end of the pipes waterproof, the reason of this decision was to avoid the direct contact between the solution and the ductile iron of the lower end when the pile was immersed in the salt water. Thus, for waterproofing the lower end a plastic disc was glued on the end with silicon and epoxy for preventing the penetration of the solution. In the ductile iron of the upper end a thin hole was drilled for putting a screw, which was used for connecting the cable to the datalogger or power supply. (Fig. 4.2)

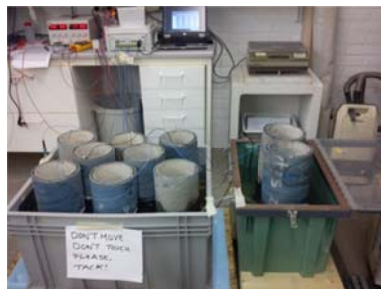
Figure 4.7. VRS-ZM specimens - salt bath test.

Thus, the test was started by imposing an external electrical field between the ductile iron (as anode) and the titanium mesh (as cathode) with the purpose to accelerate the corrosion process, but it was proven difficult due to too high current even under a very low potential difference. By this reason it was to try to monitor the open circuit potential of each ductile iron specimen against a gel type of silver-silver chloride (Ag/AgCl) reference electrode, which was connected to the salt bath solution through a salt-bridge with a KCl (3M) solution. The solutions in the two boxes were electrically connected by a plastic tube fully filled with the same salt bath solution. The potential was recorded each 30 minutes by the datalogger. (Fig. 4.3)

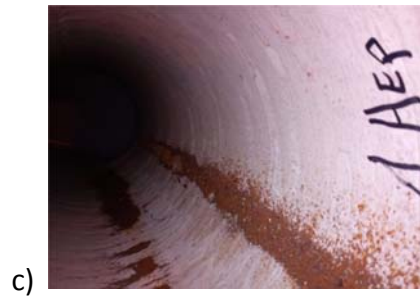
In the first VRS-PRO specimen tested, the ball weight was marked in the impact point deforming the iron layer. The epoxy was not unstuck. In the interior were not found cracks in the concrete layer (Fig. 5.10).

Figure 5.19. 1.AE<sub>p</sub> specimen after impact. a) wide external view b) close external view c) wide internal view.

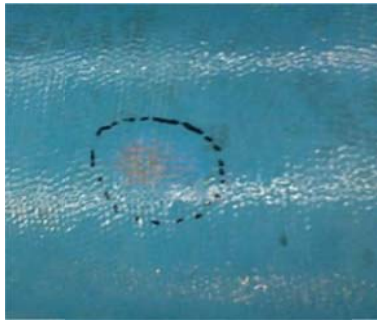
After the sanding of the epoxy layer of R.AE<sub>p</sub>, the specimen looked perfectly except the sanding region, which had a metal colour, it showed the zinc layer (Fig. 5.15).

Figure 5.24. Close external view of R.AE<sub>p</sub> specimen after sanding.

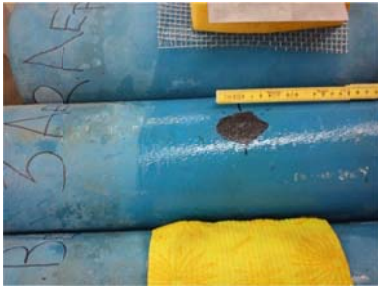
Furthermore, the specimen had an aspect of the mark of approximately 3x6 cm with the epoxy layer unstuck (Fig. 5.22).

Figure 5.31. Half-cell potential measurement - 3.AE<sub>p</sub> specimen after saturation.

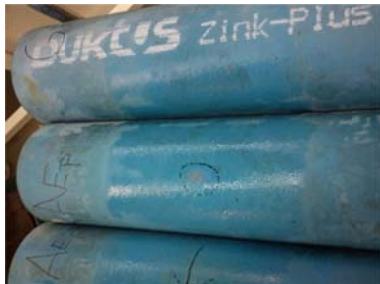
The final image of this specimen had a silver mark representing the zinc surface of approximately 2x4 cm, with some blue points of epoxy (Fig. 5.23).

Figure 5.32. Half-cell potential measurement - R.AE<sub>p</sub> specimen after saturation.
