Relationship between Fatigue Properties and Surface Treatment of Aluminum Alloy

Master's Thesis in Materials Science and Technology

MASTER'S THESIS 2023

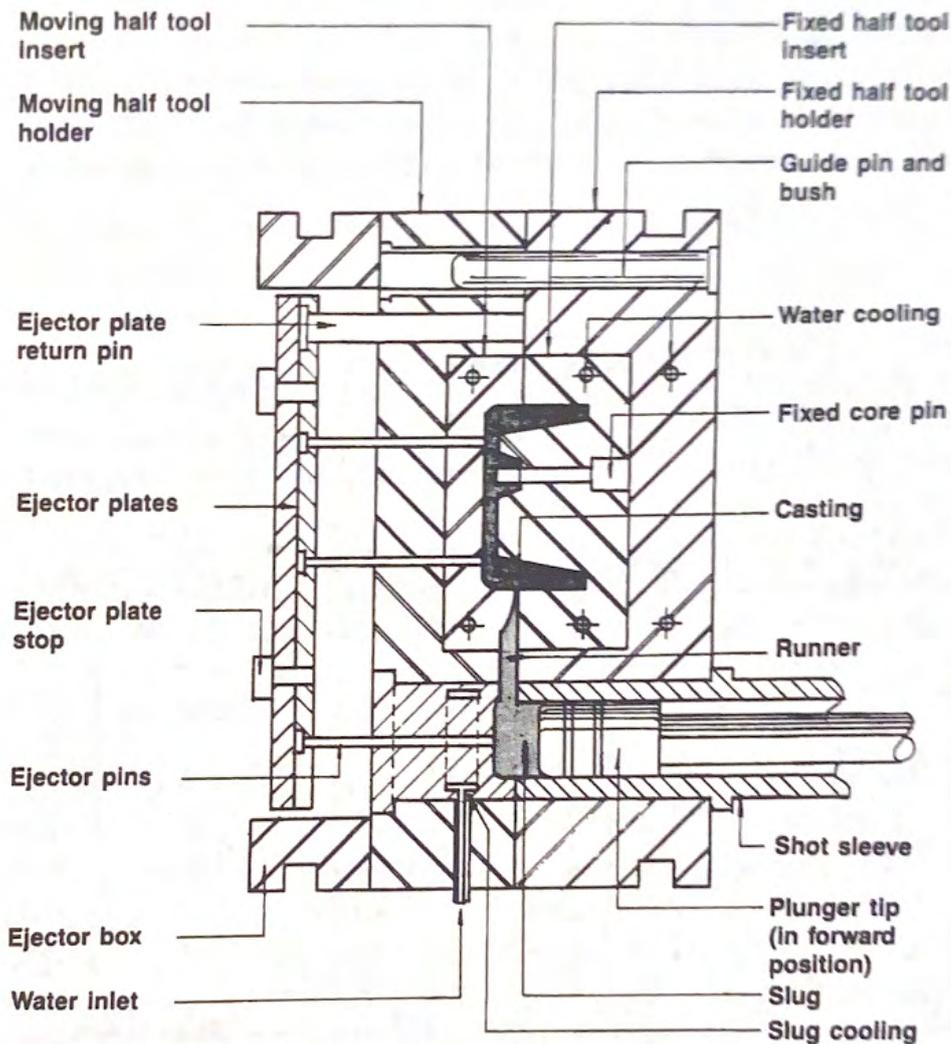
Figure 2.1: HPDC Cold Chamber

The die base must be strong enough to support the die against the heavy locking pressure applied to it, and often, mechanisms of racks, plates, and pinions are used for pulling cores and ejecting the casting. Ejector pins are used in the ejector half of many dies and actuate after the die opens to push the casting out of the cavity and off any fixed cores. See figure 2.1

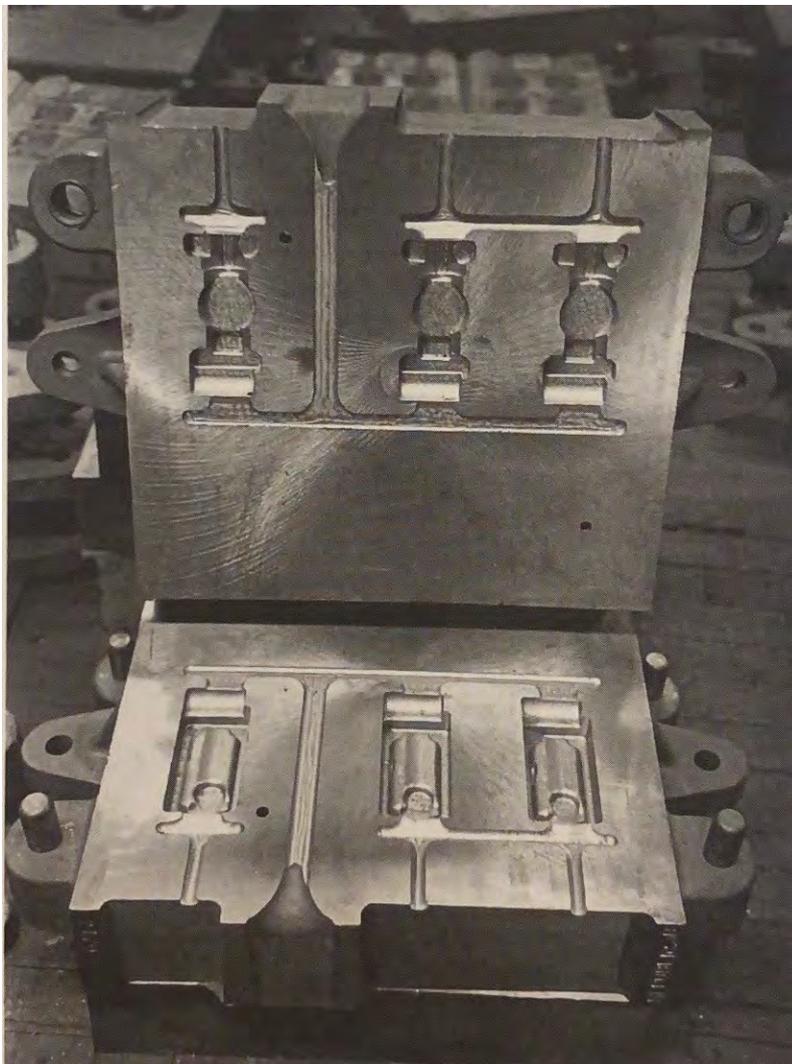
Figure 2.2: PMC Mold

1. Spray release agents onto preheated mold surfaces at temperatures between 121-260°C.
2. Close the mold.
3. Heat the alloy to its melting temperature.
4. Pour the molten alloy into the mold.
5. Allow the alloy to solidify.
6. Open the mold.
7. Remove the finished part.

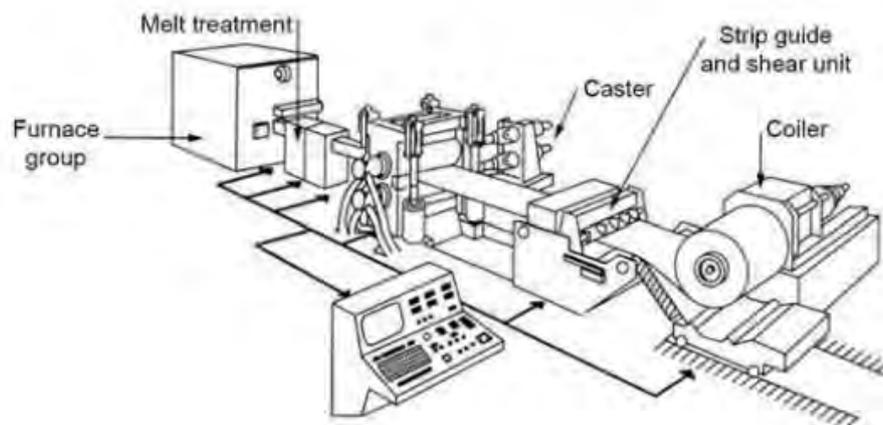
The strip cast stock produced by twin-roll strip casting is the principal source of aluminum foil. The average annual capacity of a strip caster is approximately 18,000 Mg (40 million lb), and casting speeds range widely but average approximately 2.0 to 2.5 m/min (7 to 8 ft/min). The conventional re-roll gauge's of the strip are between 3.18 to 11.4 mm (0.125 to 0.450 in.), which typically serve as stock for subsequent cold rolling or, in some cases, may be rolled in-line to finished sheet gauge's.

Figure 2.3: Typical arrangement of a twin-roll horizontal caster used in the aluminum industry.[8]

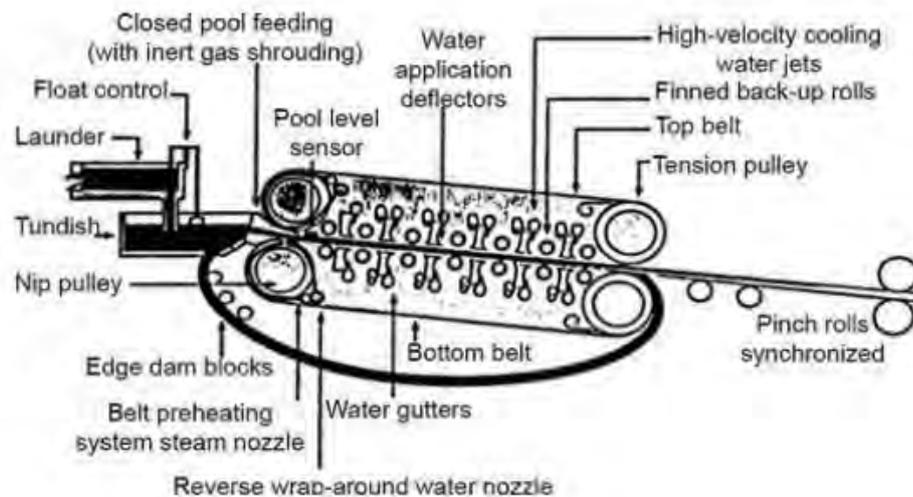
Figure 2.4: Twin-belt slab caster. Courtesy of Light Metal Age. [9]

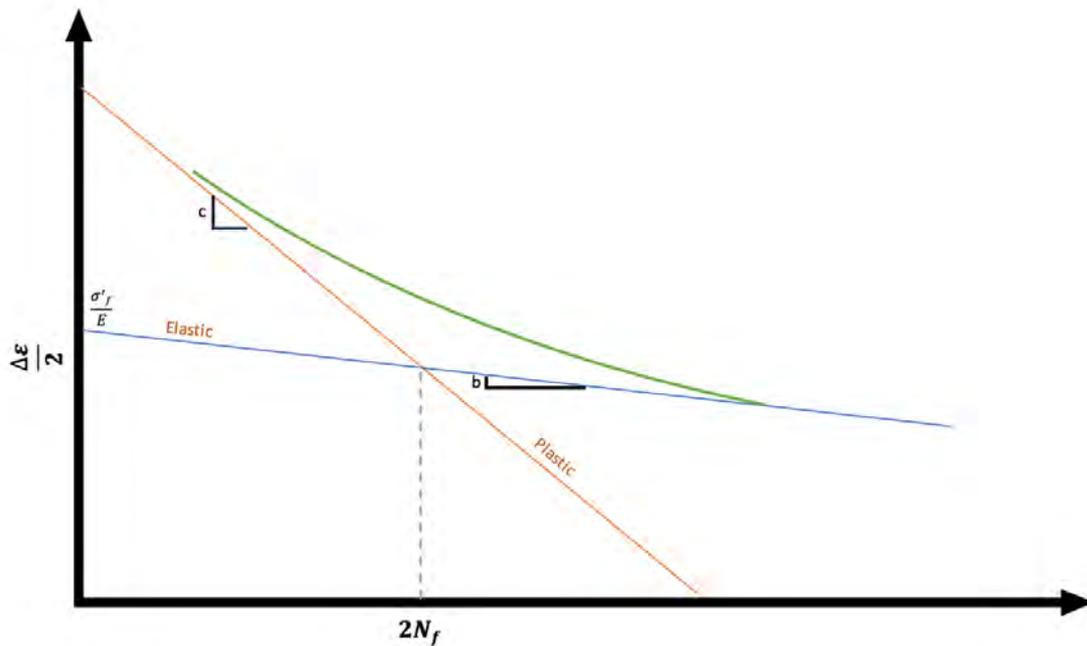
Here, σ_f represents the fatigue strength coefficient, N_f is the number of cycles to failure, and b is the fatigue strength exponent. On a log-log plot, this relationship appears as a straight line with a slope of b . In high-cycle fatigue, the material's behavior is primarily elastic, and the stress amplitude is directly related to the elastic strain amplitude ($\frac{\epsilon_e}{2}$).

Figure 2.5: Like S-N curve but with logarithmic strain amplitude – proportional to stress amplitude for elastic response

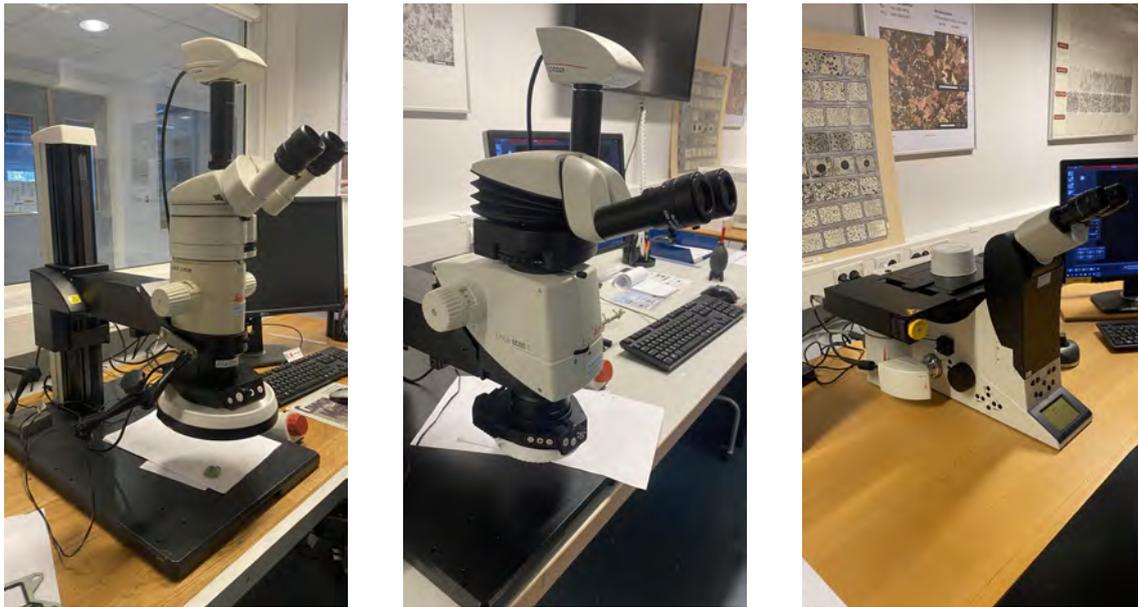
Figure 2.6: Microscopes

(a) Leica MZFLIII,

(b) Leica M205C

Light optical microscopy (LOM) examination was conducted at the Volvo Material Technology Department using three different microscopes, namely Leica MZFLIII, figure 3.5a, the Leica M205C, figure 2.6b, and Leica DMI5000 M, figure 3.5c. The observations were made at various magnifications. Specifically, Magnifications of 0.8 were employed, with a scale of 2.5 mm for capturing overview images and a scale of 3.2 for pinpointing the approximate crack propagation area. The region of interest was identified for further analysis using scanning electron microscopy.

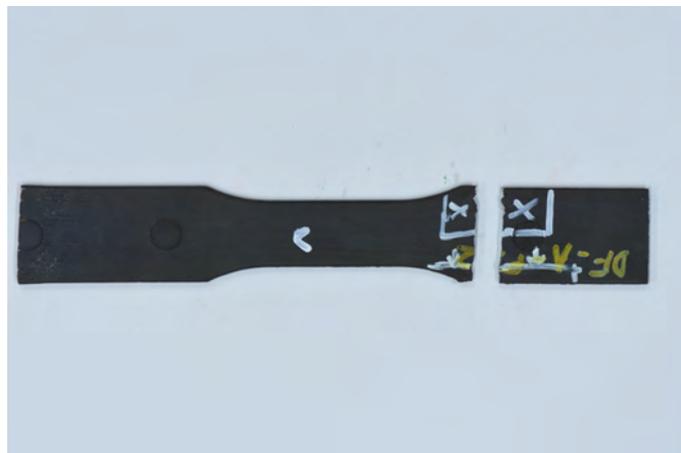
**Figure 2.7:** DF-A-F2 sectioned

After achieving successful results, further research on the grain structure surrounding the crack required proper sectioning. In the figure 2.7, two symbols were used for sectioning: **X** and \uparrow , which pinpointed the selected areas for the next steps. The **X** symbol was used to indicate a perpendicular direction to the surface, while the \uparrow symbol indicated a perpendicular direction to the sectioned area.

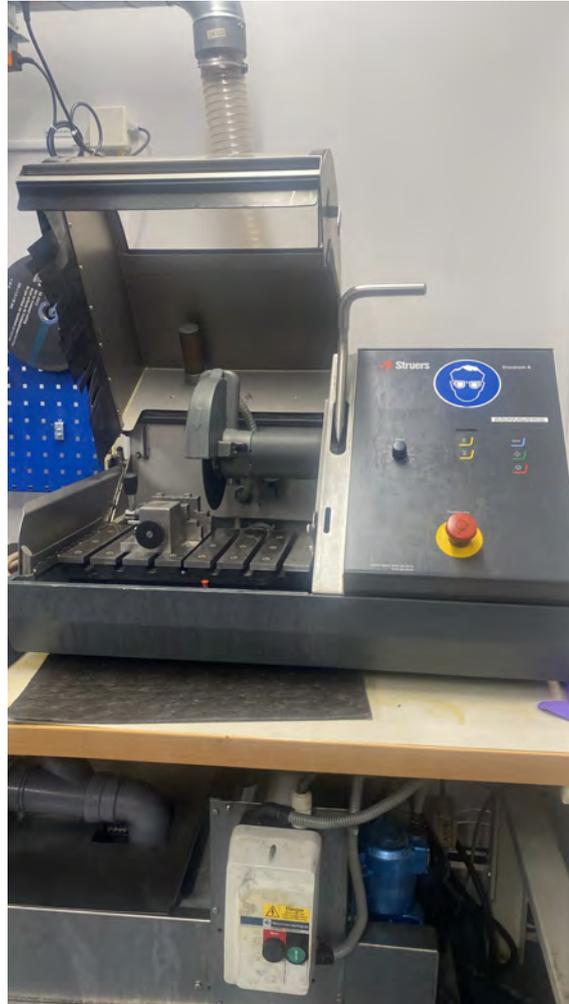
Figure 2.8: Discotom-6

- **Cutting :** Prior to cutting aluminum, it is crucial to select a suitable cutting tool, ensure proper feed speed, and use a high-quality cut-off wheel to prevent damage to the material. In this particular case, the Discotom-6 2.8 cutting tool was utilized, and a high-quality num60A25 cut-off wheel was mounted on the machine for cutting the sample. Care was taken to avoid damaging the part during the cutting process.

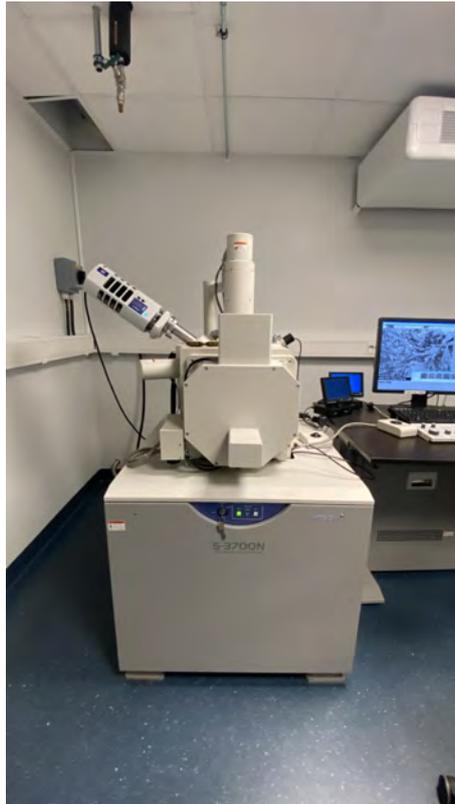
Figure 2.9: Hitachi S-3700N

is scanned on the surface of the sample in a raster pattern and electrons scattered from the surface are detected using detectors. The brightness and contrast of the images reveals information on the topography, composition and other properties of the fracture surface. Hitachi S-3700N SEM, as seen in figure 2.9, at Volvo Material Technology, was utilized during the thesis to analyze specific locations on different samples. Fatigue striations, which are perpendicular to the direction of crack propagation, and beach marks can also be observed using SEM. Overall, the purpose of utilizing SEM was to detect these features and gain insight into the causes of fatigue failures.

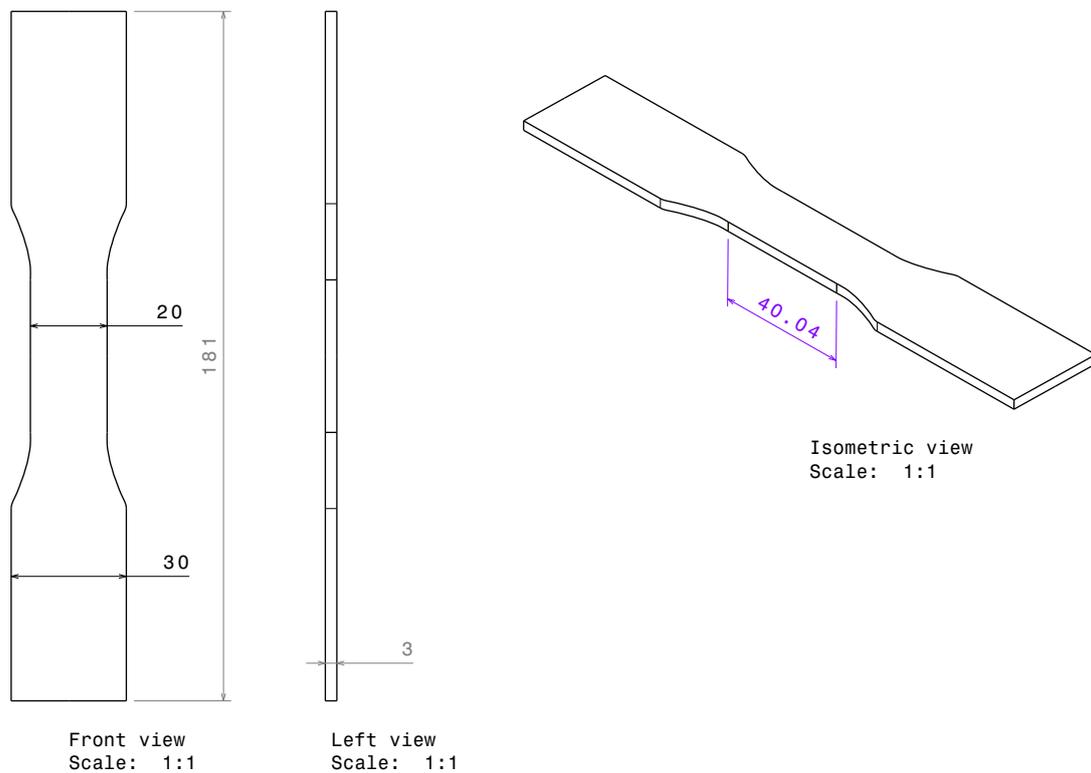
Figure 3.2: Dog Bone fatigue Specimen test sample dimensions (mm)

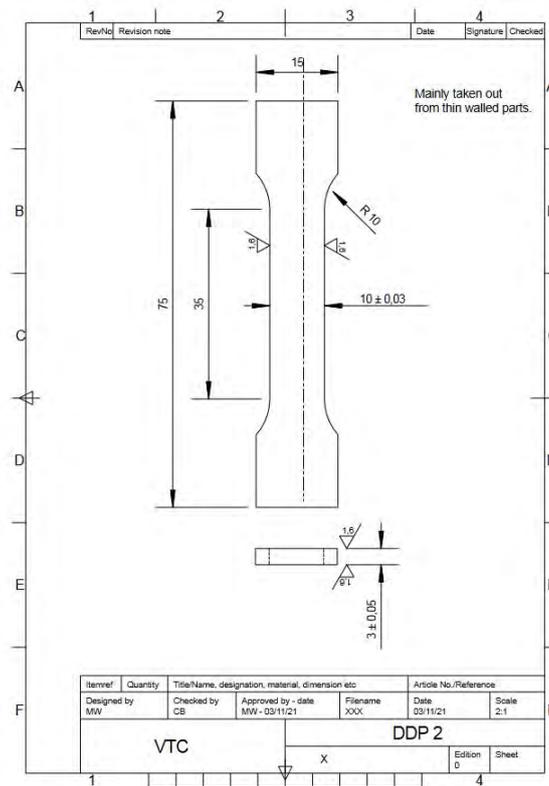
The Tensile tests were carried out at the Material Technology department of Volvo. As per the ASTM standard [14] for tensile testing, the dimensions differed from those of the fatigue specimens as shown in figure 3.3 . Consequently, the SM tensile DBS were water cut at Chalmers University of Technology's Porto type lab, while the PMC was sent to Ljungs Mekaniska AB for machining, as shown in the figure 3.4 .

Figure 3.3: Dog Bone tensile Specimen test sample dimensions (mm)

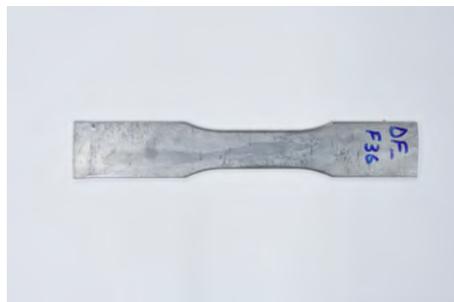
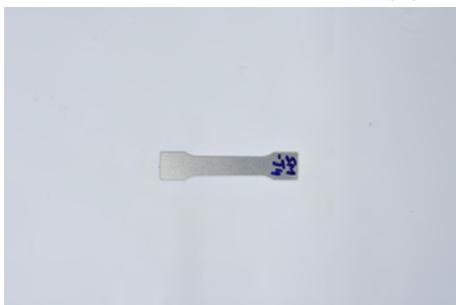
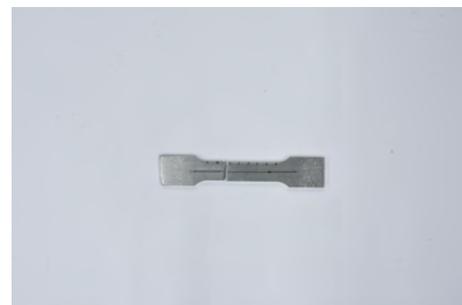
Figure 3.4: Tensile DBS

(a) High Pressure Die Cast

(b) Sheet Metal

(c) Permanent Mold Cast

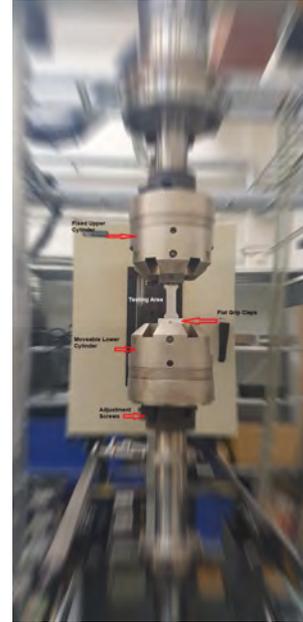
Figure 3.6: Fatigue test rig

Figure 3.6 below shows the Fatigue Test Rig at Chalmers that was used for the entire project. Here it is loaded with one HPDC anodized samples. A threshold of five hundred thousand (500,000) cycles was set to simulate high fatigue life of the test samples.

The flat structure of the samples necessitated the use of flat grip clamps on the test rig. For cylindrical samples, a different set of clamps was employed. The lower cylinder had the capability to move, while the upper cylinder remained stationary. Throughout the testing process, the rig maintained a constant frequency of 20Hz, while the amplitude of the applied load varied based on the material characteristics, following the staircase method.

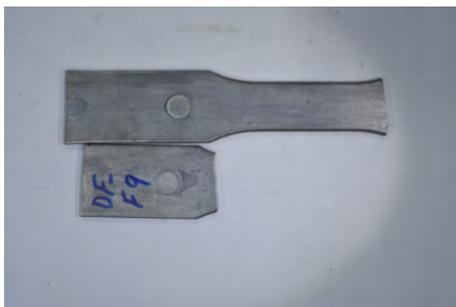
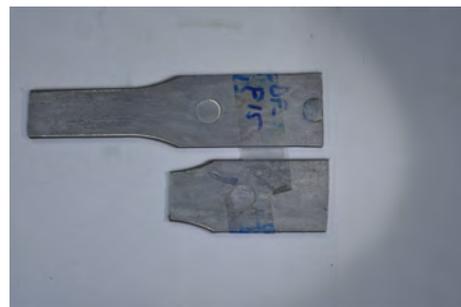
Figure 3.12: HPDC - reference chosen samples

Two samples are mentioned in figure 3.12a and 3.12b that did not pass the high cycle fatigue threshold, however the test run was valid as the samples fractured within the testing area.

The three spots marked as 1, 2, and 3 were thought of as probable causes of premature failure in the sample shown in figure 3.12a. A closeup of spot 1 and spot 2 is shown in figure 4.10.

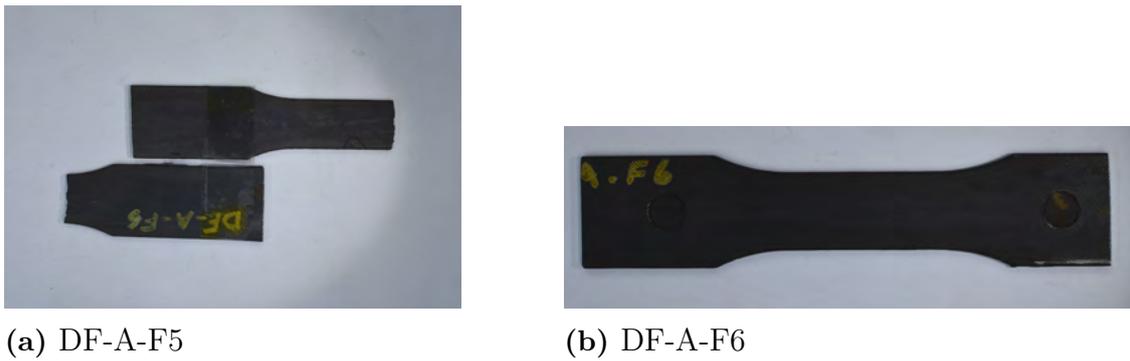
Figure 3.13: HPDC Anodized chosen samples

Similar to the HPDC reference section, two samples for the HPDC anodized batch are shown in figure 3.13. Both test runs were deemed valid, however, a point to note here was that sample 3.13b did not break and the test was stopped after the threshold cycles had been reached.

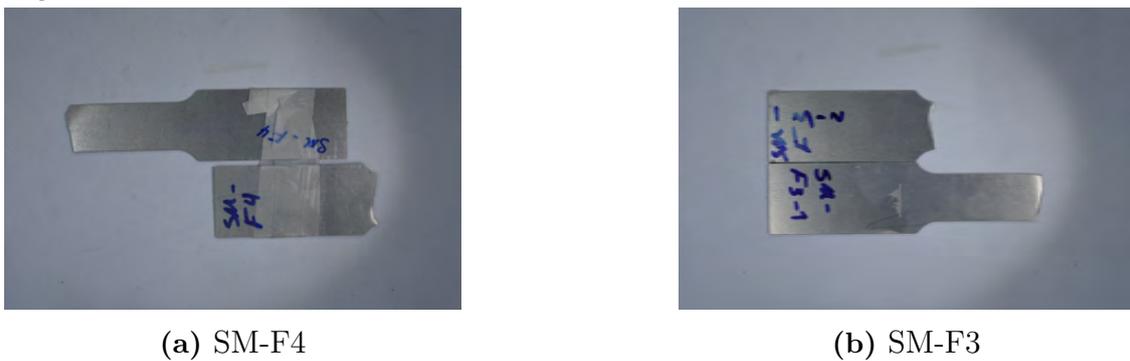
Figure 3.14: SM chosen samples

Following suit, the sheet metal samples were visually inspected as well for any obvious signs of damage and/or clues as to how the fracture may have been initiated. Figure 3.14 shows two samples from the sheet metal reference batch.

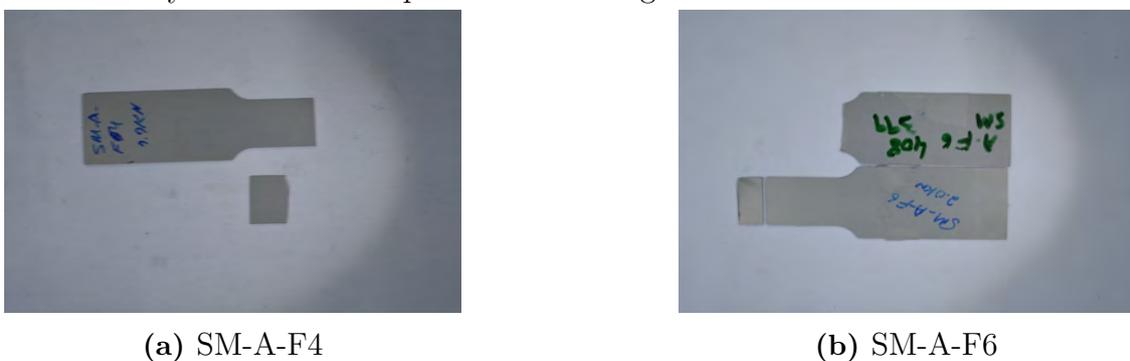
Figure 3.15: SM Anodized chosen samples

The sheet metal anodized samples were carefully removed from the test rig for further analysis and two samples are seen in figure 3.15.

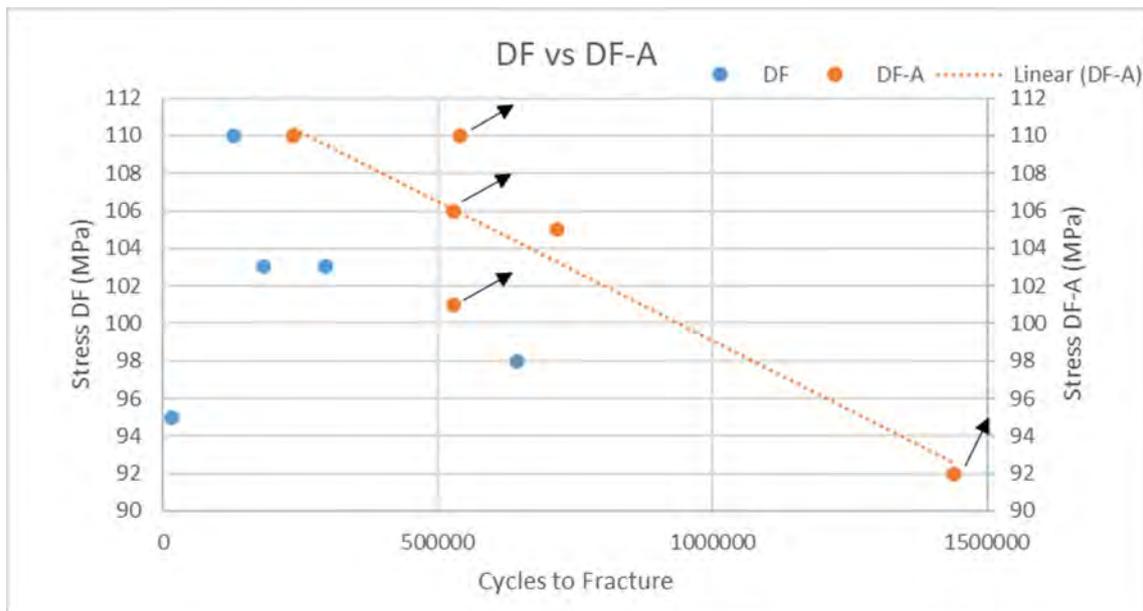
Figure 4.1: Data Plot HPDC

Figure 4.1 shows the data points plotted for the HPDC test samples both before and after amortization along with a trend line for the later batch. The small arrows seen here are the samples that did not break after achieving the threshold value of 500000 cycles. The test was manually stopped for these samples. It is clearly seen that the anodized samples show a higher fatigue strength than the unanodized samples at a prescribed stress level. This trend can also be noted in table 3.4 previously.

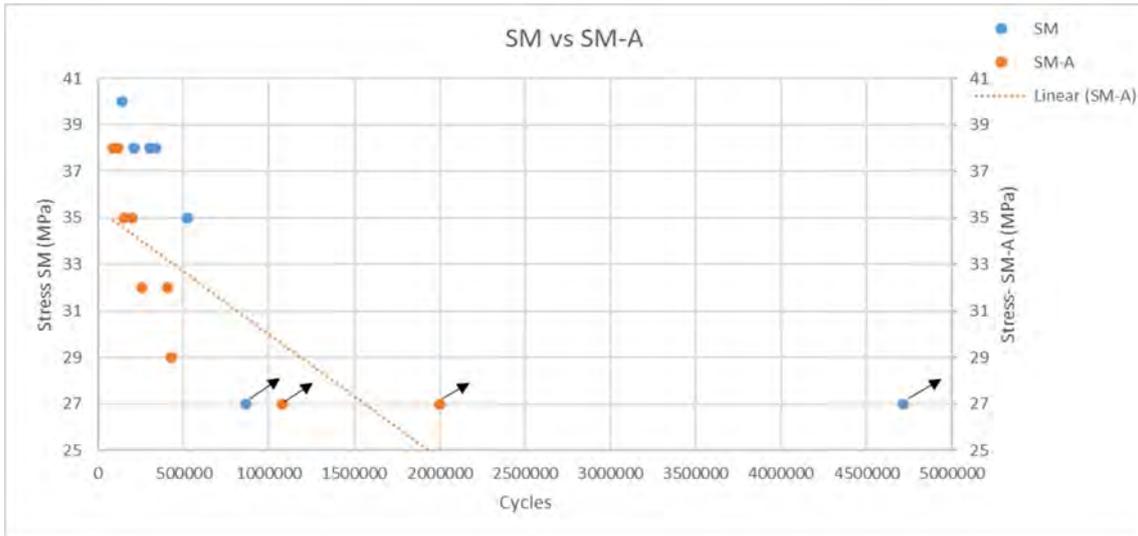
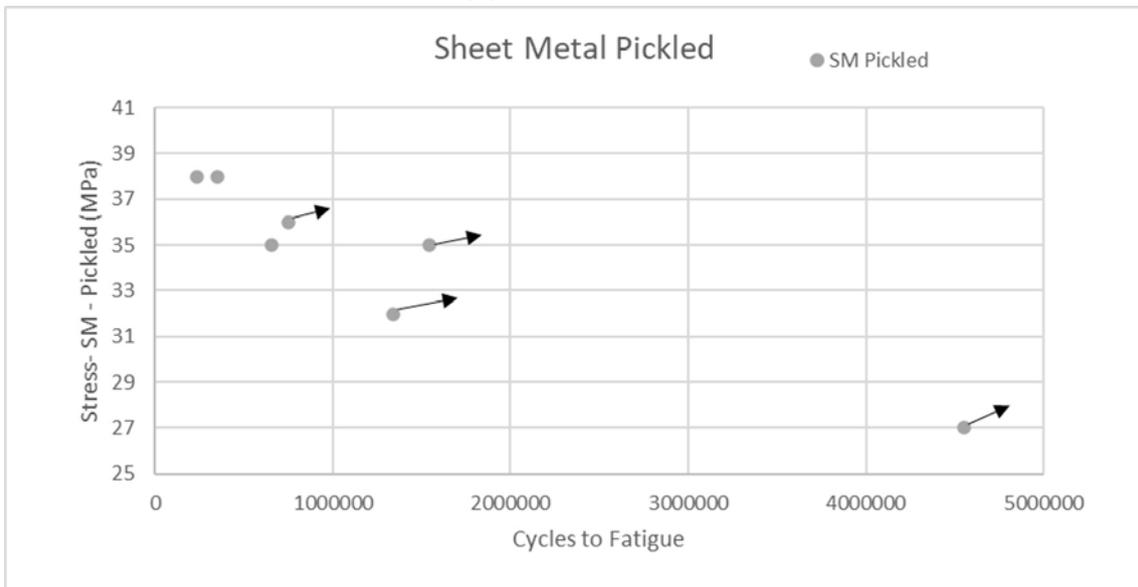
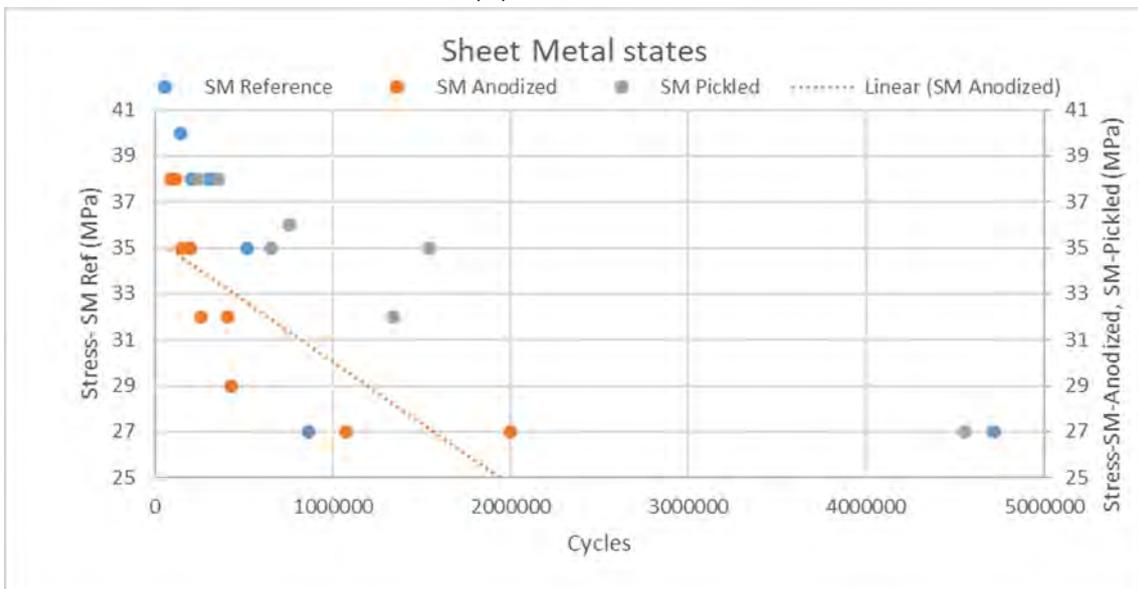
Figure 4.2: Data Plot Sheet Metal

Figure 4.2 here shows three plots for sheet metal. The first plot 4.2a depicts the comparison of sheet metal samples before and after anodization. Similar to the previous figure, the arrows here also show the samples that did not break and the tests were stopped manually. It is evident that at lower stress levels, the samples showed the best fatigue behavior. Such behavior was expected as the sheet metal displayed the lowest tensile strength out of all the alloys as seen in figure 3.5b. The pickled samples displayed the best fatigue characteristics out of the three states for sheet metal samples. As seen in table 3.8 and figure 4.2b, most of the test runs were successful and had to be manually terminated in order to start a new test. Pickling not only rids the metal of any undesired oxides, or scale build-up but leaves the surface with corrosion pits that prove to be the cause of future fatigue failure. The reason why these test samples behaved the way they did was attributed to the lack of such pits on the surface post-treatment. Once more the arrows point out the samples that did not break. Figure 4.2c shows the comparison of reference, pickled, and anodized sheet metal samples. It is fairly evident that the pickled samples show the best fatigue properties out of the batch staying consistent with the assumption that anodization alone does not cause a decrease in fatigue strength.

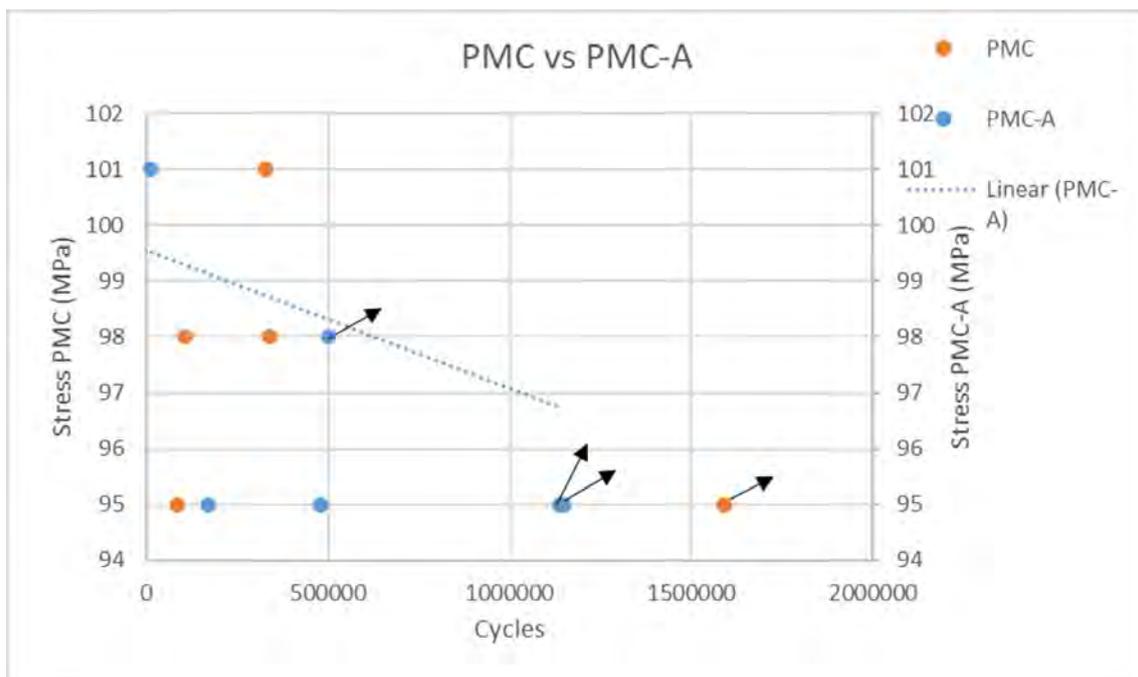
Figure 4.3: Data Plot PMC

Figure 4.3 and tables 3.9 and 3.10 show a spread of data across the various stress levels for permanent mold cast samples. As always the threshold was set at 500000 cycles for a successful high-cycle fatigue run, and the sample had to fracture in the testing area for the test to be valid. The failed samples also display a spread of data owing to the contribution of the presence of pre-solidified material defects, shrinkage porosity, and internal stresses. The in-depth analysis of both the cast materials, i.e. HPDC and PMC, showed a similar pattern of defects causing the samples to fail well before the threshold. Figure 4.4 is an overview of both the cast alloy's anodized

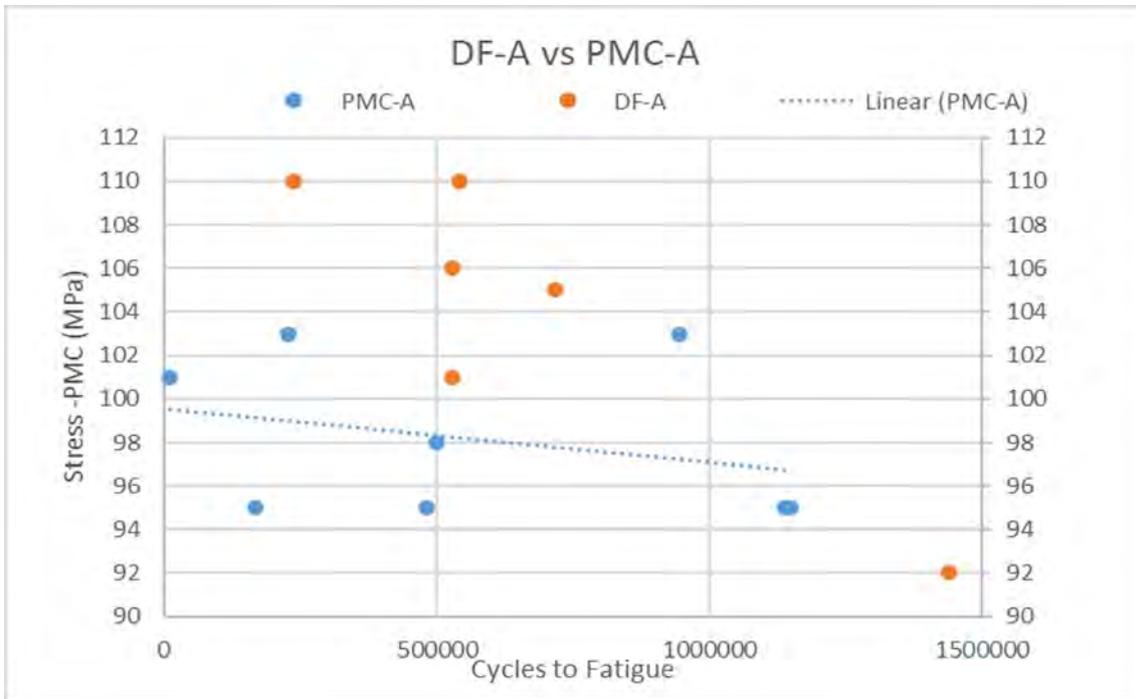
Figure 4.4: Data Plot DFA vs PMCA

sample. It is seen here that quite a few samples had a successful test run with the HPDC samples having a higher fatigue strength than the PMC samples.

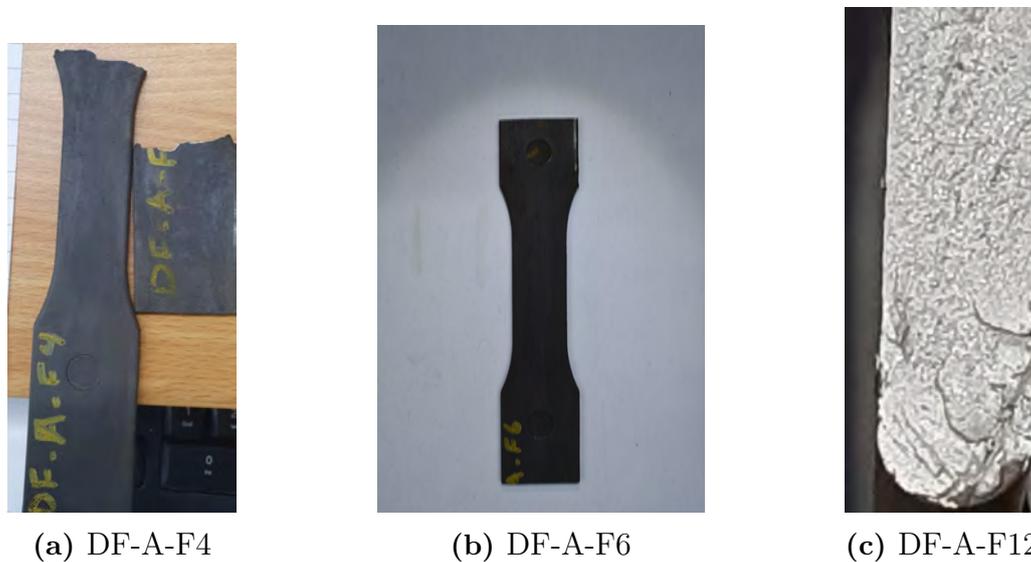
Figure 4.6: DF-A Test Samples

Figure 4.6 shows two examples of invalid samples that broke outside the testing area (a & c) and one that did not break at all (b).

It is evident by looking at figure 4.6a above that the fracture happened outside the testing area specifically in the clamping jaws. Similarly, in figure 4.6c the fracture occurred at the bottom of the sample. Conversely, in figure 4.6b, one sees that the fracture did not initiate. This sample passed the test and survived the threshold. NDT was also performed on 4.6b and no surface cracks were observed.

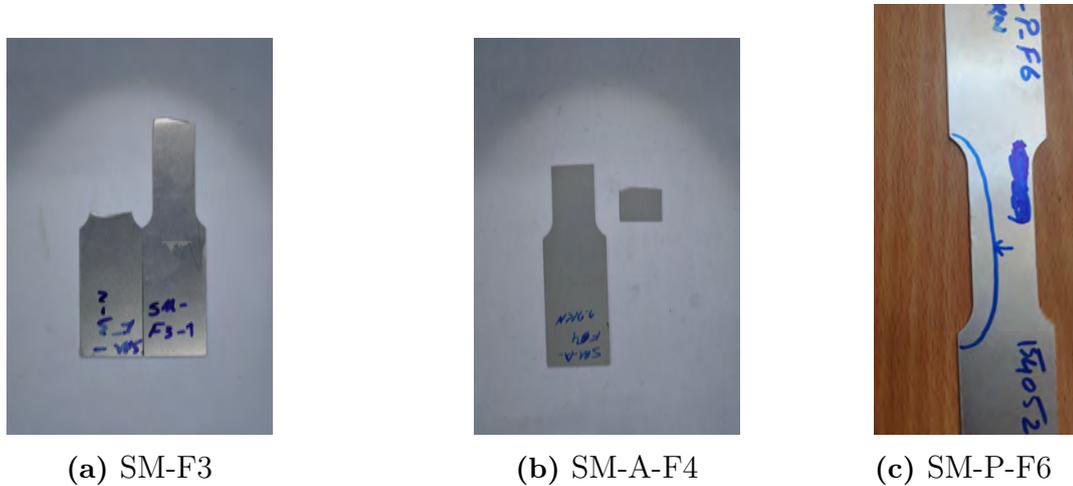
Figure 4.7: SM Test Samples

face defects could be attributed to misalignment of the test top and bottom jaws by applying slight shear along with the designated tension force. Since there was no compression load applied in any of the tests, buckling was ruled out as a possible cause of the defect. The test, however, remains valid.

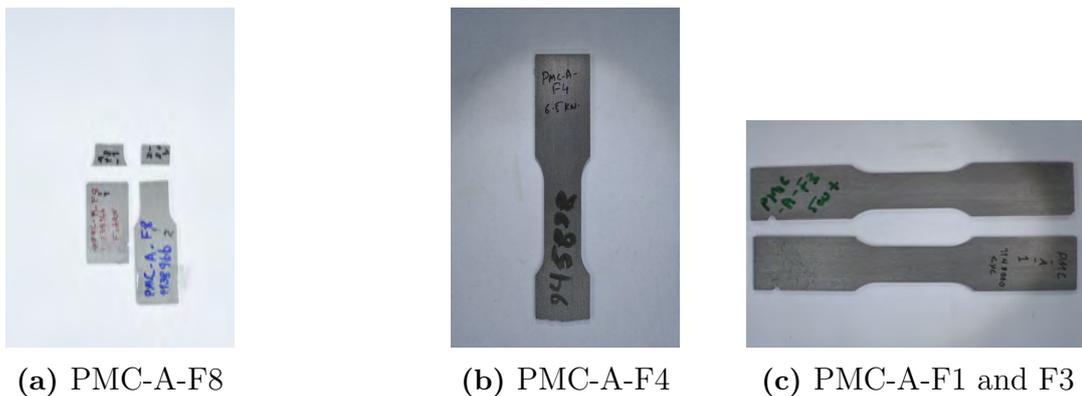
Figure 4.8: PMC Test Samples

Similarly, all PMC samples were subjected to visual inspection as well. Samples 4.8a and 4.8b fractured after passing the fatigue test, however, as seen in the respective figures the later one fractured in the clamping area and was deemed as invalid test. On the contrary samples in 4.8c not only survived the high cycle fatigue test but the test had to be manually stopped.

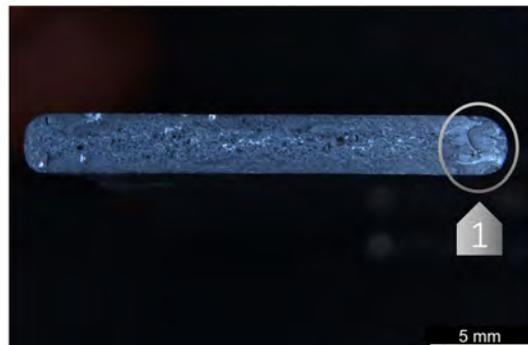
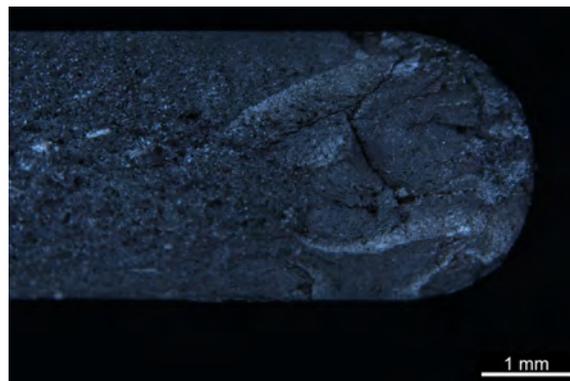
The figures 4.11 and 4.12 show the overview and closeup, respectively, of the fracture surface from the other half of the HPDC reference sample DF-F9. Furthermore, the second peculiar sample in the HPDC reference batch is shown from figure 4.13 to figure 4.16. The connotations "-1" and "-2" represent two halves of the fracture surface. An overview and a closeup of the marked spot is shown for both halves.

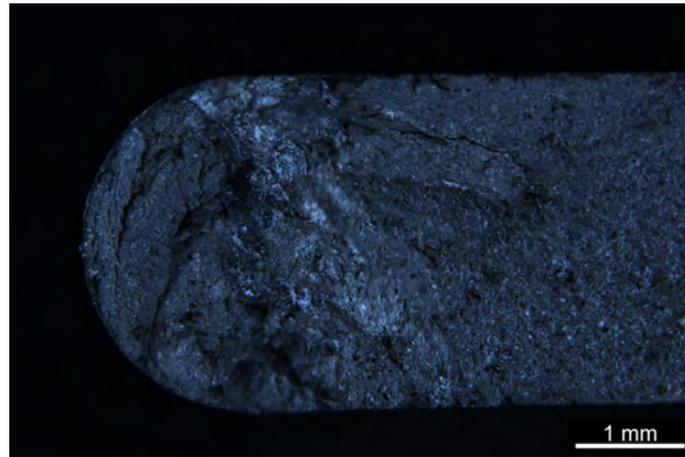
Figure 4.16: DF-F15-2 Defined Section

Figures from 4.13 to 4.16 represent the other un-anodized HPDC sample that fractured extremely quickly at a low-stress level. Starting from the left side of the figure 4.16, multiple crack initiation sites along with possible pre-solidified oxide inclusions can be seen before the final static fracture towards the middle and proceeding to the right side.

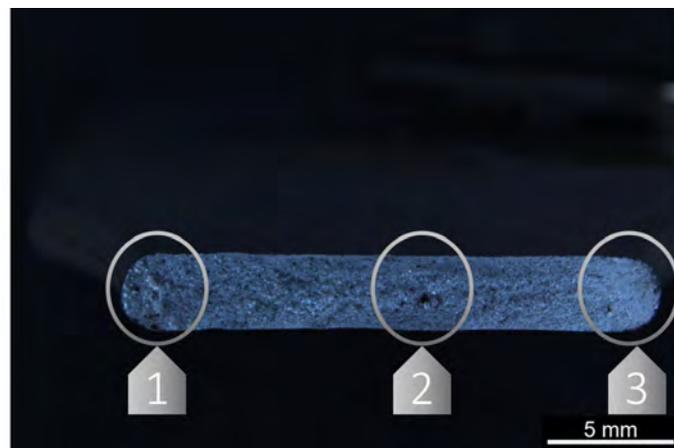
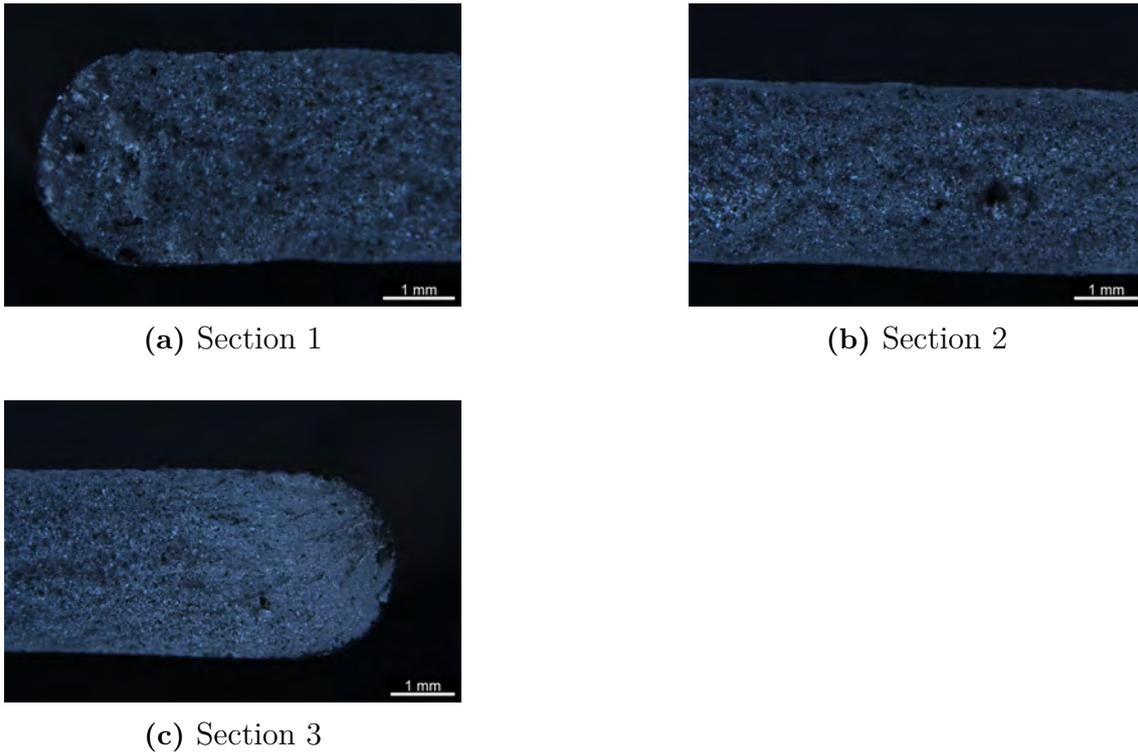
HPDC anodized samples were tested on the fatigue rig afterward. During the testing, one sample, DF-A-F5 exhibited failure at a low number of cycles and was subsequently examined under a light optical microscope. The microscopic examination aimed to gain insights into the fracture and identify potential factors contributing to the failure. Figure 4.17 shows three sections on the sample that were suspected to have been the cause of failure, whereas figure 4.18 shows the close-up of the sample.

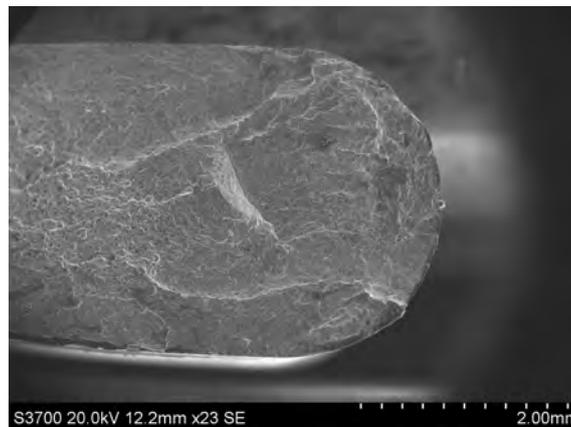
Figure 4.21: DF-F9-2 at section 1 SEM

Figure 4.21 below shows an un-anodized fractured sample. One sees signs of fatigue fracture towards the right end of the figure. The left side of the figure shows a static fracture. Multiple cracks are seen initiating from the surface of the sample and propagating towards the center of the sample. The thick white mark in the center of the figure is suspected to be a double-folded oxide layer, which expedites crack growth by creating internal stresses.

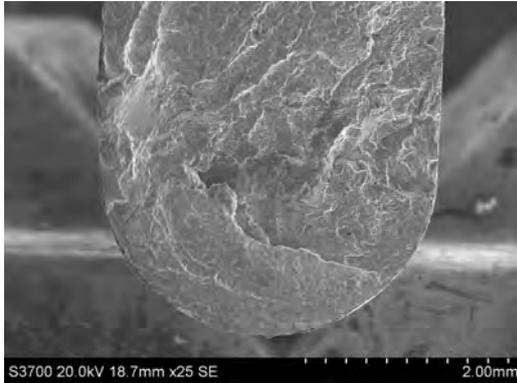
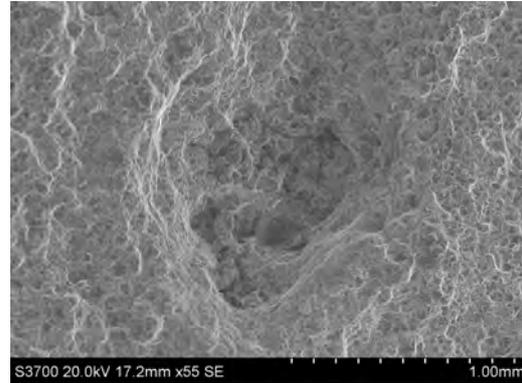
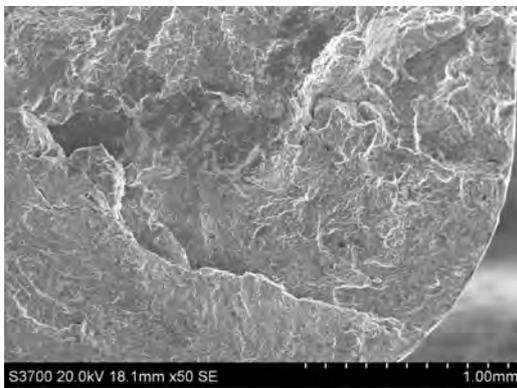
Figure 4.22: DF-15-2

structure to fully develop. Figure 4.22c shows several secondary cracks and oxide layers contributing to the fracture.

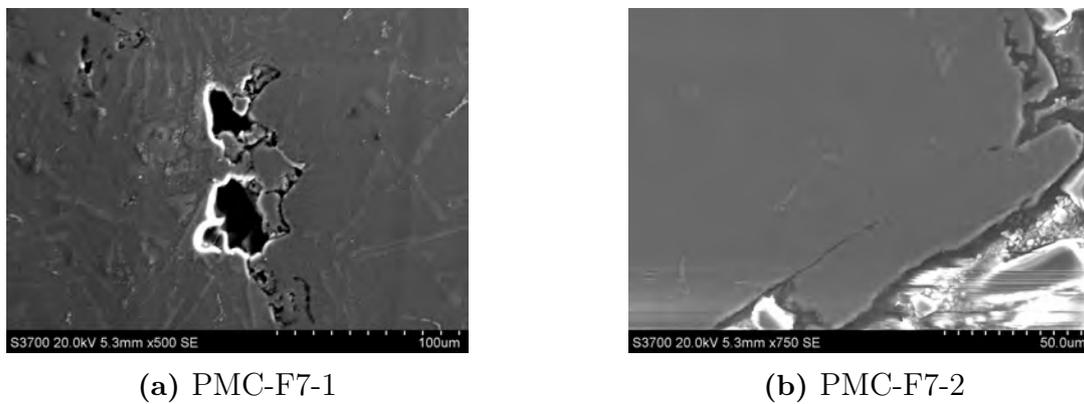
Figure 4.25: PMC-F7

Figure 4.25 below shows the SEM image of an unanodized PMC sample that achieved over one and a half million cycles of fracture. Upon examination of the sample, one defect resembling pre-solidification could be seen at a resolution of 100 m. The rest of the material displayed homogeneous material characteristics.

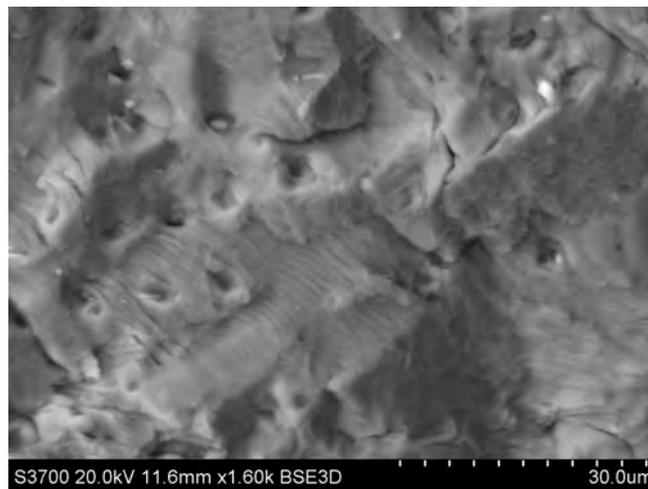
Figure 4.27: SM-A-F6

The image shown in figure 4.27 achieved close to the threshold number of cycles to fatigue failure. The nature of the metal made it extremely difficult to detect any anomalies in the microstructure that could have caused the failure, however, at a resolution of 30um distinct striations could be seen.
