Finding and Eliminating the Root Cause of Defects Identified in Customer Complaints

A case study using the Six Sigma methodology to facilitate root cause analyses

Master's Thesis Project in the Master's Degree Program Quality and Operations Management

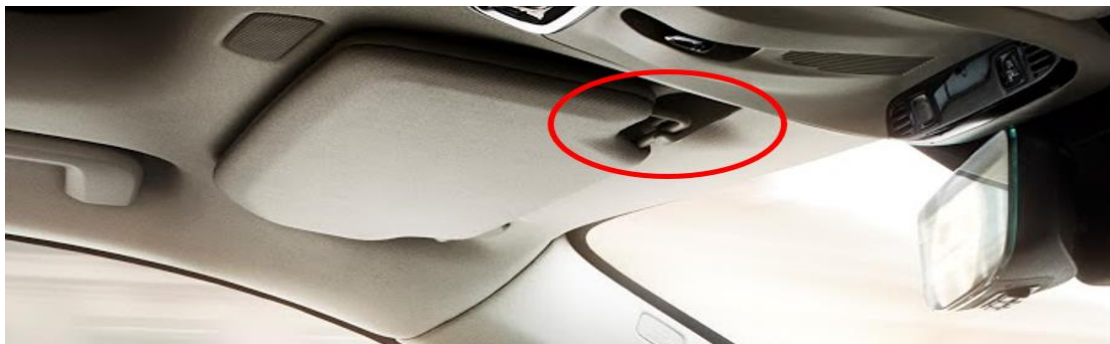
Figure 1. Picture of the sun visor and placement of the support bearing (Volvo Cars, 2020b).

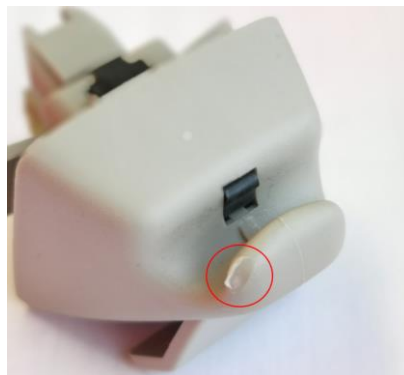
During the authors' observation of the damaged support bearings that are replaced within production, additional defects on the sun visor hook have been noticed, see Figure 12 below. This defect does not affect the function of the support bearing but can be visible to the customer that can affect the customer's perception of the car and the customer satisfaction. This issue has not been noticed by the production team previously, the defect varies in size but occurs among a majority of the analyzed replaced support bearings. The press marks occur both on the left and right part of the support bearing. Observations within production and non-defect support bearings assembled to the cars show that there are press marks on several of the support bearings. Although, these marks are not identified on the incoming material, which indicates that they emerge during the assembly at VCT.

Figure 12. Picture of the defects identified on the sun visor hook.

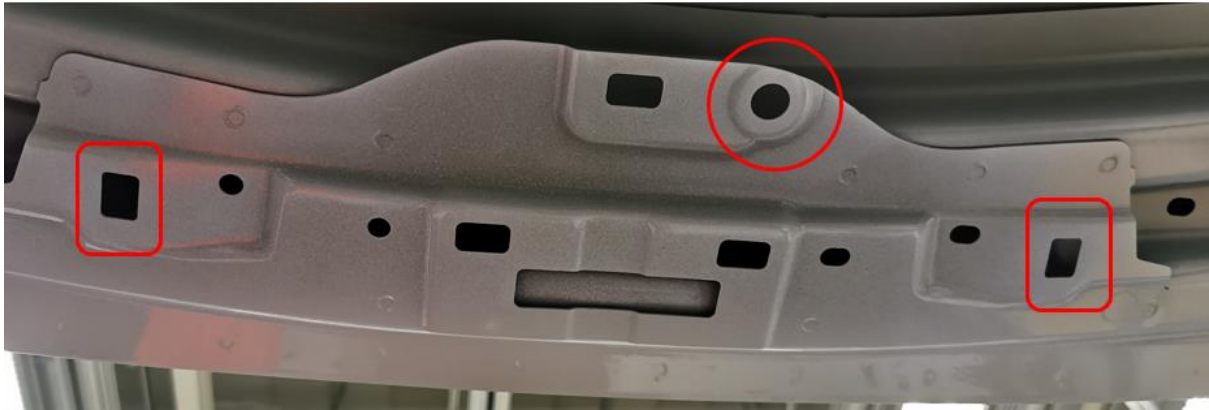
The car body is produced and welded at Volvo's plant in Olofström, Volvo Cars Body Components (VCBC). In the car body, several holes have been stamped out. There are different purposes with the stamped holes, some work as attachment points, and others as positioning holes, which make sure that the positioning of the equipment is correct during assembly. At VCBC, they are responsible for the arrangement and size of the attachment and positioning holes. Depending on the car model, the car body is different; examples of differences are the thickness of the steel and placement of the holes for the support bearing. Although, the size of the holes for the support bearing should be equally big. One of the consoles is shown in Figure 13 below. The attachment points for the support bearings are shown in the two red squares, and one positioning hole is marked by the red circle. The positioning hole's purpose is to make sure the palette, with the headliner on, gets correctly positioned into the car when it is attaching.

Figure 13. A picture on one of the consoles to the V90 where the support bearings attach. The two holes marked by red squares are where the support bearing attaches and the hole in the red circle is one positioning hole.

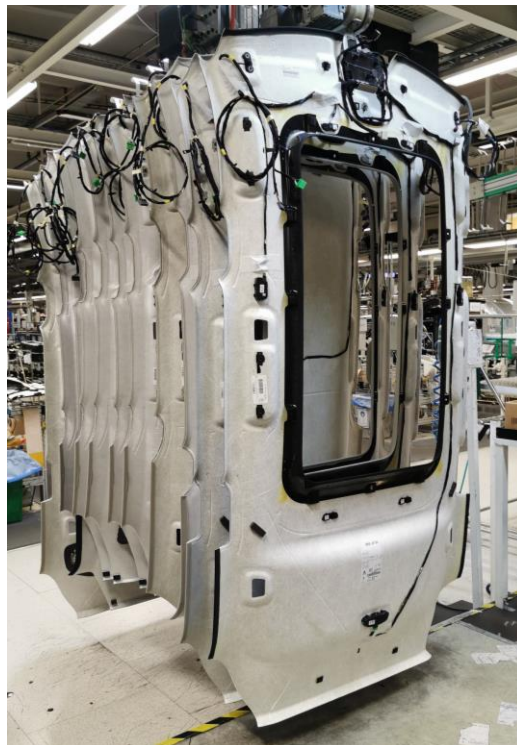
The headliner is delivered from two different external suppliers to VCT but is assembled within production. A headliner ready for assembly into the car body at the palette is shown in Figure 14 below.

Figure 14. Picture of the headliner before it is put onto the palette and attached to the car body.

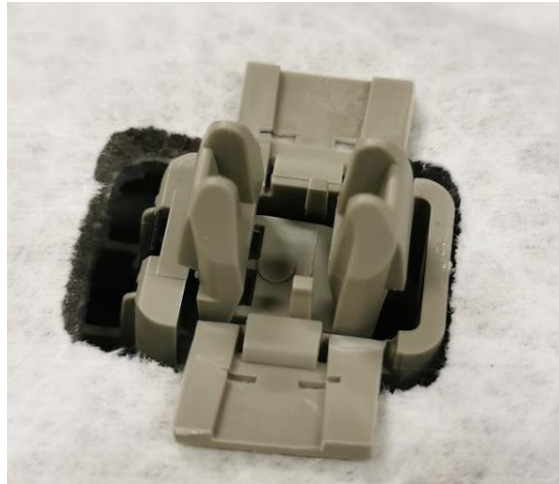
pre-made holes is slightly bigger than the support bearing, as shown in Figure 15 below. The holes are slightly bigger to make sure that the support bearing can be adjusted and more easily attached to the car body. This gives the operator the opportunity and space to adjust the components positioning in the hole to place down the support bearing into the contact lug correctly.

Figure 15. Showing the placement of the support bearing to the headliner, it is attached by the transport clips to make sure it does not fall off during the transportation between the stations.

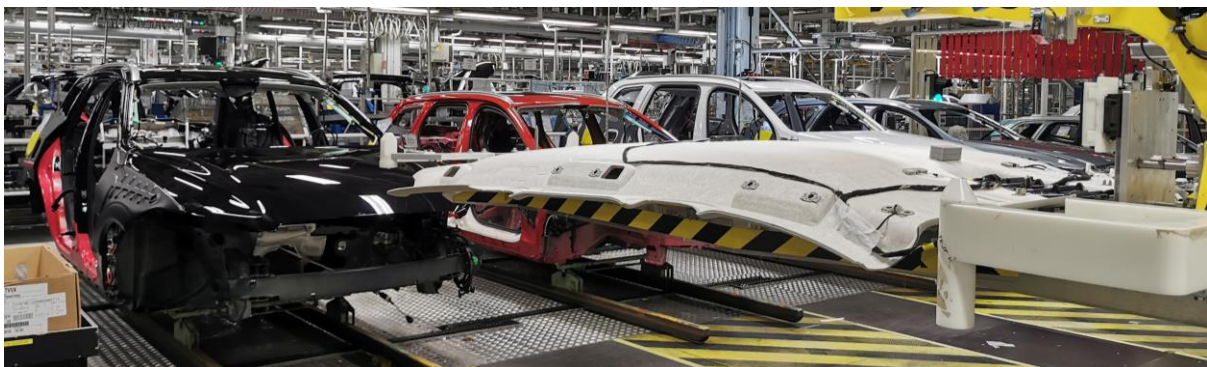
Before the first station, the specific components for each car are gathered in boxes according to the production sequence and brought to the station. At station 1, an operator assembles the sun visor and support bearing together and places it at the headliner for the operator at station 2. Both the left and right sun visors are attached to the headliner at station 2. This is done by putting the support bearing through a hole in the headliner to fold out the transport clips. The headliner is then moved to station 3 and 4, where it is positioned onto a pallette that later will push up the entire headliner to the car body at station 5. At VCT, there are three different pallettes within the production, one for V90 and V90CC, the second one for V60, and the last one for XC60 and XC90. A picture of one of the pallettes is shown in Figure 17 below.

Figure 17. Picture of one headliner placed on a pallette ready to be moved into the car and attached to the car body.

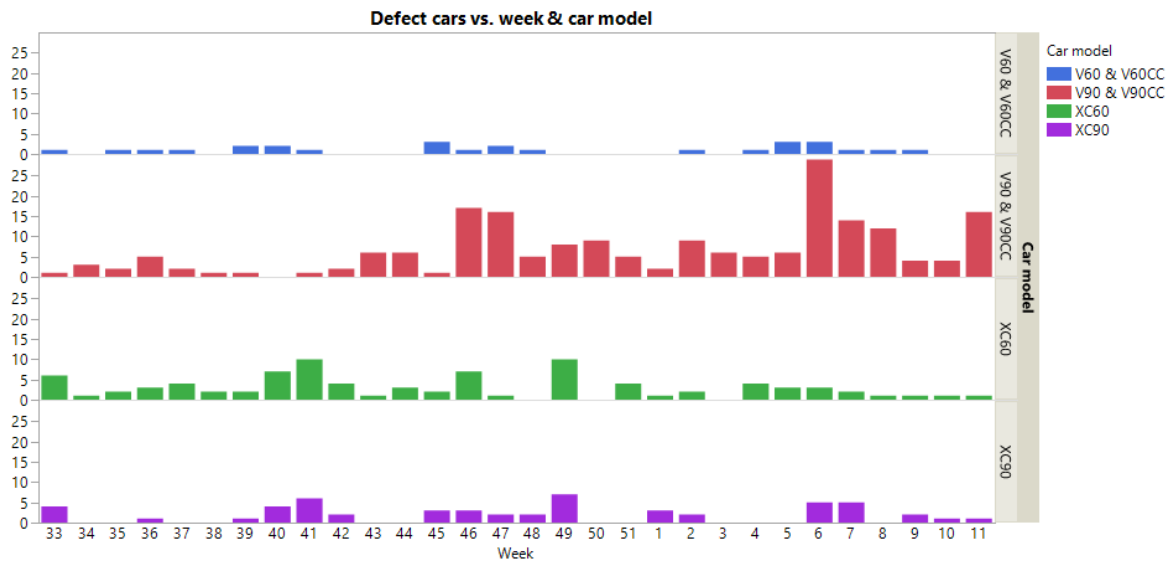
A compilation of the ATACQ data of the number of reported loose support bearings, categorized after the different car models, weekly from week 33, the year 2019 to week 11, the year 2020, is represented in Figure 19 below. The number of defect support bearings varies each week, but V90 and V90CC have the highest total number of cars with reported loose support bearings. V60 and V60CC have the lowest number of cars with defects. The same palette assembles the car models XC60 and XC90, and as shown in Figure 19 below, the number of defects follows a similar pattern. During week 45, the First Line Analysis was conducted by the production team. After this analysis was initiated, the number of reported loose support bearings increased drastically, especially for V90 & V90CC. Because of a significant lack of data before week 45, the following analysis will focus mostly on week 45 and onwards. Furthermore, an apparent increase can also be seen for week 6. During this week, the team leaders were under the instructions that they should not only report the broken support bearings but also collect them. These two occasions indicate that the number of reported loose support bearing increases when the problem is given more attention. Therefore, the real number of defect support bearings could be higher for the other observed weeks, since it is possible that not all the cases with defect support bearings are registered into ATACQ. This is always the risk when the data is registered manually since it depends on the human factor.

Figure 19. Amount of reported loose support bearings compared against production week and car model.

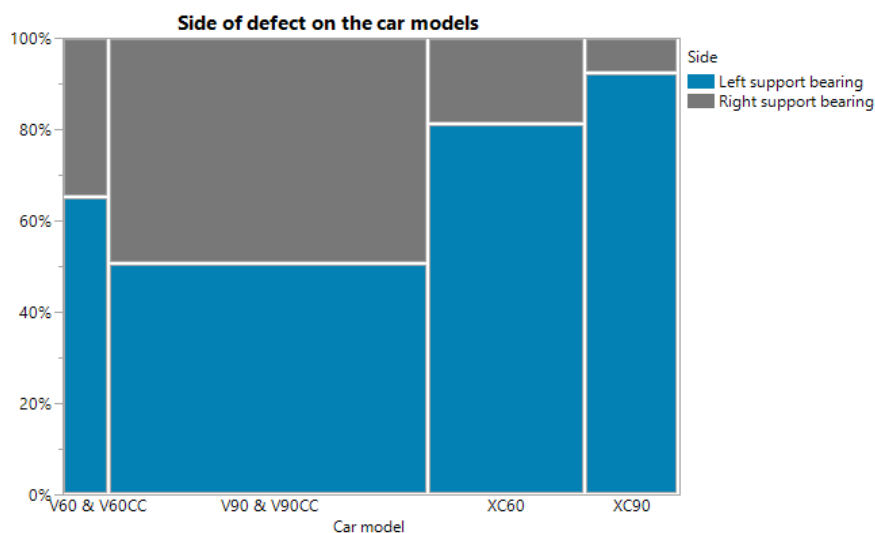
Since the support bearings are present at both sides of the cars, the defect can be reported on either left or right side. Figure 20 below shows the number of reported defects from week 33, 2019, until week 11, 2020, stratified into the left or right side, along with the car model. The left support bearings are slightly overrepresented, with 64 percent of all the reported defects. One interesting observation is that for V90 and V90CC, there is an equal distribution between left and right, with only 51 percent of the defects being on the left side. For both XC60 and XC90, most loose support bearings have been reported on the left side. This leads to a potential hypothesis that both the right and left attachment sides need to be considered for the V90, who also has the highest number of reported loose support bearings.

Figure 20. Visual representation of the number of reported loose support bearings. The Figure shows the left support bearings in blue and the right support bearings in grey. The bars vary in size due to the varying number of loose support bearings.

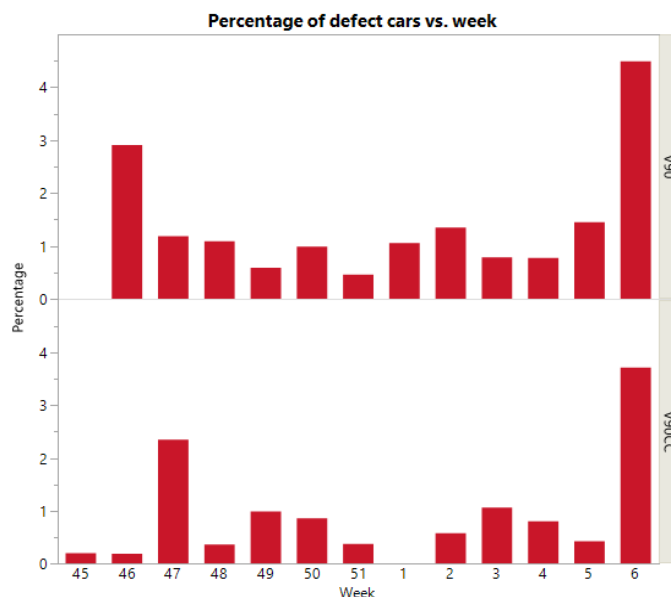
The car models V90 and V90CC have a similar car body and are assembled on the same palette. Figure 23 below shows the difference in the number of loose support bearings between the two models. As the Figure below shows, there is no significant difference between the number of defects for the two-car models, and they are continuously analyzed together.

Figure 23. Representation of the percentage of defect cars for each week for the car models V90 and V90CC.

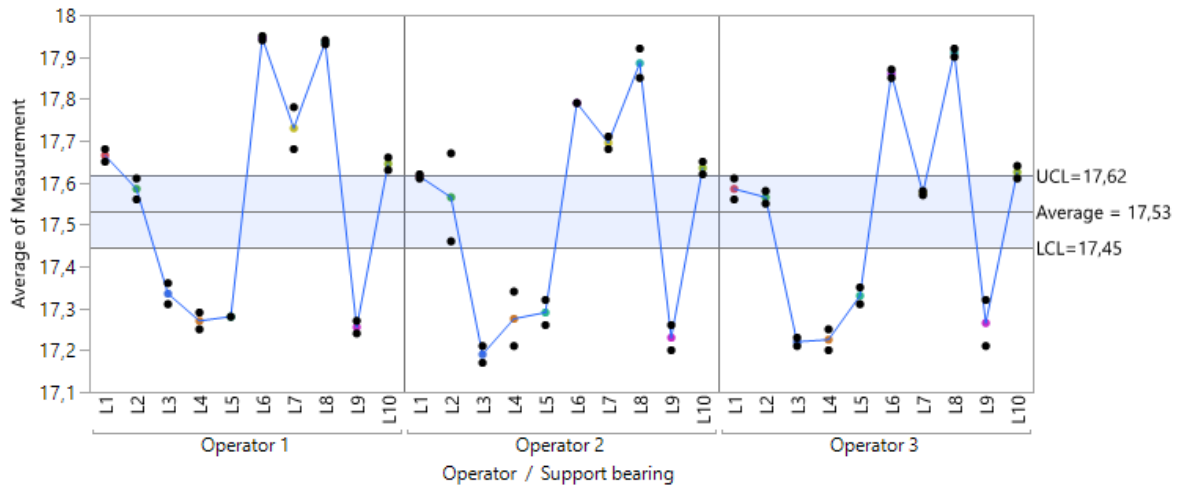
The measurements were performed with a digital caliper by three operators with one replication, as described in Chapter 3.2.1. The average width between the lock pins of the ten measured support bearings was 17,53 mm that is 0,82 mm larger than the specification. There was also a high variation between the parts with the smallest at 17,17 mm and the largest at 17,95 mm. A visual representation of the measurements is shown in Figure 26 below.

Figure 26. Visual representation of the measurements performed on incoming material. Shows measurements of 10 randomly chosen components by three operators with two replications.

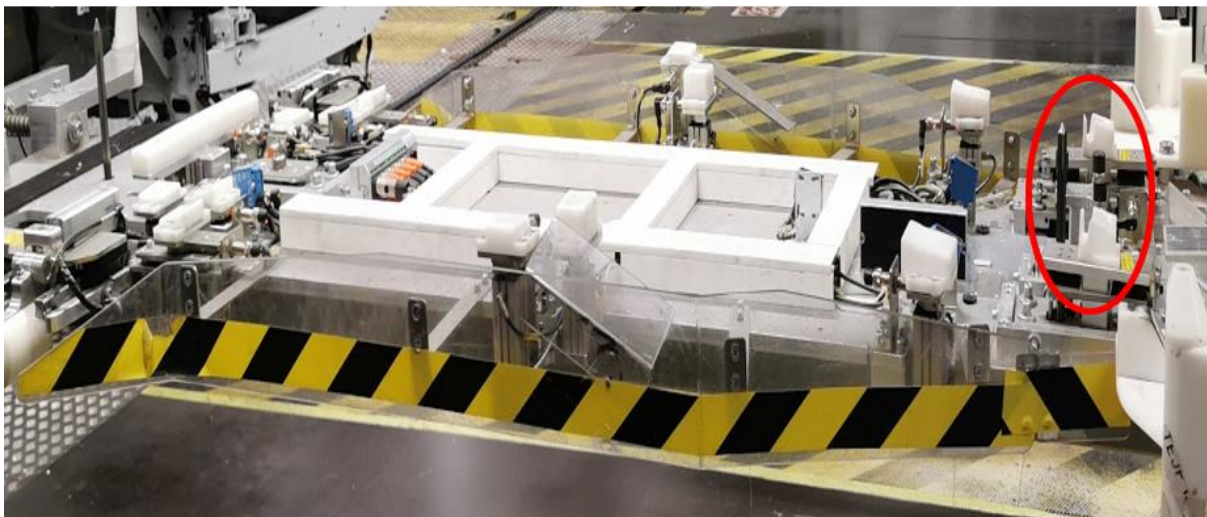
The automatic assembly process of attaching the headliner to the car body is performed at previously described station 5 in chapter 4.3. The headliner is put onto a palette by two operators, see the picture of one of the palettes in Figure 28 below. The operation begins by the palette moving forward into the car body, and thereafter it presses up the headliner into the car body and makes it attach to several attachment points. To ensure that the positioning of the headliner aligns with the car body, the palette has several fixtures and tracking pins where the different parts of the headliner are positioned by the operators. The two support bearings are placed into contact lugs with the purpose of making sure the headliner is correctly placed at the palette (see Figure 28 for placement of contact lugs). As described previously, the palette is pushing up the headliner and the pushpin in the support bearing, which makes the support bearing expand and attach to the car body. Within production in VCT, three different palettes exist, the first one is used for XC60 and XC90, the second one for V60 and V60CC, and the third one for V90 and V90CC. The function of all palettes is the same, but they look slightly different depending on the car body's geometry.

Figure 28. Picture of the V90 palette, the contact lugs to the support bearing are the white fixtures in the red circle.

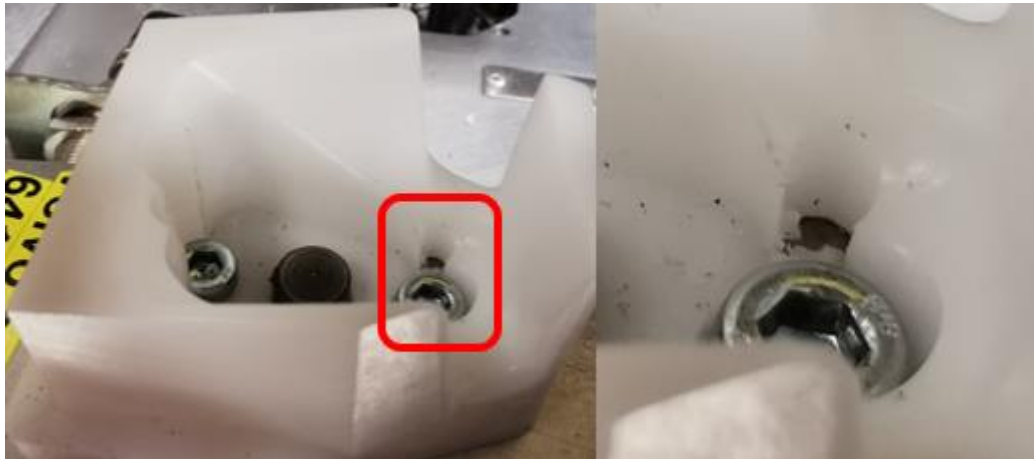
Maintenance states that these fixtures have not been replaced since the equipment was installed. When observing them, some wear can be seen inside them close to a screw, as seen in Figure 31 below. This makes the fixture have some sharp edges that come in touch with the support bearing. Those are not affecting how the support bearing is pressed up and is therefore not likely to be the reason for the loose support bearings. These sharp edges could although lead to other visual defects on the support bearing, such as press marks identified on the hook.

Figure 31. Picture showing defects in the contact lug.
