FRP STRENGTHENING OF RC BEAMS WITH CORRODED REINFORCEMENT

Master's thesis in Structural Engineering and building technology

FRP STRENGTHENING OF RC BEAMS WITH CORRODED STEEL REINFORCEMENT

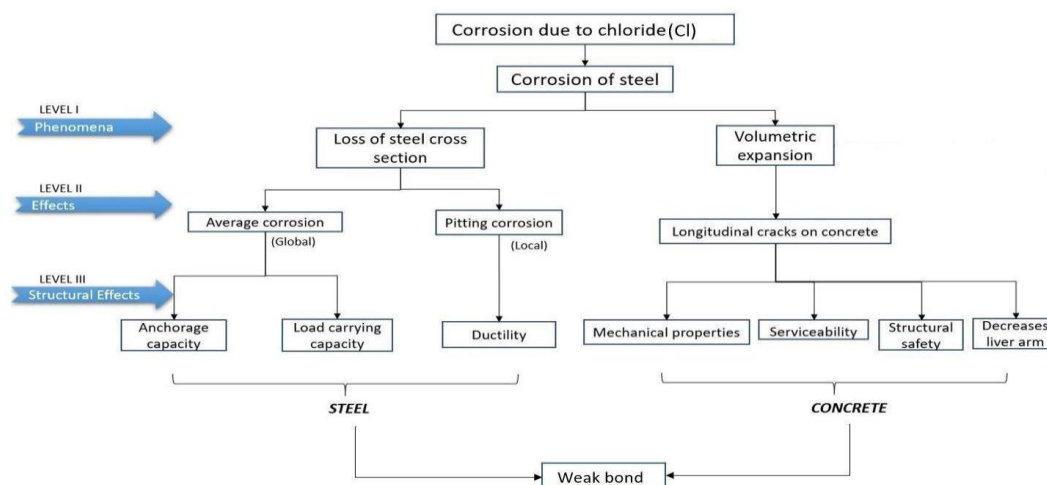
Fig: 1 Effect of corrosion on a structural level

The structural problems arising after corrosion are wide range, which contributes to bad structural behavior of RC structures in its service life. Such as fatigue problems, reduction in strength, limited ductility, weak bond strength, loss of shear capacity. As a consequence of corrosion, it reduces the effective cross-section of structural components. This will reduce the axial, and flexural strength of elements, and makes them structurally weak. Even if corroded elements look stable, it does not mean they are safe; in fact, the corroded structures become vulnerable for ultimate loads. Corrosion of steel bars produces rust materials that occupy a larger volume than the original steel. Due to this large volume of rust creates pitting stress acting on the concrete leading to cracks with larger width making spalling of concrete cover. Meanwhile, these cracks will intensify the corrosion process thereby changing the structural behavior of the structure i.e. the interaction between the steel reinforcement and surrounding concrete. Another complication, structural effect of corrosion is on the fatigue strength of steel elements, connections, and RC elements. Corrosion may accelerate fatigue crack propagation in structural steels. The development of pitting corrosion introduces additional points of stress concentration at which cracking may develop, which will reduce the fatigue strength of the structure. Corrosion can significantly reduce the ductility of RC sections. This is critical in seismic design and evaluation. Corroded sections have lower ductility, which means their plastic deformation is limited. This will affect the seismic response of the elements. Corrosion of reinforcement in the lap splices will affect the load transfer in the laps, preventing the to develop yield stress. Effects of corrosion due to chlorides and its structural effects are discussed following Fig [1]

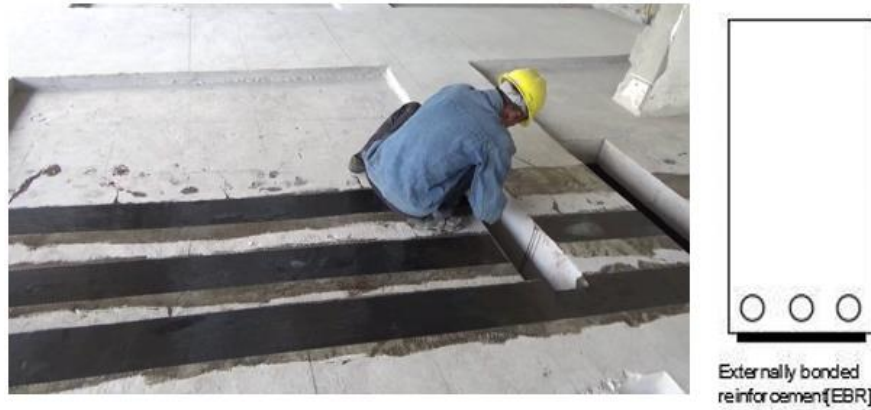
Fig:3 Application of FRP External bonded reinforcement

This technique involves strengthening of corroded RC beams by providing different configurations to the external surfaces. Such configurations can be provided in layers The deficiency of longitudinal reinforcement in beams and columns due to corrosion, leading to flexural failure. In such cases, the bending capacity of concrete elements can be increased through the use of externally bonded FRP plates and, strips at the tension side of the beam. Providing the bond between the FRP laminates and concrete prevents the spalling of concrete cover and longitudinal steel rebar is controlled. Flexural and shear capacity of the corroded beam can be improved by externally bonded reinforcement by proving FRP laminates in the transverse direction to the RC member [28]. This system can be provided in the form of laminates or wraps in several layers with different materials. Efficiency and flexural behavior of strengthened RC beams were studied [6] using EBR-CFRP plates to conclude that the beam flexural capacity was increased which later failed due to debonding. Also, the beams were tested by an increasing number of layers of EB-CFRP[10]. In the paper[17] researchers experimented by using EBR-CFRP laminates along with U wrapping resulted in less deflection with improved load capacity and fewer shear cracks.

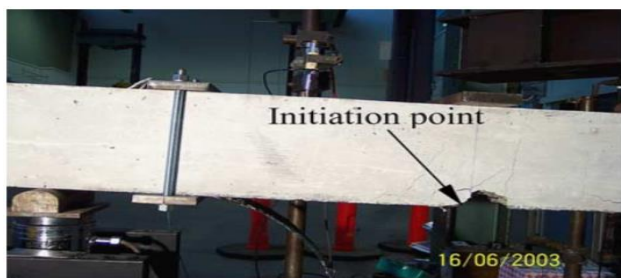
Fig: 8 Debonding of FRP strip[4]

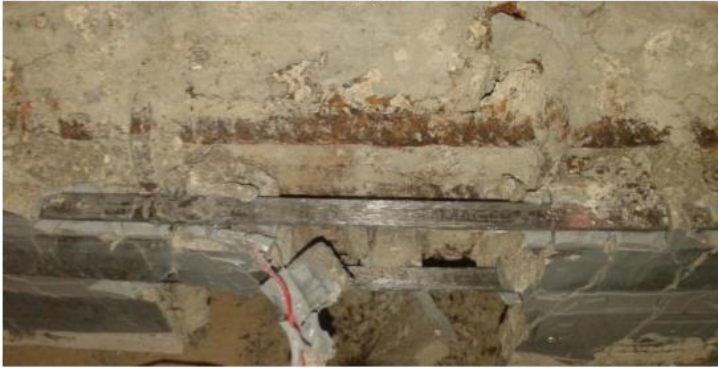
Fig : 10 Disclosour of NSM plate after cover crushing[3]

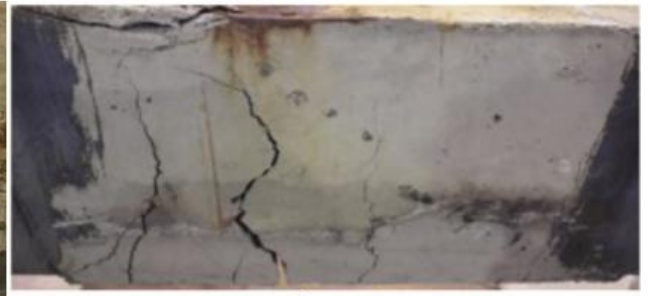
Fig: 11 Rupture of corrosed tensile bar back face crack[42]

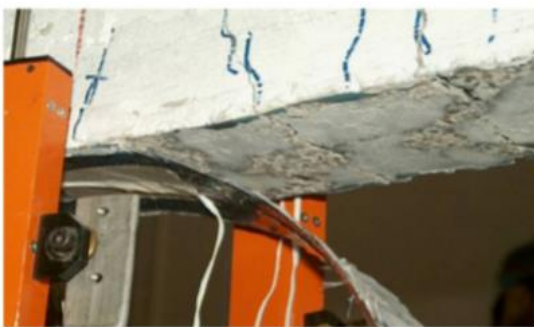
Fig : 12 Debonding of FRP laminate [20]

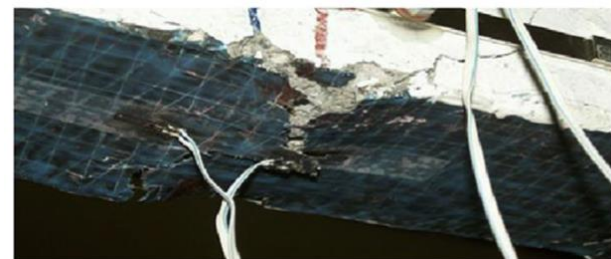
Fig : 13 FRP laminate rupture[20]

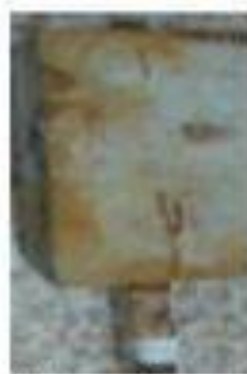
(a) pullout failure

Figure 8 Failure mode- Bar pulloutref -29

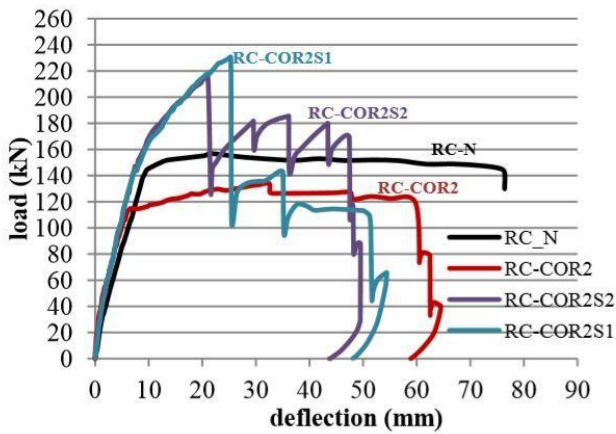
Fig: 17 Load deflection for SM patch repaired for medium corrosion level [42]

yield load, and ultimate load respectively. This is due to the insufficient tensile strength of the section because of the large reduction in tensile steel reinforcement. But, there was an increase in strength up to 69% in the strengthened beam concerning the corroded beam. the beam with high corrosion level up to 30% and 40% steel loss displayed a raise of 2.5 to 9 times in load-carrying capacity when to corresponding corrosion damage beam. Triantafyllou G et al. (42) Experimental test was carried out for the beams which were subjected to three different levels of corrosion from low(7.5%) medium(15.5%) and high(24%), the beams were patch repaired and strengthened using CFRP EBR and NSM techniques. Table (2) below shows the experimental results RC-COR1 (low corrosion level), RC-COR2 (medium corrosion level), and RC-COR3 (high corrosion level). It is seen that the beams strengthened with NSM patch repair showed good flexural strength at low corrosion level compared to EBR, nevertheless, EBR patch repaired exhibited very good flexural capacity at medium and high corrosion level at maximum and ultimate loading conditions.

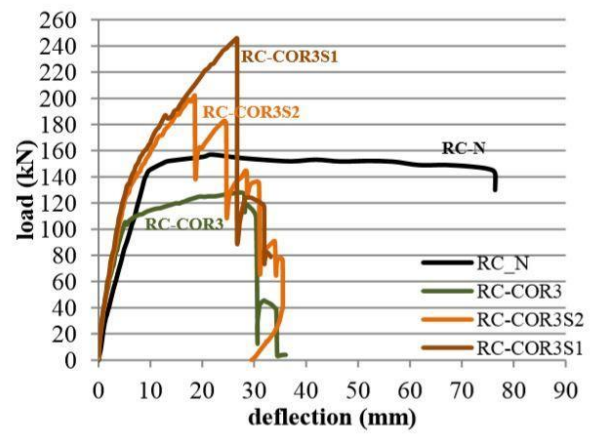
Fig: 18 Load deflection for SM patch repaired for high corrosion level [42]

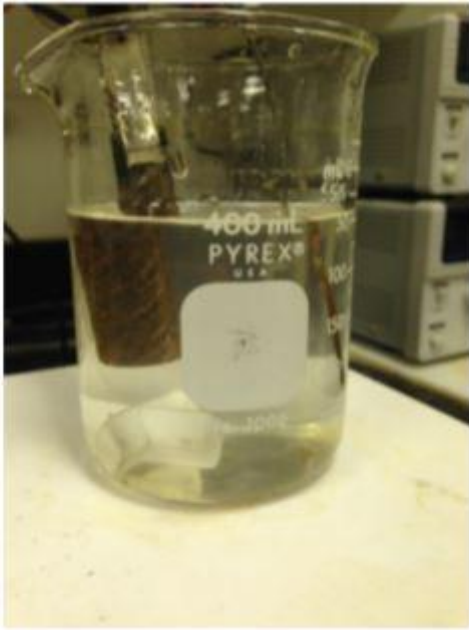
Figure 1. Small corrosion test setup.

Fig :23 Sample of rebar for corrosion ref (18)

Ahmed Abdel and Hui Shen (18) studied the strength restoration capacity for the corroded reinforced concrete beams that were subjected to high levels of corrosion. They experimentally conducted a small scale corrosion test to determine the relationship between the amount of mass loss of steel reinforcement due to corrosion and an electric current passed for corrosion. They carried out the macroscopic galvanic study to corrode the steel reinforcement and the arrangement is shown below Fig.[23],[24]. They followed the chemical method to corrode the steel reinforcement by adding NaCl salt solution and the current was supplied which connected steel to the positive terminal and copper to the other.

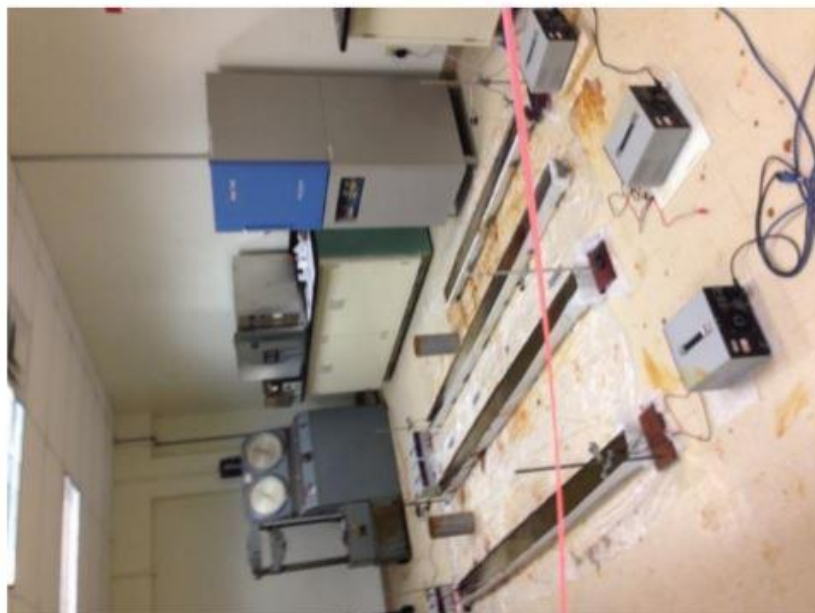
Figure 4. Actual corrosion test setup.

Fig:11 Experimental setup for Electric corrosion- Ref(18)

They used this same technique for the corrosion of steel reinforcement in the large scale. The steel bars were continuously subjected to corrosion for several days until they reached their experimental target study for the corrosion level. Similar procedures which they followed in small scale corrosion tests were used to determine the target percentage of mass loss. They mentioned the number of days it took to reach the maximum targeted 50% steel mass loss. Fig. [25], [26] shows the details of experimental work researchers done in the large scale corrosion process.

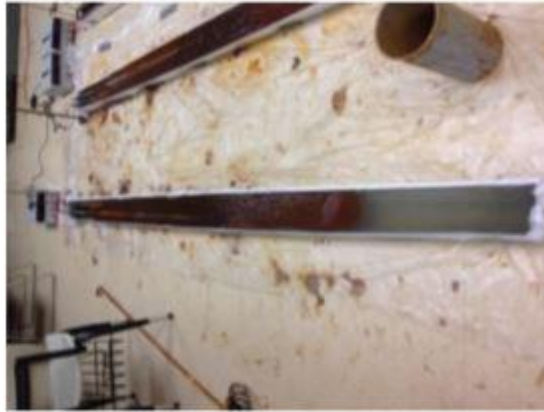
Figure 6. Steel rebars are corroding during the test.

Fig:12 Rebars under corrosion ref (18)

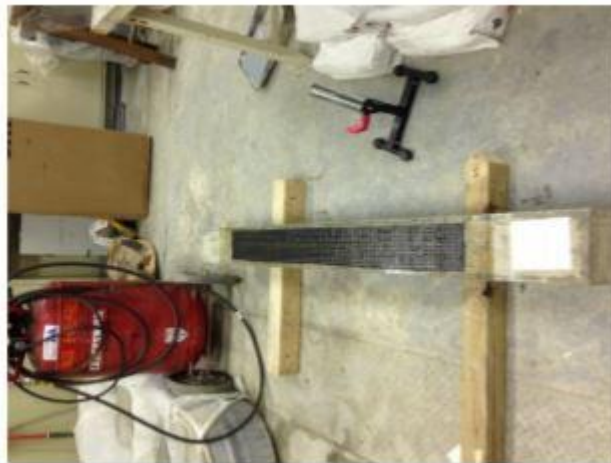
Fig:13 Repaired and strengthened beam with CFRP sheets Ref(18)

Later they repaired and strengthening work by providing CFRP sheets for a few of the corroded RC beams as shown in Fig. [27]. A brief comparison study was carried out between strengthened and unrepaired corroded RC beams. They U wrapped CFRP sheets for the beams with a maximum 50% mass loss of corrosion. The installation method of the CFRP sheet is shown below.

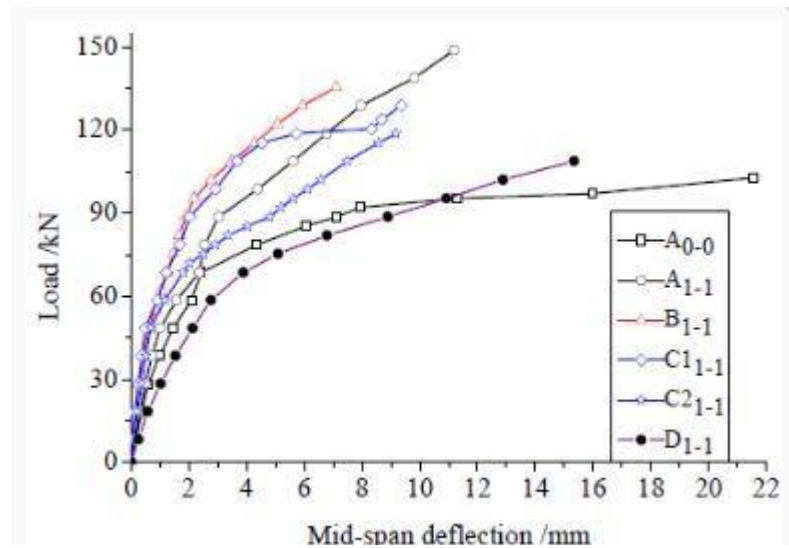
Fig: 16 Graph plotted to explain the influence of strengthening ref(36)

Also, they clearly explained the influence of strengthening for different levels of corroded beams with 2 different strengthened methods. From the result plotted below Fig. [30] concluded that the beams with higher levels of corrosion showed higher deflection. Finally, they concluded that the beams strengthened with CFRP sheets showed improvement in bearing capacity and stiffness when compared to unstrengthened beams. This made the authors conclude that the strengthened beams are less ductile and ductility reduced when compared to unstrengthened beams.

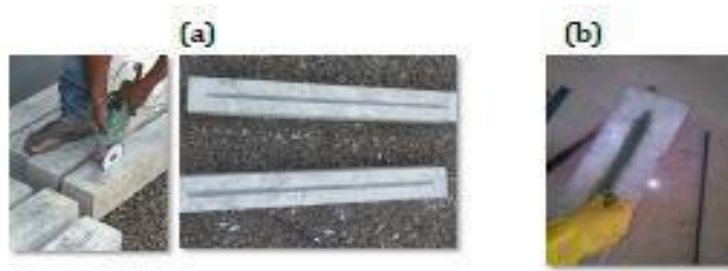
Fig -4: (a) Cutting of grooves and (b) filling of grooves with epoxy

Fig:17 Experimental setups to groove the steel bars -NSM technique Ref(46)

the EBR method. The below figures explain the experimental set up as shown in Fig. [31] and [32] to groove the steel bars for the NSM technique and also they experimented with the varying number of grooves.

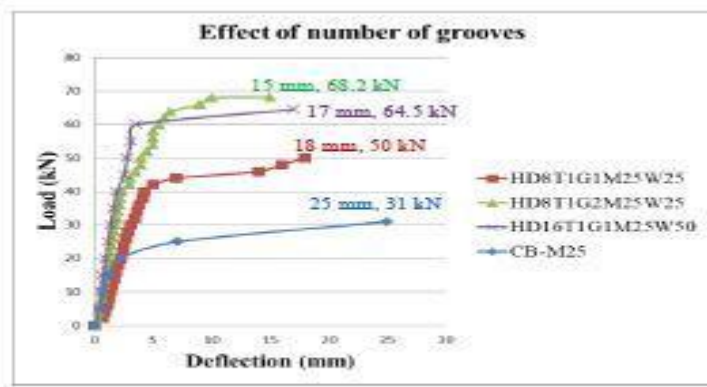
Fig -16: Effect of Number of Grooves

From the experimental test results, they made conclusions on different mechanical properties like load carrying capacity, the effect of ductility, and also on the effect of stiffness. The average increment of the ultimate load-carrying capacity was 82%, compared to that of the control beam.[46] They studied ductility in terms of two factors like deflection ductility and energy ductility. The deflection ductility of beams is calculated as the ratio of deflection at failure divided by the deflection at first steel yielding. Energy ductility of beams is calculated as the ratio of energy absorbed till failure divided by the energy absorbed till the first steel yielding.[46] As the tension reinforcement increased, the section changed from an under reinforced section to an over reinforced section. From the result, they observed lower ductility index values and also mentioned the change in failure mode was from ductile to brittle. They also concluded this combined method of strengthening was found to be effective for the beams with fewer mix ratios.

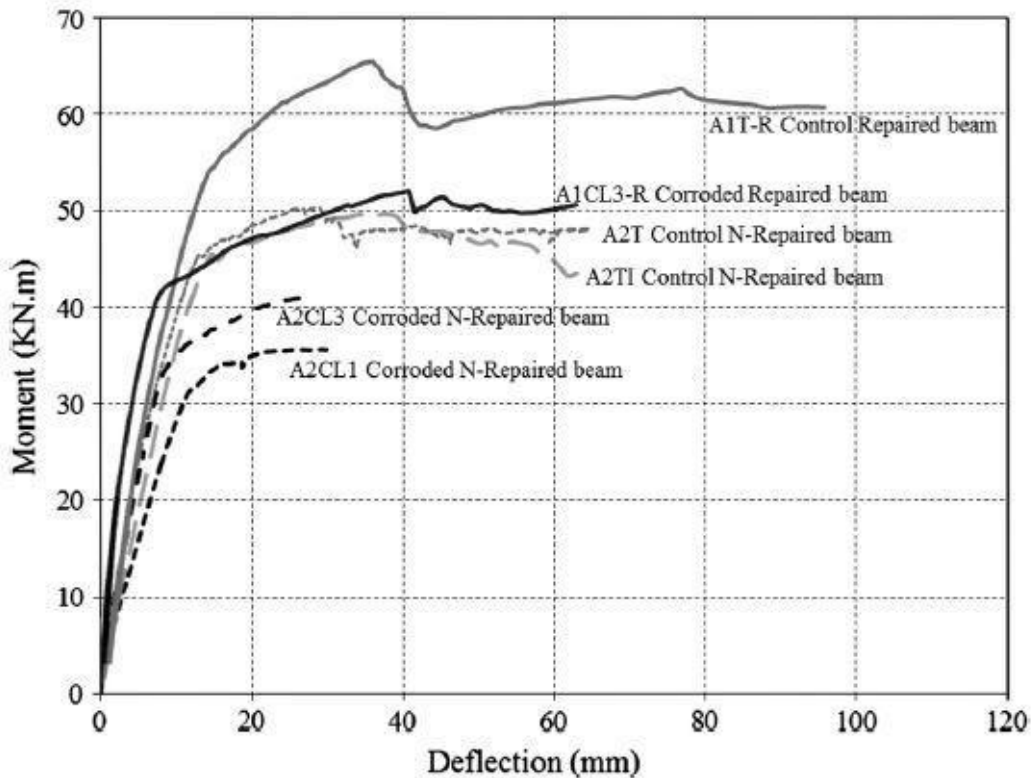
Fig: 20 Results plotted for an ultimate capacity of corroded, strengthened and controlled beams at different percentages of steel mass loss ref(6)

In 2015, Belal Almassri et al. (6) worked on the behavior of corroded reinforced concrete beams strengthened with carbon fiber-reinforced polymer (CFRP) rods. They rehabilitated the structure using a near-surface mounted method (NSM) where rods were grooved along the tensile face of the beam.

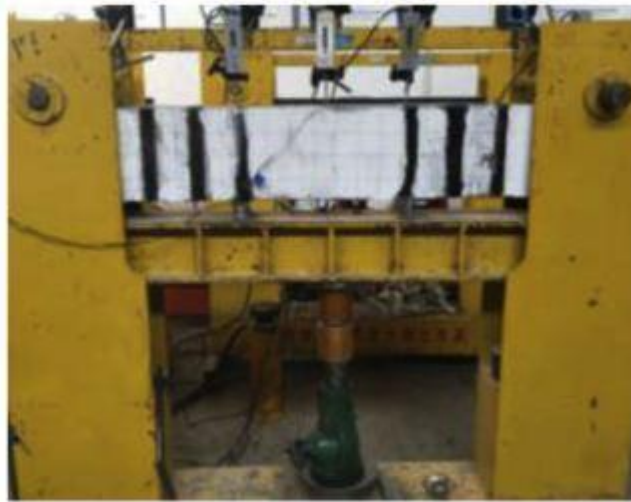
Fig: 21 Experimental test for CFRP strengthened beam - ref(19)

Another experimental test was conducted by Huifeng, Jin Wu, and Chengjun in 2019 where they used carbon fiber reinforced polymer in strengthening the corroded RC beams (19) that were subjected to different levels of corrosion. Here, authors, U wrapped the polymer throughout the beam as shown in the figure below Fig. [35]
