Investigation of the neutral voltage in an unearthed network

Causes, effect and mitigation

Department of Energy and Environment
Division of Electrical Power Engineering
CHALMERS UNIVERSITY OF TECHNOLOGY
Göteborg, Sweden 2007

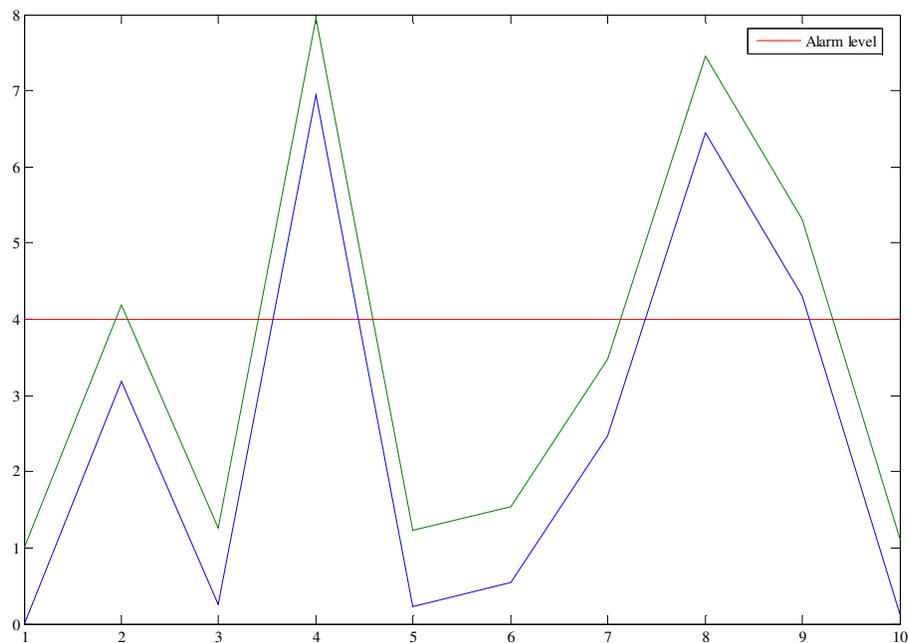
Figure 2.5: Illustration of raised base level influence on alarm frequency

Figure 2.5 illustrates the influence raised base level have on the number of alarms. Both the curves have the same variations, but the green also have an extra offset added and this results in an extra alarm being triggered at point 2 on the x-scale, since the alarm level has been exceeded for the green curve but not the blue on. This alarm may not have been an issue if there hadn't been an offset on the green curve.

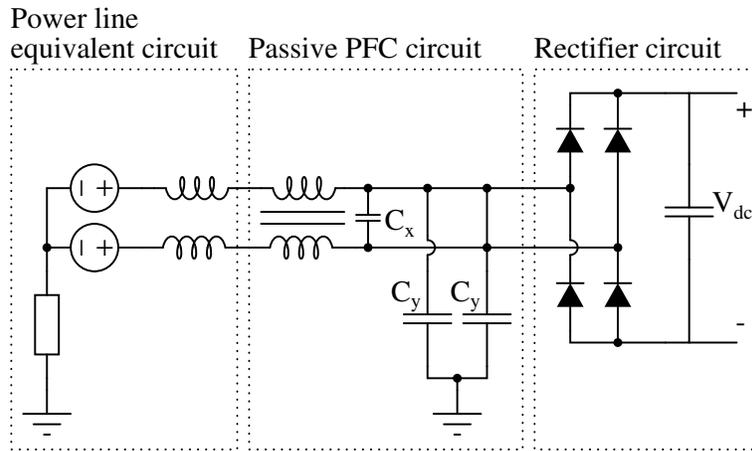
Figure 4.3: Reduced equivalent circuit of a power supply unit with passive power factor correction

In Figure 4.3, a scheme of a one-phase power factor corrected switched-mode power supply with passive correction circuit is shown. The C_y capacitors connect to earth from both phases which very well may increase the total capacitive fault current [7]. The transformer that is connected as a common mode impedance in series may affect this capacitive current somewhat but the way is not investigated in this report.

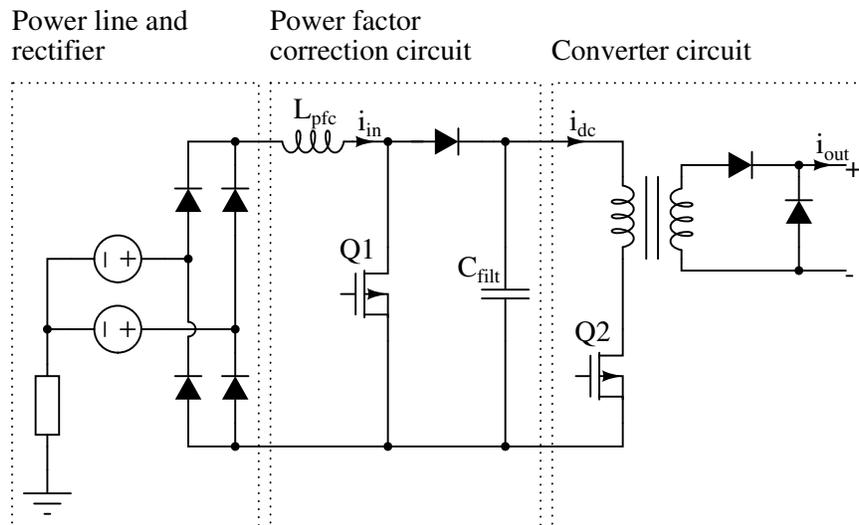
Figure 4.4: Reduced equivalent circuit of a PSU with active power factor correction

The equivalent circuit for the power factor corrected PSU shown in Figure 4.4 contains only the most vital parts, with an inclusion of an almost complete converter circuit to explain the connection from AC- to DC-side. The power factor correction circuit is basically a boost converter where the transistor Q1 controls the current i_{in} sinusoidally [7]. The filtering capacitor, C_{filt} , is charged and the voltage over it used as the DC-link voltage for the converter circuit. It is clear from the equivalent circuit that there is no intentional connection to earth in the power factor correction circuit or the converter circuit and it can therefore not create any

The difference between the two types of PFCs is, in the area of relevance for this report, the intentional connection to earth. In the passive circuit there is a connection to earth through a capacitor whereas the active circuit have no intentional connection to earth at all. This capacitive connection that the passive circuit have could be trouble in the analysed system. The capacitive current could contribute to the total leakage current of the system and therefore create excessive midpoint voltage.

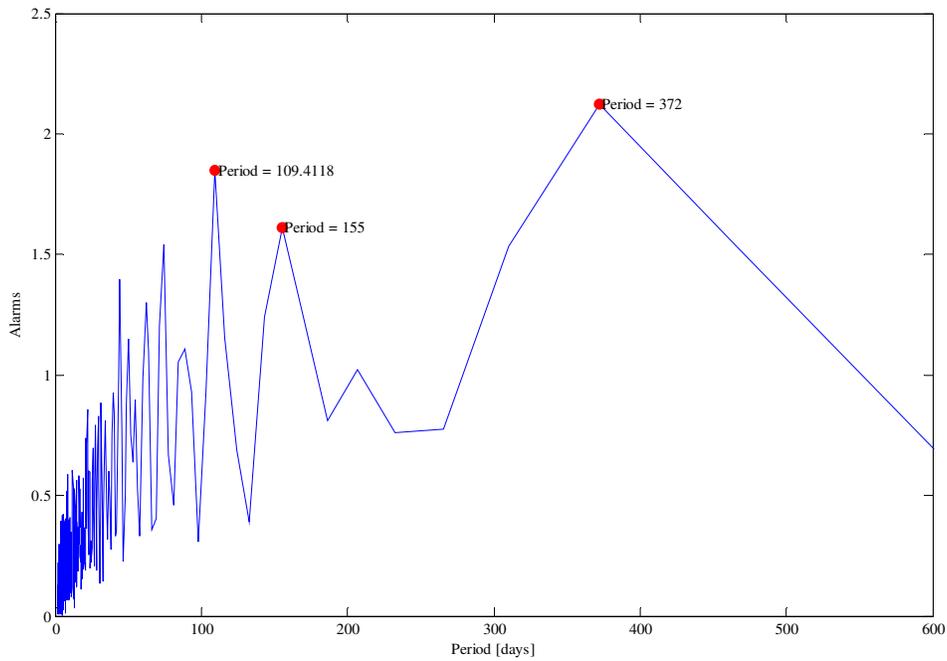
Figure 4.7: Alarm frequency analysis since 2003

Frequency analysis supports this theory to some extent. There is a large spike at around 12 months, which is as of now unexplained and also spikes at 110 to 155 days are observed. In Figure 4.7 below the three largest spikes have been marked with the period time.

As is shown in Figure 4.7 there is a slight overweight on longer time periods, though the precision is not very good at those period lengths. The most likely reason to the emphasis on long periods is the fact that there have been a few large isolated disruptions which happened to occur at random, large intervals and that these happens to be separated by that number of days. Figure 4.8 below shows the alarm distribution since the first alarm in August 2003.

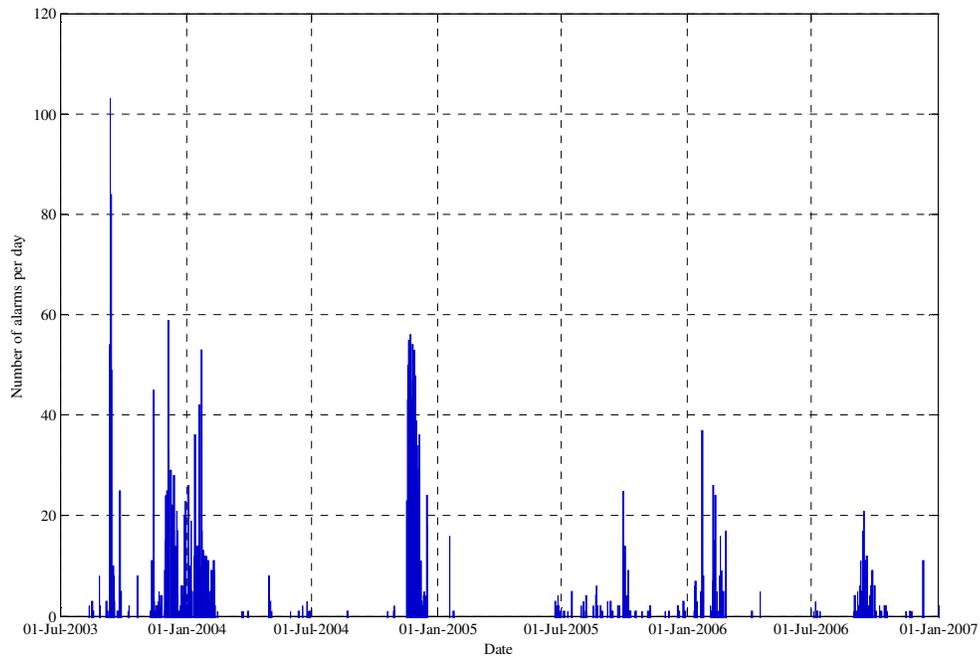
Figure 4.8: Number of alarms per day since Jul 2003

Figure 4.8 shows the number of alarms per day since the alarms started showing up. It is clear from this plot that the likelihood of multiple alarms the same day is high since there are short periods that have a large amount of alarms and longer periods with a low amount of alarms per day.

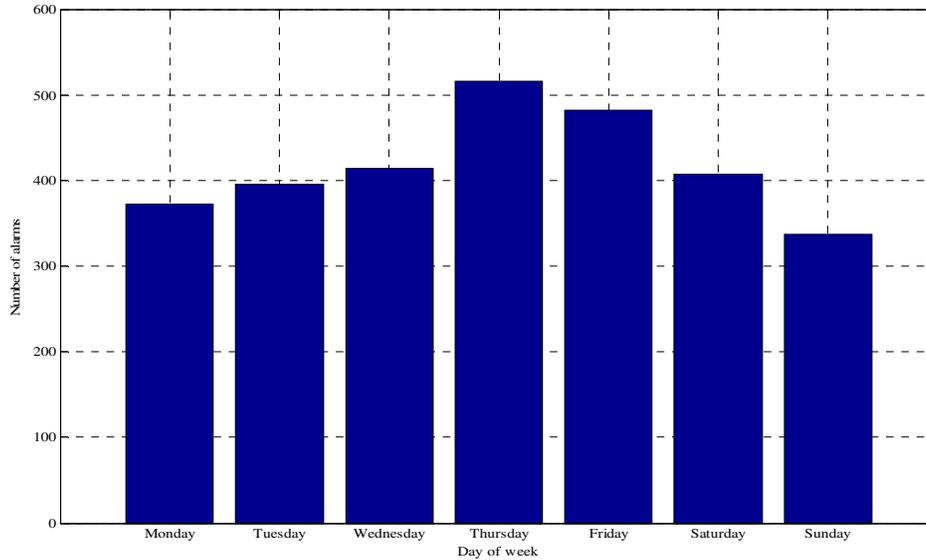
Figure 4.9: Number of alarms each day of the week; between August 2003 and January 2007

The number of alarms sorted by day of week does not really present anything interesting. Figure 4.9 shows an even distribution of alarms during the week. Thursday and Friday have a bit more alarms, but it is not an overwhelming number of alarms and therefore it is not likely that there is any statistical significance to the difference.

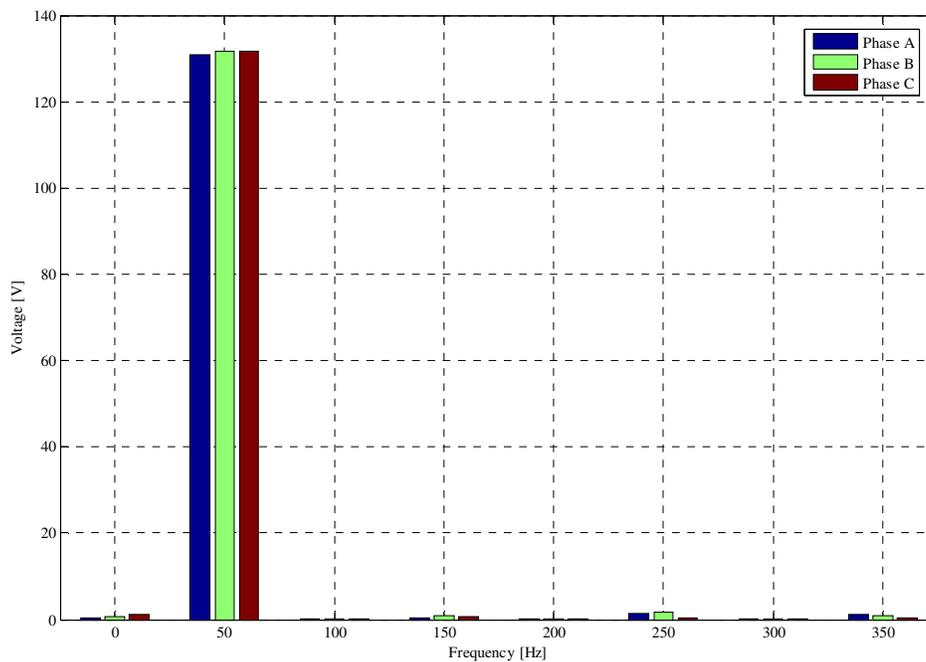
Figure 4.13: FFT of voltages on sub B

The harmonics above 350 Hz in Figure 4.13 are very small and can be neglected. As is clearly visible the voltages are very nicely shaped as almost perfect sine waves with nearly no dc offset. Frequencies above 350 Hz is well below one volt each.
