TRM Strengthening of Historic Masonry Vaults

Evaluation of use in the Church of Saint Bassiano in Italy and possibilities for Skörstorp's Church in Sweden

Master thesis in the Master's Programme Structural Engineering and Building Technology

ANNIE SKEPPSTEDT

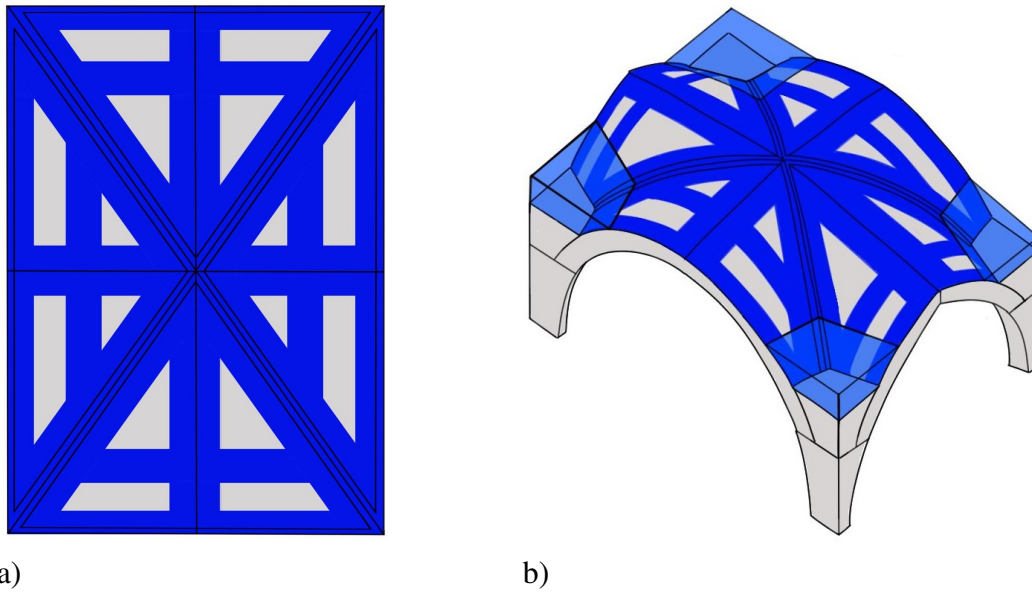
Figure 3.9: Pattern of the TRM application in St. Bassiano a) from planview and b) showing 3D point of view.

The intervention consisted of two more large-scale efforts; the replacement of the existing roof structure and the reinforcement of vaults and arches in the main nave and semi-dome in the apse using a TRM application. The original roof system was replaced with a truss-based structure, redistributing the loads on to the side walls and significantly reducing the stress on the nave's vaults and arches. The TRM used for this case was a system made up of a carbon mesh (X Mesh C10 from Ruregold, previously Ruredrill) and a pozzolanic based hydraulic mortar (X Mortar 25 from the same company) applied on the extrados of the masonry vaults. The pattern for the TRM application on the vaults can be seen in Figure 3.9, a) shows the pattern from planview and b) shows the pattern from a 3D point of view. Figure 3.10 shows the TRM pattern applied to the semidome. Figure 3.11 shows pictures of the TRM application more up-close in its current state taken during the survey made by author in march 2025.

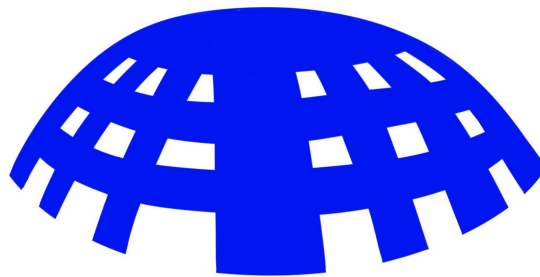
Figure 3.10: Pattern of the TRM application in St. Bassiano on the semi-dome. Schematic drawings made from pictures taken during intervention phase.

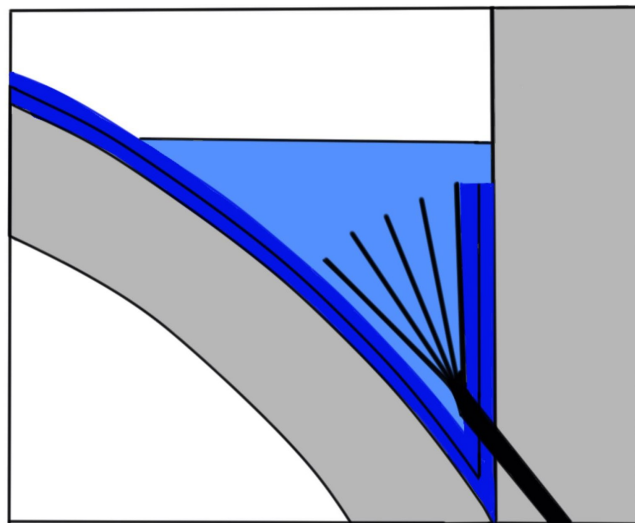
Figure 3.12: C-joint connector applied in vault corner.

The intervention process began with the cleaning of the masonry vaults, followed by the removal of backfilling material and the repair of the cracks (extrados) using Rurewall R/Z mortar. Once the surface was prepared, the reinforcement system was applied in multiple layers. The surface was dampened before the first layer of inorganic matrix mortar was applied with a thickness of roughly 3-5 mm. The first layer of the carbon-mesh textile reinforcement is embedded in the fresh mortar, ensuring proper integration. A second layer of inorganic matrix mortar is then applied to cover the textile. In the case of st. Bassiano, a second layer of textile reinforcement is positioned and embedded following the same procedure, with a final layer of inorganic matrix mortar applied over the entire system. To ensure structural integration, the reinforced mortar system was connected to adjacent elements using C-joint connectors, see Figure 3.12. The TRM strips are connected along the edges, see Figure 3.13a and in the corners of the vault, see Figures 3.13b and 3.12. For some structural purposes and a more level floor providing easier accessibility over the vault, corner fill was added, which can be seen as the light blue fill in b) Figure 3.9b and Figure 3.12. After the reinforcement layers were applied, the surface was smoothed and finished.

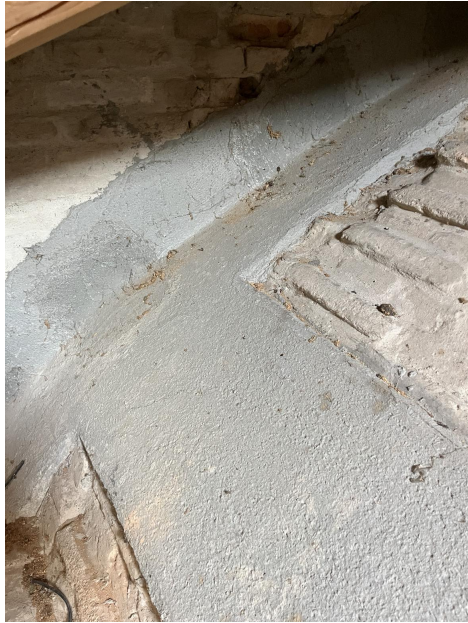
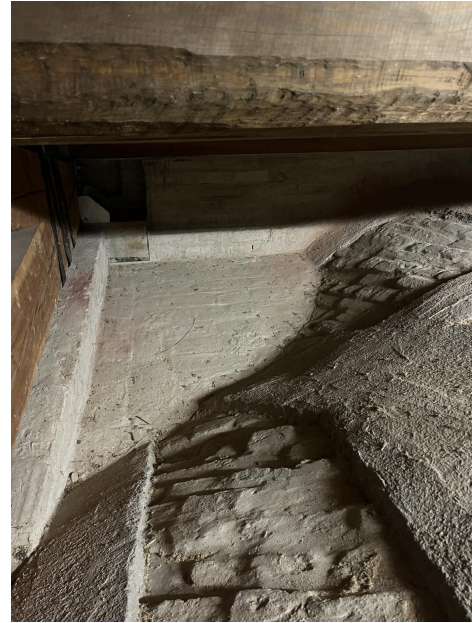
Figure 3.13: Pictures from the TRM application in St. Bassiano on the vault extrados a) connection to side-walls and b) corners of the walls filled up.

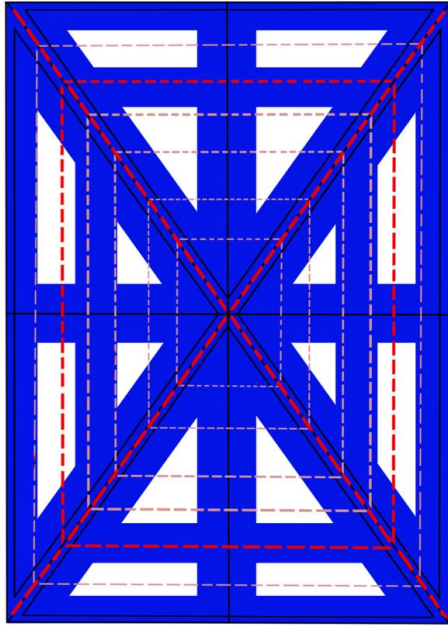
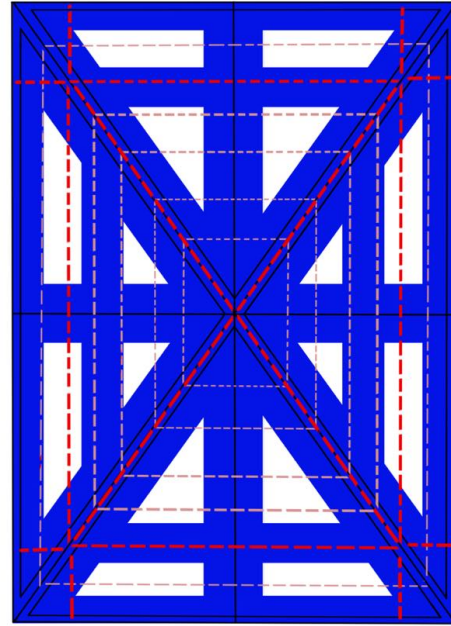
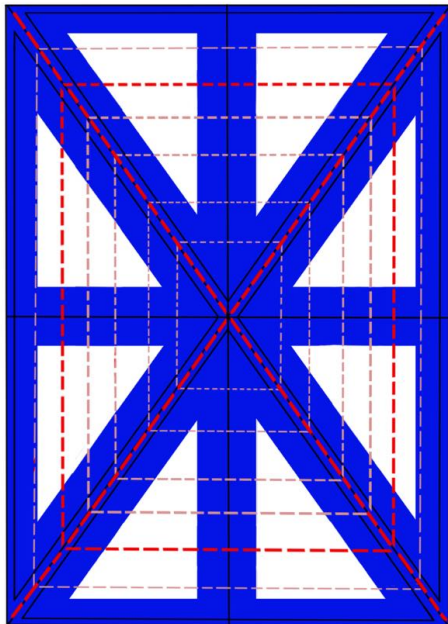
In Figure 3.16a and Figure 3.16b, these possible crack-patterns (red dashed lines) Como suggested are overlapped with the TRM layout in blue applied to the extrados of the vaults on St. Bassiano. The TRM has been strategically placed along the vault's arch bands, diagonal ribs, and perimeter zones, corresponding to areas where tensile stresses are expected to concentrate under load. This distribution of TRM is intended to counteract the development and propagation of cracks by providing additional tensile resistance along the main thrust lines of the vault. The reinforcement layout aligns with the load paths and acts to bridge potential discontinuities, thus enhancing the structural response and contributing to the overall stability of the vault system.

Figure 3.16: Schematics of two possible crack-patterns (red) on the extrados, mentioned in 2.2.4, overlaid on the TRM layout (blue) for the vaults in St. Bassiano. Image a) and b) show the actual TRM-layout of the vaults in St. Bassiano with the two possible crack-patterns mentioned previously and c) shows one of these possible patterns overlaid on the suggested simplified TRM-layout.

The TRM is providing the best counteraction to the crack-formation when applied perpendicular to the cracks. Therefore, one might suggest that the central square of TRM strips might be considered redundant in its application to prevent certain cracks. Although, they might still contribute to increasing the rigidity of the vault structure, providing a more conservative solution. This increased stiffness could prove beneficial in the context of seismic performance, where a more unified and continuous response may help mitigate damage during dynamic loading. Nevertheless, without considering the need for the vault to maintain stability during seismic actions, Figure 3.16c shows a possible TRM layout that might be a sufficient application to withstand the largest tensile forces in the vaults.

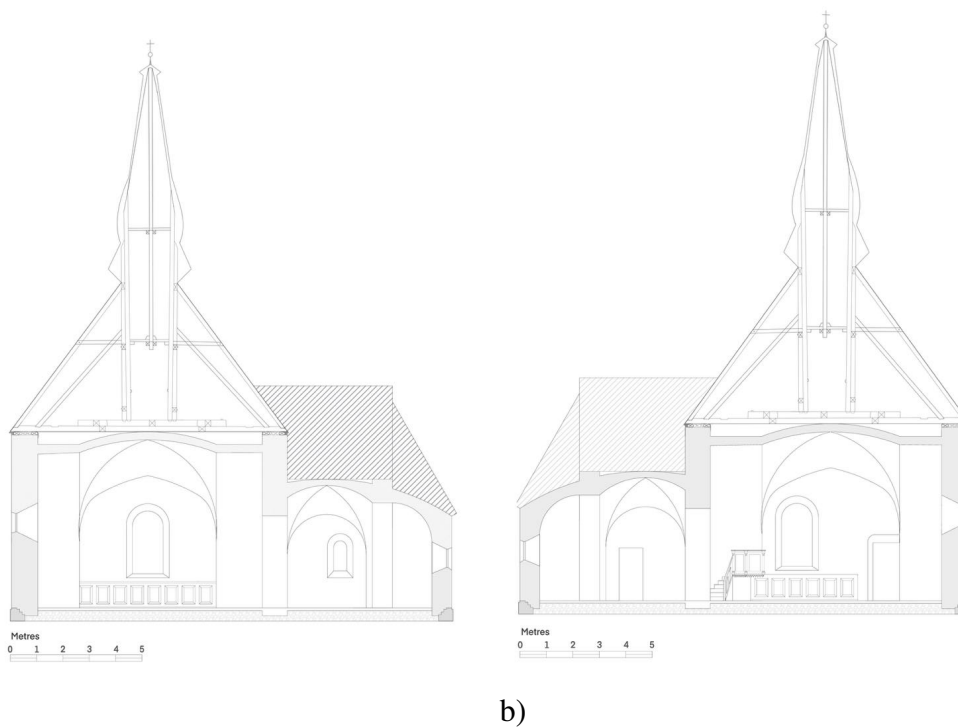
of the church, as well as the cross section of the roof structure on top of the round main nave. The sectional views were produced to illustrate the general layout and vertical crack patterns in the walls; these are schematic in nature, only rough measurements were made, and should therefore not be considered precise.

Figure 4.3: Sectional view of Skörstorp's Church a) section A north and b) section B south.

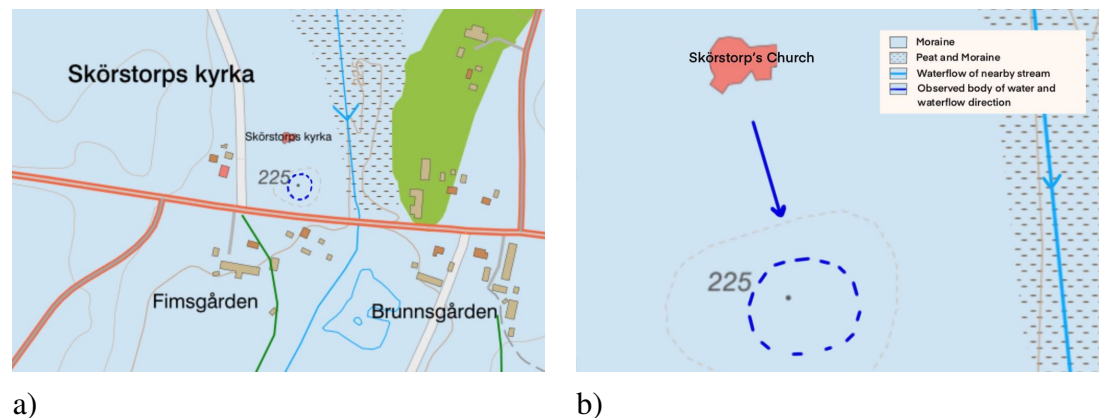
Analyzing the crack patterns suggests several interacting factors behind the ongoing damage. The diagonal cracking across the vault, particularly toward the southeast, may point to settlement on that side of the building. See Figure 4.10a showing a map overview of soil types, taken from SGU (SGU, n.d.), of the area where Skörstorp's Church is situated. Close to the church, a small pond was observed in the south-east direction, aligning with the natural flow of water from north to south, indicated by the waterflow direction of the nearby stream. These aspects may suggest the presence of a slow process of soil movements, which may contribute to differential movements. Figure 4.10b shows a close up of this map with indications on the type of soil in the area, which is mostly moraine. In conjunction with the roof renovation a soil sample was

taken to investigate the church foundation walls. It was found to be topsoil to a depth of 0.4 m and below that clay-mixed moraine, consistent with the map from SGU.

Figure 4.10: Images taken from SGU on geological aspects a) showing a map of the area where the church is situated and b) a close up indicating type of soils.
