Reimagining a Sixties House

- Into a contemporary house with studio spaces for arts
and crafts

Chalmers School of Architecture
Department of Architecture & Civil Engineering

Building Design and Transformation / 2024

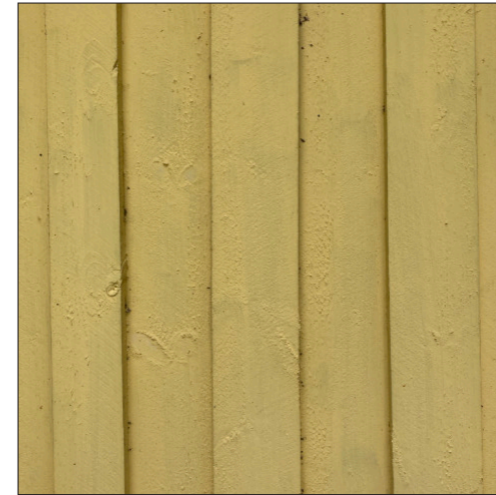
Cover boarding was used on the facade after the latest transformation.

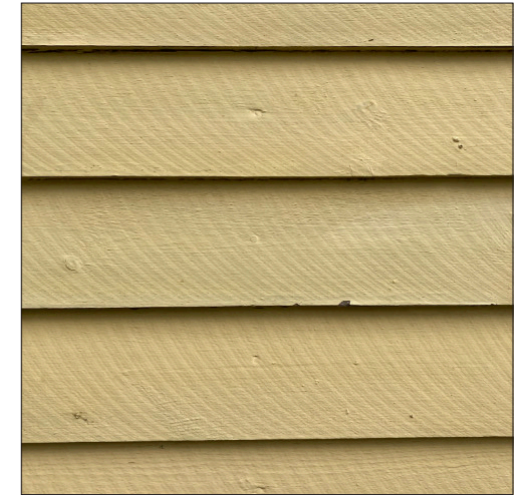
Feather edge timber cladding with visible marks from circular saw during production was used on the original building. Under the yellow acrylate paint there is signs that the facade use to be brown.

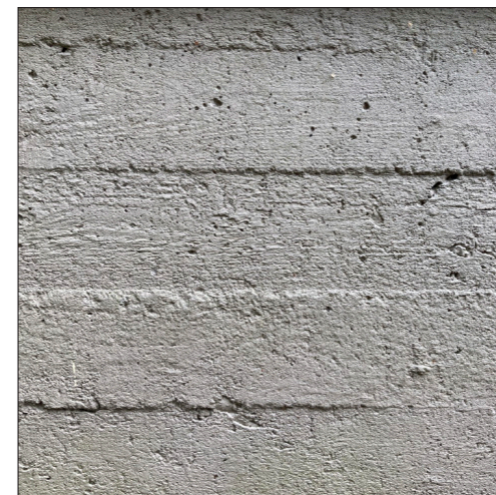
Timber formwork was use as mould for the reinforced concrete foundation. The boards used are still saved as flooring in the attic, as seen in figure ?.

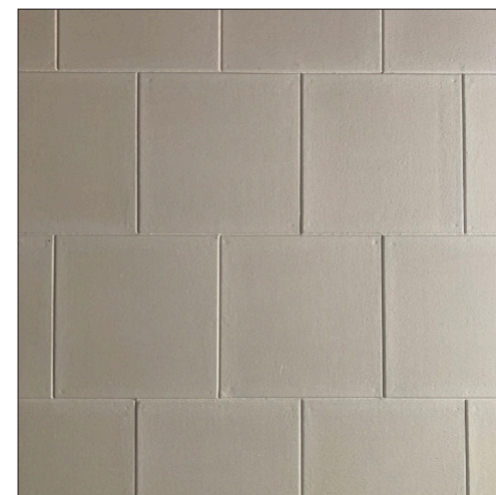
Soft wooden fibre boards painted in white was used as interior roof covering.

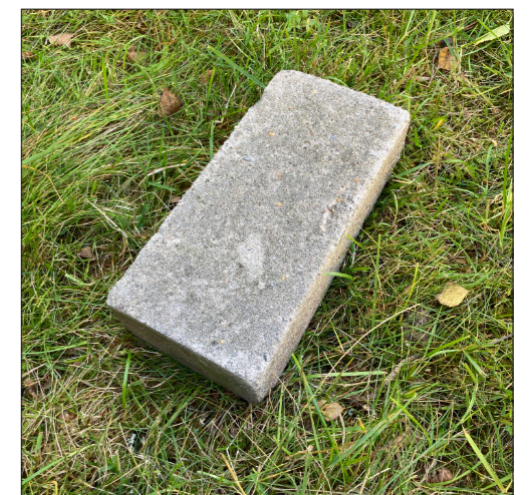
Bricks of concrete was used to lay the chimneys.

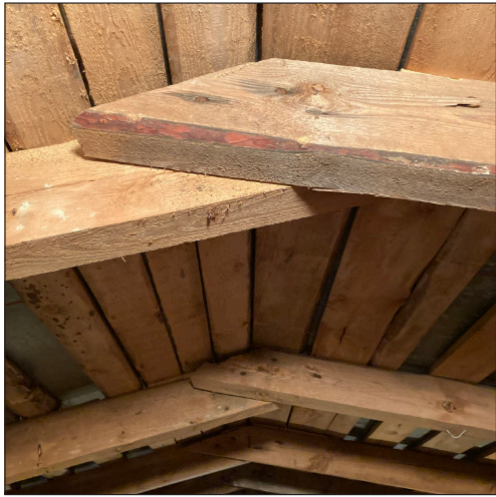
Roof beams were placed side by side and nailed together. No ridge beam was used. To support the roof two beams with studs running parallel on both sides along the ridge were used. Roof angle is about 12 degrees.

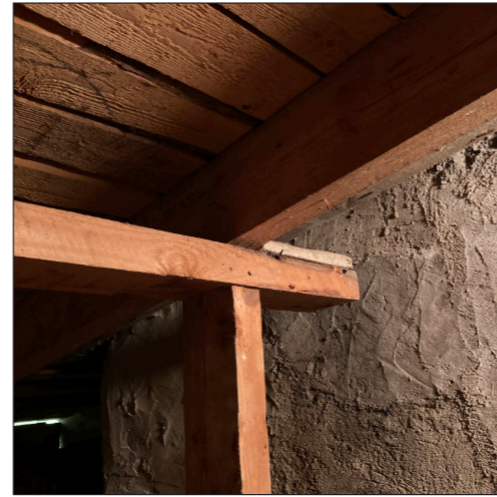
Simple support of the roof beams, sawn where necessary to make room for the chimneys.

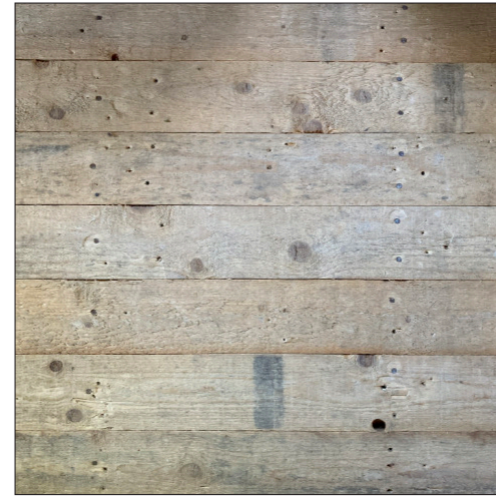
95mm wide raw cut timber floorboards were found under linoleum carpet. Underneath there is sawdust used as insulation.

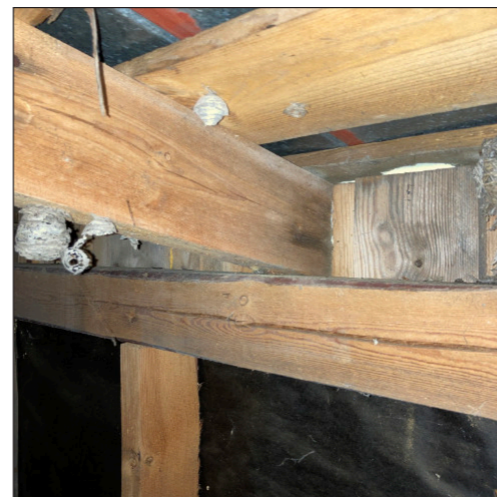
Boards to support the sheet metal roofing were placed sparingly with varying distance.

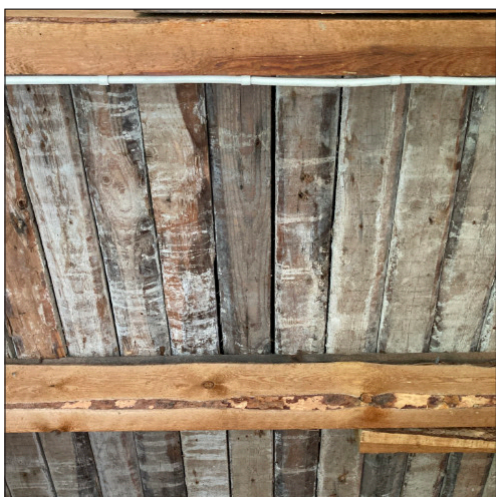
Everything was used. The timber from the formwork was used as flooring on the attic. Traces of concrete are clearly visible. These could be reused in future formwork.

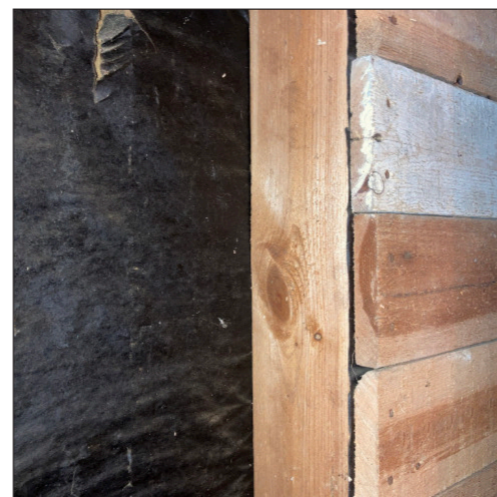
Exterior wall is made up of 100x50 mm studs, clad with bituminous paper and timber boards. Space between studs was filled with sawdust insulation which later was replaced with mineral wool, particularly under windows.

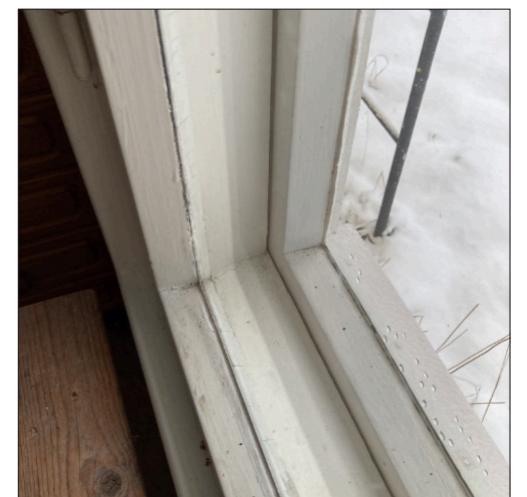
Window arches are almost as deep as the external wall and are made up of two single sashes.

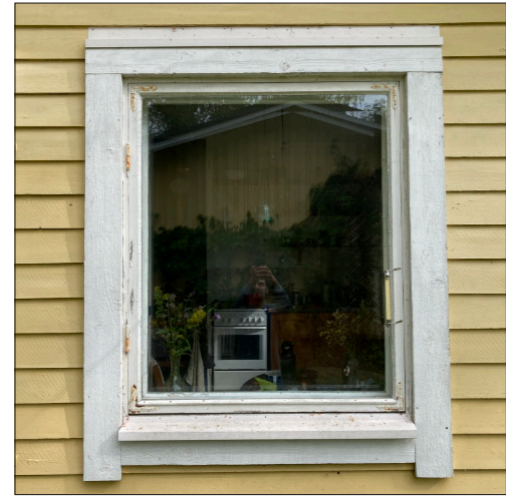
All windows are of a traditional double glass type where the exterior frame opens outwards and the interior one opens to the interior. There is a metal sill above and under the window.

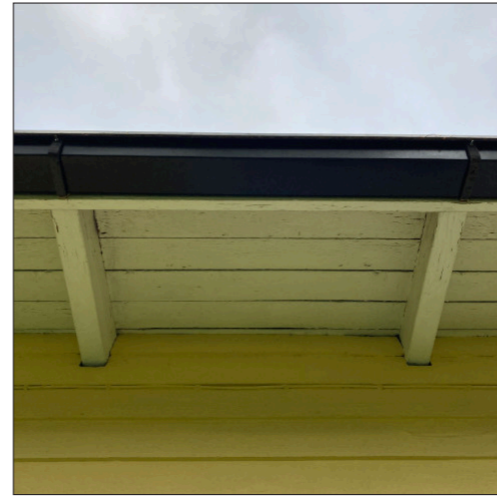
The building has been fitted with a square type water drainage and the distance between the roof beams is around 920 mm.

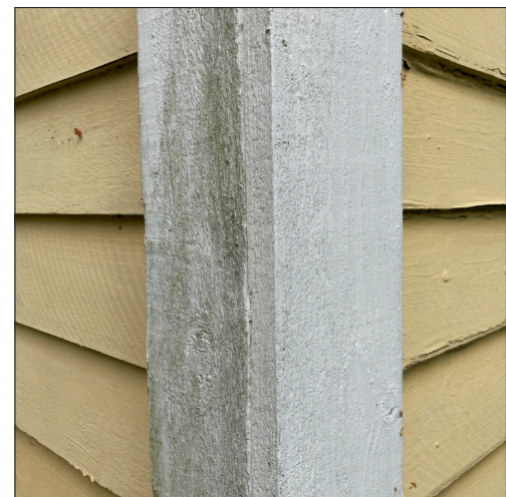
The corners are covered with timber, organic growth is evident on most parts of the building that has been painted in white.

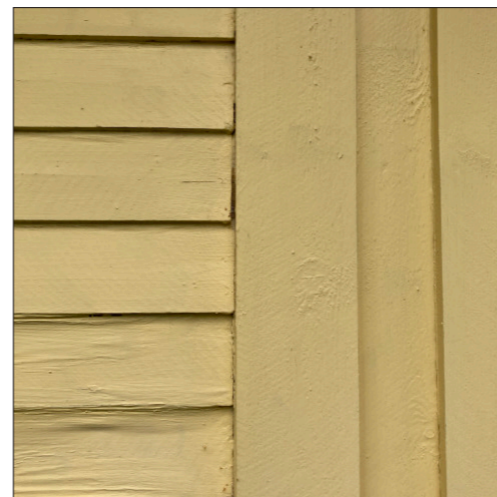
When the house got an expansion somewhere between 1962 and 1992 the existing facade was kept next to the new one. The paint on the old facade is peeling off.

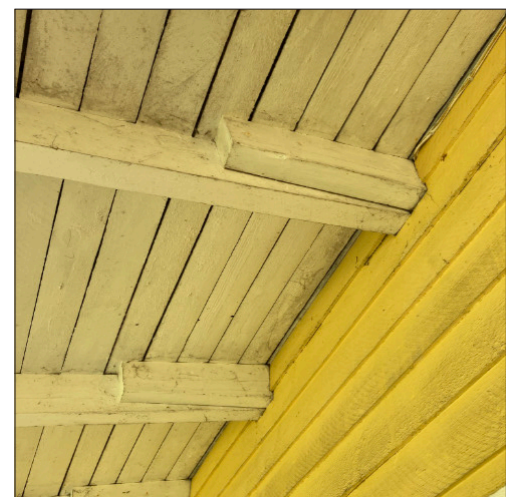
When the house got an expansion somewhere between 1962 and 1992 the existing roof beams simply got extended.

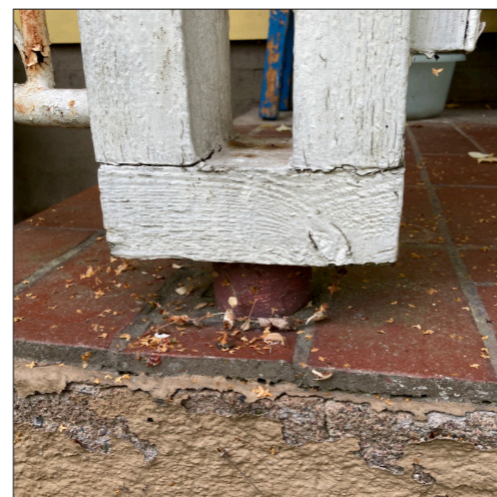
The columns holding up the roof above the entrance is raised from the foundation by a metal footing.
