Evaluation of quick clay failures and the impact of climate change on slope stability

ACEX11 Bachelor thesis

BACHELOR'S THESIS 2024

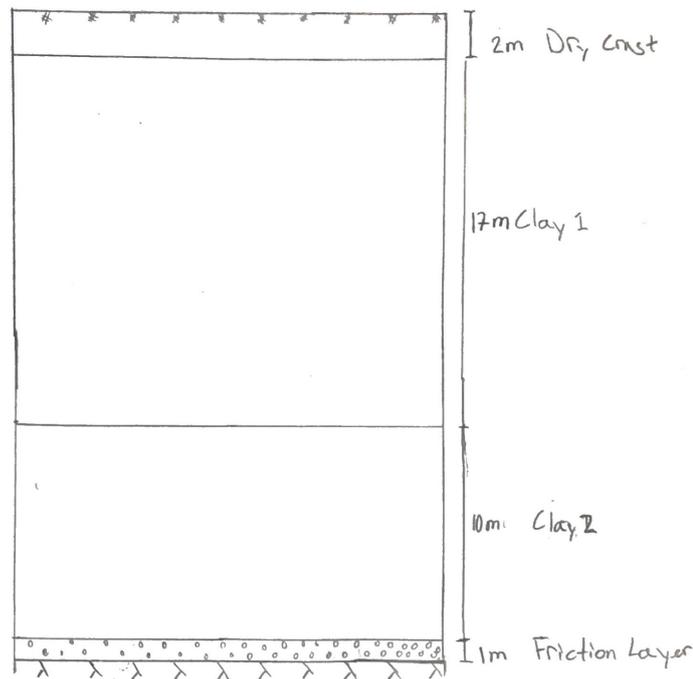
Figure 9: General Cross section and soil layer of the Tuve Area illustrated by authors.

The chosen section to analyze is the case of Tuve. For the simulations, a sequence of the layers in the soil has been estimated with a dry crust in the first two meters followed by a thick layer of clay which has been divided into two categories as seen in Figure 9. This is mainly based on the cone penetration tests performed in the area which indicate an increase in Shear strength in the first layer followed by a decrease in the second one [6]. This graph is shown in the appendix A. On top of the bedrock, a frictional layer with high conductivity is expected to generate high artesian pressure triggering the failure.

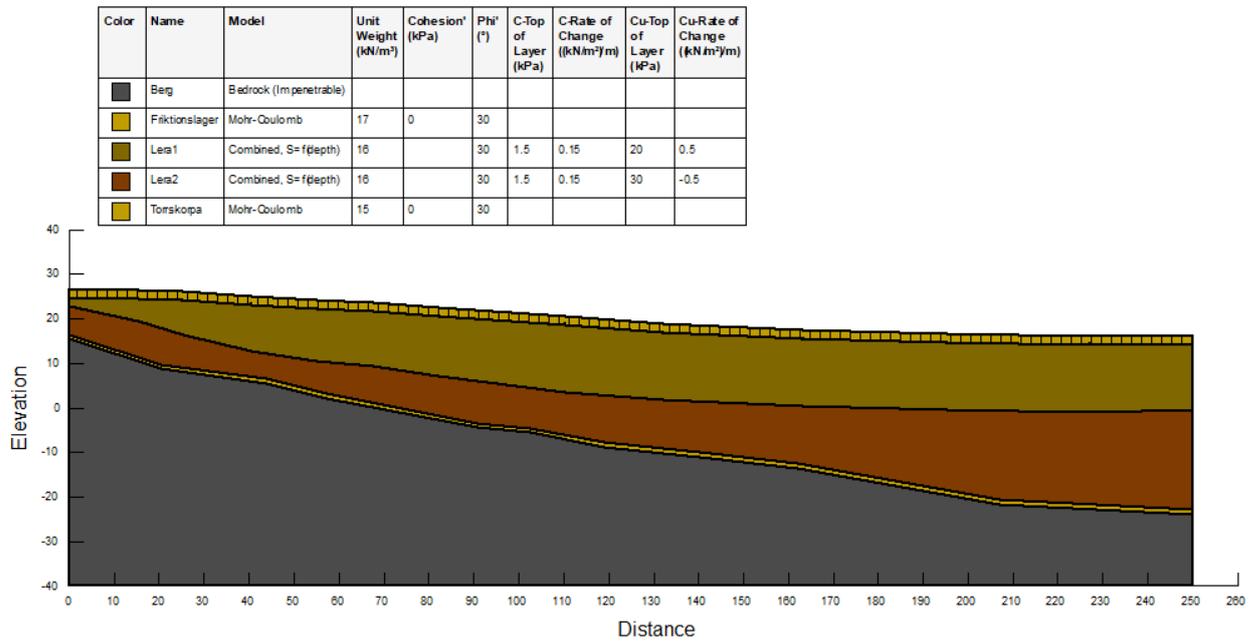
Figure 16: Soil layers in section A-A.

Figure 16 presents the sequence of soil layers for section A-A with their properties respectively.

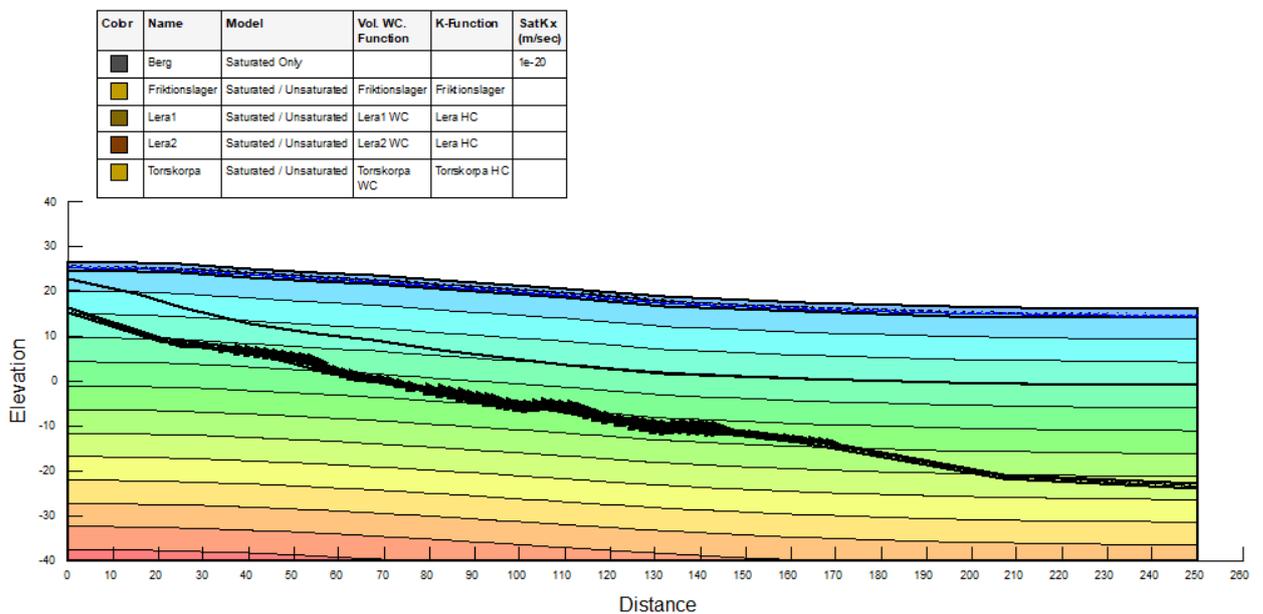
Figure 17: Initial conditions in section A-A.

Figure 17 shows the initial water flow in section A-A by arrows in the friction layer

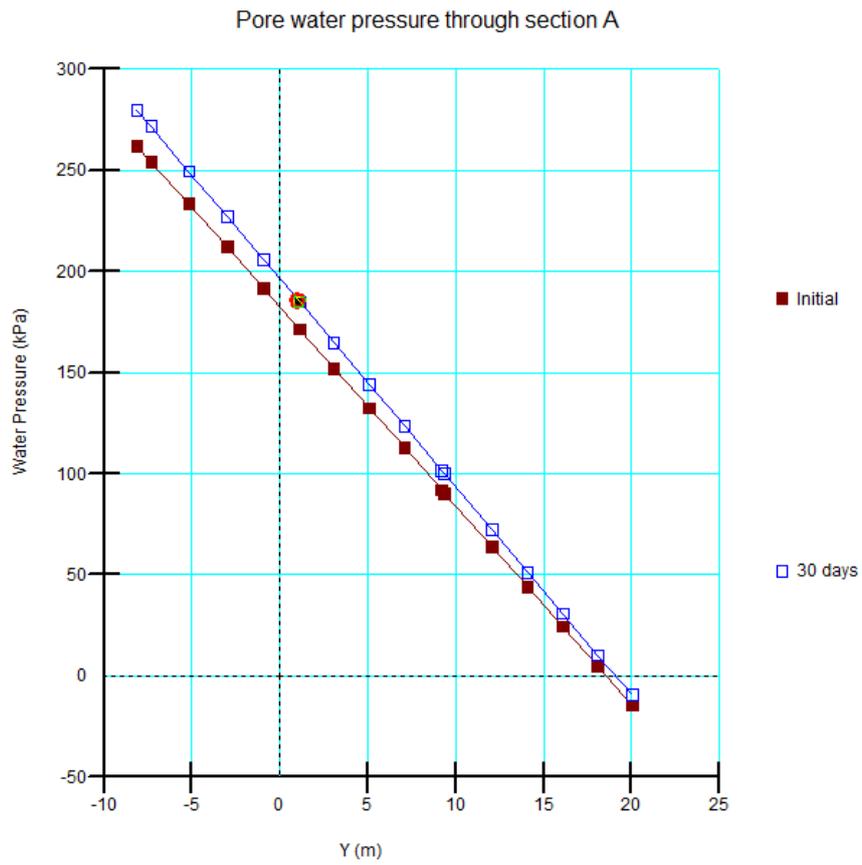
Figure 19: Pore water pressure through section A-A at the start and after 30 days. The conditions viewed are located at a distance of 116 meters.

Figure 19 shows the pore water pressure trend line changing from the initial case without infiltration, to an increased trend line after 30 days of infiltration.

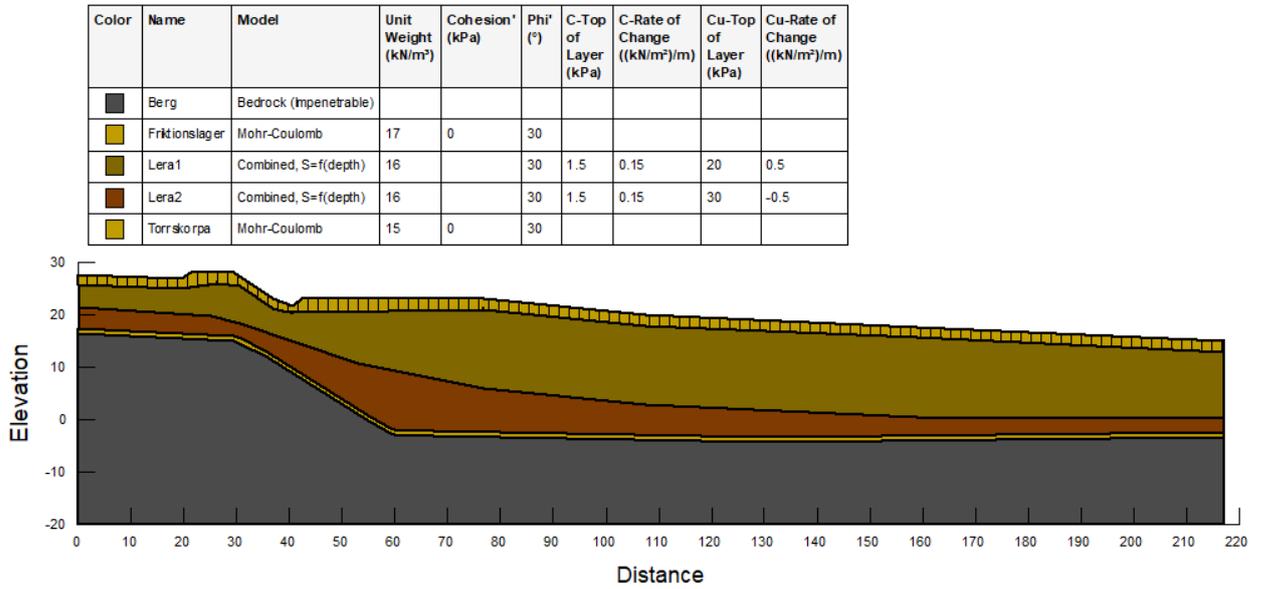
Figure 21: Soil layers in section B-B.

Figure 21 presents the sequence of soil layers for section B-B with their properties respectively.

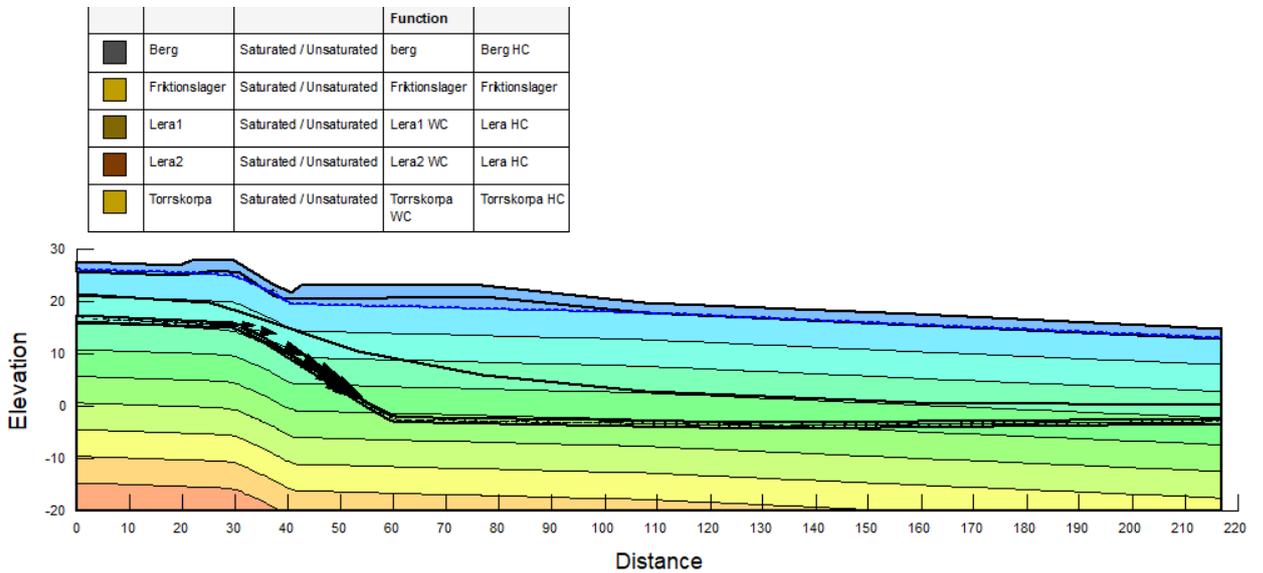
Figure 22: Initial conditions in section B-B.

Figure 22 shows the initial water flow in the friction layer for section B-B before infiltration.

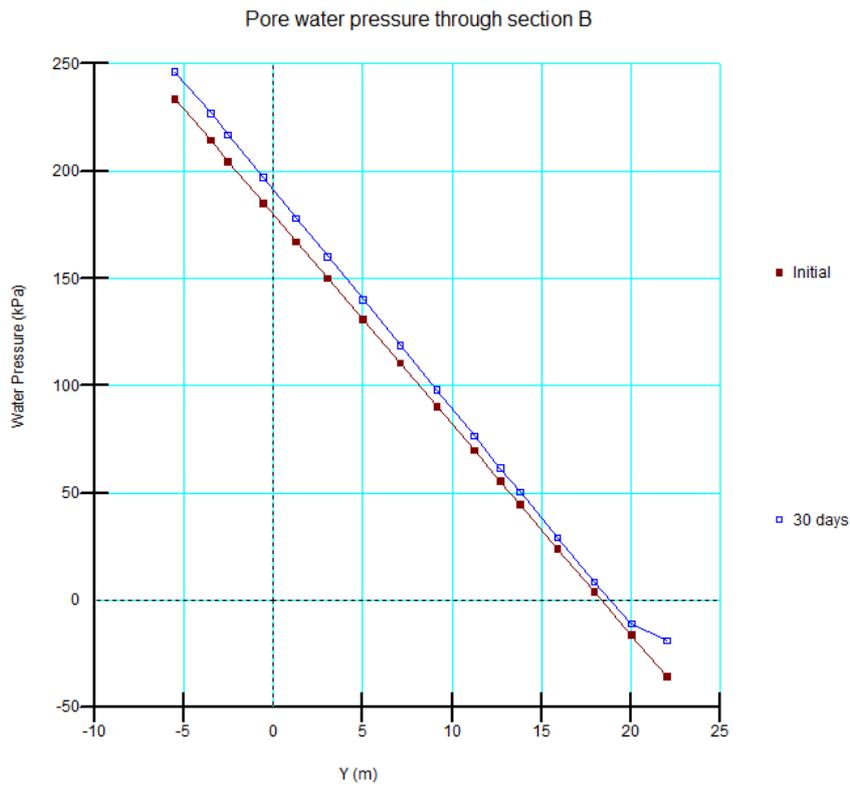
Figure 25: Pore water pressure through section B-B at the start and after 30 days. The conditions viewed are located at a distance of 85 meters.

Figure 25 Shows the pore water pressure trend line increasing after applying infiltration for 30 days.

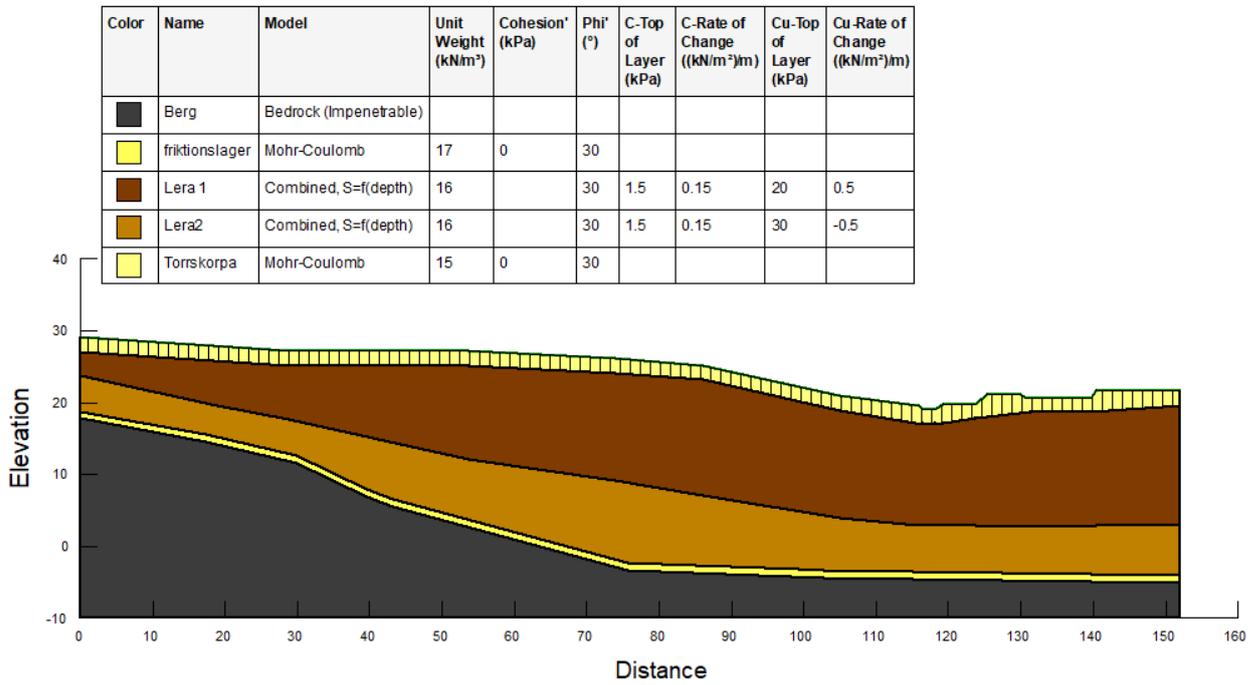
Figure 28: Soil layers in section C-C.

Figure 28 presents the sequence of soil layers for section C-C with their properties respectively.

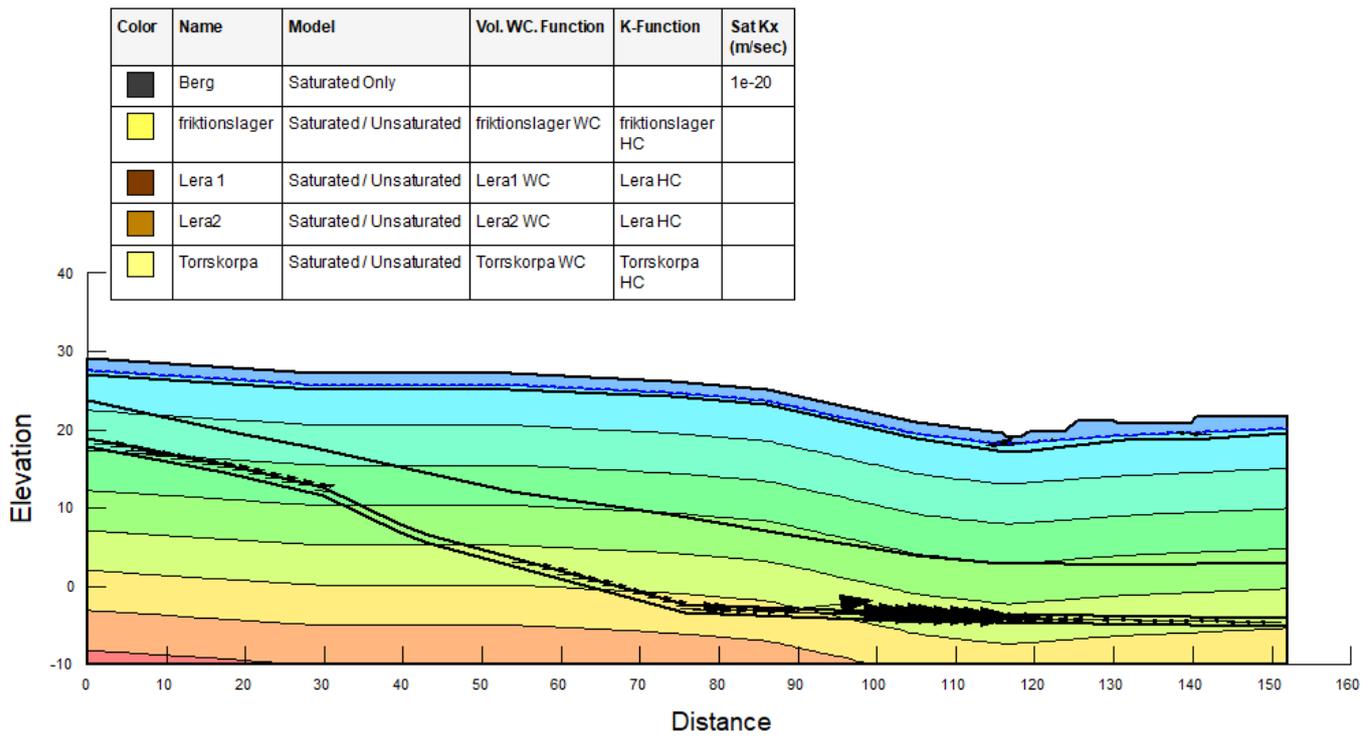
Figure 29: Initial conditions in section C-C

Figure 29 Shows the water flow in the friction layer of section C-C before infiltration.

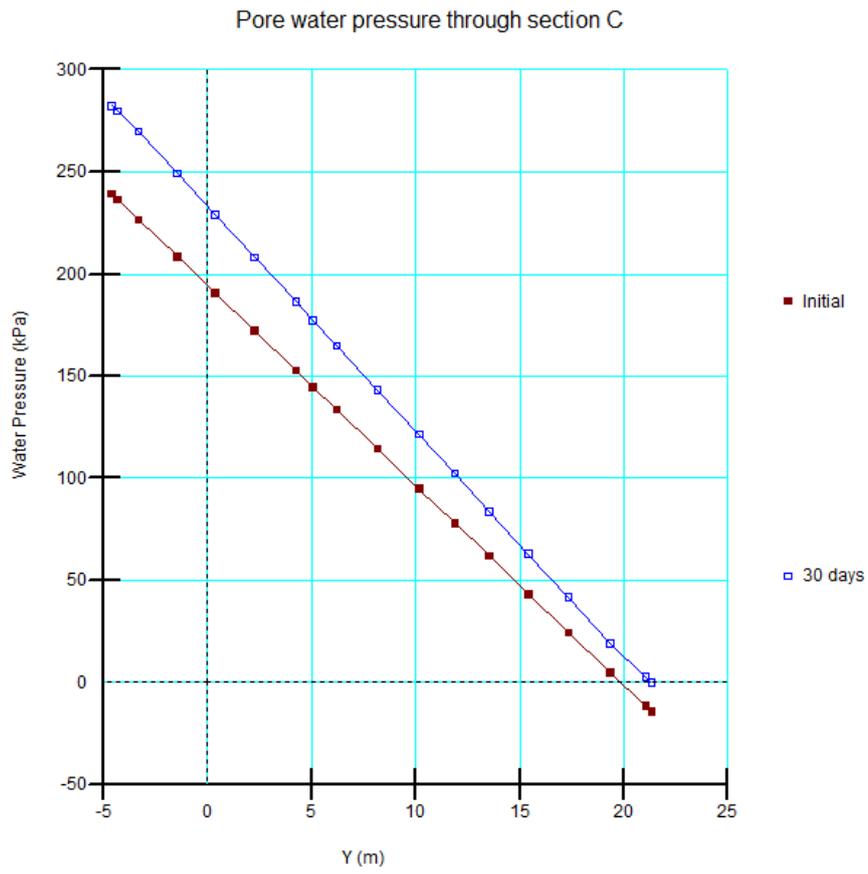
Figure 31: Pore water pressure through section C-C at the start and after 30 days. Conditions viewed are located at a distance of 103 meters.

Figure 31 shows the increase in pore water pressure trend line from the initial phase and after 30 days of infiltration.
