# Repair of submerged concrete piles with FRP composites

Master's Thesis in the Master's Programme Structural Engineering

MASTER'S THESIS 2017:68

Deterioration of concrete piles in marine structures due to harsh environmental conditions has highlighted the need of continuous maintenance and renewal of such structures. To repair these structures a relatively new and emerging repair method is to wrap the piles with fibre reinforced polymer (FRP) materials. The lightweight, high strength and flexibility of the FRP material provide for a quick and effective repair. The idea is that the FRP material with low permeability and good resistance to harsh environments will provide the pile with a protective layer and thus increase the durability of the pile.

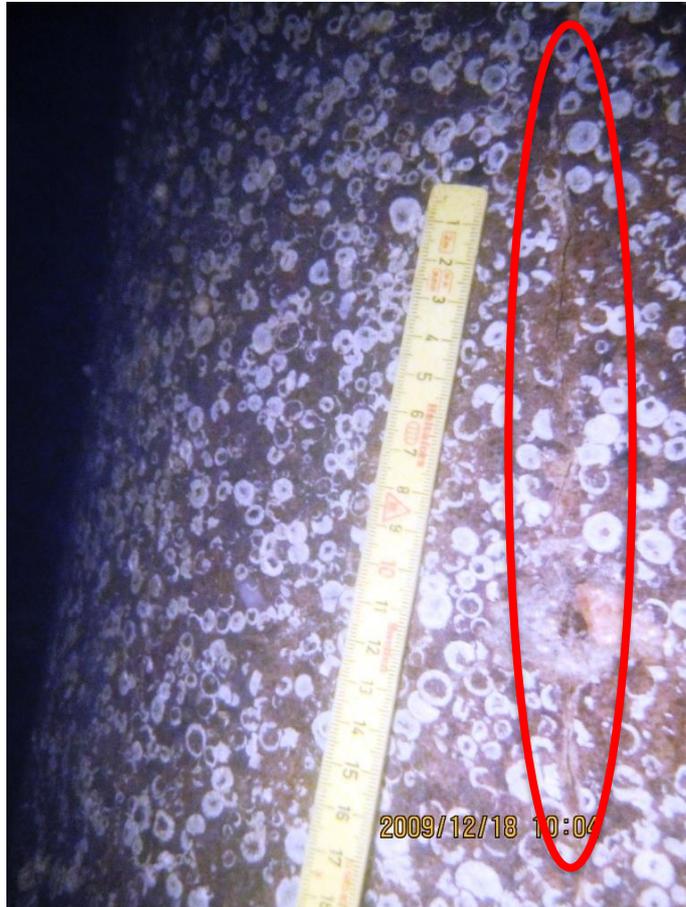
Figure 3: Vertical crack, ettringite (Robert Klein)

Sulphates in the seawater can react with the hydration products from the calcium aluminate phases of the hardened cement (Domone and Illston 2010). These reactions are expansive and form ettringite. Because the reaction is expansive it can cause cracks and spalling, see Figure 3. The damage starts at corners and edges and progresses inwards until failure. However, this process usually takes several years.

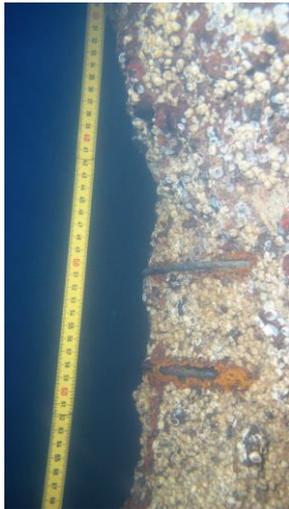
Figure 4: Abrasion in the splash zone (Robert Klein)

The piles are mainly subjected to abrasion in the splash zone, see Figure 4. The sources of the abrasion are waves and water-borne sediment and drift ice that wears on the surface of the pile. Of this two, drift ice is the most severe which in time can wear through the concrete cover and cause exposure of reinforcement (Bengtsson and Thornström 2011). Newly-produced submerged piles are provided with an ice protection to prevent this from occurring. However, in the Port of Gothenburg for the modern docks built in the 50's, 60's and 70's no ice protection was included when the piles were constructed<sup>1</sup>.

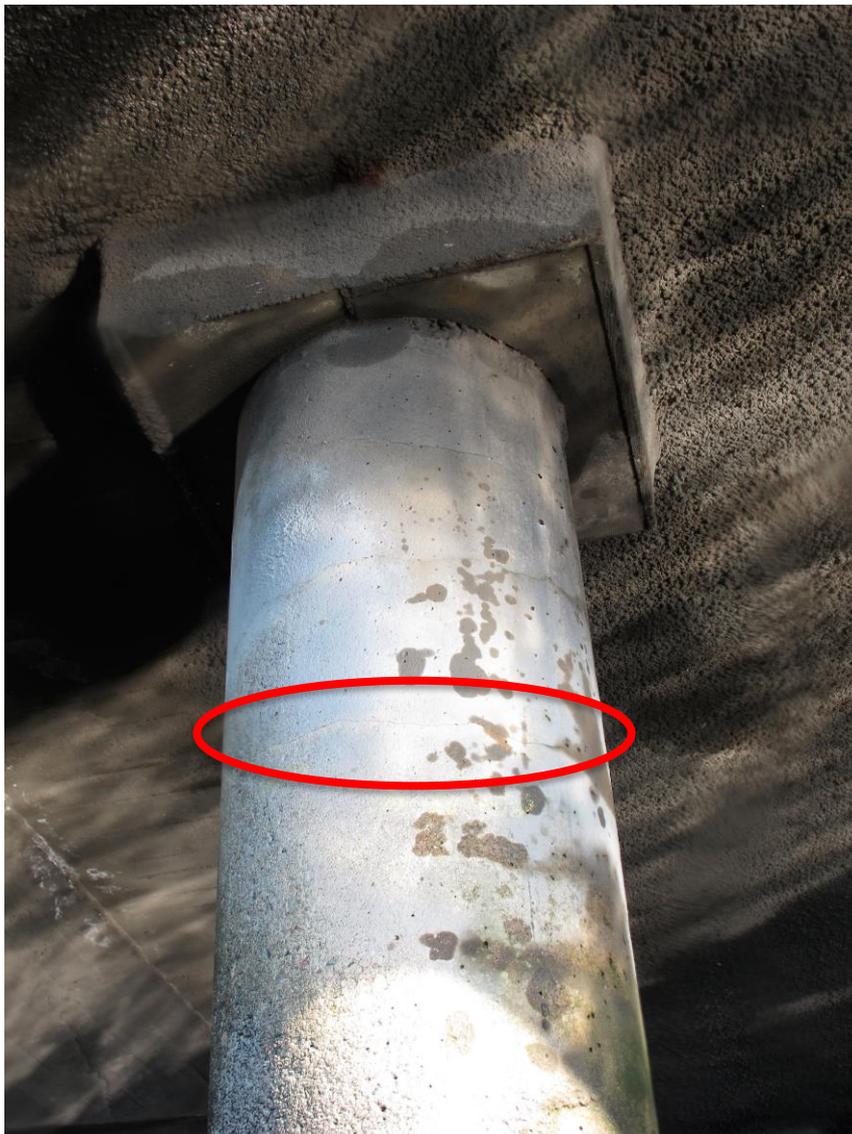
Figure 6: Horizontal cracks due to the applied stroke at installation

Damages on piles can occur already before installation. Defects can be missed at production, introduced during transportation and/or at site. During installation of driven piles horizontally aligned cracks can occur because of the applied stroke<sup>1,2</sup>, see Figure 6. Piles installed with an angle can intersect and accidentally collide during piling resulting in cracks and spalling of concrete. Initial defects as these reduce the service life of the piles, because of the reduced concrete cover which enables increased rate of deterioration.

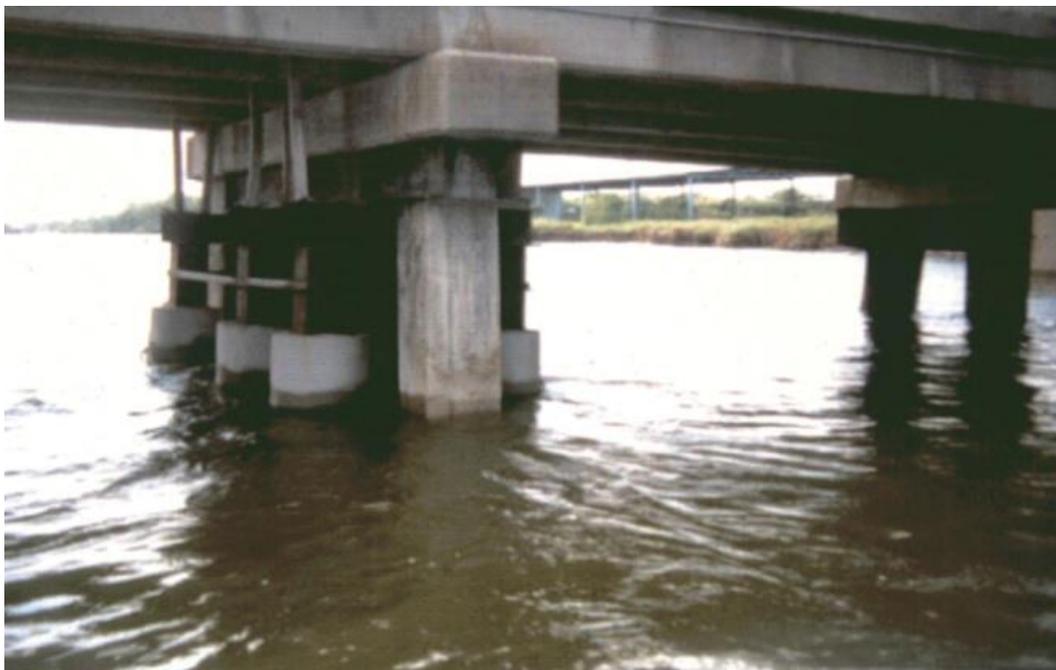
*Figure 9: Supplemental pile bents (Browne et al. 2010)*

Replacements of complete piles can be necessary when for instance, the concrete is subjected to ettringite or at severe damages of the structural integrity (Browne et al. 2010). Instead of removing the damaged pile, supplemental pile/piles, which fulfil the same functions as the existing piles, are constructed in the vicinity of the damaged pile. The construction is made possible by cutting holes in the deck/platform where the piles are driven through. The pile cap and bracings are then modified to transfer the loads to the new supplemental piles, see Figure 9, and the holes are repaired.

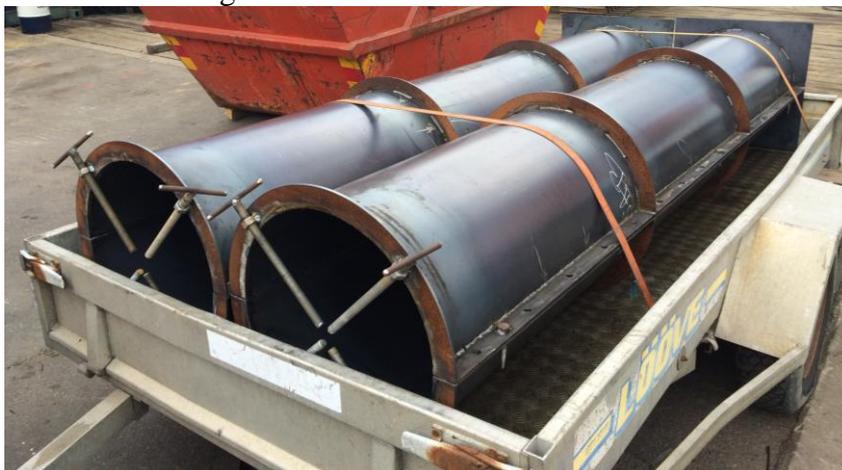
Figure 10: Cylindrical forms in steel for submerged concrete casting, (Robert Klein)

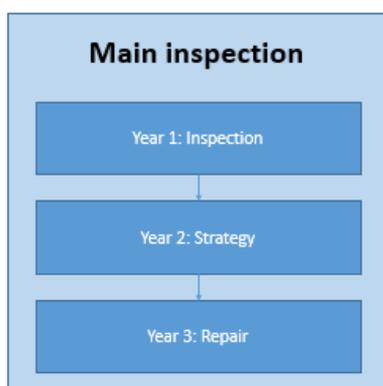
Figure 12: Main inspection every 6:th year. Inspection year one, strategy year two and repair year three.

To obtain and decide the need of repair for submerged piles, main inspections are carried out every sixth year. The process, from detecting the damage to performing the repair work is summarised in Figure 12. In the case of severe damages, the strategy and repair can be executed more quickly.

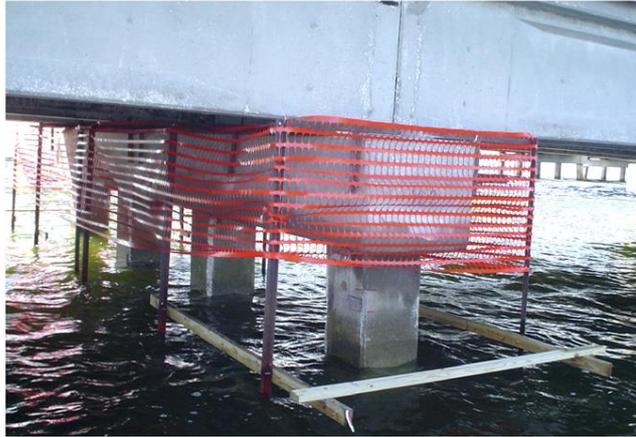
Figure 17: Scaffolding system suspended from the pile cap (Sen and Mullins 2007a)

For accessing the piles, a lightweight four-parted scaffolding system with cut-outs for the piles was built and installed. The scaffolding was suspended from the pile cap, see Figure 17 at a height that allowed the wrap to be applied from the pile cap and 1,84 m down.

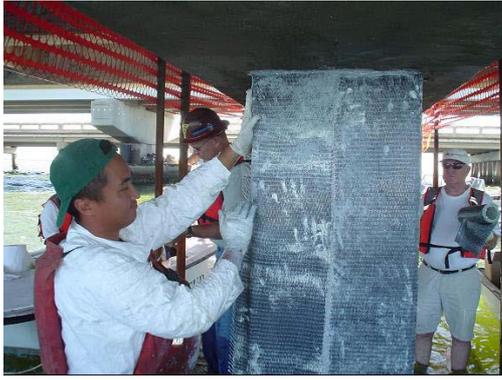
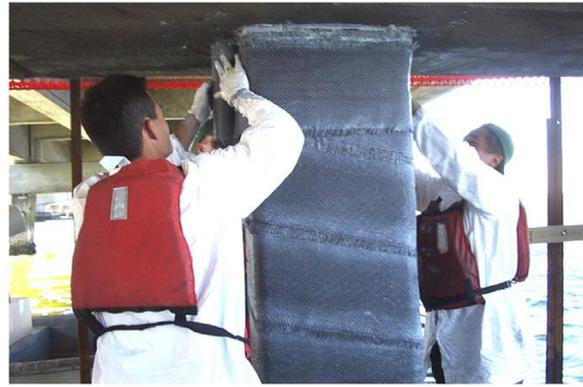
Figure 18: a) Applying the longitudinal CFRP layer (Sen and Mullins 2004), b) Applying the second transverse CFRP layer (Sen and Mullins 2007a)

The pre-preg system was pre-impregnated with resin at the factory and arrived at the work site in hermetically sealed pouches. Before the bags were opened Aquawrap® base primer 4 was applied by hand on the prepared surface. The carbon fibre was used in a longitudinal layer of uni-directional fibre, see Figure 18a, followed by two transverse layers of bi-directional fibres, see Figure 18b. The transverse layers were spirally wrapped around the pile without overlap. For the glass fibre wrap the same process as the carbon fibre was used and repeated because of the double number of layers. To consolidate the wrap and provide a better finish both the CFRP and GFRP system was applied with a glass fibre veil that was wrapped with a 50 mm overlap. For maintaining the wrap in place while curing, a plastic shrink film was used. The whole wrapping procedure was made in less than one hour a pile. This was within the working time of the Aquawrap® which according to (“Aquawrap®” 2017) is one hour. After a day of curing the plastic film were removed and the wrap was painted with base primer 4 for protection against UV radiation.

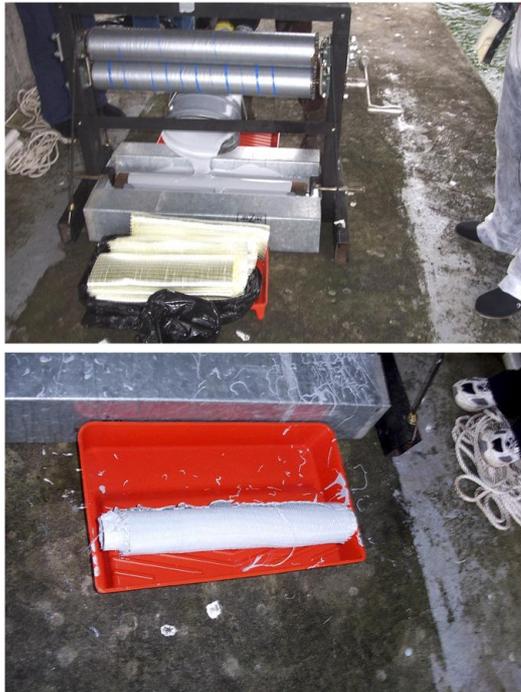
Figure 19: On site saturation of fibreglass fabric (Sen and Mullins 2007a)

In the wet layup, the resin was impregnated by hand on-site which provided higher flexibility of wrap lengths but also more planning of the logistics. One of the two piles were wrapped using different epoxies for the dry and the submerged region. However, this pile was re-wrapped three months later because of poor bonding in the dry area. The weak bonding was a result of wave action and splashing, which made the dry region wet. For the re-wrap, the epoxy was impregnated in the fabric with a resin impregnator, see Figure 19, and the wrapping procedure was the same as for the pre-preg system.

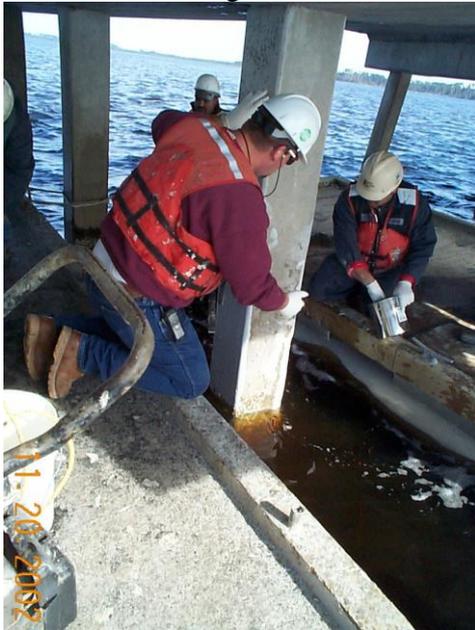
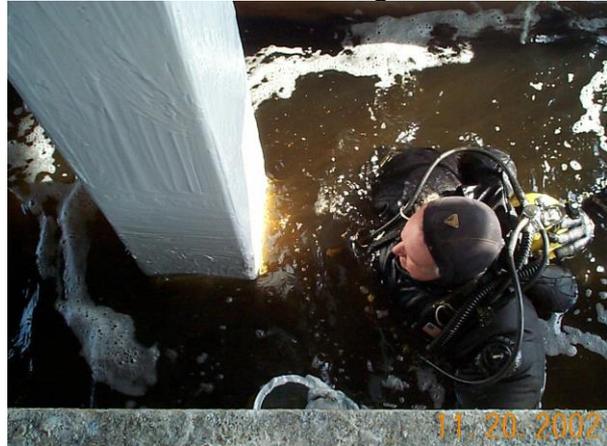
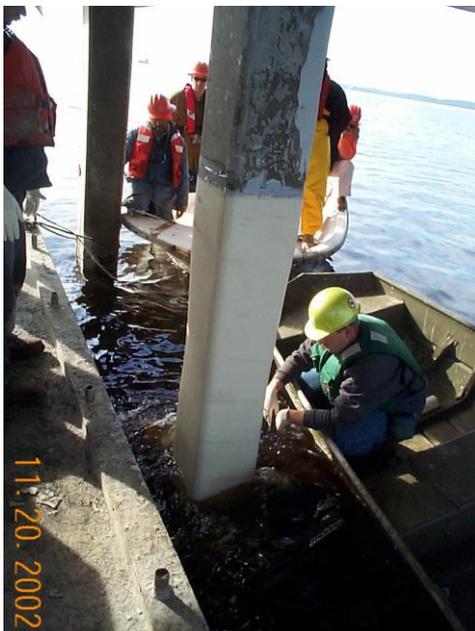
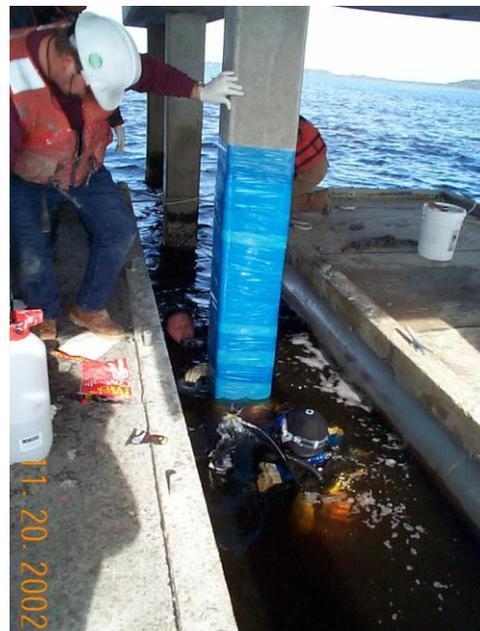
Figure 22: Installation of Aquawrap repair system, a) epoxy applied by hand above water, b) epoxy applied by divers below water, c) divers wrapping bi-directional GFRP, d) divers wrapping the plastic stretch film<sup>6</sup>

This system was applied from 350 mm below the low water line and up to the pile cap resulting in an area along 2.44 m and 1.83 m of the first respectively the second pile. The installation was made by first preparing the concrete surface. For the first pile, this was made by thoroughly cleaning and patching the surface while the second pile only was cleaned and marginally patched. When the surface preparation for the piles had been performed, an underwater epoxy was applied to the concrete surface, see Figure 22a. The wrap was then applied using 200 mm wide rolls starting from the top of the pile. One turn was wrapped around the top then the wrapping continued spirally downwards without overlap. At the bottom one turn of wrapping was made before

proceeding back up. This was made until three layers were applied see Figure 22c. Above the waterline, water had to be sprayed on the surface before wrapping to activate the resin. To consolidate the wrap and provide a better finish a 250 mm wide veil was wrapped with a 50 mm overlap. During curing the pile was also wrapped with a temporary plastic stretch film, see Figure 22d. After removal of the stretch film, a layer of epoxy adhesive was applied to the wrap as a protective coating. The entire operation was made in less than a day by a crew that were new with this installation. The total man hours were eighteen for the contractor staff and six for the diving team.

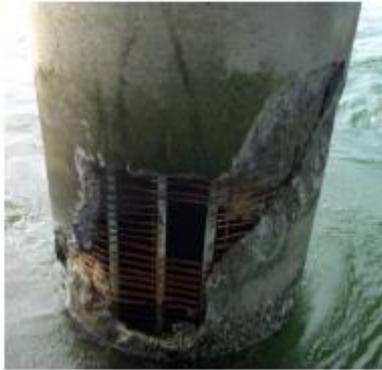
Figure 23: Damaged pile at Chesapeake Bay bridge (Neptune Research Inc 2012)

In 2012 a barge collided and damaged several 54” OD concrete piles of Chesapeake Bay Bridge (Neptune Research Inc 2012). The damages were located in the splash zone, in which the concrete cracked and exposed the reinforcement, see Figure 23. Site conditions as tidal currents and rough waves increased the difficulties using traditional repair methods.

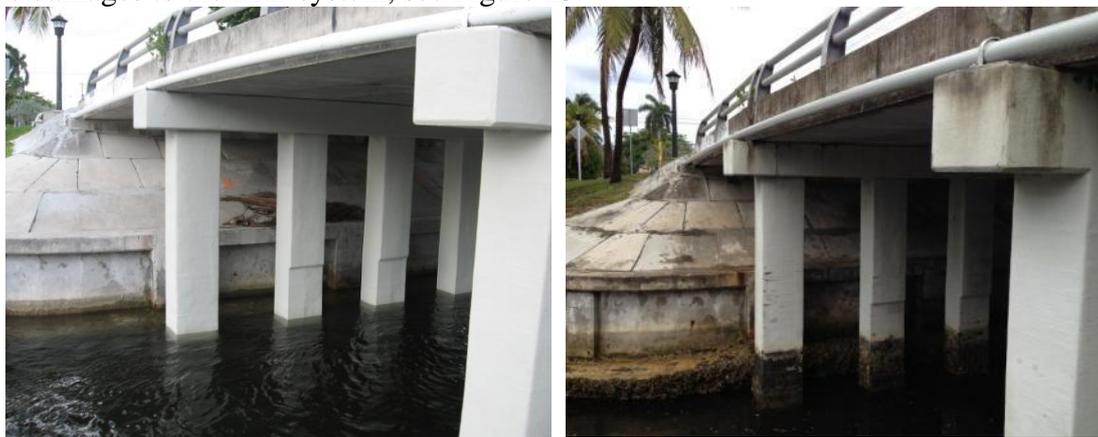
Figure 25: CFRP repair of piles, a) directly after installation, b) revisit five years later (QuakeWrap 2012)

The reparation was made in 2007 and five years later, 2012, QuakeWrap revisit the bridge. They observed marine growth and some paint loss in the submerged region, but no damages to the FRP system, see Figure 25.

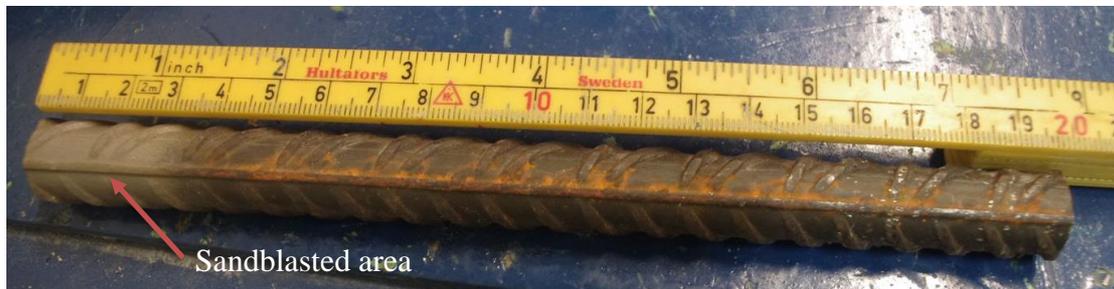
Figure 38: First three centimetres to the left is the sandblasted area.

Reinforcement bars of 16 mm diameter and 200 mm length were chosen for the tests. A small area around the bar was sandblasted in order to provide a better electrical connection between the reinforcement bars and the wires during the accelerated corrosion test, see Figure 38.

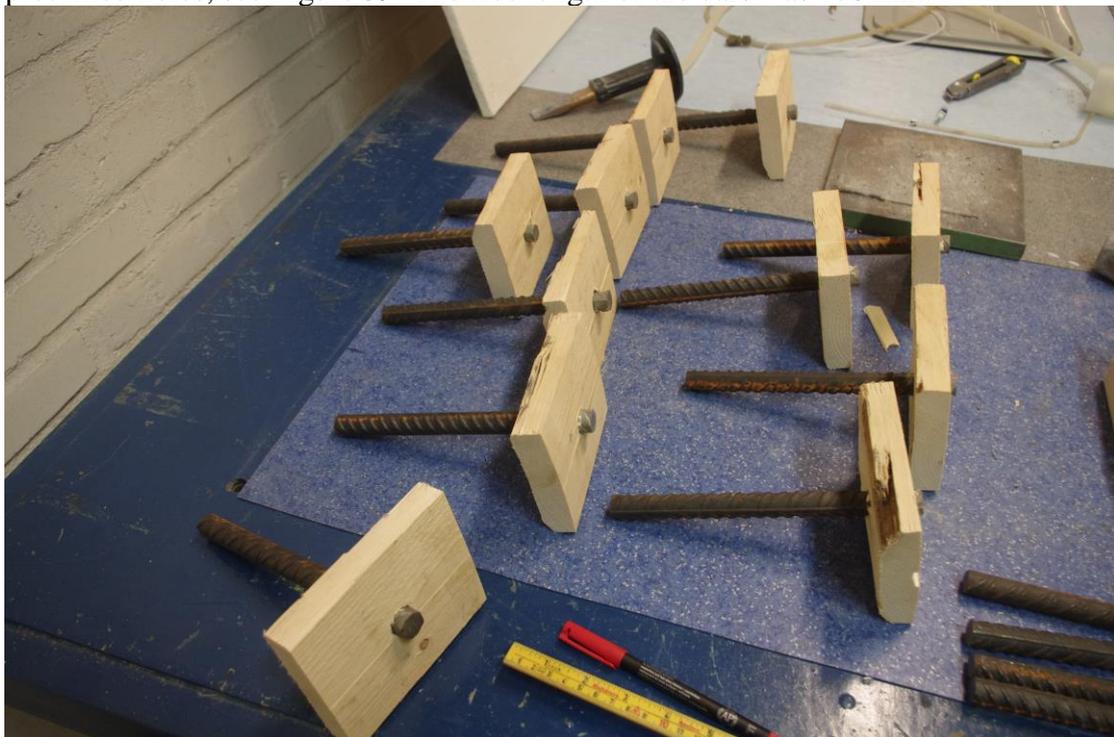
Figure 39: Reinforcement bars attached to wooden boards prior to casting

After the sandblasting, the reinforcement bars were weighed and the individual weight of the bars was recorded. In preparation for the casting, the sandblasted side of the reinforcement bars was attached to wooden boards of 10 mm thickness through predrilled holes, see Figure 39. The free length of the bars was 170 mm.

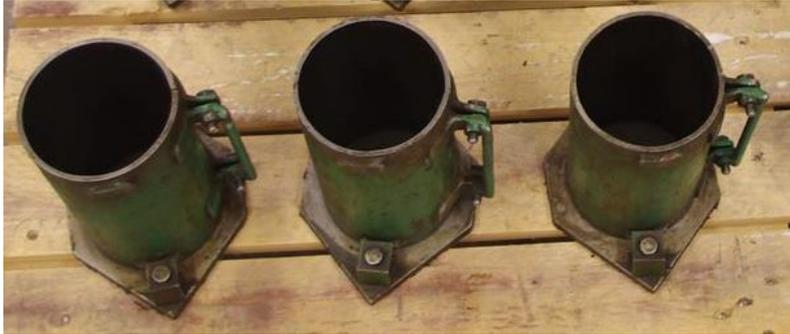
Figure 40: Cylindrical steel forms used for casting

Cylindrical steel forms, see Figure 40, with a diameter of 100 mm and a height of 200 mm were used for the casting.

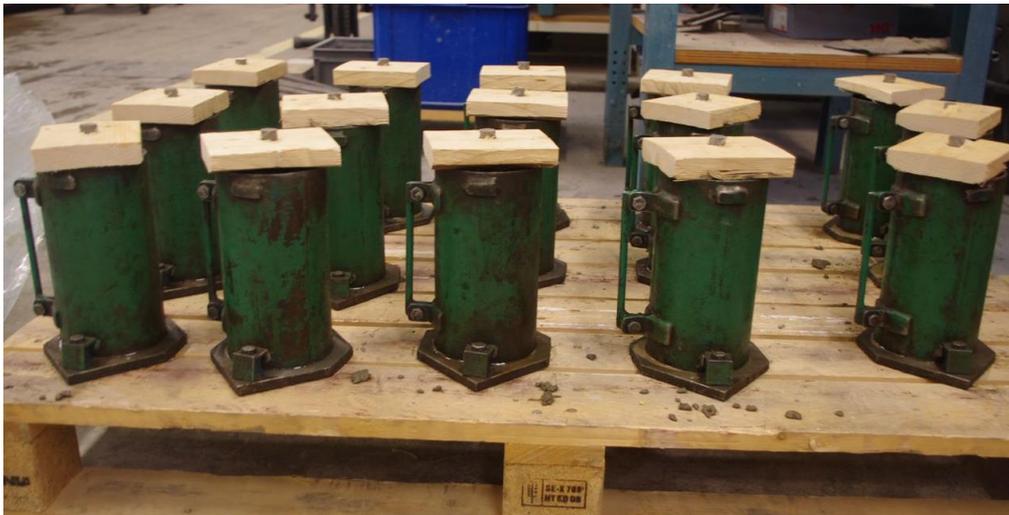
Figure 41: Casting of the specimens

Before casting, the forms were greased with form oil to ease the demoulding. The forms were then partially filled with concrete and the prepared reinforcement bars were placed in the centre of the cylinder, held in place by the wooden boards resting on the top edges of the form, see Figure 41.

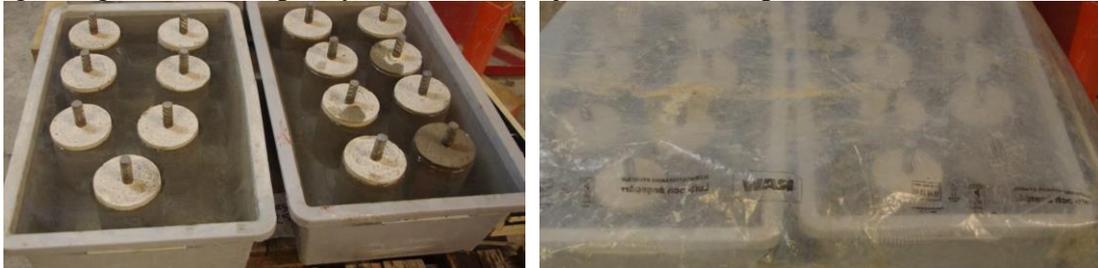
Figure 43: Water curing

The concrete had cured for one and a half day at room temperature before the cylindrical forms were demounted and the specimens were placed to cure in a water bath for 12 days, see Figure 43. The tests started before the concrete was completely cured due to time limitations in the project. This was judged as reasonable considering that tests regarding structural capacity were not an objective of the experiment.

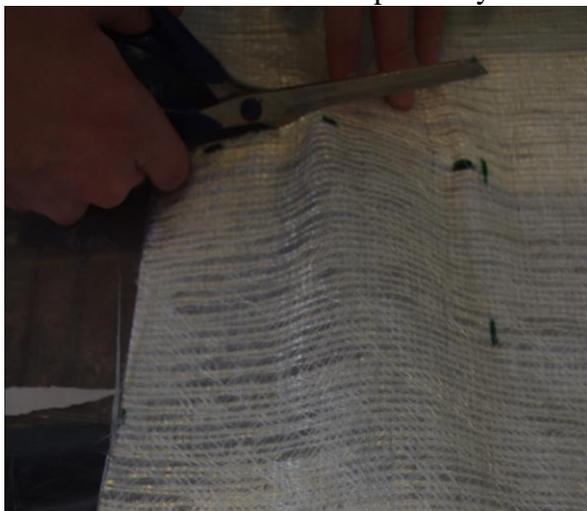
Figure 44: Cutting of glass fibre mats

The used material in the tests was a  $0^{\circ}/90^{\circ}$  bi-directional glass fibre weave with a density of  $1273 \text{ g/m}^2$ . It was delivered in a 10 m long and 1.270 m wide roll and the first step was to cut the glass fibre in sheets with dimensions of  $180 \times 350 \text{ mm}$  and  $180 \times 380 \text{ mm}$  for the first respectively second layer, Figure 44.

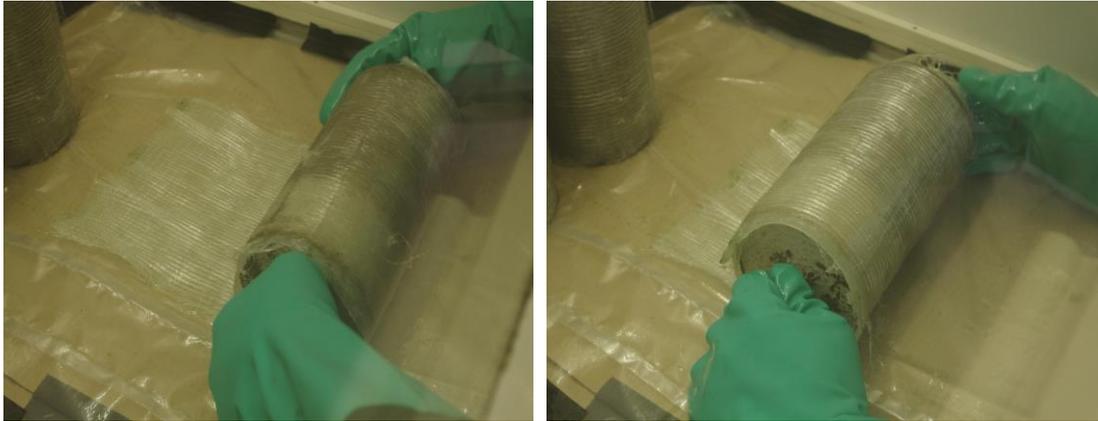
*Figure 45: Wrapping of concrete specimens with saturated GFRP sheets*

Wet layup method was used for applying the GFRP to the specimens. The pre-cut glass fibre sheets were saturated with epoxy in a tray before being applied to the concrete specimens. The first layer was wrapped around the specimen with the second layer of wrap applied directly after the first, which can be seen in Figure 45. The second layer was applied with a one-quarter lap shift to ensure that the joints of the different layers were separated. After wrapping the epoxy was allowed to cure for a day.

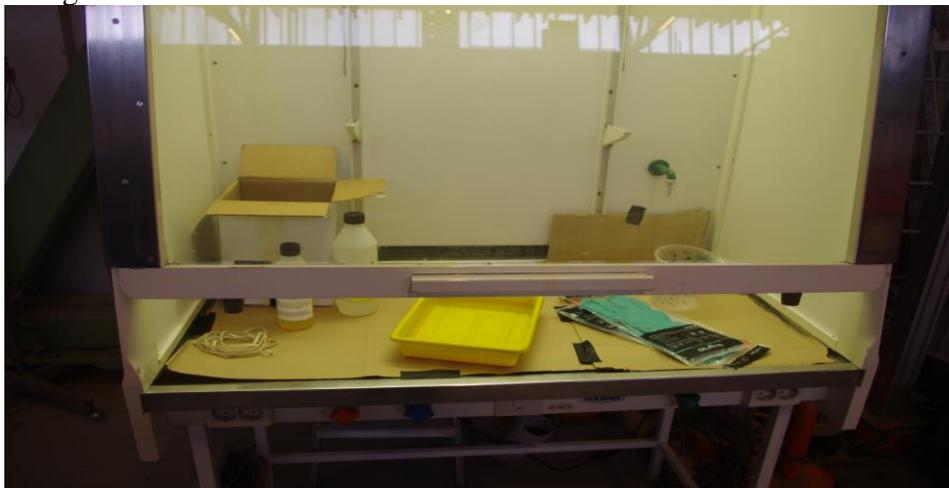
*Figure 46: Fume hood, work station for epoxy*

As a security measure, the work involving epoxy and curing was made in a fume hood, see Figure 46, to lead away by-products from the curing of the epoxy which can cause allergic reactions.

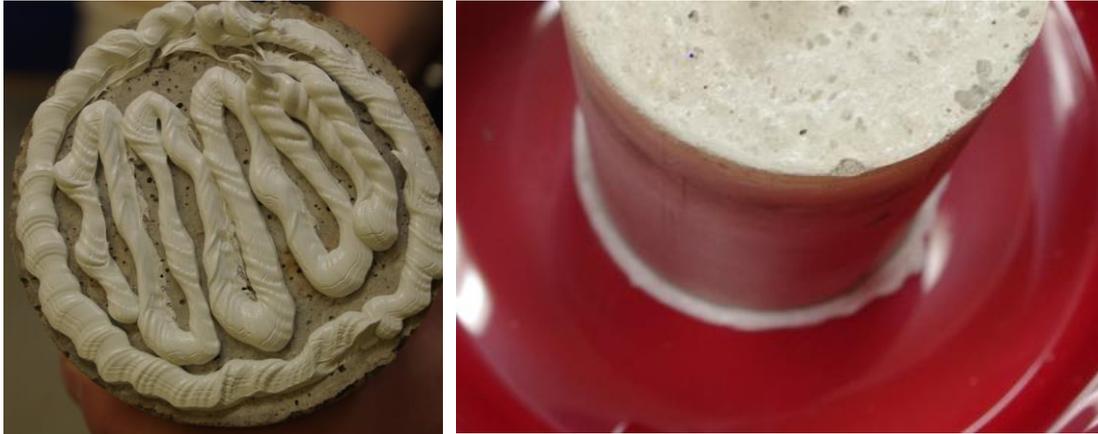
Figure 49: Sealing of bottom surface

All the specimens were placed in one bucket each and sealed to the bottom with a layer of silicone to prevent chloride penetration from the bottom, see Figure 49. To achieve the electrochemical cell a copper mesh was wrapped around each specimen and kept in place with rubber bands. Wires were attached to the reinforcement bar, acting as the anode, and to the copper mesh, acting as the cathode, for connecting the specimens in series. The cell was then completed by filling the bucket with 3.5% salt solution, acting as the electrolyte, so that the water level covered two-thirds of the specimen, see Figure 50.

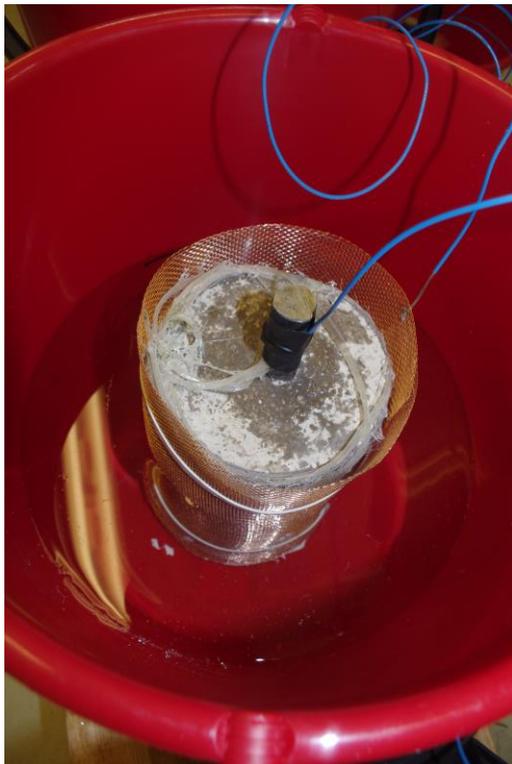
Figure 50: Wiring to and from one specimen

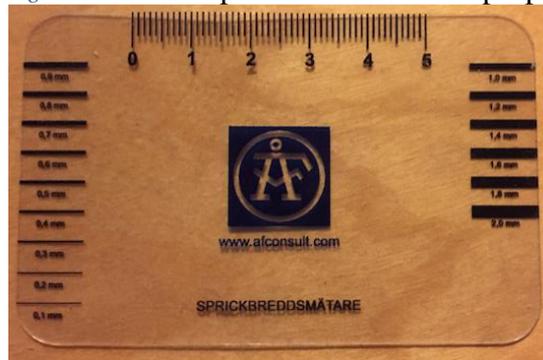
*Figure 53: Measure card for cracks*

During the experiment the cracks were measured continuously with the card shown in *Figure 53* for comparison of the crack propagations.

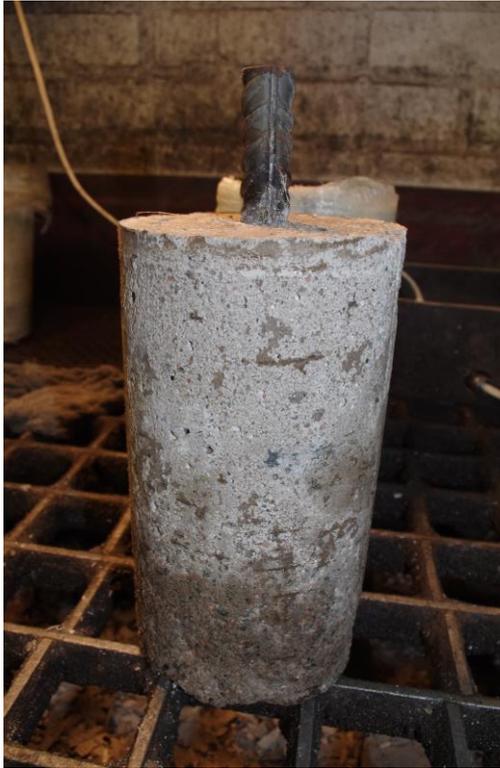
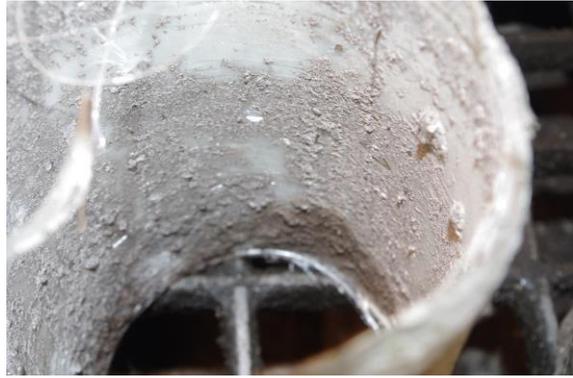
Figure 60: Bond failure in concrete, a) specimen A3, b) inside of wrap A3

The inter-laminar bond between the GFRP layers was stronger than the bond between the GFRP and the concrete. The specimens in group A had the strongest concrete/GFRP bond followed by the specimens in group D and the specimens in group C had the weakest concrete/GFRP bond. For the specimens in group A the bond failure occurred in the concrete, see Figure 60, in group D failure could be seen in both concrete and epoxy, see Figure 61, while the failure in group C mostly occurred in the epoxy, see Figure 62. It was also noted that the concrete/GFRP bond was weak at rust deposits as can be seen in Figure 62. Bubbles that could be seen in the GFRP were a result of poor wrapping and no new or enlargement of the existing bubbles could be observed during the experiment.

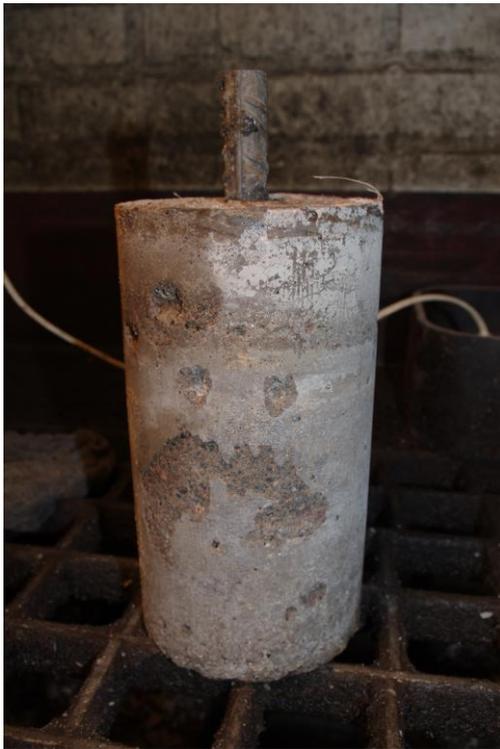
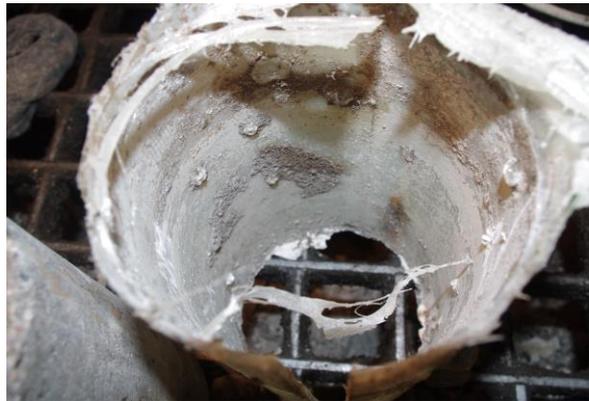
Figure 61: Bond failure in concrete and epoxy, a) specimen D1, b) inside of wrap D1
