Initiation of localised corrosion on bearing steel

Diploma work in the Master programme Materials Chemistry and Nanotechnology

Diploma work No. 168/2015

at Department of Materials and Manufacturing Technology
CHALMERS UNIVERSITY OF TECHNOLOGY
Gothenburg, Sweden

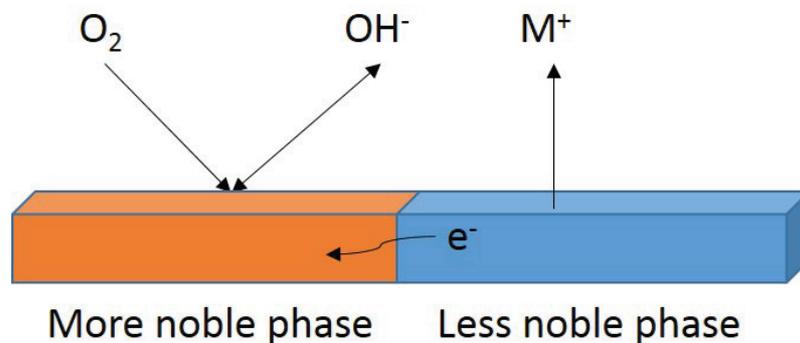
Figure 2.1: Schematic image of micro-galvanic corrosion

Galvanic corrosion occurs when materials with different nobleness are in contact. The more noble material will be able to avoid being oxidised by acting as a cathode for the other metal. The less noble of the metals will therefore corrode while the other will keep its metallic form [12]. In some alloys, e.g. Magnesium alloys, the different phases in the material can have different nobleness which enables galvanic corrosion on a microscopic level [14]. This means that one phase can be dissolved while the rest of the material is unaffected [15]. In figure 2.1 a schematic image of the phenomenon is presented where oxygen reduction is given as an example of cathode reaction.

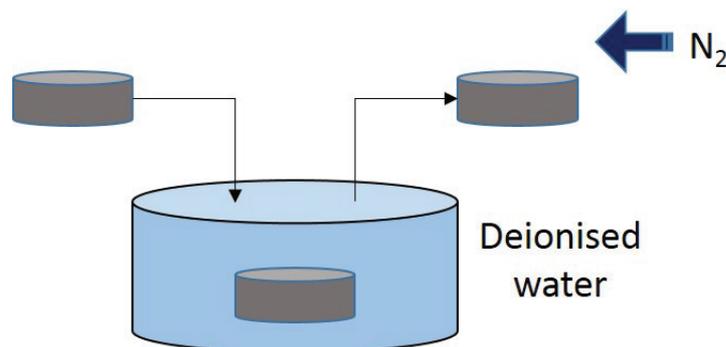
Figure 4.1: Schematic image of the exposure in the corrosion test.

The samples were placed in a container with deionized water for a controlled period of time, see figure 4.1. Different exposure times were tried during the project to be able to see different sequences of the corrosion process. The exposure times used in the project were 1 minute, 2 minutes, 5 minutes and 10 minutes. Directly after the samples were withdrawn from the distilled water the surfaces were flushed thoroughly with compressed nitrogen to remove all water from the specimen. This was done to be able to stop the corrosion process on the surface. The samples were then put in the desiccator until the sample was put in the SEM. The time after the exposure until the sample was put in the SEM was always less than 15 minutes and in cases immediate.

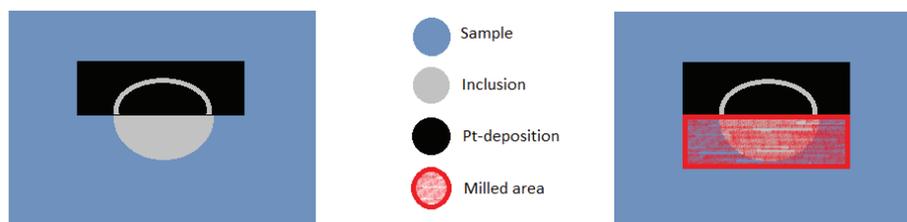
Figure 4.2: Schematic image of the Pt-deposition and milling, seen from top view

4.3.1.3.2 Corrosion tests - SEM - analysis - FIB-SEM FIB-SEM was used on two samples to be able to do a local (micron-scale) cross section through some inclusions. The studied sample were samples exposed for 5 minutes and 10 minutes respectively. The sample was mounted, polished and exposed according to the scheme in section 4.3.1.1 and 4.3.1.2. The procedure in the FIB-SEM started with a search for interesting areas on the samples to find inclusions where corrosion has started. Some imaging with secondary electrons were also performed. Where a cross section was to be performed platinum deposition of roughly $0.3\mu\text{m}$ was applied to protect the near-surface region from unwanted milling, see figure 4.2. The deposition started with charging of the surface with electrons which attracts platinum ions

from the atmosphere that adsorb to the surface. Then the area was sputtered with platinum ions to create a thicker film. The cross section was made by bombardment by gallium ions which was set to create a rectangular pit which is deepest close to the platinum deposition . Images of the cross section was taken and the sample was then transferred to an SEM with and EDX so chemical information could be obtained.

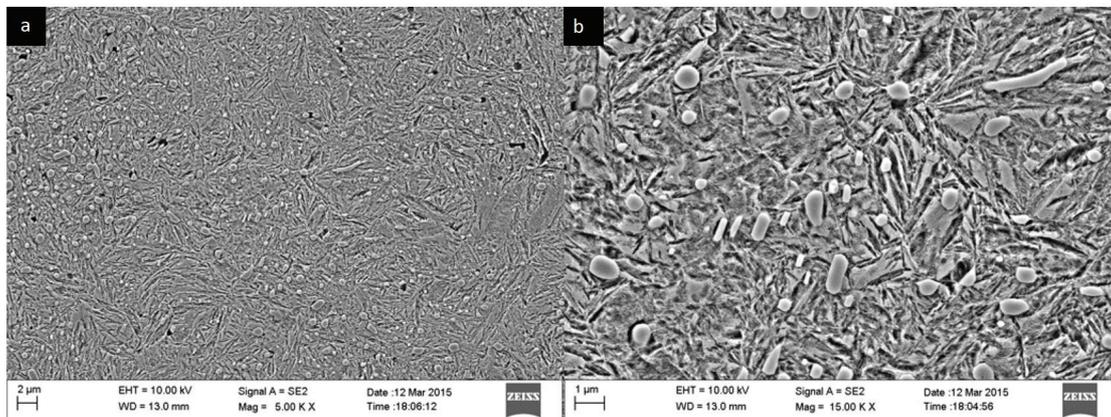
Figure 5.1: SEM image of etched sample imaged with secondary electrons, a and b are with different magnifications

The analysis of the microstructure of the steel is presented in figure 5.1 . The images shows the spheroidized carbides in the microstructure and the martensitic needles .

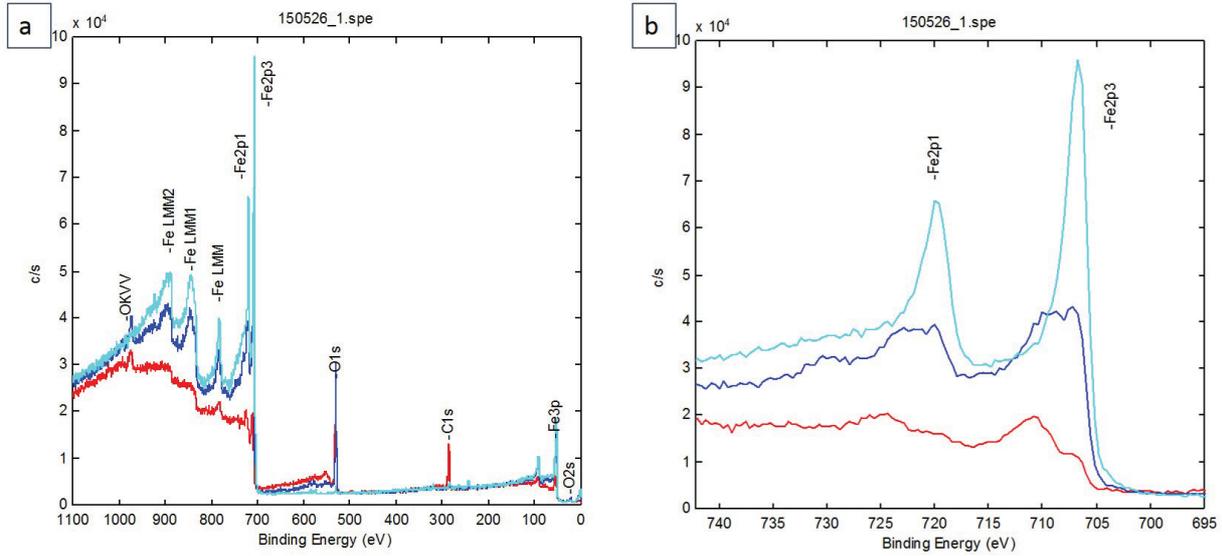
Figure 5.2: XPS spectra for non exposed sample, a) is the general spectrum and b) the iron spectrum. The red lines are from the depth of 0 Å, dark blue from 10 Å and light blue from 50 Å.

In figure 5.2 the overall spectrum for non exposed sample can be seen and in table 5.1 the chemical composition on the different depths are presented. The same information for a sample exposed for 5 minutes can be found in figure 5.3 and table 5.2.

The XPS analysis showed that there is no difference in oxide films on the exposed and non exposed samples, both regarding thickness and composition. Given the large analysis area (diameter 0.8 mm) and the limited coverage of localized corrosion exemplified below, the XPS results will represent the some few nm thin oxide film covering most of the surface. This indicates that the corrosion process during the 5 minute exposures does not generate a general oxide film that is thicker than the one formed in air. A prolonged exposure with rinsing of the sample in deionised water was also performed, but the results were the same. The XPS was not able to detect manganese or sulphur signals that were strong enough to be able to study the peak shifts of the elements. In a case where the manganese or sulphur signals would be strong enough it would be interesting to see if a peak shift could

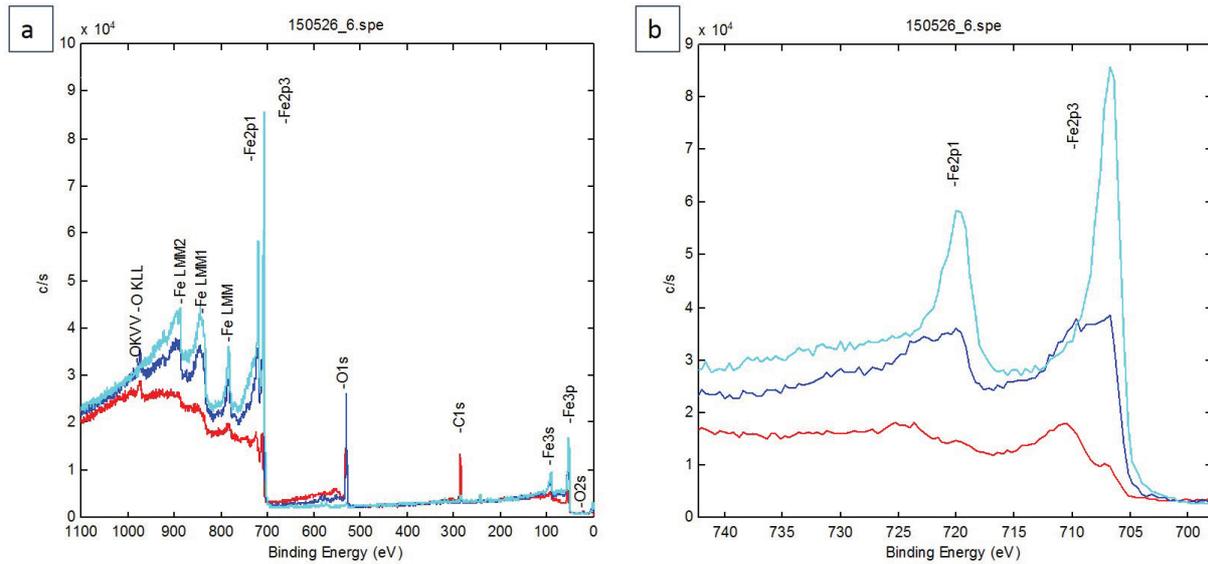
Figure 5.3: XPS spectra for sample exposed for 5 minutes, a) is the general spectrum and b) the iron spectrum. The red lines are from the depth of 0 Å, dark blue from 10 Å and light blue from 50 Å.

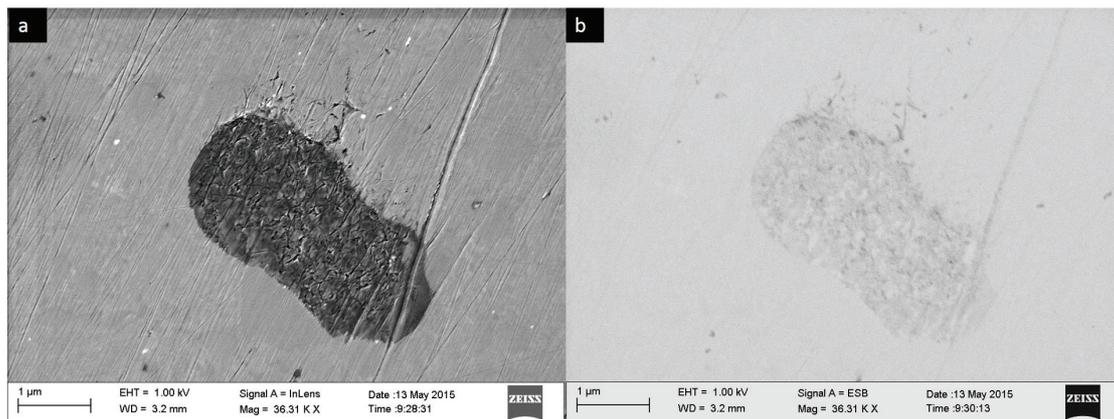
Figure 5.4: SEM image (1kV) of a MnS inclusions from unexposed sample, a inlens, b ESB detector. The image show that the inclusions is affected by the sample preparation and get some scratches from the polishing.

The image show how the surface of the inclusion is affected by the polishing and sample preparation.

Images of inclusions from samples that have not been exposed are presented to get a reference. Images of one MnS inclusion that has been affected by the polishing is seen in figure 5.4.

Mn K α 0.637 keV-energy and Fe L α 0.705 keV -energy. The results confirm that inclusions with similar appearance as seen in figure 5.4 and 5.5 are MnS inclusion with some iron.

An example of an inclusions that has corroded can be seen in figure 5.14. The surface of the inclusions is rough and has decomposed (corroded). Compared to the samples that have not been exposed, see figure 5.4 and 5.5, the surface is more rough which means the roughness should not only come from the sample preparation. The matrix close to the inclusion is affected and gives bright edge contrast in the inlens image. A small crevice in the top of

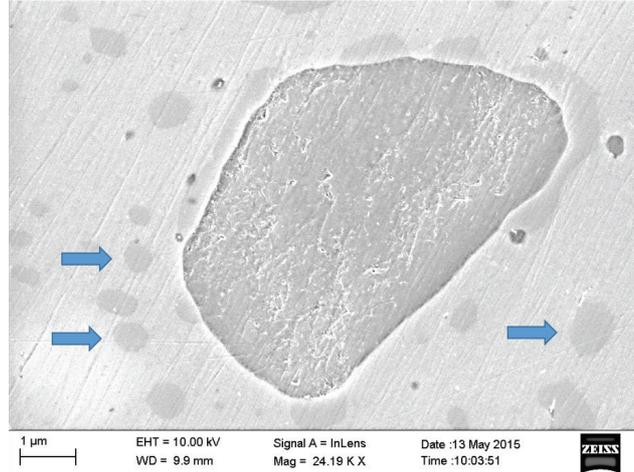
Figure 5.5: SEM image (10kV) of a MnS inclusions from unexposed sample. The image shows that the inclusions do not have a completely smooth surface appearance even though few scratch marks can be observed. Note the presence of carbides around the inclusion, see arrows

A MnS inclusion that has not been as affected can be seen in figure 5.5. In this image the inclusion do not show deep scratch marks on the surface but the surface of the inclusion is not completely smooth.

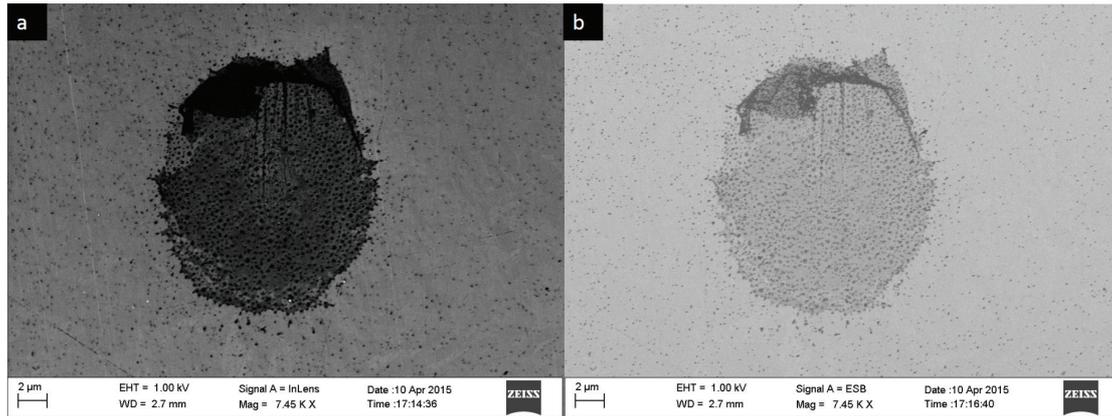
Figure 5.6: SEM image (1kV) sample exposed for 1 minute, a inlens b ESB . The image show an area which could be an inclusions covered with diamond or just a mark from the drying.

There are no clear signs of corrosion after 1 min exposure. The discernible effects of the exposure are limited to what are believed to be effects from sample preparation and some contamination. This is exemplified in figure 5.6 and is supported by EDX analyses seen in figure 5.7 where any signal from oxides or inclusions are lacking.

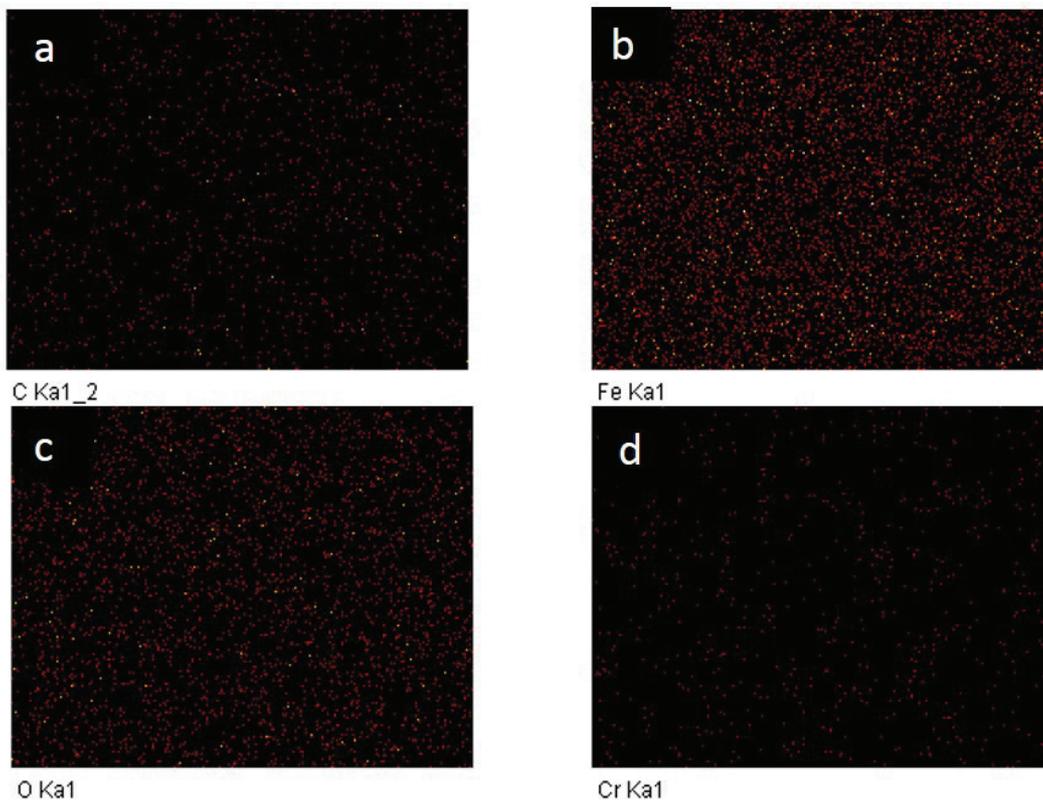
Figure 5.7: EDX mapping of area in figure 5.6, a-d are mappings of different elements significant for oxides or inclusions

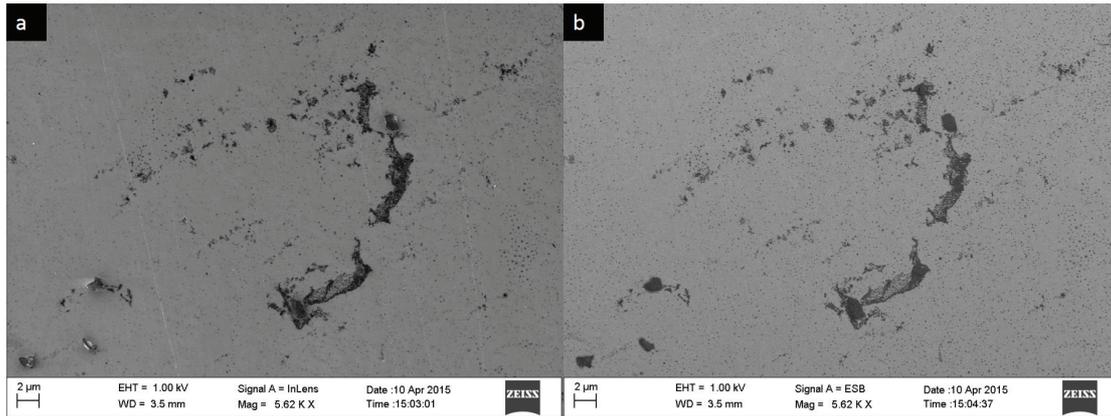
Figure 5.8: SEM image (1kV) of a area on sample exposed in 1 minute, a inlens b ESB. The image shows an area which could be mild localcorrosion on the matrix or possibly dirt.

Even though no inclusions that showed signs of corrosion were observed areas with possible corrosion on the matrix could be observed, see figure 5.8. The image shows that the surface appearance is different which means that the sample could have corroded.

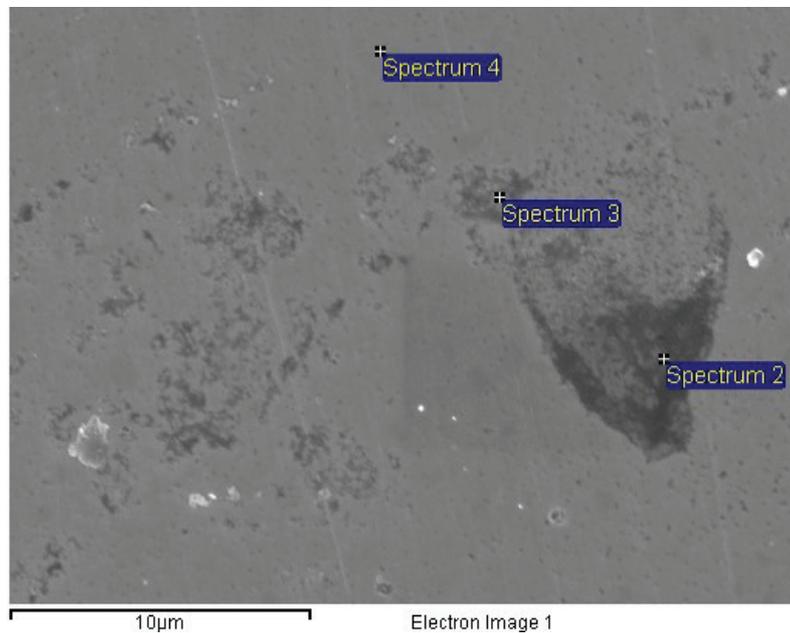
Figure 5.9: SEM image (10kV) sample exposed for 1 minute, The image shows an area which could be corrosion on the matrix.

Another example is shown in figure 5.9 where the composition of the analyses spectrum are presented in table 5.4 which show that some oxygen was found in the region, but also some carbon. This indicates that the region can either be thin oxides or contaminants but it is not possible to tell which with this technique.

Table 5.4: EDX analysis of points marked in figure 5.9 (at%)

Spectrum	C	O	Fe	Cr
2	2.30	1.46	90.14	2.21
3	4.91	-	95.09	-
4	3.80	0.62	93.51	2.07

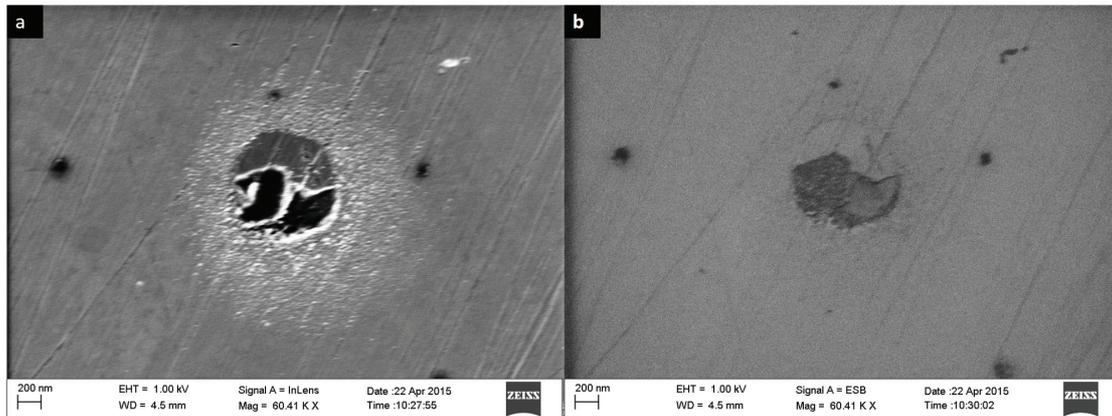
Figure 5.10: SEM image (1kV) sample exposed in 2 minutes, a inlens detector, b ESB detector. The image show a complex inclusion with unknown composition. The region around the inclusion have changes in surface appearance and there crevices can be observed

After 2 minutes some signs of corrosion were observed. A complex inclusion where corrosion has initiated can be seen in figure 5.10. The region around the inclusion shows changes in surface appearance and the inclusion is uneven which could be due to corrosion of the vary inclusion. The white area is assumed to be some kind of oxide. The particular inclusions was not studied in with EDX and the composition of the inclusion is therefore unknown. The most probable inclusion type is a MnS-AlO based on other observations.

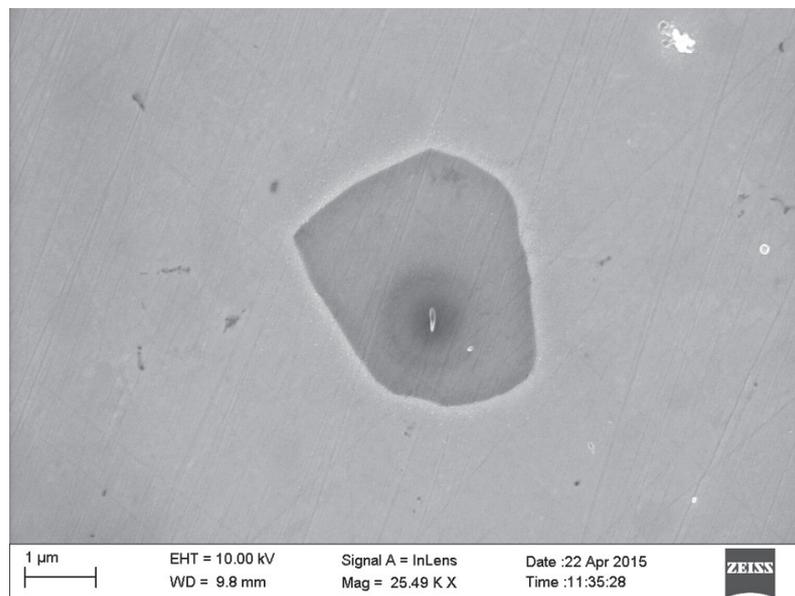
Figure 5.11: SEM image (10kV) sample exposed for 2 minutes. The inclusion show some signs of corrosion around the edges based on the difference in imaging contrast, but no other changes can be observed

Inclusions which showed minor or no signs of corrosion were found, see figure 5.11 and 5.12. Only small changes in imaging contrast around the interface between the inclusion and the matrix can be observed.

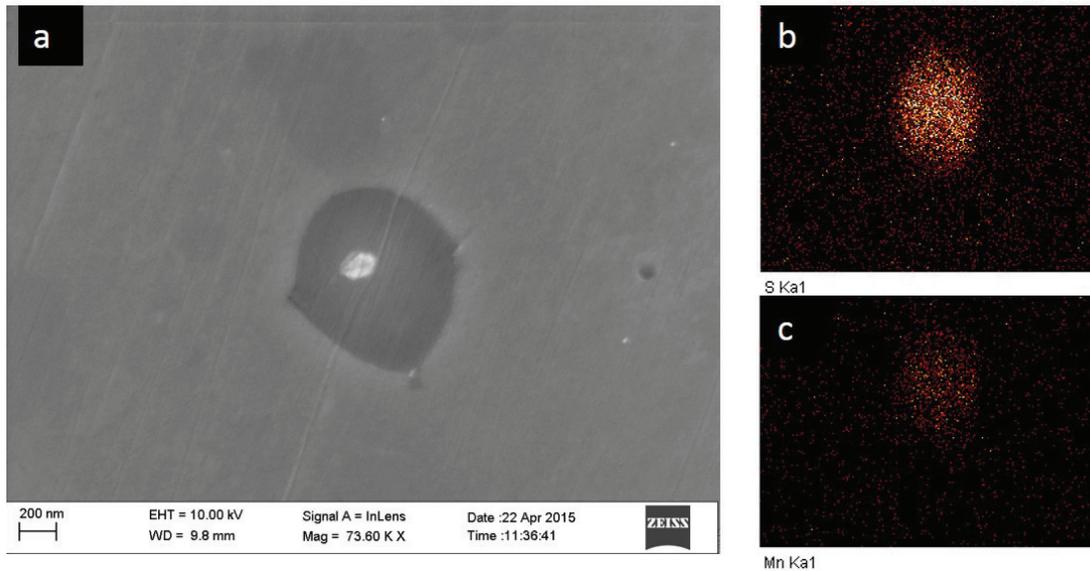
Figure 5.12: SEM image (10kV) sample exposed for 2 minutes, where a is inlens , b sulphur mapping and c the managnese mapping. The inclusion show some signs of corrosion around the edges, and what is believed to be sample preparation effects in the middle, but no other changes can be observed

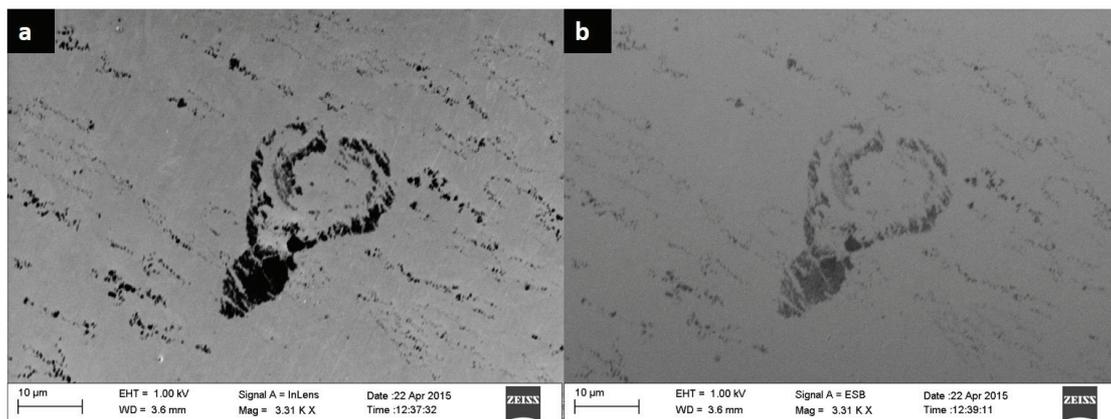
Figure 5.13: SEM image (1kV) of a area on sample exposed in 2 minutes, a inlens detector, b ESB detector. The image show possible corrosion on the matrix of the steel or dirt.

observed, see figure 5.13.

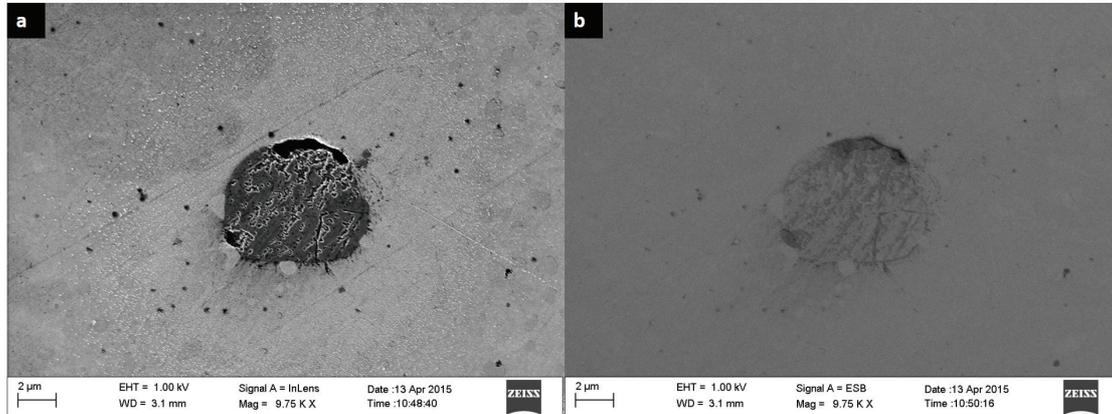
Figure 5.14: SEM image (1kV) sample exposed for 5 minutes, a inlens detector, b ESB detector. The image shows that some of the inclusion have been dissolve due to the increased roughness of the surface. The composition of the inclusion is unknown

the inclusions can be seen, it can be either a result of the corrosion, sample preparation (partial loss of any factured piece of inclusion), or bad incorporation of the inclusion in the processing. No EDX was performed on the inclusion but based on observations of other inclusions it is most likely a MnS.

decomposed or that it has been effected by sample preparation. The region around the inclusion show similar effect as observed in figure 5.14. No EDX was performed on the inclusion which makes the composition unknown.

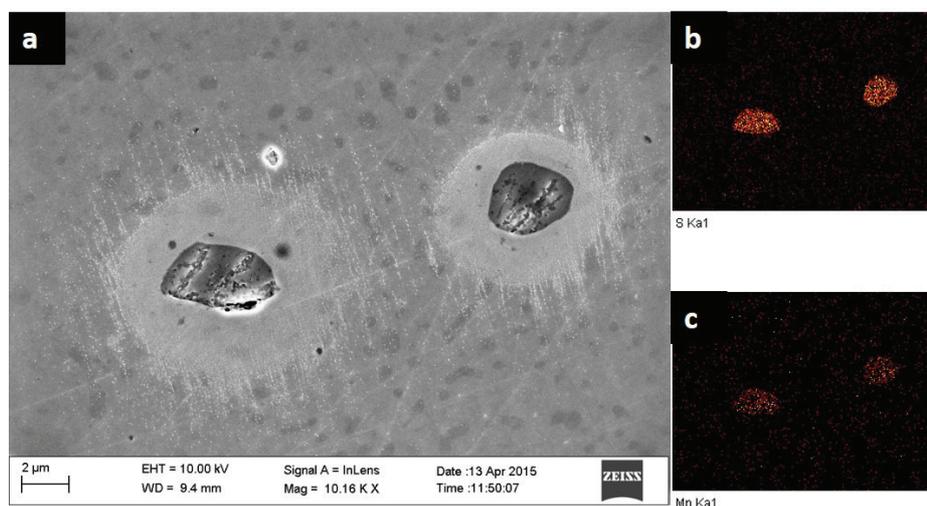
Figure 5.15: SEM image (10kV) sample exposed for 5 minutes with S and Mn mapping. a inlens , b S- mapping and c Mn-mapping. The image shows that some of the inclusion has decomposed (corroded) due to the increased roughness of the surface

More inclusions which show similar signs of corrosion can be seen in figure 5.15. The inclusions have a rough surface and show some signs of crevices in the interface between the inclusion and the matrix. They also show a more distinct region around the inclusion which has changed, this could be some kind of corrosion product.

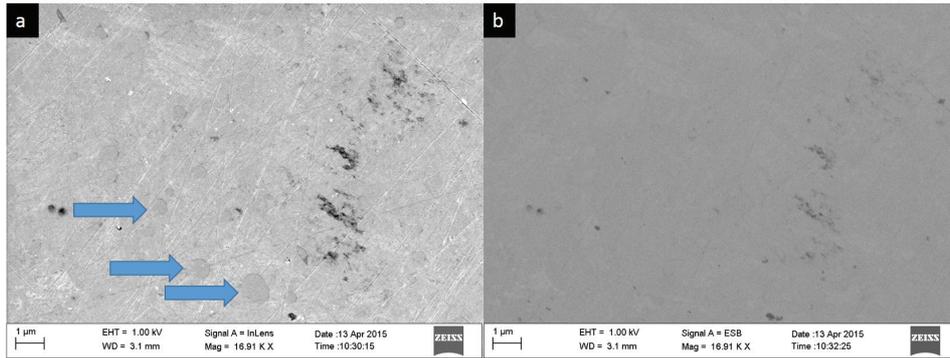
Figure 5.16: SEM image (1kV) sample exposed for 5 minutes, a inlens and b ESB. The image show that the carbides (marked by arrows) are not affected of the corrosion process but are inert.

In figure 5.16 carbides can be seen (some are marked by arrows) and no changes close to them can be seen which means corrosion has not initiated at them.

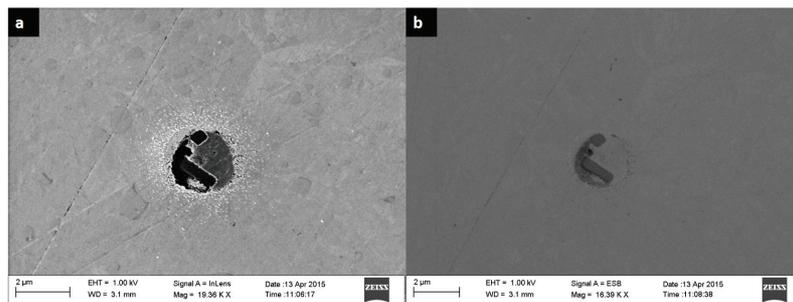
Figure 5.17: SEM image (1kV) sample exposed for 5 minutes, a inlens , b ESB . The image shows a image of a complex inclusions with a crevice on the left side.

A complex inclusion with a crevice formed around one side can be seen in figure 5.17. Since the crevice is formed on one side it could mean that one part of the inclusion is preferentially

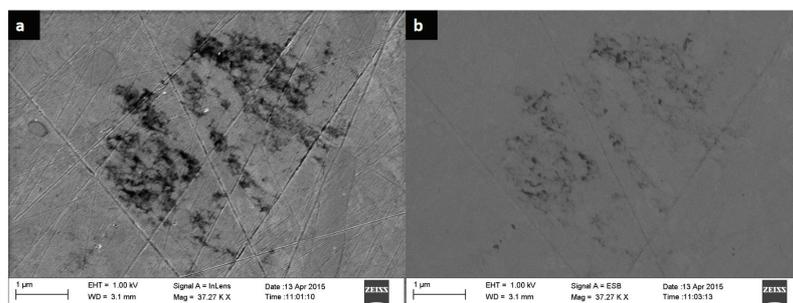
Figure 5.18: SEM image (1kV) sample exposed in 5 minutes, a inlens , b ESB. The image shows corrosion on the matrix on the steel or dirt.

Some areas showed changes in the surface appearance as seen in the shorter exposures were also observed. In figure 5.18 this phenomenon can be observed.

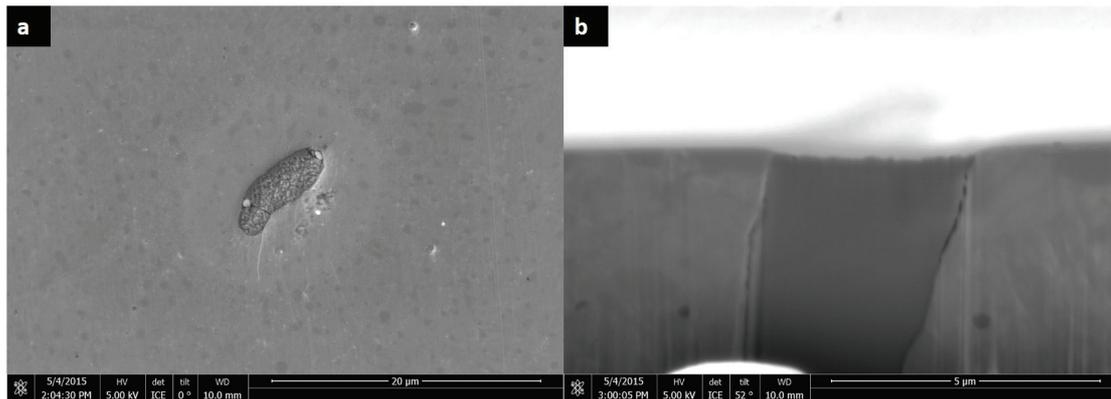
Figure 5.19: SEM image of an inclusion with cross section. a before cross section and b after cross section. The surface of the inclusion is rough and the cross section show that the very inclusion had corroded (decomposed).

Two cross sections were done in the FIB SEM on a sample exposed for 5 minutes. One of the inclusions is presented in figure 5.19. The images show that the surface of the inclusion is rough and that a circular region of matrix around the inclusion is changed due to the corrosion. It is also possible to detect a increased roughness in one spot in this circular region to the right of the inclusion. The cross section of the inclusion shows that the surface of the inclusion is lower than at the surrounding matrix. No EDX analysis was performed on the inclusion.

The other inclusion studied in the FIB SEM is presented in figure 5.20. The inclusion shows the same characteristics as described for the inclusion in figure 5.19. The inclusion also show some signs of poor incorporation in the matrix on the left side in the cross section. This inclusion was studied with the EDX which showed that the inclusion is a MnS.

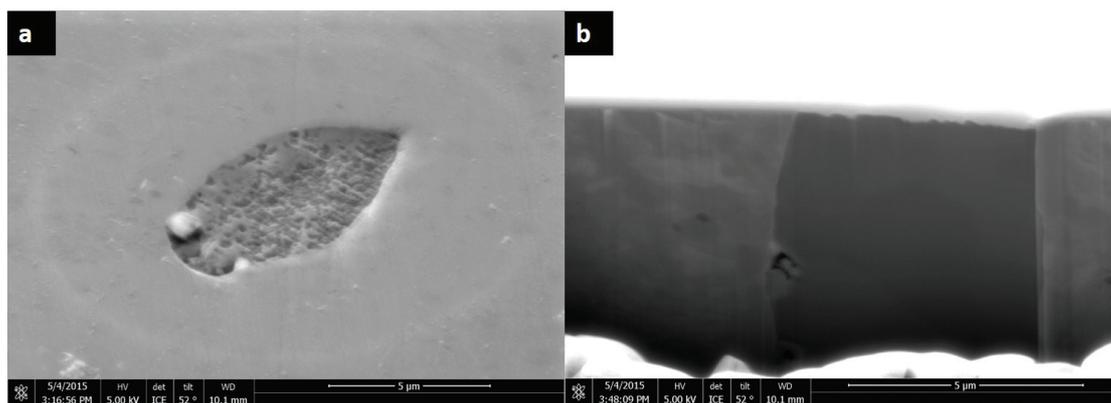
Figure 5.20: SEM image (5kV) of a MnS inclusion with cross section. a shows the inclusion before the cross section and b shows it after the cross section. The surface of the inclusion is rough and the cross section show that the very inclusion had corroded (decomposed).

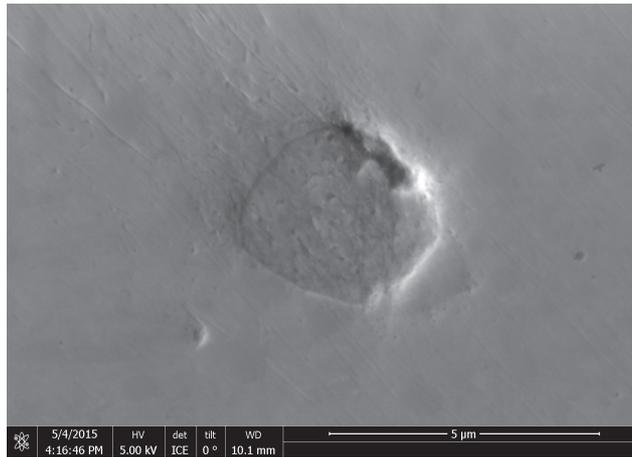
Figure 5.21: SEM image (5kV) of inclusion in 10 min exposed sample. The surface is rough which indicates that the inclusion has decomposed. Scratches from sample preparation are visible towards the top-left corner

The 10 min exposure caused significant corrosion, most pronounced at manganese sulphides. Samples exposed for 10 minute were studied in two separate occasions in the FIB SEM, one studied inclusion from the first session can be seen in figure 5.21. The surface of the inclusion is rough which indicates that the inclusion has decomposed (corroded). It was not possible to determine if the inclusion is more or less decomposed than in the 5 min exposed samples.

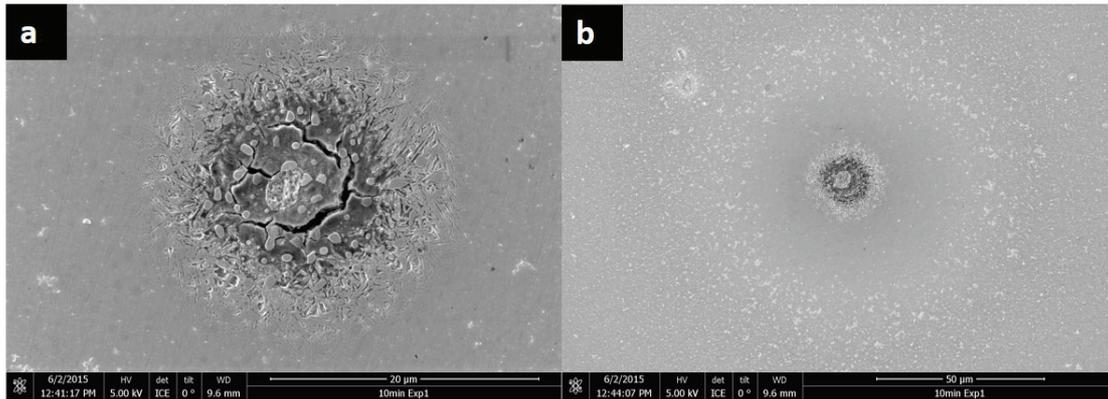
Figure 5.22: SEM image of inclusions and corroded areas in the 10 min exposed sample studied in the FIB/SEM. a-b are different inclusions observed

Below some images from the FIB/SEM are presented. Three micro cross sections were performed and will also be presented. The two inclusions in figure 5.22 show similar results where an area around the inclusion is darker and is covered by something assumed to be a thicker oxide film with cracks, the area outside the dark oxide is smoother than the bulk steel matrix. This area will further on be mentioned as oxide.

Three micro cross sections were performed and are presented below. In figure 5.25 an inclusion and corroded area are presented in two different angles and the FIB micro cross sections are shown in figure 5.26. The figures show that an oxide film has formed close to the inclusions and that several cracks have formed. The surface of the film is flaking and it is possible to see that the film is not completely adhered to the metal. The micro cross section shows that the crevices go down in the material and that a part of the material close to the inclusion has started to spall since the cracks surround this part.

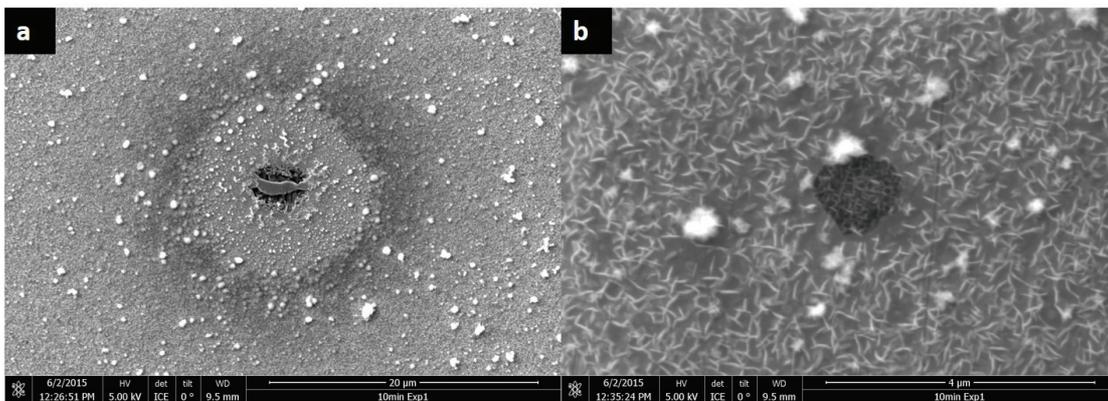
Figure 5.23: SEM image of inclusions and corroded areas in the 10 min exposed sample studied in the FIB/SEM. a-b are different inclusions observed

Figure 5.23a shows an inclusion that has partially decomposed and the oxide film shows no signs of cracks, figure 5.23b shows a region where whiskers are growing inside a pit or on top of an inclusion as well as around it. Figure 5.24 shows the same characteristics as seen in figure 5.22 but the cracked area is larger and more cracks can be observed. It is also possible to see that the dark oxide film has started to flake from the material.

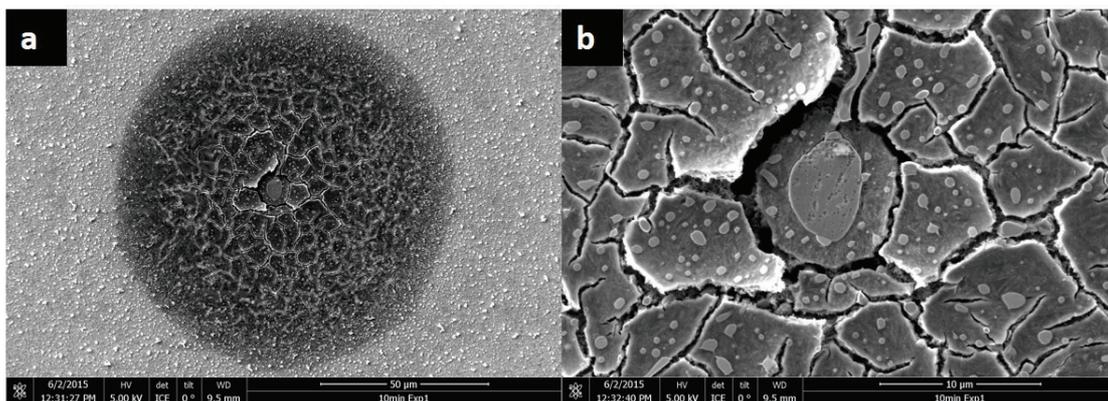
Figure 5.24: SEM image of inclusion and corroded area in the 10 min exposed sample studied in the FIB/SEM. a and b are imaged with different magnification

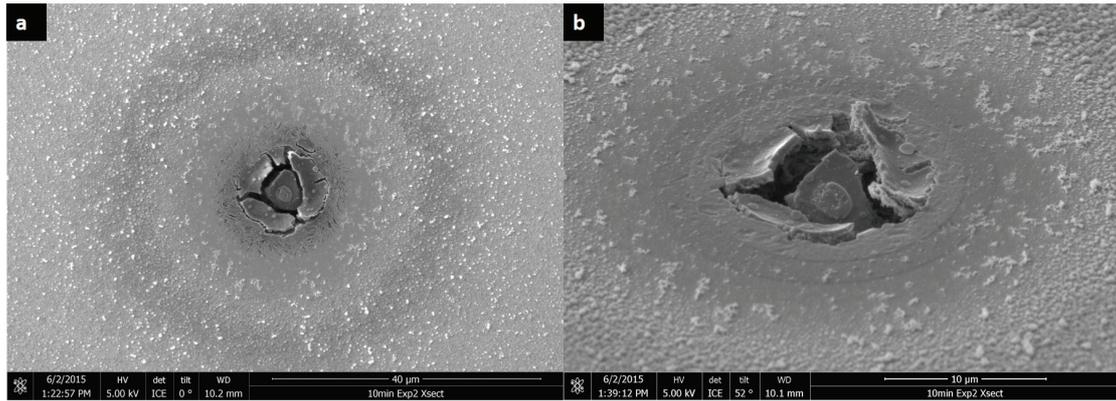
Figure 5.25: SEM image of inclusions and corroded areas the in 10 min exposed sample studied in the FIB/SEM. a is taken perpendicular to the surface and b is with a tilted sample (some Pt is deposited in a circle over the inclusion in b).

More EDX analysis was performed on the 10 min exposed sample, in figure 5.31 an inclusion with similar characteristics as e.g. figure 5.25. A pseudo phase diagram (Oxford INCA software, where the ratios of three elements are set as indicative of a phase) between iron oxygen and chromium was performed which is presented together with the element maps in figure 5.32, the mean composition of the phases is found in table 5.5.

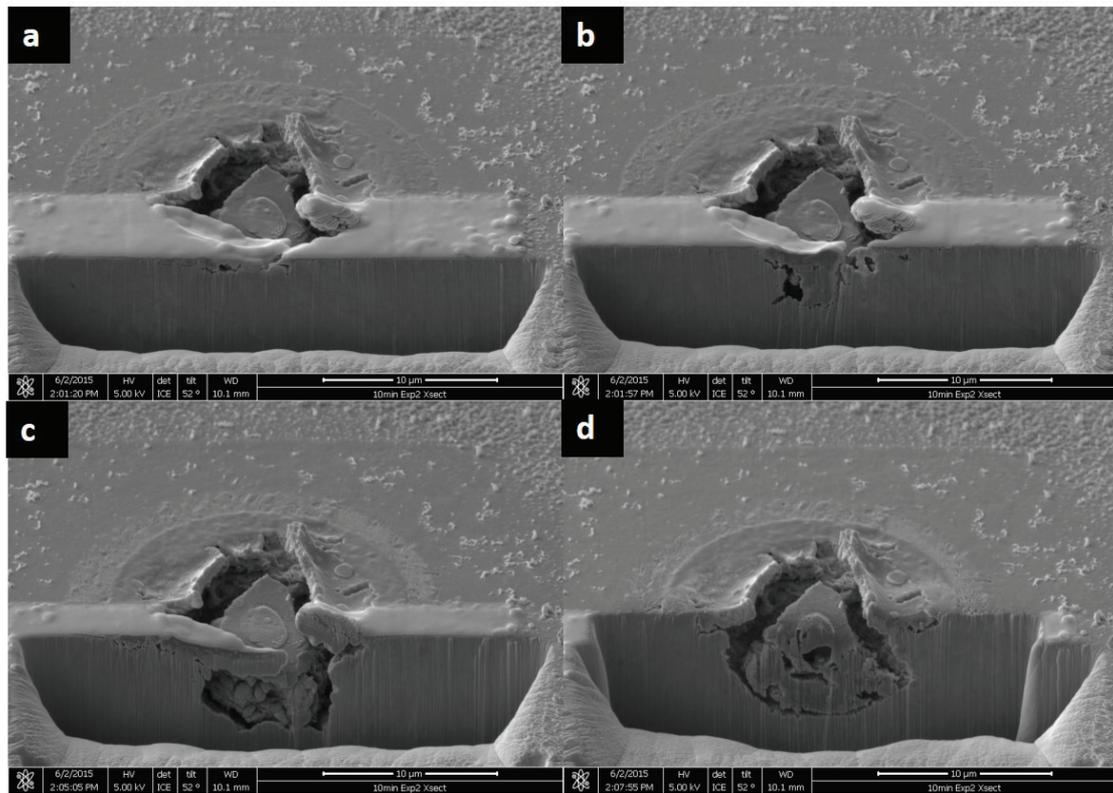
Figure 5.26: SEM image of the etching process of region in figure 5.25, a-d show different times of the ion milling.

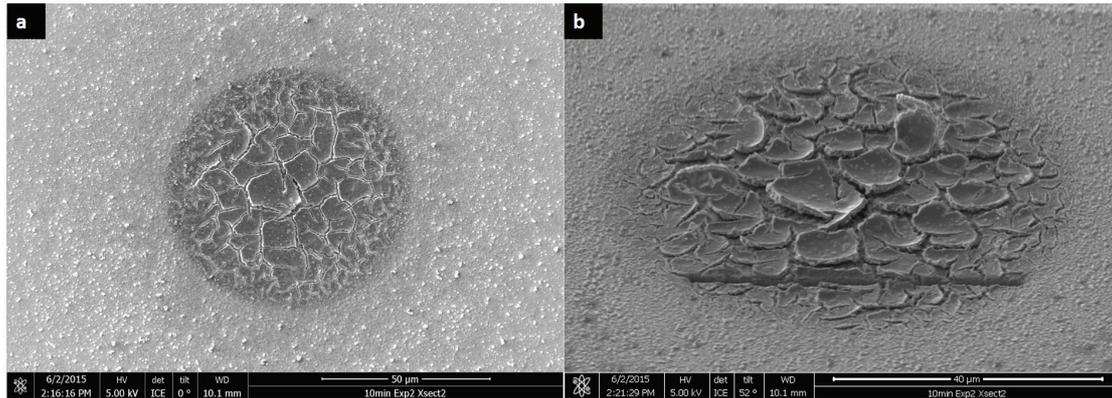
Figure 5.27: SEM image of inclusions and corroded areas in the 10 min exposed sample studied in the FIB/SEM. a is taken directly over the surface and b is with a tilted sample where also the first ion mill region is visible (line).

In figure 5.27 a corroded area but no clear center with an inclusion can be seen. The area is covered by an oxide with cracks and the surface has started to flake. The micro cross section, figure 5.28 reveal cracks below the surface and similar characteristics as observed earlier when crevices form around a certain area. No inclusion can be seen in the image but

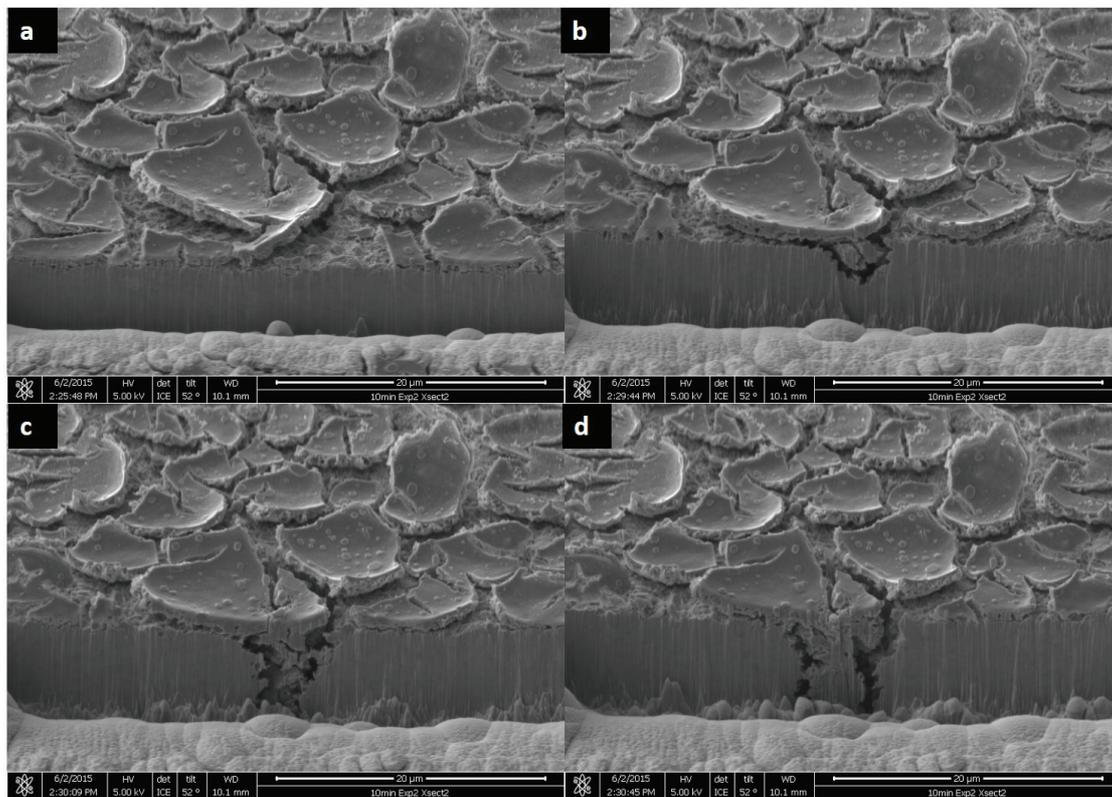
Figure 5.28: SEM image of the etching process of region in figure 5.27, a-d show different times of the ion milling where flaking of the area of assumed oxide can be seen.

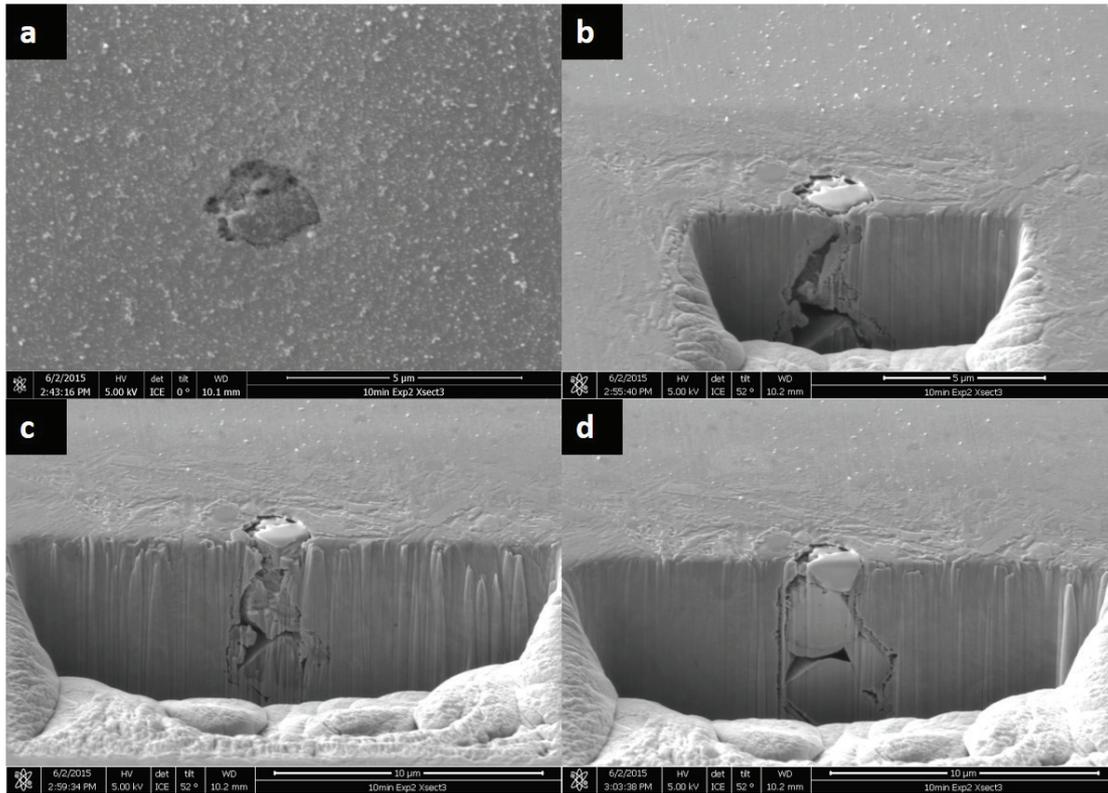
Figure 5.29: SEM image of inclusions in 10 min exposed sample, a is a overview and b-d different times of the ion milling in the micro cross section

In figure 5.29a an inclusion with less signs of corrosion than the other studied inclusions is presented, in figure 5.29b-d the micro cross section is presented. The inclusion show several grains and the inclusion does not look well incorporated to the steel. A border with porous material can be seen between the inclusion and the steel. The micro cross section was also studied with EDX and the results of this is shown in figure 5.30. The inclusion consist mainly of Al, Mg and O.

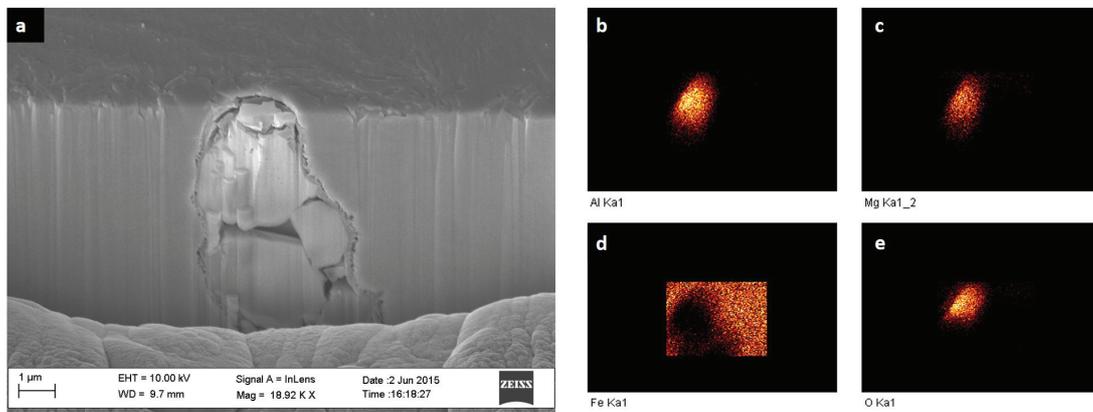
Figure 5.30: SEM image of inclusions in 10 min exposed sample, a is a overview and b-e different different element maps

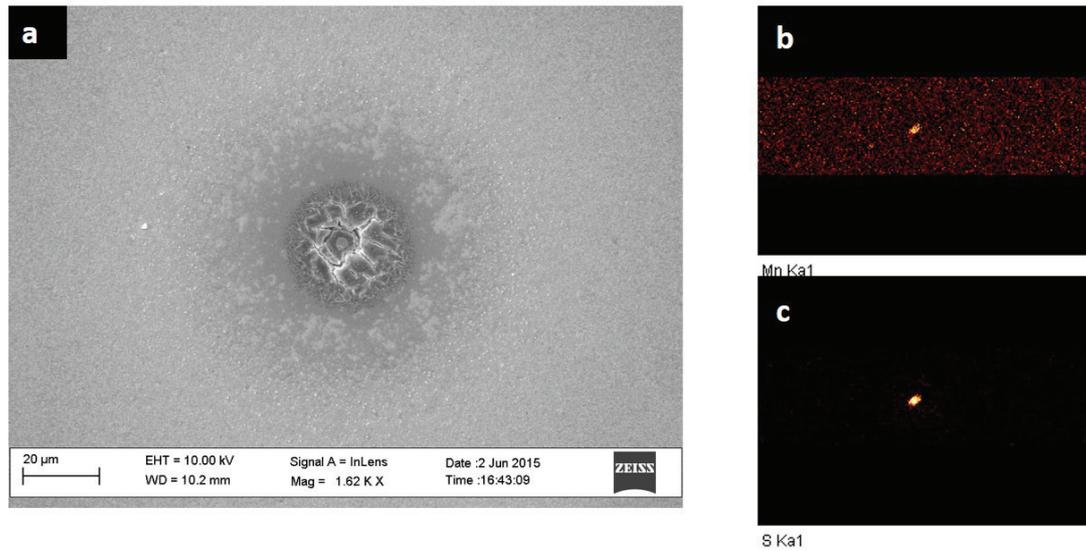
Figure 5.31: SEM and EDX analysis of inclusions in 10 min exposed sample, a is a overview and b-e different different element maps
