Initiation of localised corrosion on bearing steel

Diploma work in the Master programme Materials Chemistry and Nanotechnology

Diploma work No. 168/2015

at Department of Materials and Manufacturing Technology
CHALMERS UNIVERSITY OF TECHNOLOGY
Gothenburg, Sweden

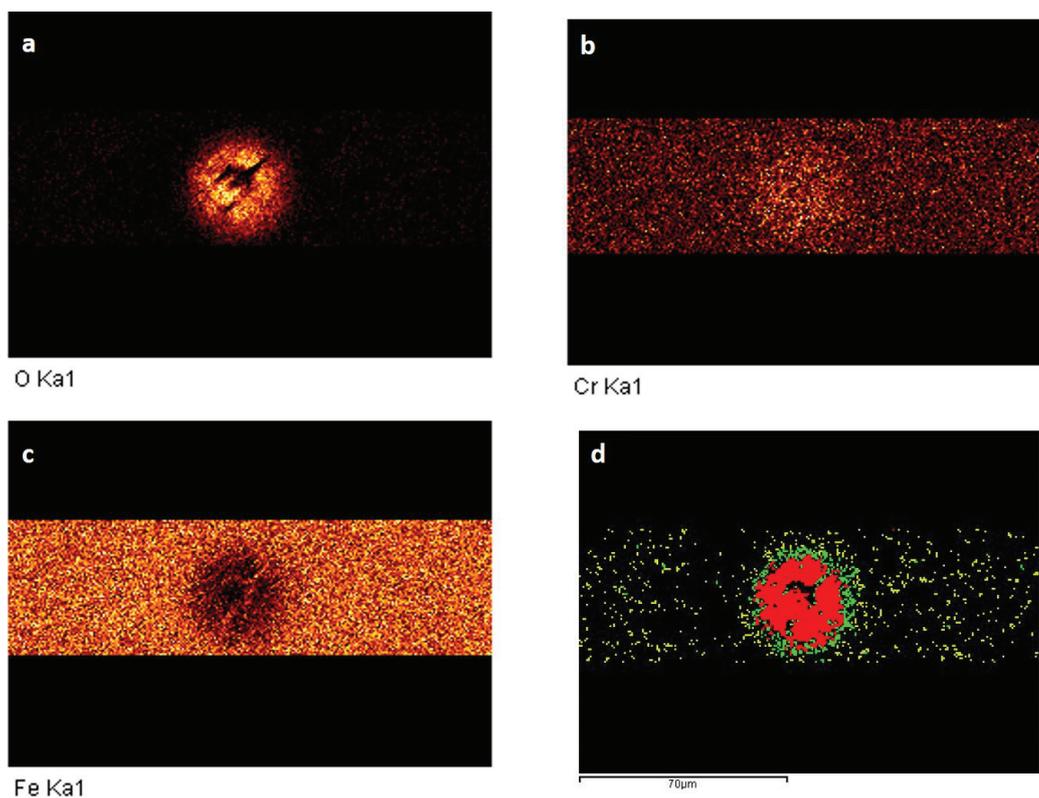
Figure 5.32: Pseudo phase map and EDX analysis of inclusions in 10 min exposed sample, a-c are element maps and d the pseudo phase digram where the red is the most oxygen rich, green roughly equal parts oxygen and iron, and yellow most iron rich parts of the oxide

More EDX analysis was performed on the 10 min exposed sample, in figure 5.31 an inclusion with similar characteristics as e.g. figure 5.25. A pseudo phase diagram (Oxford INCA software, where the ratios of three elements are set as indicative of a phase) between iron oxygen and chromium was performed which is presented together with the element maps in figure 5.32, the mean composition of the phases is found in table 5.5.

The EDX results show that the region around the inclusion is oxidised, that the iron content is low close to the inclusion and that the chromium content is higher close to the inclusion. The

reason that the chromium content is higher close to the inclusion might be due to corrosion of the iron which then will make the relative chromium content higher. The pseudo phase diagram show that the there is more oxygen in the middle which indicates that this part has corroded the most as a thicker oxide would yield higher O signal. It is also possible to detect region outside the heavily oxidised part (red-green) where very little oxygen compared to iron is found.

Table 5.5: Mean composition for phases in figure 5.32 (wt%)

Phase	O	Fe	Cr	S
Red	14.13	59.76	24.59	1.69
Green	7.64	82.77	8.68	0.08
Yellow	2.27	93.32	4.93	0.14

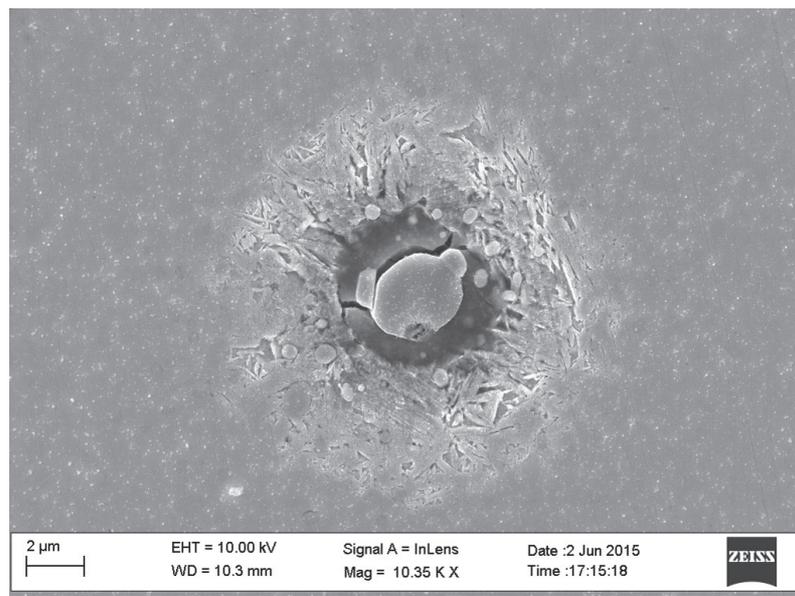
**Figure 5.33:** SEM image of inclusions in 10 min exposed sample

In figure 5.33-5.34 an inclusion of mainly Mn, S and Mg is studied. The inclusion also have

some aluminum in one part and is a complex inclusion. The area around the inclusion is oxidised but no oxide films with cracks can be observed. This could mean that the corrosion at this inclusion is in a earlier phase in the process than the other studied inclusions in the

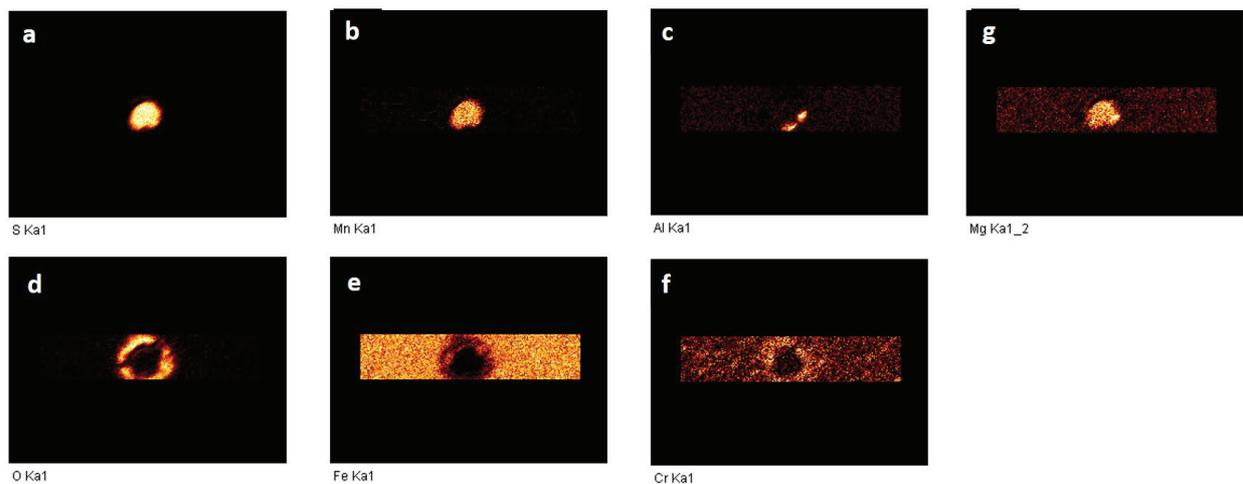
**Figure 5.34:** EDX analysis of inclusions in figure 5.33, a-f is maps for different elements

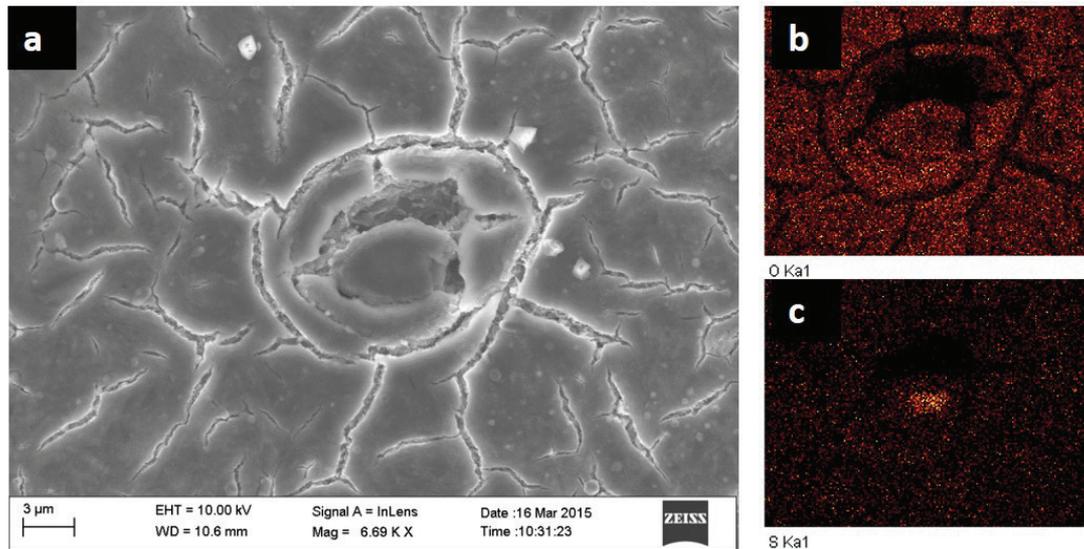
Figure 5.35: SEM image of inclusion the in 10 min exposed sample with old rinsing method. a is the inlens image, b the oxygen mapping and c the sulphur mapping.

Some samples from the first exposures when rinsing with deionised water was used in the sample preparation showed some heavily oxidised areas. One inclusion where a thick oxide was formed can be seen in figure 5.35. The EDX analysis showed that the surface around the inclusion is oxidised and that the inclusion contain sulphur.

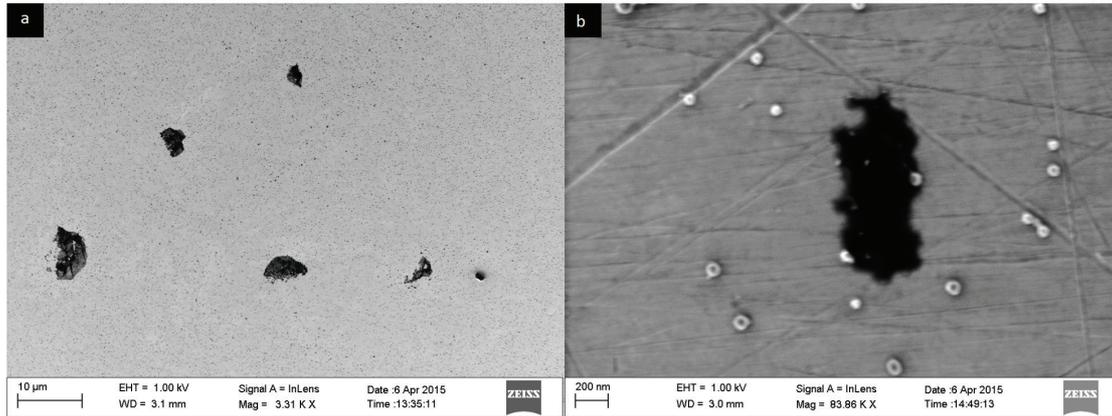
Figure 5.36: SEM image of samples where different cleaning the in the sample preparation, a is rinsed with deionised water and ethanol, b is only rinsed with ethanol. In a corrosion can be observed but not in b where the black area is dirt.

The results of the study of sample preparation in the SEM is presented in figure 5.36. The images show that the the sample that was rinsed with deionised water have corroded. The black areas in figure 5.36a is an attack on the steel since no large topographic difference can be seen, this means that it is not dirt. The black areas on figure 5.36b must be dirt since it is laying on top of the metal and bear no resemblance to known corrosion products. In all images from the sample only rinsed with ethanol no signs of corrosion could be observed, only changes on the surface as observed in image B could be seen. This means that there is a difference between the samples depending on the rinsing method and that the samples that was rinsed with deionsed water before the corrosion experiment will have corroded more than originally planned.

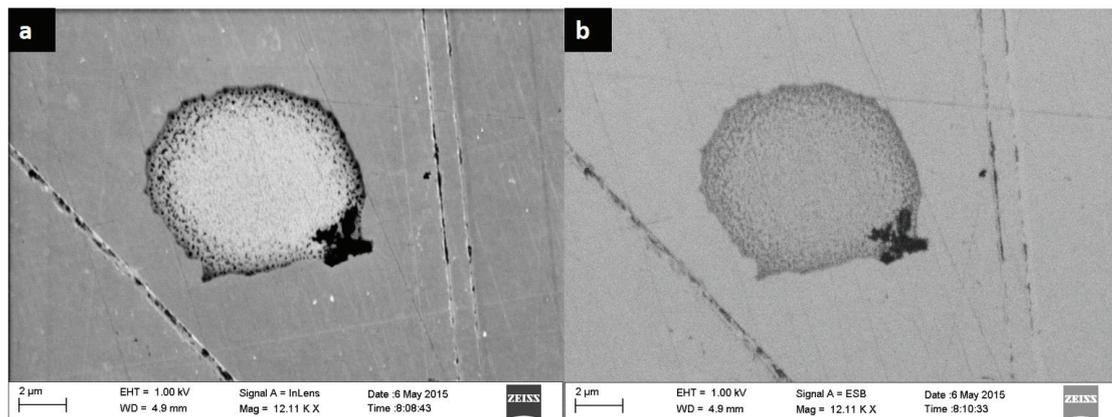
Figure 5.37: SEM image of sample with anti corrosion liquid applied. Corrosion was not found on this sample. The image show residuals of the anti corrosion oil.

The samples with anti corrosion oil showed no sign of corrosion, only areas of residuals of the oil could be found after cleaning the sample, see figure 5.37. Many similar spots were

observed and covered most of the surface. Thus the protection worked in this environment since no corrosion could be observed, but it would be more certain if inclusions were found and then compared to the ones in the corroded samples.

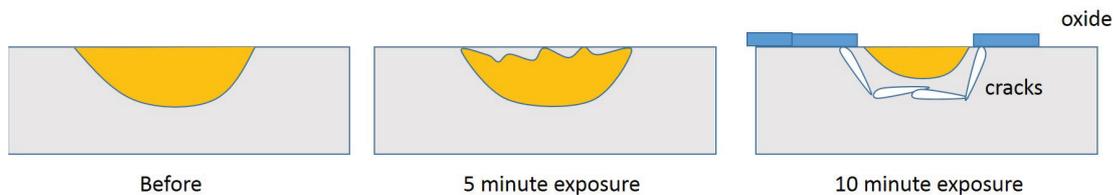
Figure 6.1: Schematic figure of the two processes discussed in this report

Two main observations are one where the inclusion is decomposed (5min) and one where the area around the inclusion have started to crack and sometimes flake (10min), see figure 6.1 for schematic figure. These two theories could be different part of the same corrosion process or just two different processes.
