Renovation for the future

An investigation of environmental impact and lifecycle costs from design choices during a renovation project

Johanna Olin
Chalmers School of Architecture
Department of Architecture and Civil Engineering

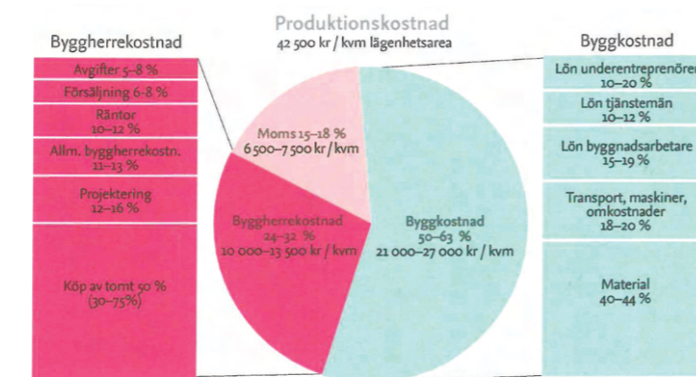
Figure 1: Illustration showing general division of production costs

The production cost can be divided into building costs, cost for the developer, and VAT and are generally divided as illustrated in figure 1.

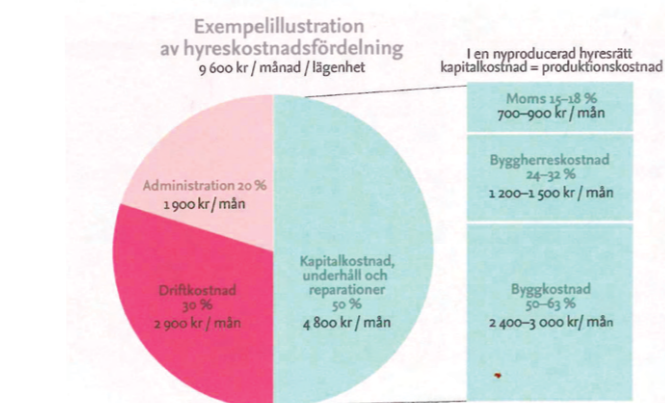
Figure 2: Illustration showing general division of rental costs

The costs included in the rent are also dependent on costs for administration and operation costs as illustrated in figure 2. Consequently, if the building's costs were to be reduced by 20% it would only lead to a total reduction of rent by 5%. While high building costs often is blamed for increased rents, this shows that it can't be the only cause.

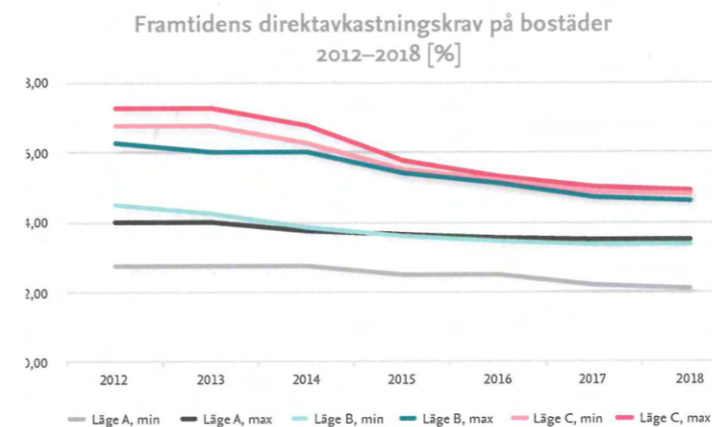
Figure 3: Development of required rate of return from the Framtiden group

The rate of return is lower in central attractive areas since they are considered to have lower risk for vacancies compared to more remote areas. To make up for the risk of vacancies a higher required rate of return leads to increased rents. Kurvinen (2020) questions the relevancy of this system in Sweden today since the housing shortage has led to an overall low vacancy risk. The higher rate of return in remote areas is also problematic since the higher rent on its own causes a higher risk of vacancies. Since people are willing to pay more for central areas, the rents for new production in central areas tend to be higher anyways. Due to the current low risk of vacancies, the required rate of return used by the Framtiden Group in Gothenburg has over the last years been lowered in general. There is also a smaller difference between different areas.

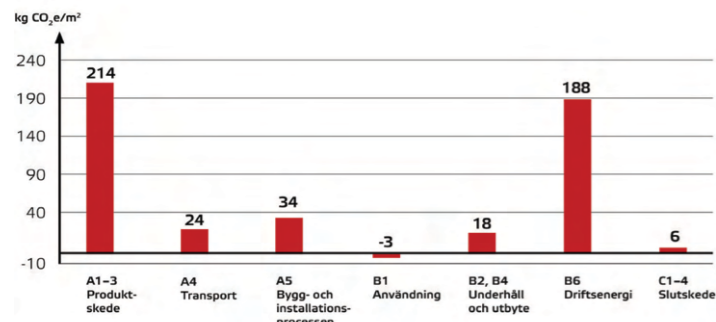
Figure 6: Typical division of climate impact (GWP) between the different life stages

The guidelines for life cycle assessments are determined by a set of international standards. Following the EN 15978 (SIS, 2011) and the EN 15804 (SIS, 2019) standards the lifetime of a building is divided into four different phases, the building phase (A), the use phase (B), the end-of-life phase (C) and a fourth phase (D) that includes the loads and benefits beyond the system boundary. These phases are then divided further as shown in figure 10 (Offentliga bostäder, 2022).

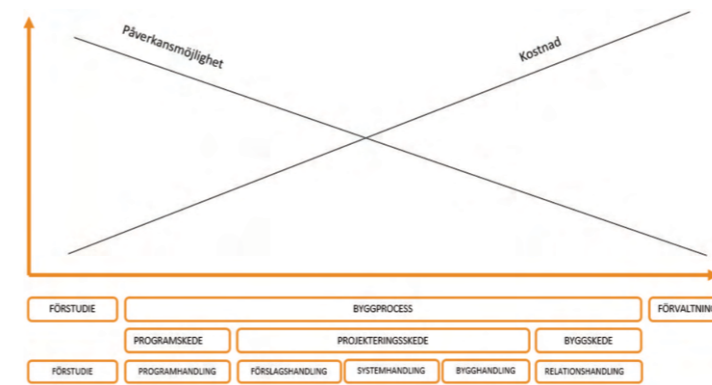
Figure 9: Diagram over impact potential in comparison to costs during a construction project

While the bills of climate impact used in declarations and certifications are good for increasing the general usage of LCA, the tool is more powerful used in an early project phase. By introducing LCA early in a project the possibilities for the results to impact decisions increases while the cost for performing the changes is lower (Boverket, 2019). Using LCA and LCC for comparisons within the same project also decrease some of the demands on the simulation precision of the results since it is showing a difference rather than a life-like result.

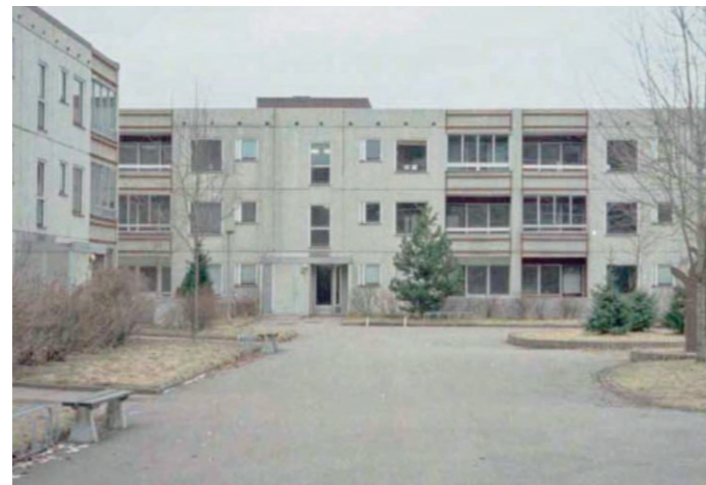
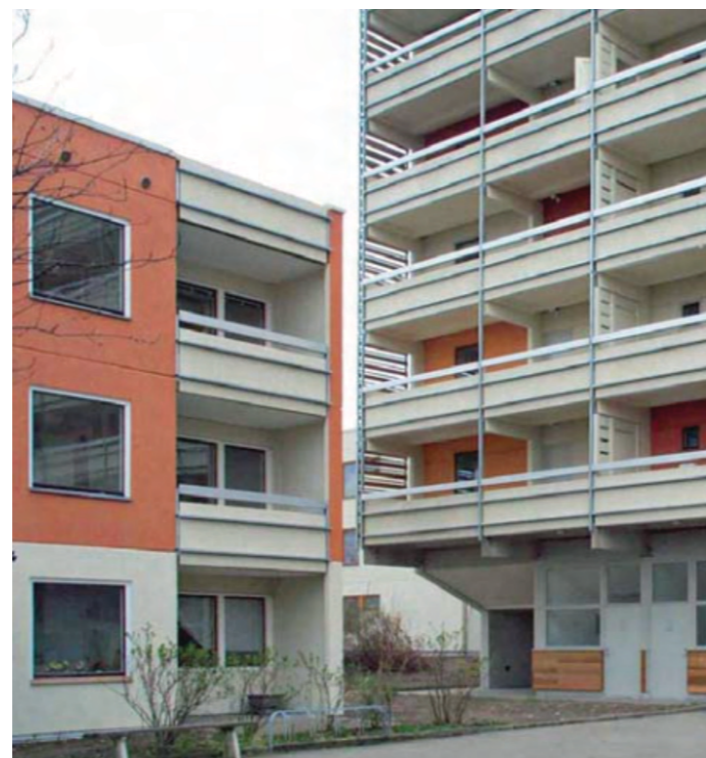
Figure 15 & 16: The building facades before and after the renovation

By glazing the balconies and external corridors ventilation air can be preheated in the spring and autumn when sunlight hits the balconies. The glazing also protects the façades and lowers the transmittance heat losses. Other passive energy saving measures included exchanging the inner windowpane of the 2-pane windows to a low-emission version and increased insulation by the roofs and gables. Insulation was also added to the building base in connection to the renovation of drainage pipes.

After discussion with tenants, the open entrance floors were glazed and used as greenhouses connected to common spaces and laundry rooms. The façades were painted in brighter façade colours as the initial grey of the concrete was looked upon negatively by many. Renovation of entrances and staircases was also done.

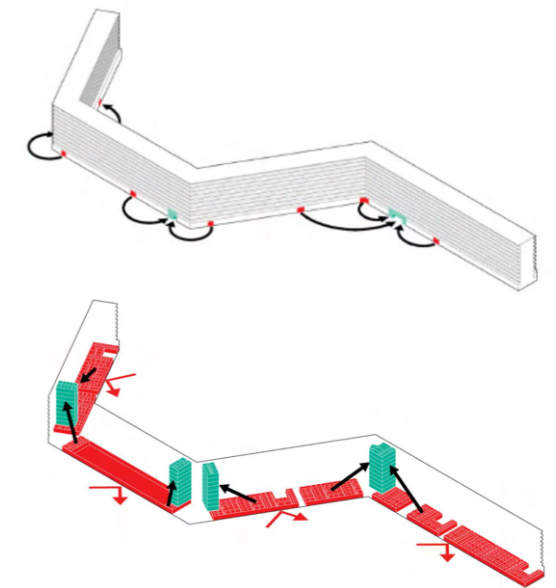
Figure 26 & 27: Movement of entrances and storage spaces

The overall strategy to bring back the original vision of the architects is something that could potentially be applied in Gärdås as well if the quality of the original building allows it. Reconfiguring of functions to provide a friendlier meeting with the street would also be interesting to investigate, in particular if the underground garage were to be removed since it would open up new potential solutions for entrances and activities facing the yard.

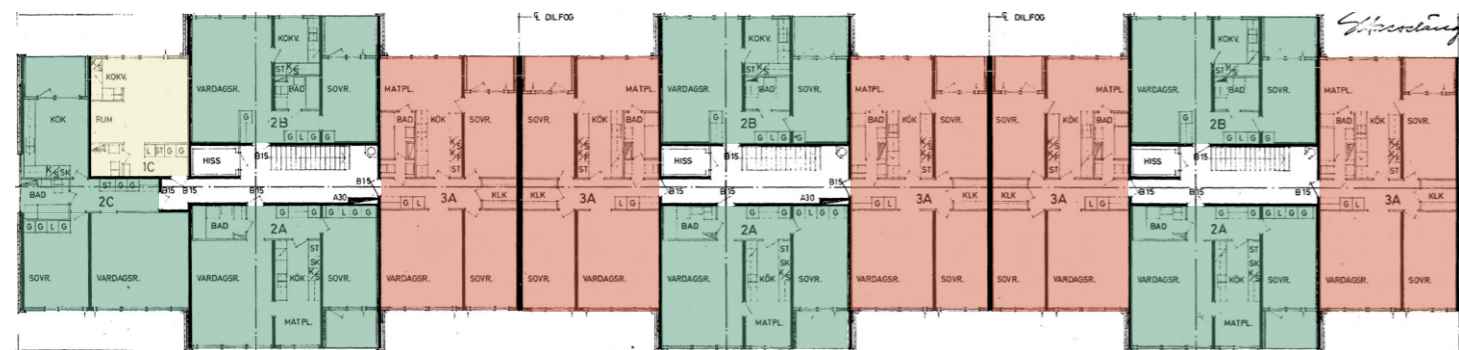
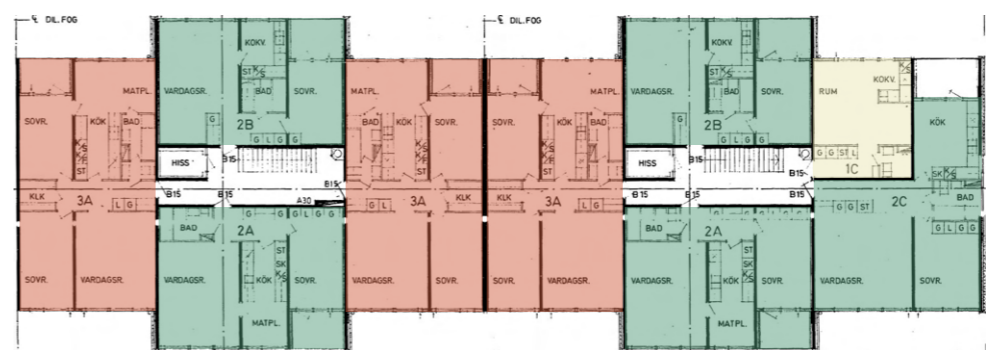
Floor 1-5

- 1-room apartments
- 2-room apartments
- 3-room apartments

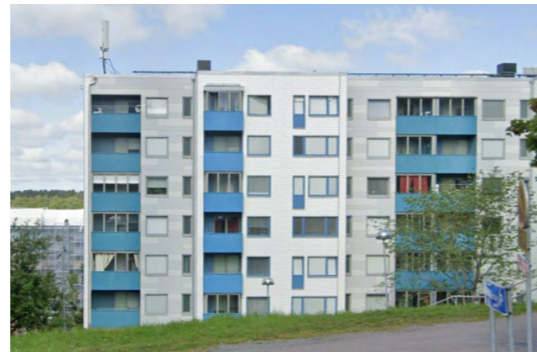
The facade after the renovation

The building's windows were original 2-pane windows from the 70s and had issues with leakages of heat and dust particles. There were also issues with collection of rainwater. In the renovation the old windows were replaced with new three-pane windows and the glazed balcony doors were replaced as well. Due to corrosion and expansion of armament, some of the balconies were given a new layer of concrete and in some cases the armament was replaced (Hamon et al., 2016).

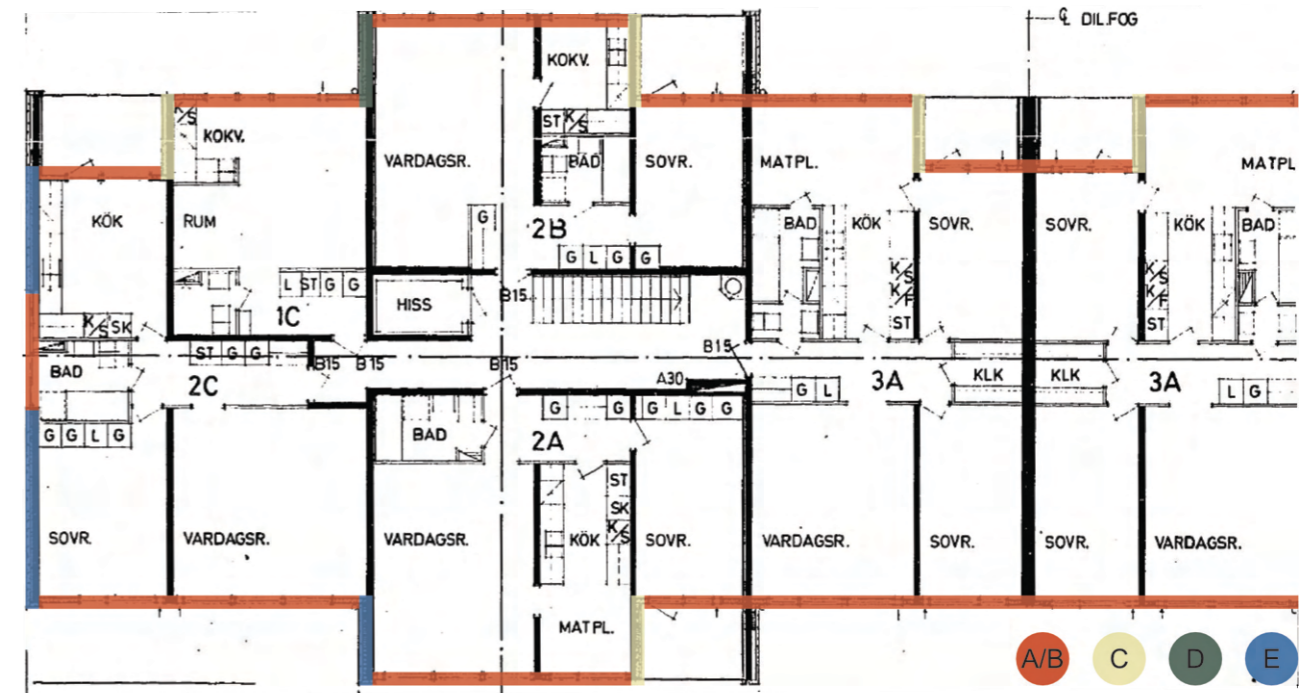
Walltypes changed in the renovation

The technical report from the investigation before the external renovation revealed that the buildings in the area had issues with large leakages of heat concentrated around the windows and by the connections between the façade and the concrete structure. The walls both had a low amount of initial insulation and the existing insulation had partially caved in, resulting in low insulating properties of the walls. In the renovation the building's joints were insulated, and new insulation replaced the old one. Since some of the wooden studs in the walls still were in good condition, they were kept in the façade. The changes to the walls have been adapted to the walls of the investigated building as illustrated in the drawings on the next page.

8mm cement fibreboard
55mm air gap + aluminium facade system
70mm stonewool insulation +
aluminium facade system
80mm concrete
100mm mineral wool
150mm concrete
50mm mineral wool

Removed: PCB removed from joists

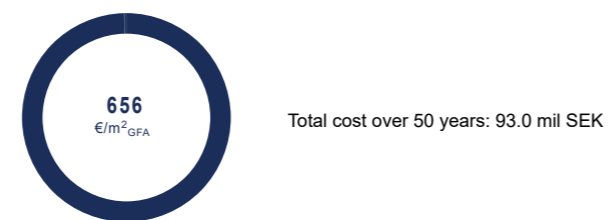
Lifecycle costs - Before renovation

The lifecycle cost is unlike the global warming potential already summarized over the 50 years of the investigation. In this case the gross floor area is ca 12 600 m² for the unrenovated building and ca 13 000 m² for the renovated building. The currency is in euro and one SEK is assumed to be 0.089 euro. Just as in the LCA any costs for the existing material have been excluded. In reality there would also be high costs from repair, maintenance and replacements in the

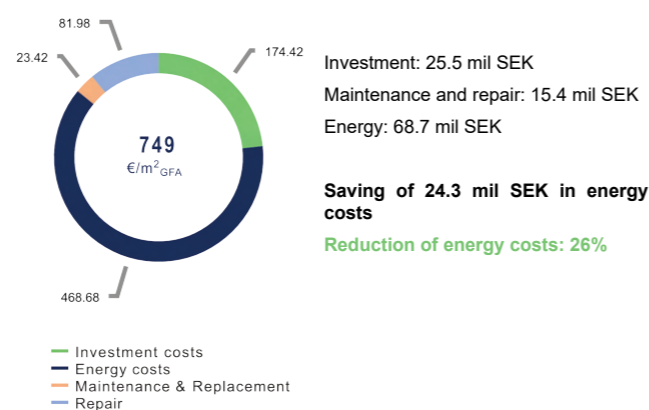
Lifecycle costs - After renovation

unrenovated building, especially since many of the building parts are nearing the end of their lifetime. The total investment cost is ca 25.5 mil SEK and has been manually added as investment costs/m² material area for each building part. The cost for work is included and VAT excluded. The cost for materials has been gathered from one of the already renovated buildings as a total cost and has then been applied to the original renovated building to get the material cost per m². Those costs per m² were then applied to the investigated building assuming similar measures will be performed. Since the buildings aren't identical there is a risk of error to this value.

The investment cost is ca 23% of the total cost during the 50 years while the cost for energy usage is ca 61% which makes sense since costs for building parts like the foundation and loadbearing structure could be excluded in the renovation. The reduction of total energy costs from 93.0 mil SEK to 68.7 mil SEK, a reduction of almost third, indicates that there should be good potential for the renovation to lower the long-term costs.

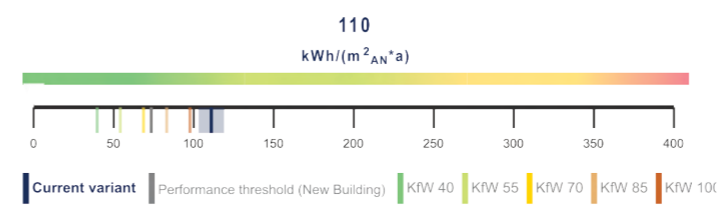
Primary energy demand - Before renovation

With Boverket's values the primary energy demand for the renovated building is above the reference value of 75 kWh/m²,year for residential buildings as stated in Boverket's regulations. However, since the old building's primary energy demand also is higher than that stated in the energy declaration this could be a fault of the model, and potentially the overall air tightness and thermal bridges should be improved for both the calculations. After the renovation the building's energy usage is lowered by ca 25% which matches the energy reduction of 20% from the previous renovations, indicating that the overall reduction of GWP and cost from energy usage in the calculations should be close to realistic values.

Primary energy demand	110 kWh/(m ² AN*a)
District heating CHP	127 kWh/(m ² AN*a)
Hot water	19 kWh/(m ² AN*a)
Auxiliary electricity	6 kWh/(m ² AN*a)
User Electricity	0 kWh/(m ² NFA*a)

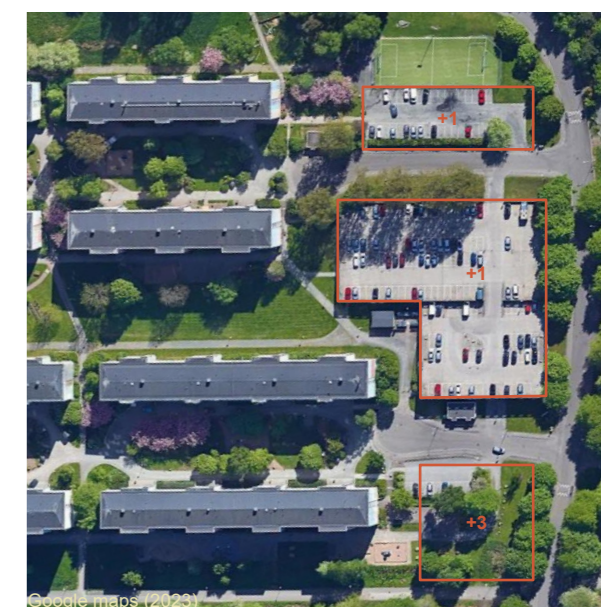
Potential placement of the new garage

It can be concluded from this test that the cost for building the new garage is slightly cheaper than the renovation and since it is also more interesting from an architectural perspective to investigate, that's the option which was chosen. Since these calculations all are based on estimated values and there is no developed plan for the new garage there could be other results from a more in-depth investigation.

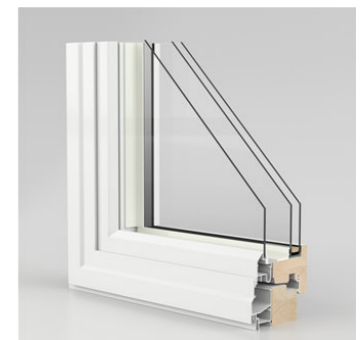
Figure 38: Window type used in the original renovation

In the original renovation the double-glazed windows from the 70s were exchanged due to issues with leakages. The replacing windows are triple glazed with a U-value varying from 0.9 to 1.2 W/m²K. In CAALA the U-value 0.9 has been used, which is one of the lowest U-values available. Using Wikells Sektionsfakta it can be assumed that the investment cost for a more energy efficient window would be ca 25% higher than the original cost, which in this case would not be profitable.

The windows have a wooden frame with an aluminium cover. While aluminium is a material with a high embodied carbon it in this case it lowers the need for maintenance of the wood since it doesn't need painting. A window with a wooden frame needs to be painted around every 10th year but has low environmental impact and a low investment cost. With a window fully in aluminium the need for maintenance is low but the embodied carbon is much higher. The aluminium covered wooden windows seem in this case to be a good compromise and the original window choice has been kept in this study.

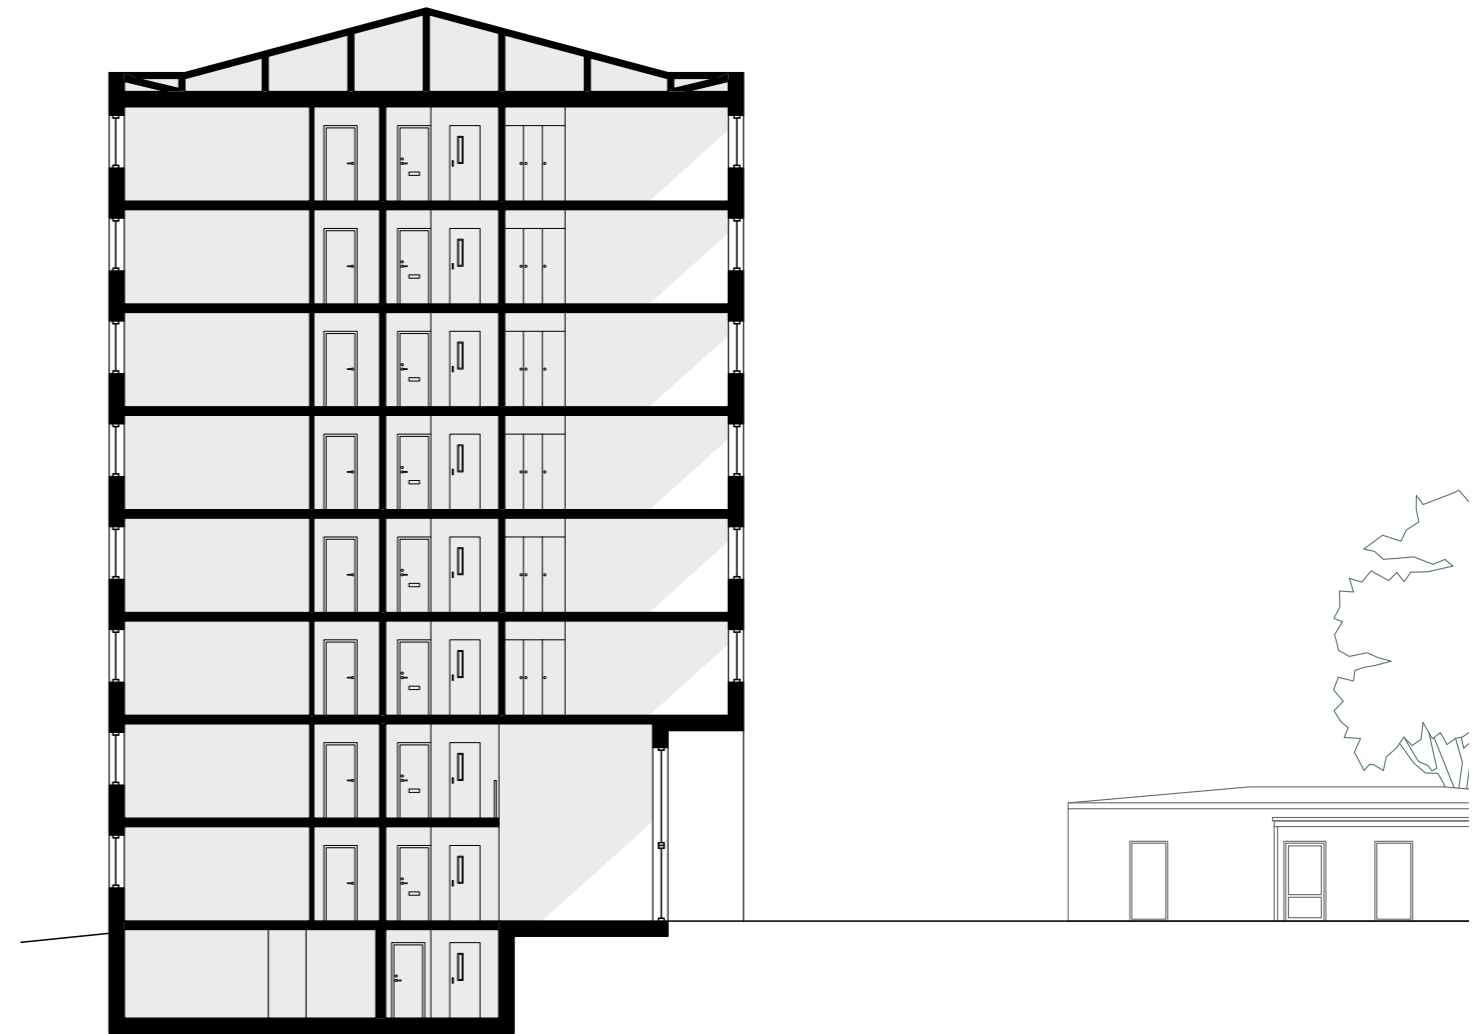
New section through entrances 1:200

With the removal of the garage a new entrance situation is created when entering the souterrain floor from the yard. Since the layout on the souterrain floor is similar to that of the entrance floor, there is potential to open up the entrances over two floors. This would increase the brightness by the entrances and function as a more welcoming space when entering the building. The larger opening would also be an improvement of the connection to the yard by increasing the visibility from the staircases to the outdoor spaces.

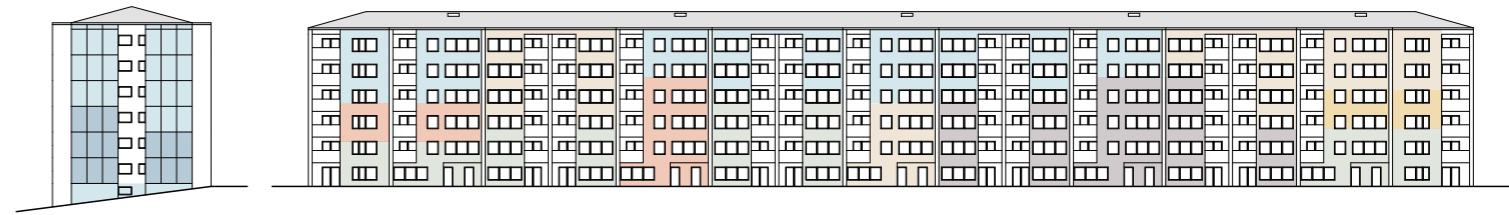
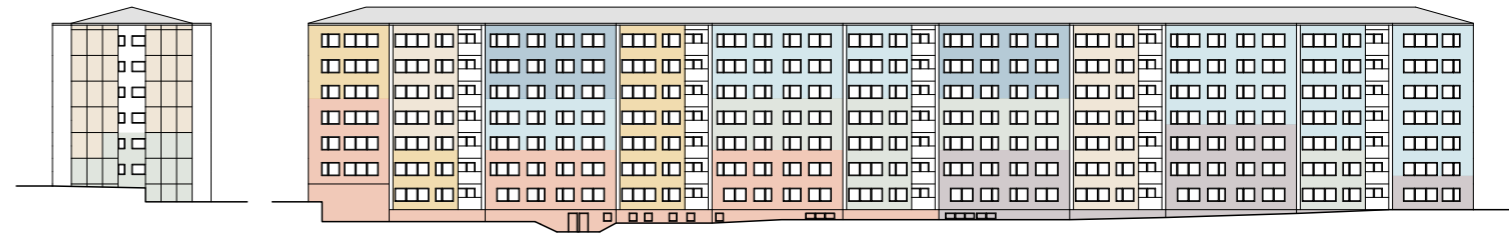
Old facades, 1:800

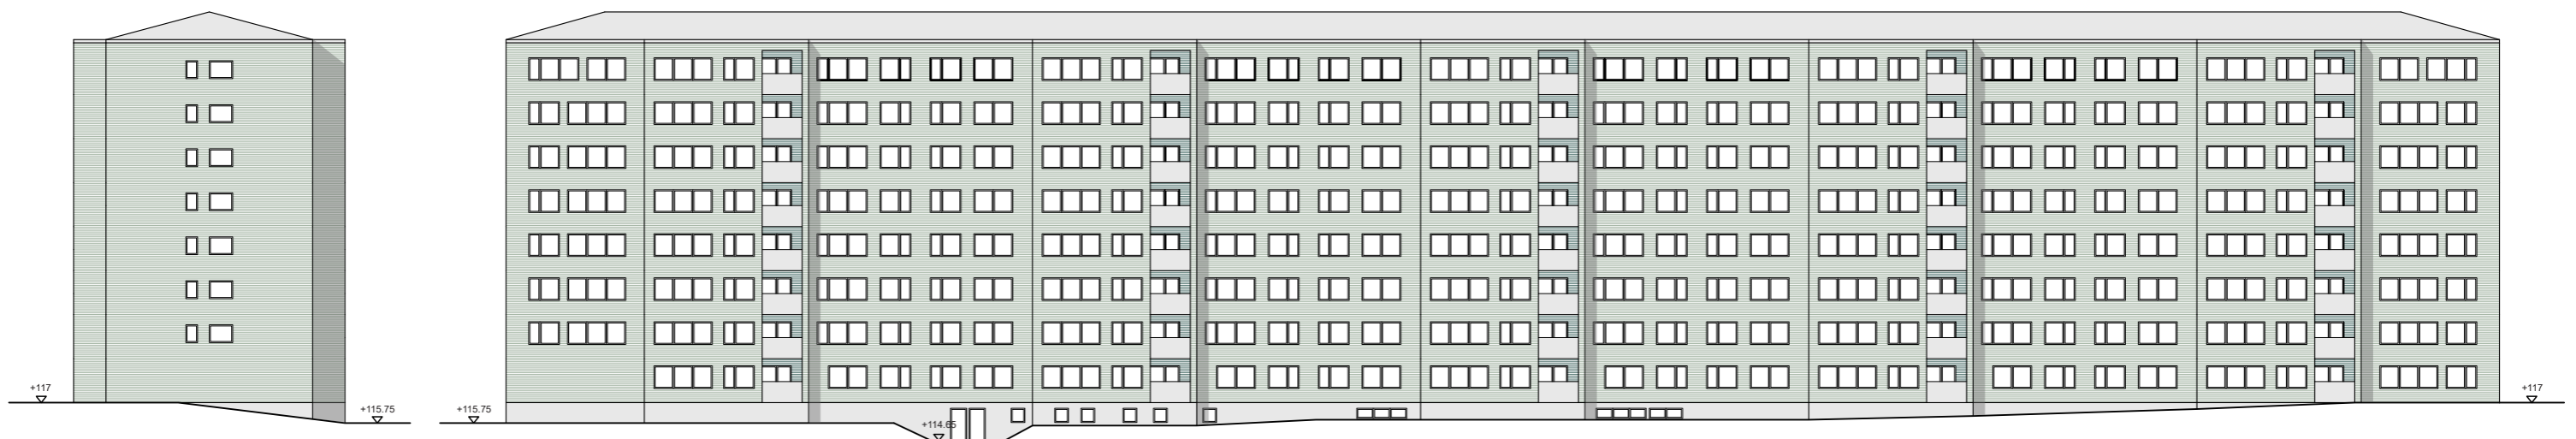
In the new façades the rooftop extension and new entrances have been added. The existing roof has been reused and placed on top of the extension. The old mosaics are removed but could be replaced with new drawings on the wooden facades. This suggestion is of a more coherent façade expression and is using a neutral colour scheme, but the final colour is something that could be decided in conversation with the tenants.

New facades, 1:400

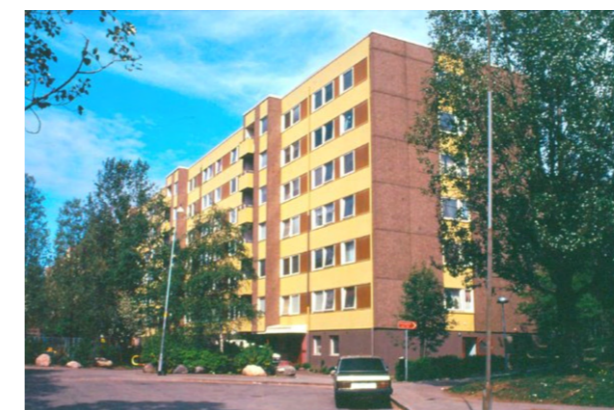
Figure 32

Figure 32: The original facade

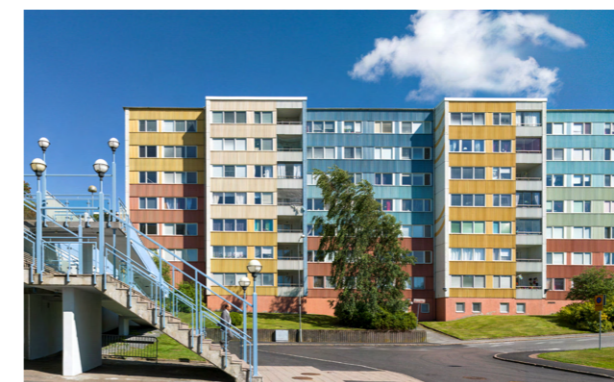
Figure 33

Figure 33: The current facade from the 90's
