# RESURRECTING HERITAGE

BRINGING NEW SPIRIT INTO A CHURCH RUIN

MASTER'S THESIS  
2024

Chalmers School of Architecture  
Department of Architecture and Civil Engineering

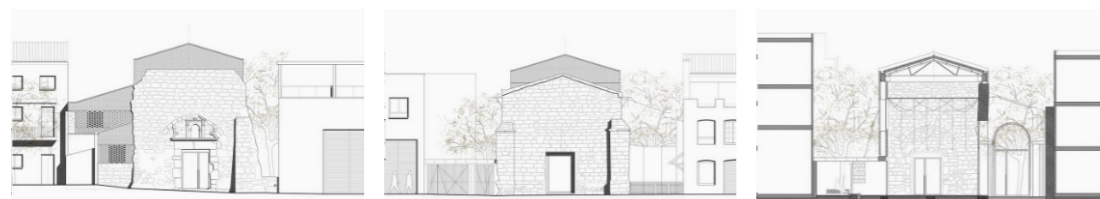
Elevations and sections after transformation. Source: <https://www.archdaily.com/803620/santa-maria-de-vilanova-de-la-barca-aleaolea-architecture-and-landscape> (access 02/02/2024)

The preservation of church ruins while restoring its original appearance and adding contemporary fill-ins to the structure, including new roof, prevented it from further deterioration. The architects however focused on visibly differentiating new and old by using contrasting colors and textures between the old and new parts. Another step was accentuating the beauty of raw walls with precisely designed interior lighting. Then, by adapting the interior for a multi-purpose hall, the project gave this place a new life and potential for flexibility further functional changes in the future. The final effect is a successful example of a mix of adaptive reuse and reprogramming the space.

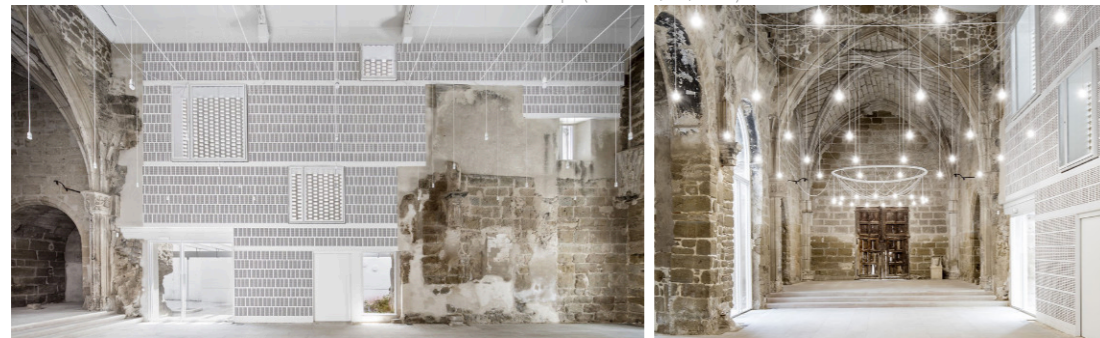
Photos of the church's interiors after the intervention. Source: <https://www.designboom.com/architecture/aleaolea-church-vilanova-de-la-barca/>

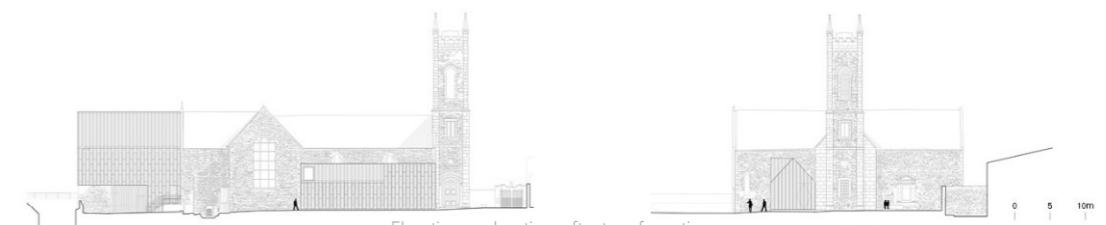
Elevations and sections after transformation. Source: <https://c3diz.net/medieval-mile-museum-by-mccullough-mulvin-architects/> (access 02/02/2024)

This 13th century church was deteriorated, but not yet a ruin. Thanks to the transformation project by McCullough Mulvin Architects, further decay was prevented. The transformation project by McCullough Mulvin Architects prevented further decay.

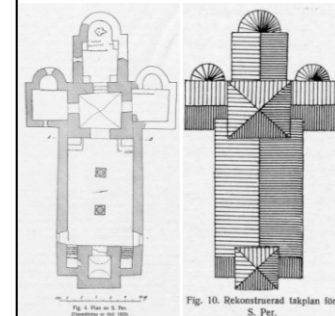
Fig. 10. Rekonstruerad takplan för S. Per.

Left: plan view reconstruction, 1923;  
Right: roof view reconstruction, 1923;  
Source: <https://pub.raa.se/dokumentation/aaeca065-be88-4cb4-89cc-ee3a5aa0ea3/original/1> (access: 17/10/2023)

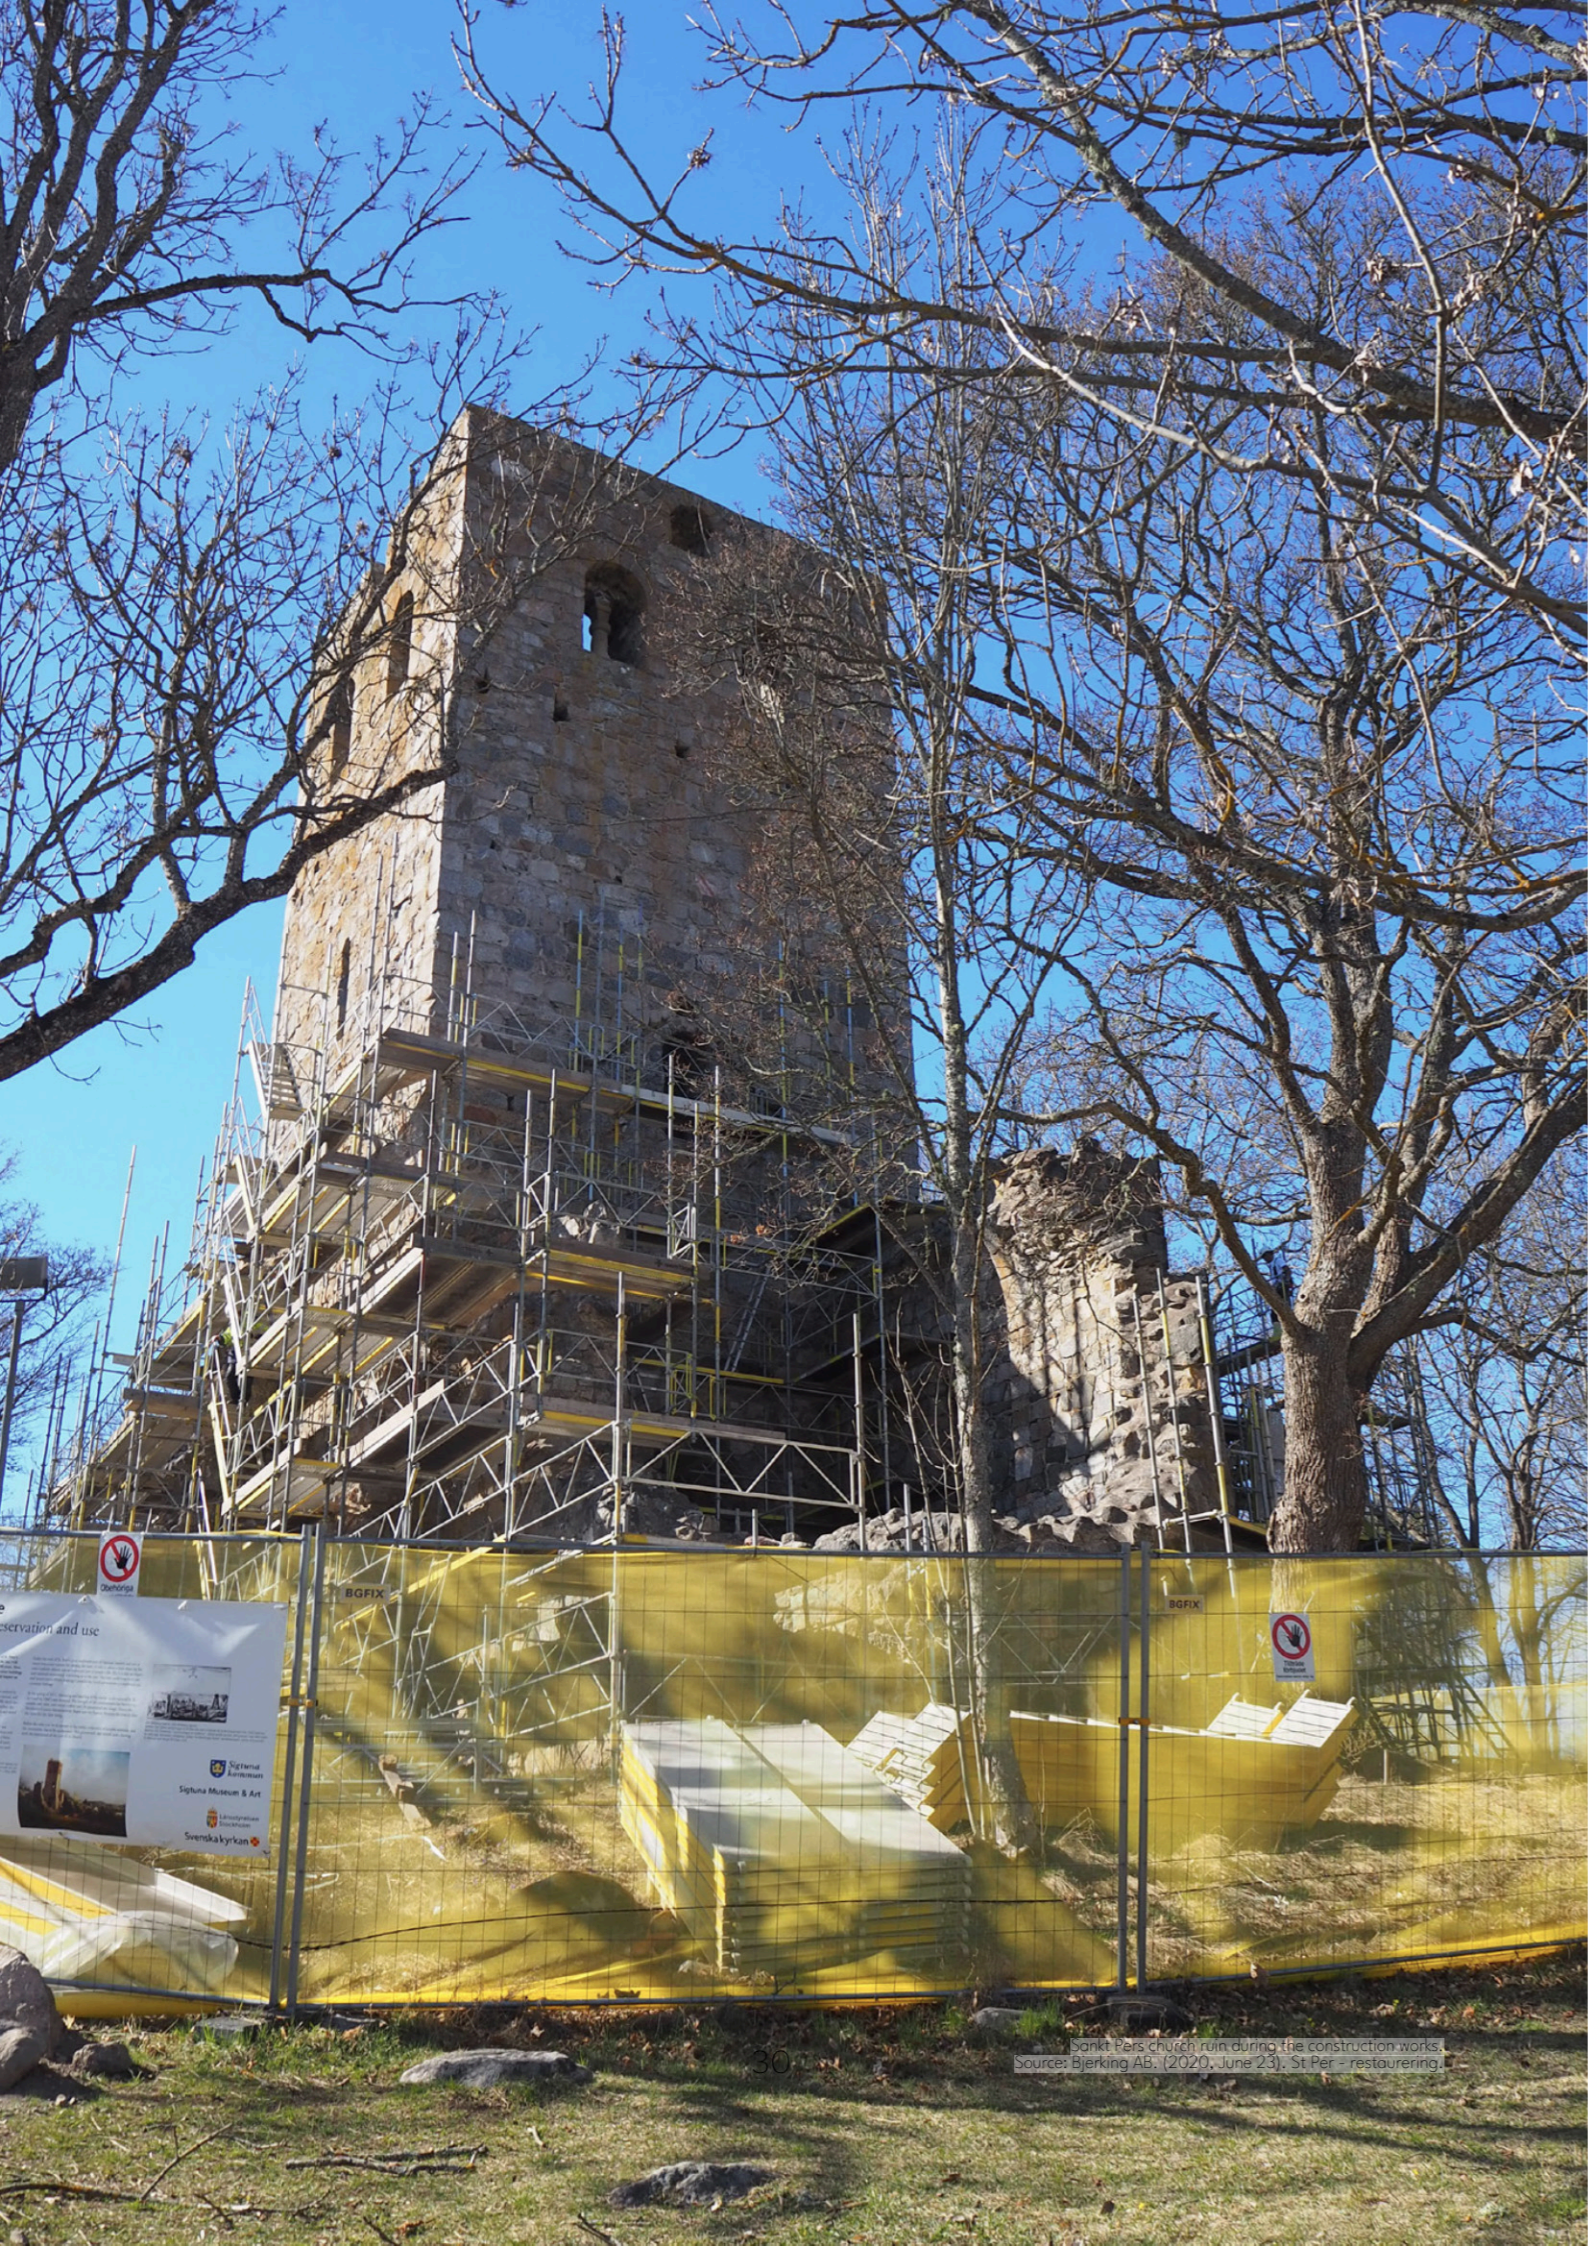
In 2019, Bjerking AB <sup>[18]</sup>, on behalf of Sigtuna parish, contributed to the archaeological efforts during the renovation of St Per's church ruins, which commenced in 2015. The restoration aimed to assess damages thoroughly and plan phases accordingly. St Per's church, among Sweden's oldest stone church remains, holds significance for early medieval Christianity and city development. The restoration primarily focused on preserving the ruin's integrity for the future, addressing technical deficiencies without altering its character significantly. These measures were deemed necessary to prevent gradual deterioration and were considered justified without impacting the site's cultural heritage.

The ruin features massive stone walls in shell masonry with mainly chastened stone, occasionally finely hewn, and sandstone details in the central tower's openings. Over time, recurring damage like cracks, shell separations, and missing cement joints occurred due to moisture and vegetation. Restoration efforts date back to the 19th century, including various reinforcements like iron anchoring, injections, and concrete applications. Examination in 2019 confirmed expected damages, with occasional hidden issues. Loose joints were prominent, particularly in intact facades where over 80 percent of the joints were renewed. Extensive rejoining was done inside, especially in the longhouse. Yellowish discoloration from growth on the central tower was effectively removed.

Various actions were taken to address issues with the wall crown, facades, lime mortar joints, vaults, and wall reinforcements of the ruin. While repairs were initially planned with concrete and lime mortar, a test area showed an overuse of concrete, prompting adjustments to minimize its spread on stone surfaces. Lime mortar joint rejoining continued, with loose joints replaced and a majority renewed internally. Vault treatments deviated from the prescribed plan, opting for asphalt over a proposed bitumen mat for the central tower's vault to avoid potential complications. Reinforcements involved abandoning proposed cintec bars in favor of continuous iron bars for practicality. The design of the anchor irons was simplified to coordinate with previous reinforcements. These actions aimed to preserve the ruin's integrity while minimizing visual alterations and introducing new materials cautiously, ensuring effective execution of the restoration efforts.

The church ruin renovation employed lime alcohol-based algae wash for facade cleaning and a lime and hydraulic Öland lime mortar mix for masonry and grouting. Weber laying mortar C25/30, a cement-based screed, was used for masonry crests and sloping surfaces. Rust protection paint and Alcro Komplet Base and topcoat metal ensured corrosion resistance for steel components. Stainless steel bands anchored corners, secured with threaded rods and Hilti grout. Continuous iron braces with anchor ends were made of acid-resistant stainless steel, embedded in hydraulic lime mortar. Core drilling and stone replacement techniques replaced Cintecstags with stainless threaded rods, concealed with glued-in stones.

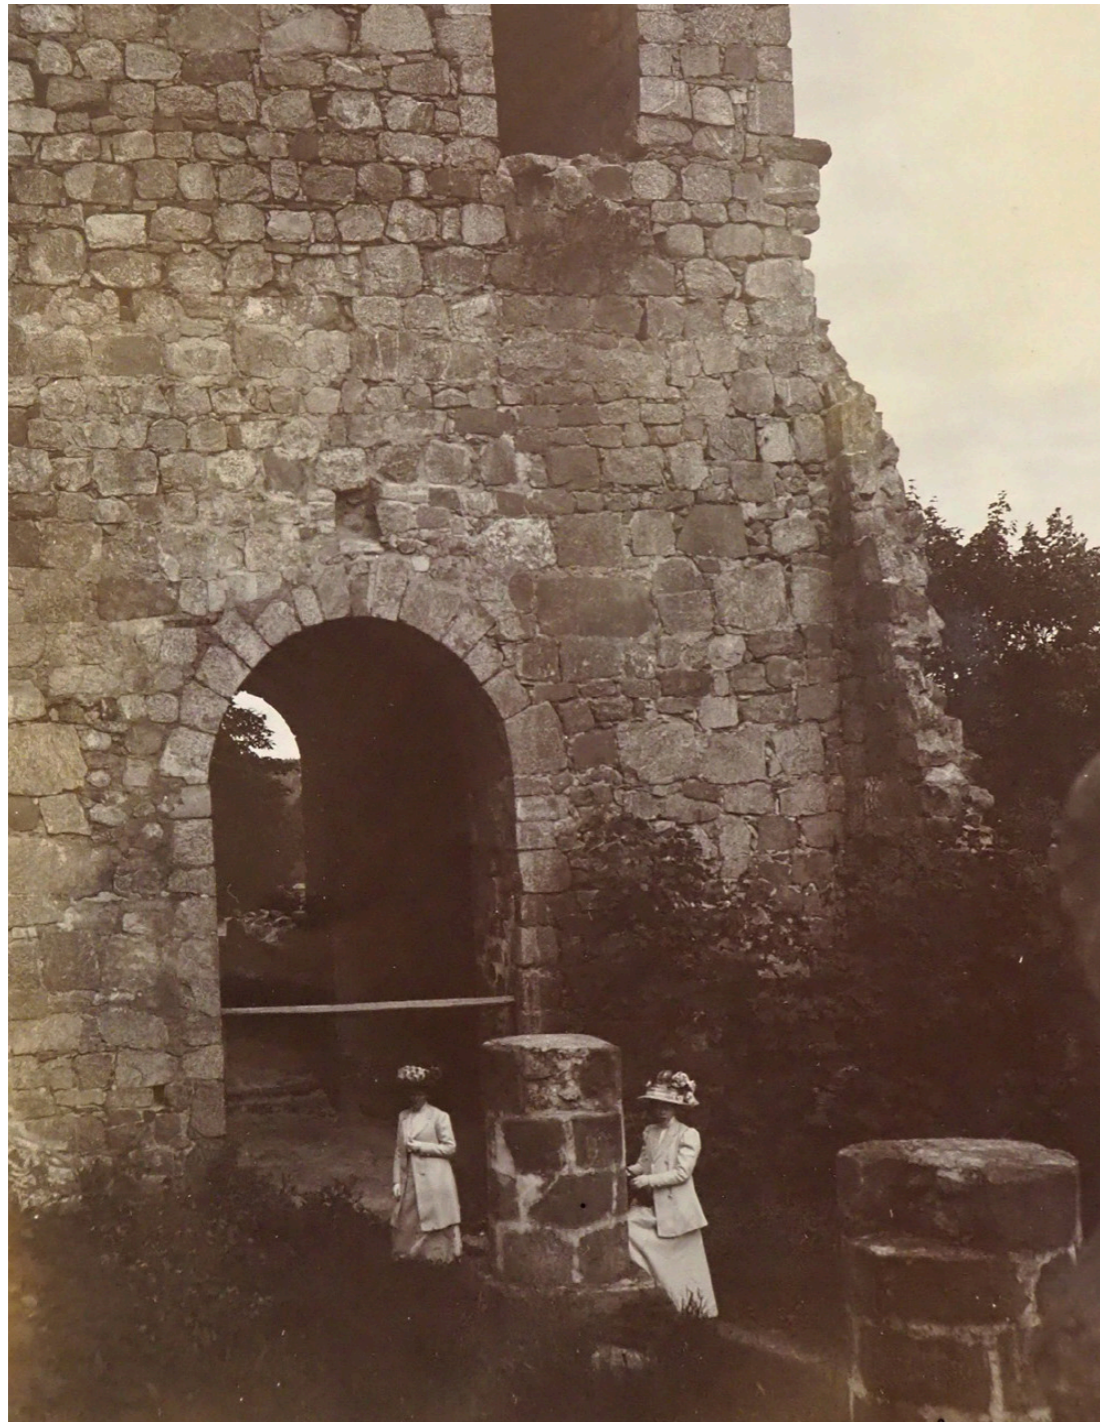
The ruin is explored by two women after the 1890s restoration. The masonry is secured and the central pillars bricked up to an even level. Vegetation still occurs inside the nave. E Eckhoff, 1890s.  
Source: Bjerking AB. (2020, June 23). St Per - restaurering. p.4.

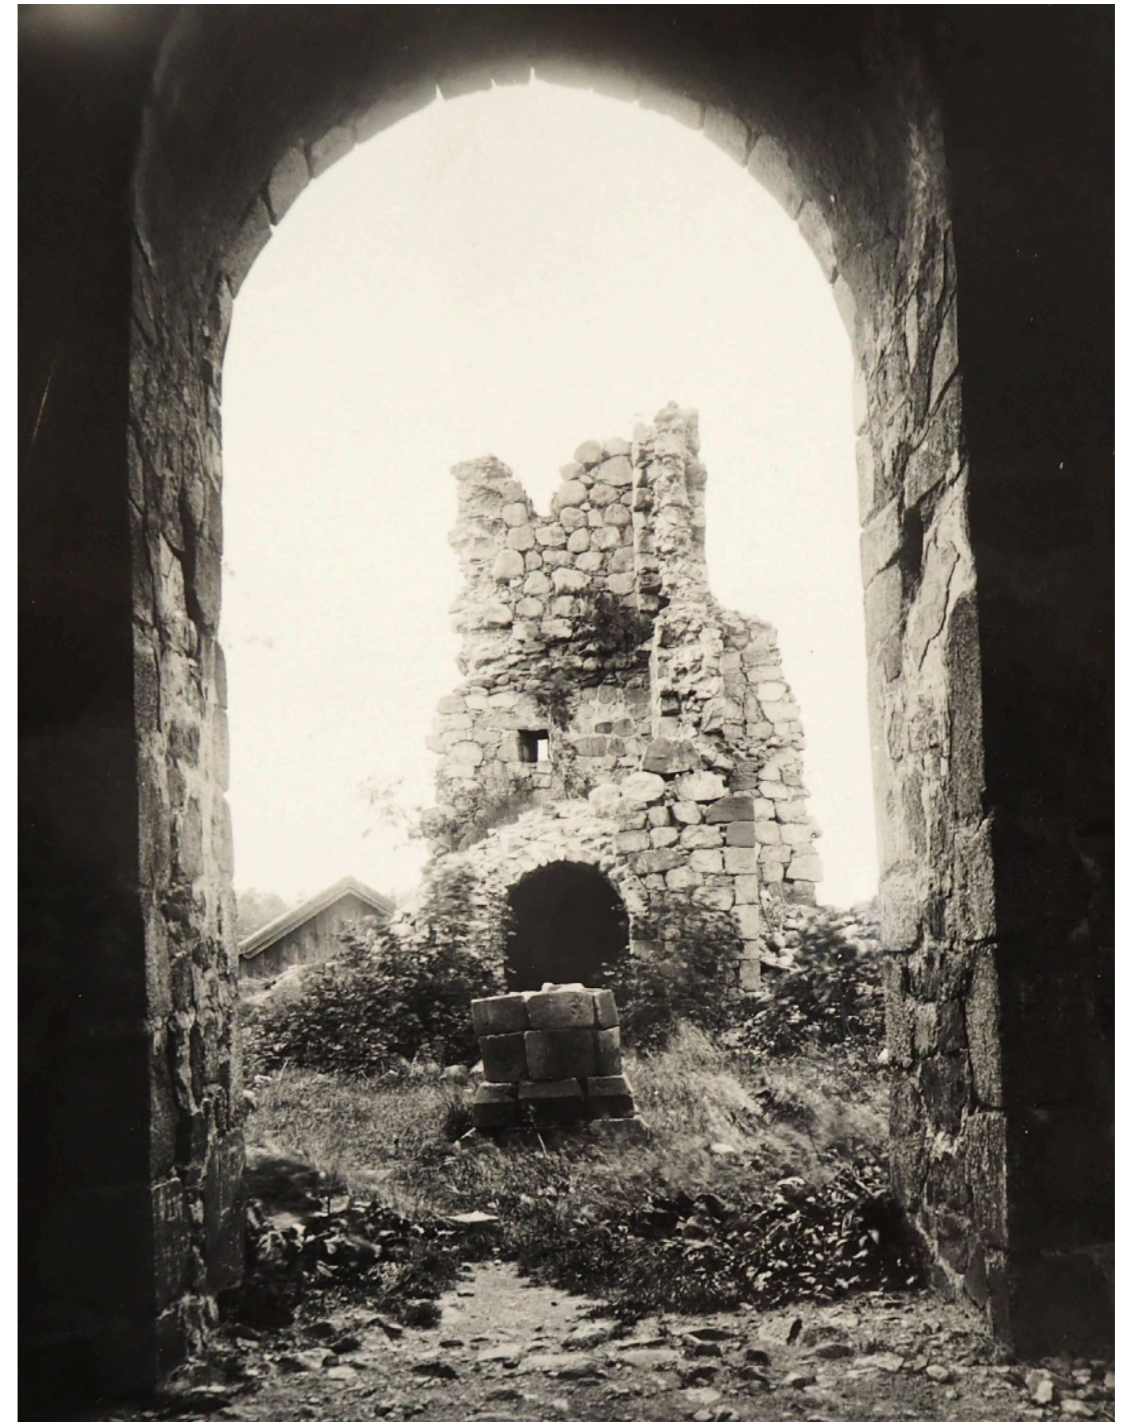
The ruin before the extensive restoration carried out in the 1890s. View from the central tower towards the nave and the west tower. The ruin is nestled in greenery and the central pillar appears to be leaning and missing several stones in the lower parcels. Unknown year.  
Source: Bjerking AB. (2020, June 23). St Per - restaurering. p.4.

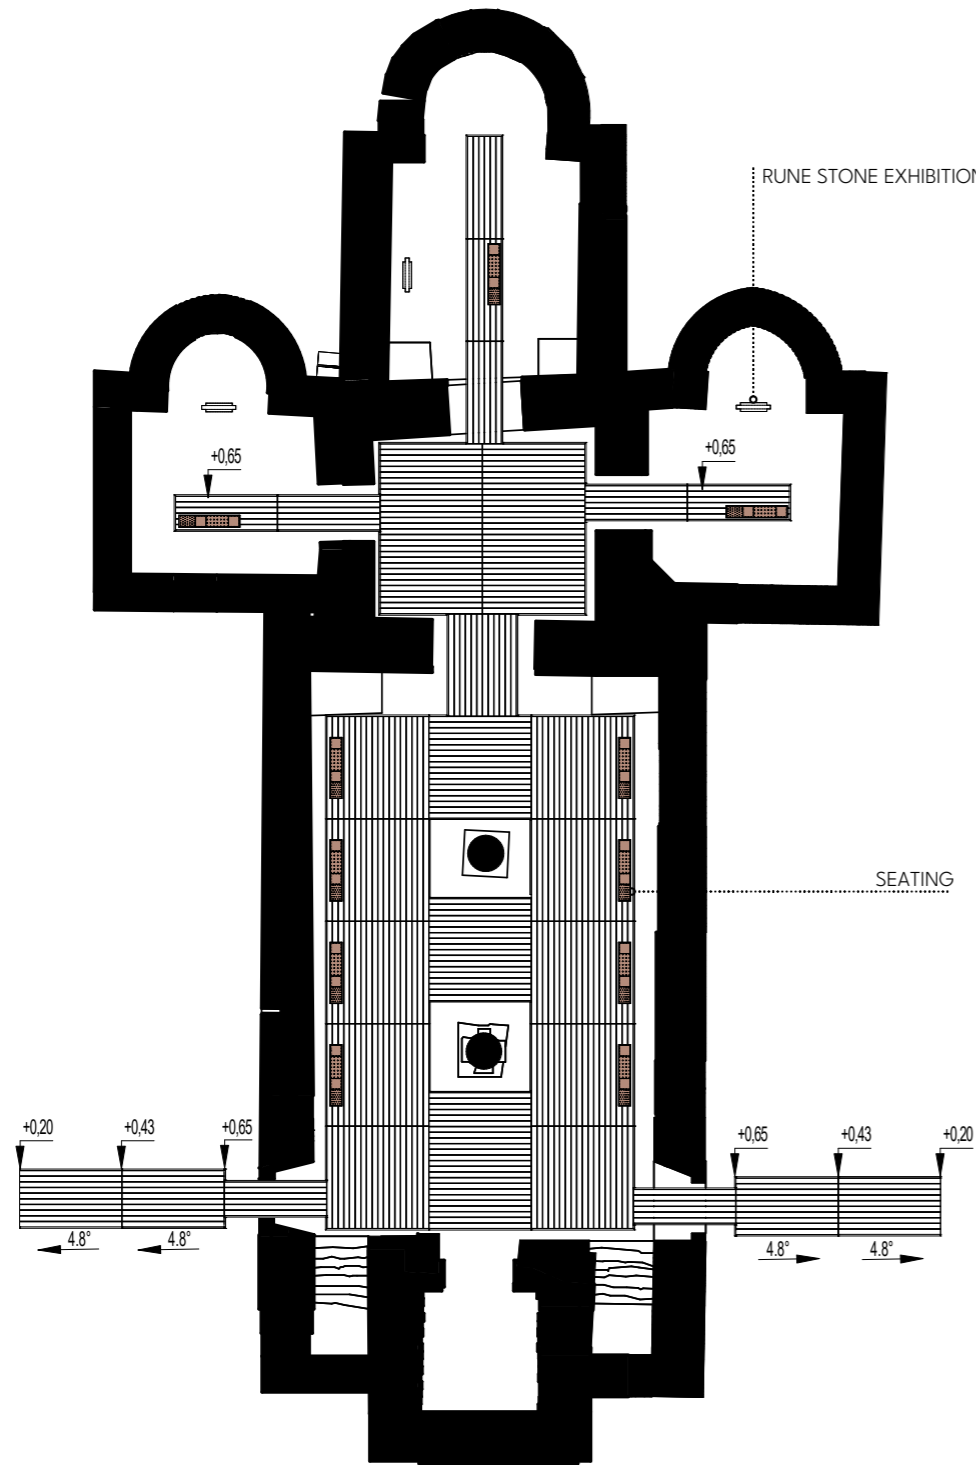
PLATFORM PANELS' LOCATION WITHIN THE RUIN, 1:200

The modular platform within the ruin is an innovative solution that enriches the visitor experience while preserving the historic structure. Constructed from spruce and mounted on height-adjustable brackets, the platform provides a safe and stable performance space, while also preventing further deterioration of the ruin beneath

Importantly, the platform is self-sufficient in terms of construction, as any local wooden workshop can easily assemble it without external assistance. This makes it a sustainable and versatile addition to the site, which can be reused as needed.

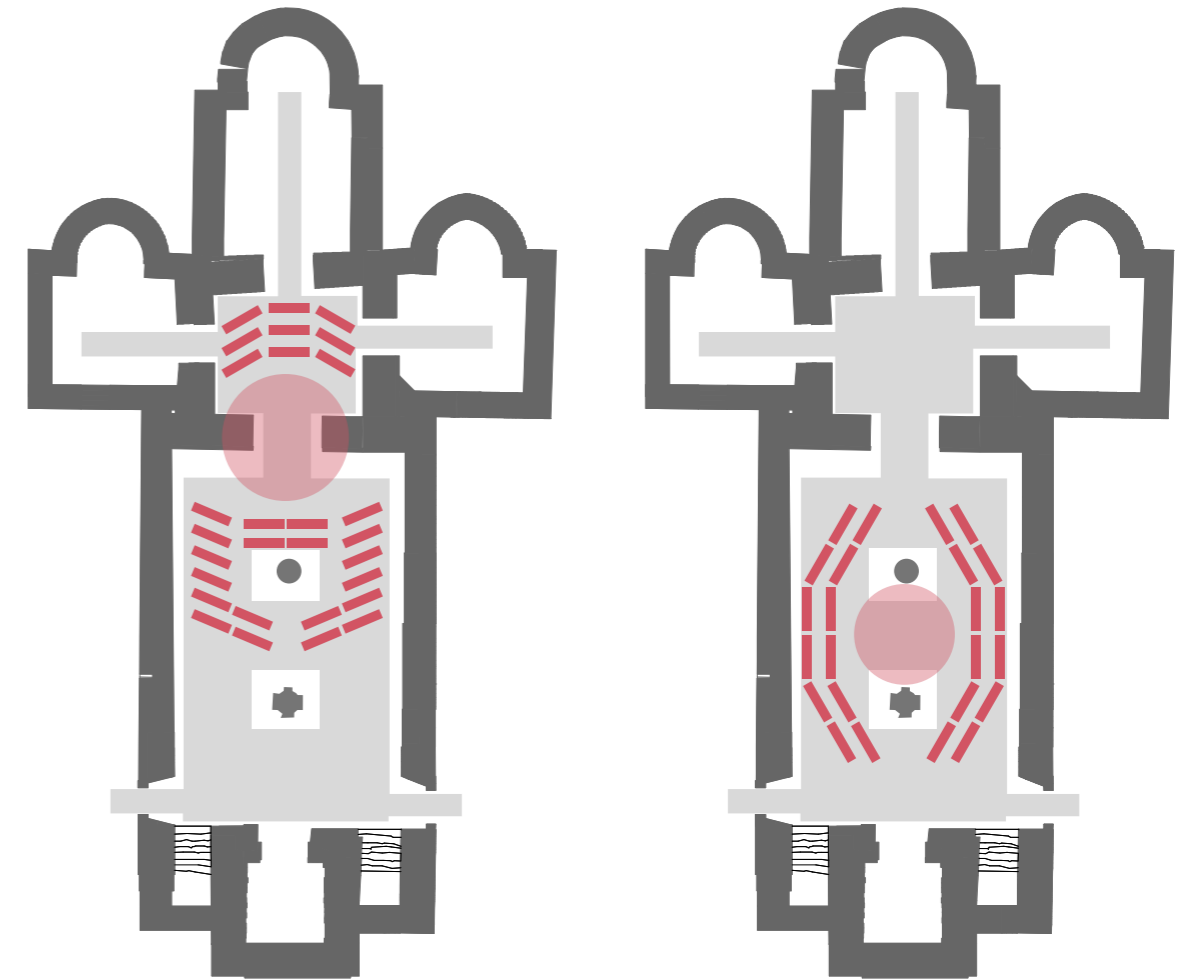
Non-fixed seating solution gives a high flexibility with the layout depending on the specific needs of the users. During a regular day seatings can be arranged along the borders, giving free space in the middle and allowing the bare walls and rune stones to be discovered. During a performance focused in the middle of the ruin, seating can become a theatre around it. In a situation when an event would be held under the tower, visitors can gather in the transept, choir and main nave. The possibilities are flexible and adaptable. When a need of elevating the stage arises, an additional panel without a margin can be safely stacked on top of the basic set.

Determined by the situation, platform can accommodate up to 150 sitting visitors or 50 walking visitors at once.

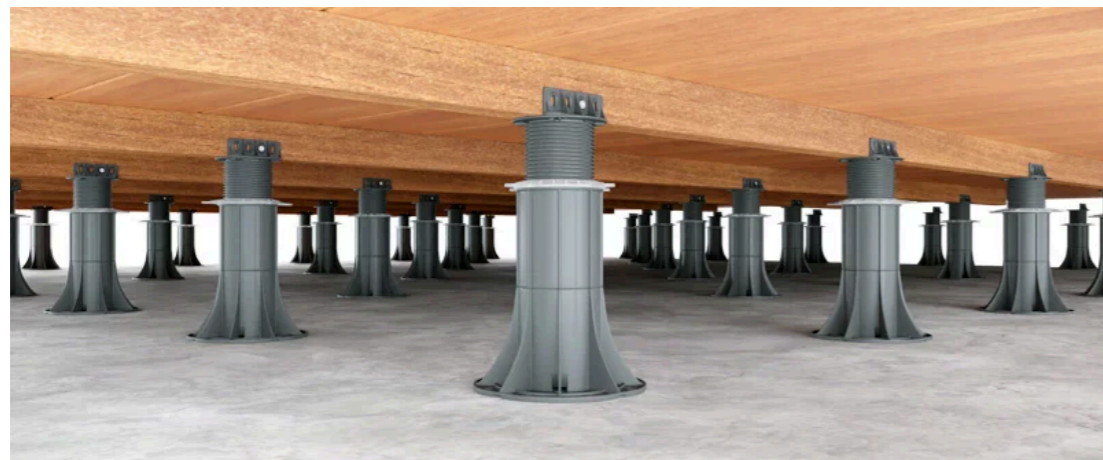
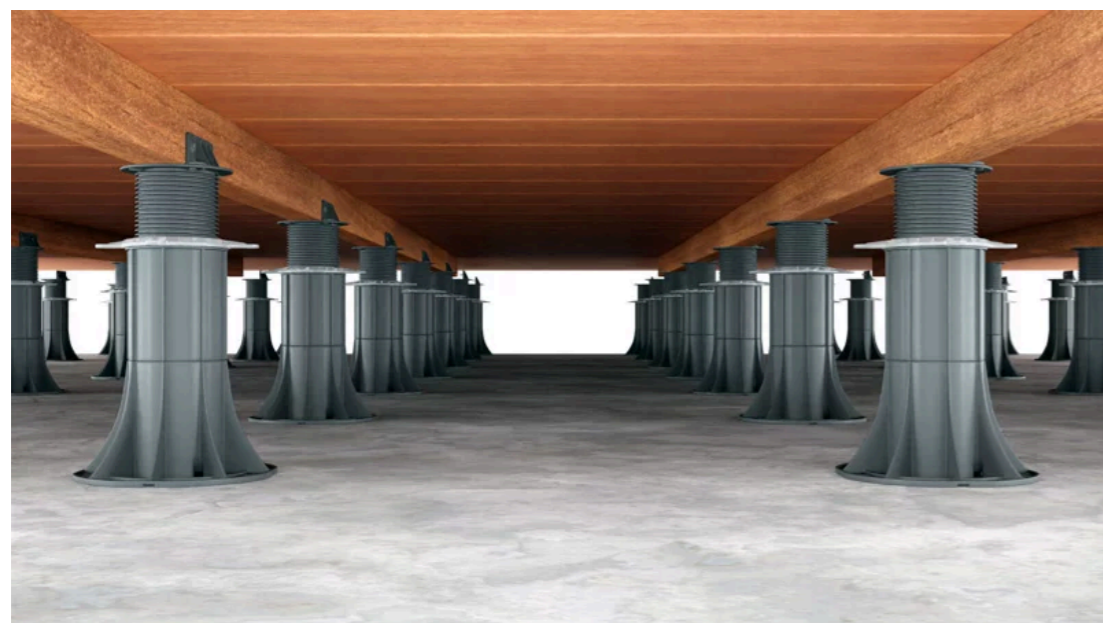
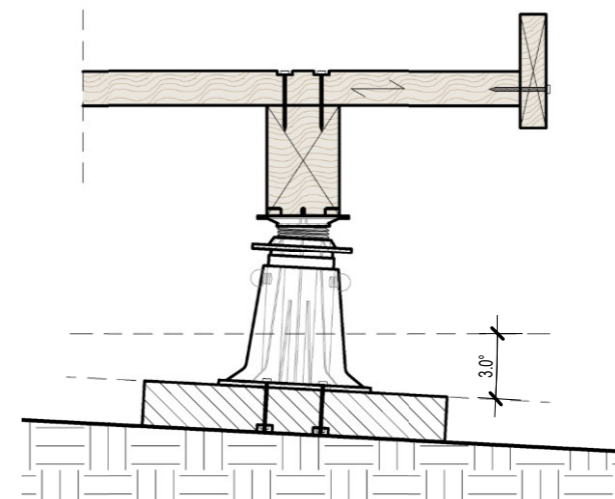
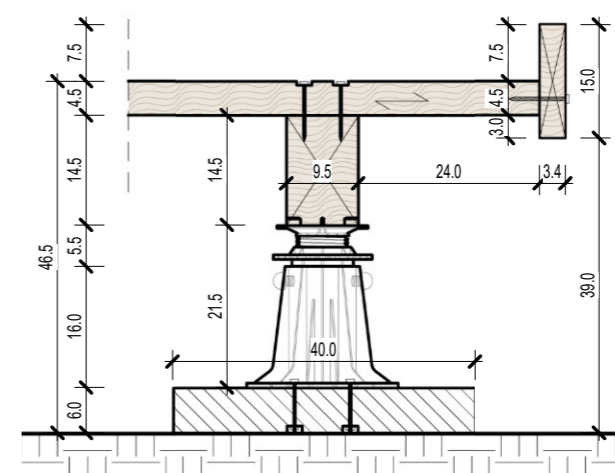
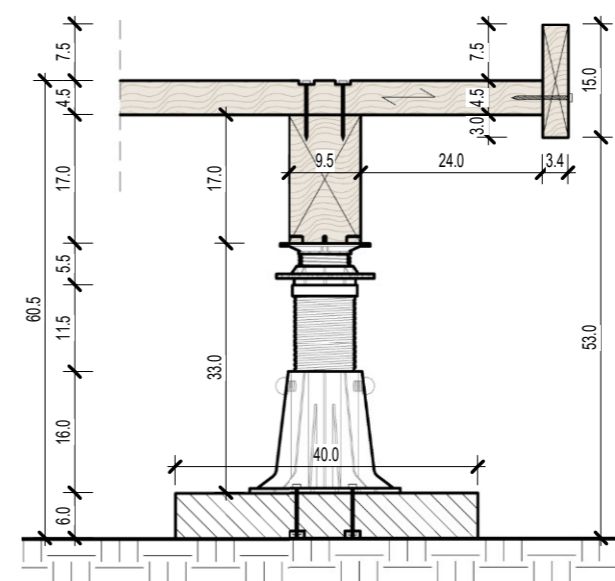
**TERRACE BRACKET BY DD GROUP EU.  
EXAMPLE PRODUCT SOLUTION.**

Minimum height: 95x145mm beam with 215mm bracket results in total height of 465mm from ground to walking level. Maximum height: 95x170mm beam with 330mm expanded bracket results in total height of 605mm from ground to walking level. The brackets' angle can be adjusted up to 3 degrees.

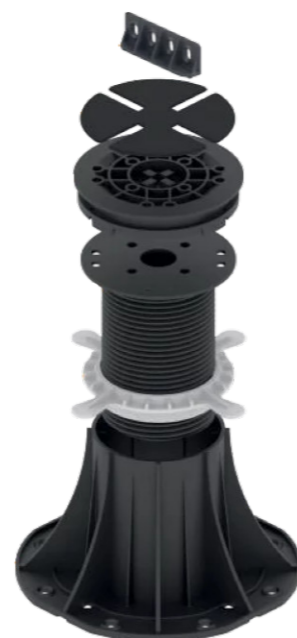
**HEIGHT ADJUSTED  
BRACKETS; DETAIL,  
SCALE 1:10**

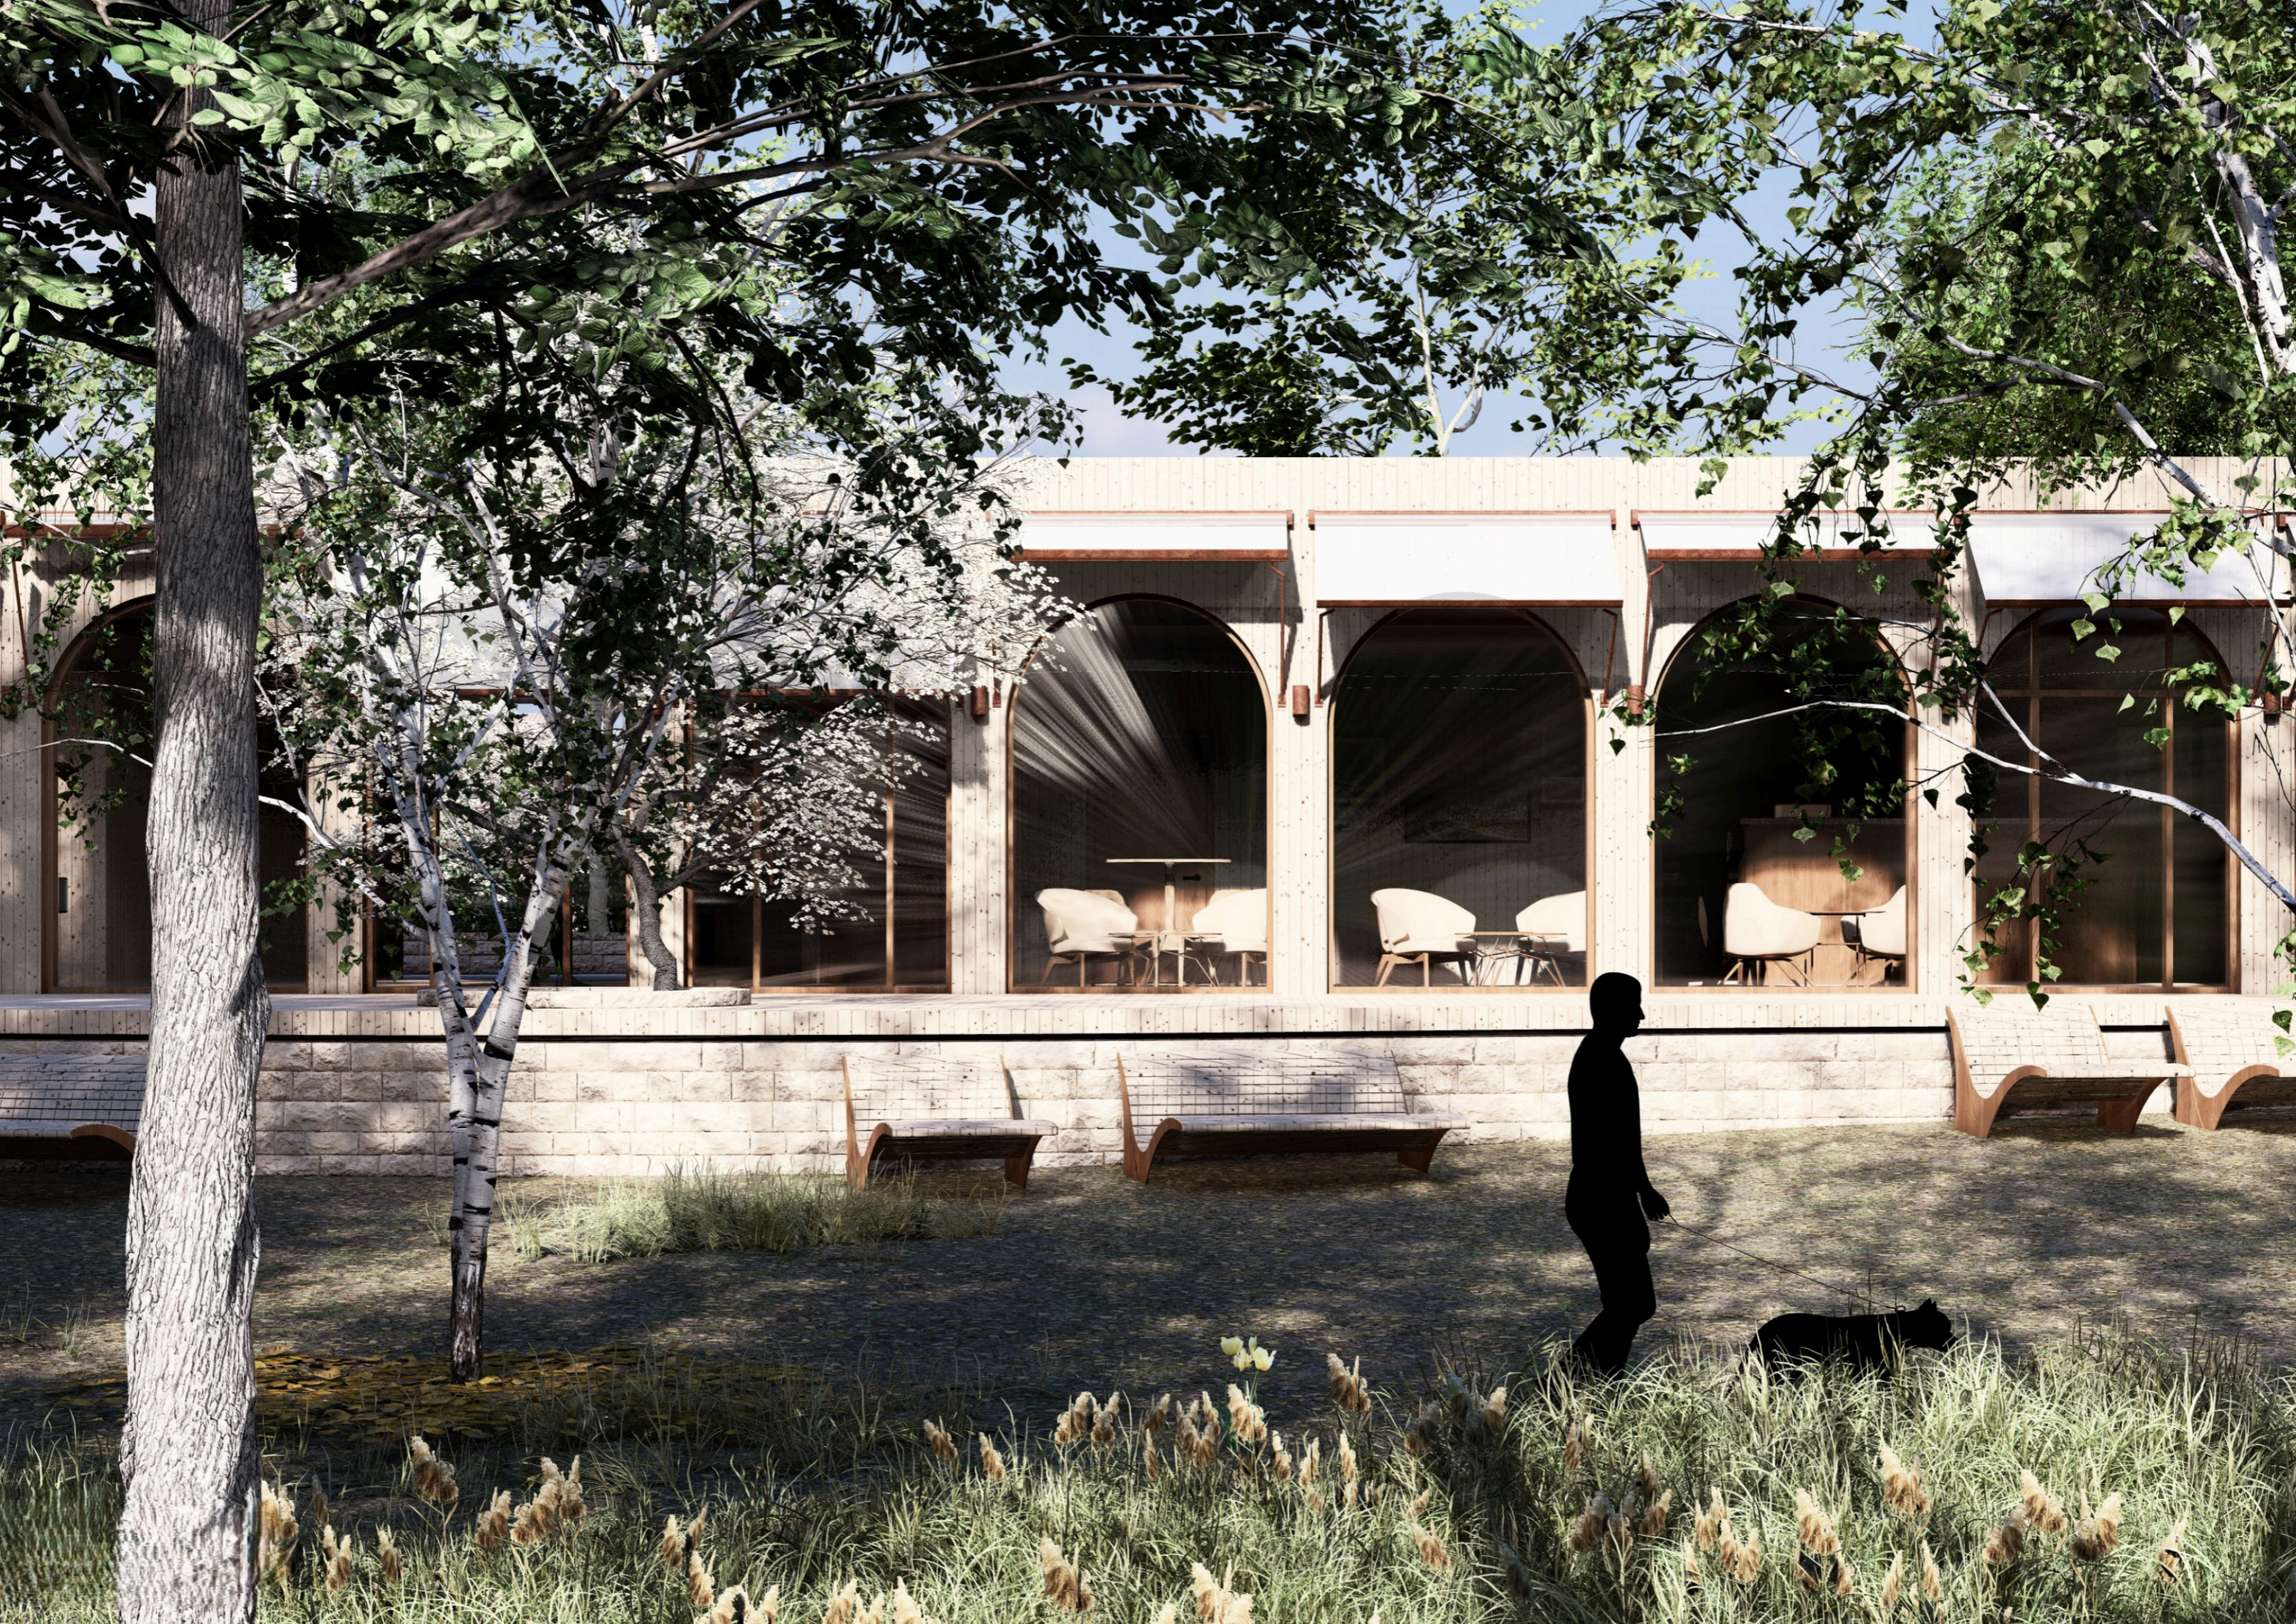
The auxiliary building's design ensures that it blends seamlessly into the surrounding landscape, creating a sense of continuity and harmony with the natural environment. The use of locally sourced materials not only reflects the region's cultural heritage but also reduces the environmental impact of the building's construction.

The construction of this building is intentionally designed to align with the most popular construction methods in Sweden, specifically wooden beam construction. This not only allows for local builders to easily construct and maintain the facility but also fosters a sense of community involvement and ownership in the preservation of the historic site.

## CONSTRUCTION LAYERS SOLUTION

### Ground floor on point foundation:

- flooring 25mm
- hydro insulation
- beams 70x95mm / wooden fiber insulation 95mm  $\lambda=0,036$
- timber beams 220x45mm / wooden fiber insulation 220mm  $\lambda=0,036$
- boarding 25mm
- rigid insulation 6mm, sealant
- timber beams frame 170x45mm x2
- capillary break
- reinforced concrete 250x250mm column foundations with footing and steel rebars
